**Stinson Beach
Lifeguard and
Concessioner Café
Repairs and
Replacement
Alternatives**

Golden Gate
National Recreation Area

**SCOPING TRIP
REPORT**

November 25, 2019

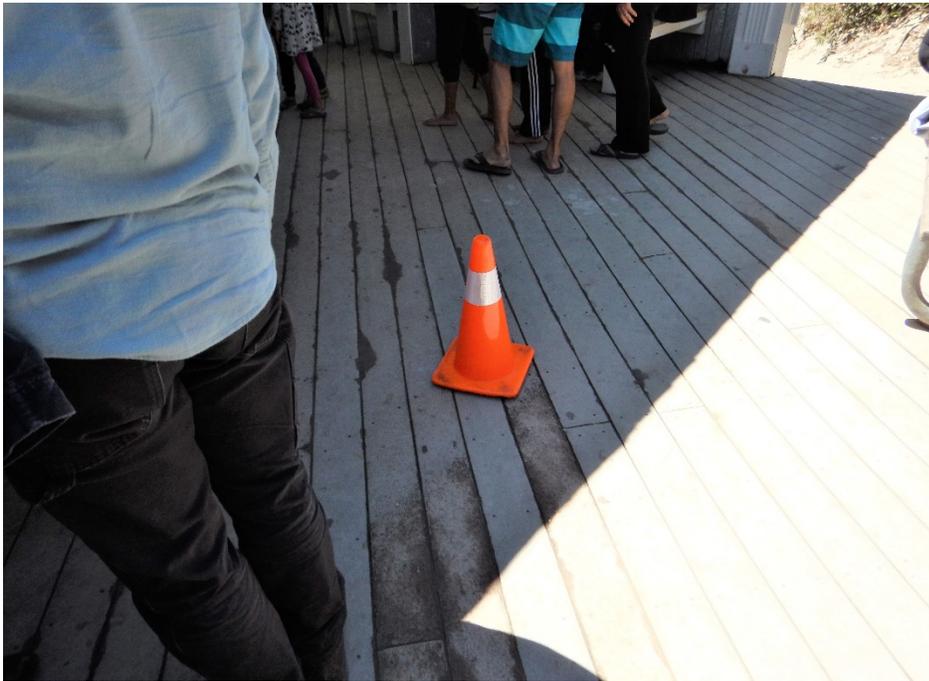
Concrete elements are intact and functioning properly with little or no indication of settlement cracking or deterioration. Composite deck is intact at most locations but indicates evident substructure deterioration around the floor drain. Deck settlement at this location is significantly advanced warranting a safety cone be placed over the drain to indicate the safety issue to visitors. The deck surface appears to be washed on a regular basis by concessions staff and many of the boards exhibit areas of moisture absorption which do not dry out during the day. Moisture retention at the deck surface likely indicates saturated deck framing and potentially advanced wood deterioration. Wood boardwalk/deck locations at the Lifeguard Tower are

CC-1 Deteriorated Decking at Cafe

- **CC-1** - Remove, inspect, and replace composite deck components including approximately 50 percent of individual deck boards and 90-100 percent deteriorated framing. Slope deck to drain away from building walls and toward edges of deck.
- **LT-1** - Replace wood deck walking surfaces at Lifeguard Tower with composite decking and pressure treated framing. Install rim joist closures at open ends of framing cavities.

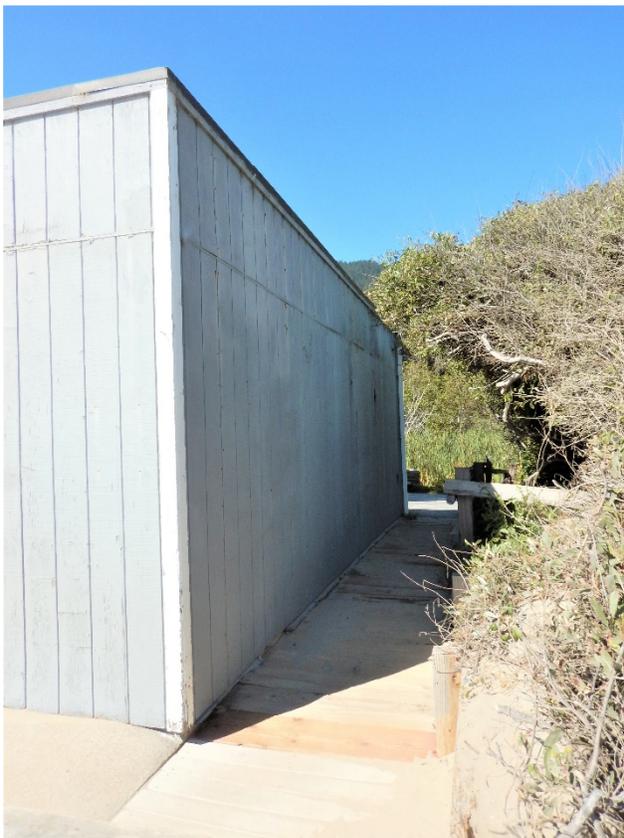
in poor condition exhibiting buckling, uneven walking surfaces, raised fasteners, wood deterioration and splintering.

LT-1 Deteriorated Wood Decking at South Garage

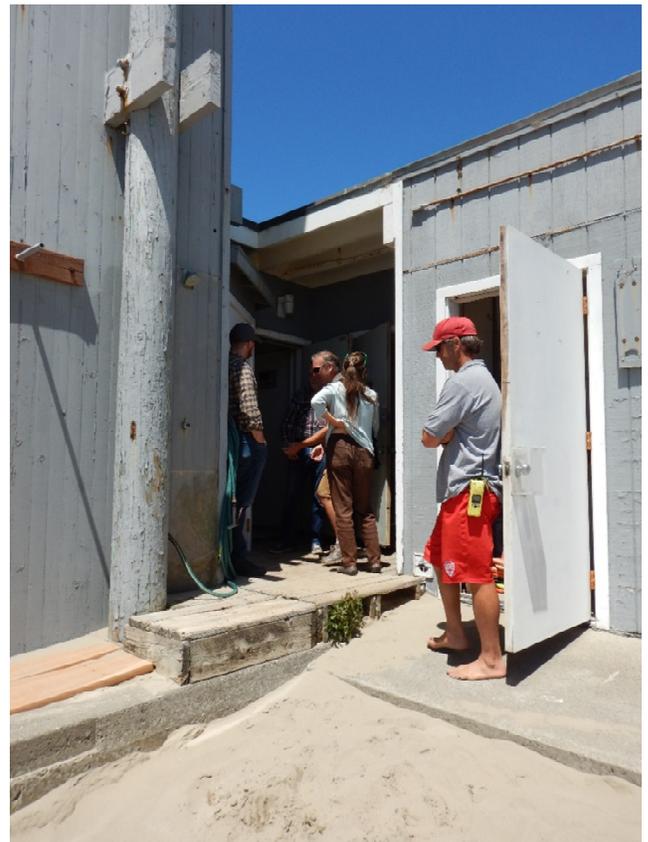
LT-1 Deteriorated Wood Decking at Lifeguard Tower Entry

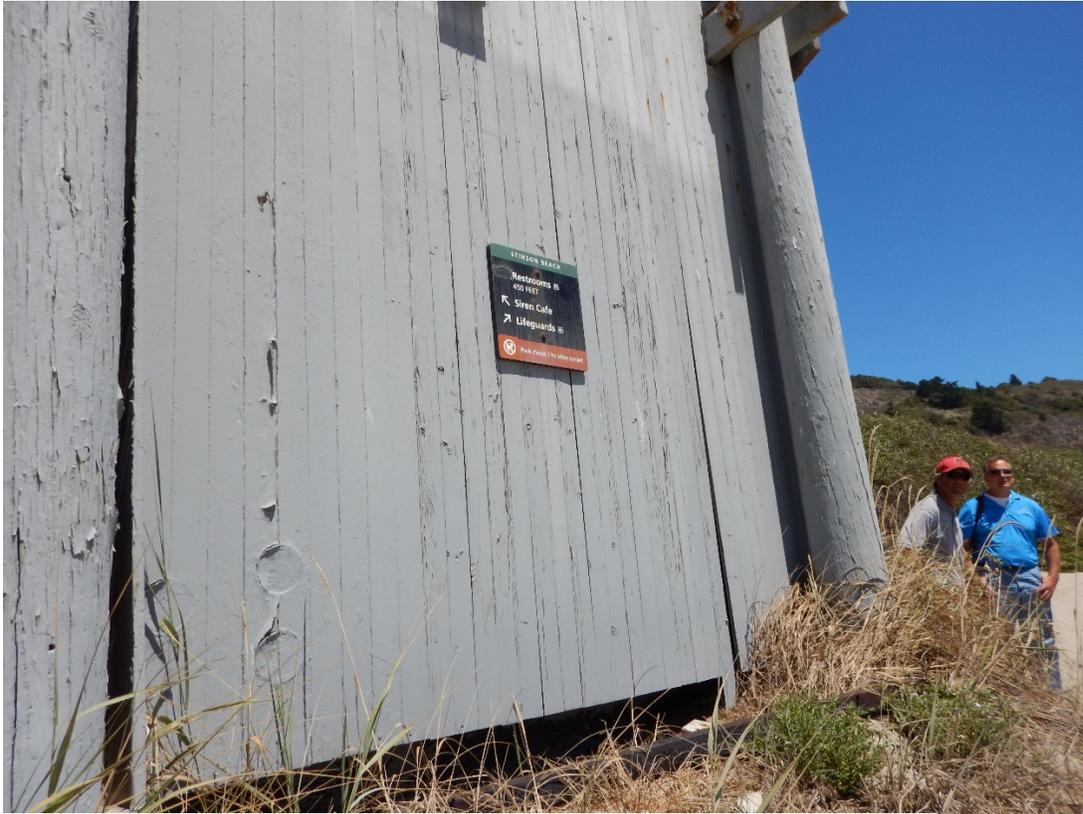
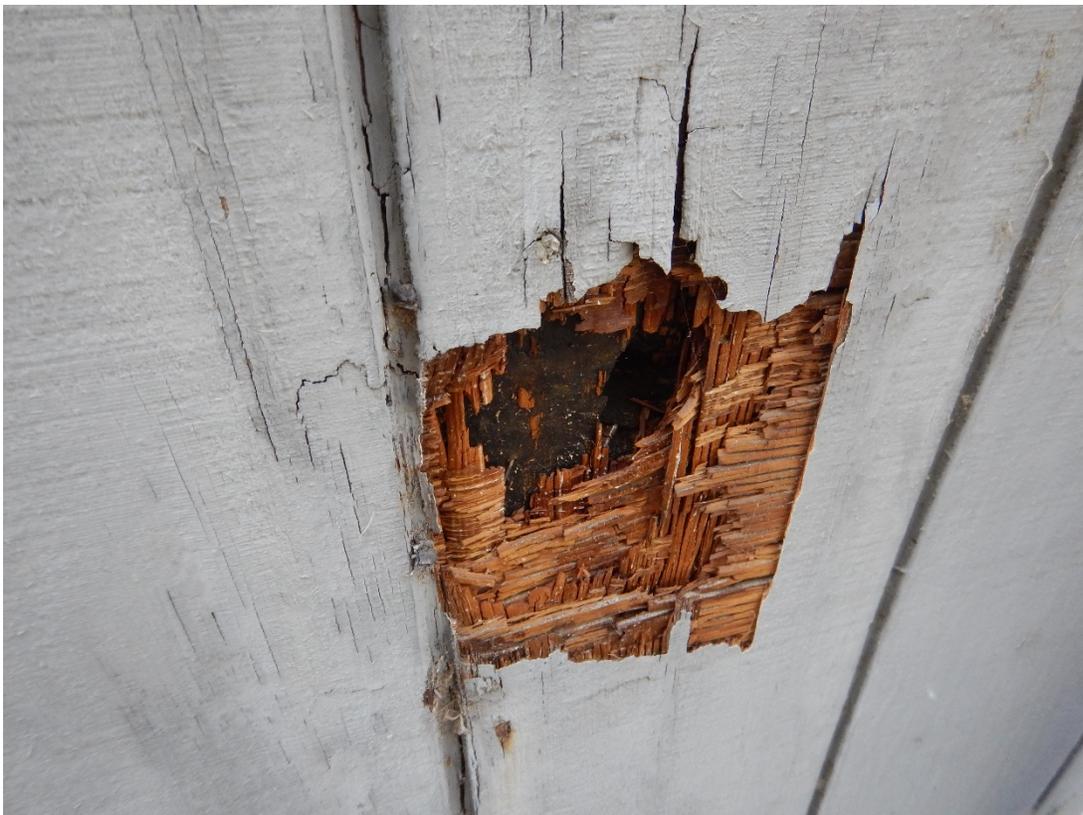
Tongue and groove siding displays signs of moisture penetration through the paint finish as evidenced by rust stains, spalling and blistering paint, grain raising, and visible separation between boards at the tongue and groove joint. Board ends located on or near grade are visibly deteriorated.

LT-2 Weathered Tongue and Groove Siding at Lifeguard Tower

- **LT-2**– Remove tongue and groove siding and underlying plywood sheathing at tower locations required to access structural framing. Scrape loose paint at tongue and groove siding and replace individual deteriorated boards. Replace salvaged boards, paint prep wood surface and apply alkyd-based primer and paint finish. Assume 25% board replacement.

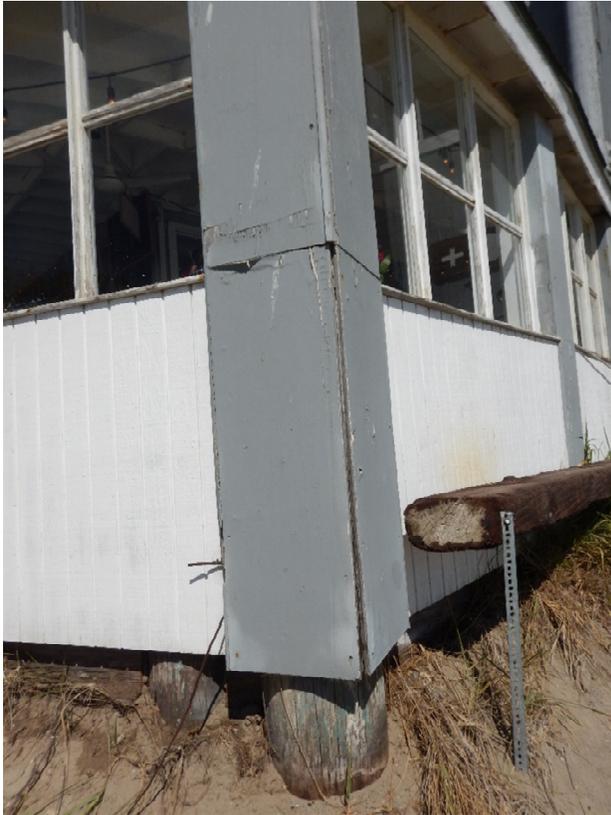
Plywood column surrounds at Café are cobbled together and rest on pole remnants from the former deck posts. Structural continuity is questionable and plywood surfaces exhibit deterioration, delamination, rust stains and blistering paint. Plywood corner joints are separating and T1-11 plywood ends near the ground are deteriorated.

CC-2 Deteriorated Pole Bases and Plywood Surrounds

- **CC-2** – Remove plywood column surrounds and pole bases and replace with new pressure treated poles up to the roof framing. Remove and replace/reinstall tongue and groove siding as required for pole replacement and deterioration. Paint poles and siding to match typical building colors.

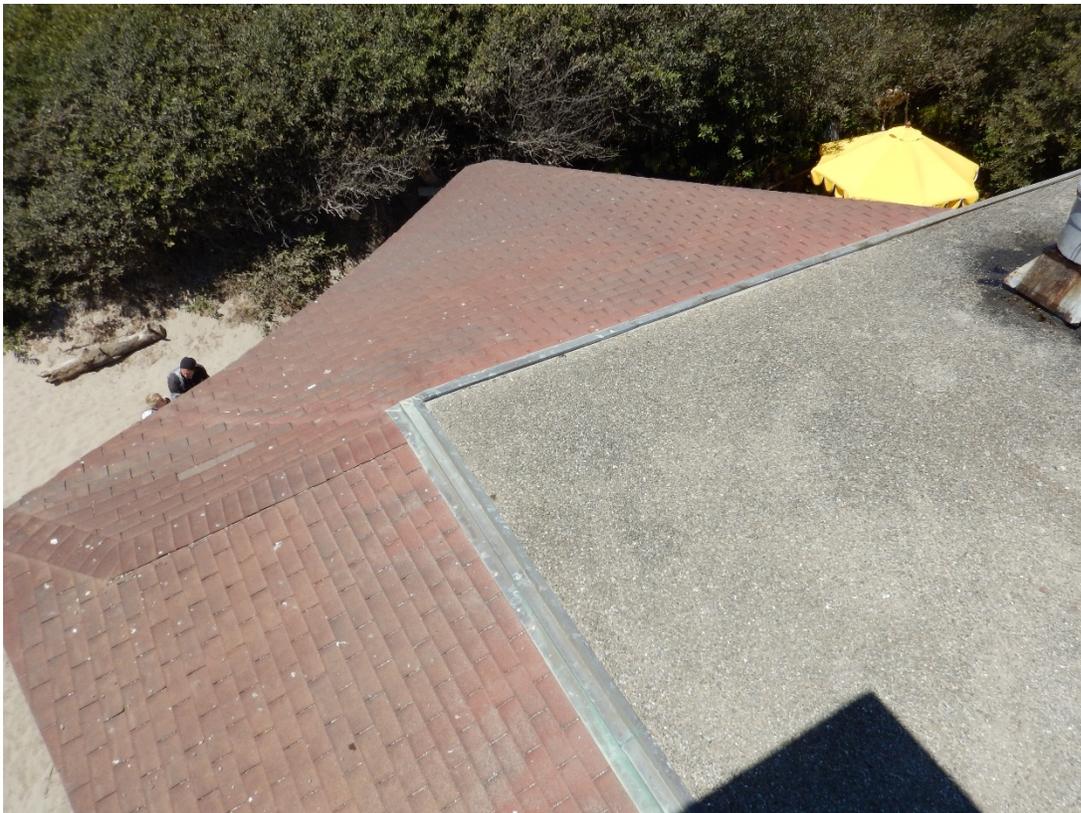
Roof coverings are functional but degraded at observed locations and likely nearing the end of their service life. Built-up roofing around the Café grill hood exhaust is visibly saturated with grease and the central roof drain is rusted and missing the dome strainer. Metal components at the upper roof soffit of the Lifeguard Tower exhibit significant rust indicating possible roof leaks. Coupled with the lack of a discernible drainage pathway, the upper roof requires additional investigation to determine overall condition.

CC-3 & LT-4 Hot Mop Built up Asphalt and Asphalt Shingle Roofs

- **CC-3** – Replace hot mop built up and asphalt shingle roof coverings at Café including metal edge flashing, metal scuppers, pipe penetration flashing and roof drain

- **LT-4** – Replace hot mop built up roof coverings at Lifeguard Tower garage, lookout platform and upper roof including metal edge flashing and garage scupper. Provide downspout pipe drainage for garage and upper roof.

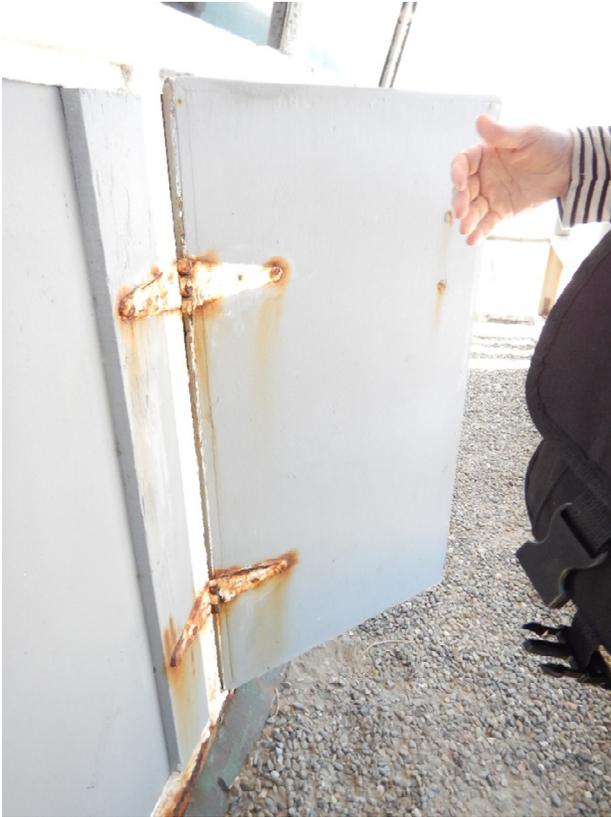
Doors are in fair location at most locations with only minor paint failure and damage from impact. Door locksets are protected at the exterior from blowing sand with clear acrylic, hinged boxes mounted around the handle locksets. Building staff have commented that door locksets must be replaced every few years, despite the box protection, due to sand infiltration. The access door at the third floor of the tower has heavily rusted hardware components.

LT-5 Rusted Door Hardware at Third Floor Lifeguard Tower

- **LT-5** – Remove access door hardware at Lifeguard Tower and repaint door to match typical building color. Replace rusted hardware with Marine Grade Type 316 stainless steel components. Bronze hardware to be considered as option.
- **CC-4** – Replace all wood windows at Café with painted wood, operable windows to match existing window configuration. Include safety glazing at locations required by the building code. Fiberglass window units to be considered as option.
- **LT-6** – Remove paint and rust from metal window and frame components at Lifeguard Tower third floor windows. Sandblast and repair metal components to original section shape and repaint with a zinc-rich primer, epoxy topcoat base and silicon-alkyd enamel finish coat. Replace single pane glazing with tinted, insulated glazing units and adapt existing metal stop to utilize rubber gasket for glazing retention.

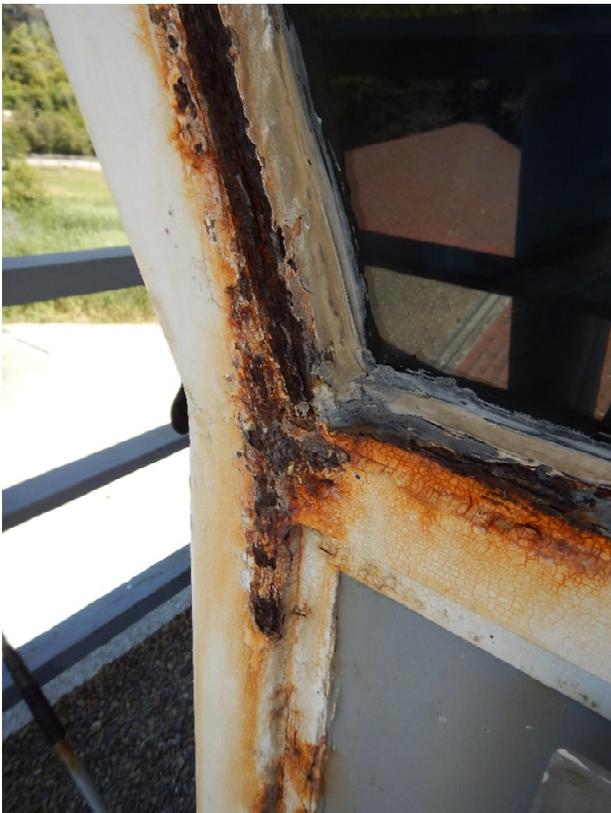
Custom steel window sash and tube steel frames at the third floor of the Lifeguard Tower are in extremely poor condition exhibiting significant paint and sealant failure, rust spalling, and loss of metal material. Due to the use of non-insulated glazing, it is anticipated there is substantial condensation on the interior faces of window frames and glazing as evidenced by paint spalling and rust on interior metal components.

LT-6 Rusted Metal Window Frames at Lifeguard Tower

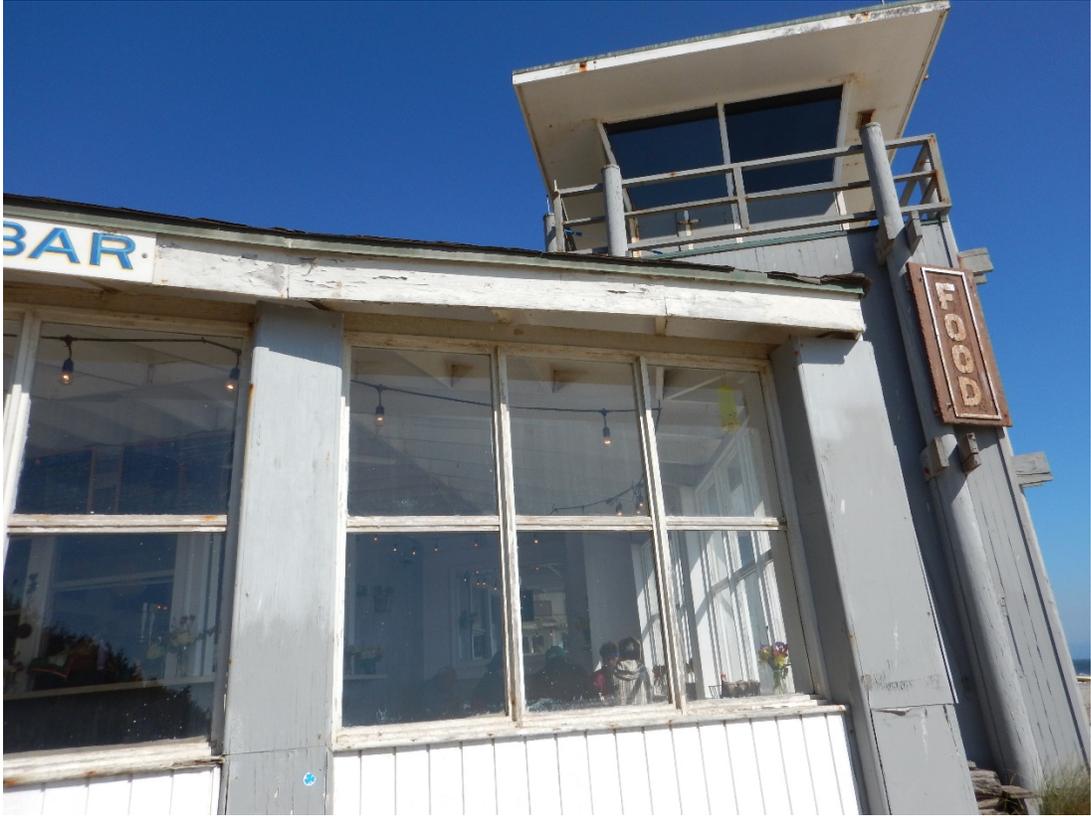
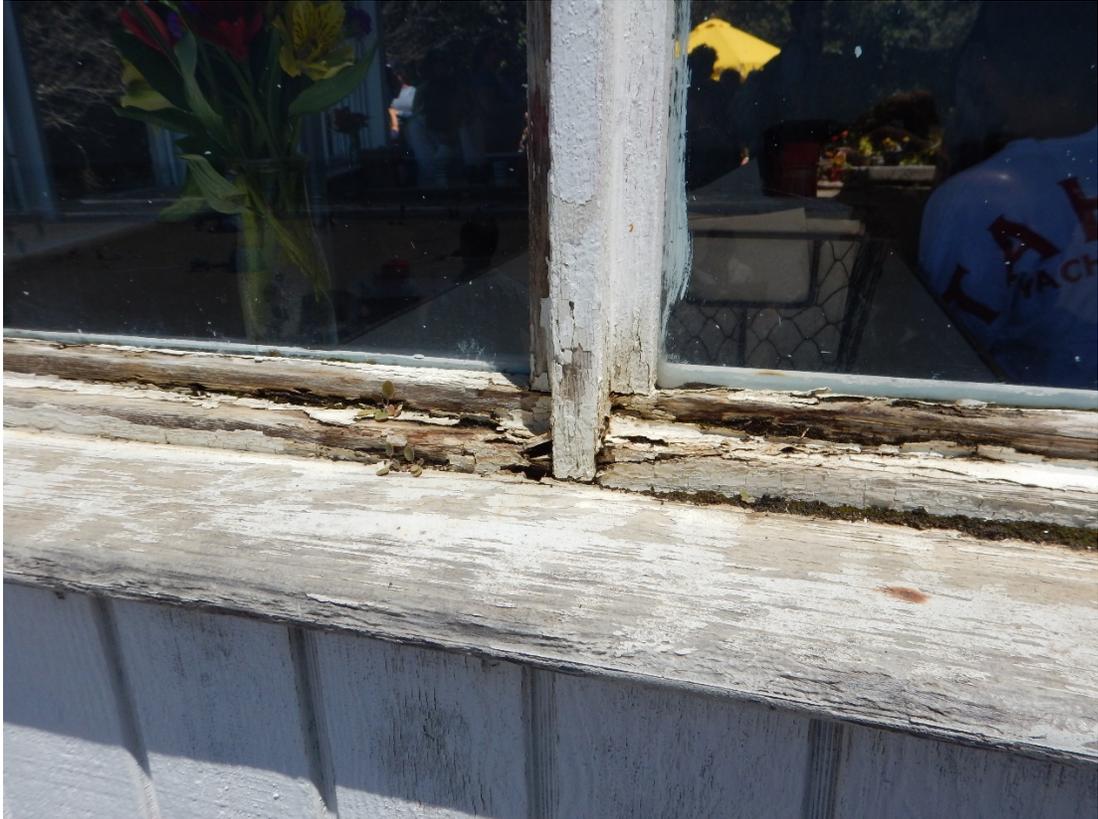
Wood windows at the Café are in extremely poor condition suffering from paint deterioration and subsequent wood deterioration. A single glass pane was observed to be cracked but many panes are loose in the frames due to deteriorated exterior wood stops.

CC-4 Deteriorated Wood Windows at Café

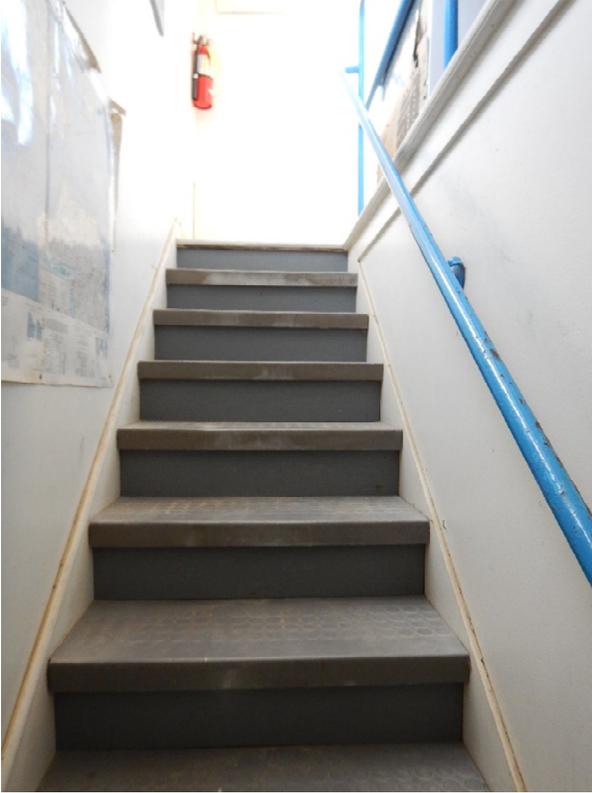
Both wood and metal spiral stairs are in good condition, but handrails do not meet current accessibility code for handrails at both sides of stairs or required extensions at landings. Metal spiral stairs are allowed by California Building Code due to the limited area of the third floor but cannot serve an occupancy of greater than 5 persons. The metal stair risers exceed the code requirements for maximum riser height of 7-1/2 inches and do not provide the minimum head clearance of 78 inches. Stair locations and configurations appear to match the original drawings and were likely code-compliant at the time of their construction. The addition of compliant handrail extensions would not be required due to an exception in the California Existing Building Code, Chapter 4 that recognizes an increased hazard associated with handrail extensions in constricted floor plan layouts. Similarly, lifeguards have conveyed a concern over the limited width of the existing stairways and conflict with heavily equipped law enforcement personnel traversing the stairways. The addition of a second handrail at the first-to-second floor stair would exacerbate this conflict and negate the limited safety benefit associated with code compliance.

LT-7 Non-Compliant Handrail at Lifeguard Tower

- **LT-7** – Install new, code-compliant handrail at stair between first and second floors at Lifeguard Tower to supplement existing handrail. This recommendation is to be further evaluated for life-safety considerations during Title I Predesign and Schematic Design project phases.
- **LT-8** - Further investigation into the stability of the guardrail, including integrity of fasteners and wood, is highly recommended. Consider replacing existing wood guardrail with metal guardrail upgraded to meet code compliance and replicate original design.

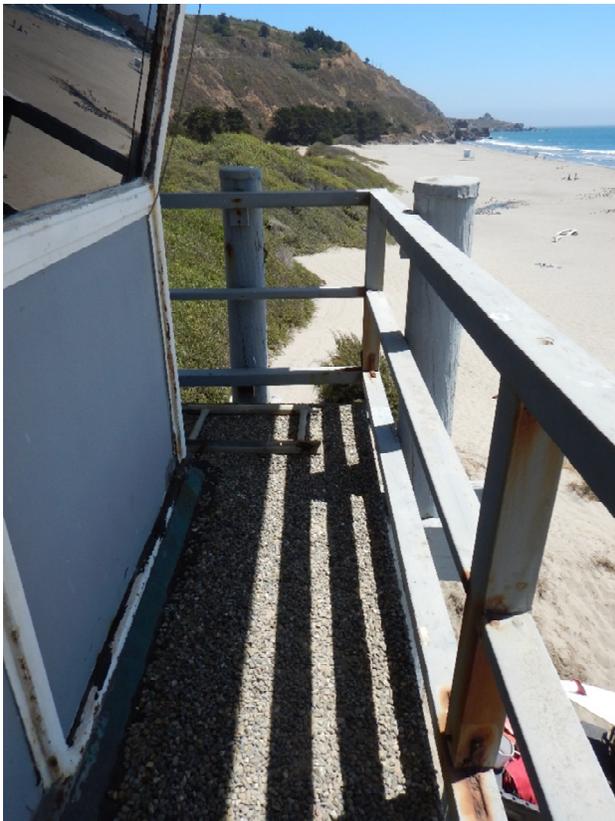
The wood guardrail at the lookout platform exhibits paint failure and rusting attachment hardware at numerous locations. AE did not measure openings at guardrail, but dimension may exceed allowable 21 inches maximum opening. Original construction drawings indicated 2 x 2 wood pickets between top and bottom rail components which are not present in existing construction.

LT-8 Wood Guardrail at Third Floor Lifeguard Tower

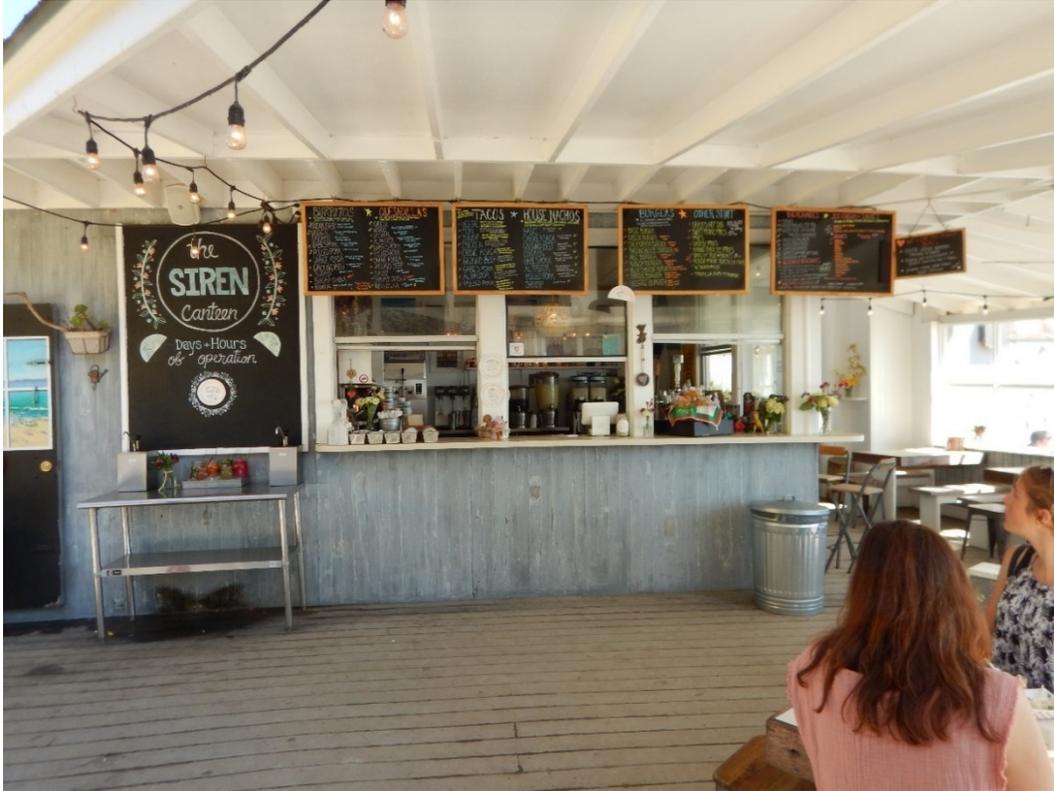
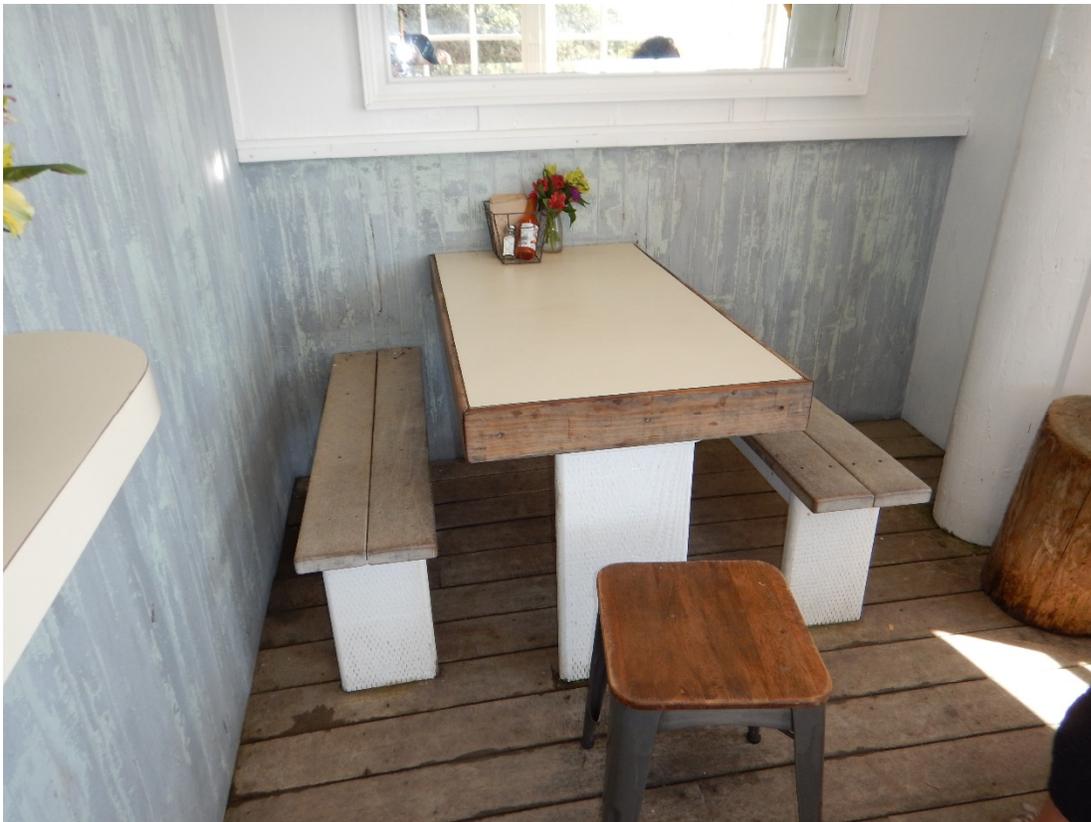
CC-5 Non-Compliant Service Counter

CC-5 Non-Compliant Dining Table & Benches

- **CC-5** – Lower service counter to required height and provide compliant knee and toe space beneath counter. Replace (6) dining tables and (12) benches with barrier-free models.

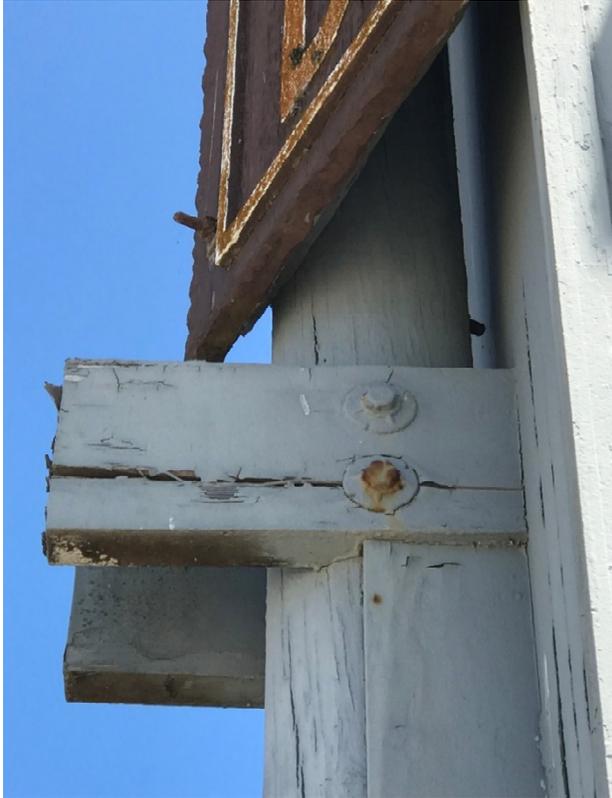
Significant deterioration in both wood framing and metal fasteners was noted in both structures at the time of our site visit.

STRUCT-1 Deteriorated Structural Wood Girders

- **STRUC-1/2/3** – Replace double 4 x 12 girders and outriggers, including corroded anchorage hardware, at first, second and third floors.
- **STRUC-2** – Replace corroded structural fasteners at girder locations.

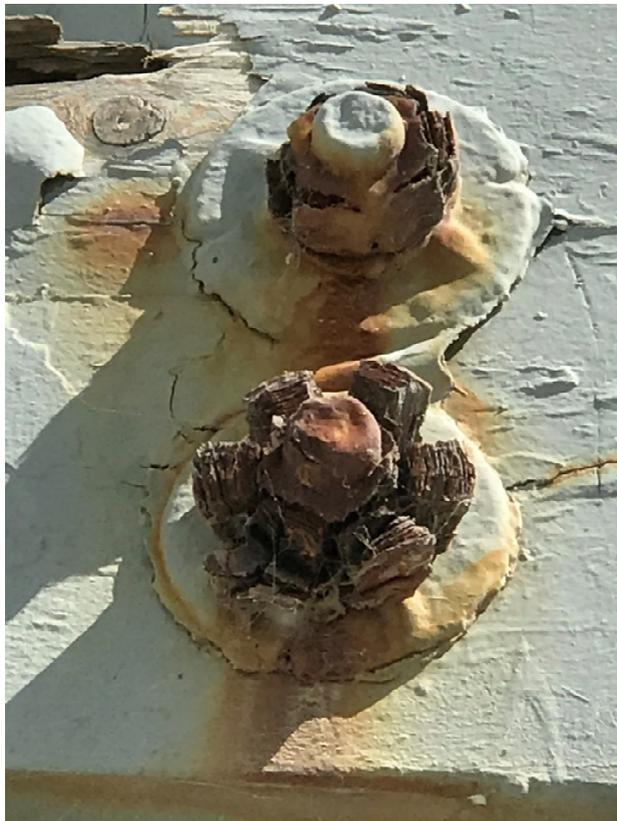
STRUC-2 Corroded Structural Fasteners

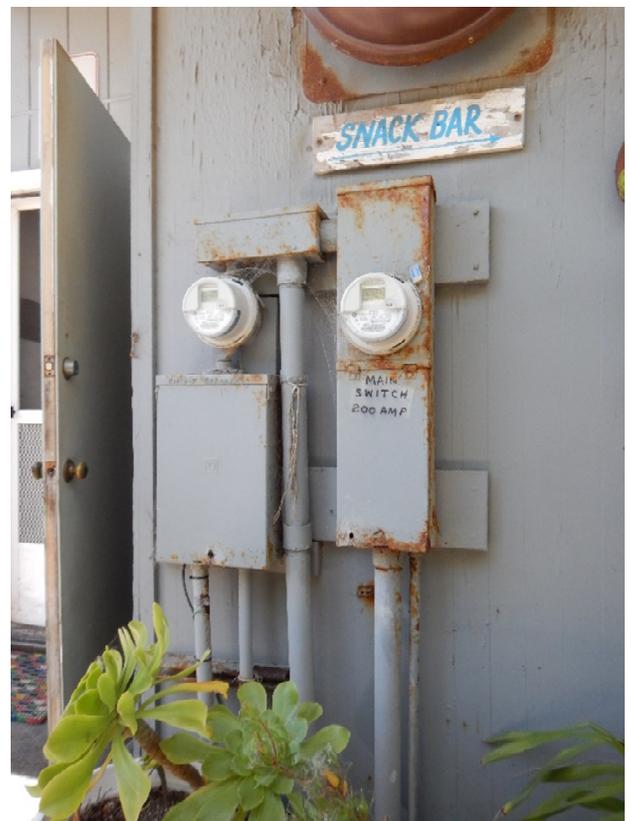
LT-10 Existing Electrical Panels and Meters

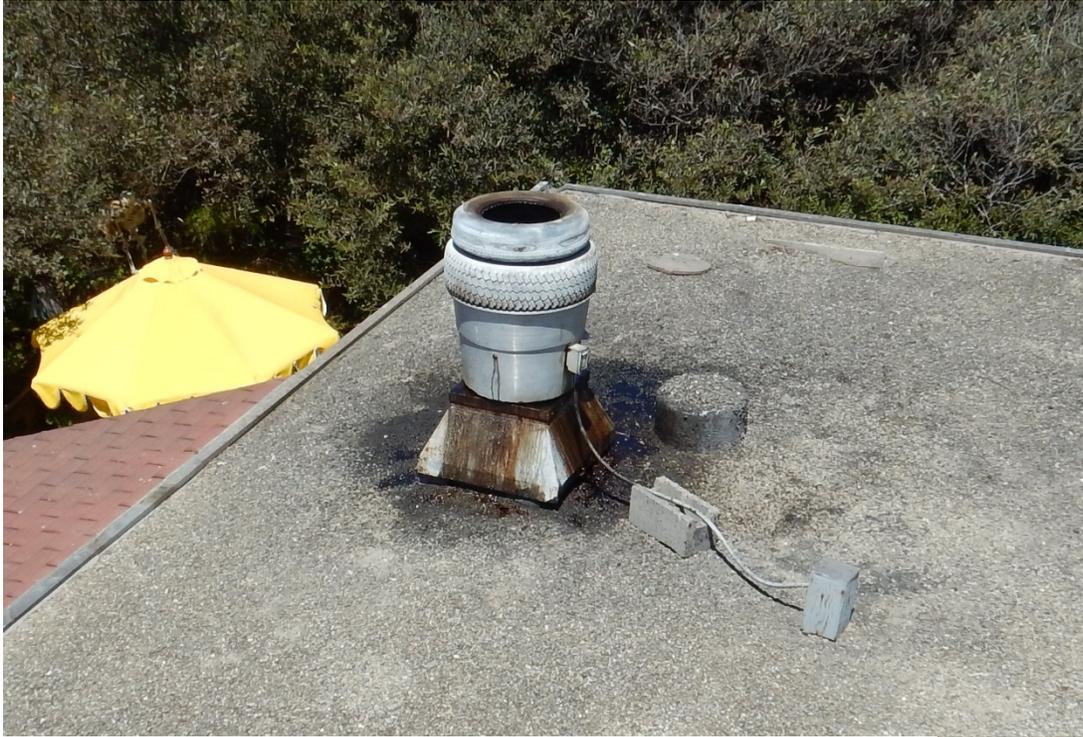
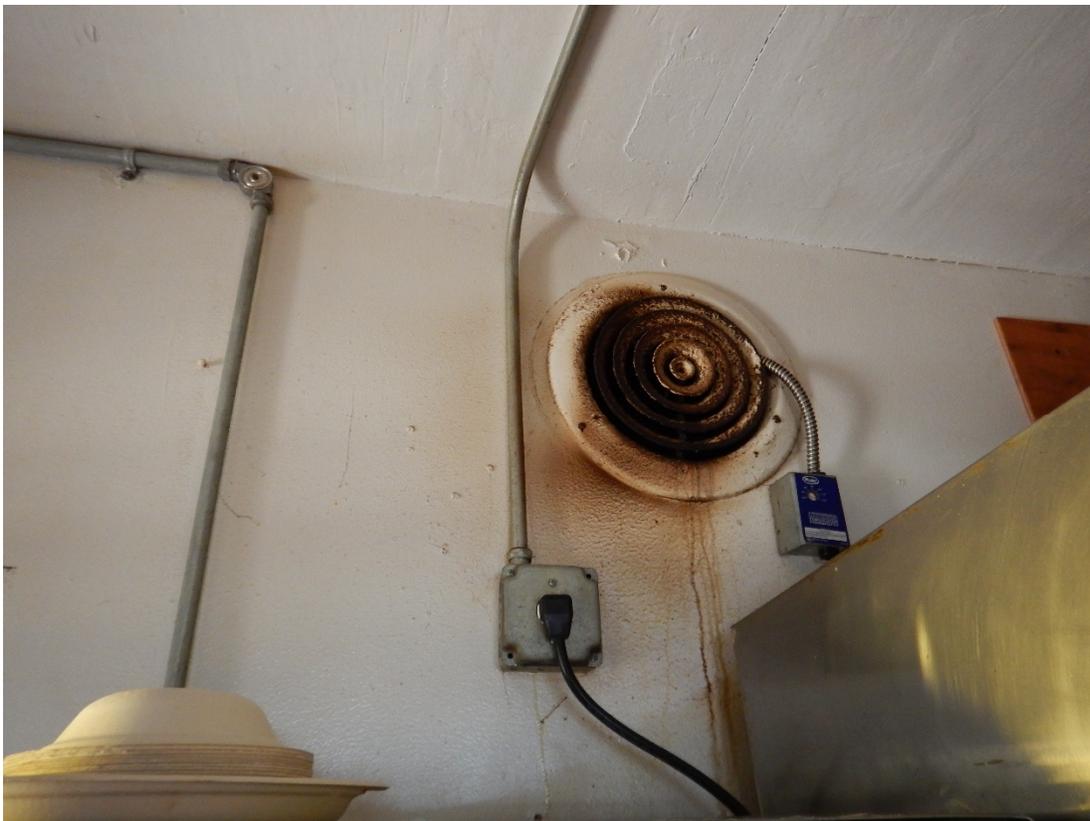
Mechanical exhaust vents at the Café, other than the grill hood, appeared heavily soiled at their interior surfaces and rusted on exterior surfaces. The rooftop termination of the grill hood is heavily soiled and

CC-6 Grease Deposition at Café Roof

CC-6 Soiled Exhaust Grille at Café

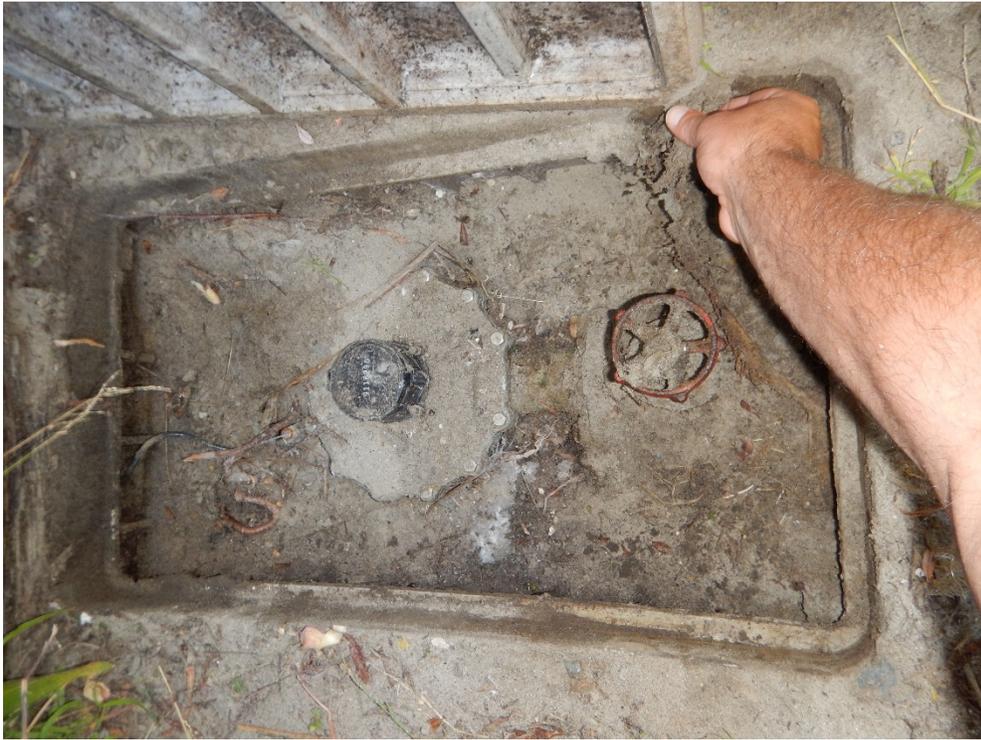
CC-7 Building Complex Water Main and Meter

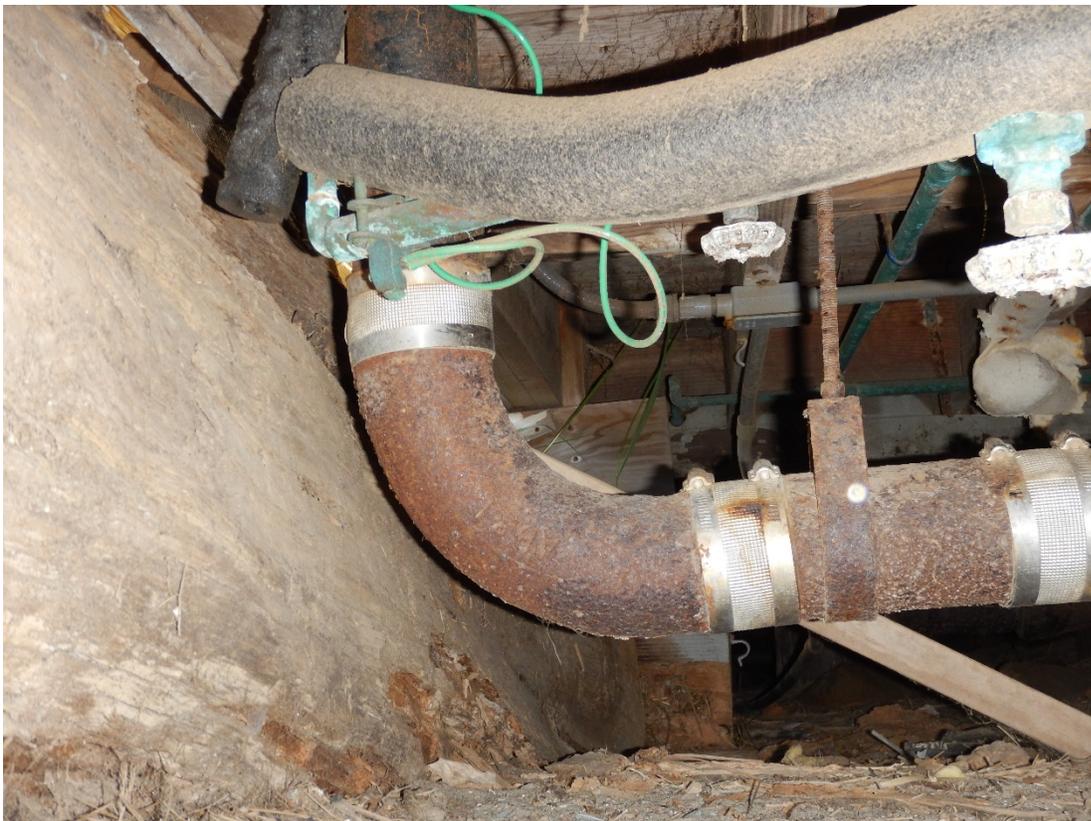
Plumbing piping was concealed at most locations but observed beneath the Lifeguard Tower and at exposed locations in the Café. Piping beneath the building typically consisted of copper domestic water lines and cast-iron waste and vent piping. Interior piping observed at the Café was a combination of copper branch lines with braided stainless hoses to individual fixtures. Waste and vent were typically ABS plastic piping.

LT-9 Corroded Domestic Water and Sanitary Piping
