RR 0705-
Survey #2-5

NEW JERSEY TRANSIT RAILROAD STATION SURVEY

- ✓ A. Name: Common East Orange ^{station} Line: Hoboken Division
Historic Morrystown Line
(DL&W)
- B. Address or location:
✓ 65 City Hall Plaza
✓ East Orange, N.J. 07108
County: Essex (Orange quad)
Municipality: East Orange City
Block & lot: part of 43/1
256/1
- C. Owner's name: N.J. Transit
Address: Trenton, New Jersey
- D. Location of legal description: Recorder of Deeds, Essex County Court-
house, Raymond Boulevard, Newark, N.J.
- E. Representation in existing surveys: (give number, category, etc.,
as appropriate)

FACILITY NAME: E. Orange

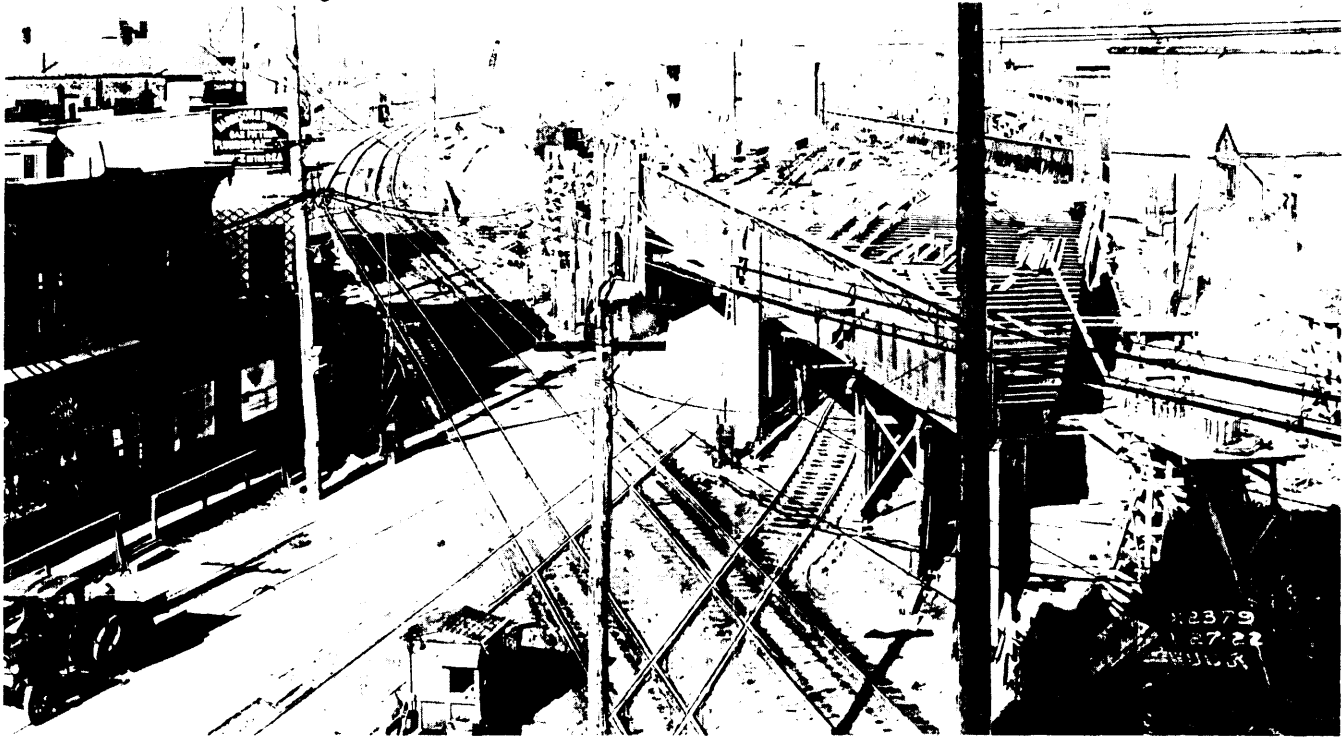
This picture was taken from the building shown in the previous picture and shows Main Street passing under the newly constructed steel girder bridge. The temporary tracks have been placed where the road was previously located. In the distance work is commencing on building the embankment.

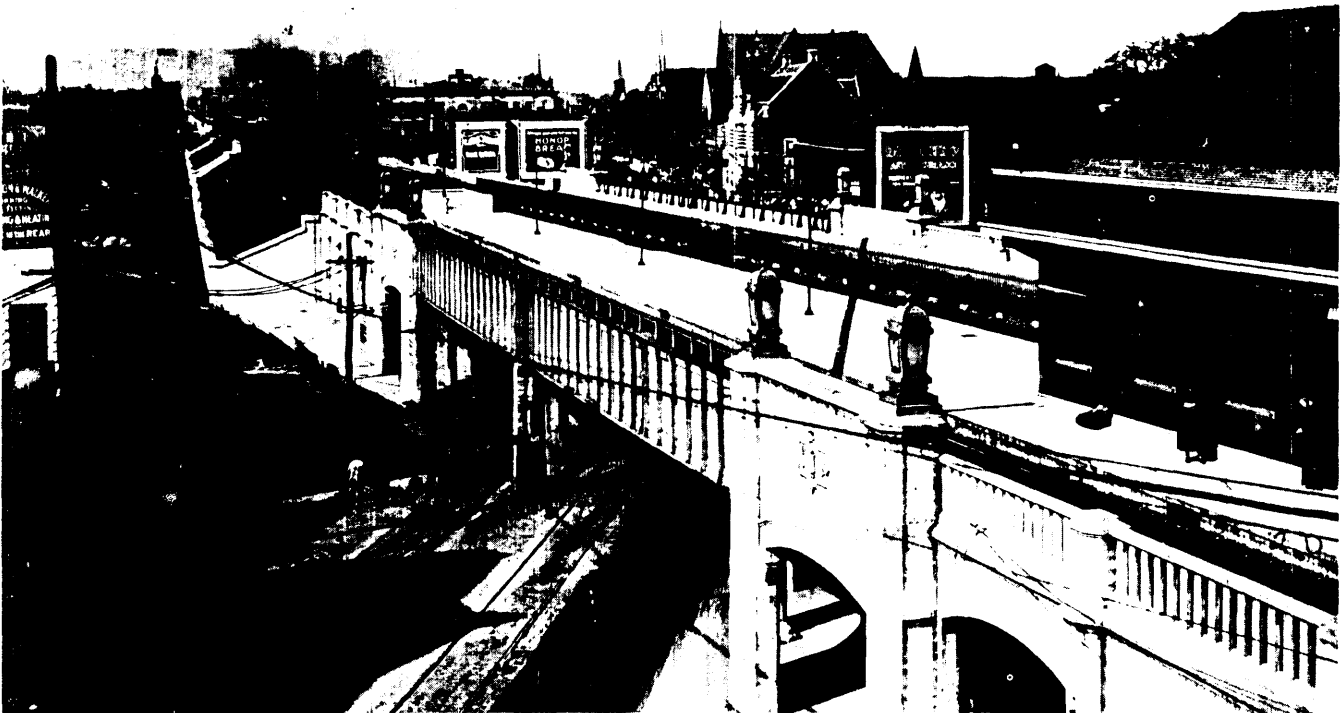
The temporary tracks have been removed and the embankment alongside the tracks has been seeded and some shrubs planted. A six car suburban train headed for Hoboken is drifting into the station with the fireman having failed to put the blower on to cut the soft coal smoke. Along with grade crossing elimination, an important aspect of all this work was the lengthening of station platforms which were just about doubled to accommodate future twelve and fourteen car trains.

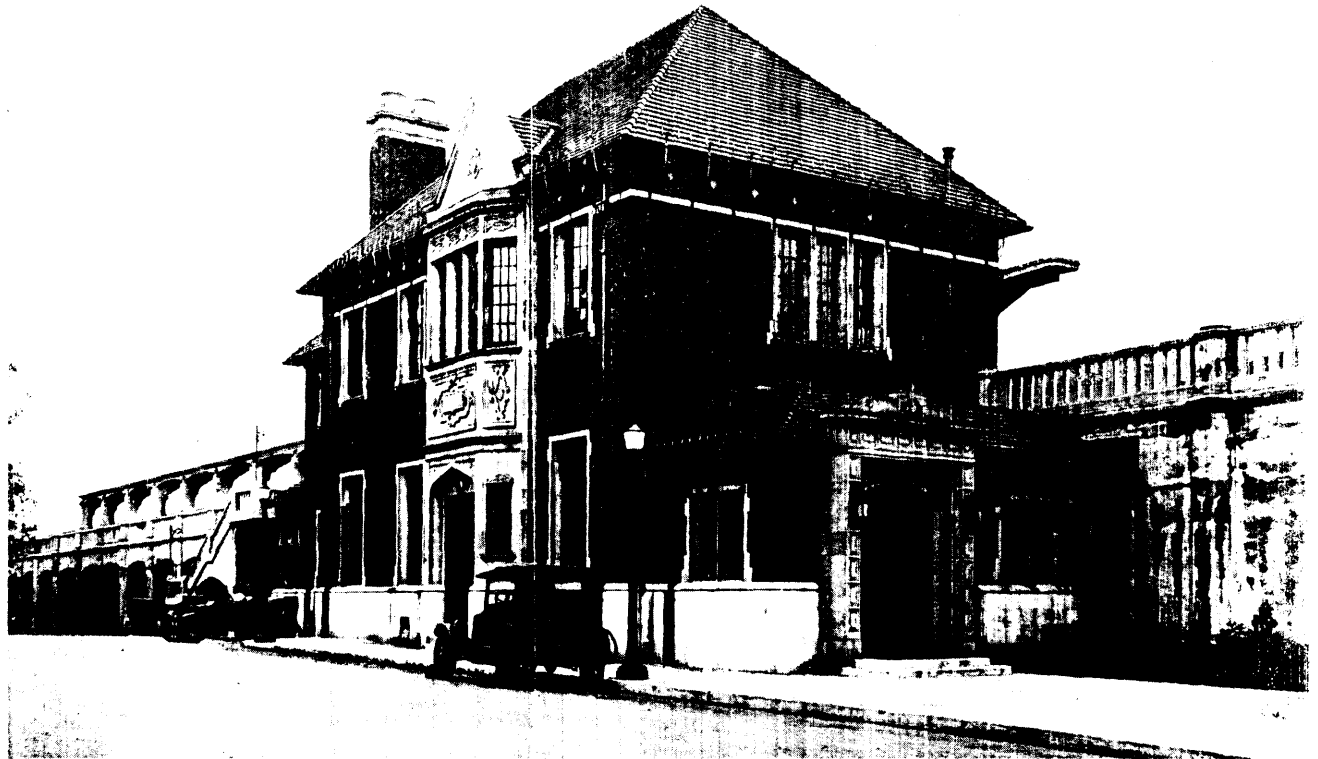
President Truesdale was never satisfied with a strictly functional structure having no semblance of any character. Most all stations on the railroad had some unique characteristics. No two stations were exactly alike. Two types, brick, concrete, occasional use of stone, or the mixing two of these basic ingredients gave a varied design. In addition at some stations particular ornamentation was added such as is evident with the East Orange station at the entrances.

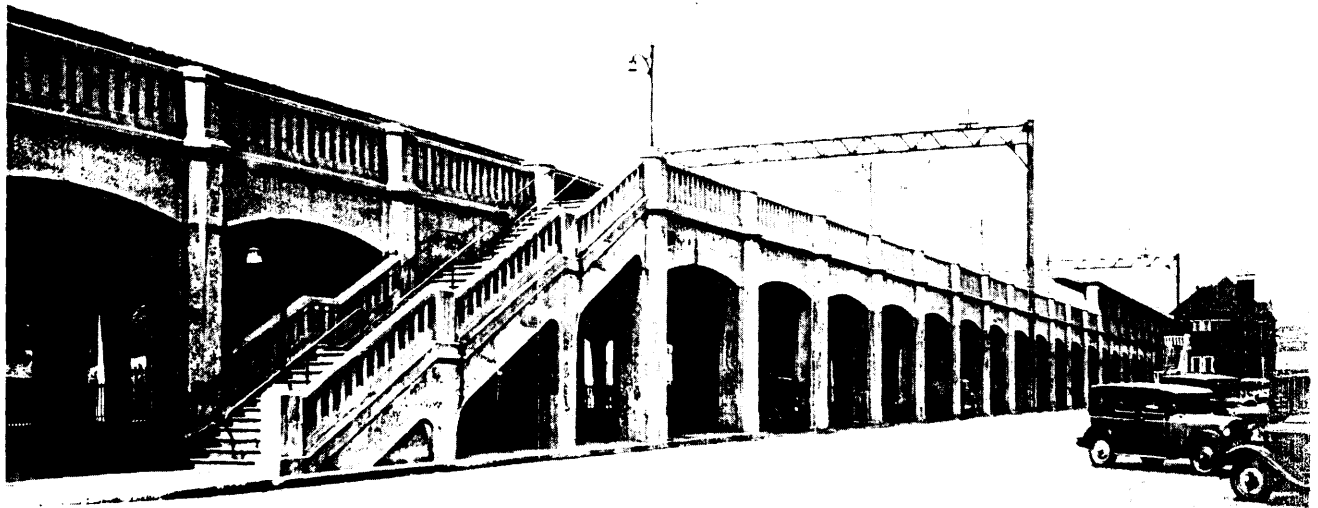
The lack of space at East Orange and Brick Church required special considerations. The 800 and 1000 foot long stations were built on pillars for Brick Church (where space was very tight) and with fascia columns for East Orange. On top of these pillars was poured a deck approximately 75 feet wide by the length of the entire station. The tracks, station platforms, and railings were built on top of the deck. Underneath the deck was room for automobile parking and additional station facilities. This photograph clearly shows the construction at East Orange.
