1. FLANIGAN DITCH (ZION N.P. MULTIPLE
2. WASHINGTON CO., UTAH RESOURCES)
3. S. KARDAS
4. 23 MARCH 1997
5. NEC. @ ZION N.P.
6. VIEW FROM WEST BANK OF VIRGIN RIVER TOWARD PA'RUS TRAIL BRIDGE IMMEDIATELY DOWNSTREAM FROM DITCH HEADWATER. OUTFLOW FROM SEDIMENT BASIN IS OUT OF PICTURE, TO RIGHT.

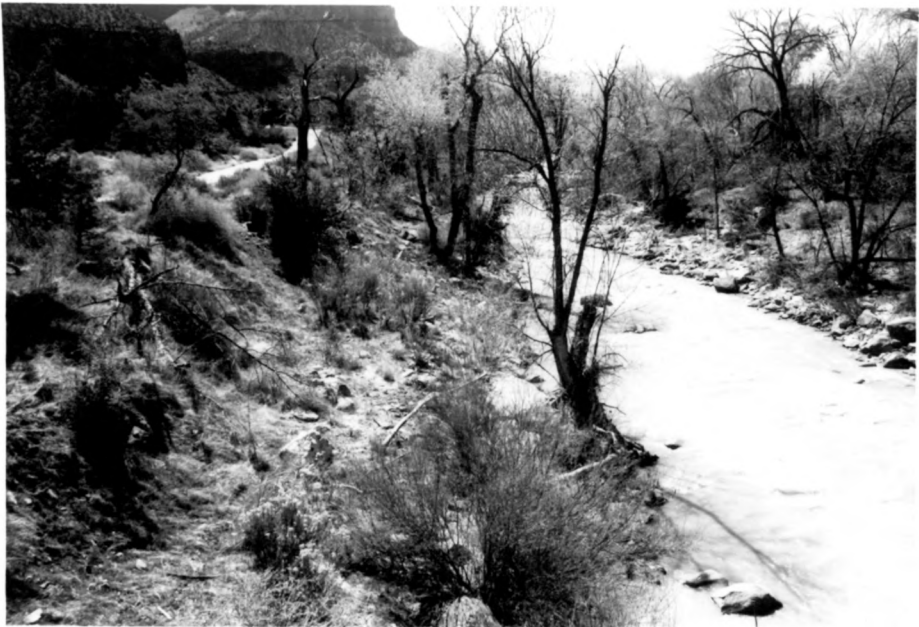
1. FLANIGAN DITCH (ZION N.P. MULTIPLE RESOURCES)
2. WASHINGTON CO., UTAH. RESOURCES
3. S. KARDAS
4. 23 MARCH 1997
5. NEG. @ ZION N.P.
6. VIEW DOWNSTREAM FROM PAROS TRAIL BRIDGE SHOWN IN EXP. 8. FOREGROUND IS RIVER BANK RECONFIGURED IN 1988 FOR INSTALLATION OF SEDIMENT OUTFLOW. DITCH IS VISIBLE BEYOND DISTURBANCE.

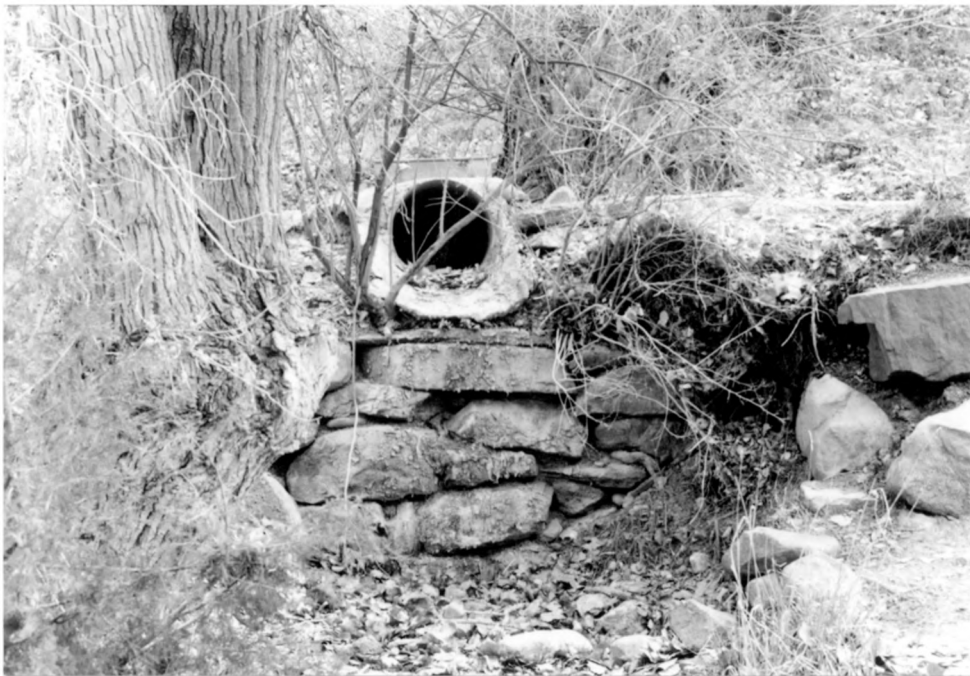
6. OUTFLOW (18 IN. DIAM) FROM DITCH, SUPPORTED ON DRY-LAID FIELDSTONE WALL (4 FT. HIGH & 6 FT. WIDE). NEAR ENTRY ROAD TO WATCHMAN CAMPGROUND. DITCH RUNS FROM L. TO R. ACROSS PHOTO.

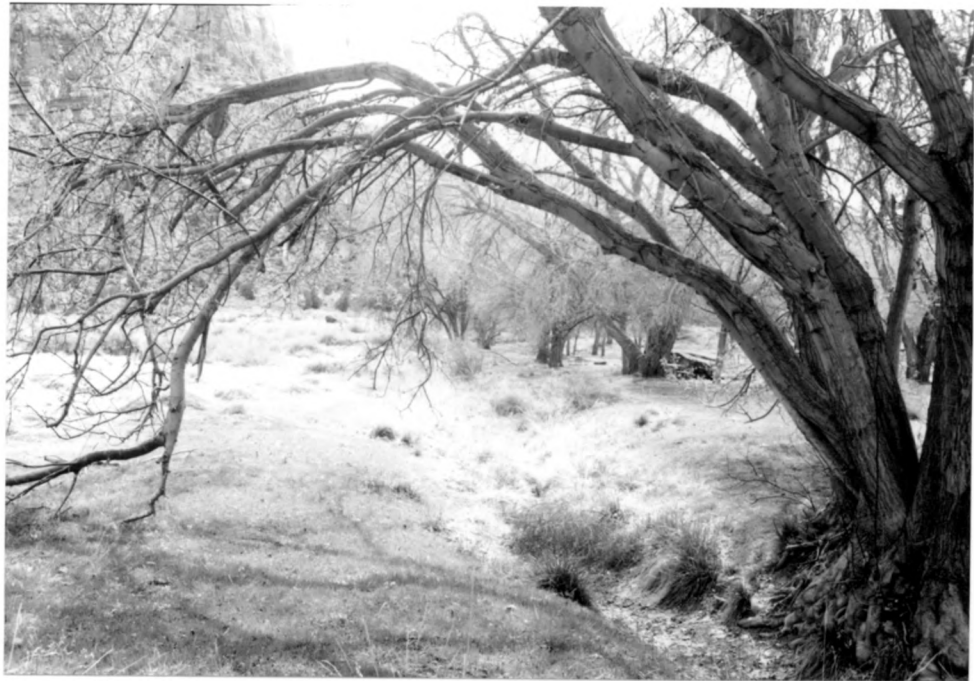
1. FLANKINGAN DITCH (ZION N.P. MULTIPLE RESOURCES)
2. WASHINGTON CO., UTAH.
3. S. KARDAS
4. 16 MARCH 1997
5. NEG. @ ZION N.P.
6. DITCH AS IT LEAVES THREE-WAY DIVERSION BOX ON EAST SIDE OF WATCHMAN CAMPGROUND (PHOTO CONNECTS WITH EXPOSURE 8a) LOOKING SOUTHWEST BY SOUTH
7. 1997 B+W ROLL 1, EXP. 7a

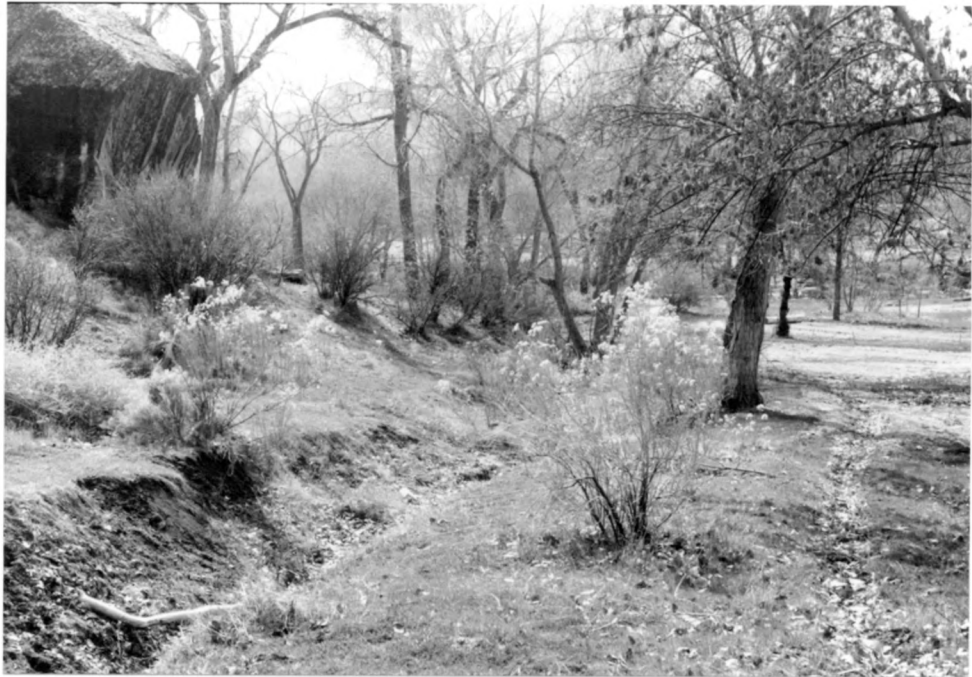
1. FLANIGAN DITCH (ZION N.P. MULTIPLE RESOURCES)
2. WASHINGTON CO., UTAH
3. S. KARDAS
4. 16 MARCH 1997
5. NEG. @ ZION N.P.
6. DITCH (NORMAL DIMENSIONS, BELOW WASH) AS IT NEARS OUTFALL TO VIRGIN RIVER (IN BACKGROUND) AT EXTREME SOUTH END OF WATCHMAN CAMPGROUND.

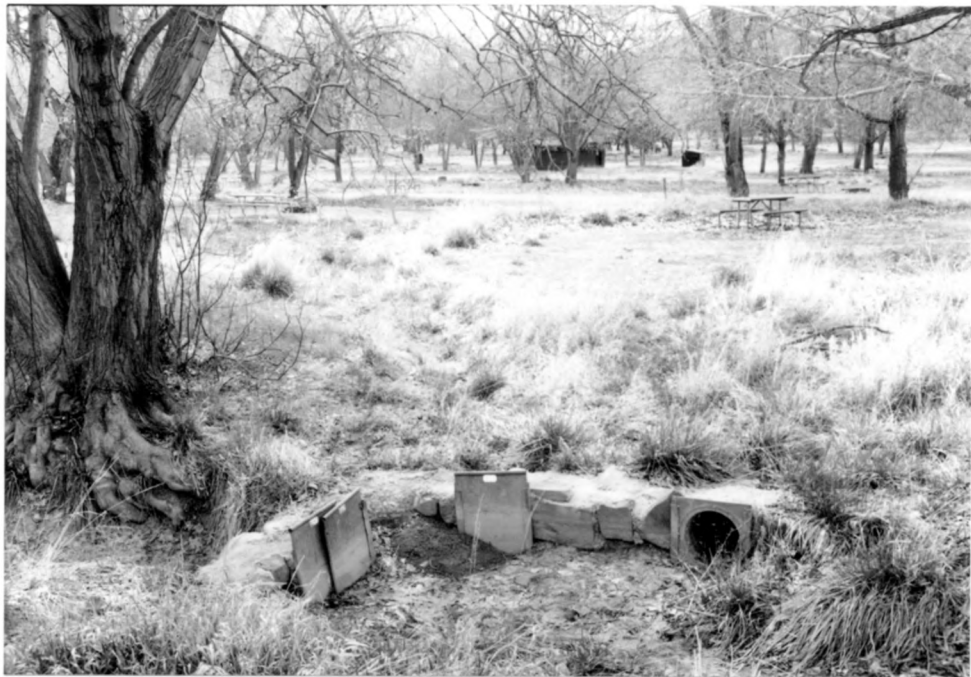
6. DITCH ENTERS THREE-WAY DIVERSION BOX
FROM RIGHT, AND FLOWS OUT TO LEFT.

TWO LATERALS (ONE CLOSED, ONE OPEN) IN
FRONT OF CAMERA IRRIGATE TREES IN
BACKGROUND (EAST SIDE OF WATCHMAN
CAMPGROUND). PHOTO CONNECTS WITH
EXPOSURE 7a)

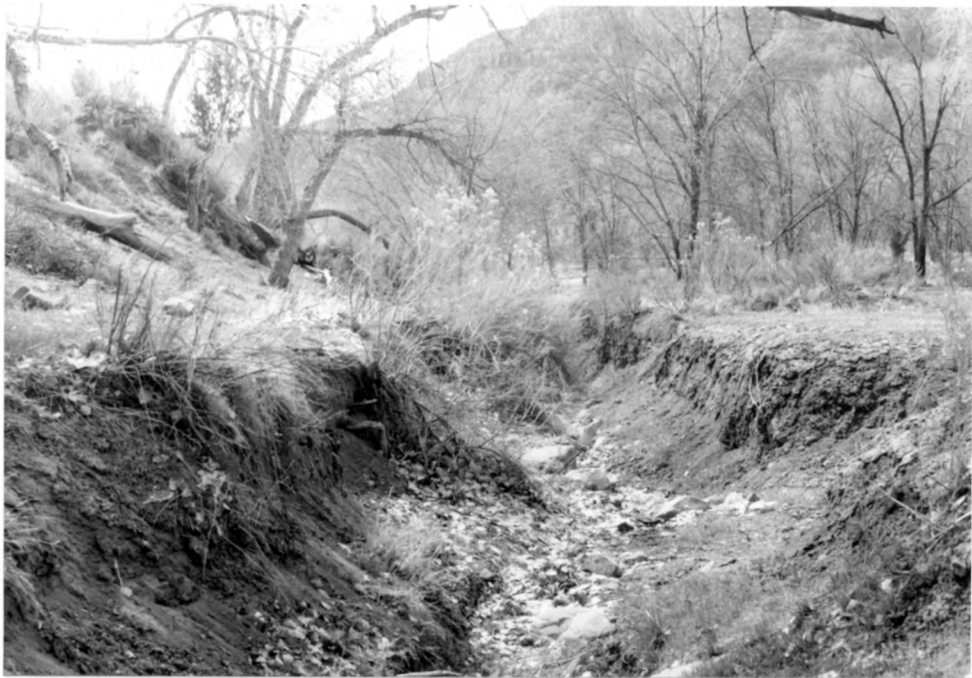
6. DITCH NEAR SOUTH END OF WATCHMAN
CAMPGROUND, WHERE A WASH FROM
THE HILLSIDE HAS ENLARGED THE
BED FOR ABOUT 300 FT.

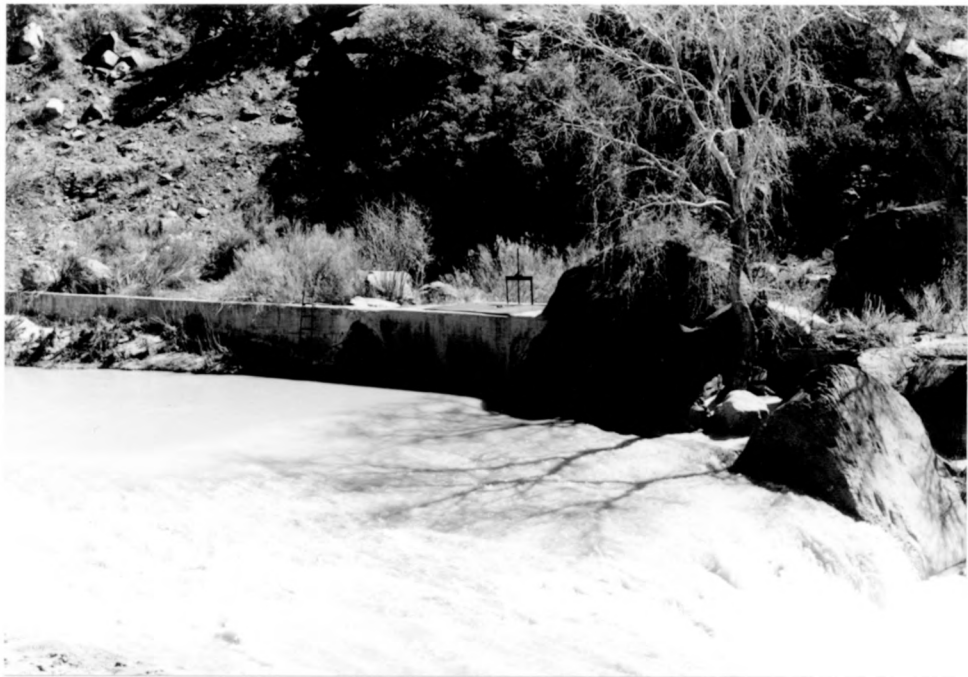
1. FLANIGAN DITCH (ZION N.P. MULTIPLE RESOURCES)
2. WASHINGTON CO., UTAH
3. S. KARDAS
4. 12 MARCH 1997
5. NEG. @ ZION N.P.
6. VIEW FROM WEST BANK OF NORTH BRANCH OF VIRGIN RIVER (FLOWING LEFT TO RIGHT) AT DAM FOR DIVERSION POINT OF FLANIGAN DITCH. CONCRETE HEADWALL (1956) HAS INLET PIPE BELOW WATER SURFACE.
LOOKING EAST.
7. ~~PPN~~ BTW ROLL 1, EXP. 20a

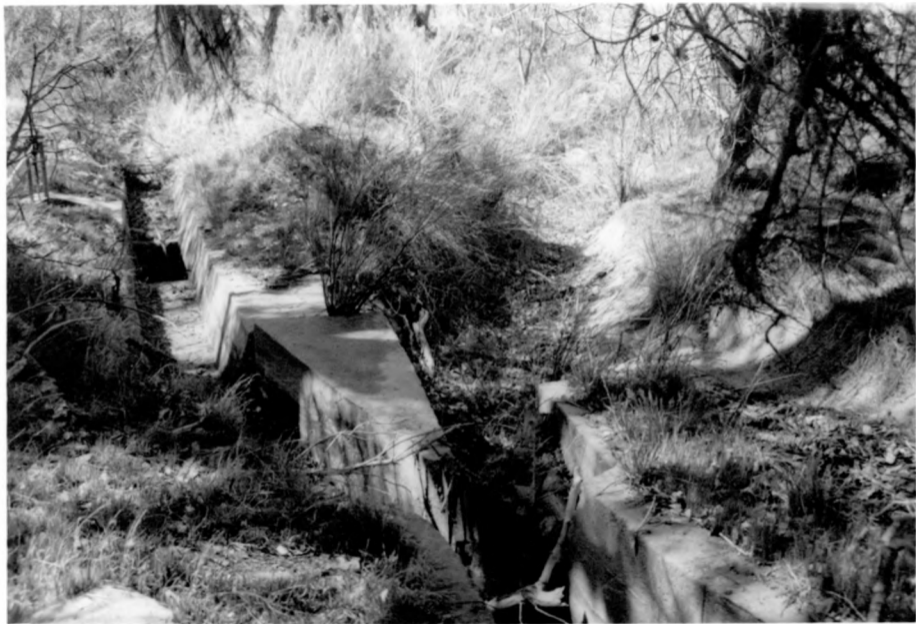
6. CONCRETE STRUCTURE (BUILT IN 1956)
THAT DIVIDED SPRINGDALE CONSOLIDATED
IRRIGATION CO. WATER (TO RIGHT) AND
FLANIGAN DITCH CO. WATER (TO LEFT).
THIS IS IMMEDIATELY SOUTH OF NPS
WATCHMAN STAFF HOUSING.

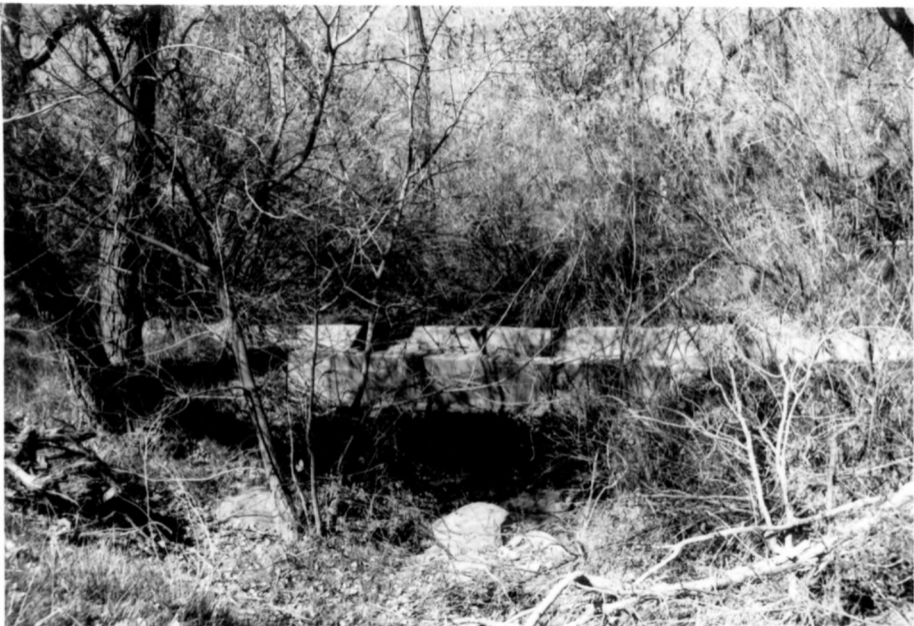
6. FLUME CARRYING DITCH OVER A
WASH SOUTH OF NPS WATCHMAN
STAFF HOUSING.

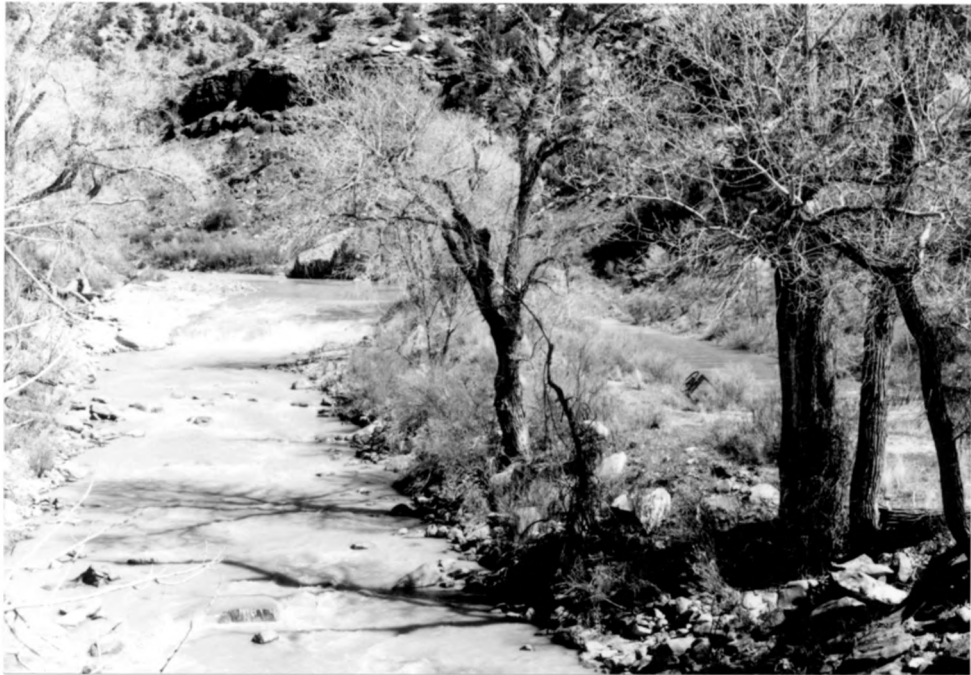
1. FLANIGAN DITCH (ZION N.P. MULTIPLE RESOURCES)
2. WASHINGTON CO., UTAH
3. S. KARDAS
4. 17 MARCH 1997
5. NEG. @ ZION N.P.
6. VIEW FROM THIRD FOOTBRIDGE SOUTH OF CANYON JUNCTION, ON PERUS TRAIL, LOOKING UPSTREAM ON NORTH BRANCH OF VIRGIN RIVER TOWARD WATERFALL OVER DAM AT DIVERSION POINT OF DITCH, METAL PLATES ON RIGHT COVER 1988 SEDIMENT BASIN. LOOKING NORTH BY NORTHEAST
7. 1997 BTW ROLL 1, EXP. 19a

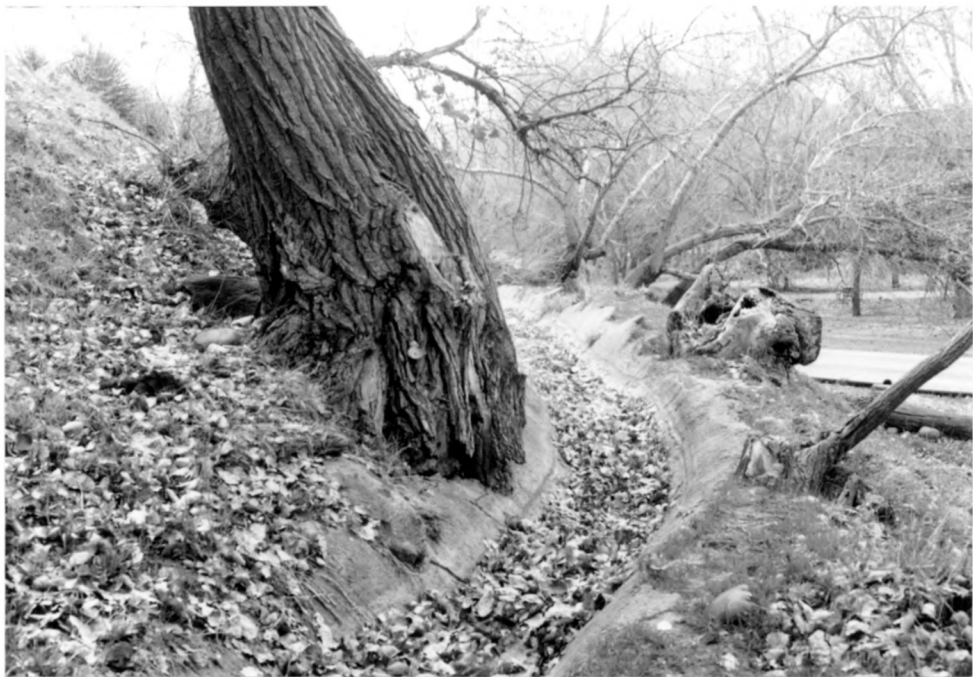
1. FLANIGAN DITCH (ZION N.P. MULTIPLE RESOURCES)
2. WASHINGTON CO., UTAH.
3. S. KARDAS
4. 16 MARCH 1997
5. NEG. @ ZION N.P.
6. CONCRETE LINING (POST-1960) IN DITCH. AS IT CURVES AROUND HILLSIDE BY ENTRY ROAD TO WATCHMAN CAMPGROUND. TREES IN BACKGROUND ARE IRRIGATED BY MEANS OF FLANIGAN DITCH.
LOOKING SOUTH
7. 1997 B+G ROLL 1, EXP. 2A

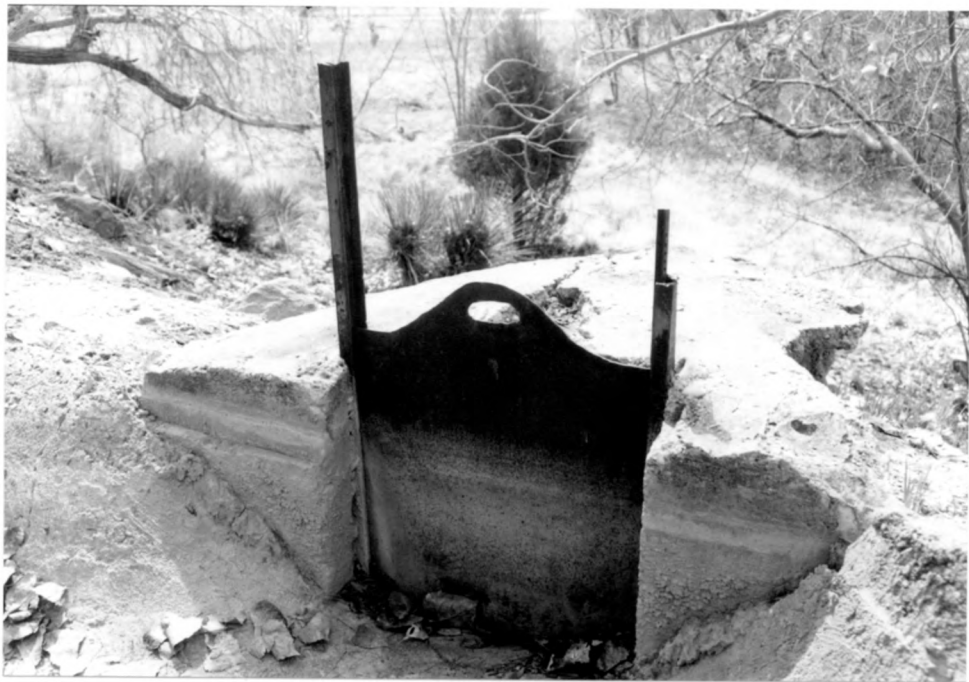
6. CUT IRON (ABOUT 18 BY 18 INCHES)
LIFT-GATE FOR LATERAL DITCH THAT
IRRIGATES WATCHMAN CAMPGROUND
(CONCRETE & IRON POST 1960)

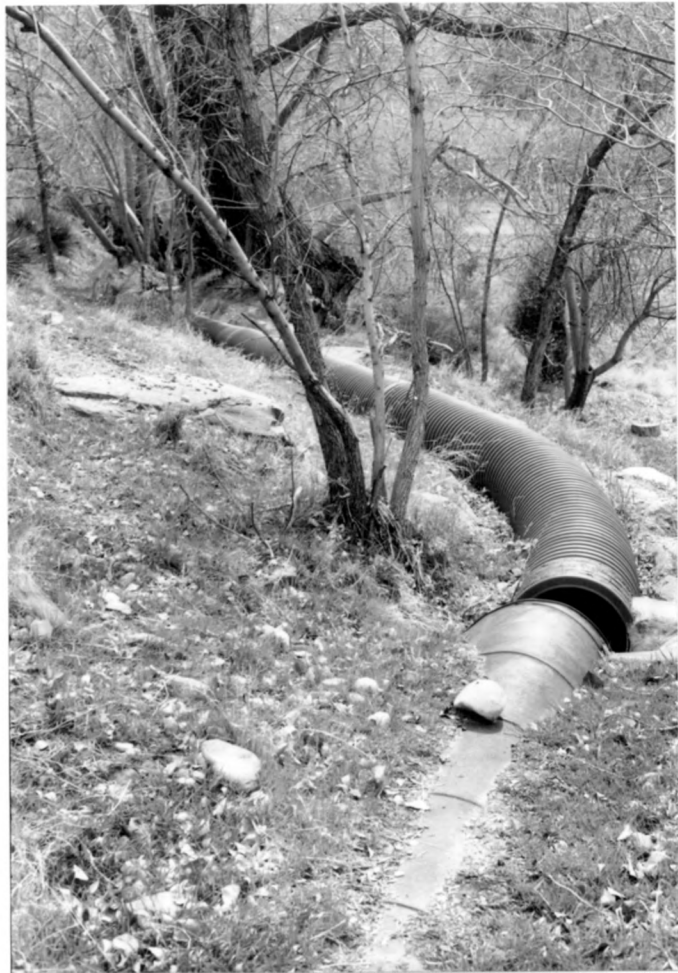
1. FLANGGAN DITCH (ZION N.P.
MULTIPLE RESOURCES)
2. WASHINGTON CO., UTAH
3. S. KARDAS
4. 16 MARCH 1997
5. NEG. @ ZION N.P.
6. SHORT SECTION OF PLASTIC
PIPE IN DITCH AS IT CURVES
AROUND HILLSIDE NEAR
ENTRY ROAD TO WATCHMAN
CAMPGROUND, MANY ~~WIDE~~
COTTONWOOD TREES
GROW ALONG DITCH.
LOOKING SOUTH
7. 1997 B+W ROLL 1, EXP. 3A

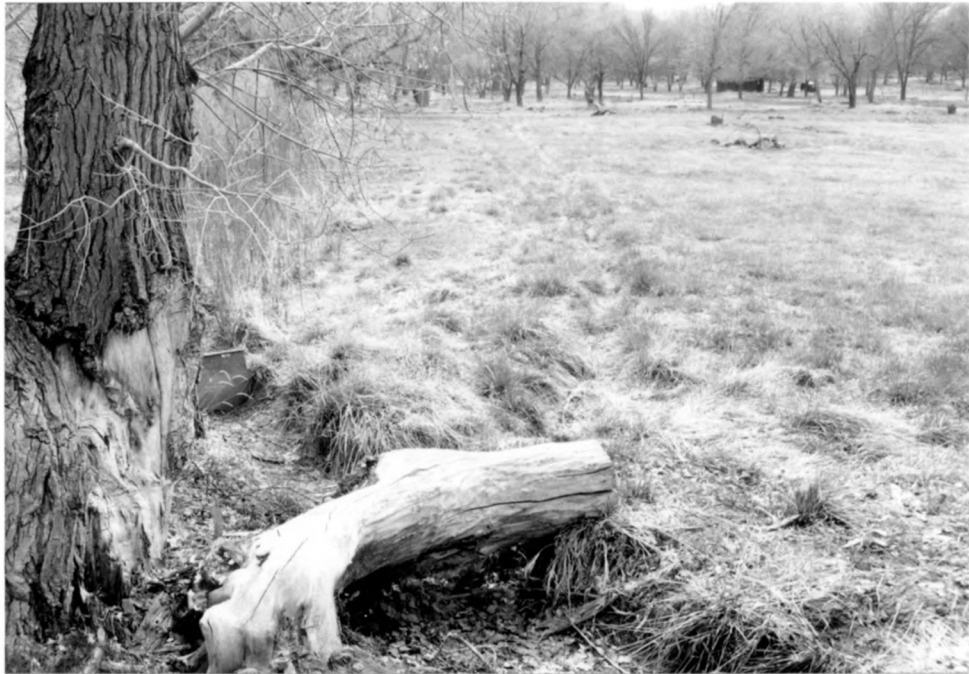
1. FLANIGAN DITCH (ZION N.P. MULTIPLE)
2. WASHINGTON CO., UTAH (RESOURCES)
3. S. KARDAS
4. 16 MARCH 1997
5. NEG. @ ZION N.P.
6. DITCH AS IT LEAVE HILLSIDE
AND RUNS ACROSS LEVEL OPEN
GROUND, TOWARD TREES IN
BACKGROUND.
LOOKING SOUTHWEST
7. 1997 B+W ROLL, EXP. 6a

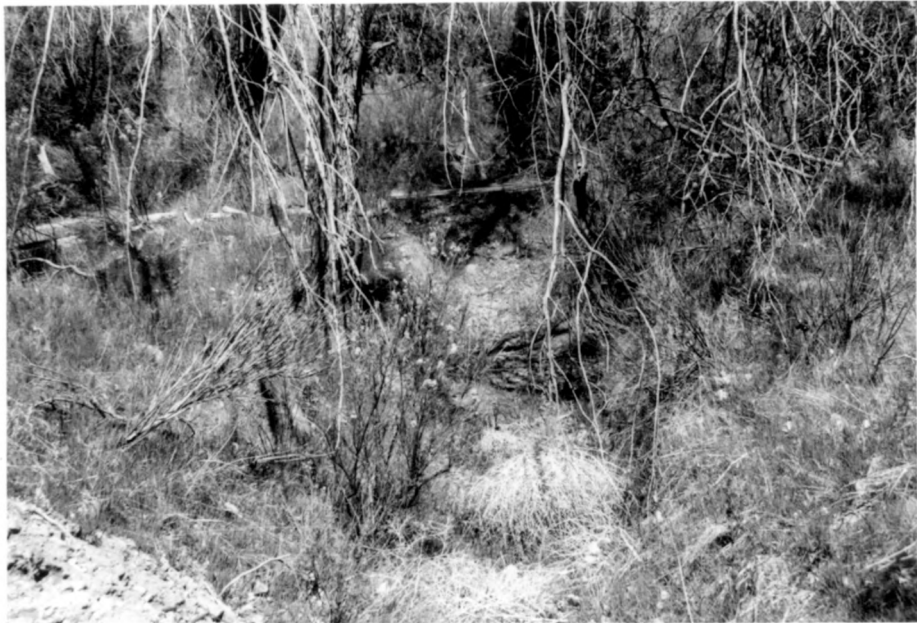
1. FRANIGAN DITCH (ZION N.P. MULTIPLE RESOURCES)
2. WASHINGTON CO., UTAH
3. S. KARDAS
4. 23 MARCH 1997
5. NEG. @ ZION N.P.
6. BED OF DITCH AS IT APPROACHES ONE OF THE FOOTBRIDGES ON THE PARUS TRAIL (VISIBLE AT TOP)

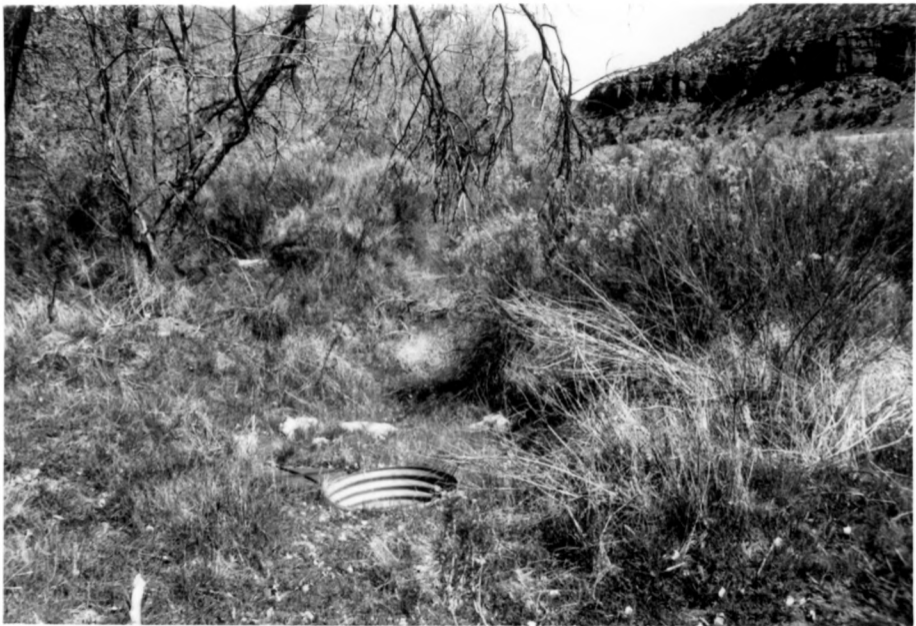
1. FLAMIGAN DITCH (ZION N.P. MULTIPLE RESOURCES)
2. WASHINGTON CO., UTAH
3. S. KARDAS
4. 23 MARCH 1997
5. NEG. @ ZION N.P.
6. BED OF DITCH AS IT APPROACHES
MPS WATCHMAN STAFF HOUSING.
THIS PORTION HAS NOT CARRIED
WATER SINCE 1988. CULVERT
PASSED UNDER APPROACH ROAD,
LOOKING NORTH BY NORTHEAST
7. 1997 B+W Roll 2 EXP. 5
