## Site Inspection of Roadway, Ridge District, Milepost 102-105

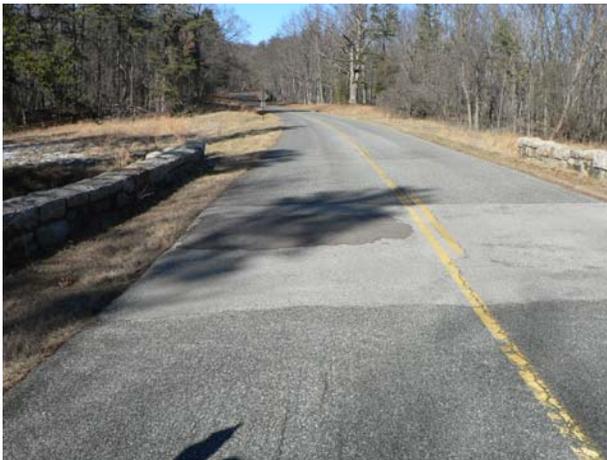
1. VA Route 652, crossing underpass at MP 104.3

This is a concrete box culvert bridge with granite wall parapets on either side of the road. The pavement is severely settled on either side of the box culvert and is very dangerous to motorists, particularly motorcycles. Repairs will require Type 2 pavement patching to a length of 50 feet and a potential depth of 3-5 feet on either side of the bridge. New road base should be built up with layers of compaction on either side of the bridge possibly to include geocomposite materials. Pavement overlay of entire bridge is 250 feet including 100 feet of pavement deep patching. Pavement should be 3 inches of asphalt base with  $\frac{3}{4}$  inch aggregate and a 1  $\frac{1}{2}$  inch wearing course overlay with  $\frac{3}{8}$  to  $\frac{1}{2}$  inch aggregate asphalt superpave mix designs.

Estimated cost including removing asphalt, installing type 2 patching, milling and overlaying asphalt across the bridge, restripe centerline is \$80,000 including contract mobilization, overhead and profit.

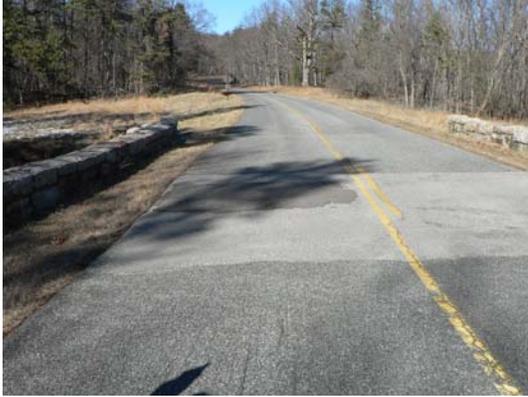
2. VA Route 657, crossing underpass at MP 104.8

This is a concrete box culvert bridge with granite wall parapets on either side of the road. The pavement is severely settled on either side of the box culvert and is very dangerous to motorists, particularly motorcycles. Repairs will require Type 2 pavement patching to a length of 50 feet and a potential depth of 3-5 feet on either side of the bridge. New road base should be built up with layers of compaction on either side of the bridge possibly to include geocomposite materials. Pavement overlay of entire bridge is 320 feet including 100 feet of pavement deep patching. Pavement should be 3 inches of asphalt base with  $\frac{3}{4}$  inch aggregate and a 1  $\frac{1}{2}$  inch wearing course overlay with  $\frac{3}{8}$  to  $\frac{1}{2}$  inch aggregate asphalt superpave mix design.

Estimated cost including removing asphalt, installing type 2 patching, milling and overlaying asphalt across the bridge, restripe centerline is \$95,000 including contract mobilization, overhead and profit.

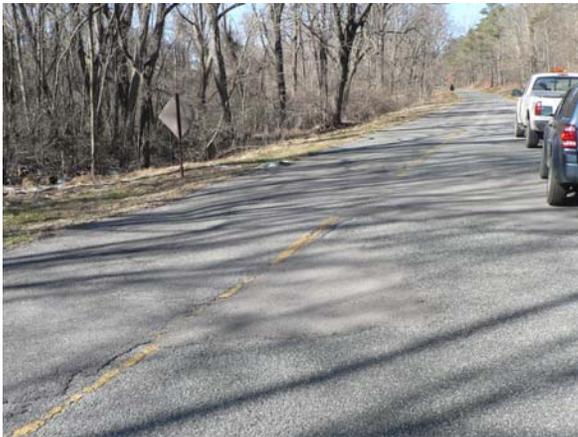
- At milepost 105, pavement has slumped on either side of a concrete culvert for a total linear distance of sixty feet. Repair will require 150 sq. yds. of type 2 patch. The pavement slump is a hazard to all motorists particularly motorcycles. The slumped areas cannot be repaired with cold patching.

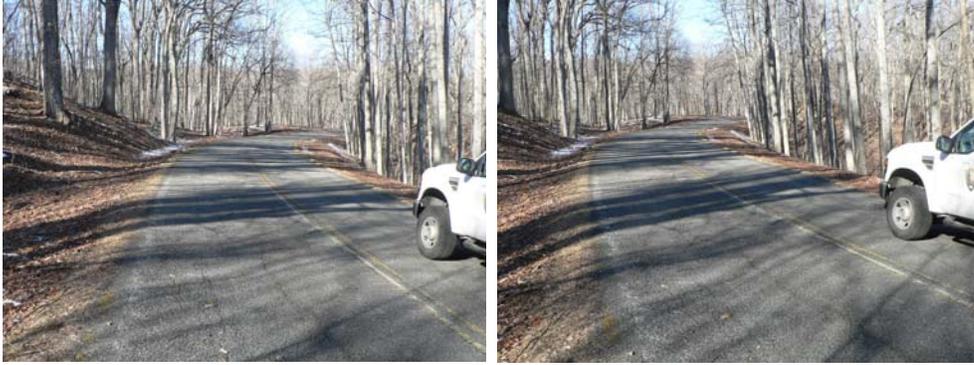
- Between milepost 102 to 103 we measured 800 linear feet of severely slumped pavement caused from fill slope settling. These areas will require deep Type 2 pavement patches to depths of 3-5 feet using geotechnical fabrics to bridge the new road base.
