GUIDELINES FOR REHABILITATING HISTORIC COVERED BRIDGES

Edited by Christopher H. Marston and Thomas A. Vitanza

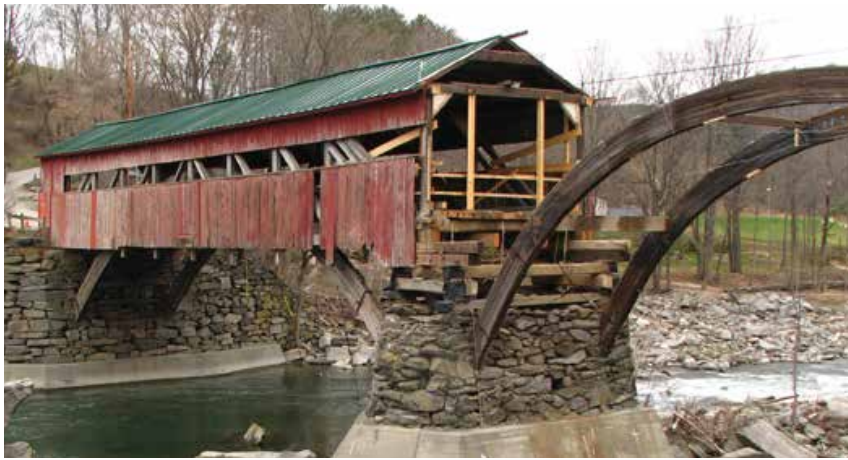
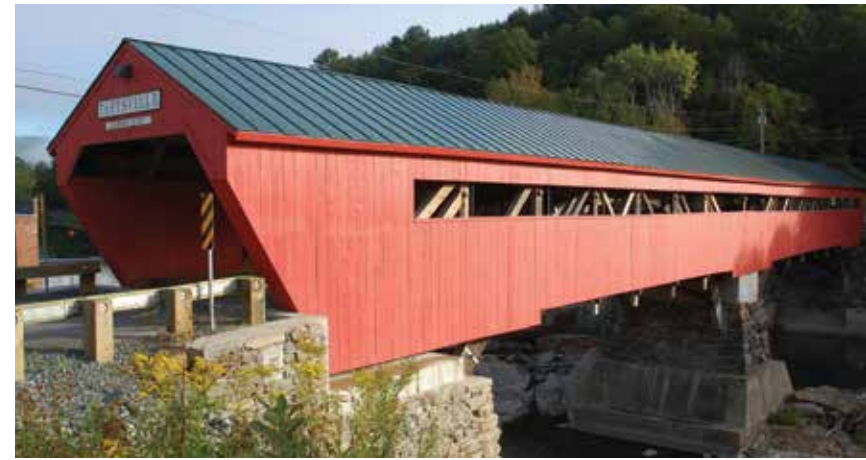
Figure 0.5a-b Vermont's Taftsville Bridge suffered major damage from Hurricane Irene in 2011. While one span needed to be completely rebuilt, a large percentage of the original hand-hewn truss members were salvaged and retained during the rehabilitation project.

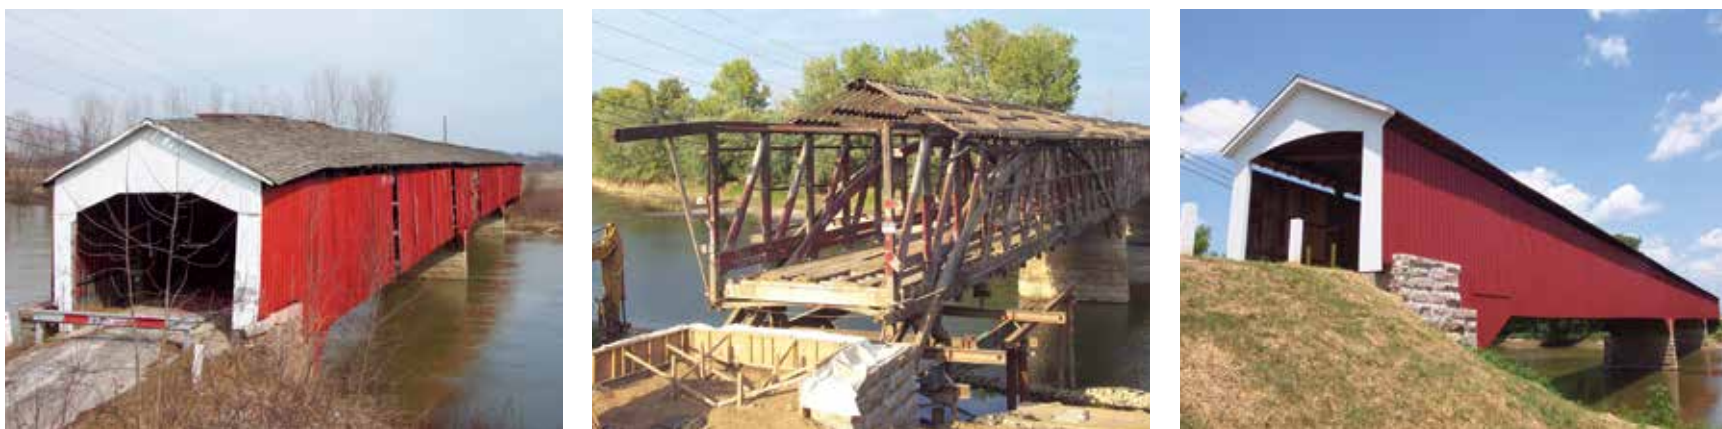
Figure 0.6a-c Before/During/After photos of Medora Bridge, IN. A complete rehabilitation was necessary due to failing abutments and a deteriorated roof causing decay in truss members. The crew carefully took apart the abutments, poured a new reinforced concrete slab, and put the original stones back in place.

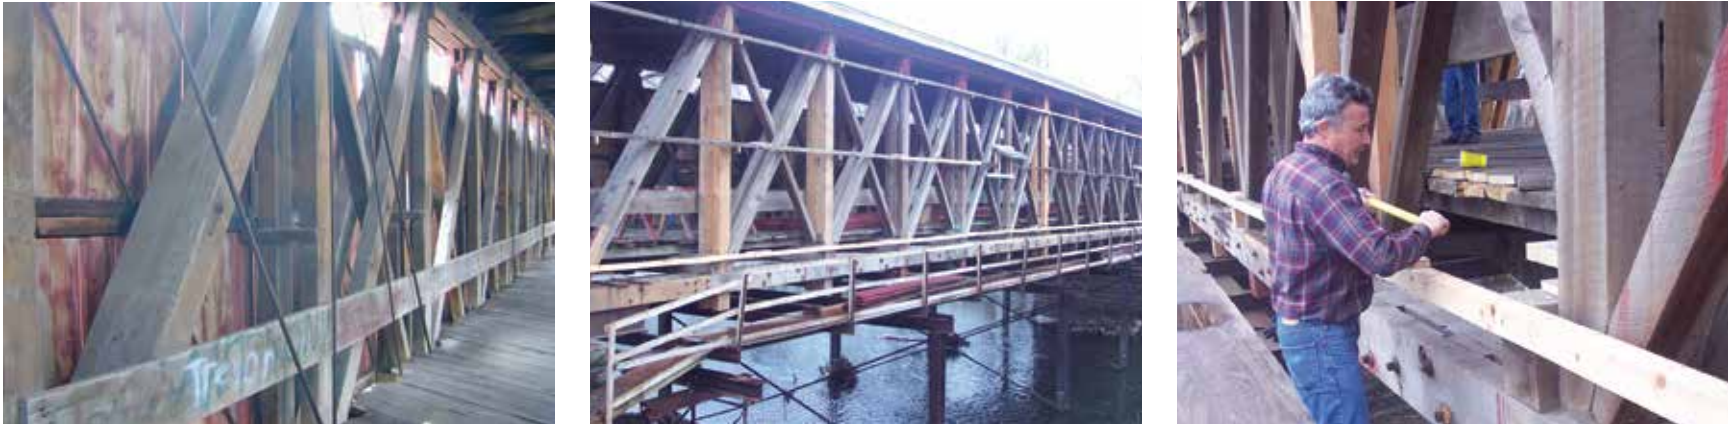
Figure 0.9a-c The 2005 rehabilitation work on the Eldean Bridge in Ohio is a good example of repairing and replacing missing historic character-defining features, and reversing an earlier inappropriate intervention. The 1960s reinforcing rods were removed on the 1860 Long truss, and replaced with wooden wedges driven in at the base of the diagonal counterbraces, thus prestressing the truss as prescribed by Stephen Long.

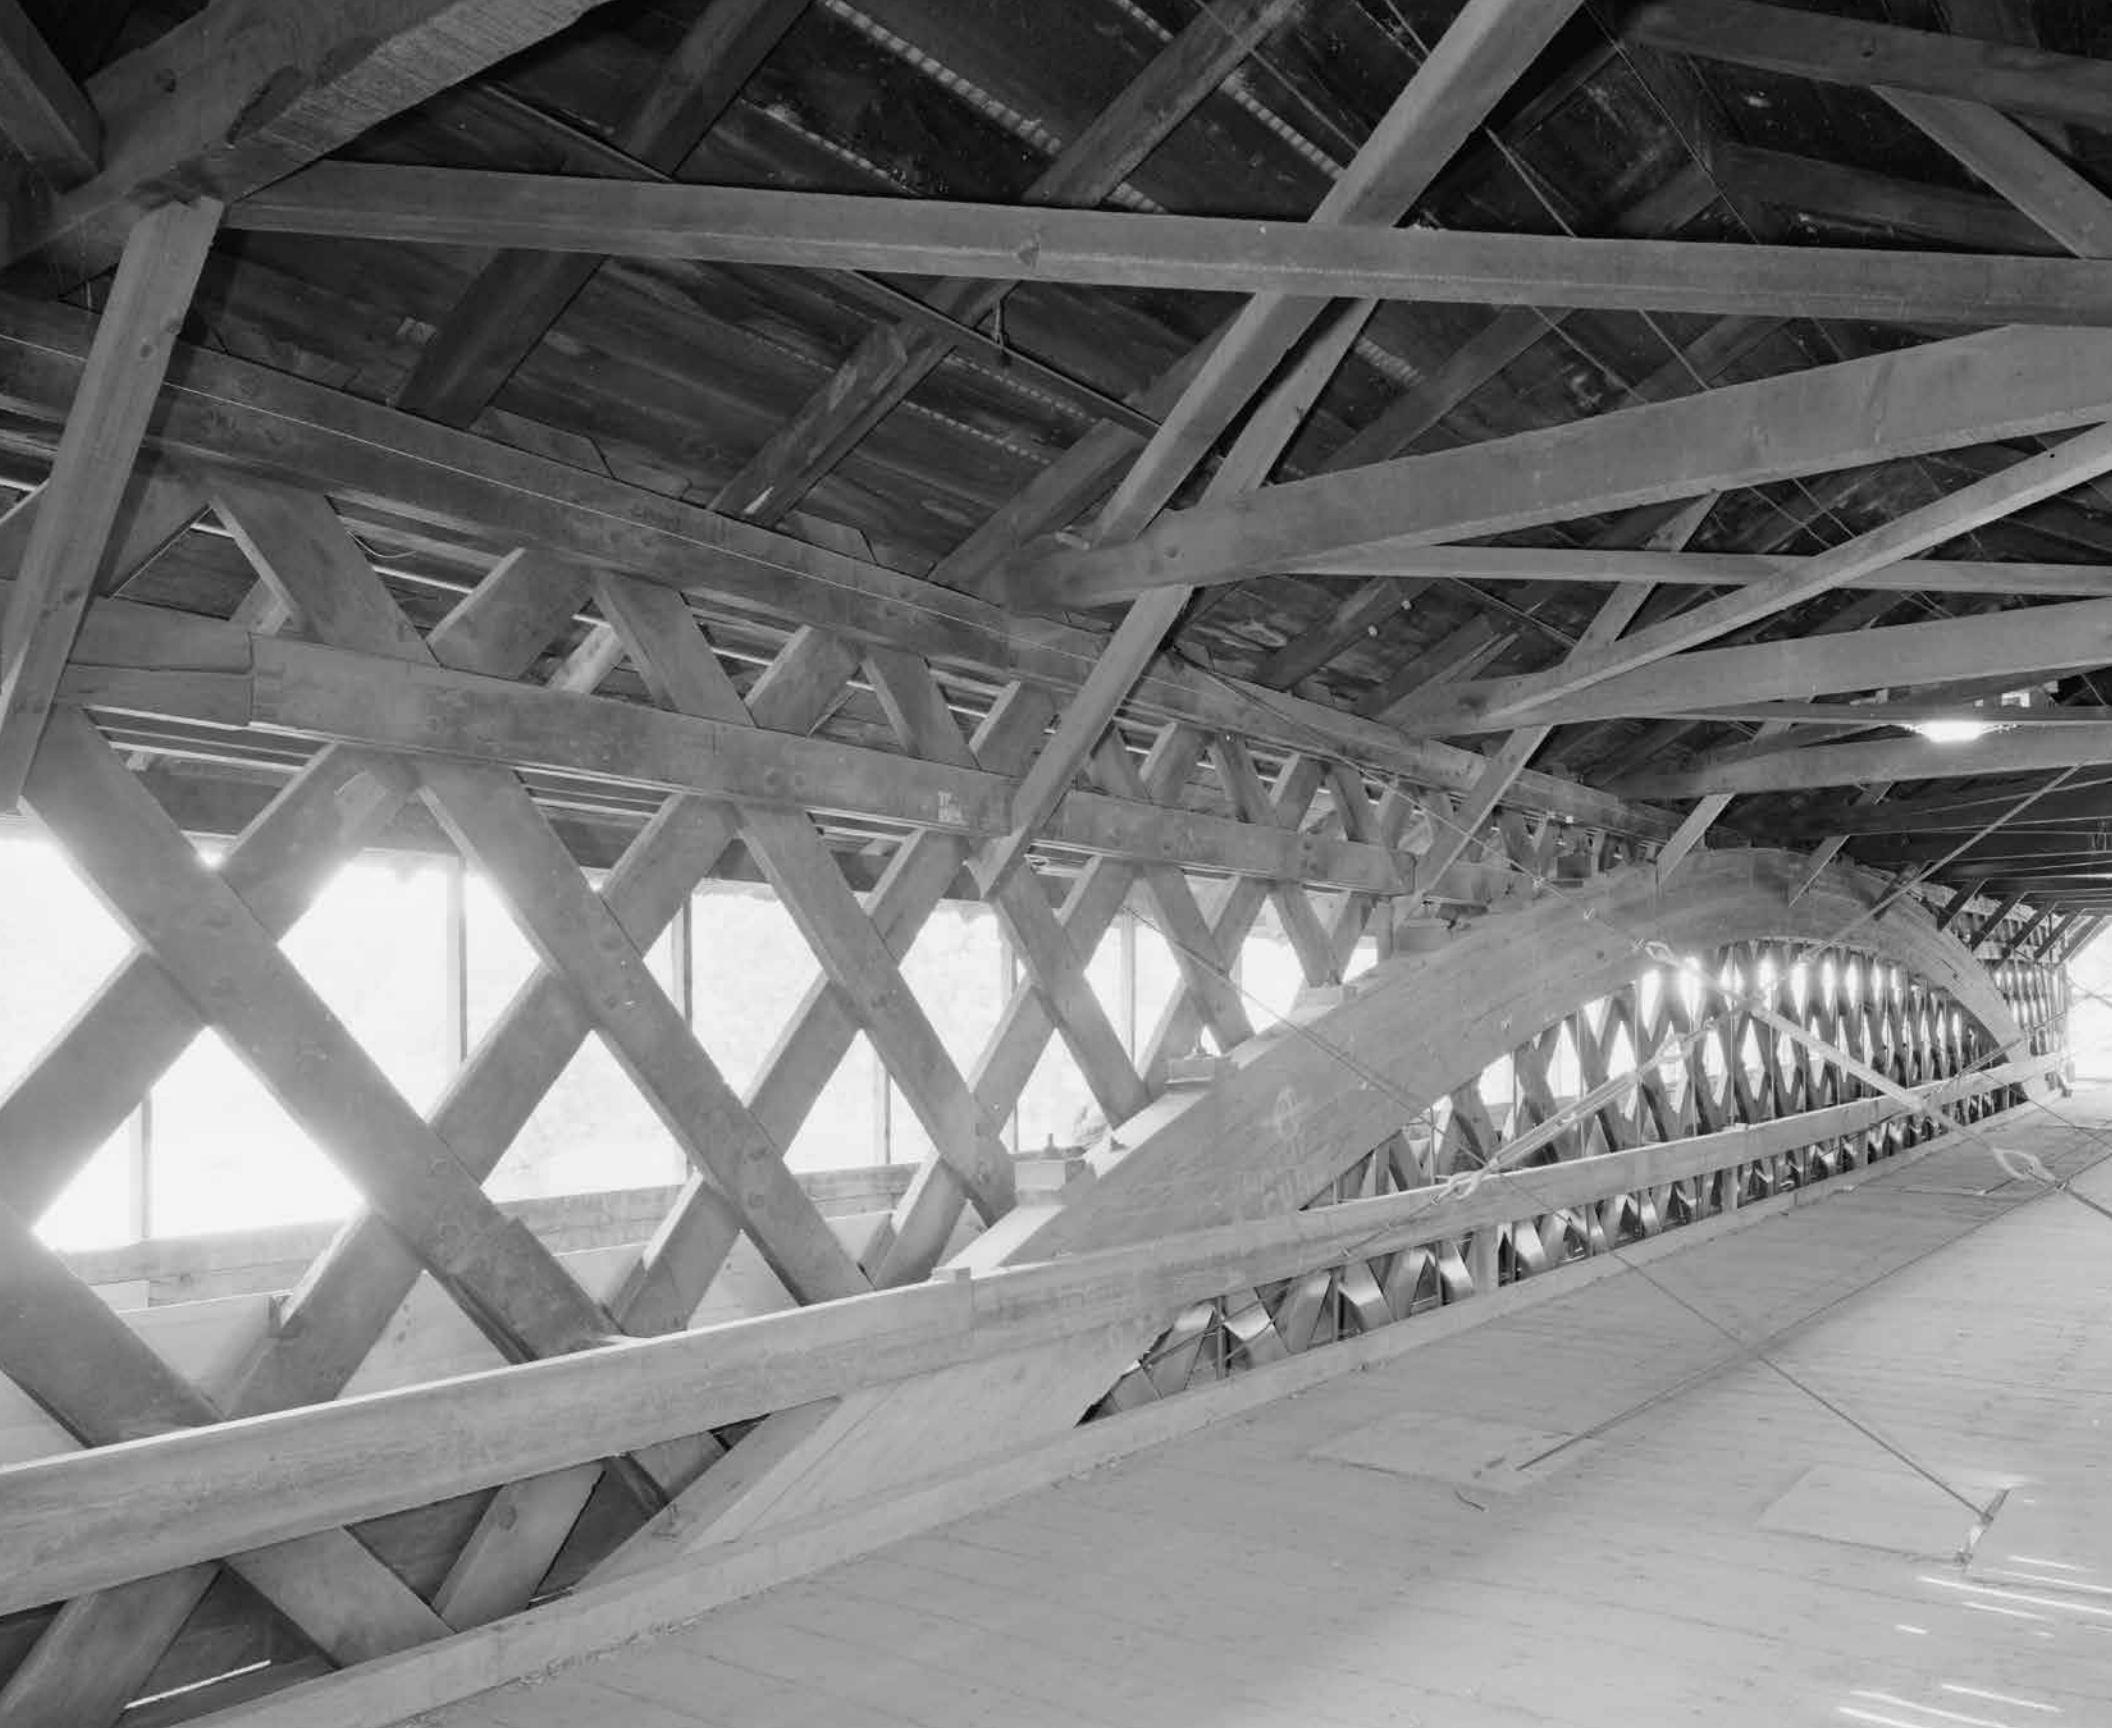
THE SECRETARY OF THE INTERIOR'S STANDARDS FOR REHABILITATION

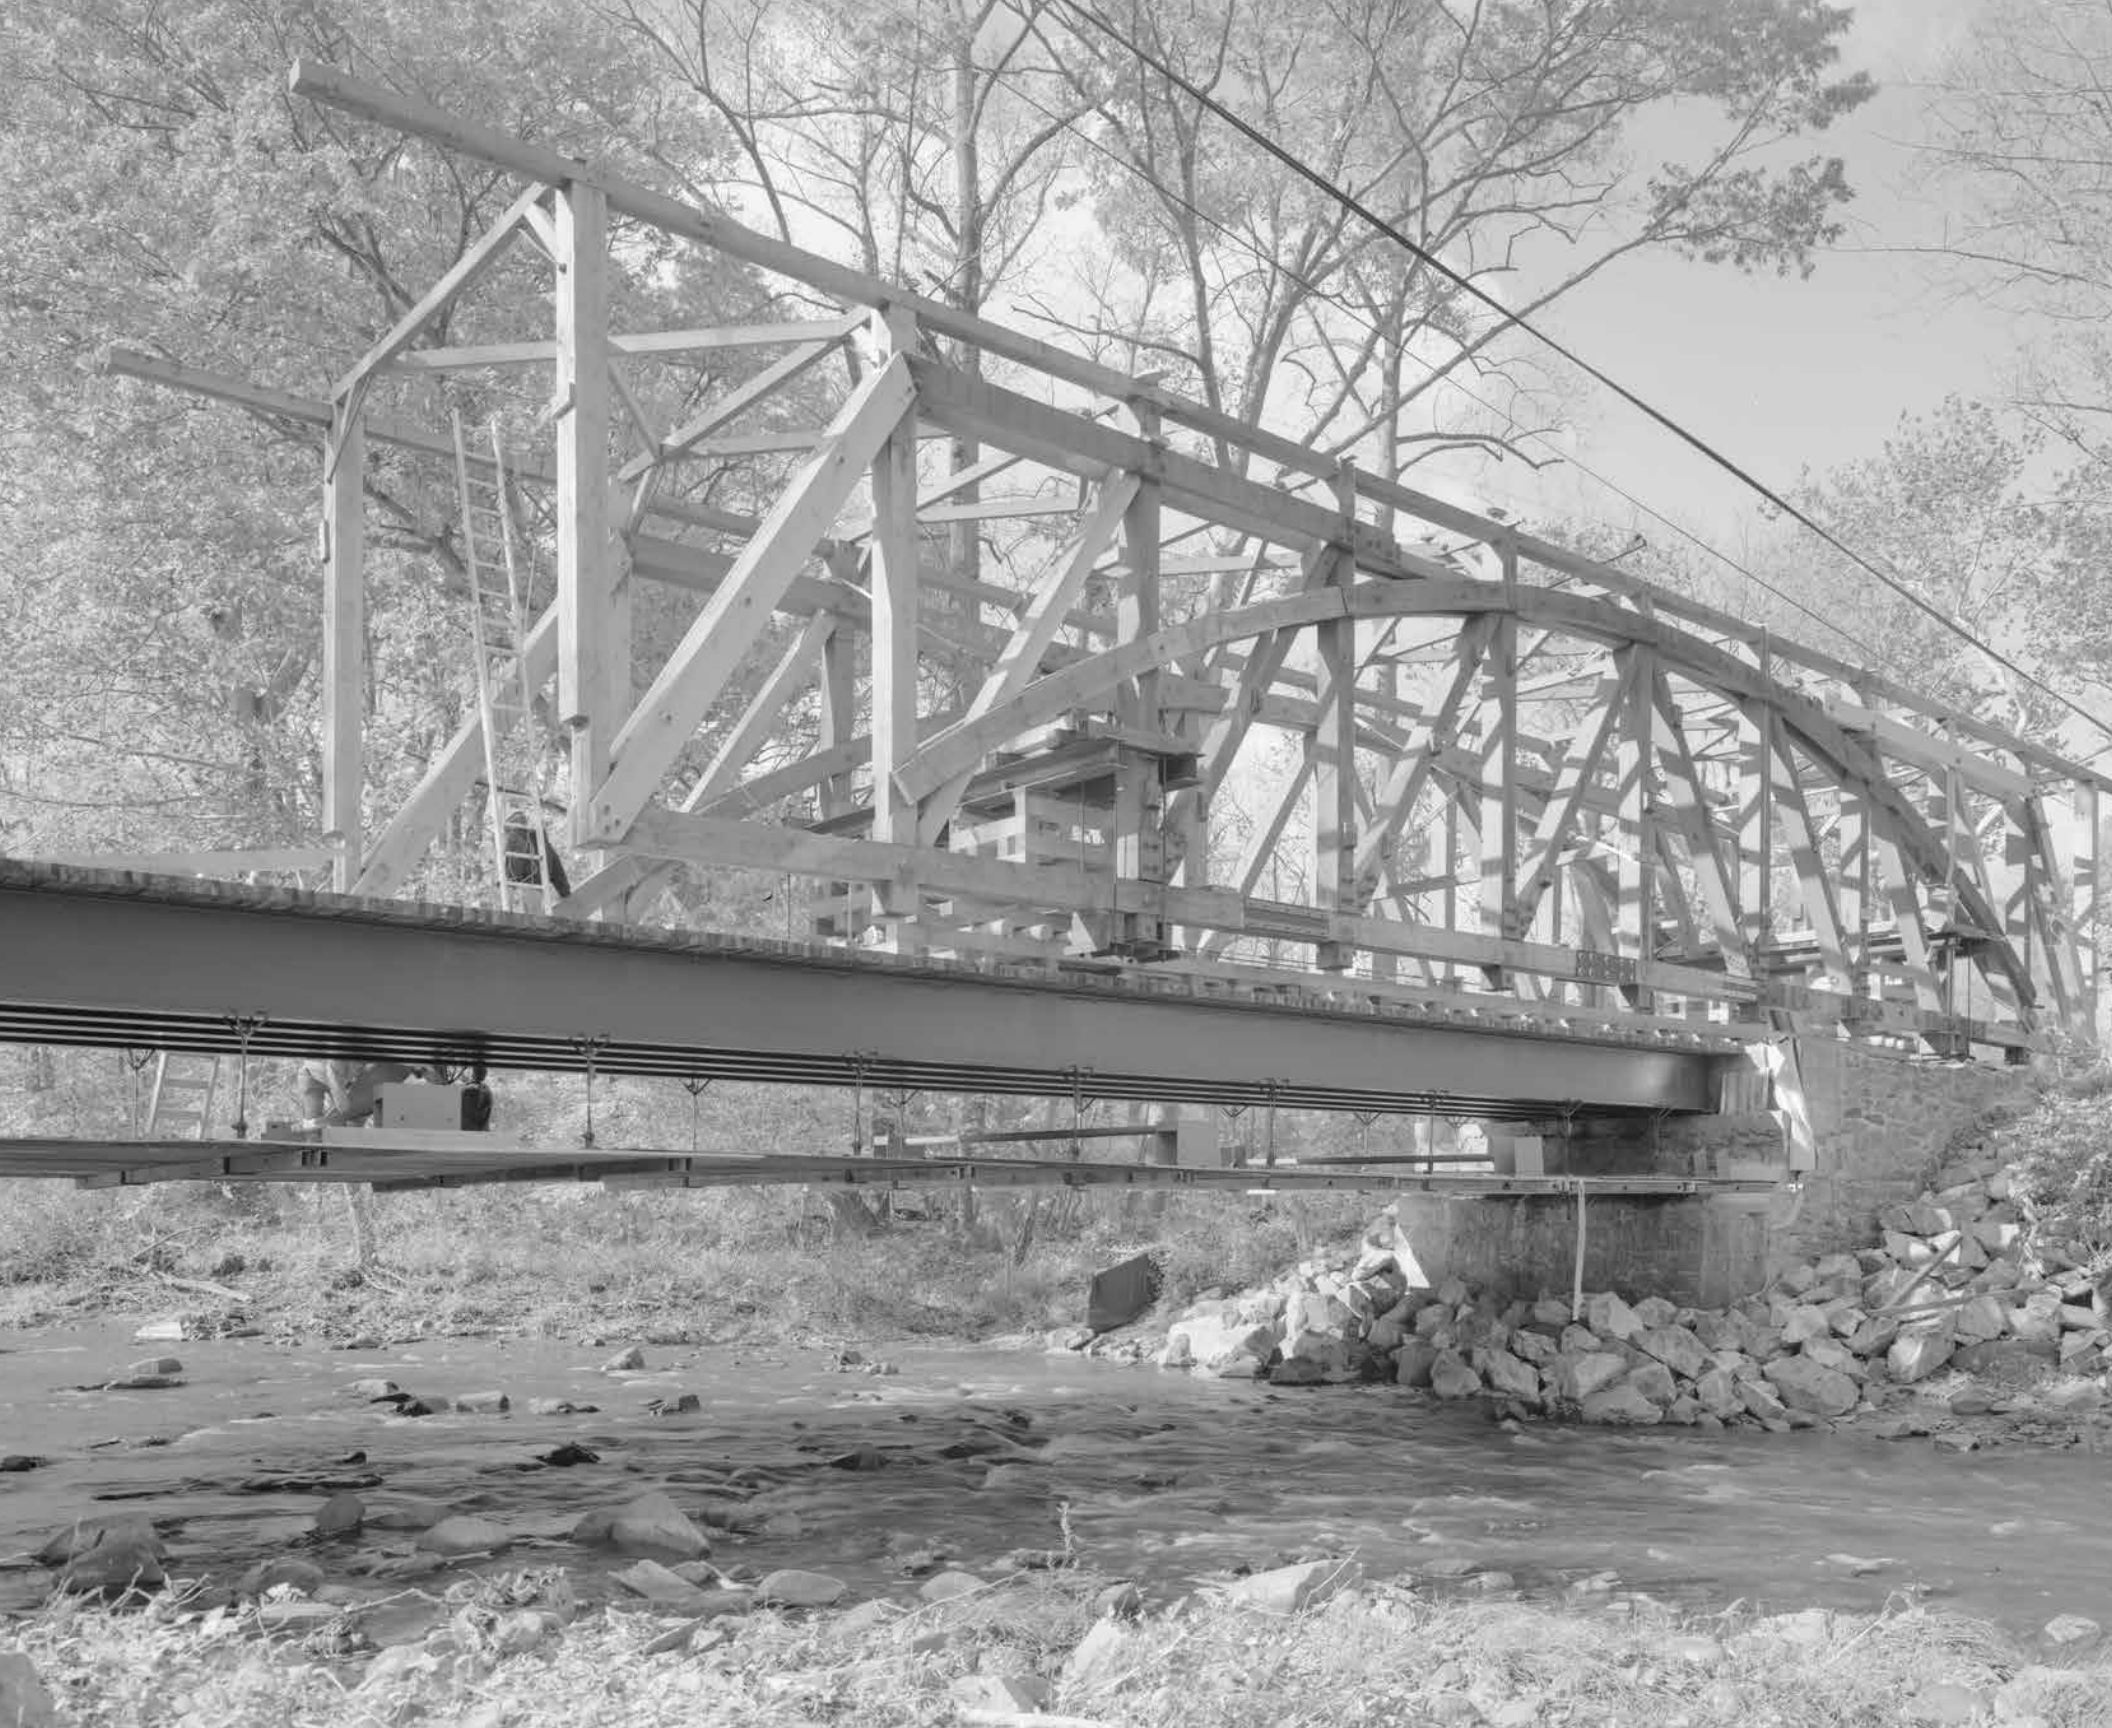
Figure 0.10 The oldest Town lattice truss in the country, the Bath-Haverhill Bridge in New Hampshire was stabilized with a series of cross-bracing to maintain the bridge's alignment during rehabilitation. HAER NH-33-14, Jet Lowe, 2003.

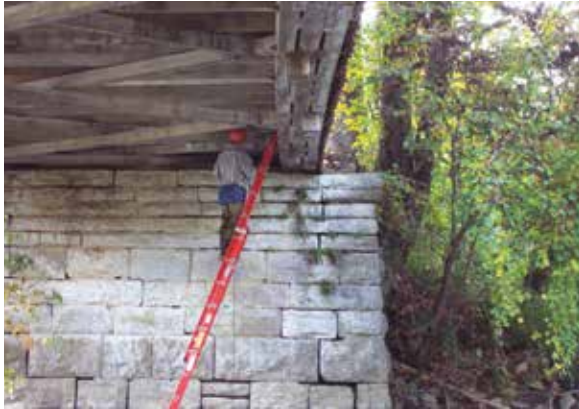
Figure 1.2a-b An engineer inspecting the abutment and lower chord, focused on analyzing the decay at the bearing seat. Below, sweeping the trusses and horizontal surfaces at least once a year is simple yet effective maintenance procedure.

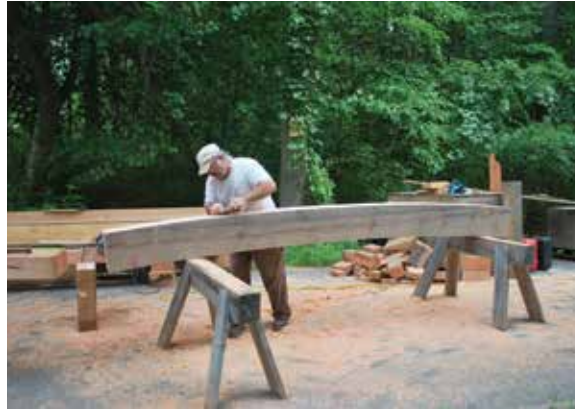
Figure 1.2c-d Using an experienced craftsman to replicate an arch member and recreate character defining features such as notches for a Burr-arch truss.

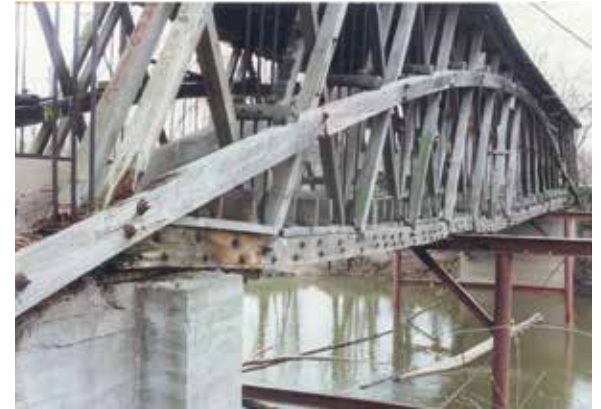
Figure 1.2e-f Negative camber from decayed lower chord at Adams Mill Bridge, IN. The solution was to jack up the bridge 2 feet and replace the lower chord with four smaller timbers, saving 90% of diagonals and arch members in the truss. A new window was added, allowing visitors to take pictures of the adjacent historic mill while an awning keeps rain out.

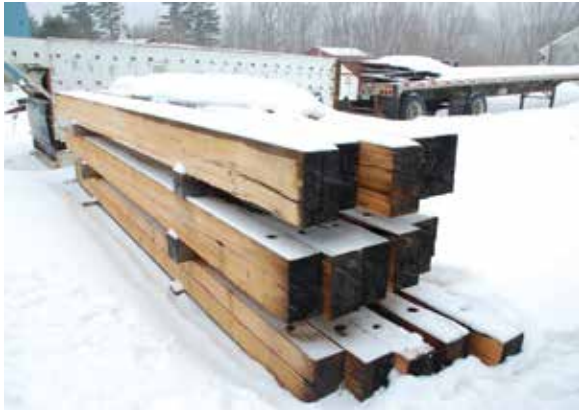
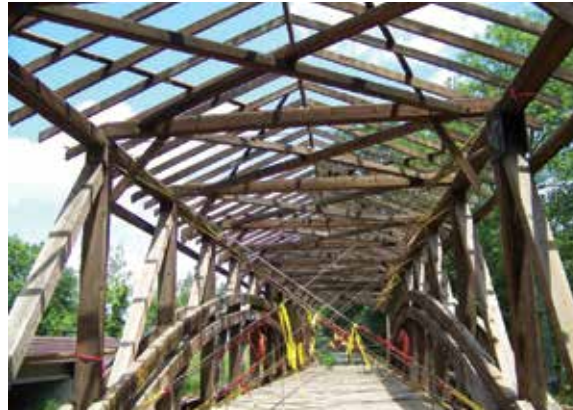
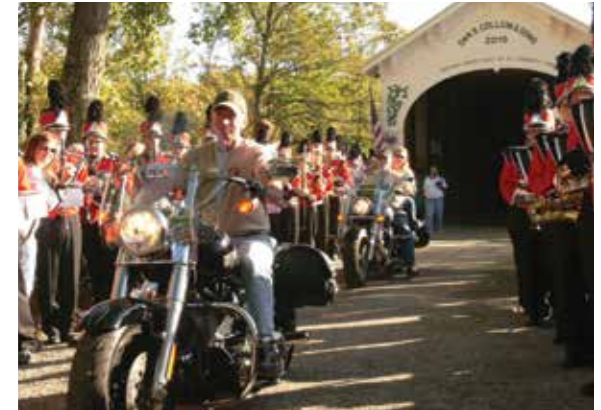
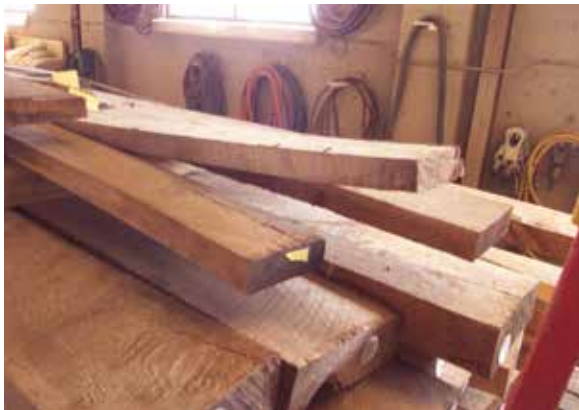
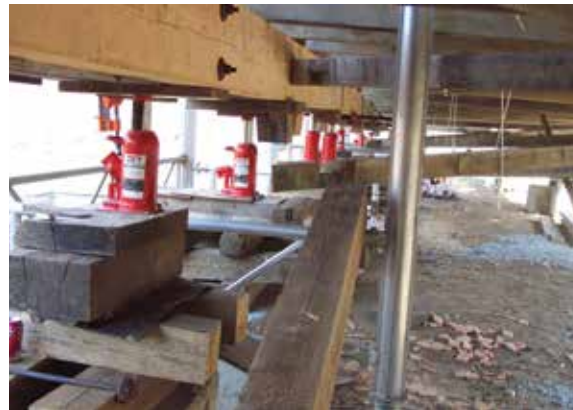
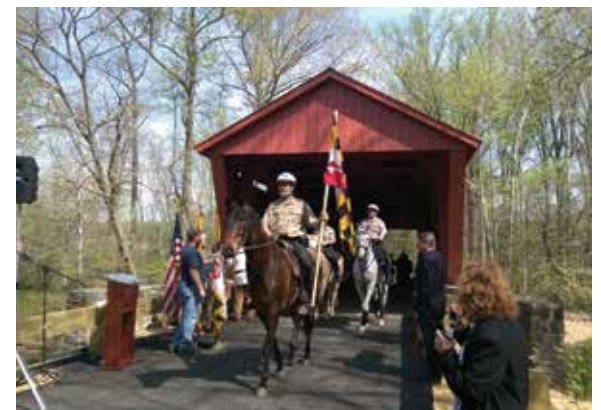
Figure 1.3a-b Seasoning timbers outdoors, even over a snowy winter, is the preferred method of drying structural timbers, time permitting. Below, white oak timbers being air-dried in a heated garage. While the drying process is expedited, the exterior of the timbers dry quicker than the interior, which can cause checking or warping. (Note that checks on compression members don't affect its structural capacity.)

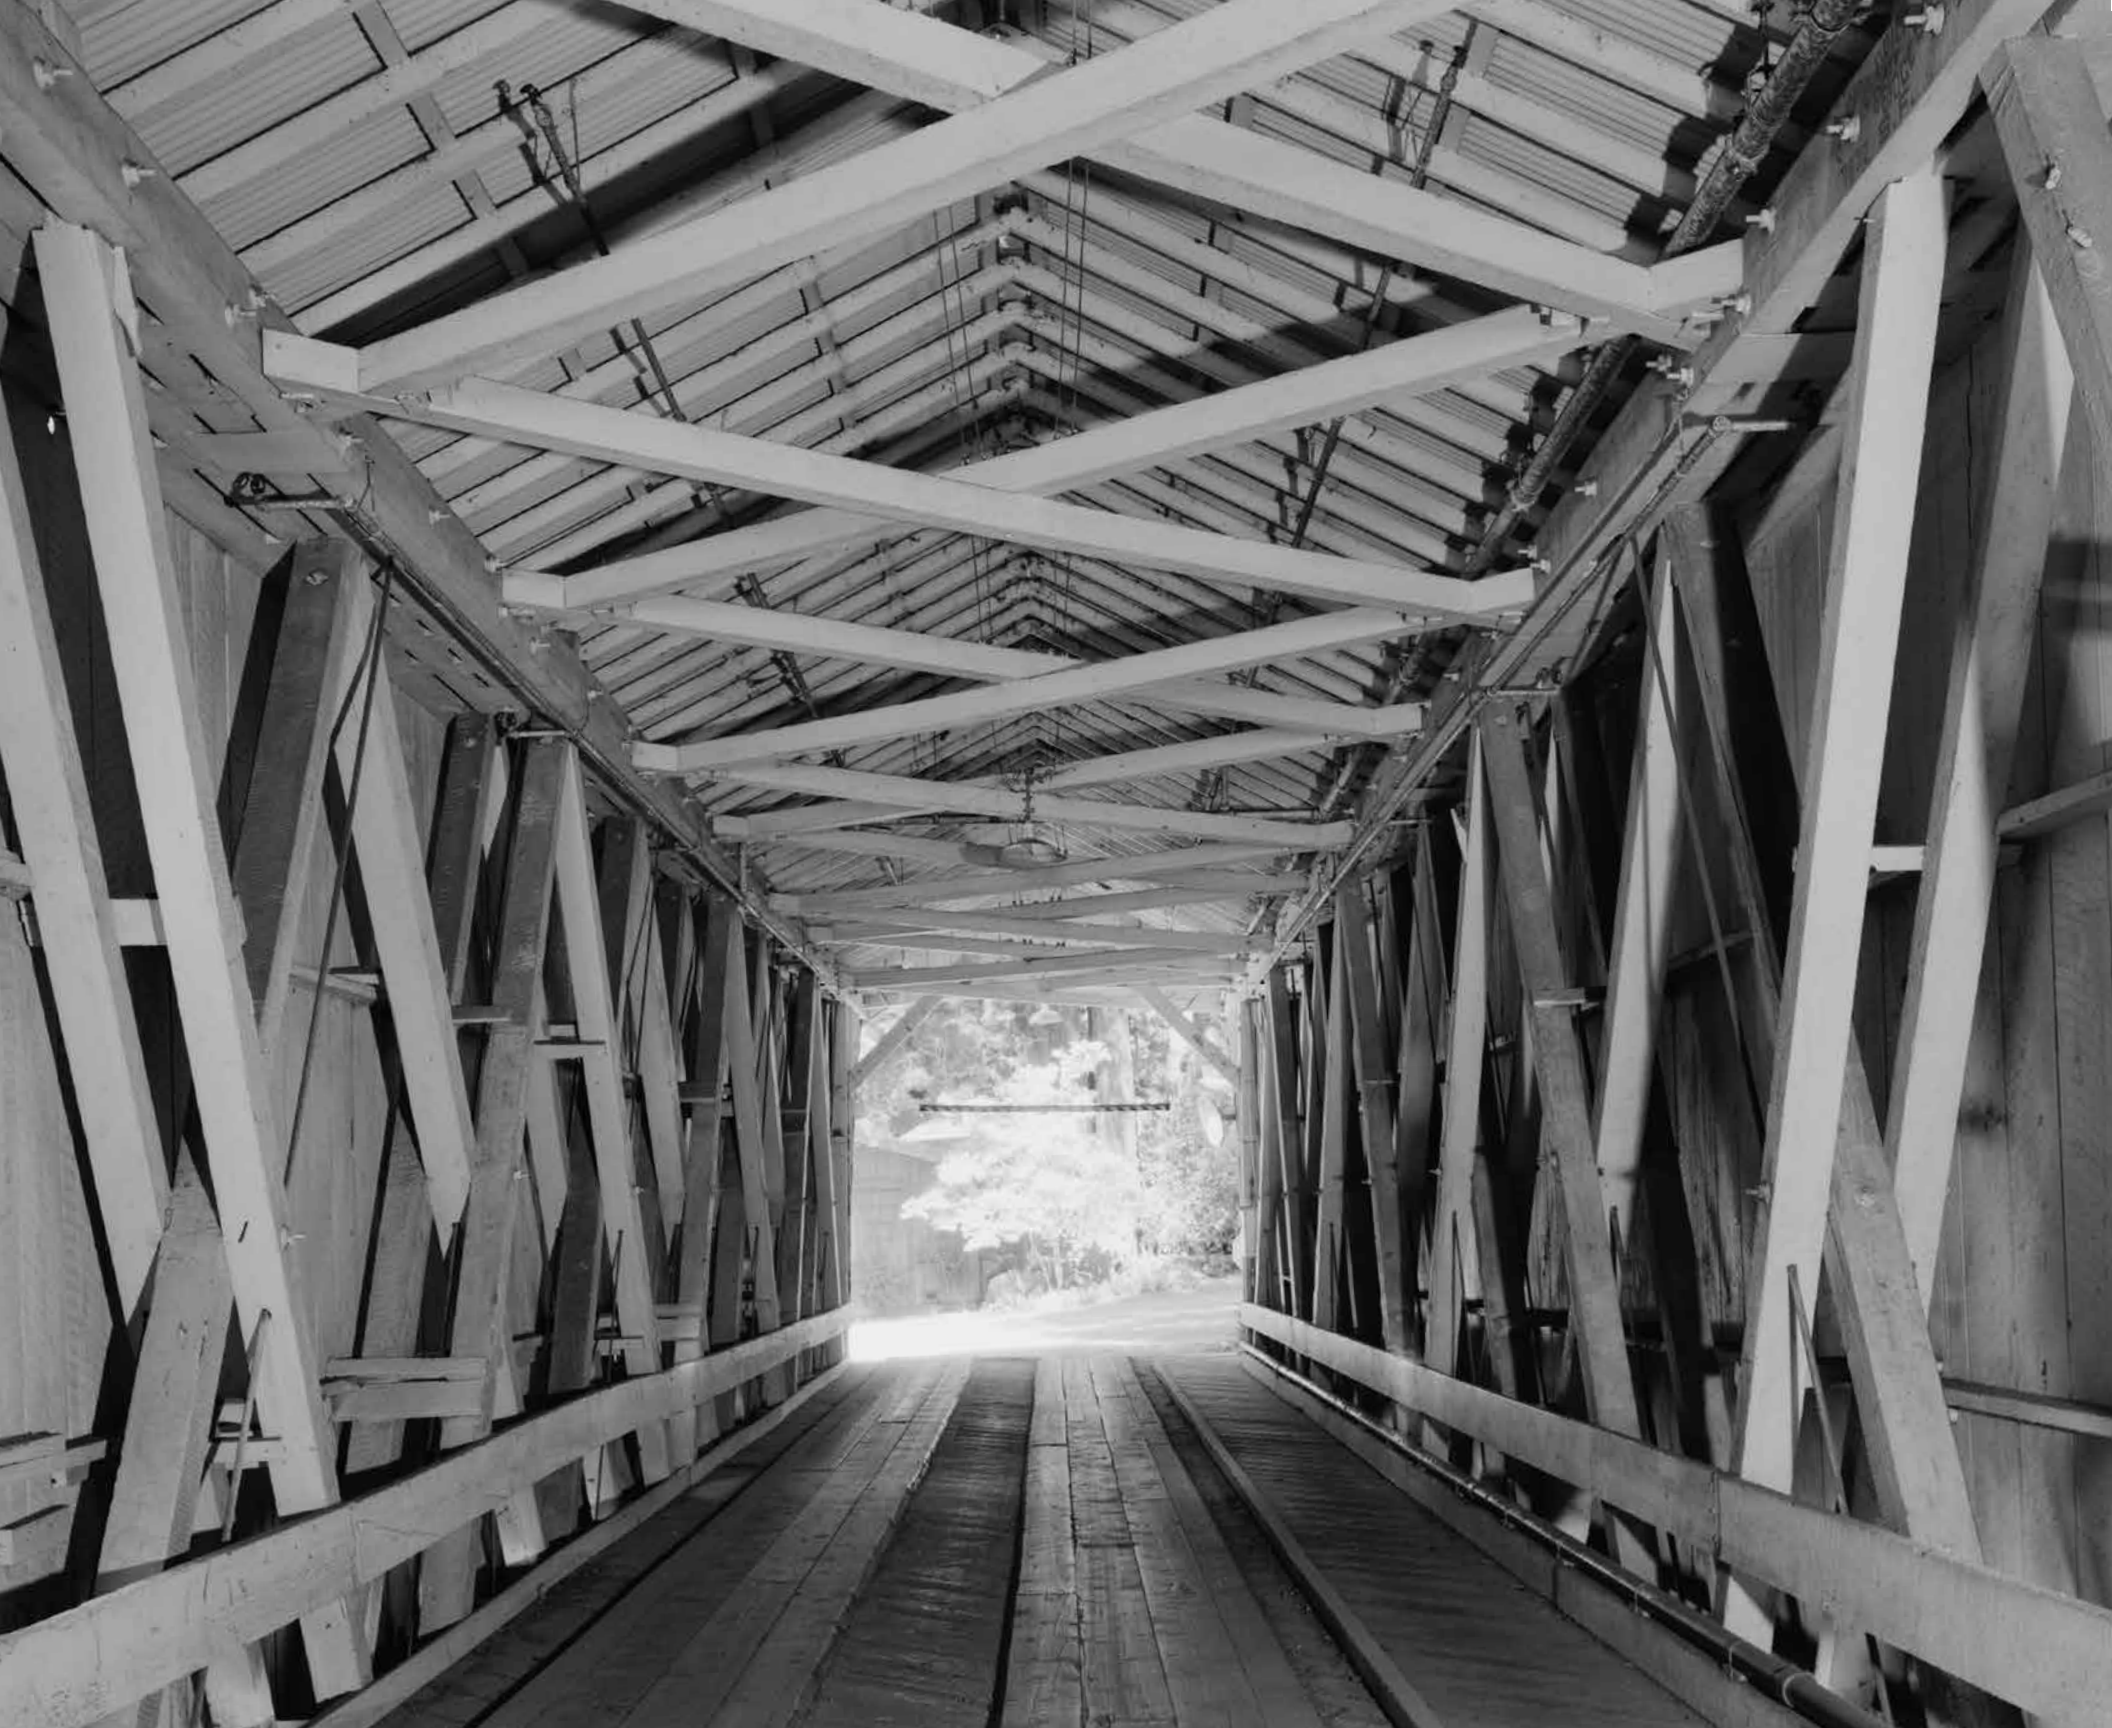
Figure 1.3e-f At the end of the project: celebrate! Indiana Governor Mitch Daniels opens the Moscow Covered Bridge leading a motorcycle parade. Below, mounted Maryland state park rangers at the Jericho Road Covered Bridge opening.

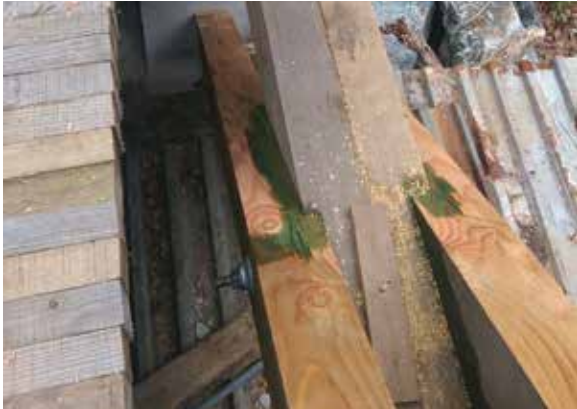
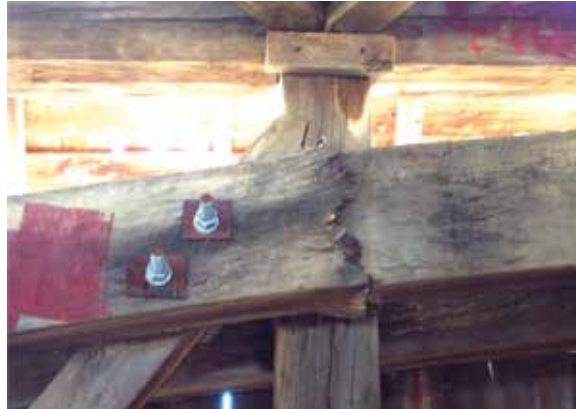
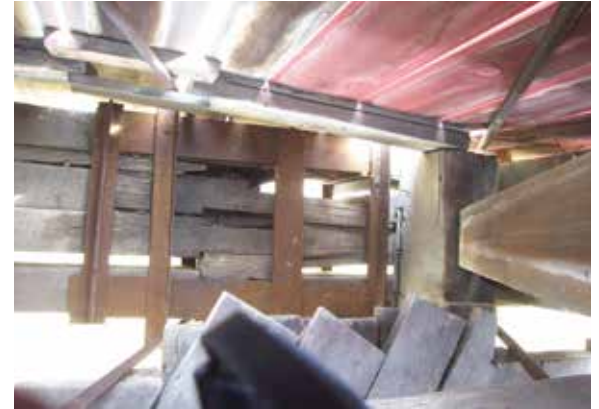
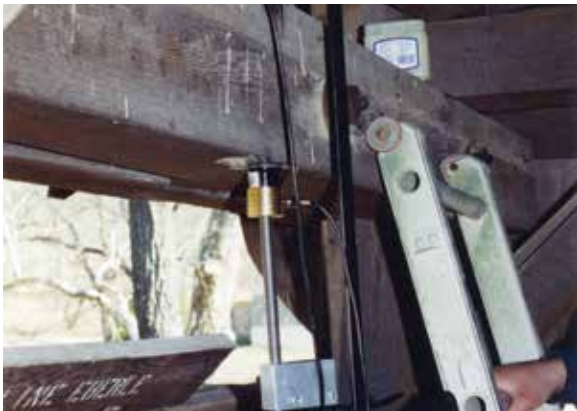
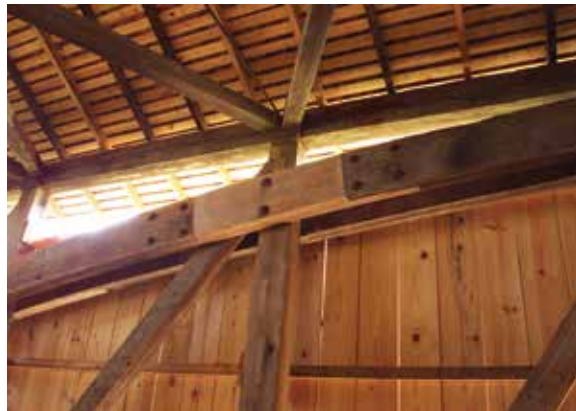
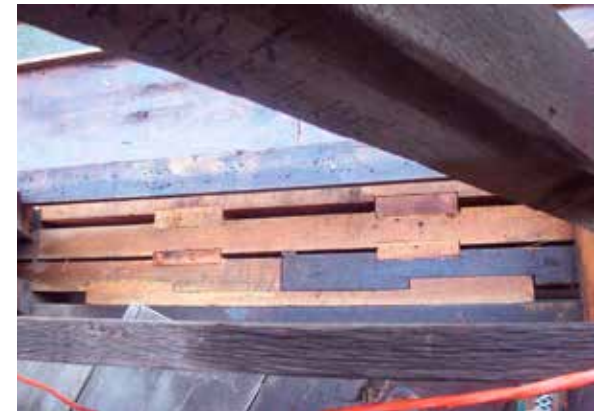
Figure 2.2a Copper naphthenate is an excellent preservative to protect from moisture infiltration, recommended to be painted on each timber to timber joint. **Figure 2.2b** Ultrasound field testing at the Salt Creek Covered Bridge, OH. The transducers read measurements which identified defective members in need of replacement.

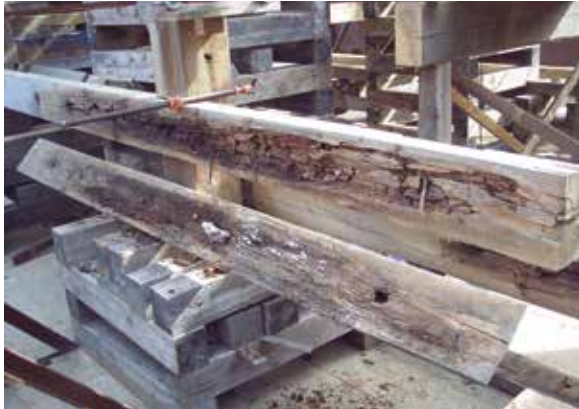
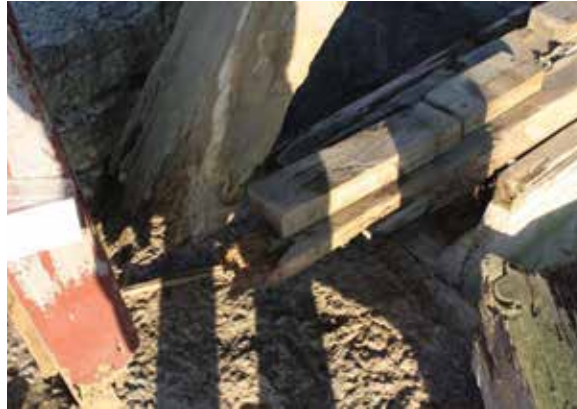
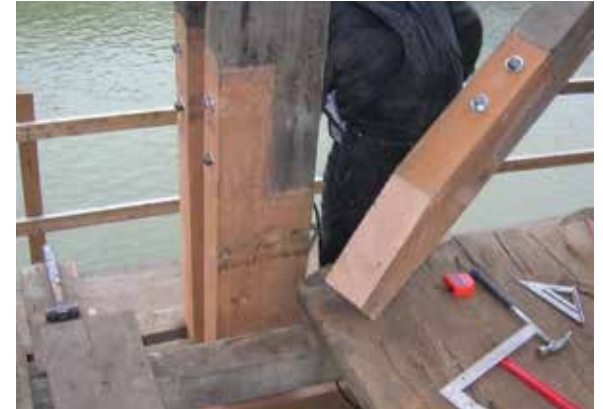
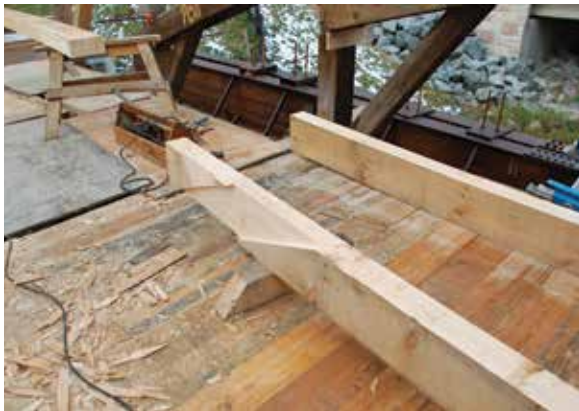
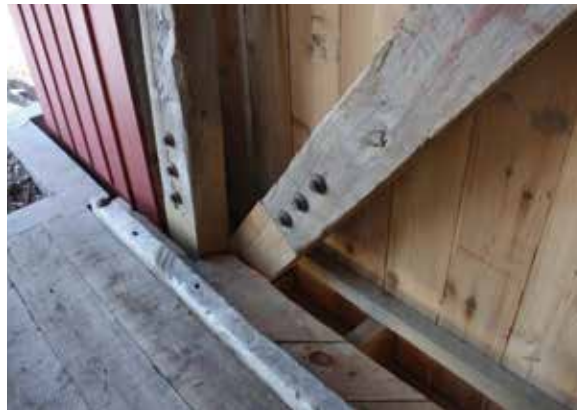
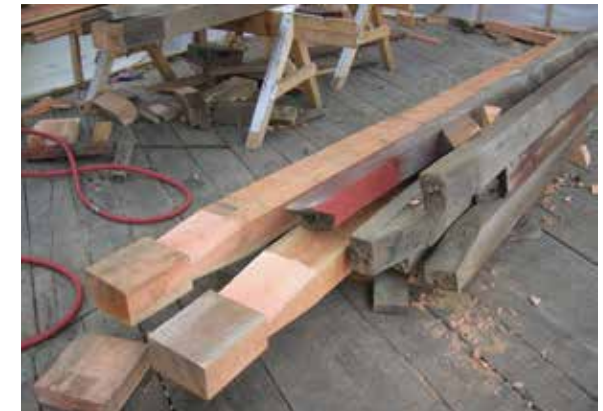
Fig 2.3a-b A rotted section of a lower chord, not discovered until after the siding was removed. Below is a sample of replacement chord members, dressed to accept the arch.

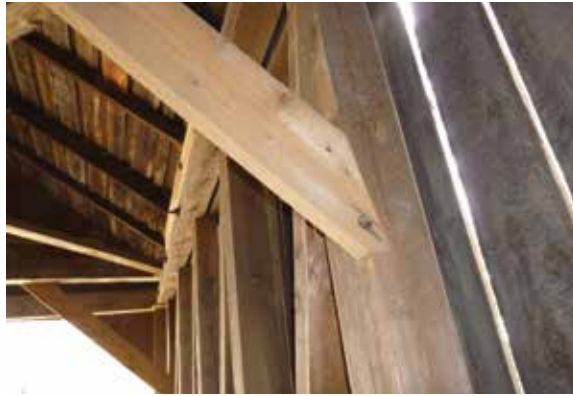
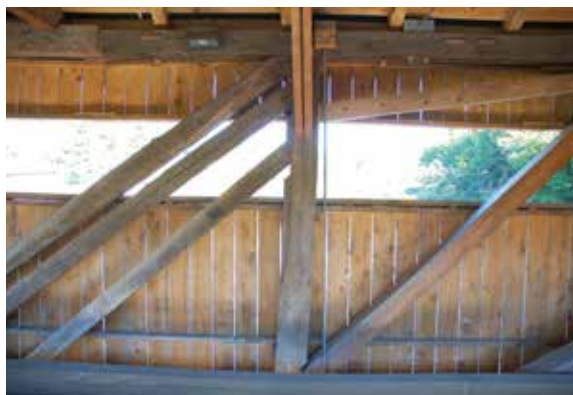
Figure 2.4c-d Top: Replacing in kind with traditional notched sway bracing, fastened with a nail. Below: Inserting replacement timbers in kind while preserving many of the original hand hewn braces at Taftsville Bridge, VT.

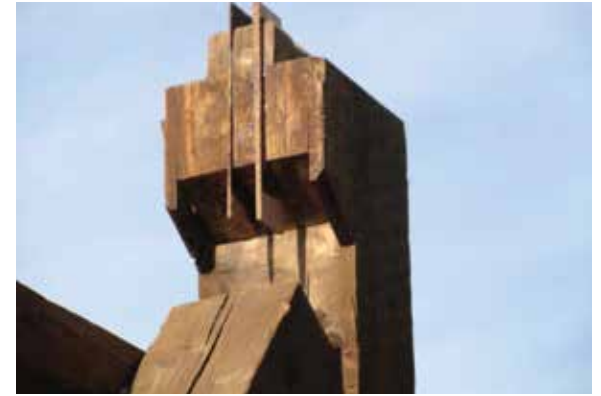
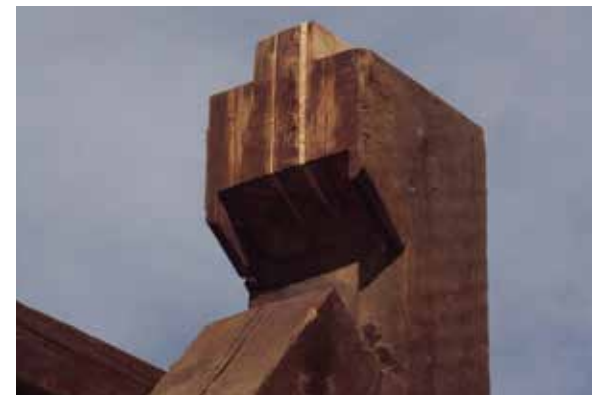
Figure 2.4e-f The repair of the jowl of this low-stressed post incorporates salvaged, in kind material at Gilpin's Falls, MD. Multiple close-fitting pieces of wood were used in the repair process, as was waterproof glue.

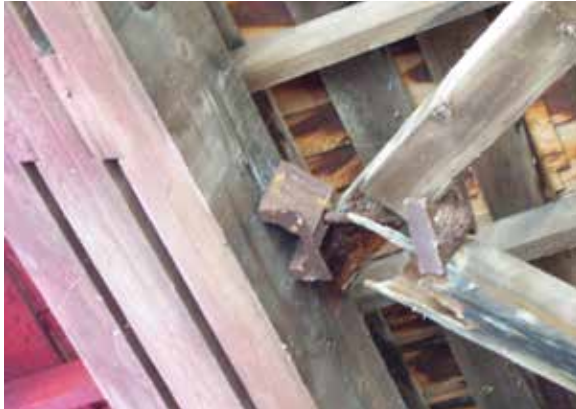
Figure 2.5a-b Original upper lateral bracing members of the Smith truss at Cataract Bridge, IN, had rotted due to a leaking roof. They were replaced in kind, keeping the original hardware.

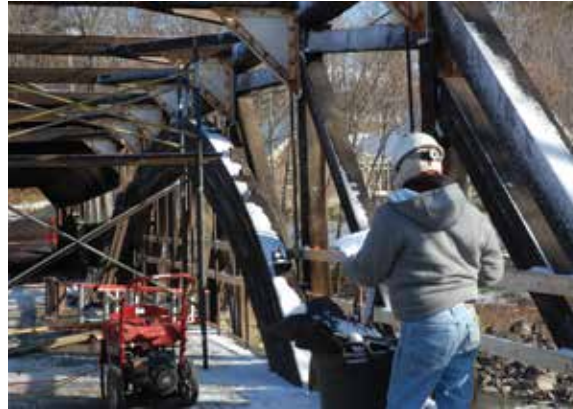
Figure 2.5c-d Riveted steel gusset plates were added in the 1950s at Taftsville Bridge, VT. This non-historical intervention was reversed during rehabilitation with traditional timber sway braces.

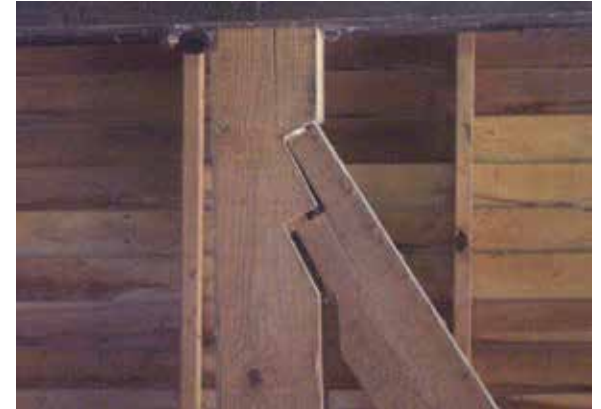
Figure 2.5e-f An example of a loose diagonal brace with traditional stepped notches in need of adjustment. Below, a replacement tension diagonal matches the double-stepped connection of the original post in a Smith truss at Rinard Bridge, OH.

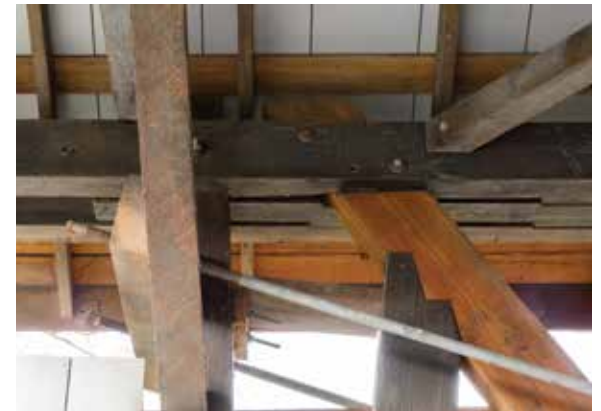
SUPERSTRUCTURE FEATURES

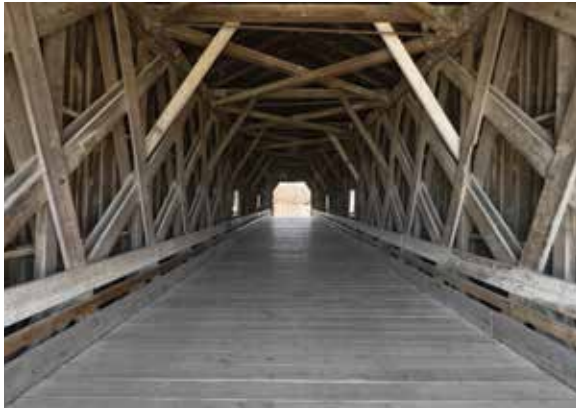
Figure 2.6a Transverse deck plank, laid below a curb and rub rail at Zumbrota Bridge, MN. **Figure 2.6b** Running boards act as a sacrificial wear surface, are often installed to accommodate heavier traffic, prolong the life of the decking, and can also act as a speed deterrent.

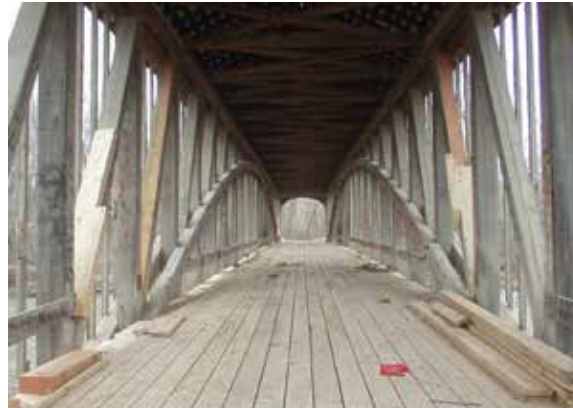
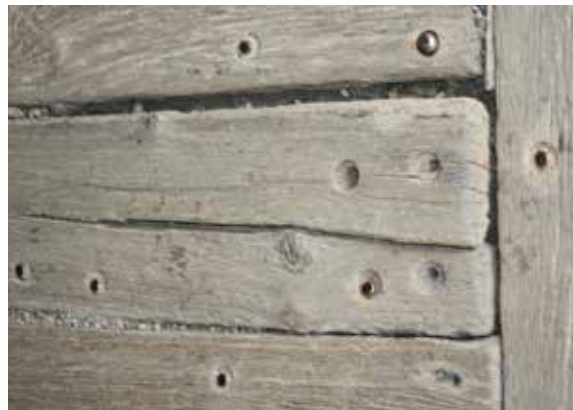
Figure 2.6c-d Newly installed longitudinal decking (running plank) at Forsythe Bridge, IN. Below, even a weathered and worn floor system should be inspected carefully to see if it could perform as required. Repairs and/or additional fasteners might preserve the floor's rich visual record of service.

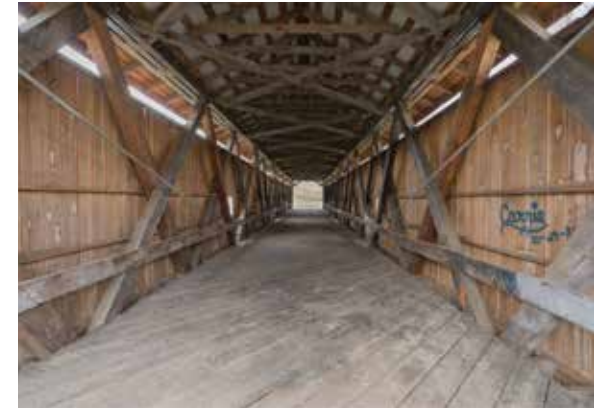
Figure 2.6e Diagonal decking found at Rinard Bridge, OH. **Figure 2.6f** Nail-laminated decking is typically not a historically correct treatment and should be replaced in most cases (unless it was the original decking system).

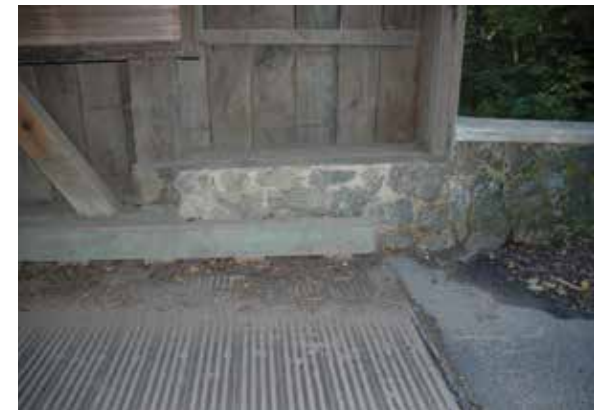
SUPERSTRUCTURE FEATURES

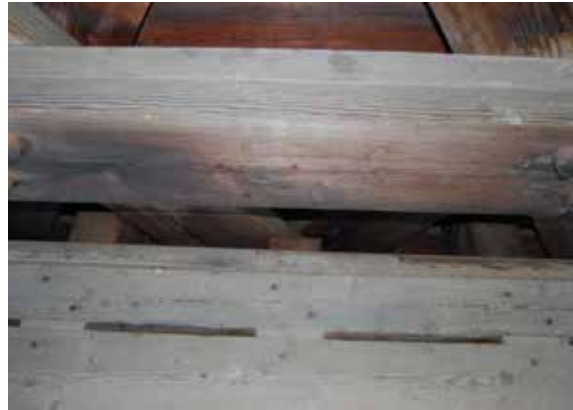
Figure 2.7c-d Detail showing spacers below the curb, allowing for dirt and runoff to easily leave the deck, reducing rot on the deck and lower chord below, at Henniker Bridge, NH. Below, original diagonal stringers preserved at King's Bridge, PA.
