GUIDELINES FOR REHABILITATING HISTORIC COVERED BRIDGES

Edited by Christopher H. Marston and Thomas A. Vitanza

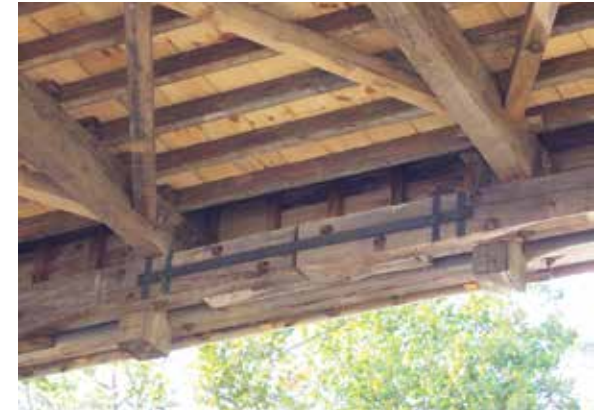
Figure 2.7e-f Metal straps and bolts used as part of the historic fishplate design on the Moscow Bridge, IN. Replacing lower lateral bracing in kind on a Howe truss at Stonelick-Williams Bridge, OH.

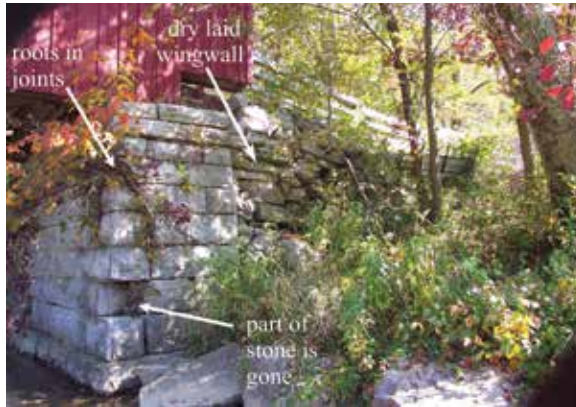
Figure 3.2a-b The engineer's assessment at Cataract Bridge, IN, detected deterioration due to vegetation and roots in the joints. After repair, the abutment stones were relaid to match and riprap added for protection.

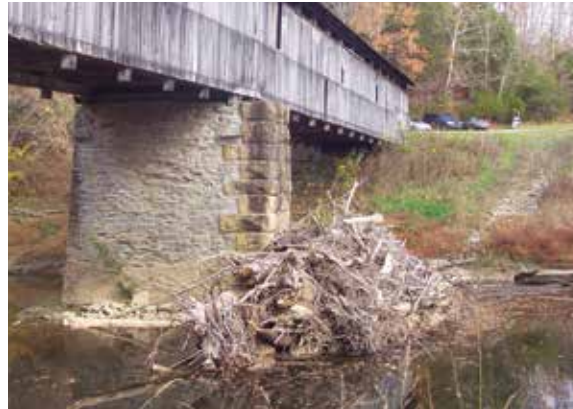
Figure 3.2c-d Flood debris piling up on the center pier at Beech Fork Bridge, KY. The condition required emergency removal to avoid further damage to the bridge. Below, evidence of splintered siding due to flooding at Zacke Cox Bridge, IN.

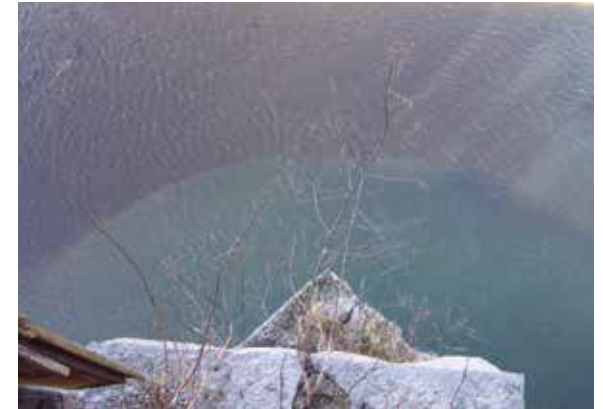
Figure 3.2e-f A circle of scour around a center pier at Medora Bridge, IN. Below, a bolster beam for a Town lattice truss at Henniker Bridge, NH. It sits on a granite pedestal, with spacer blocks below and on top, which allows for easy maintenance and good air circulation.

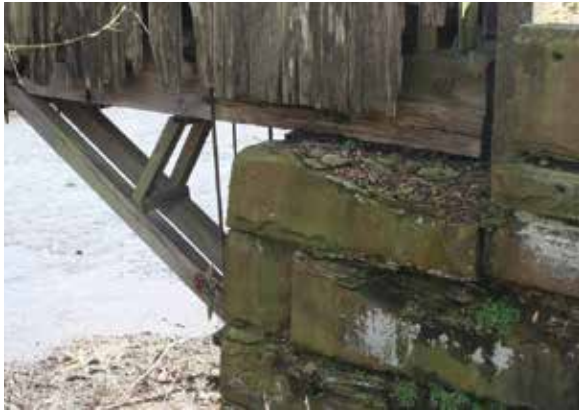
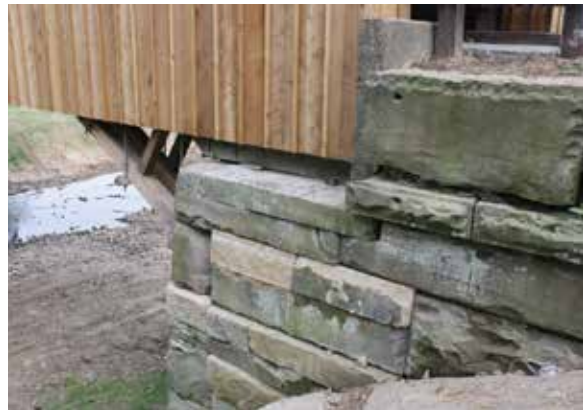
Figure 3.3a-b The timber bearing seat was rotted at Otway Bridge, OH, and replaced by a solid new timber bearing seat (bolster beam, below). Several stones were kept in place in the abutment, while some were replaced in kind.

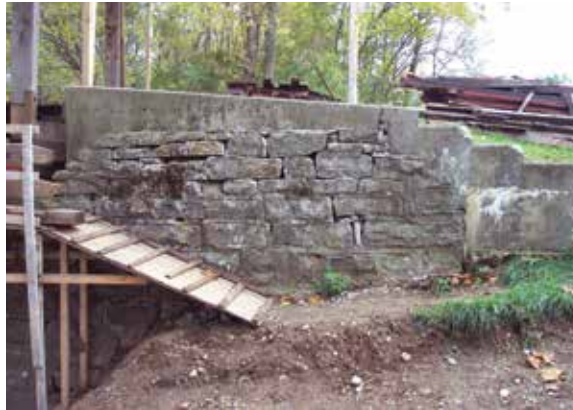
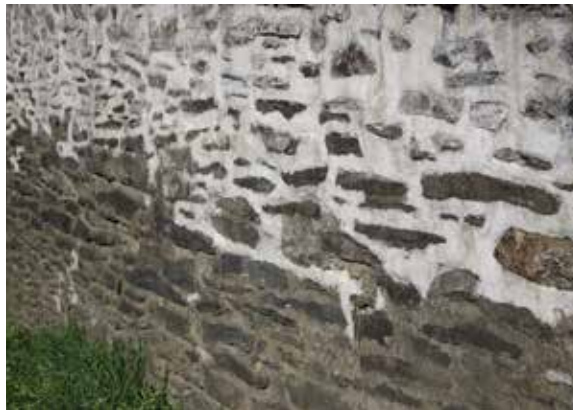
Figure 3.3c-d The reconstructed wingwall at Eldean Bridge, OH, while being cleaned of all loose mortar and being prepared for repointing. **Figure 3.3d** Not recommended: Mortars should be analyzed to determine compatibility with the surrounding masonry components. Mortar repairs should match both the color and strength of the historic material.

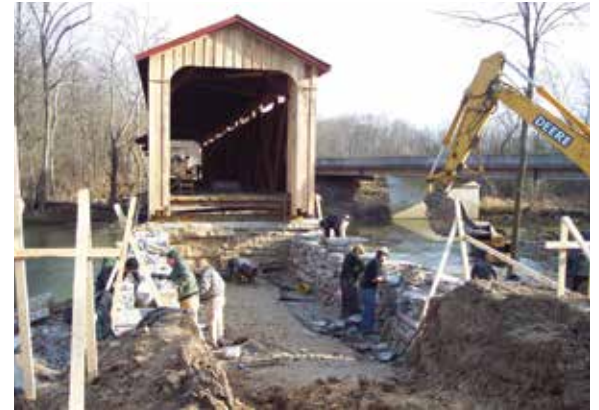
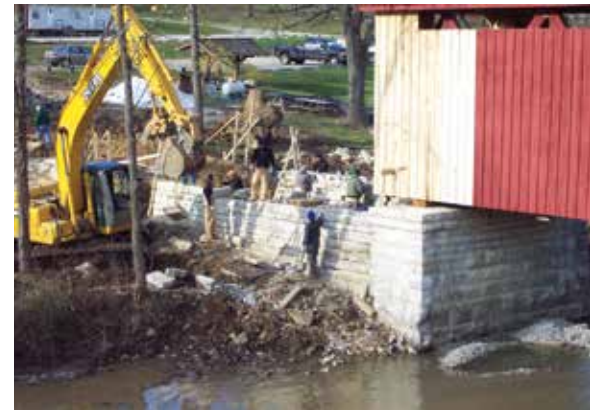
Figure 3.3e-f Reconstructing the dry-laid wing wall behind the abutment at Cataract Bridge, IN. The reconstructed wall matches the original in composition, color and texture, while improving its strength.

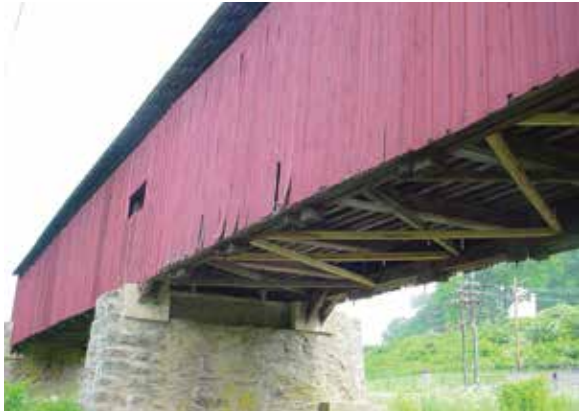
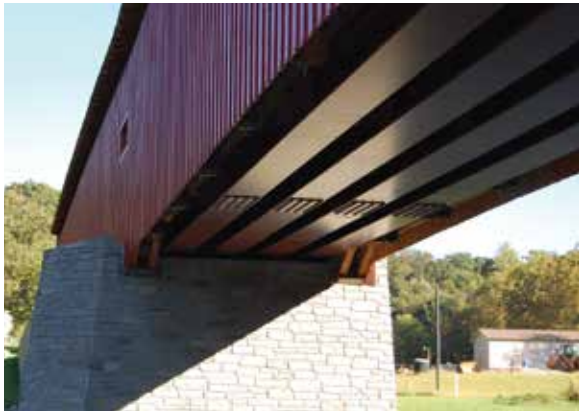
Figure 3.4a-b When repairing or replacing masonry elements, similar materials and construction techniques should be utilized. If possible, modern veneer panels should be avoided, such as at Pine Grove Bridge, PA, where the original floor system was replaced by steel I-beams.

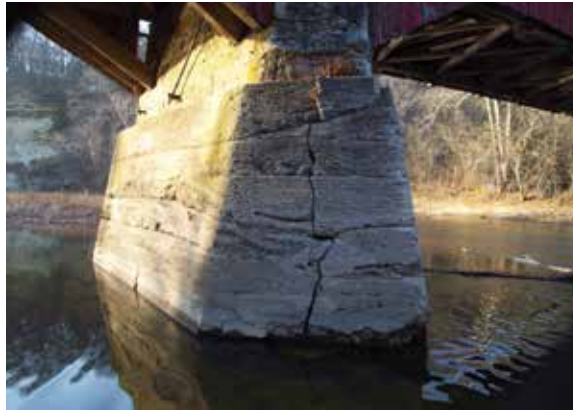
Figure 3.4c-d Structural failure due to cracking in the center pier at Deers Mill Bridge, IN. The crack was patched and a new concrete apron poured underneath to stabilize the pier.

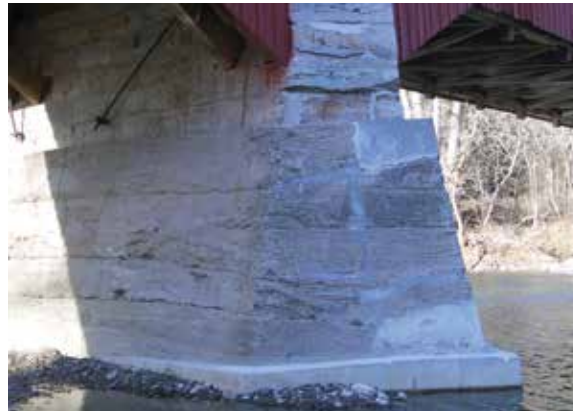
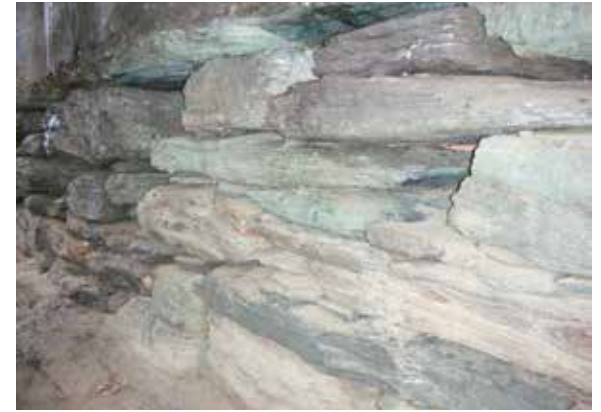
Figure 3.4e-f Chinking (filling joints with small stones) rather than the introduction of mortar is the proper rehabilitation method for a dry-laid wall. Below: Preserving the original stonework at Rinard Bridge, OH. The hold down rods (an original design feature) have been replaced in kind, which helps keep the bridge in place during a flood event.

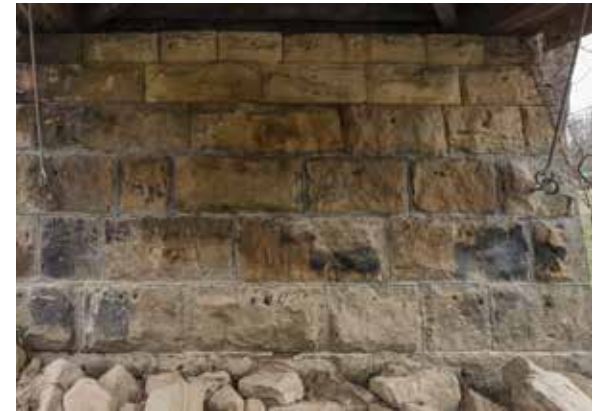
SUBSTRUCTURE FEATURES

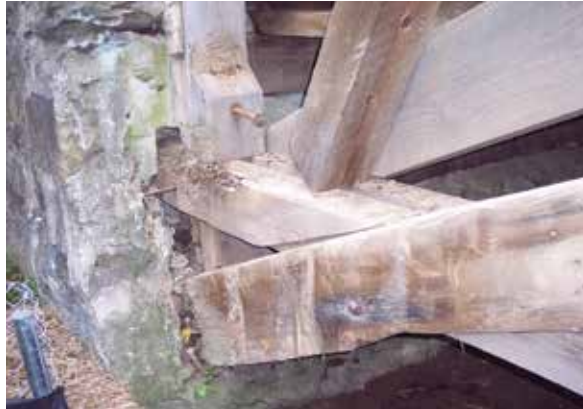
Figure 3.5c-d Before/after abutment at Gilpin's Falls Covered Bridge, MD. The arch, chord, and post were all encapsulated in concrete, leading to heavy decay. The reconstructed abutment was designed to allow ease of cleaning and maintenance. Note the use of rot-resistant black locust bearing blocks and copper naphthanate to protect and defend the arch ends, end post, and end brace against decay.

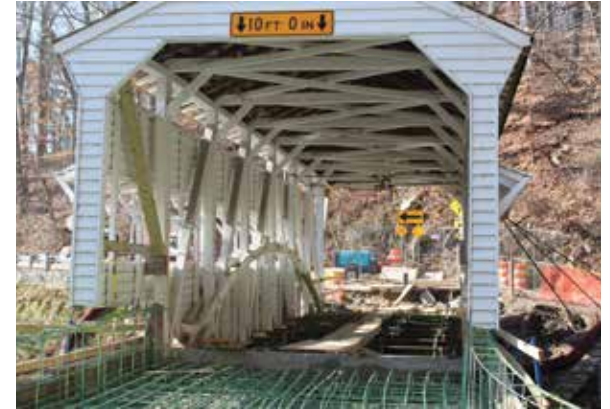
Figure 3.5e-f Before/after abutment at Knox Bridge, PA. The arch, chord, and post were all encapsulated in concrete, leading to heavy decay. The reconstructed abutment was designed to allow ease of cleaning and maintenance. Note the use of rot-resistant black locust bearing blocks and copper naphthanate to protect and defend the arch ends, end post, and end brace against decay.

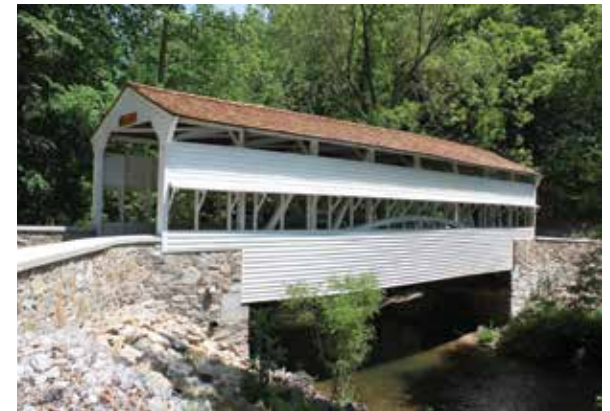
BUILT BY
1888
E.L. KENNEDY

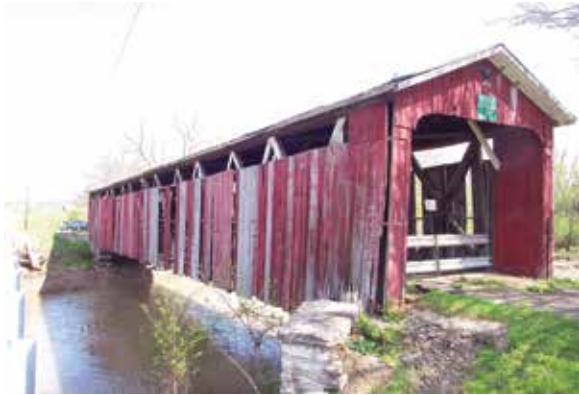
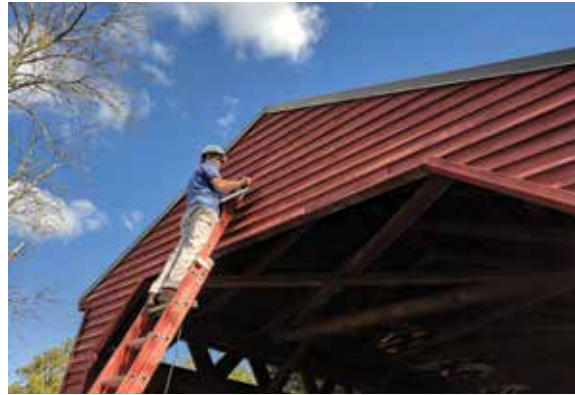
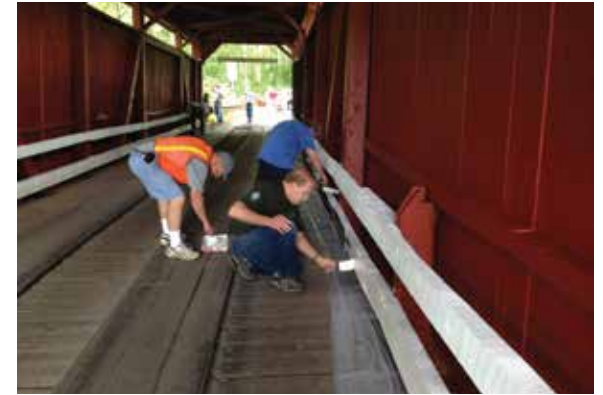
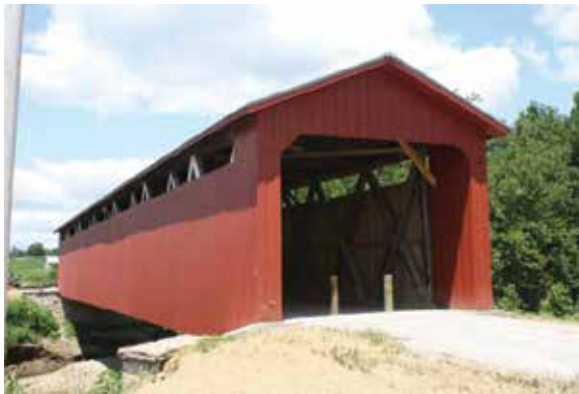
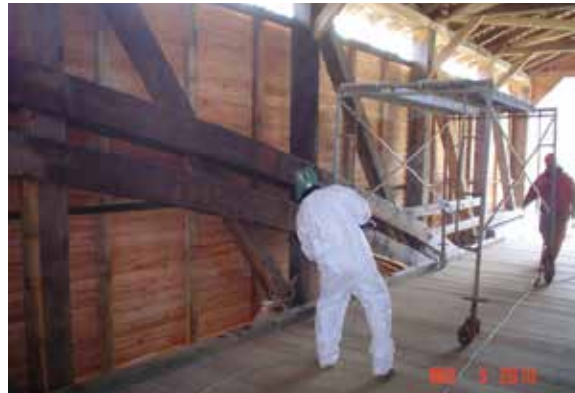
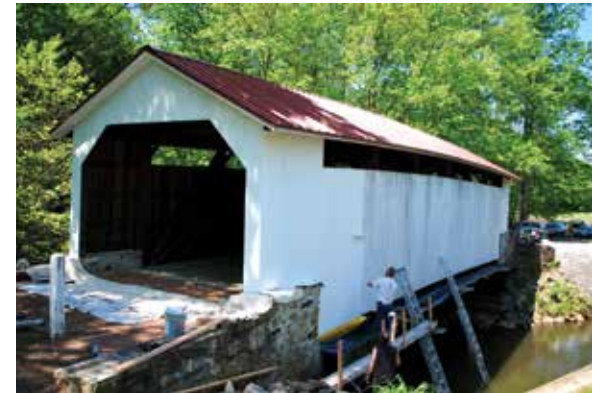
Figure 4.2 a-b Before/after views of the Engle Mill Bridge, OH. When rehabilitating the Smith truss, the bridge team re-sided and repainted in kind, maintaining the same openings to match the original.

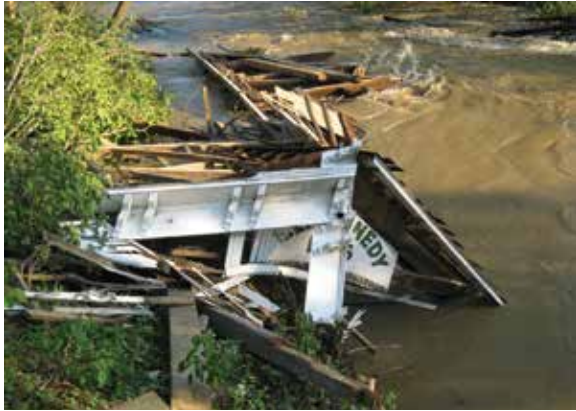
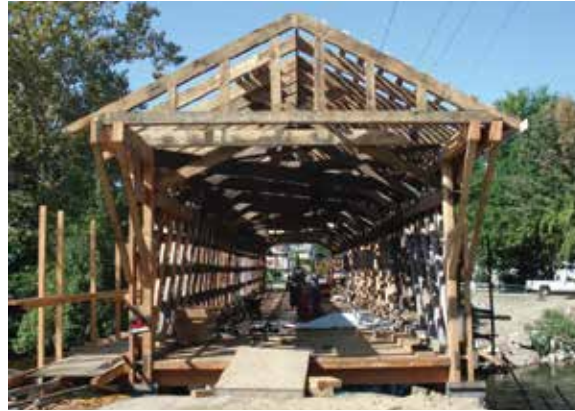
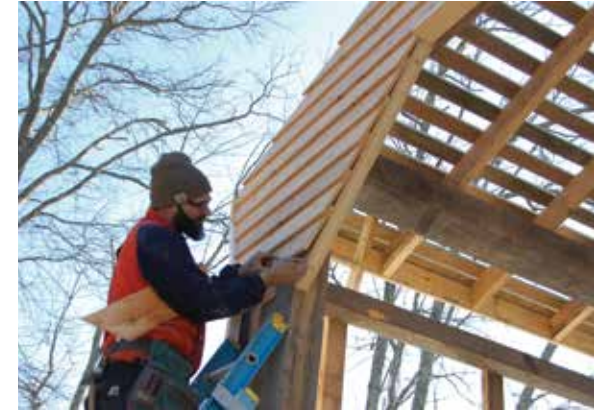
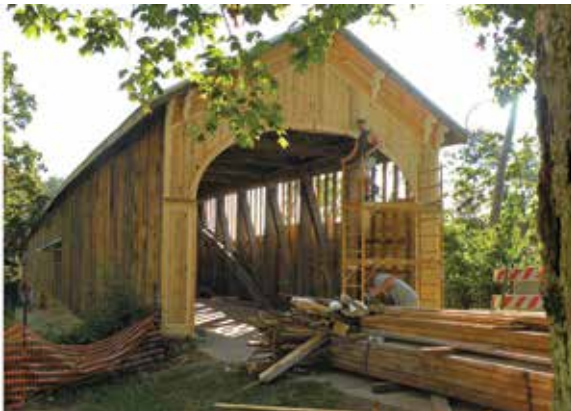
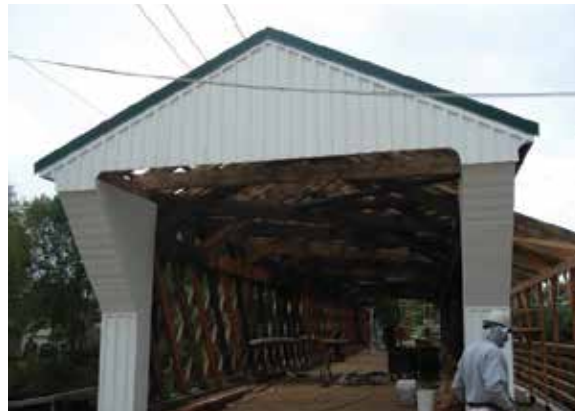
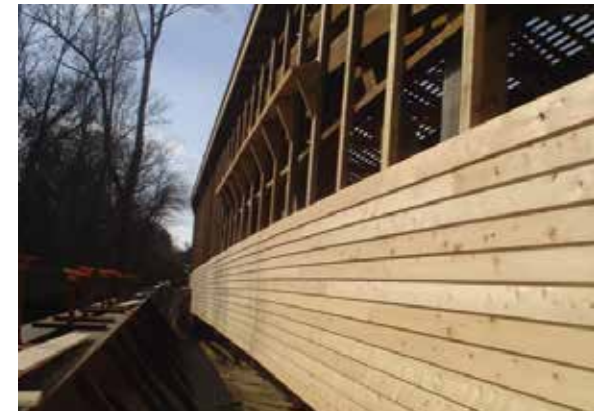
Figure 4.3a-b Although a tornado destroyed most of the Moscow Bridge in Indiana, its Kennedy Bridge character-defining features: vine decorations, roof brackets, and elliptical arch opening were carefully reconstructed, before being painted its original white.

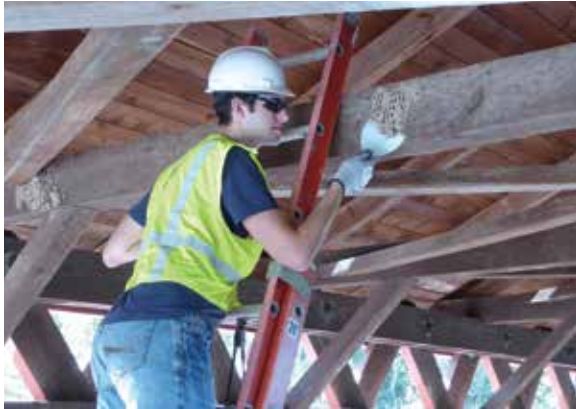
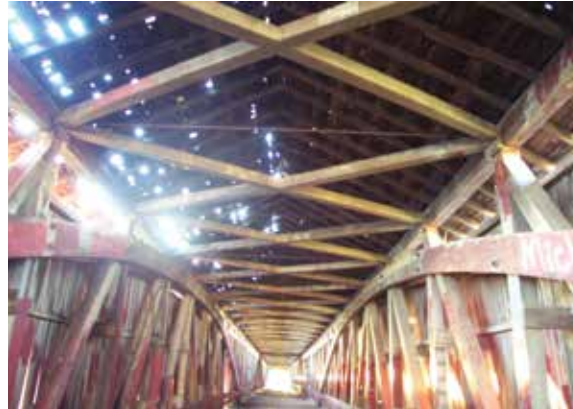
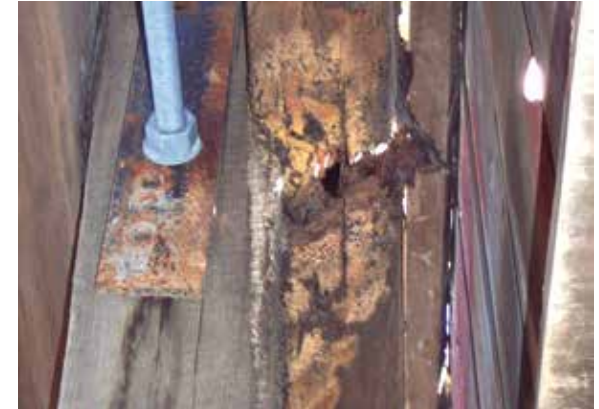
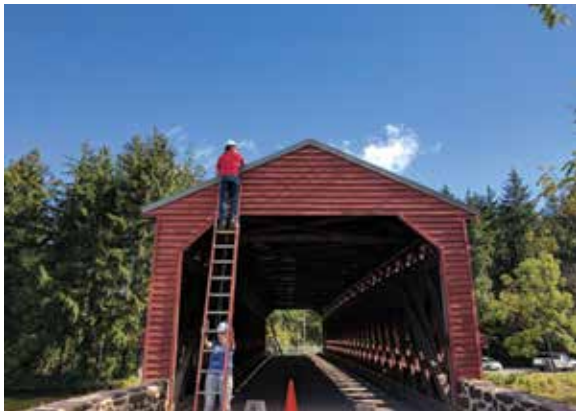
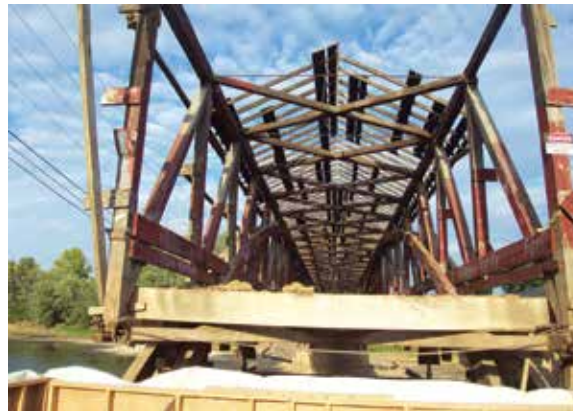
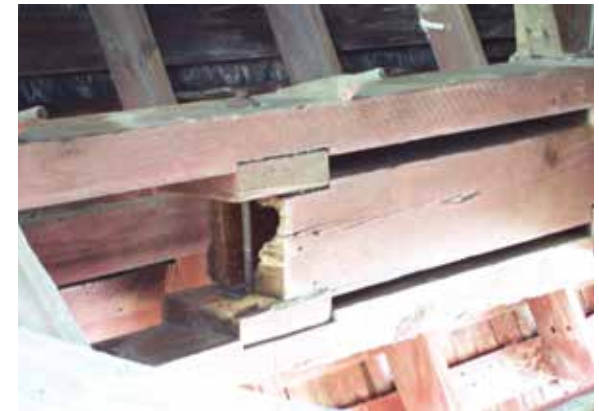
Figure 4.4a-b Scraping off mud dauber nests to keep roof and truss components free from infestation. Above, an engineer performs a periodic inspection of the roof covering.

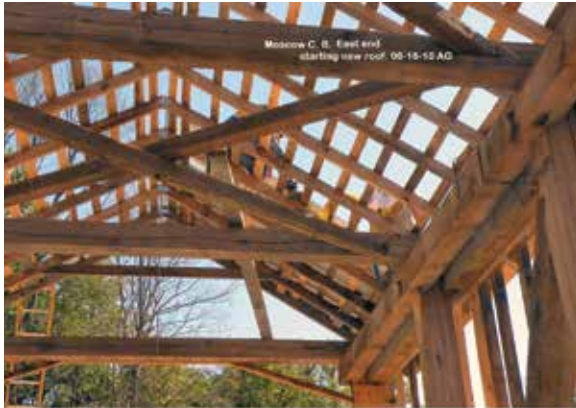
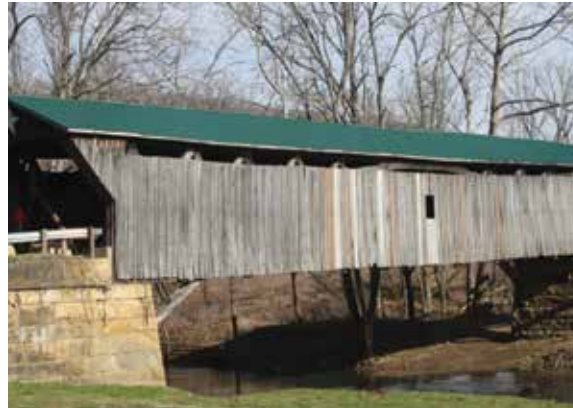
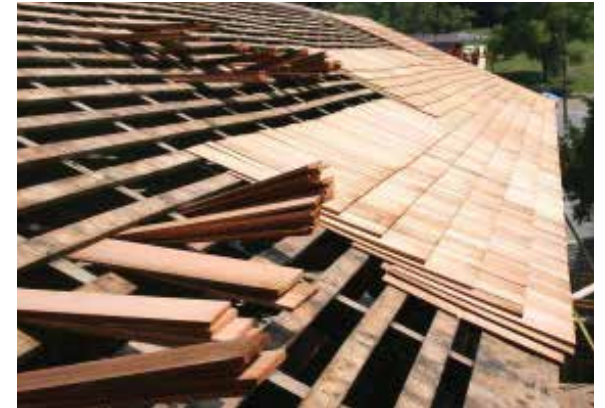
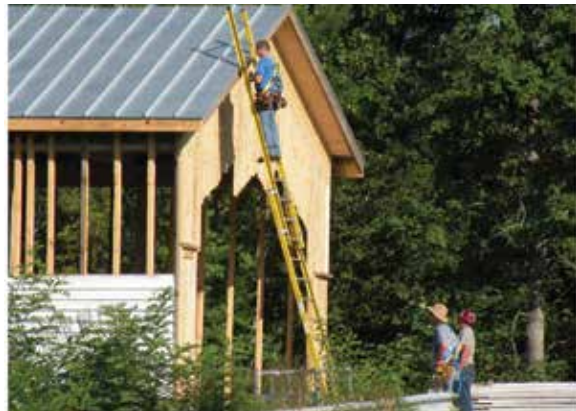
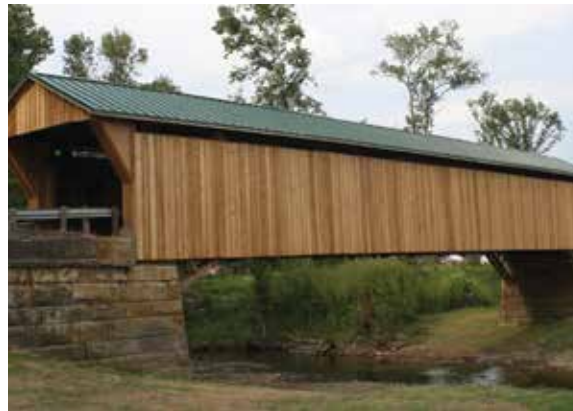
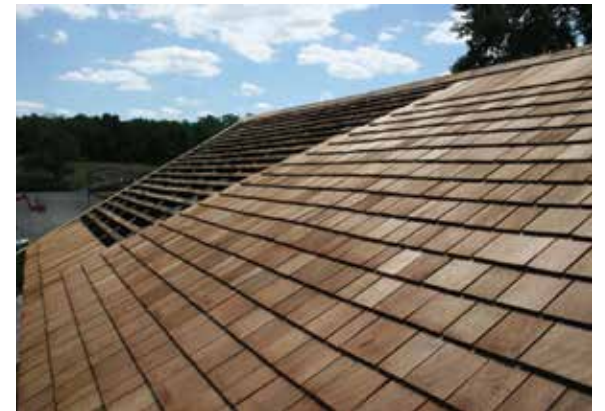
Figure 4.5a-b Nailing down new roof framing purlins, then installing a new replacement metal standing seam roof at Moscow Bridge, IN.

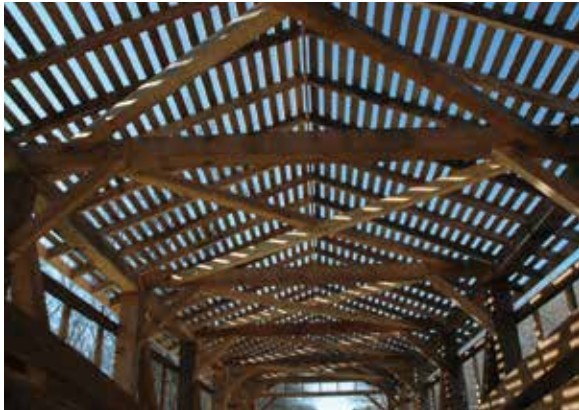
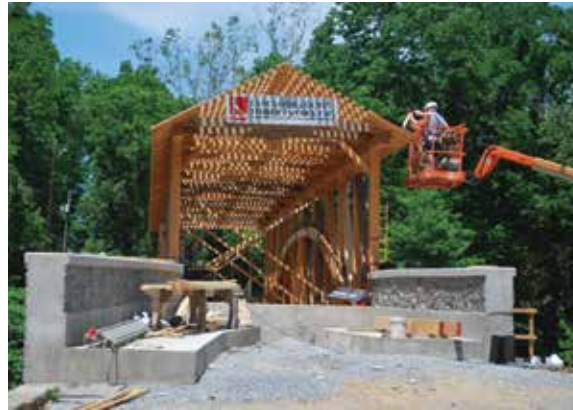
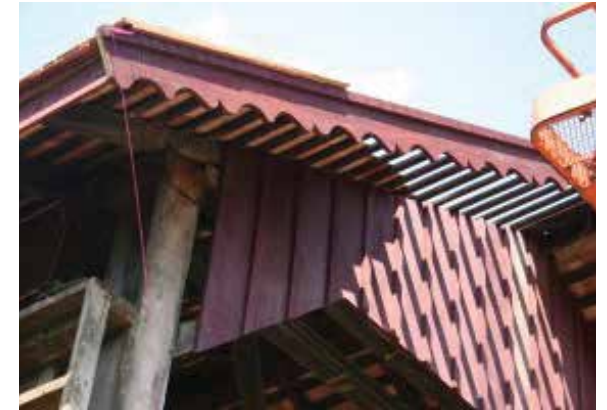
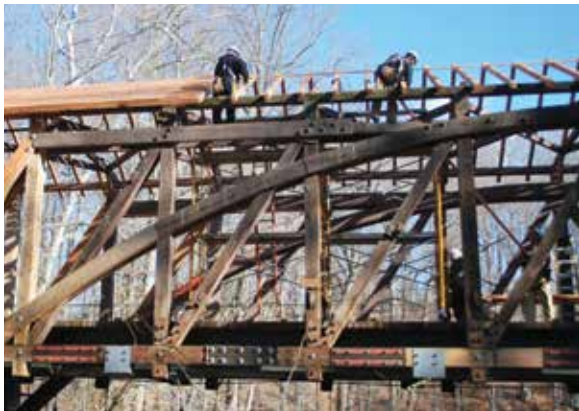
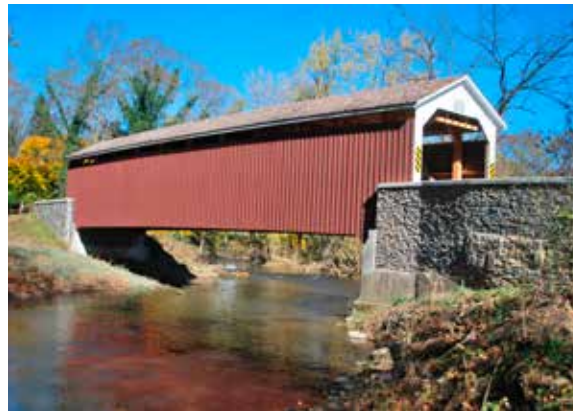
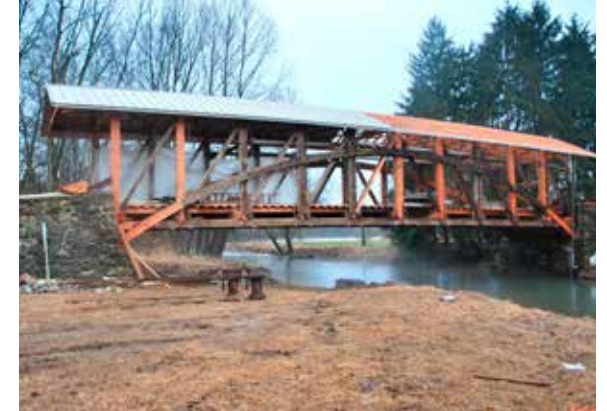
Figure 4.6a-b New roof rafters and purlins at Gilpin's are framed prior to receiving cedar shingles. Below, a harnessed crew laying out purlins prior to nailing cedar shake shingles at Jericho.

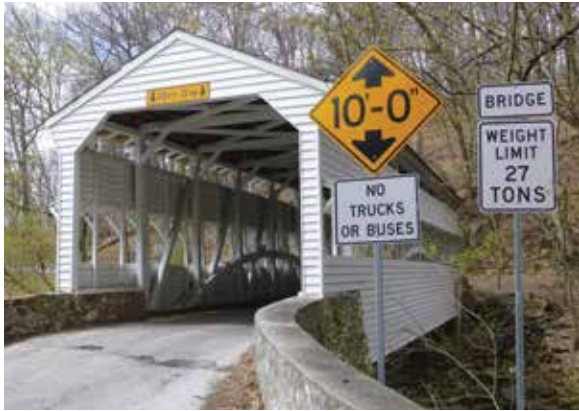
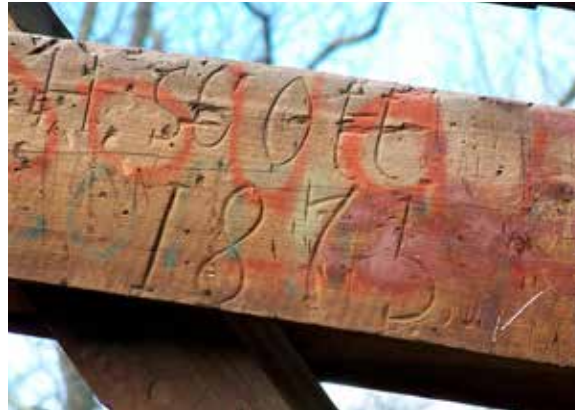
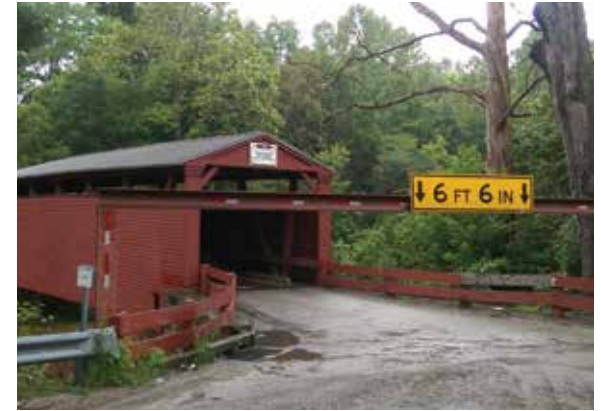
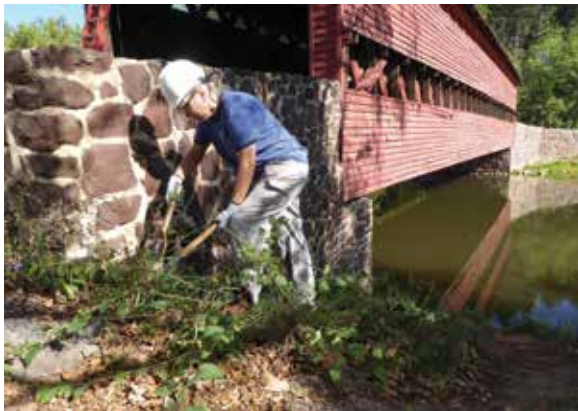
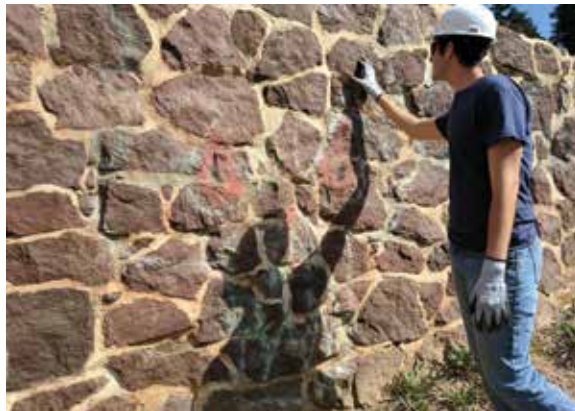
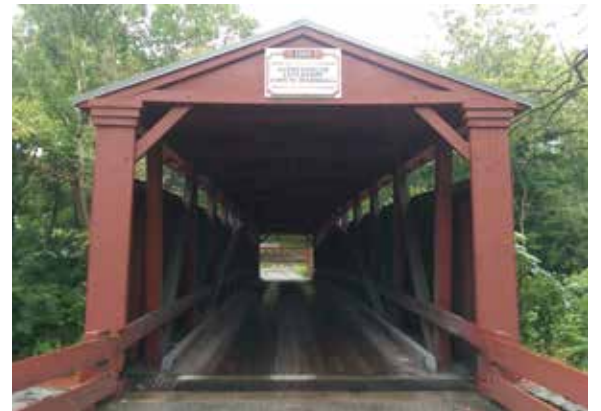
Figure 5.2a-b All traffic and safety signage should be placed in a prominent location, be clearly visible, and far enough away as to not detract from the appearance. Signage too close is not recommended. Below: Protecting the abutment by clearing the wingwall of invasives.

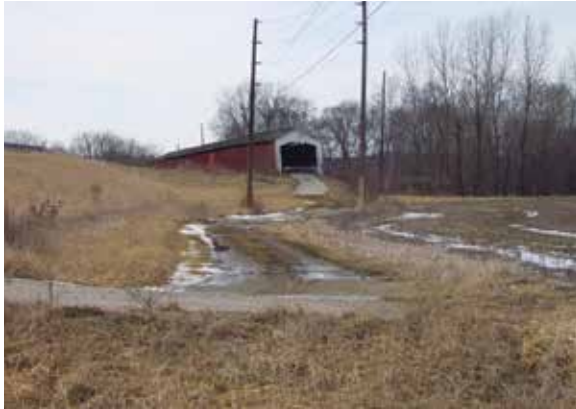
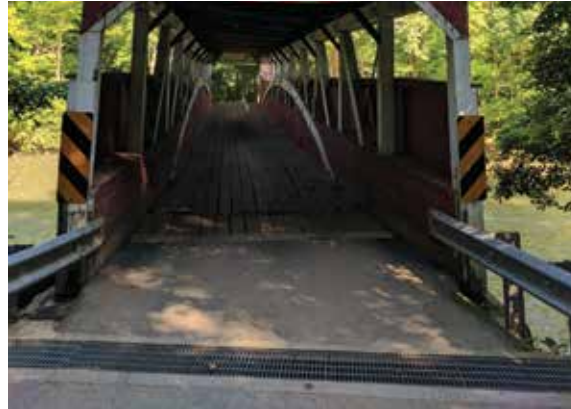
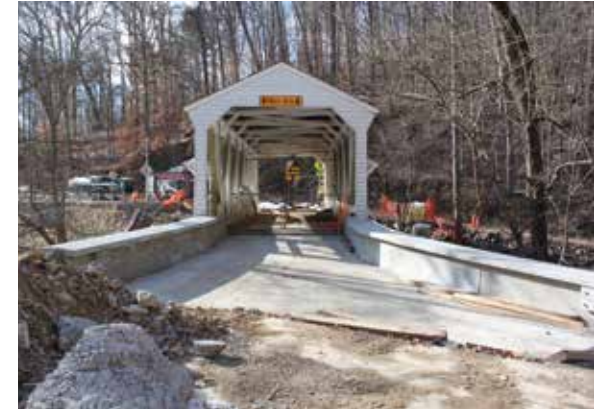
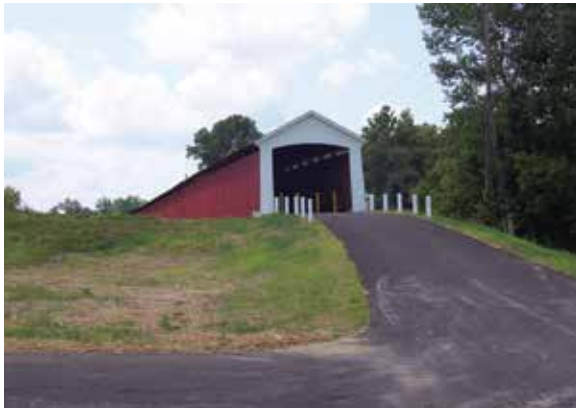
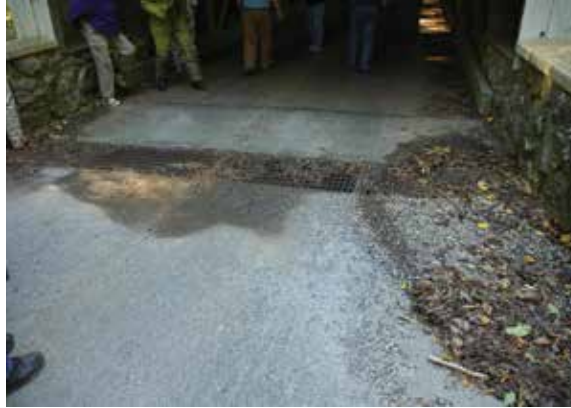
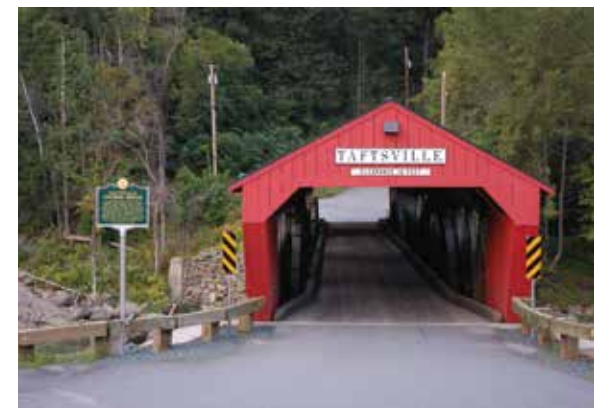
Figure 5.3a-b This deteriorated country approach road at Medora Bridge, IN, required regrading and new paving to maintain the alignment of the historic approach.

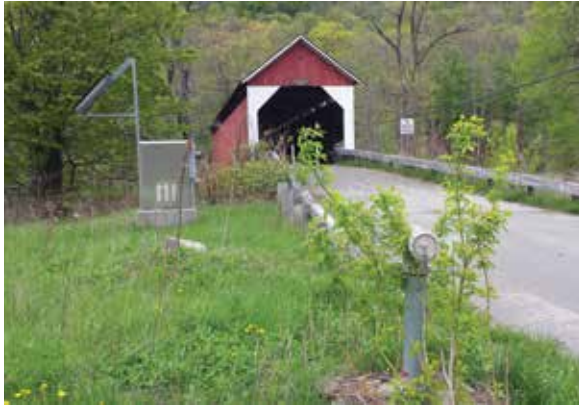
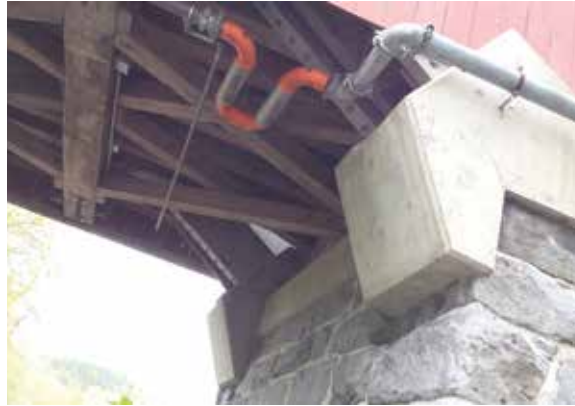
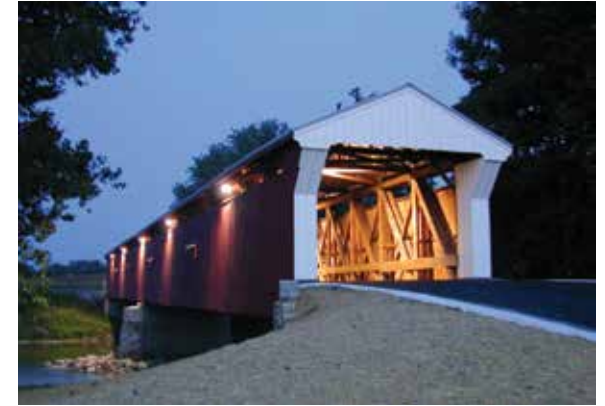
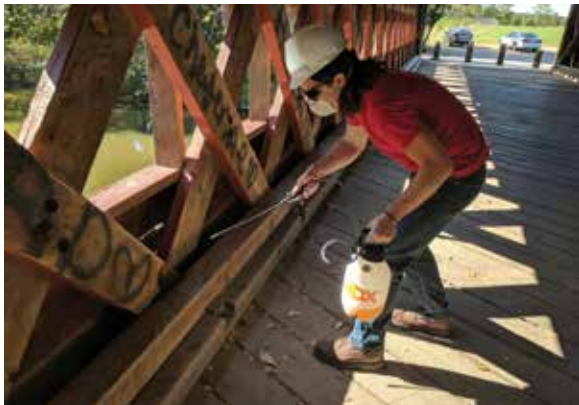
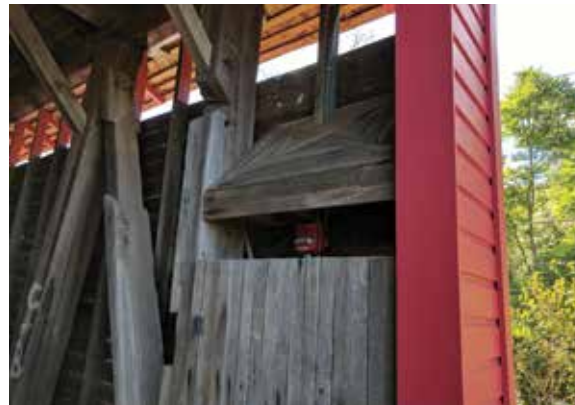
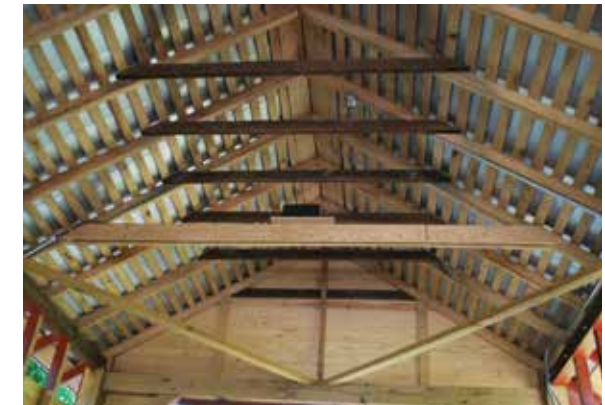
Figure 6.2a-b Sprinkler hose and solar panels protecting the Arthur A. Smith Bridge, MA. Below, spraying fire retardant on timbers as a fire prevention measure.

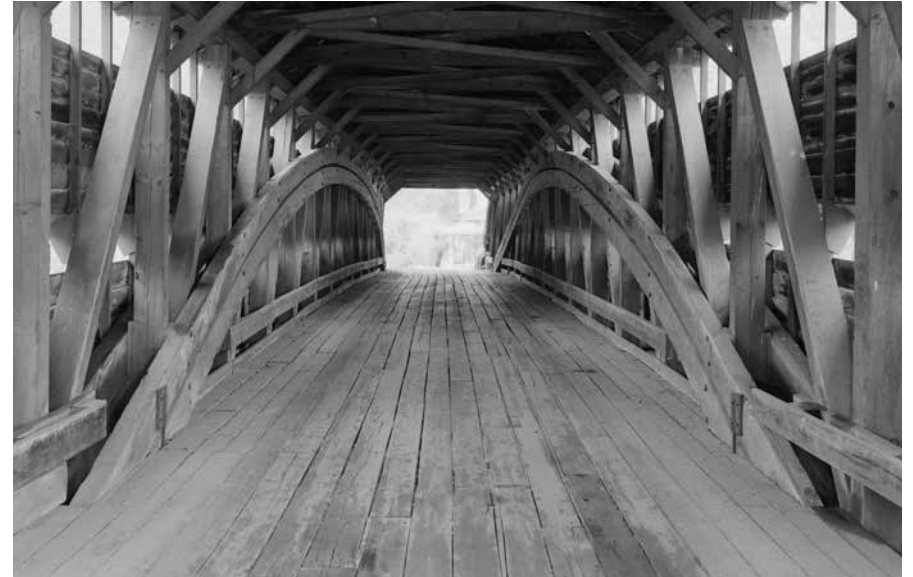
A second layer of longitudinal floor-planked bridge deck serves as the wearing surface for this Burr-arch truss.

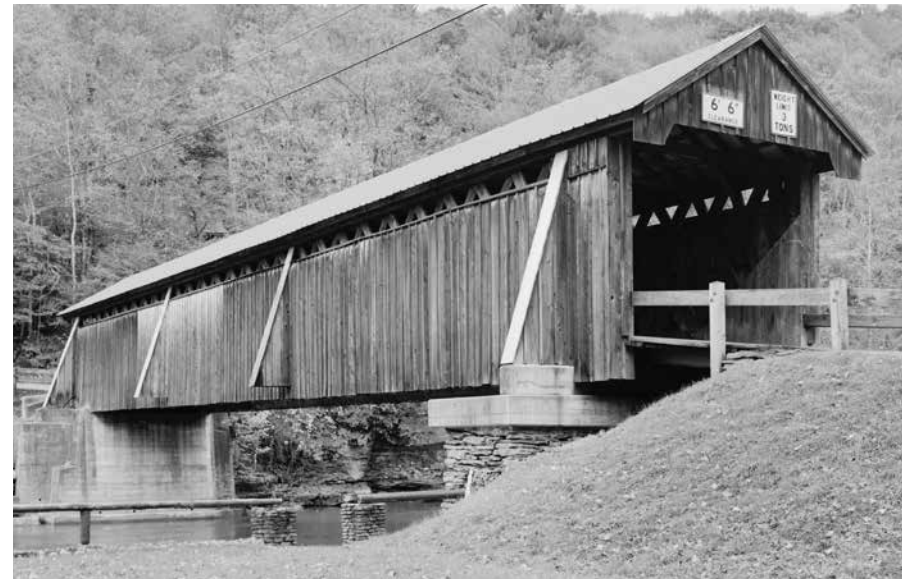
Flying buttresses or outriggers outside the trusses help control the vertical alignment of the bridge.

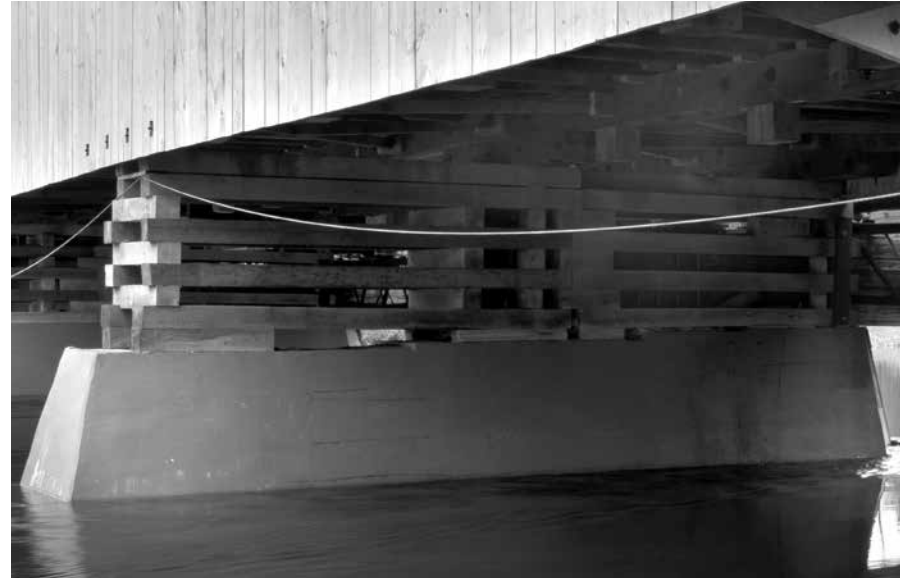
Replacement timber cribs sit atop concrete piers to support the Pulp Mill Covered Bridge, VT.

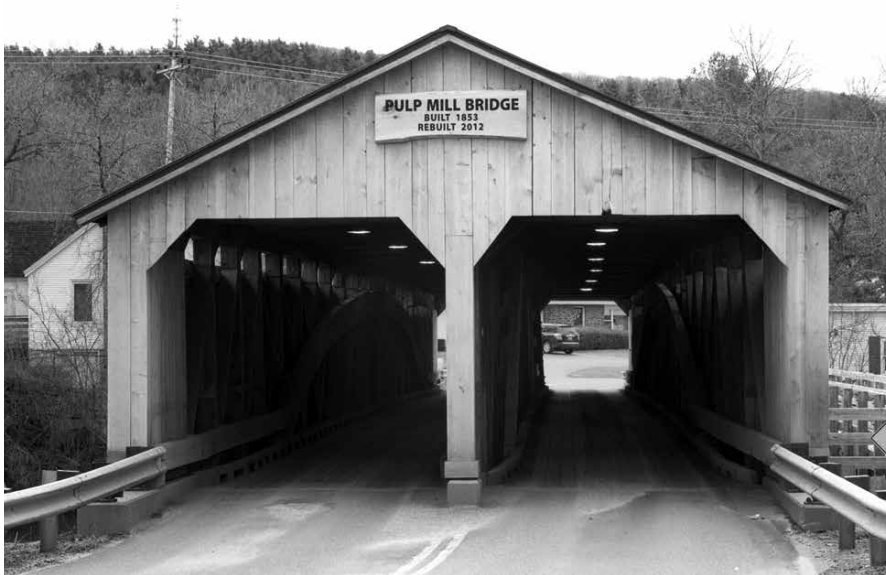
The double-barrel Pulp Mill Covered Bridge, VT, accommodates two lanes of traffic.

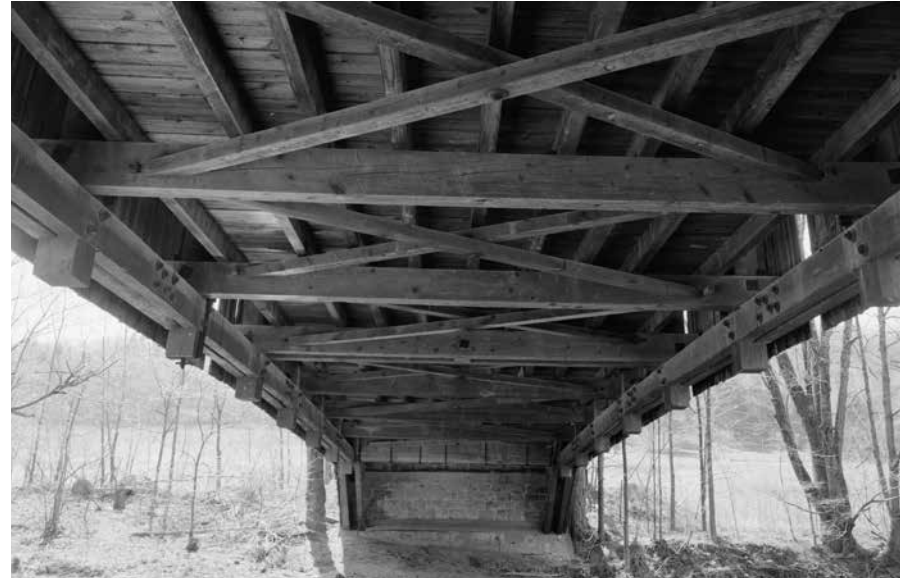
Stringer joists, laid parallel to the lower chords, sit atop the floor beams to support the deck.

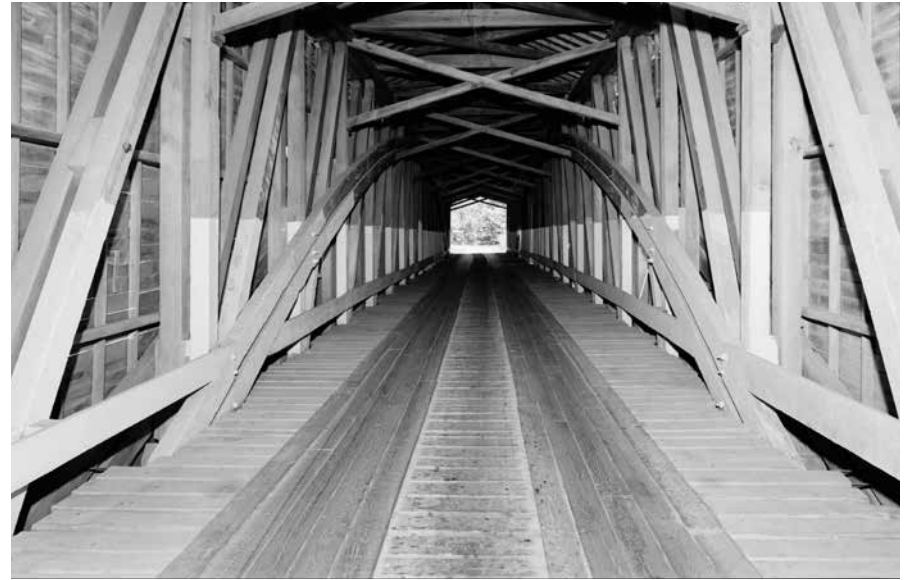
Running planks laid atop transverse decking provide an added layer as a wearing surface.

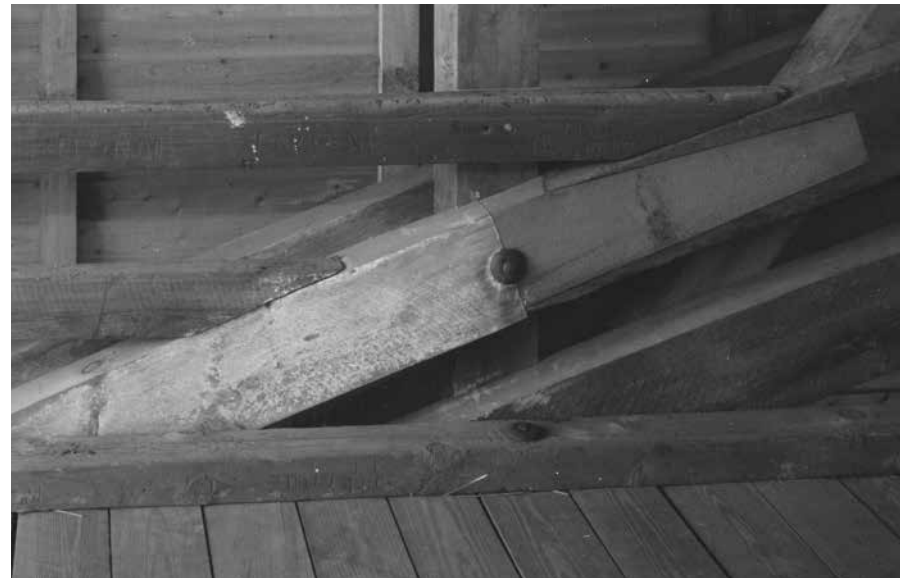
A splayed scarf joint repair abuts a replacement arch leaf. Both Burr-arch segments are secured with a single through bolt.

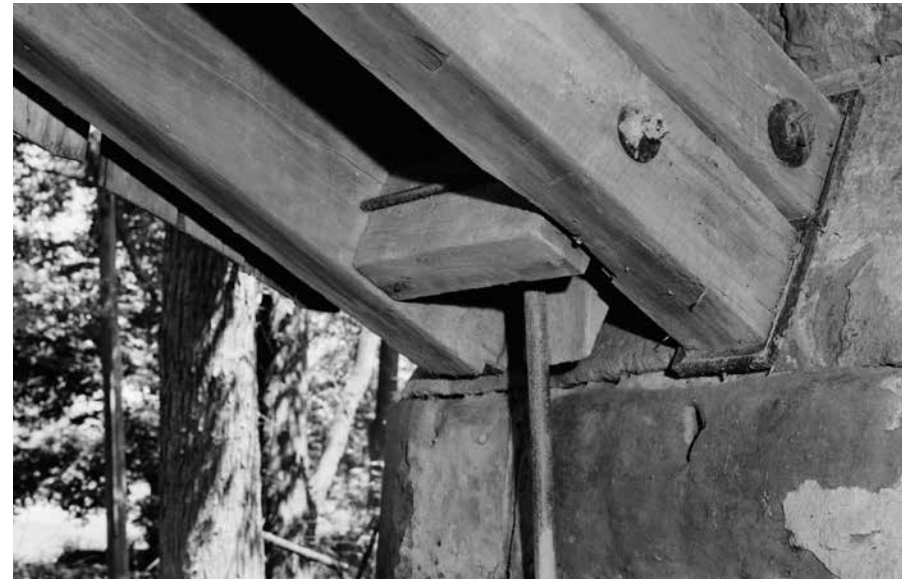
A stone skewback receiving a pair of arches, backed by a cast-iron plate.

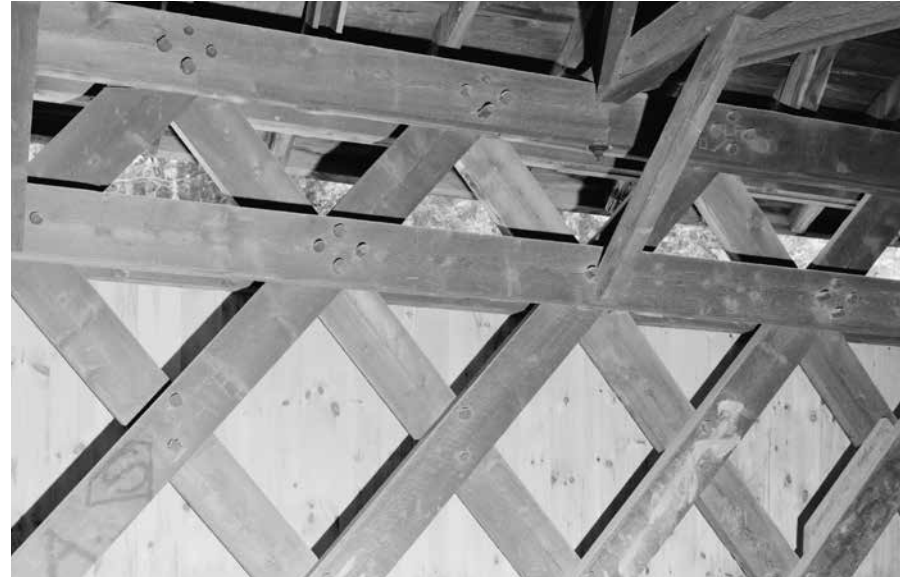
Treenails are paired at lattice intersections, and in a diamond pattern at the upper and lower chords.

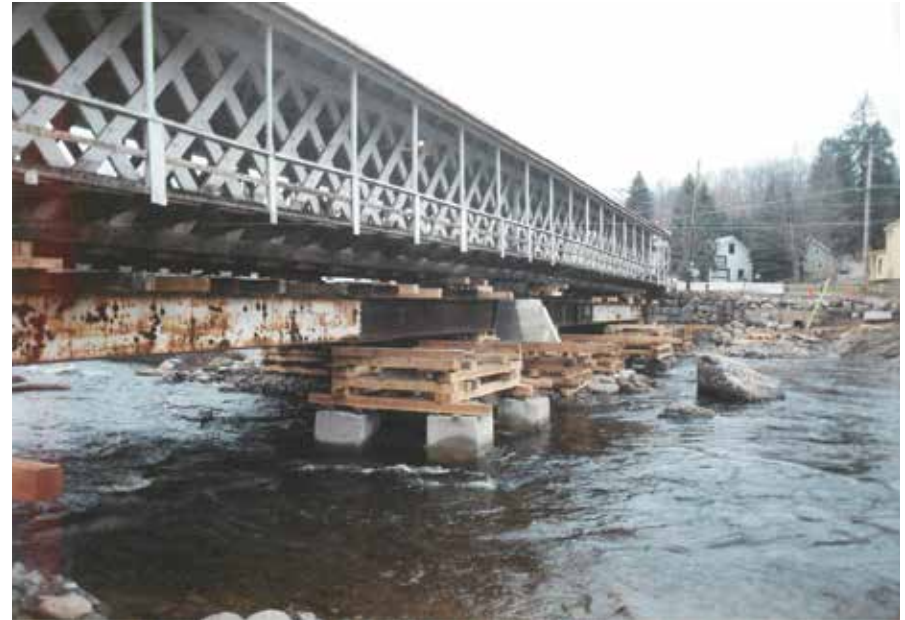
Figure C1.8 Shoring underneath bridge. Sean T. James, 1998.
