GUIDELINES FOR REHABILITATING HISTORIC COVERED BRIDGES

Edited by Christopher H. Marston and Thomas A. Vitanza

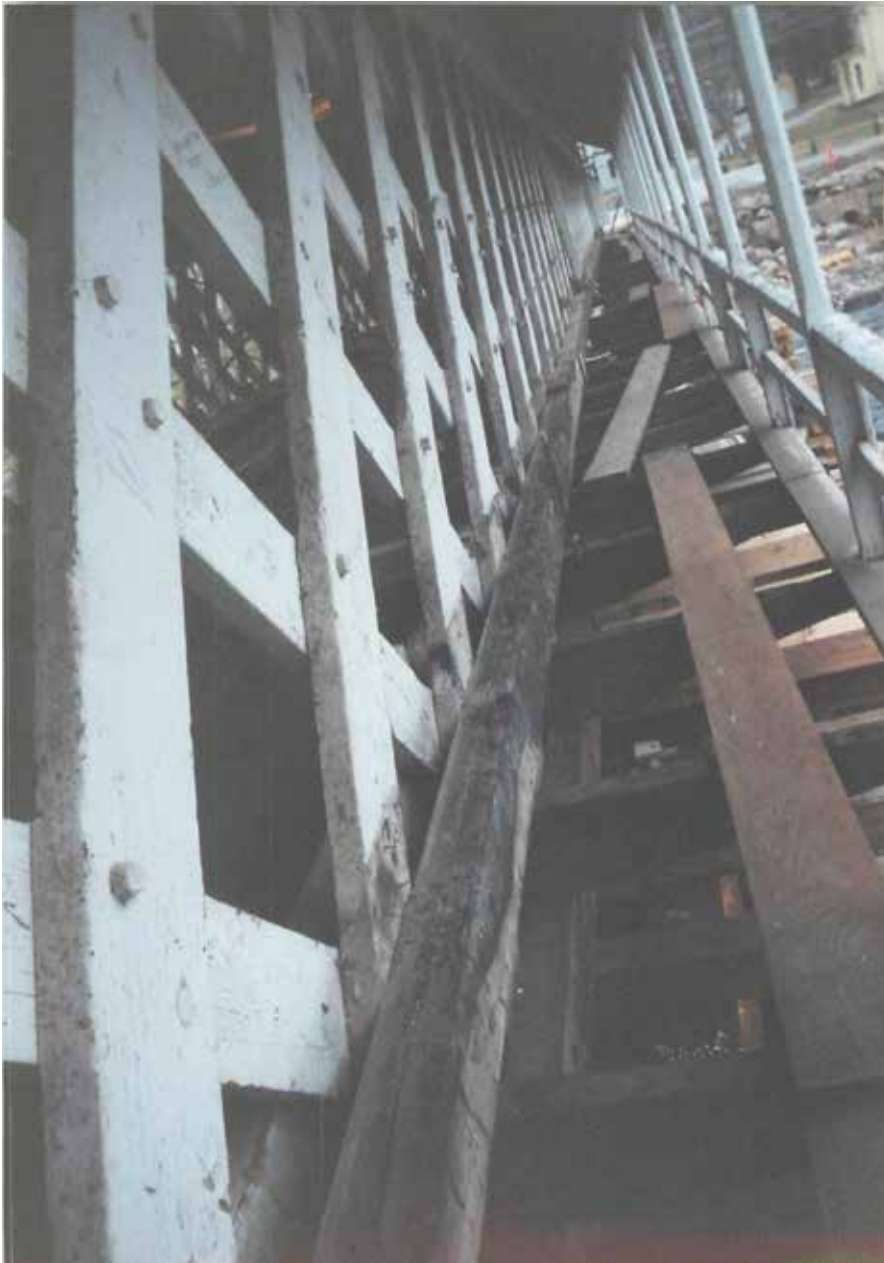
Figure C1.10 Previous fire damage of lower chord. Sean T. James, 1998.

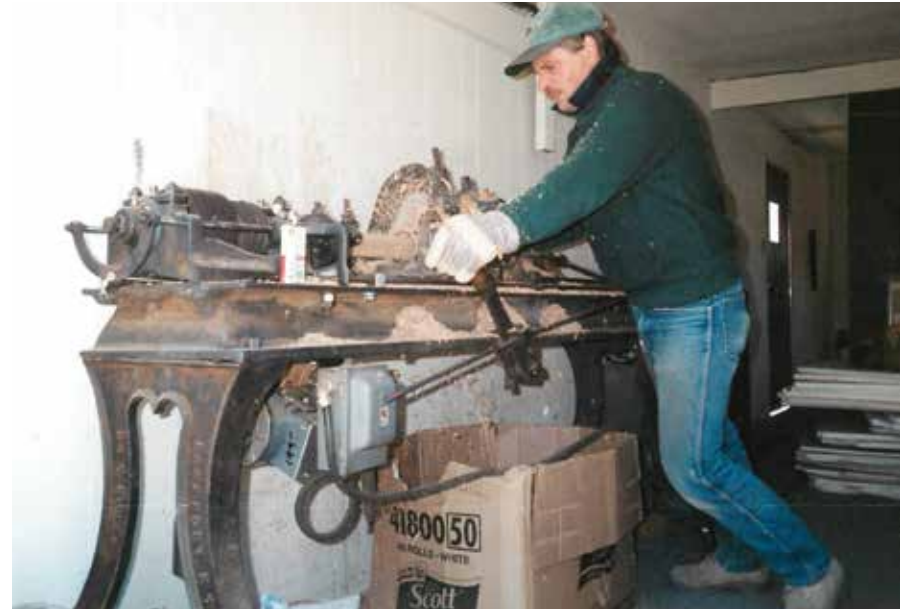
Figure C1.11 Tim Andrews fabricating replacement treenails on his Trevor treenail lathe. Sean T. James, 1998.

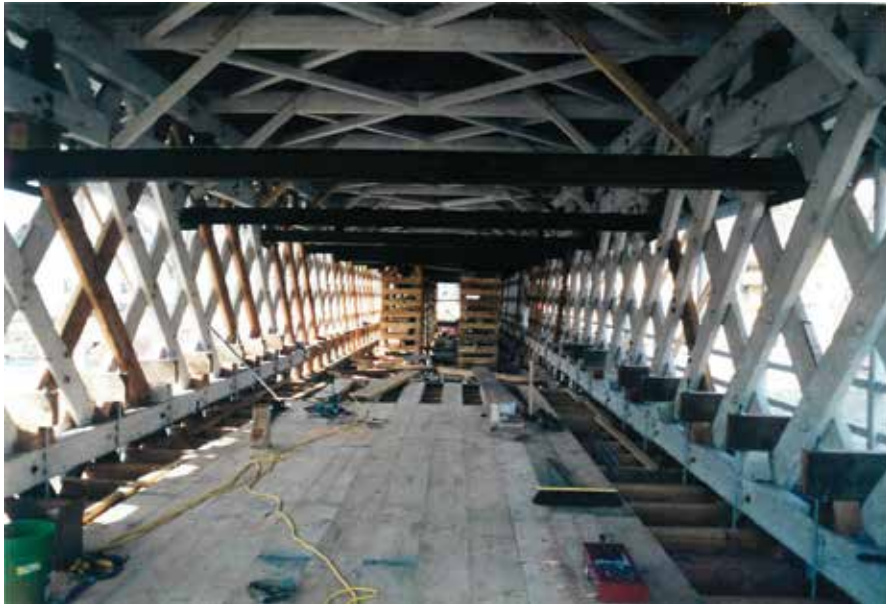
Figure C1.12 Installation of floor beams and decking; note steel needle beams supporting the top chord, spaced at every third lattice opening, 1998. Sean T. James, 1998.

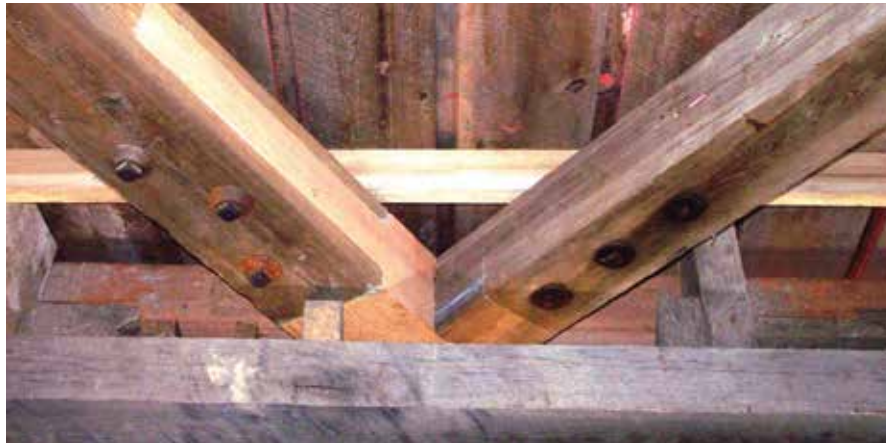
Figure C2.7 Timber repairs using new Douglas fir (left) were conspicuous. Those using salvage from original timbers (right) were nearly invisible. The Douglas fir repairs, having weathered a few years, are now less noticeable. J. A. Barker Engineering, 2004.

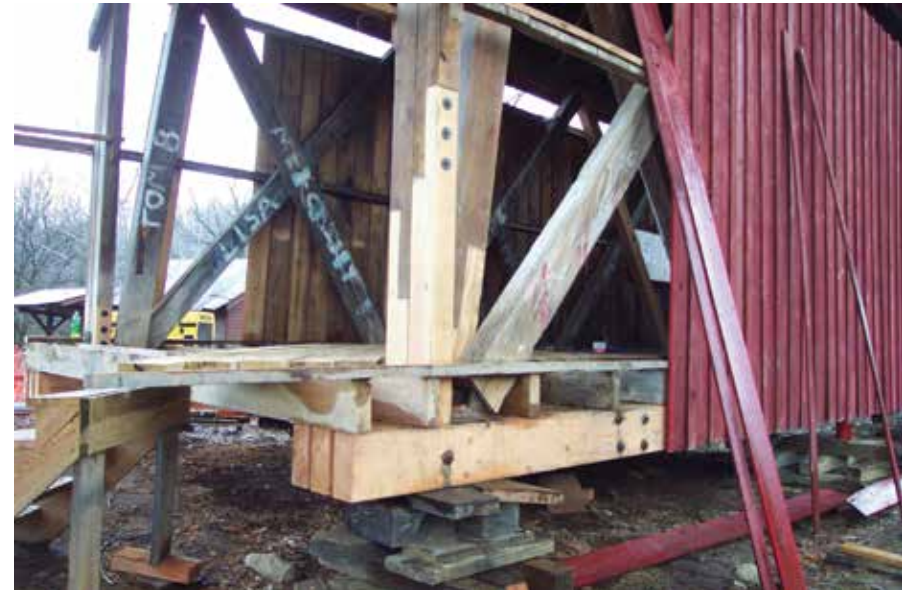
Figure C2.8 Decay at the bearings required extensive reconstruction. At the southwest corner, shown here, the two shorter lower chord timbers were replaced, while new ends were spliced onto the longest chord timber, both end posts, and a diagonal. J. A. Barker Engineering, March 2004.

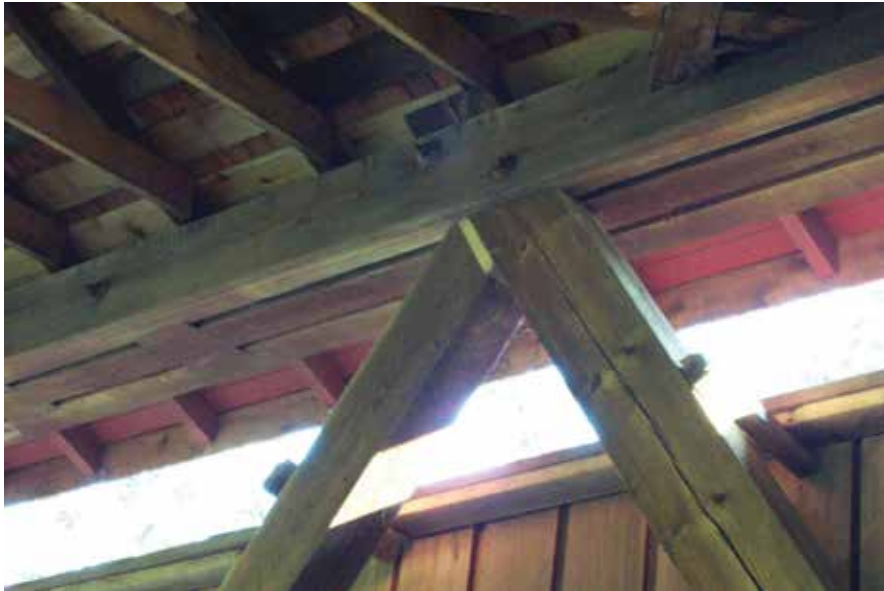
Figure C2.9 Trusses were jacked to restore camber, then held in that position by inserting shims at the top of truss compression diagonals, as shown here. J. A. Barker Engineering, 2004.

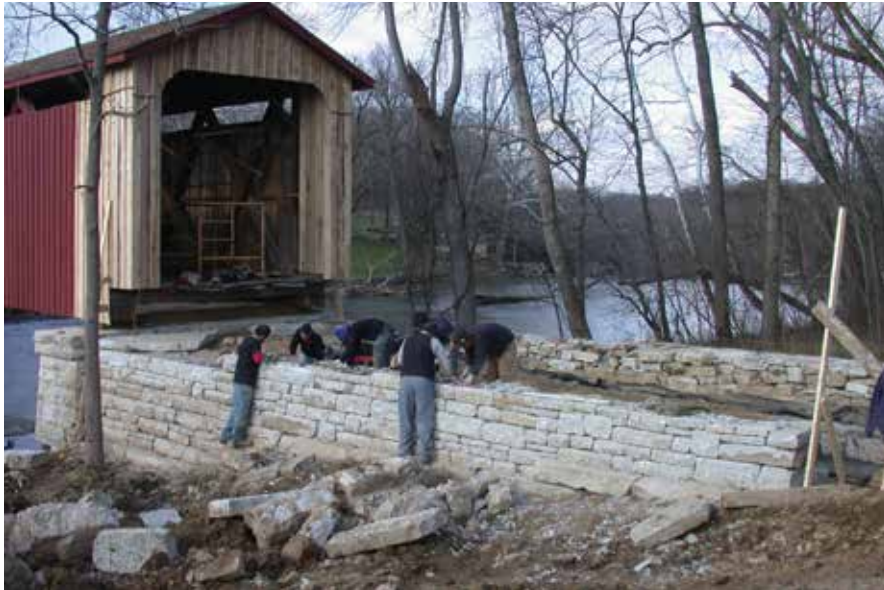
Figure C2.10 Dry-laid wingwalls under construction. The reconstructed bridge portal is complete except for paint. The top of the falls is visible in the background. McAlister Stone LLC, January 2005.

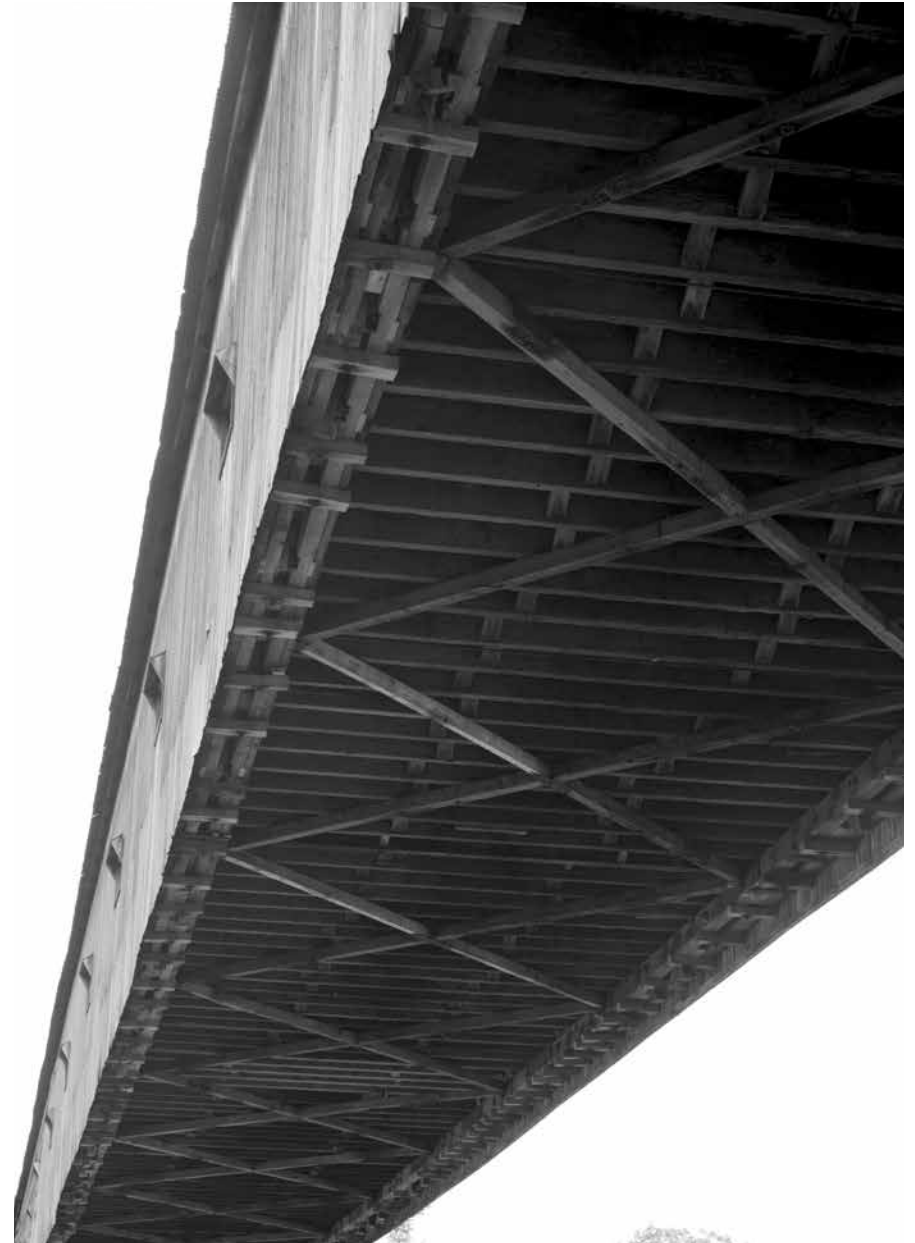
Figure C3.2 View inside bridge showing notched lattice truss, prior to being closed. HAER NH-8-10, Jet Lowe, 1984.

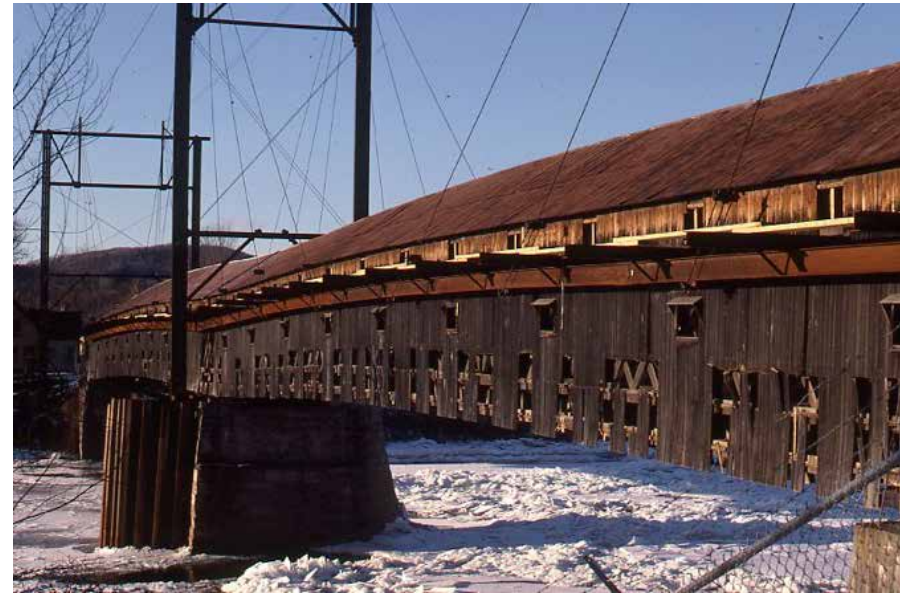
Figure C3.3 Tower system erected prior to rehabilitation work. James L. Garvin, December 1988.

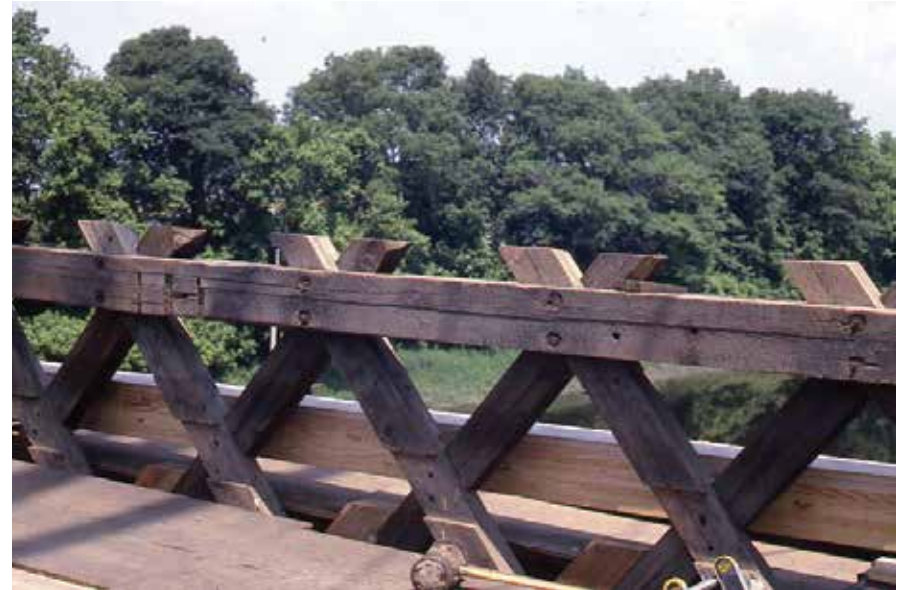
Figure C3.4 Above central pier, showing removal of Chord 3. James L. Garvin, June 1989.

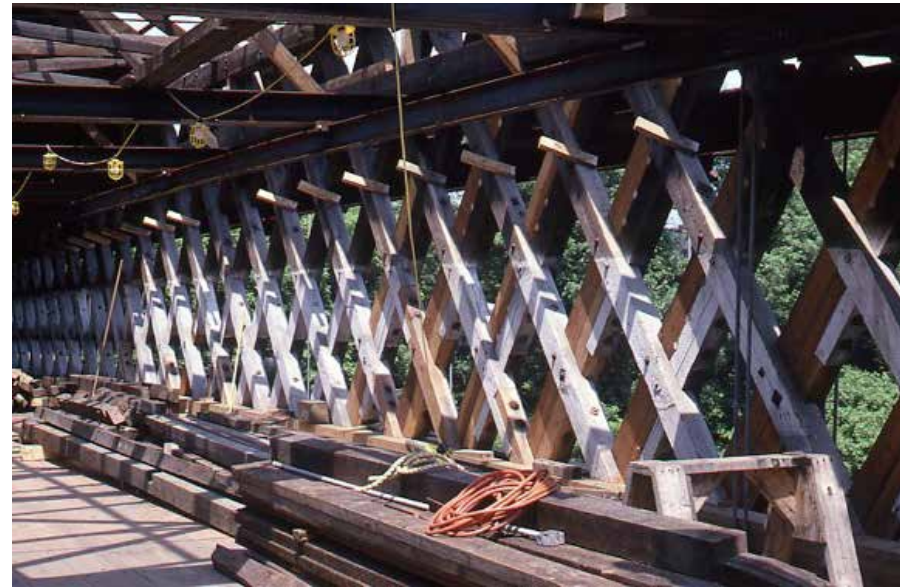
Figure C3.5 Town lattice sistering. James L. Garvin, June 1989.

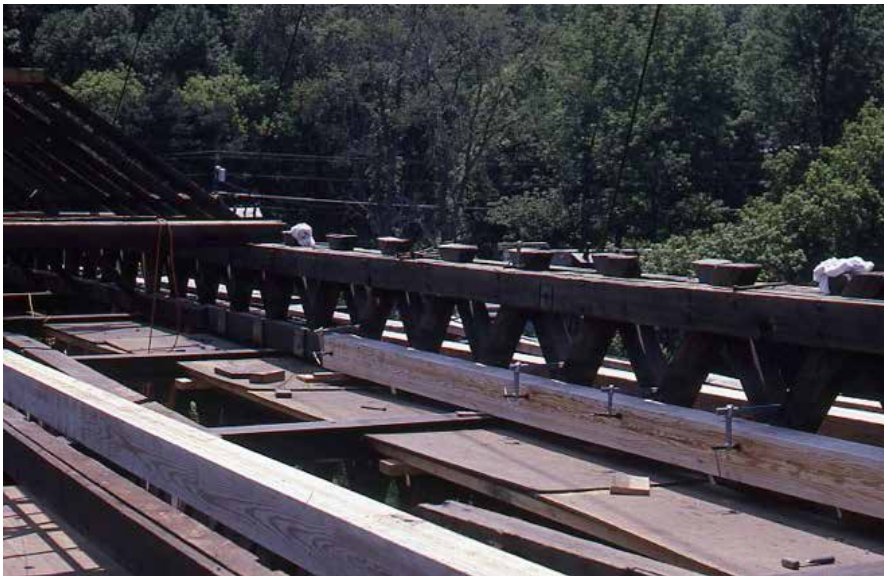
Figure C3.7 Original upper chords with glulam replacement chord. James L. Garvin, June 1989.

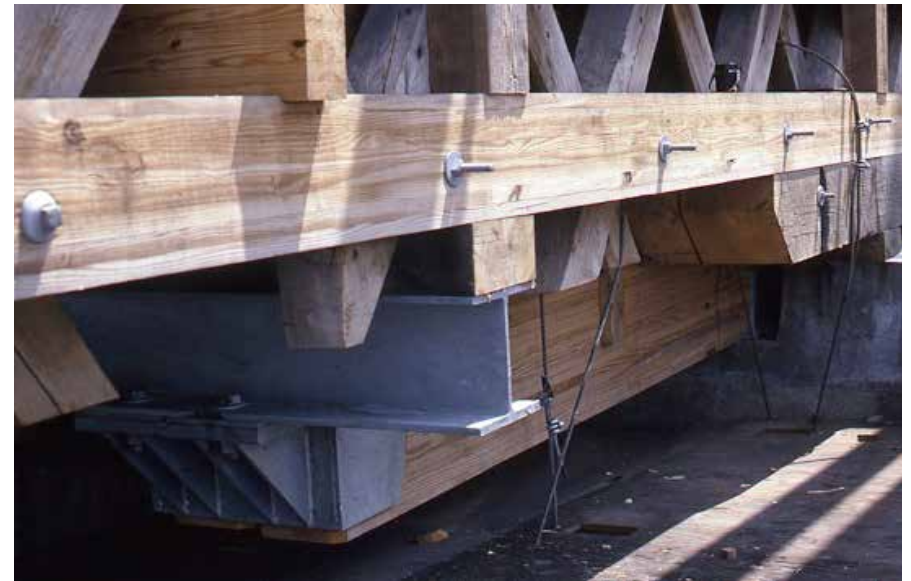
Figure C3.8 White oak bed timber and glulam bolster beam in new concrete footing, supporting truss. James L. Garvin, June 1989.

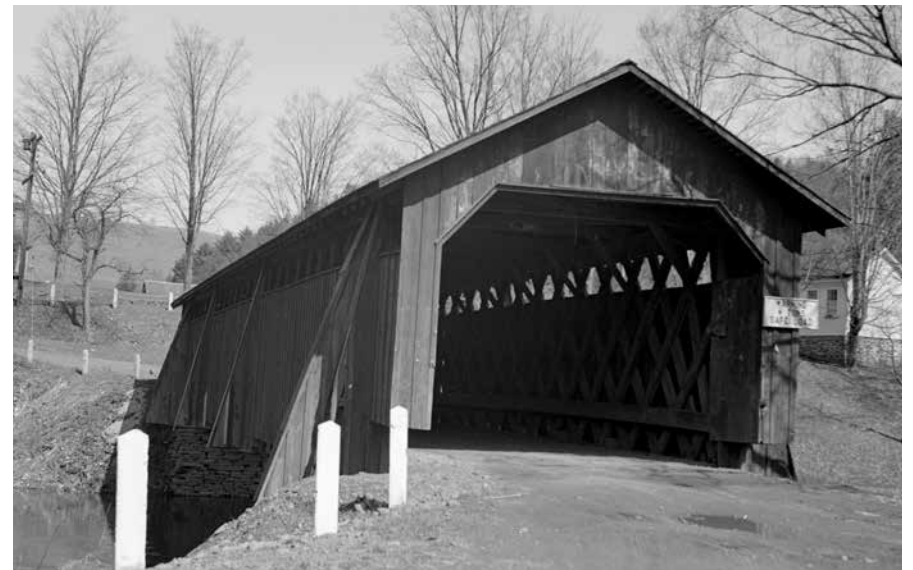
Figure C4.2 Historic view of Fitch's Covered Bridge, note outriggers. Richard Sanders Allen.

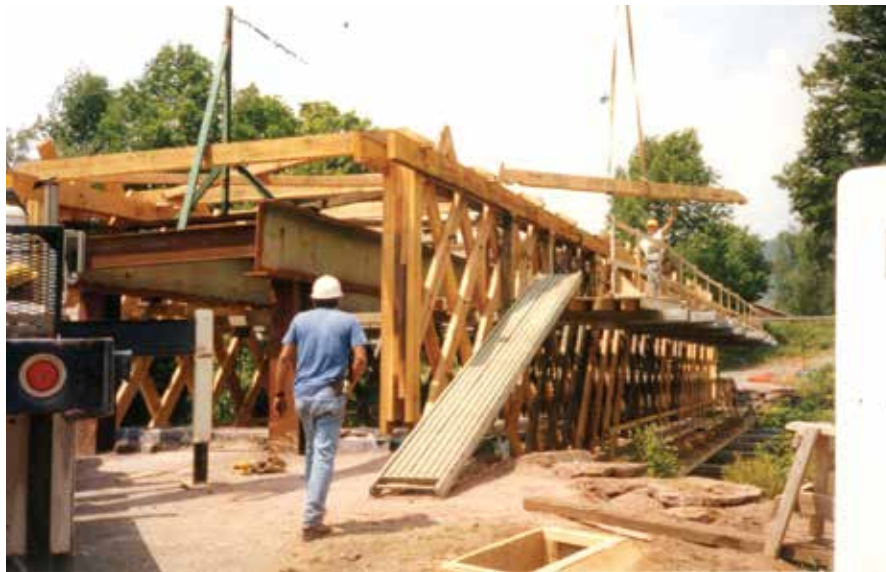
Figure C4.3 Prior to the start of the 2001 rehabilitation, a steel falsework system with adjustable work platforms was installed. This photograph shows the falsework and the installation of new tie beams. Delaware County Department of Public Works (DCDPW).

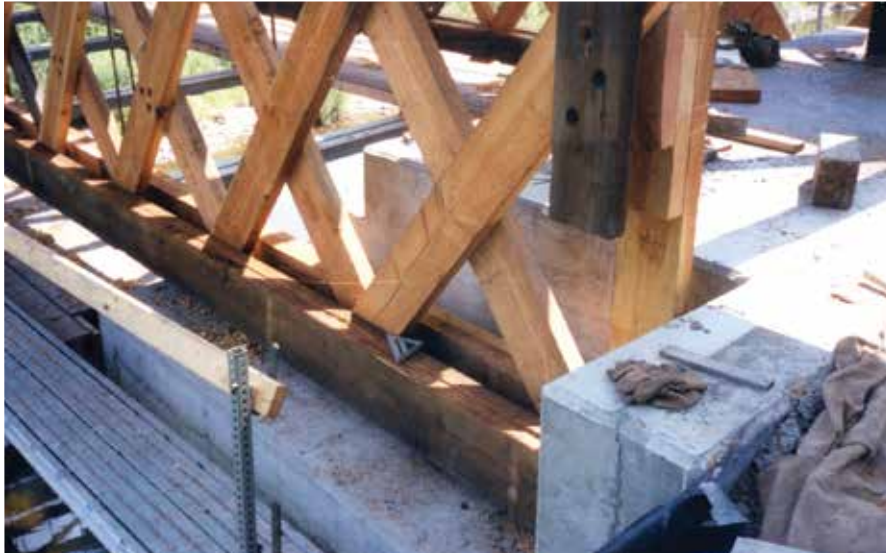
Figure C4.4 New concrete caps with pockets for longer trusses were installed on the abutments. DCDPW.

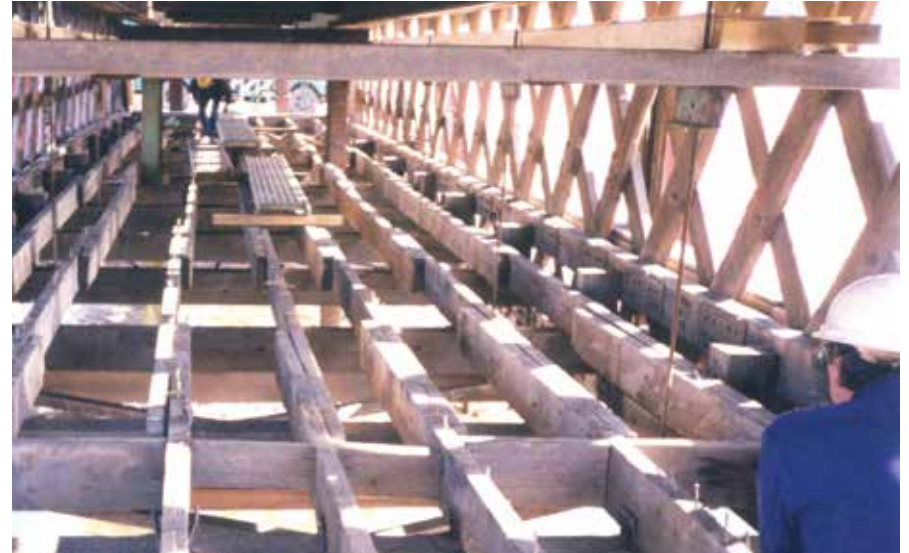
Figure C4.5 The 1976 floor system has been partially removed. The near edge of the floor is the transverse nail laminated decking. The longitudinal stringers are obviously not uniformly spaced. DCDPW.

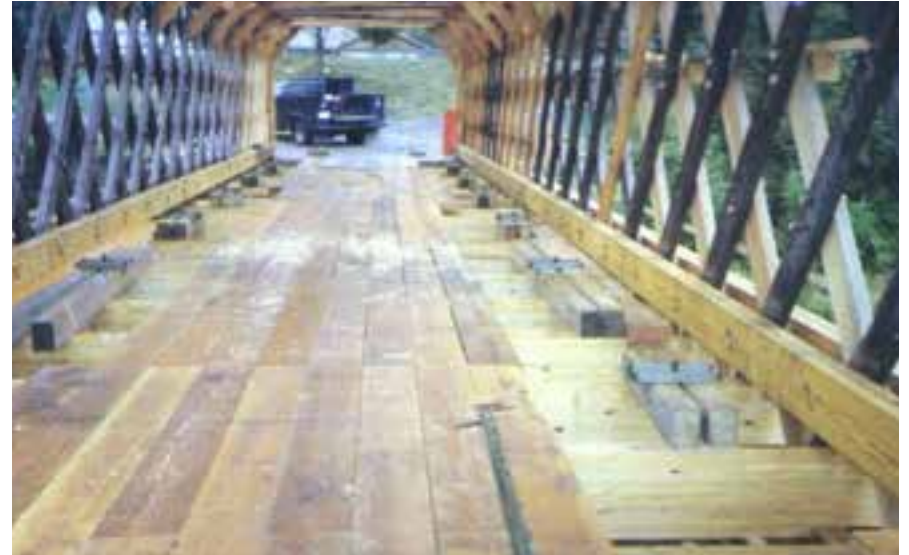
Figure C4.7 Staggered longitudinal deck planks have been installed; these were then covered with hardwood running planks. Note the darker lattice elements, which are original. DCDPW.

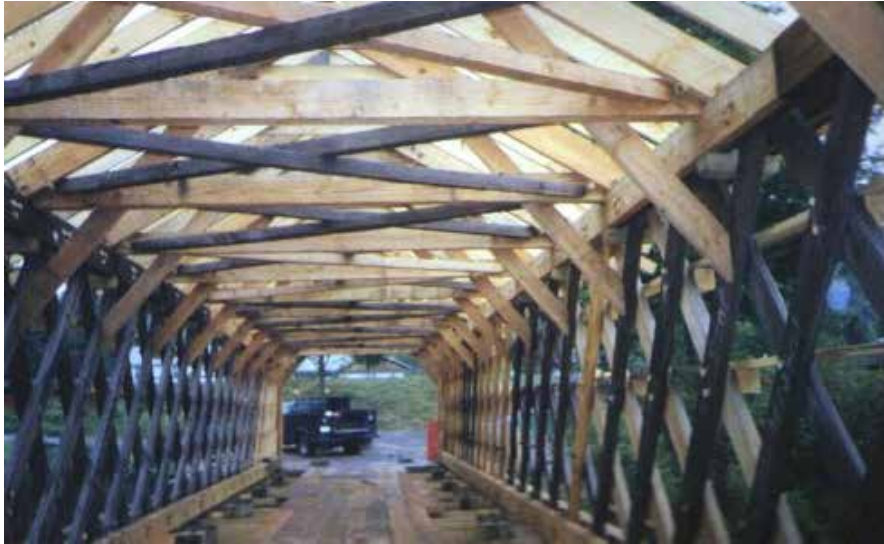
Figure C4.8 Most of the original upper lateral members were retained, but the tie beams and knee-braces were replaced with stronger components. Traditional wooden peg connectors and matching timber wedges were used, similar to those in the original construction. The darker upper lateral members are original. DCDPW.

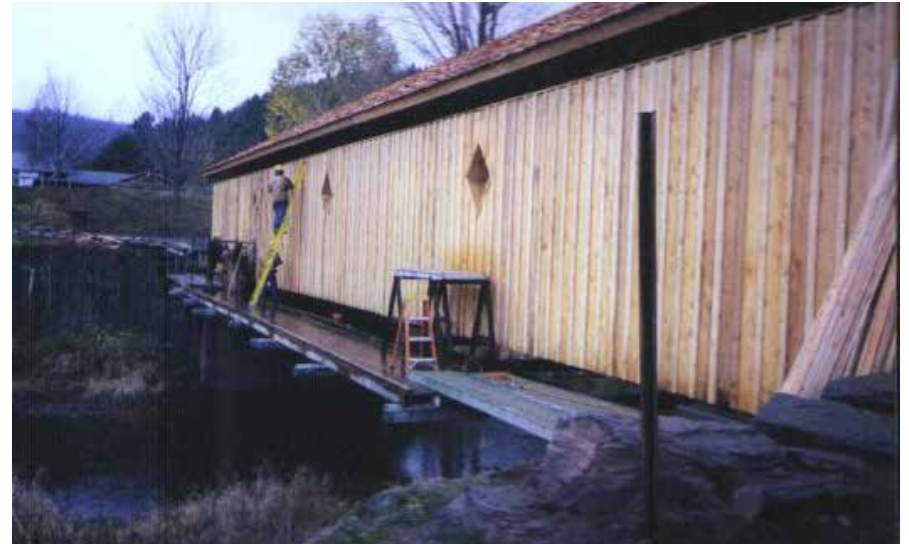
Figure C4.9 Siding being replaced with rough-cut 1" x 12" hemlock with battens. DCDPW.

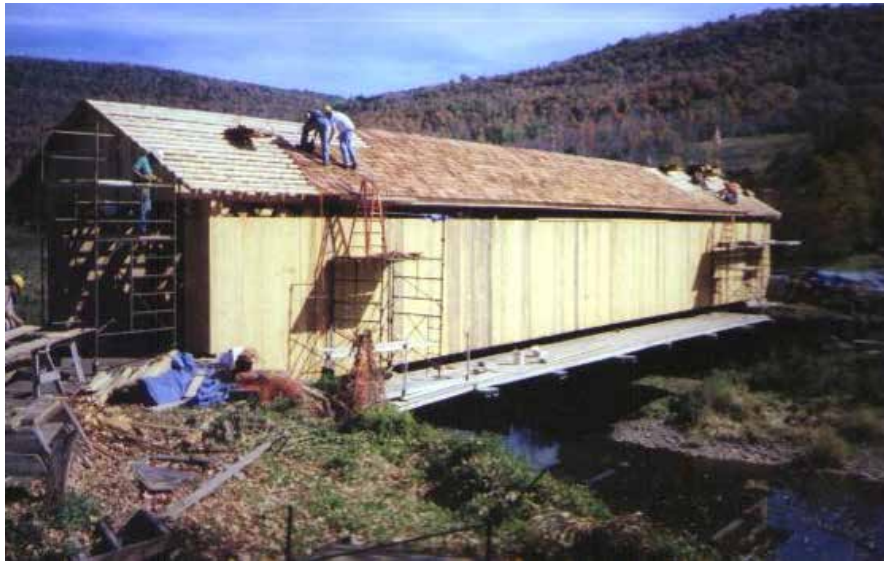
Figure C4.10 The metal roofing was replaced with traditional red cedar wood shakes, based on community preference. DCDPW.

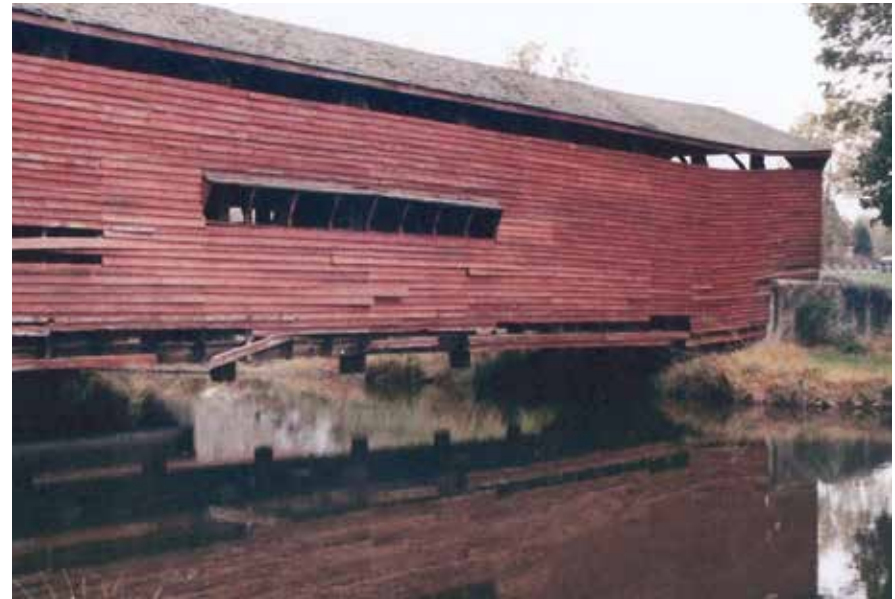
Figure C5.4 View of the bridge four years before the rehabilitation project. Failures in the lower chord contributed to the noticeable negative camber. W. Earl Simmers, 2005.

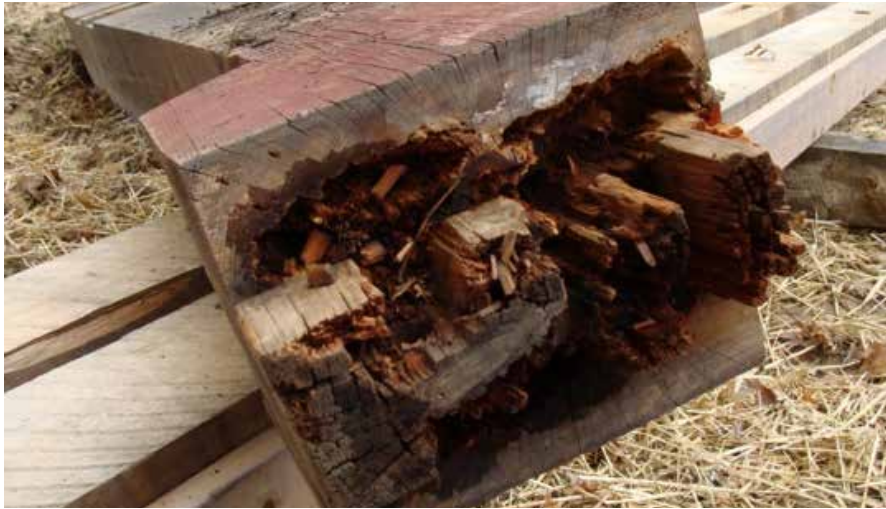
Figure C5.5 This photo of the top of a post shows the typical condition of truss members between joints. Timothy Andrews, 2009.

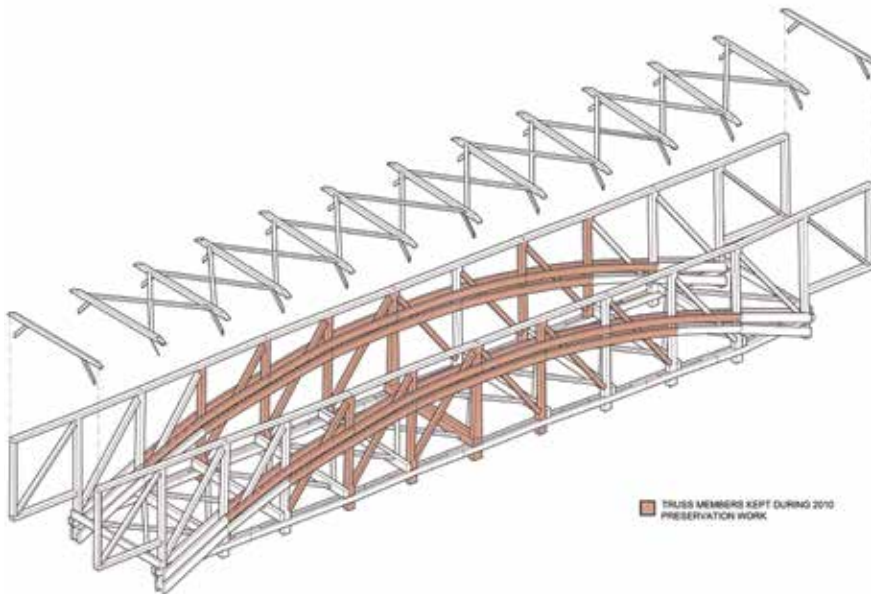
Figure C5.6 Illustration showing original truss members that were retained during the rehabilitation. The hatched sections of the truss indicate the historic fabric that was saved. All other material was replaced in-kind. Adapted from HAER MD-174, sheet 8, Jeremy Mauro, 2010.

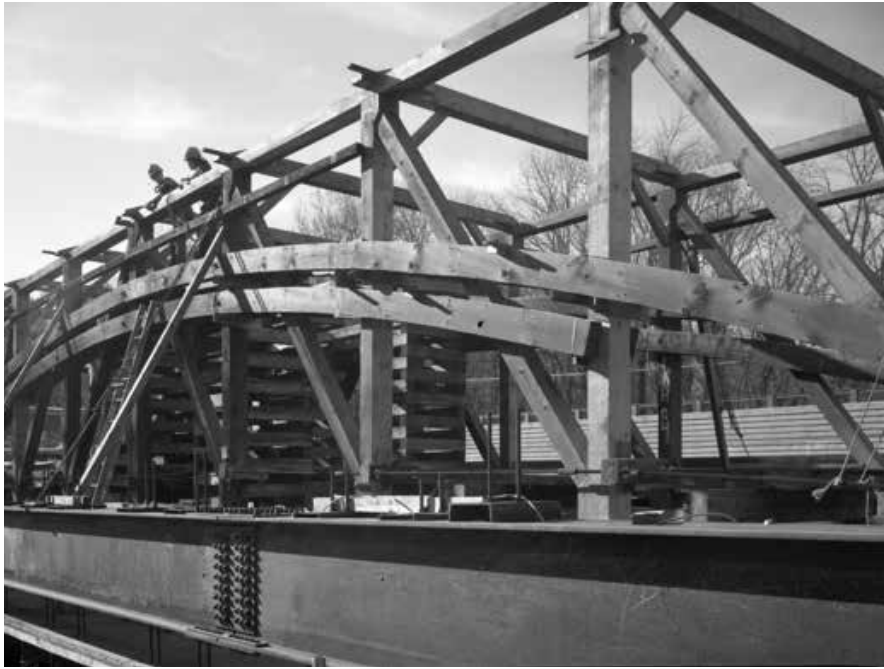
Figure C5.7 Cross chains installed to straighten the bridge in plan. Also note the deck planks are laid diagonally. The diagonal configuration was not original, and they were returned to a perpendicular arrangement later in the project. Jeremy Mauro, 2009.

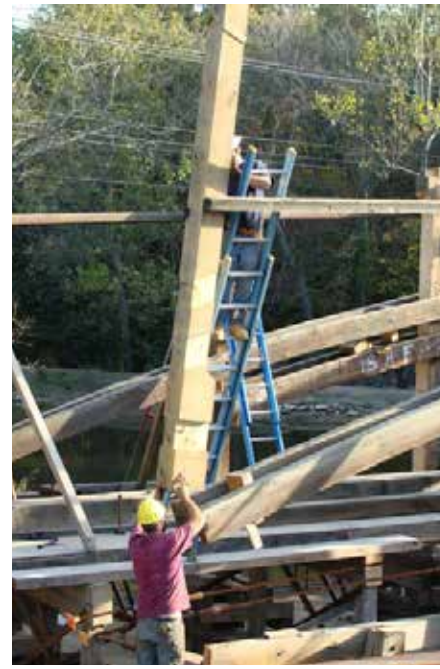
Figure C5.8 Tim Andrews (top) and Jeremy Woodliff (below) guide a new end post into position. A crane, not shown in the photo, is lowering the post. Tim Andrews, 2009.

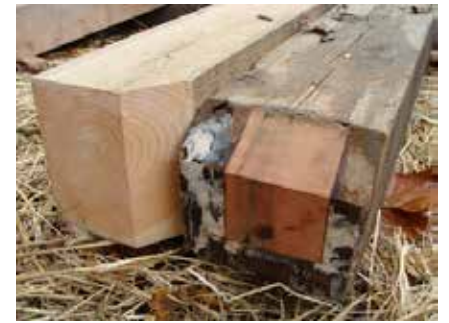
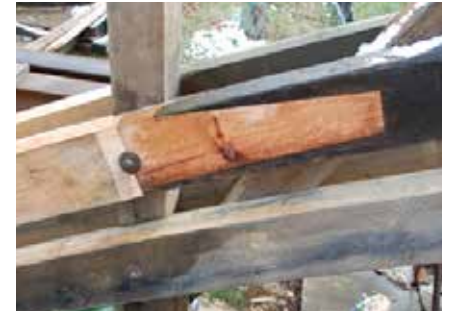
The goal of returning the truss' structural integrity was evident in the high-quality materials selected by the rehabilitation team. The first rehabilitation plans in 2009 had called for using laminated, preservative-treated timbers of a different size to achieve the needed dimensions, but that plan was amended in favor of using solid timbers matching the original species. The rehabilitation team refused the first shipment of timber because its quality did not match the structural qualities of the original bridge timber, so higher-quality, larger timbers sawn in Wisconsin were instead obtained. A substantial amount of smaller structural members were harvested and sawn in nearby Pennsylvania as well.

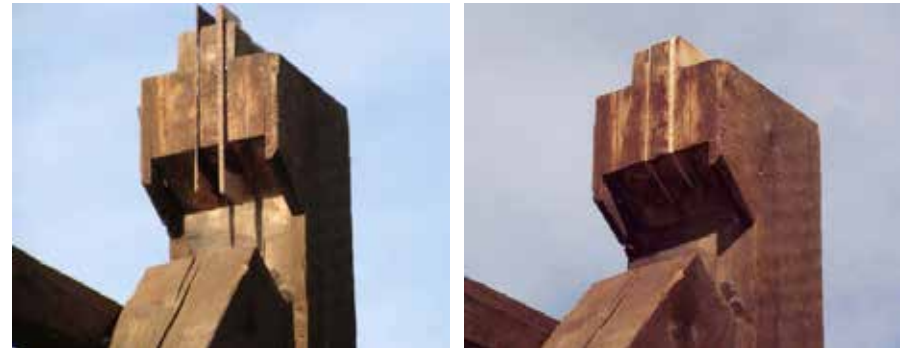
Figure C5.11 and Figure C5.12 The repair of this post required three stages of glueing to create a tight fitting Dutchman for this complex timber joint. Timothy Andrews, 2009.

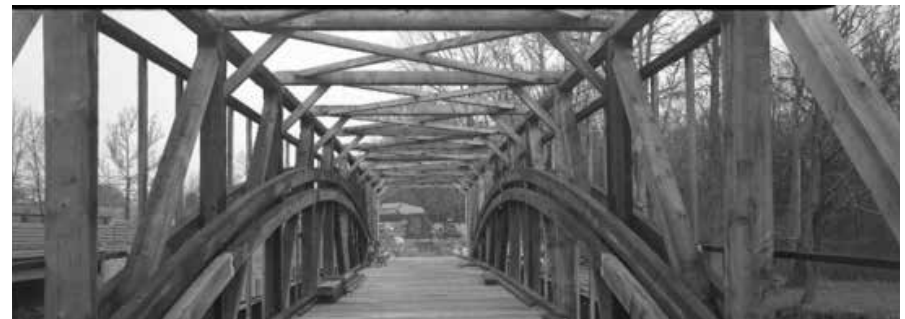
Figure C5.13 View of completed arches, trusses, bracing, and newly installed deck; awaiting curbing and sheathing. HAER MD-174-17, David Ames, 2010.

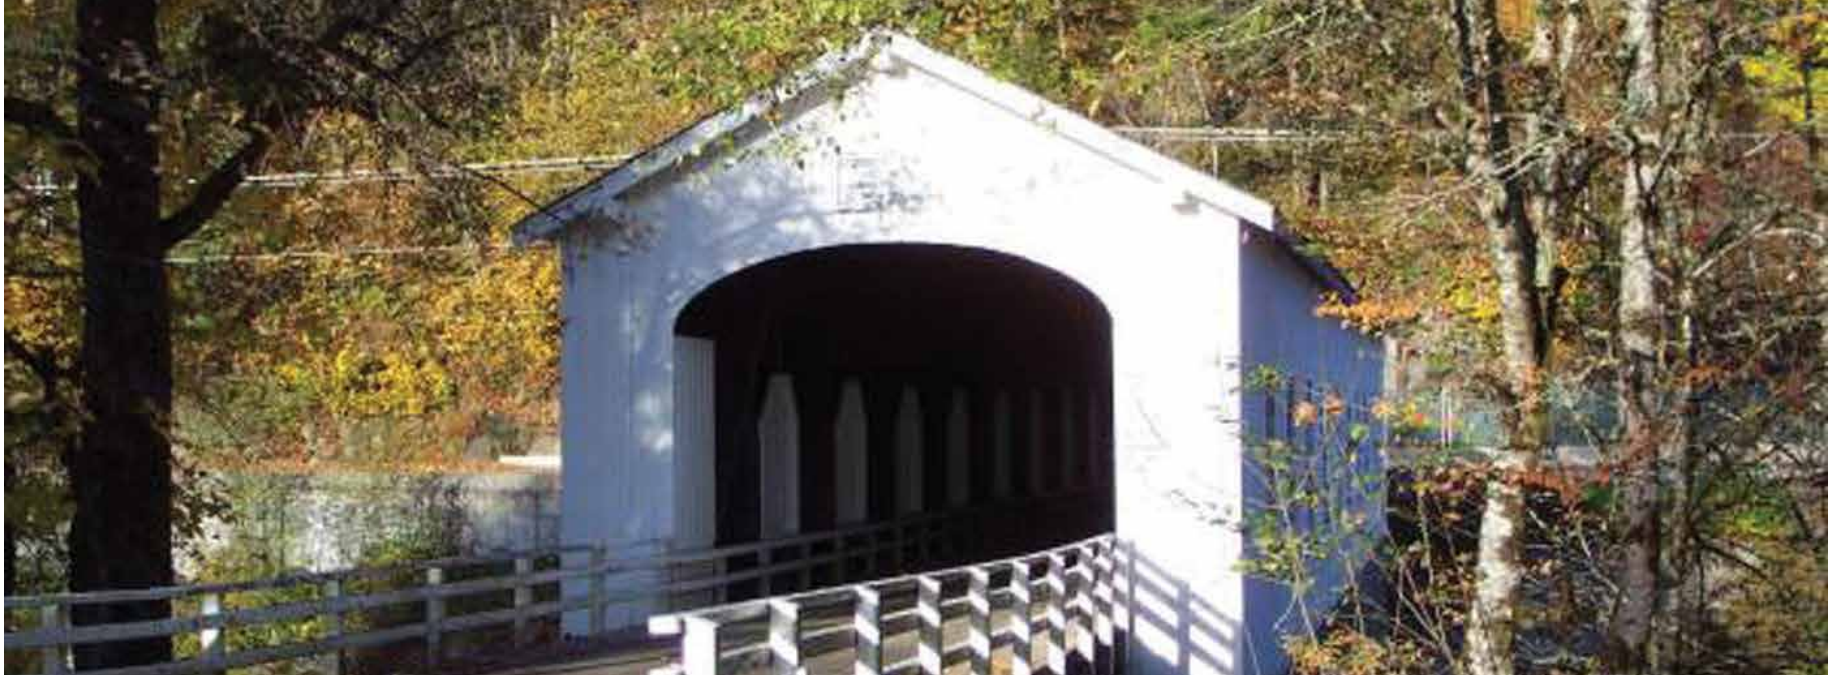
Figure C6.1 Goodpasture Covered Bridge, looking north, 2009. All photographs by OBEC Consulting Engineers, except where noted.

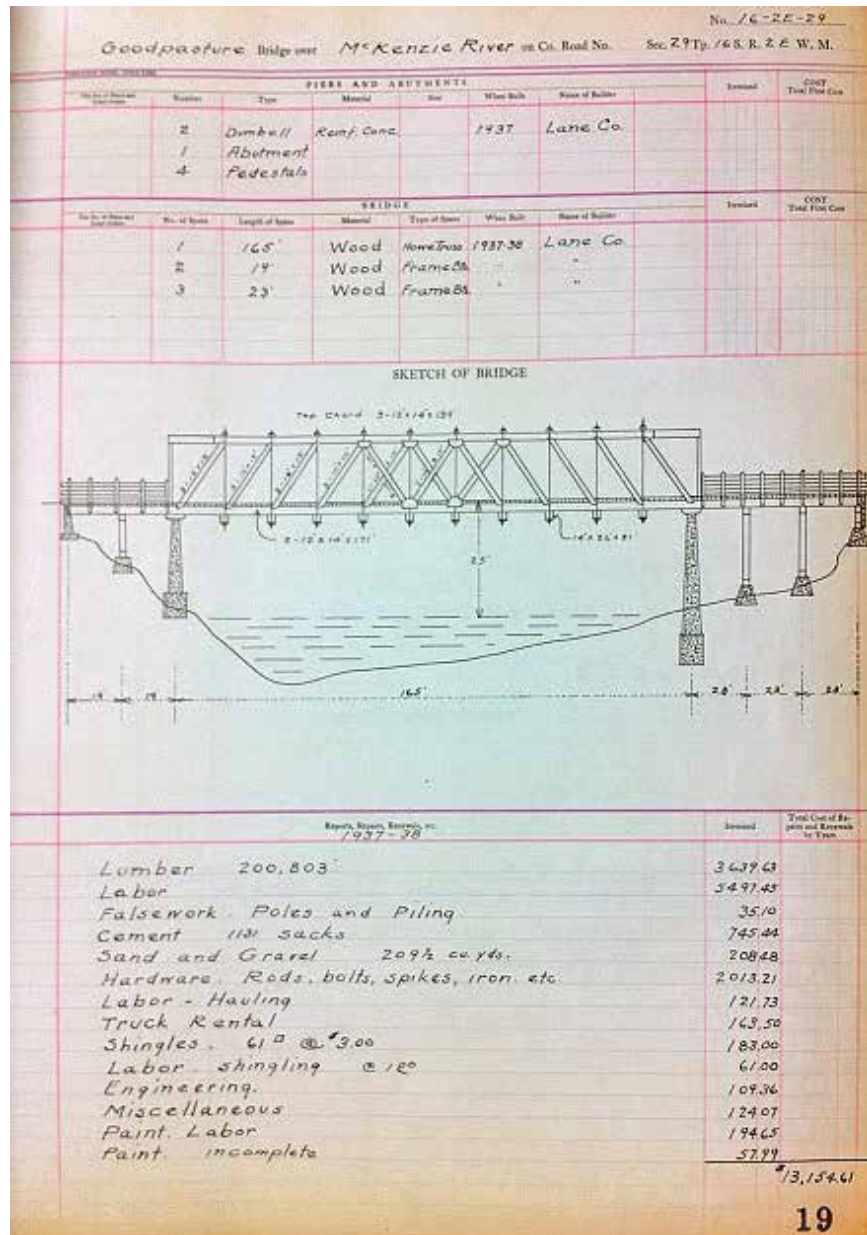
Figure C6.2 Invoice for original construction from Lane County Bridge Ledger. Courtesy of Lane County Historical Museum.

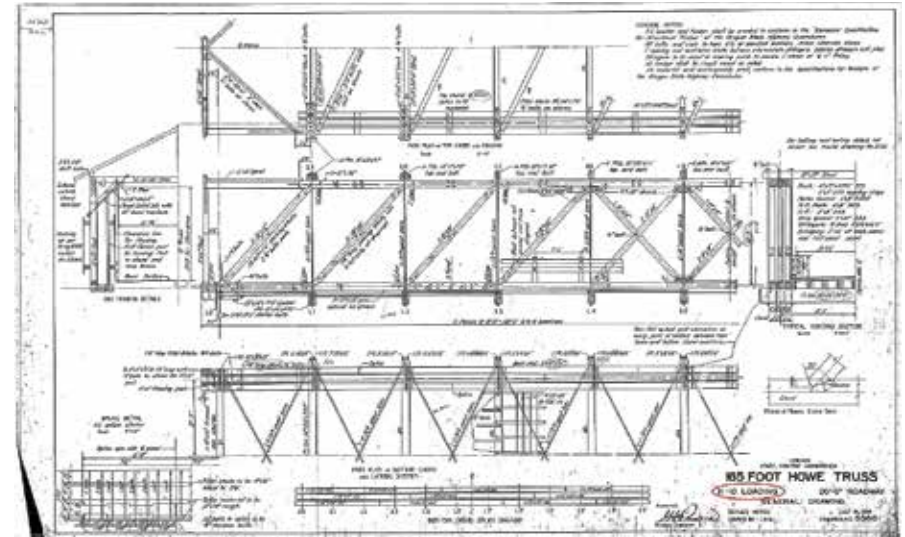
Figure C6.3 1938 standard drawing for 165-foot Howe Truss by the Oregon State Highway Commission.

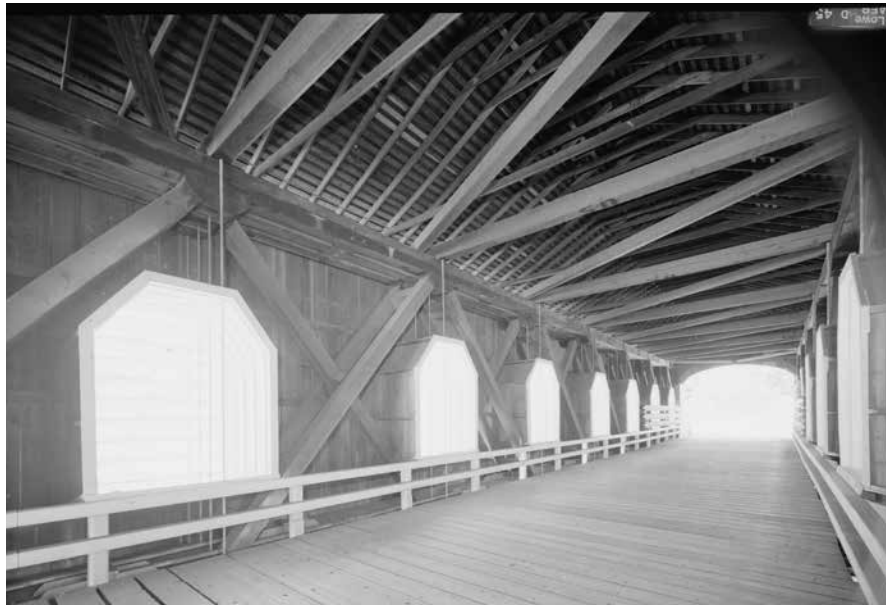
Figure C6.4 Interior of bridge showing center spans of Howe truss and boxed windows prior to rehabilitation. HAER OR-136-7, Jet Lowe, 2004.

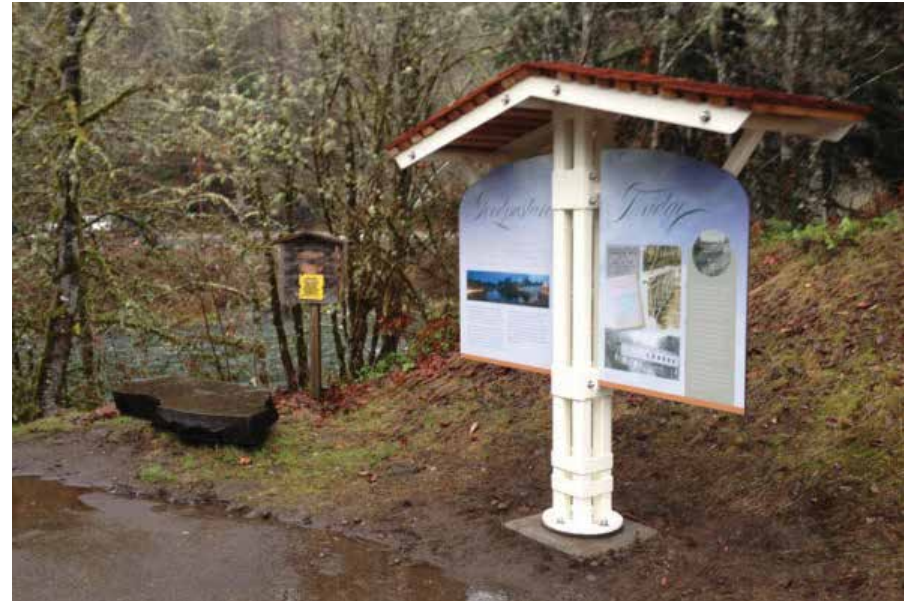
Figure C6.9 Interpretive display, 2013.

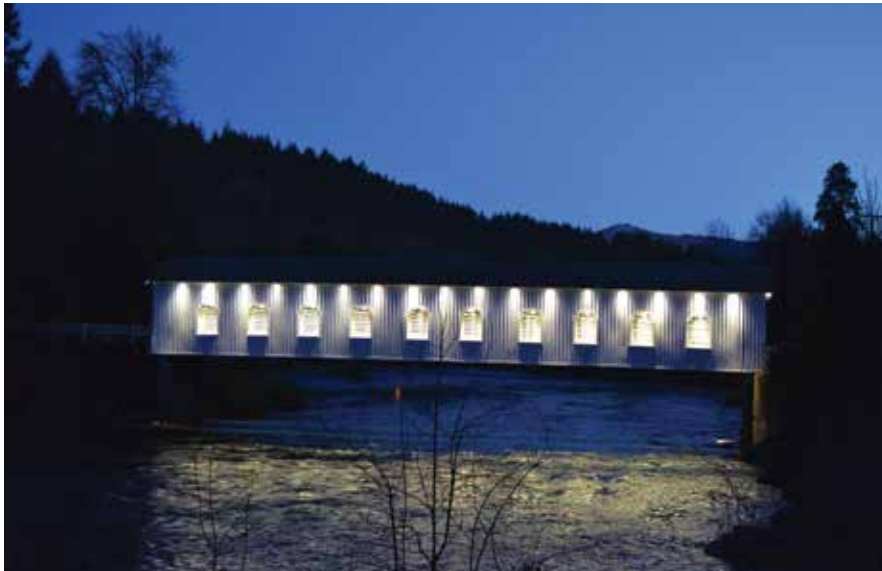
Figure C6.12 Goodpasture Covered Bridge at night, looking west, 2013.

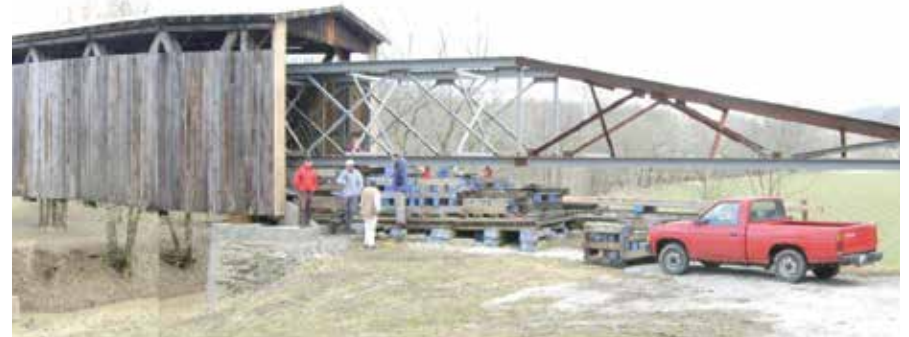
Figure C7.7 Panorama of steel truss inside of bridge, after camber was restored to 9". The center pier was removed after the truss was repaired. KTC, 2007.

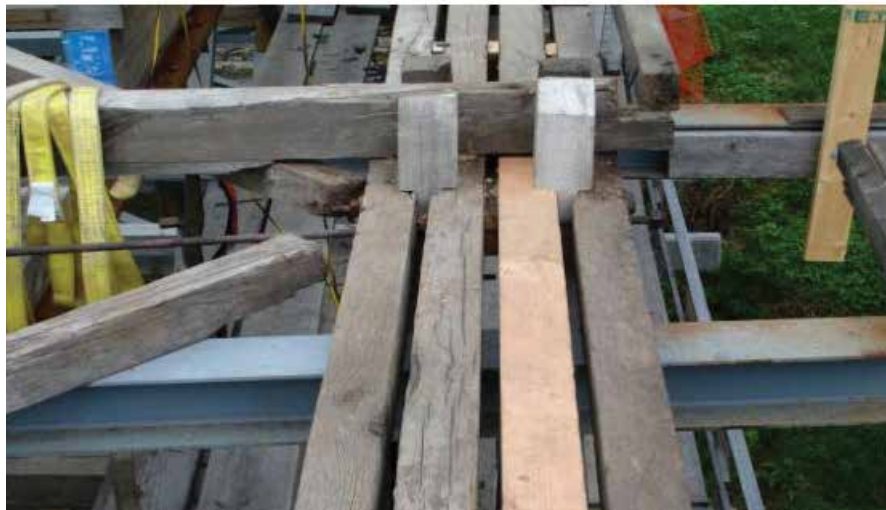
Figure C7.8 Detail of the upper chord, showing the typical joinery used throughout. Arnold M. Graton, Inc., 2007.

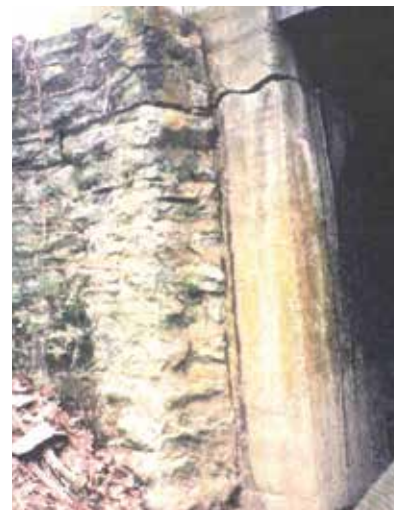
Figure C7.9 Cracks in concrete column and abutment at north end prior to rehab, KTC, ca. 2005.

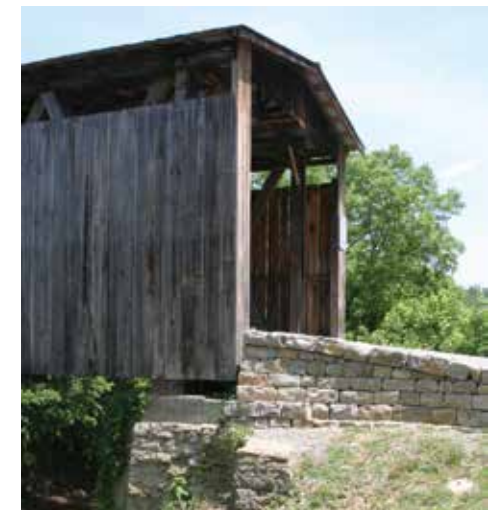
Figure C7.10 Dry-laid stone approach wall offset from the original dry-laid stone abutment. The approach wall was installed after bridge was raised 18" for flood prevention. Jen Spangler Williamson, 2010.

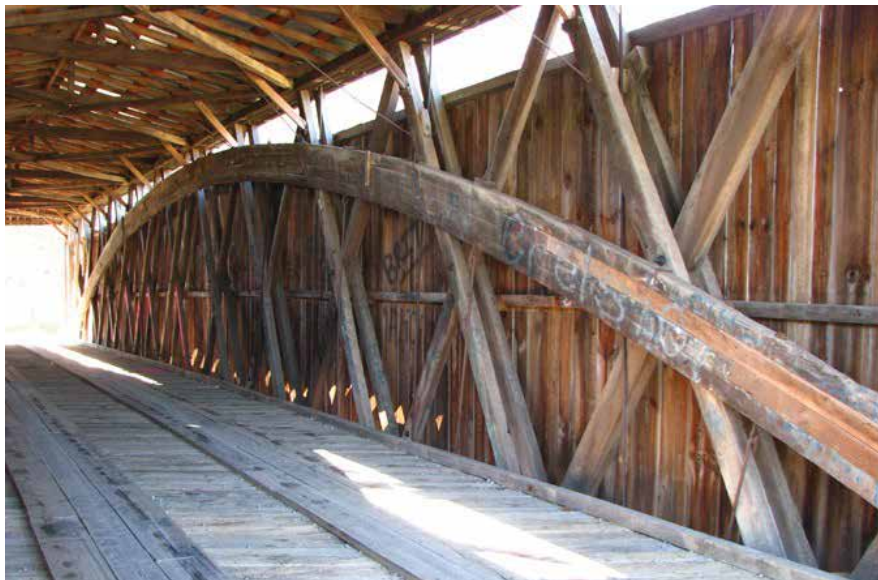
Figure C7.12 View of completed truss and deck, restored to its original geometry and camber. William Caswell, 2011.
