GUIDELINES FOR REHABILITATING HISTORIC COVERED BRIDGES

Edited by Christopher H. Marston and Thomas A. Vitanza

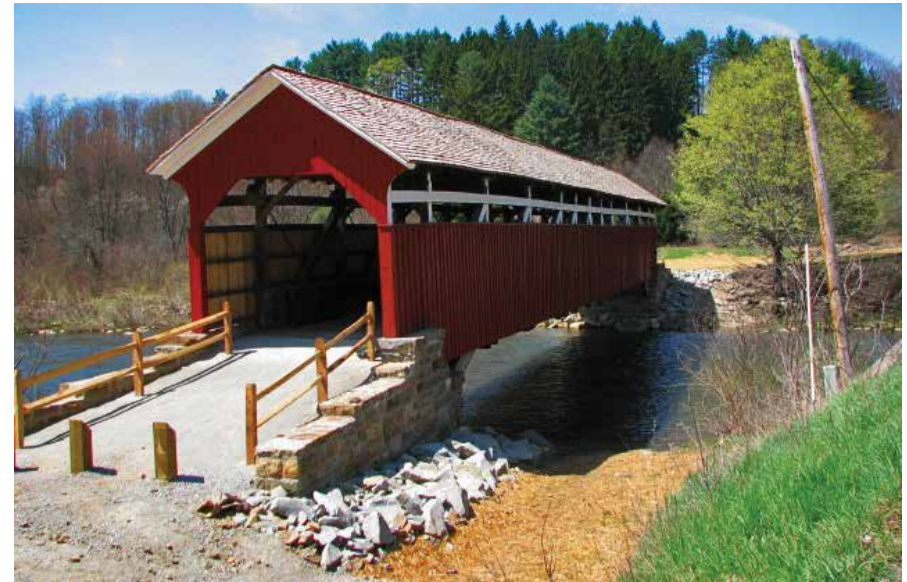
Figure C8.3 After rehabilitation at east portal SCLA, 2008.

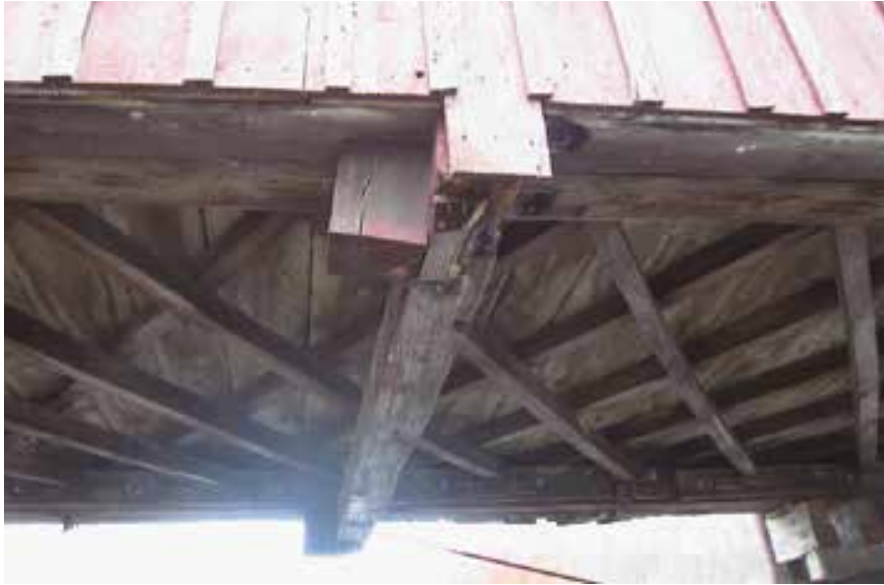
Figure C8.4 Lattice floor joist system, and lower tie beam added after original construction. SCLA.

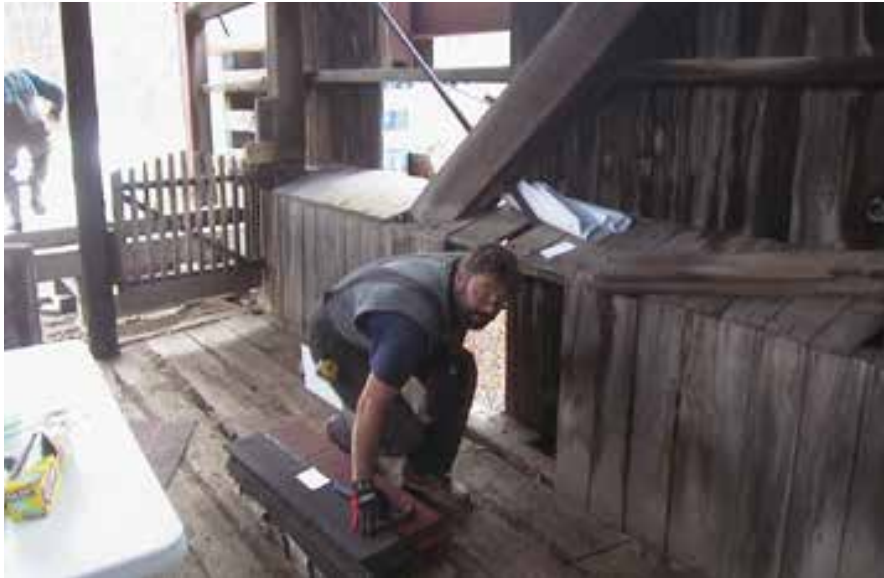
Figure C8.5 Human and livestock gates at east portal. Note the diagonal repair rods through the truss braces, which were installed early in the twentieth century. SCLA.

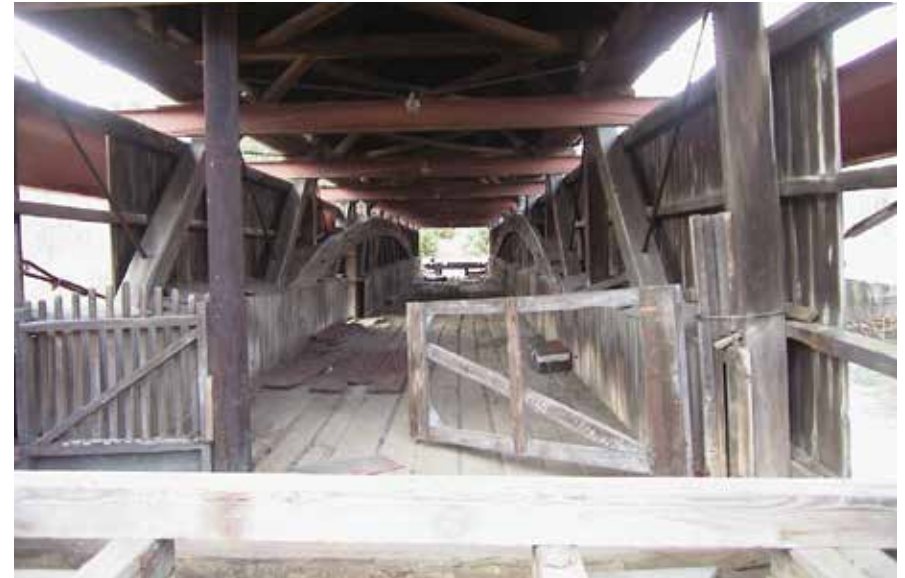
Figure C8.6 Same gates from outside. SCLA.

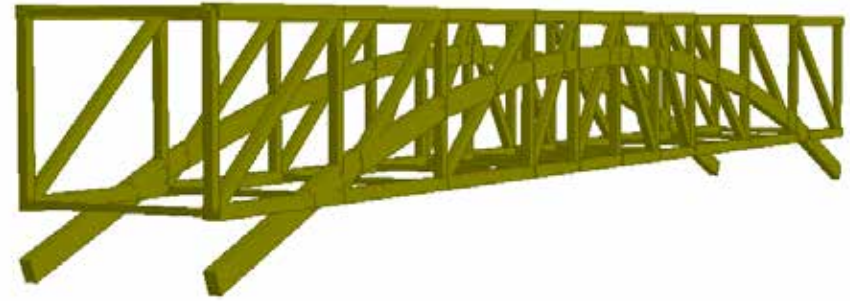
Figure C8.7 3-D Rendering (STAAD Model) of King's Bridge. SCLA.

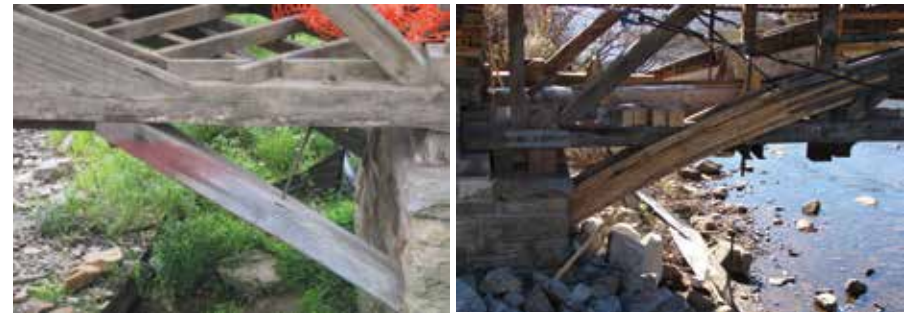
Figure C8.9 Arch tied to chord and strut below to abutment. SCLA.

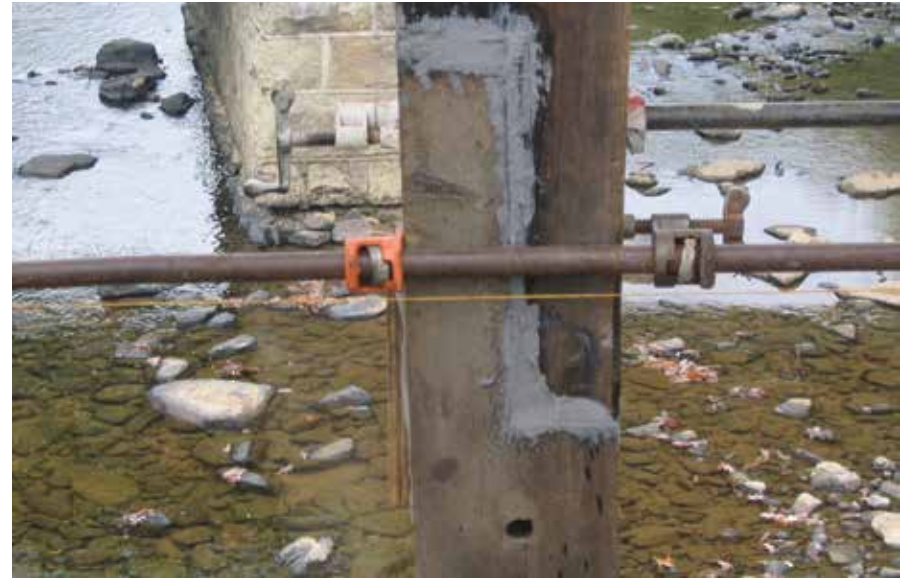
Figure C8.12 GFRP post repair. SCLA.

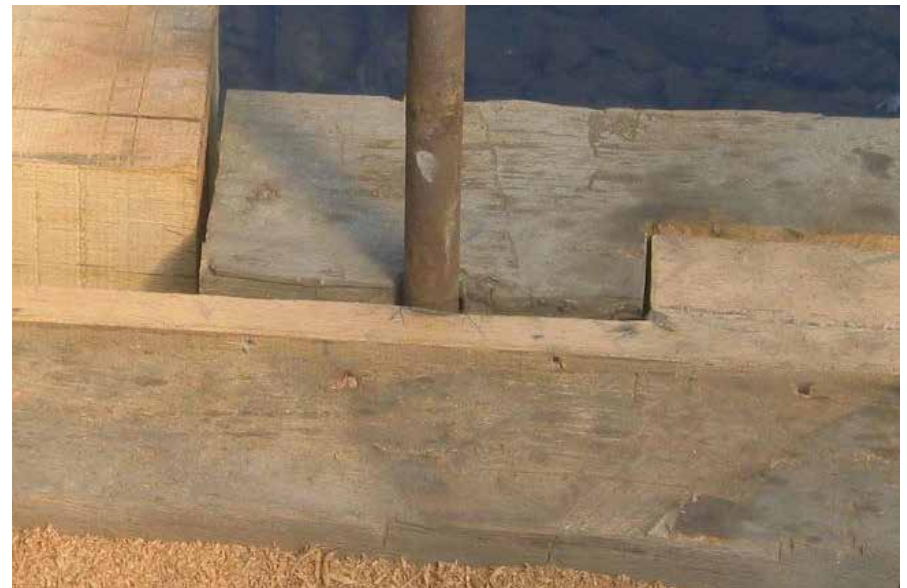
Figure C8.13 Joggle splice repair. SCLA.

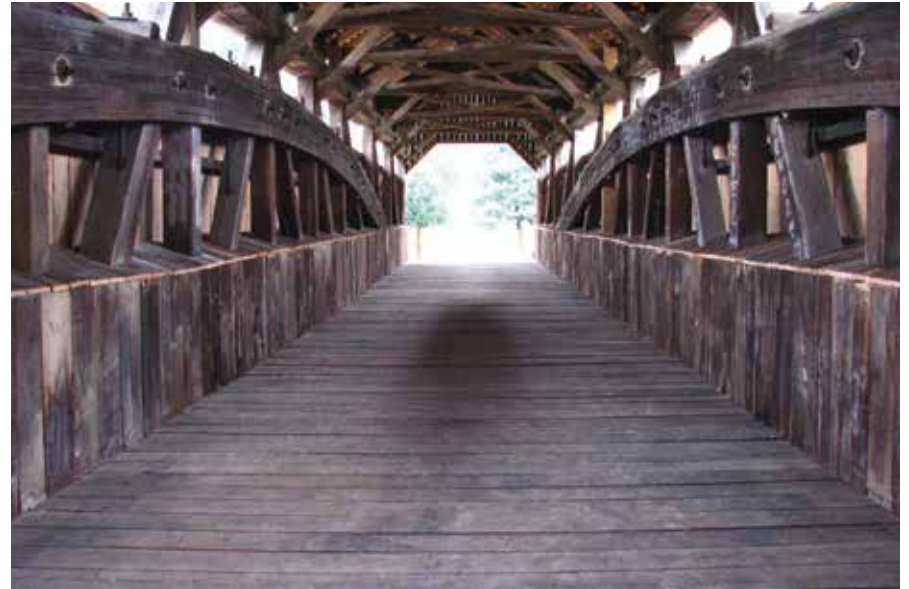
Figure C8.15 Interior rehabilitated. SCLA.

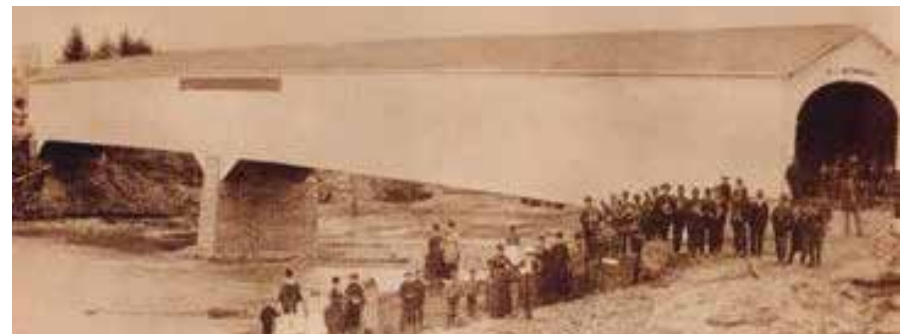
Figure C9.2 Original ribbon-cutting ceremony in 1886. Rush County Heritage, Inc.

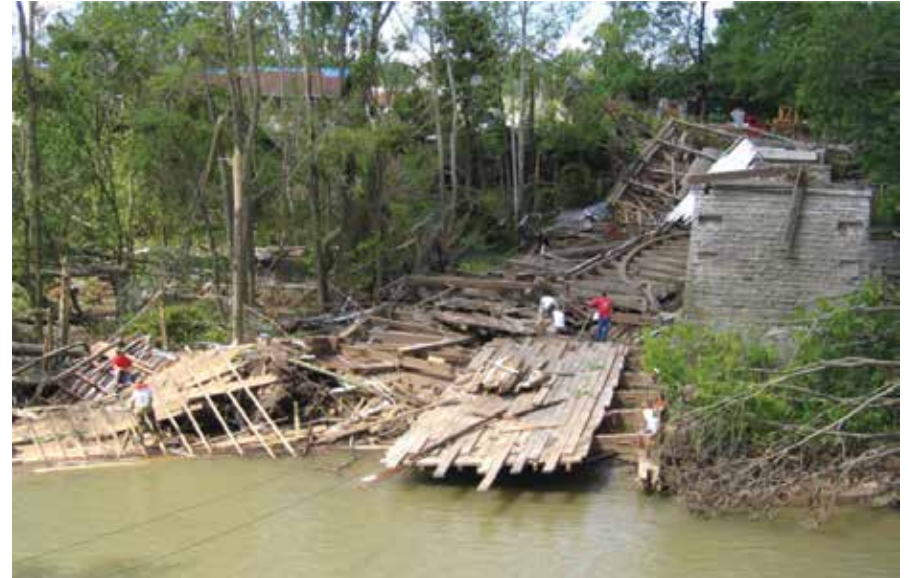
Figure C9.4 Moscow Bridge after the tornado. It seems hopeless. Wayne Goodman, Indiana Landmarks, 2008.

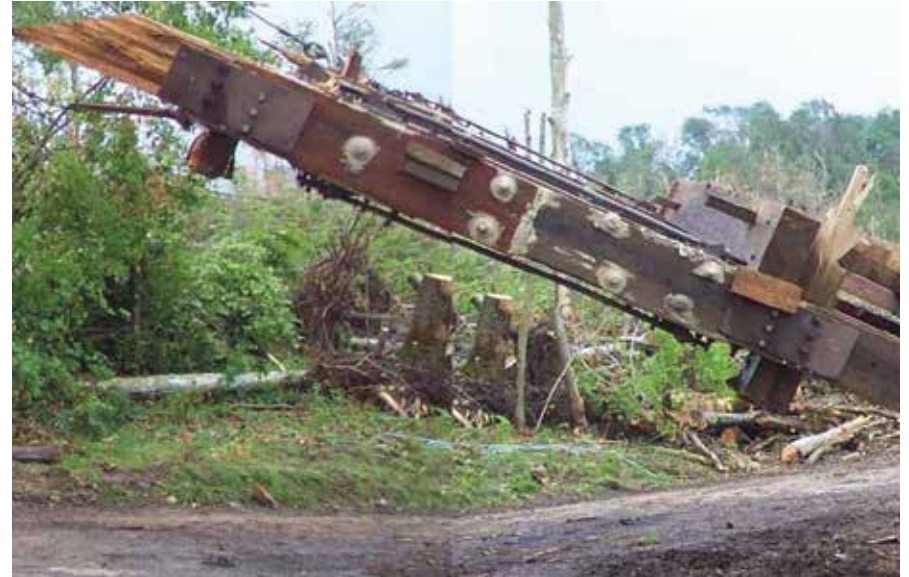
Figure C9.6 Pulling the bridge out of the water. Previous repairs included liberal use of epoxy adhesives, making it impossible to reuse these lower chord timbers. James Barker, J.A. Barker Engineering, Inc., 2008.

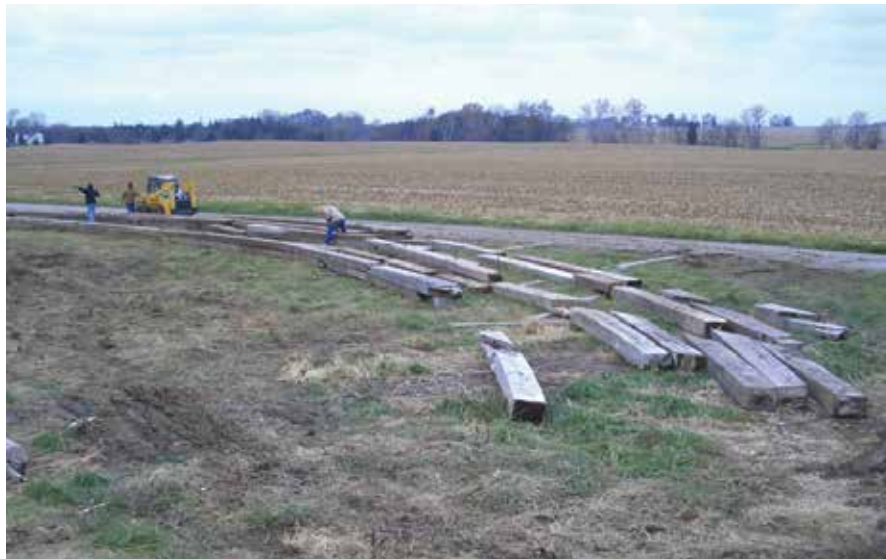
Figure C9.7 Sorting arch timbers and trying to determine the original positions. Matthew Reckard, J.A. Barker Engineering, Inc., 2008.

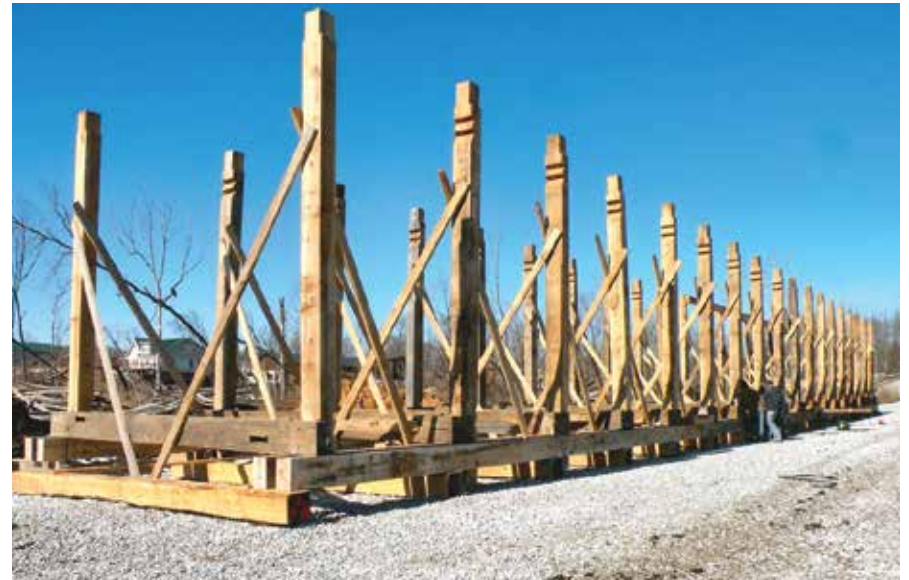
Figure C9.8 Start of framing for one span; blocking provides camber. Double notching visible at tops of posts. Arthur Gatewood, 2010.

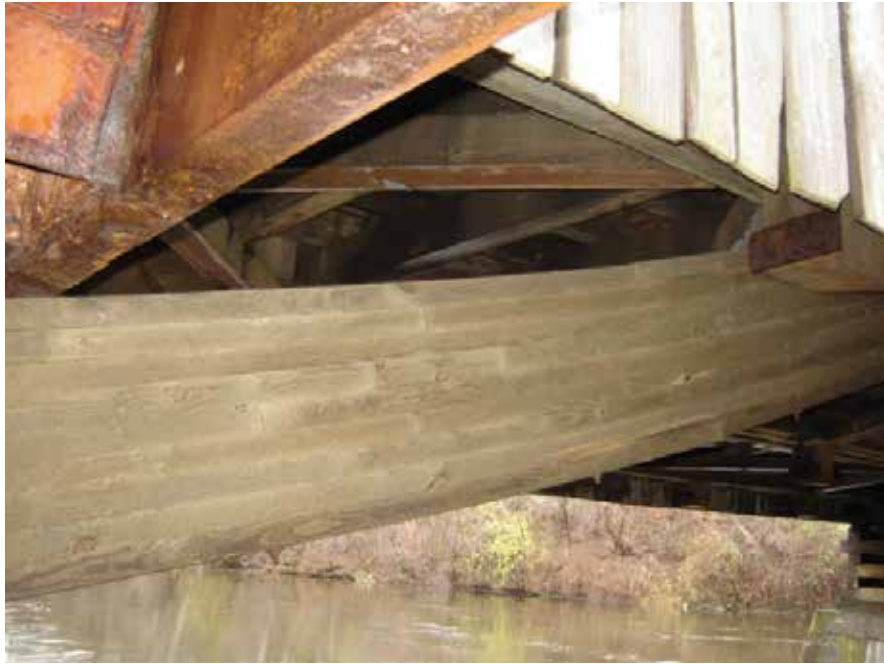
Figure C10.4 Buckling of west end of the south arch. Sean T. James, November 2006.

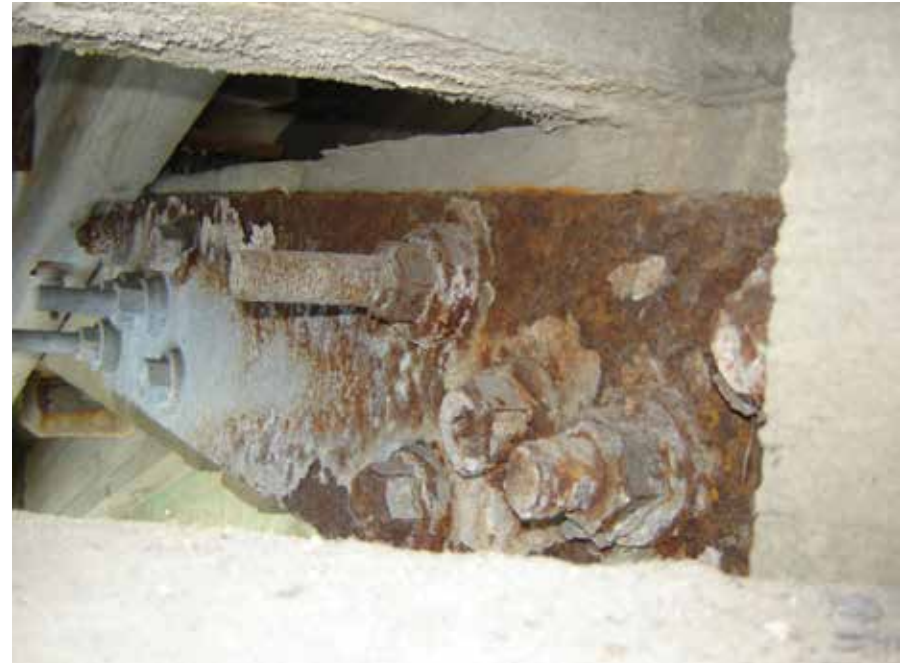
Figure C10.5 Severely corroded splice plate of interior truss at west span. Josif Bicja, August 2007.

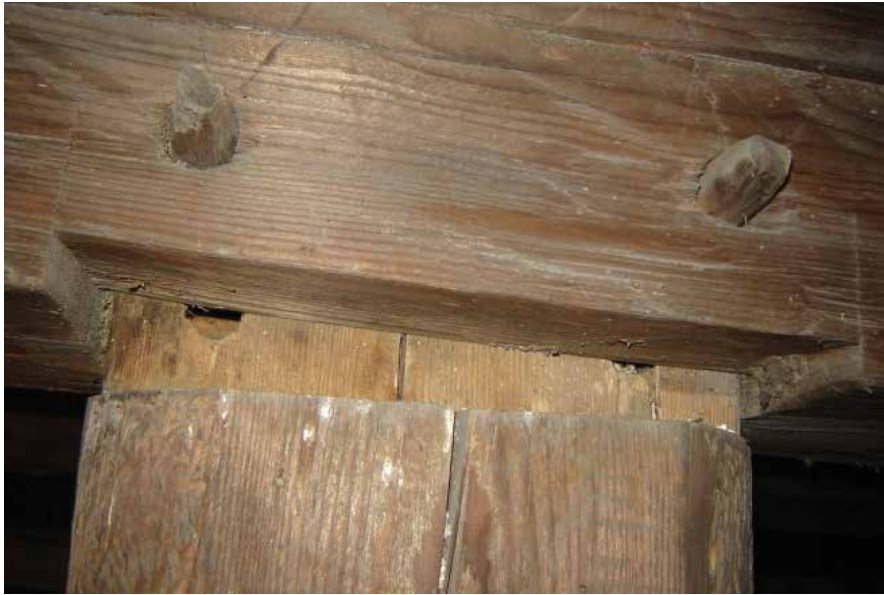
Figure C10.6 Truss vertical to top chord with failed connection at interior truss. Sean T. James, July 2007.

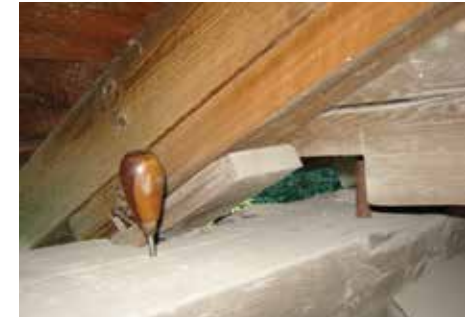
Figure C10.11 2 ½" gap between cross beam and top chord of exterior truss at Node N19. Josif Bicja, July 2007.

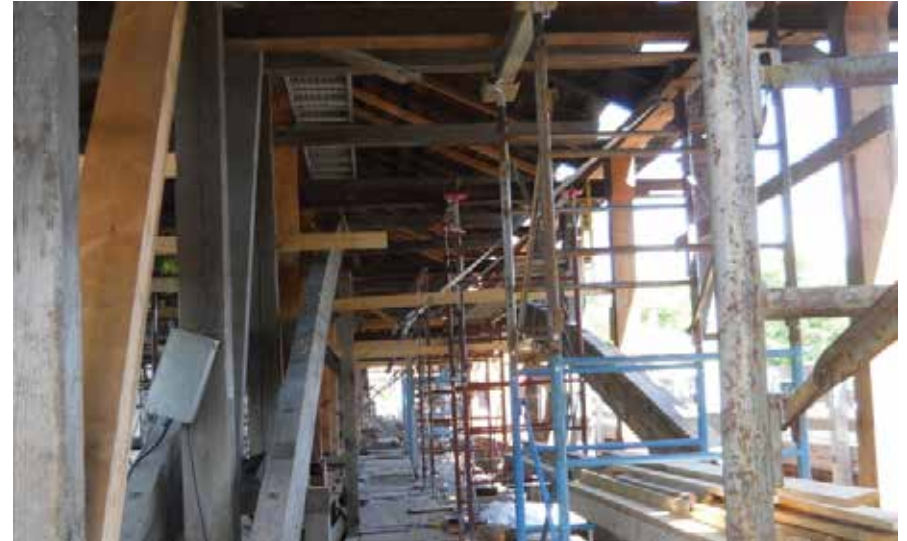
Figure C10.16 Temporary shoring system inside the bridge, looking east on eastbound barrel. Josif Bicja, July 2012.

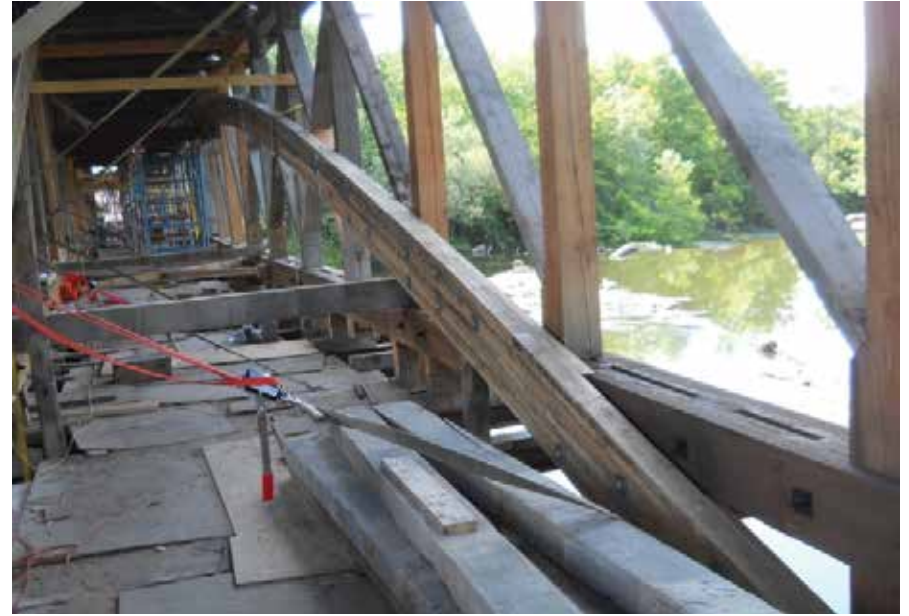
Figure C10.19 Replaced portion of north arch, east end. Josif Bicja, July 2012.

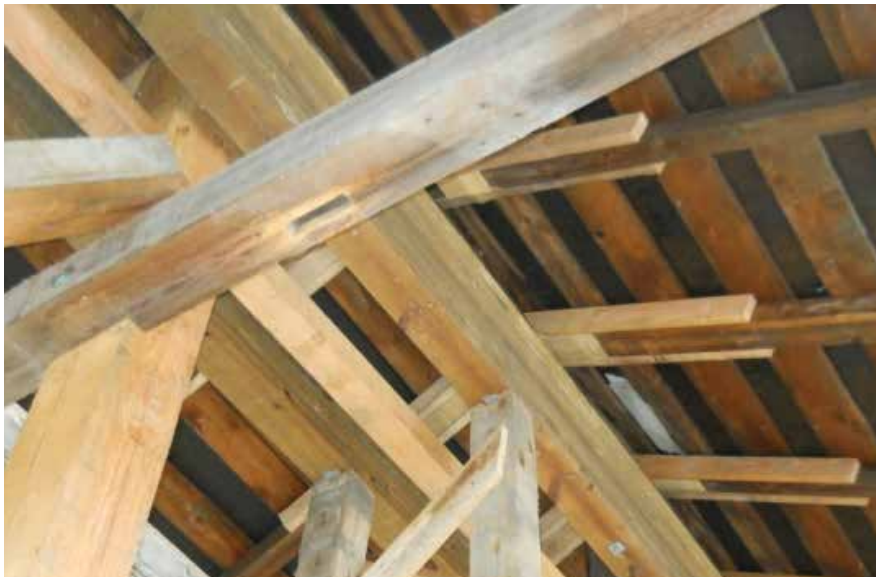
Figure C10.18 Typical sistered roof rafters. Josif Bicja, July 2012.

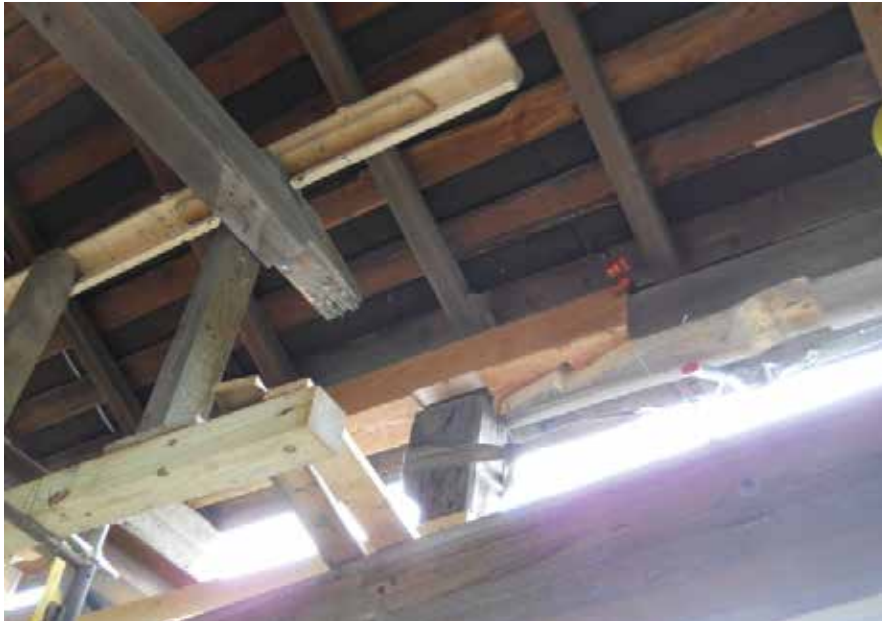
Figure C10.20 Typical top chord scarfed joint. Josif Bicja, July 2012.

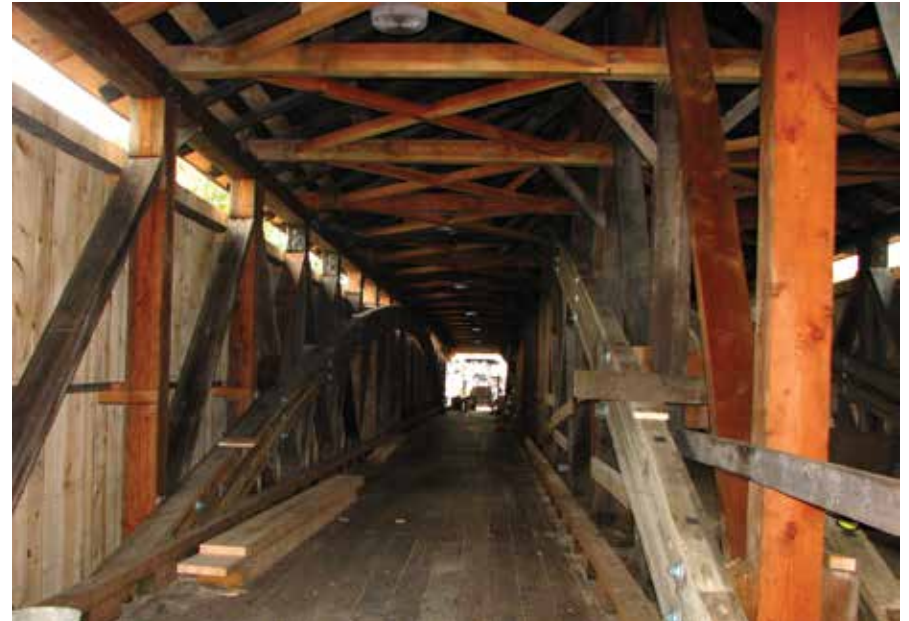
Figure C10.21 New upper lateral bracing and arches on eastbound barrel. William Caswell, September 2012.

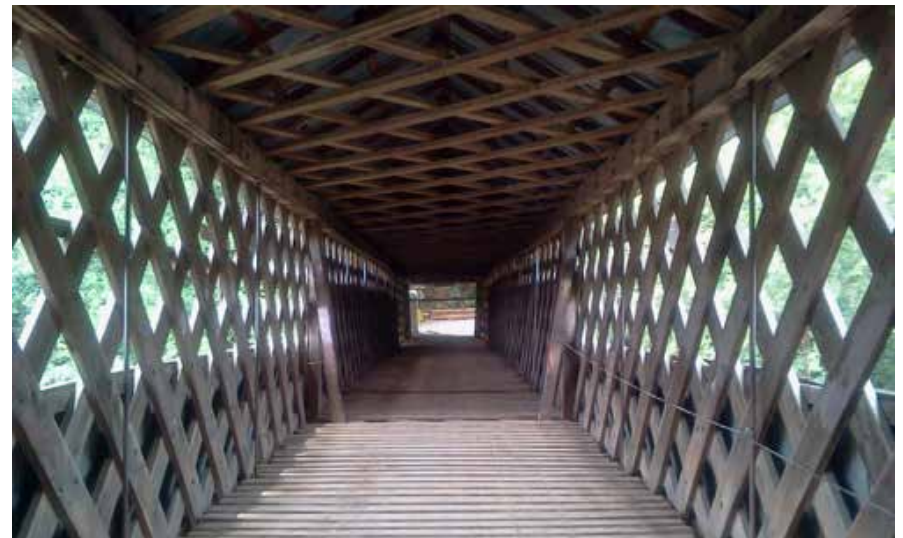
Figure C11.6 Floor, runners, and rail removed. TranSystems, 2012.

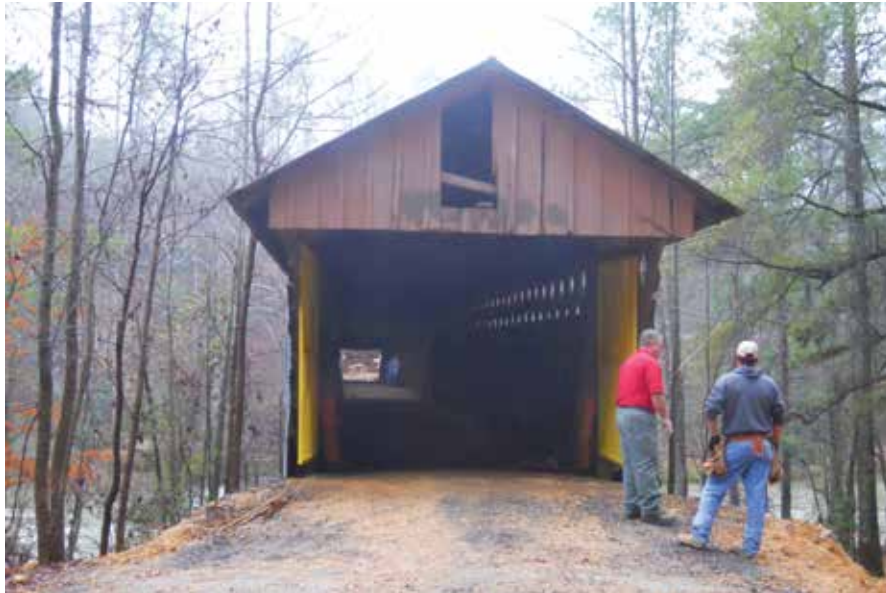
Figure C11.8 Abutment 1 showing gable with missing boards. TranSystems, 2012.

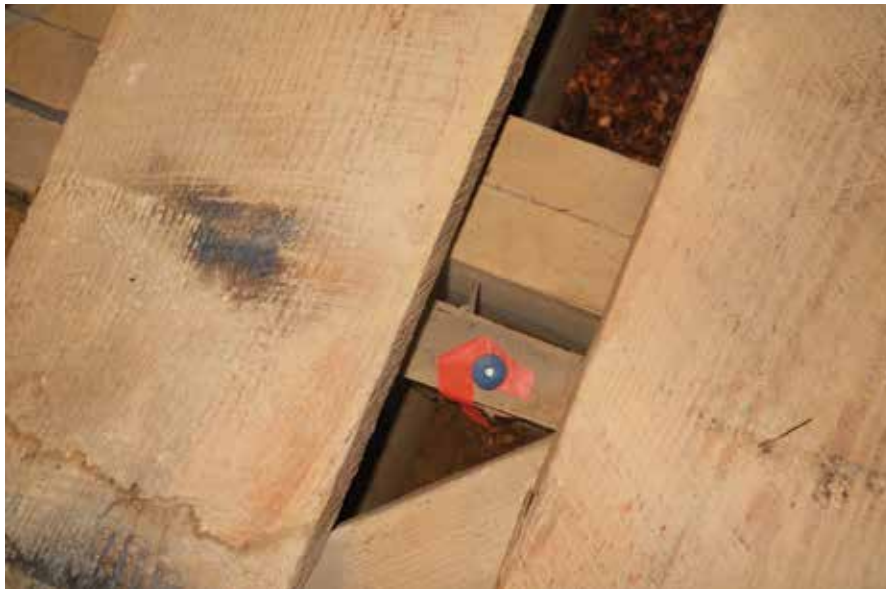
Figure C11.9 Span 1, near floor beam 2, showing separation between stringer 4 boards. TranSystems, 2012.

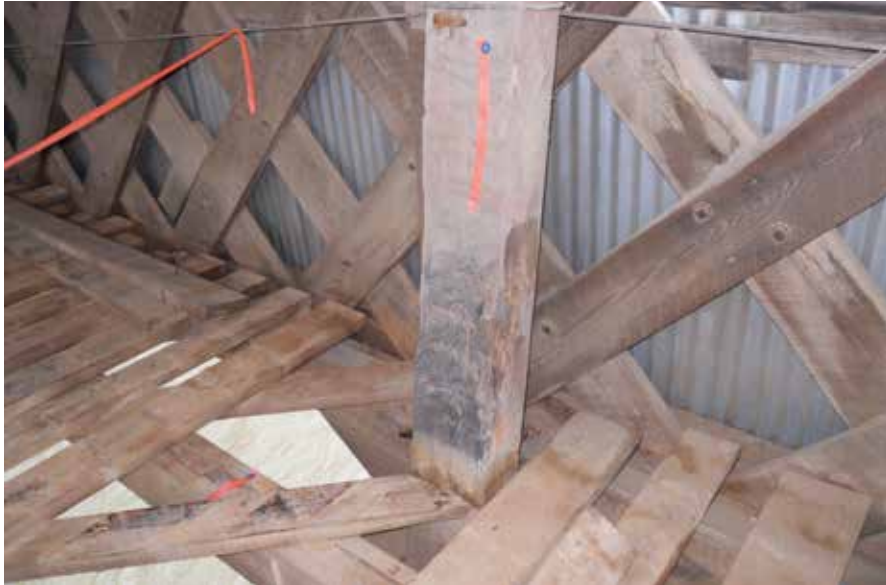
Figure C11.10 Vertical post at Pier 2 revealed deterioration on south side. TranSystems, 2012.

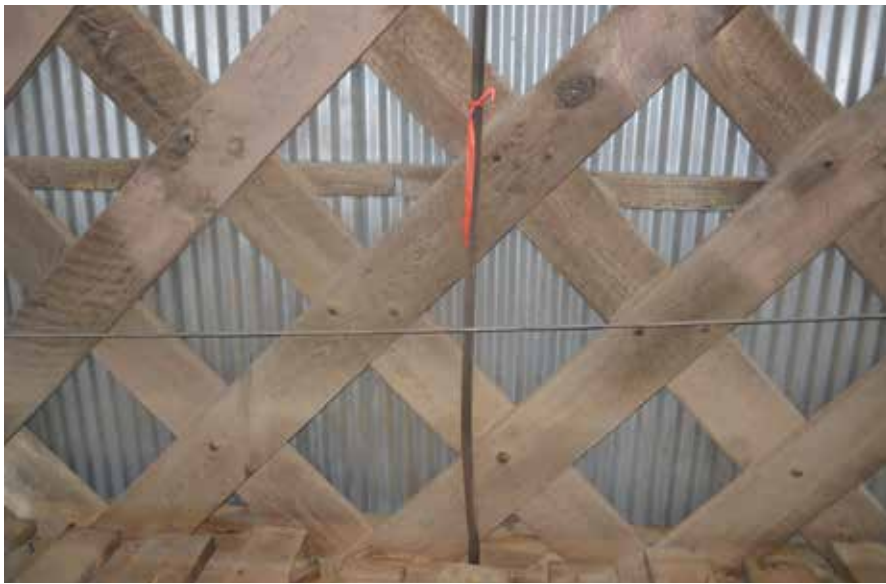
Figure C11.11 Span 3, south (right) side with bent hanger rod 1. Condition also observed at north hanger rod at floor beams 5 and 6. TranSystems, 2012.

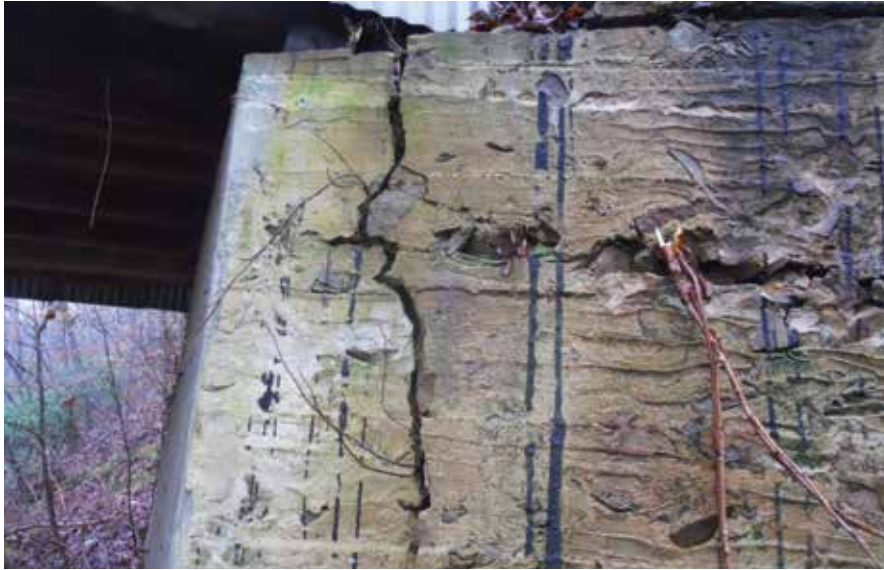
Figure C11.14 Wide crack in abutment 4 breastwall. TranSystems, 2012.
