NEVADA BREWERY #2 of 26 Nevada City, CA. Photographer: Unknown

NEVADA BREWERY

107 Sacramento Street, Nevada City, CA
Photo by Stella and Donn Walcutt

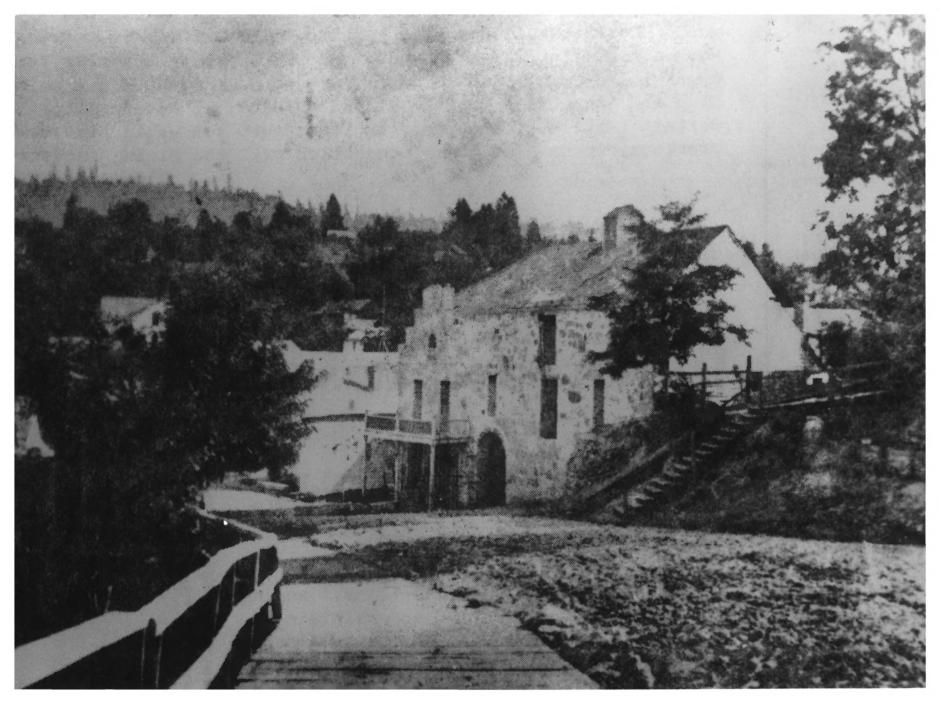
Early photograph shows original steep gable roof and second level porch at NW corner. Cast iron shutters missing from doors and windows. Note rock road and wooden sidewalk. By 1920's, street had been paved.

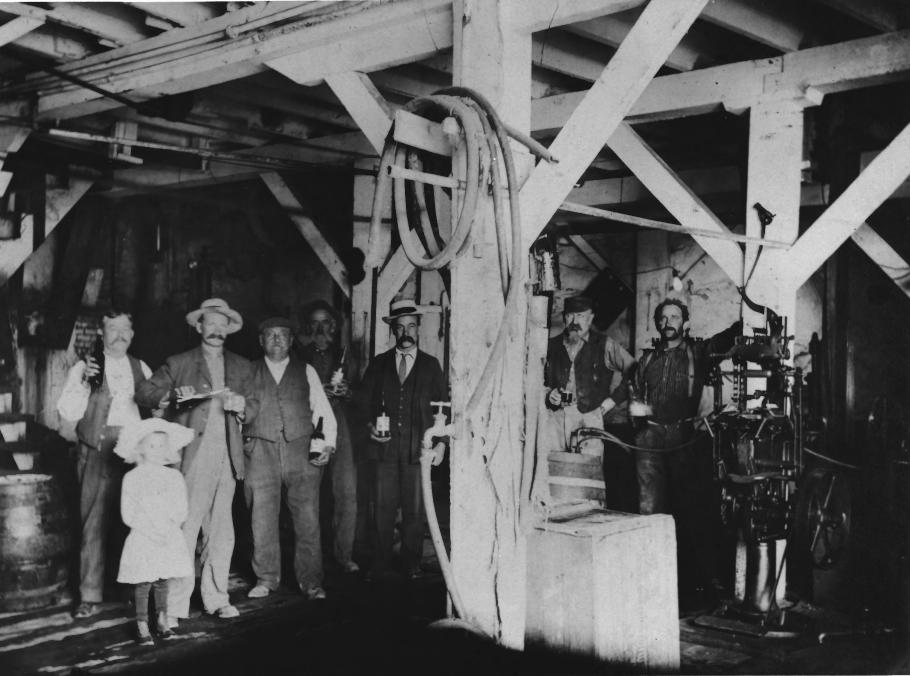
Interior, street level

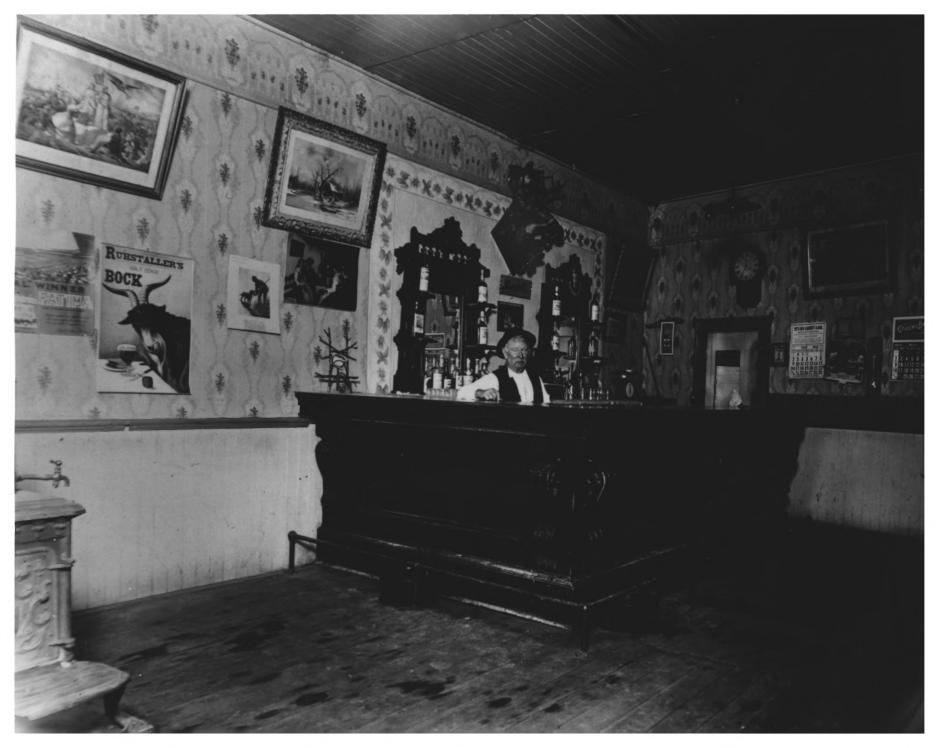
#3 of 26

Interior of original saloon area showing wood wainscot and wood floor. Note early electric ceiling fixture. Calendar dated May 1, 1915, with clock showing 11:35.

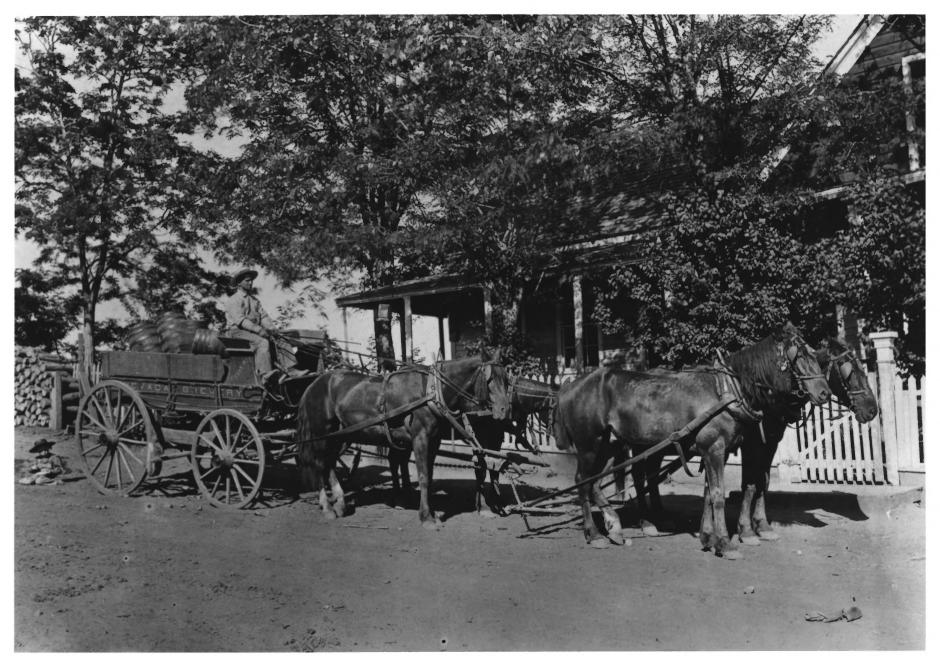
Simon Hieronimus' brewery wagon with barrels.

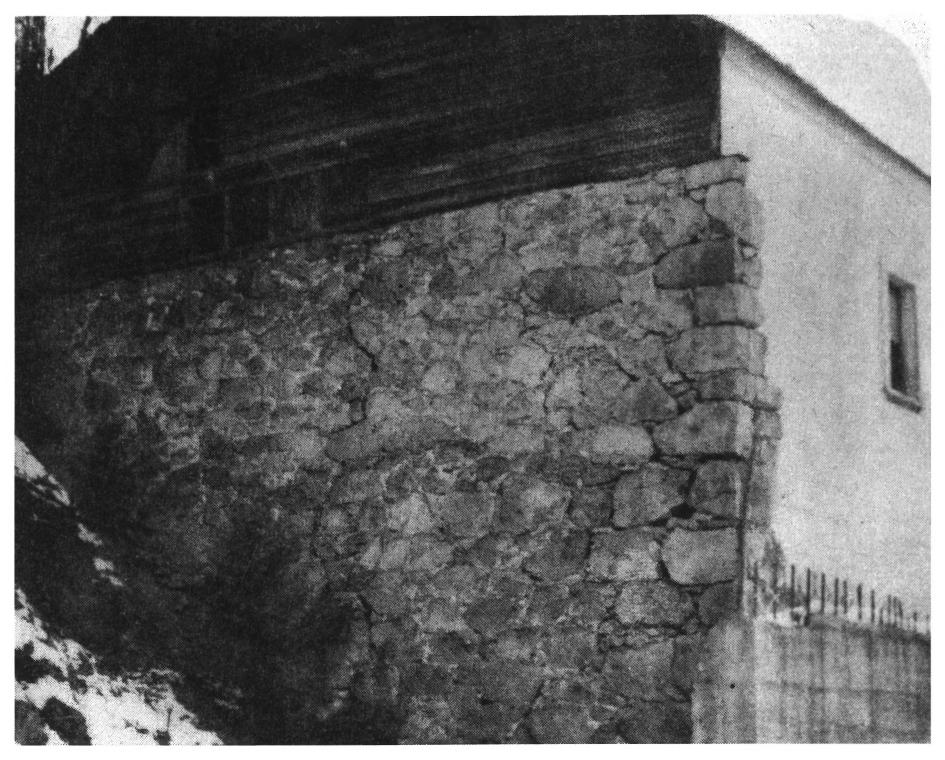
Southwest corner of building below Rough and Ready Ditch. Photograph from the Geological Guidebook Along Highway 49, Division of Mines, State of California.

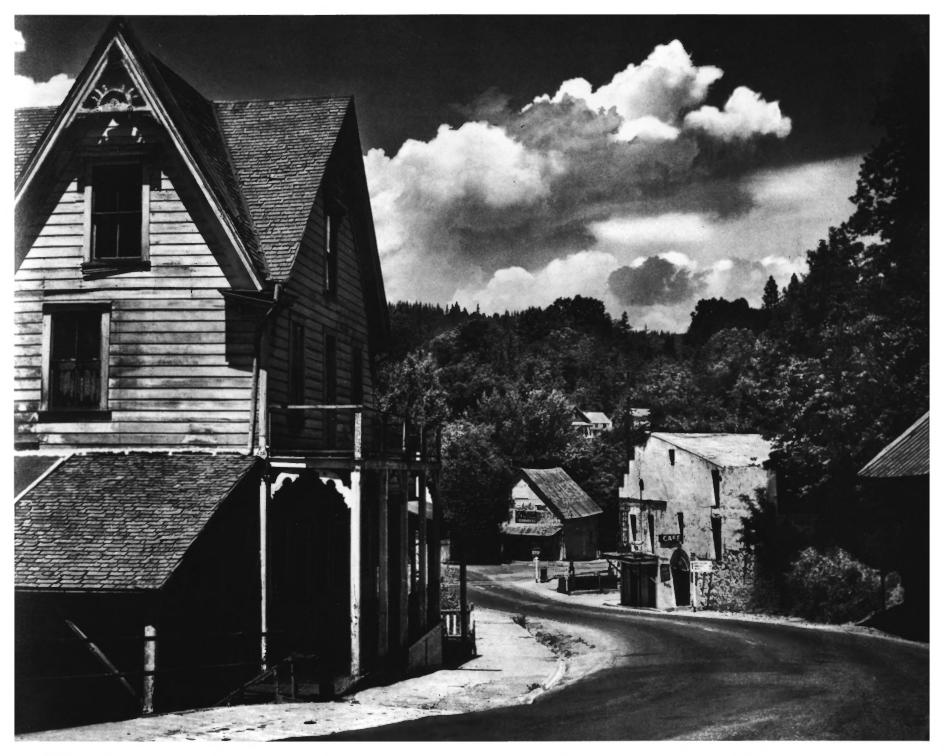
Photograph shows numerous changes from original structure, including totally different roof configuration, plastering over stone walls, change from original balcony to entry canopy only, closer proximity of street to west elevation.

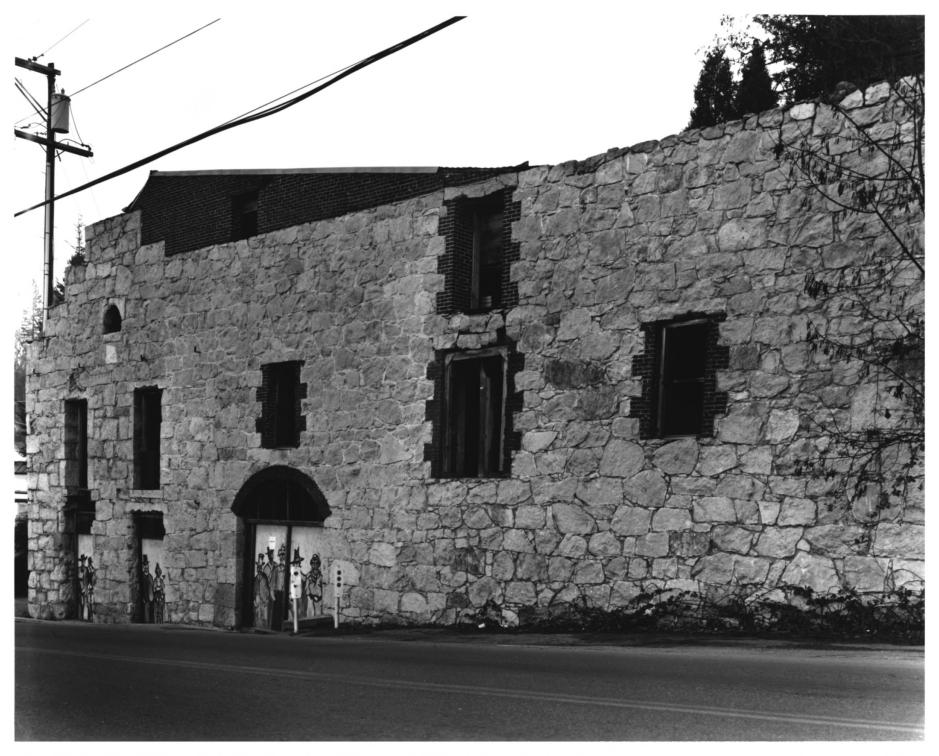
Photograph shows several changes and earlier applications. Brick parapet wall shows exact slope of later roof structure. Evidence shows original balcony height by location of iron angle ties for back ledger set between first and second story openings.

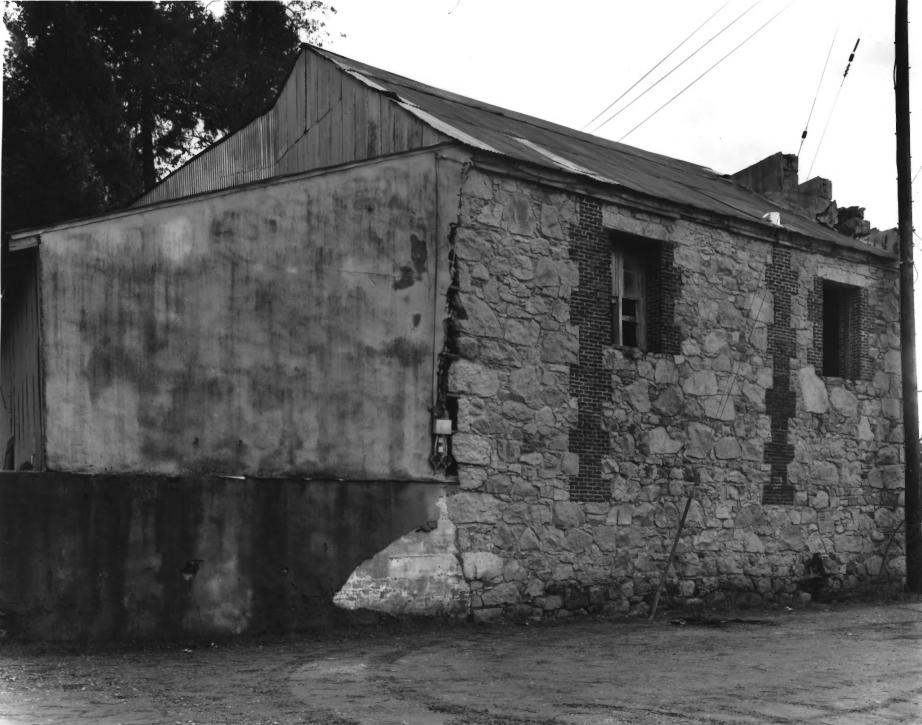
Left side of photograph shows wood frame lean-to addition at rear of stone building. Original wood shingle roof has long since been replaced with corrugated tin roof. Brick detailing at windows and brick inset for stone flues from both 1st and 2nd levels.

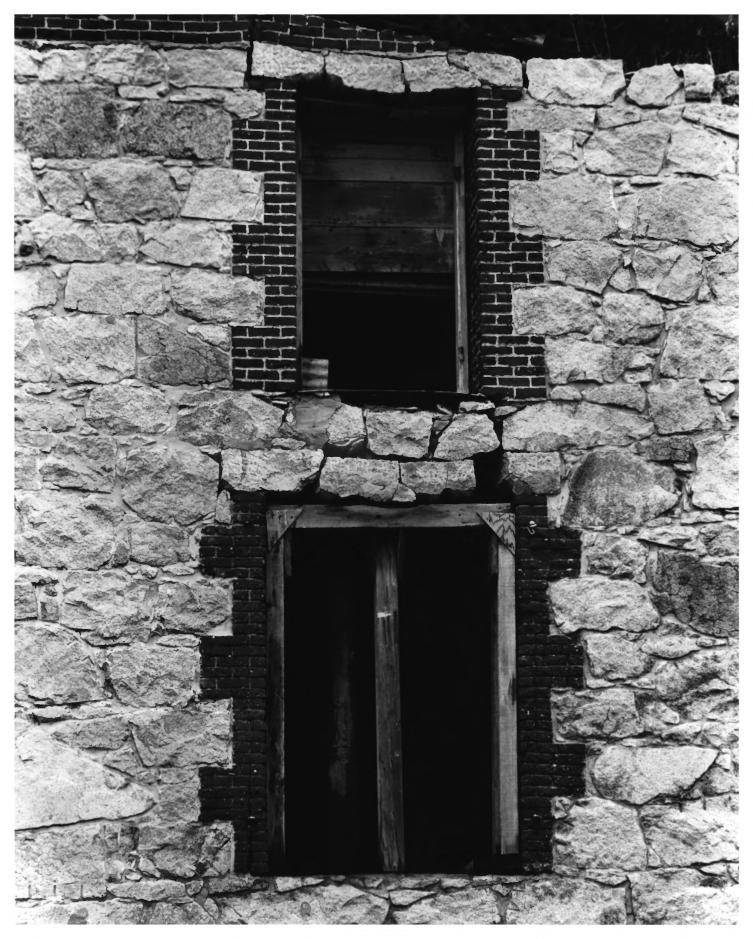
NEVADA BREWERY #9 of 26 Nevada City, CA Photographer: Nikki Pahl 1984

Shows structural failure of granite headers at both window openings. Iron pintle hinges embedded on brick window jambs. 2nd story window wood jamb has remains of original cast iron hinges for exterior wood shutters.

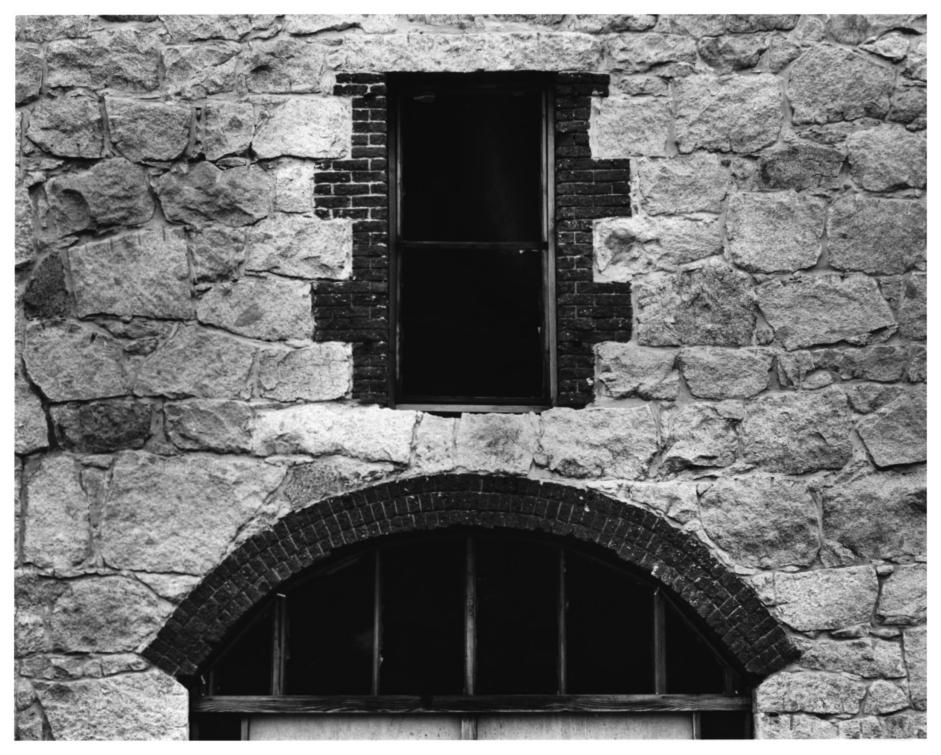
NEVADA BREWERY #10 of 26 Nevada City, CA

Detail of window and brick arch above main door at west elevation. Loaded brewery wagons made their exit onto Sacramento Street from this doorway. Pintle hinges remaining in masonry opening above arch.

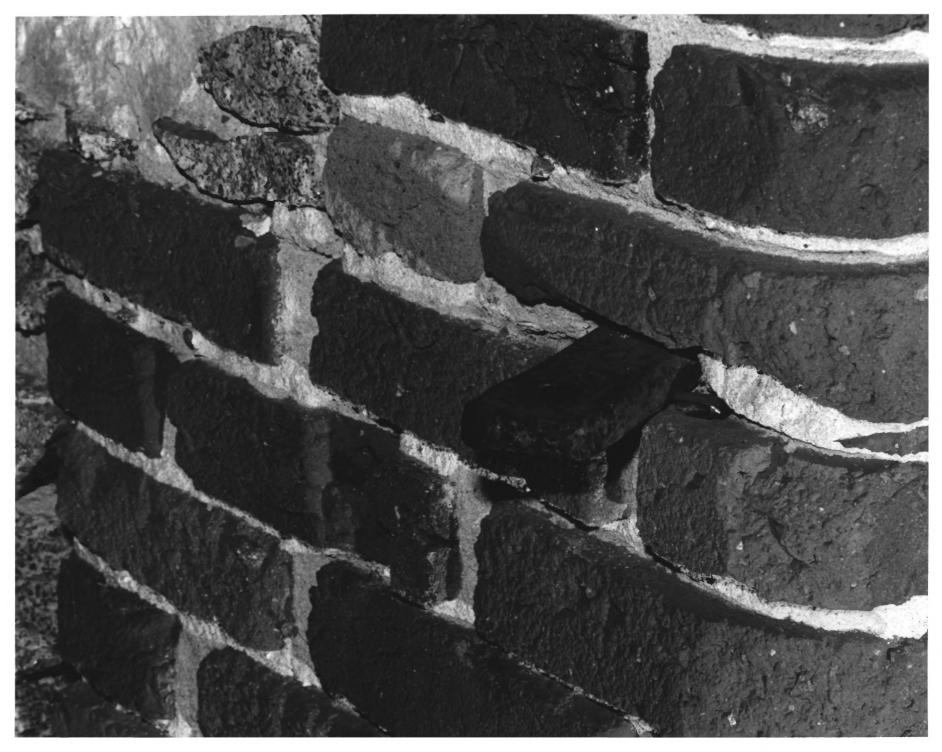
#11 of 26

Detail of iron pintle hinge remaining in masonry walls. Most exterior openings have evidence of original hinges.

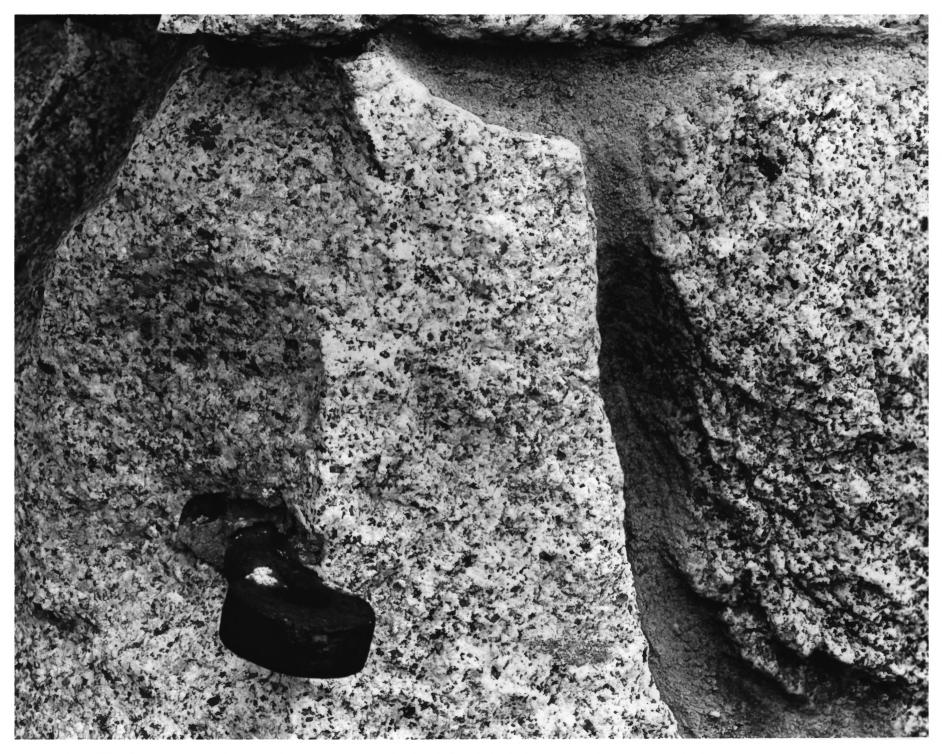
#12 of 26

Detail of iron pintle hinge remaining in granite at doorway, street elevation.

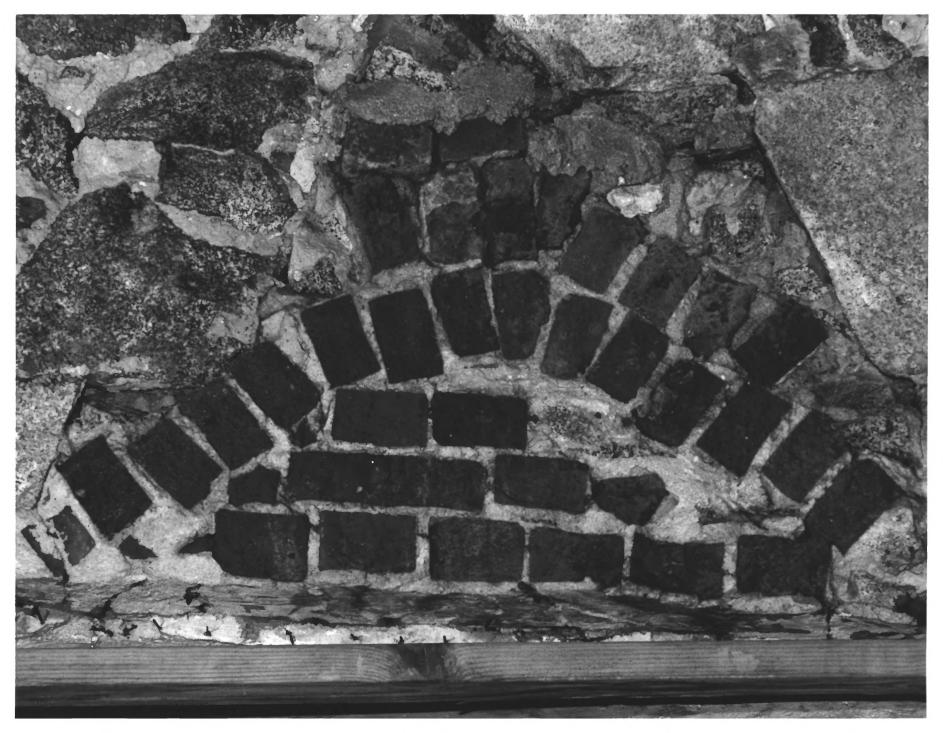
Brick vaulting detail over flat masonry header above second level doorway.

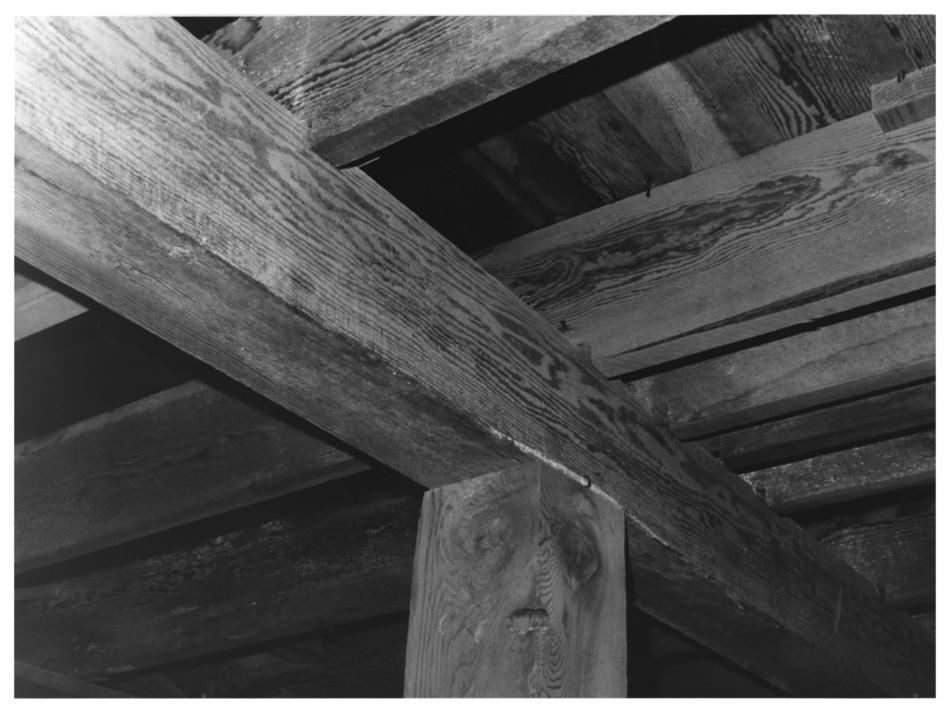
NEVADA BREWERY #14 of 26
Nevada City, CA
Photographore Nikki Bohl

Detail of post and beam construction. Note beam is notched into second level floor joist above.

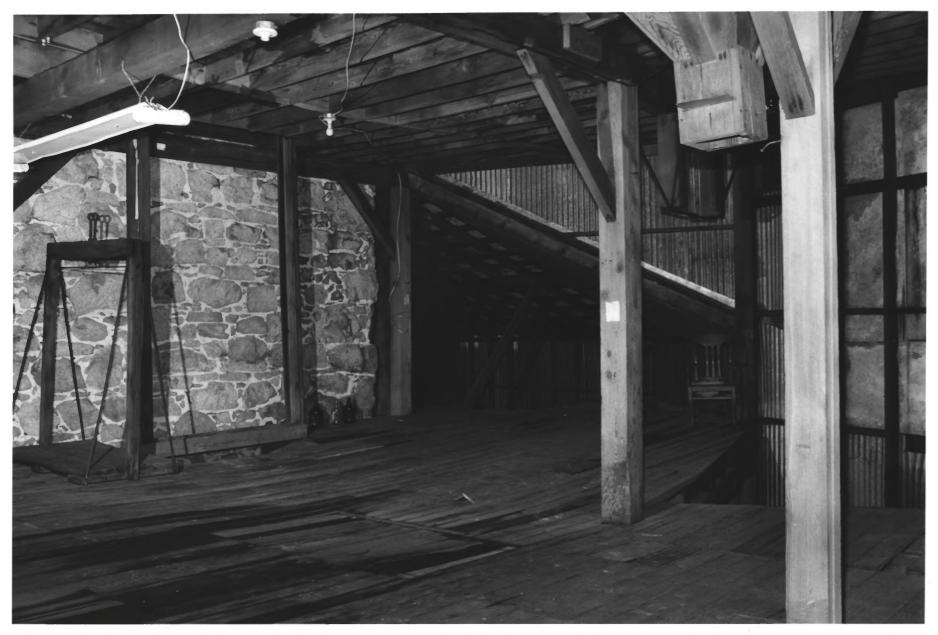
NEVADA BREWERY #15 of 26 Nevada City, CA Photographer: Nikki Pahl 1984

Second level interior, shows location of one of two grain chutes (upper right), and water hydraulic elevator platform. Shaft opening to basement is to right of platform.

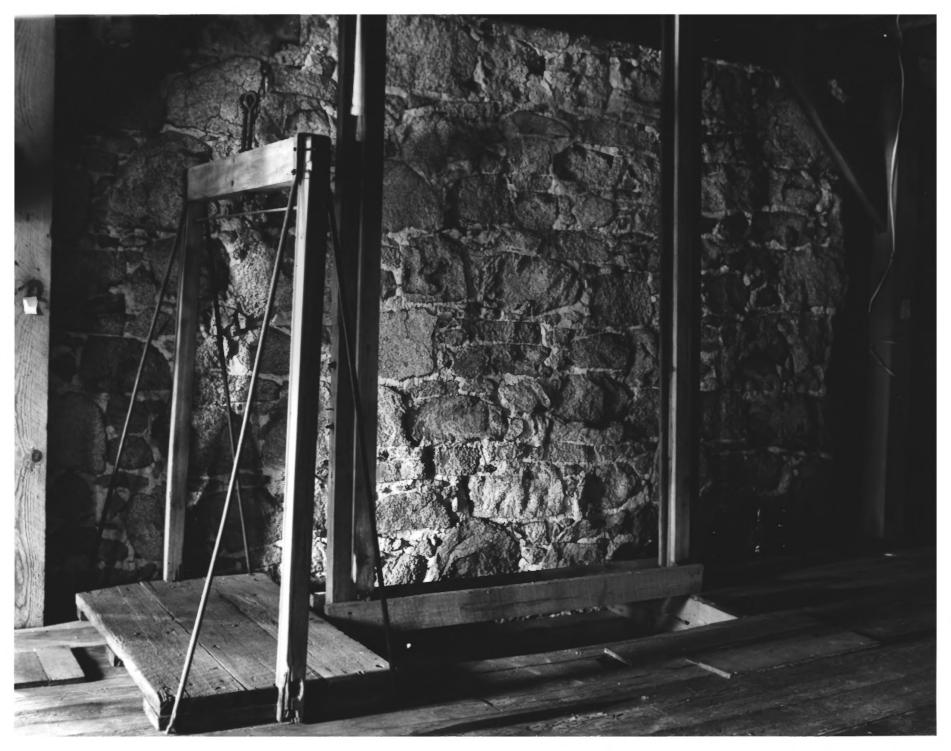
Detail of water hydraulic elevator. Note wooden elevator guide rails at right of platform. Platform is setting on floor moved to left of shaft opening.

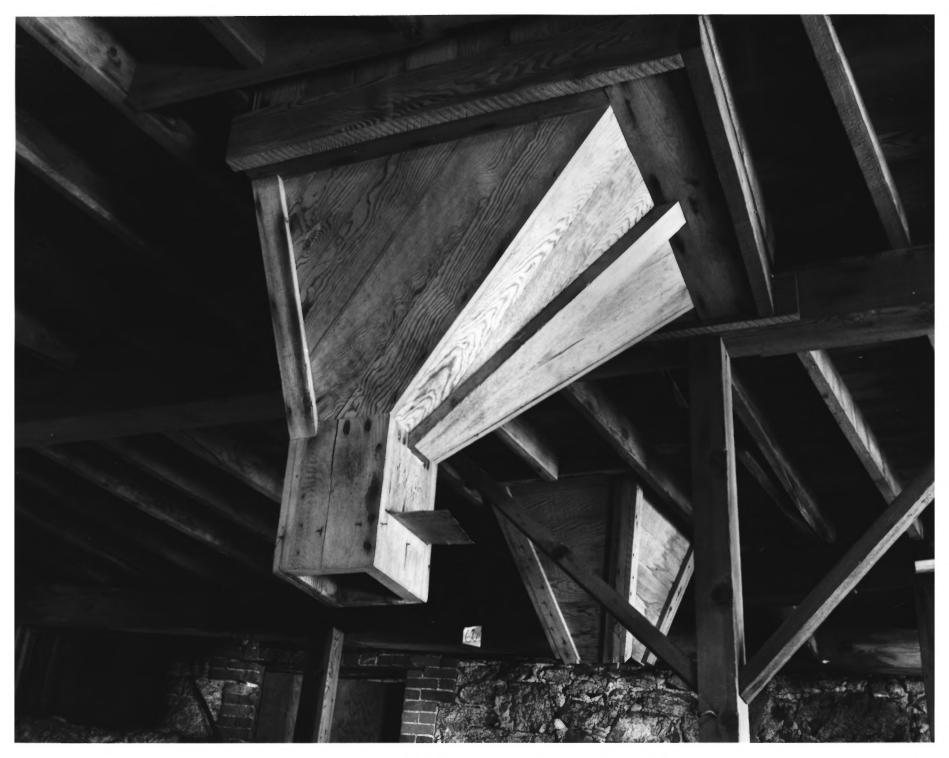
#17 of 26

Two original grain chutes, nearest one showing tin insert for regulating grain flow.

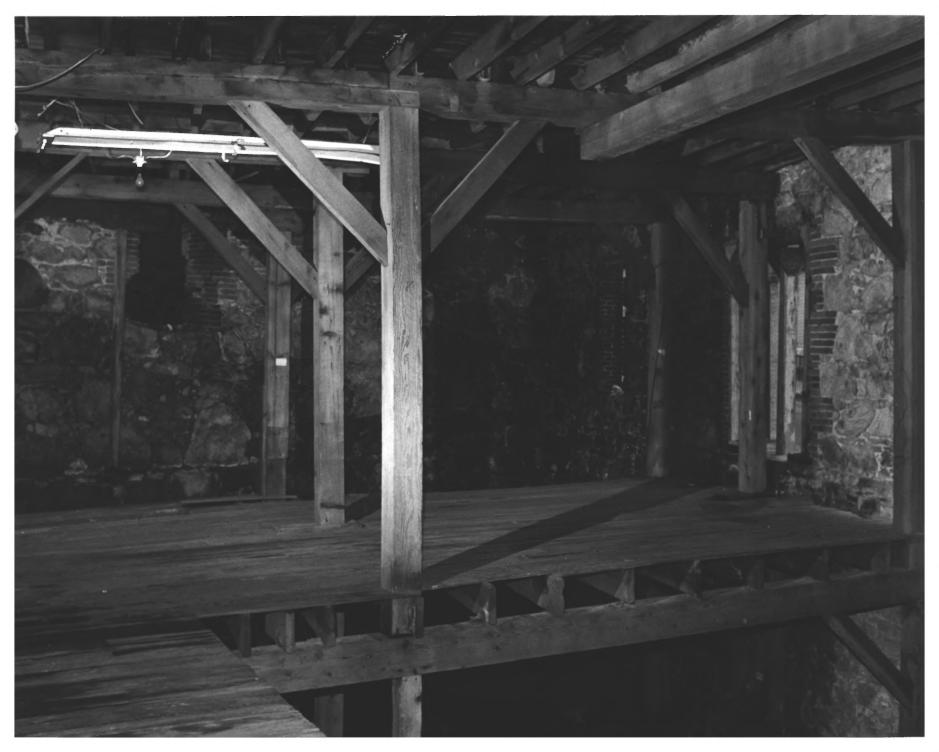
Floor openings plus post and beam construction, including diagonal braces, column to beam connection, beam splices, beam to beam tension connections, joists lapping, and other floor and ceiling framing details.

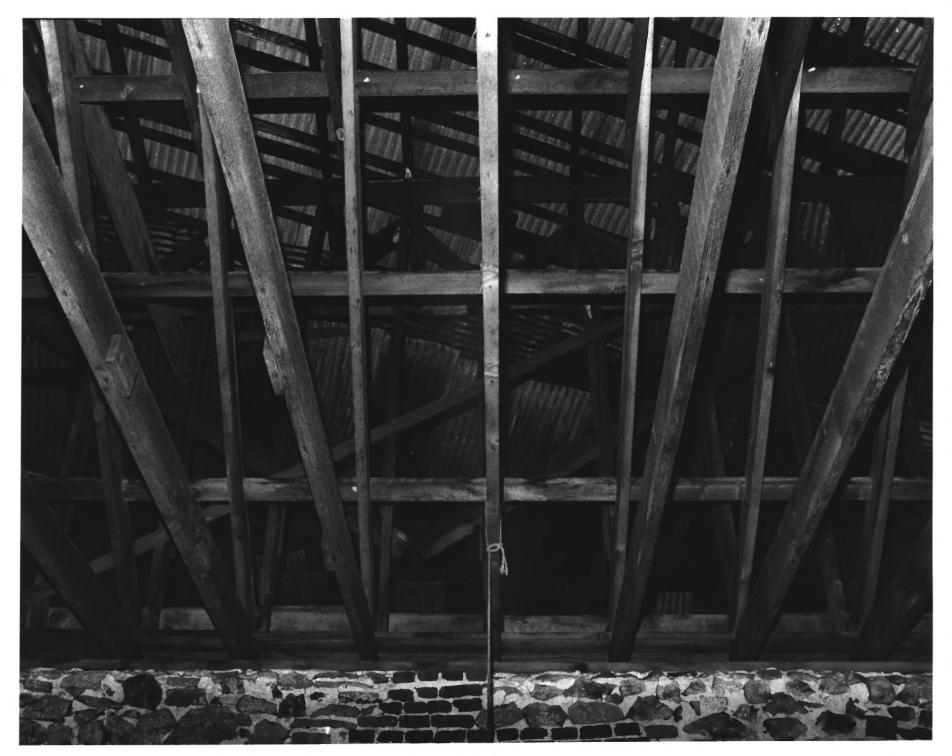
Looking up at roof framing detailing, including both original truss and purlin construction and later roof framing built over top of original roof. All original wood stripping and shingles have been removed and only corrugated sheet metal roofing remains.

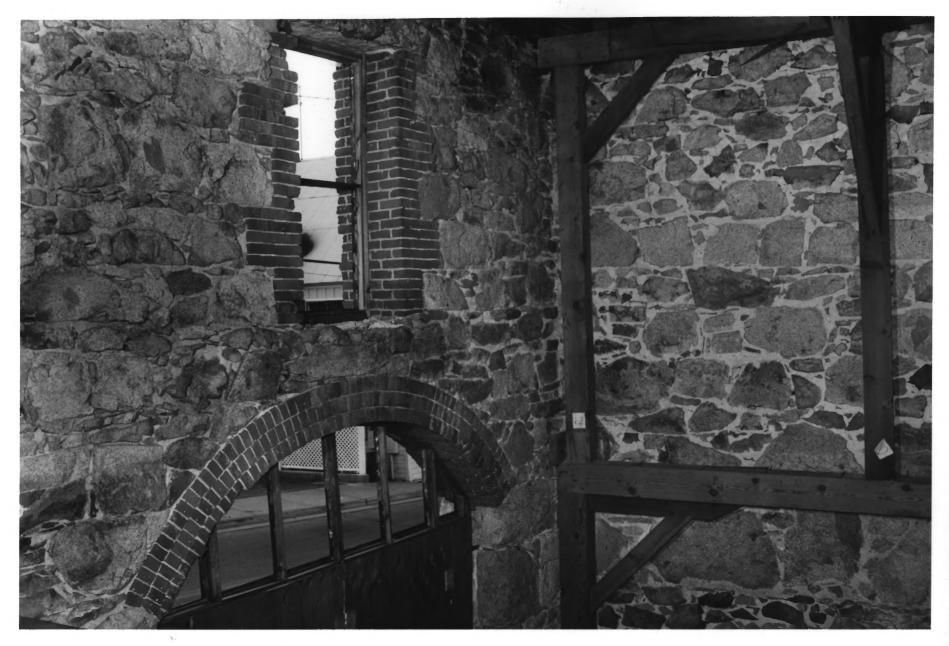
NEVADA BREWERY #20 of 26 Nevada City, CA Photographer: Nikki Pahl

Post and beam framing was part of early floor and roof support. Photograph #10 shows exterior view of same opening.

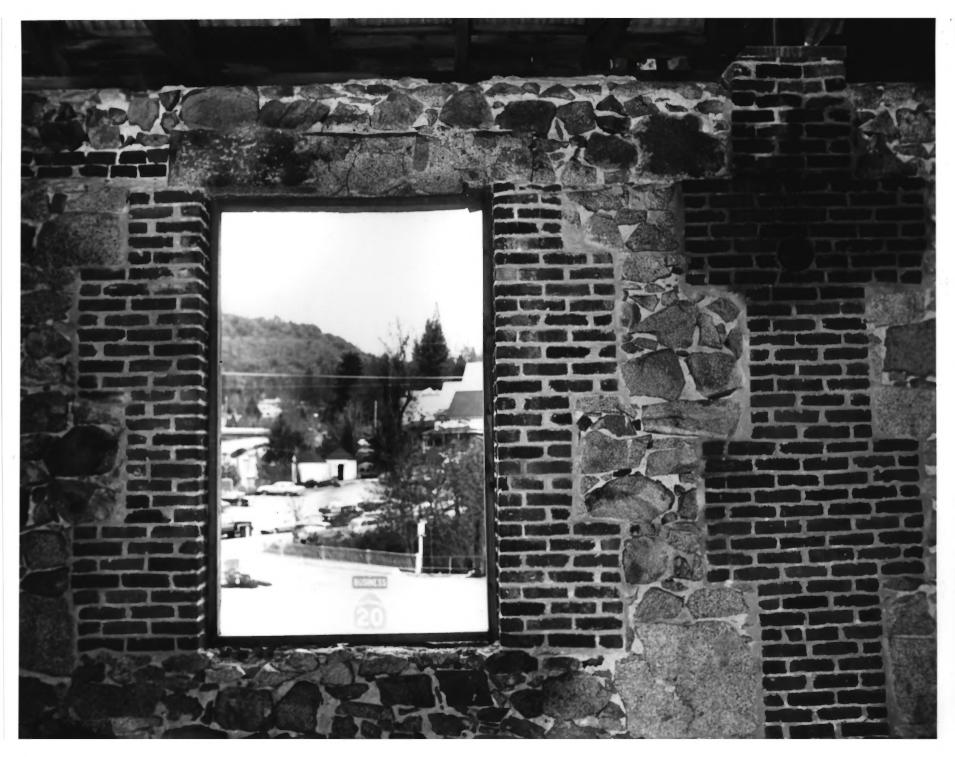
Interior, north wall, showing location of original brick flues for cast iron stove heating system. Note brick detailing at window jambs within structurally stone walls.

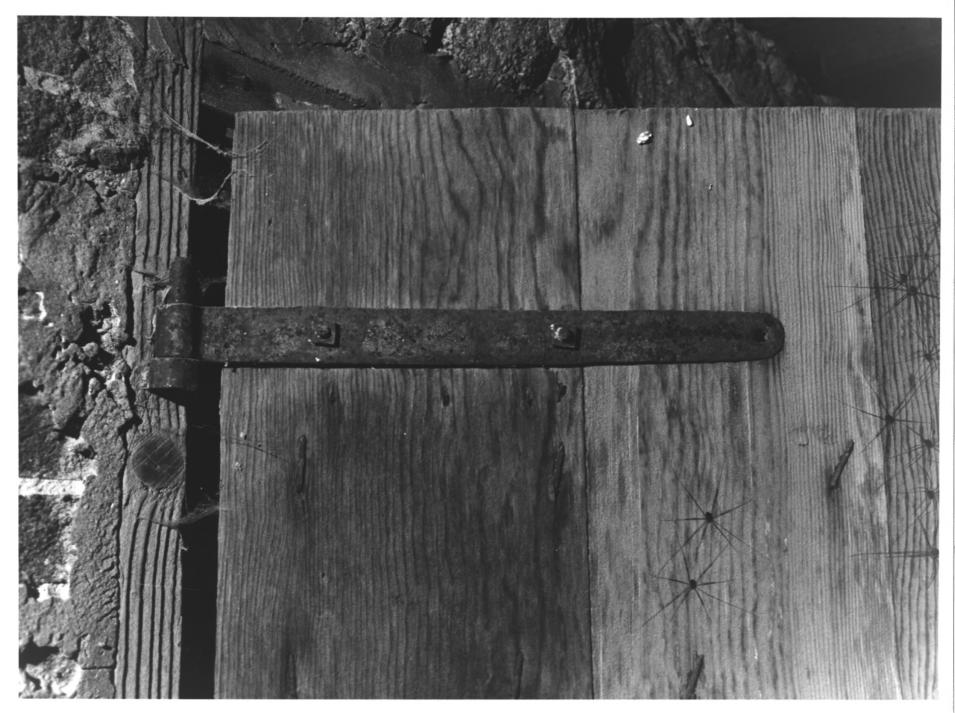
NEVADA BREWERY #22 of 26
Nevada City, CA

Detail of hand forged wrought iron strap hinge and pintle butt on basement level door leading to water hydraulic elevator shaft.

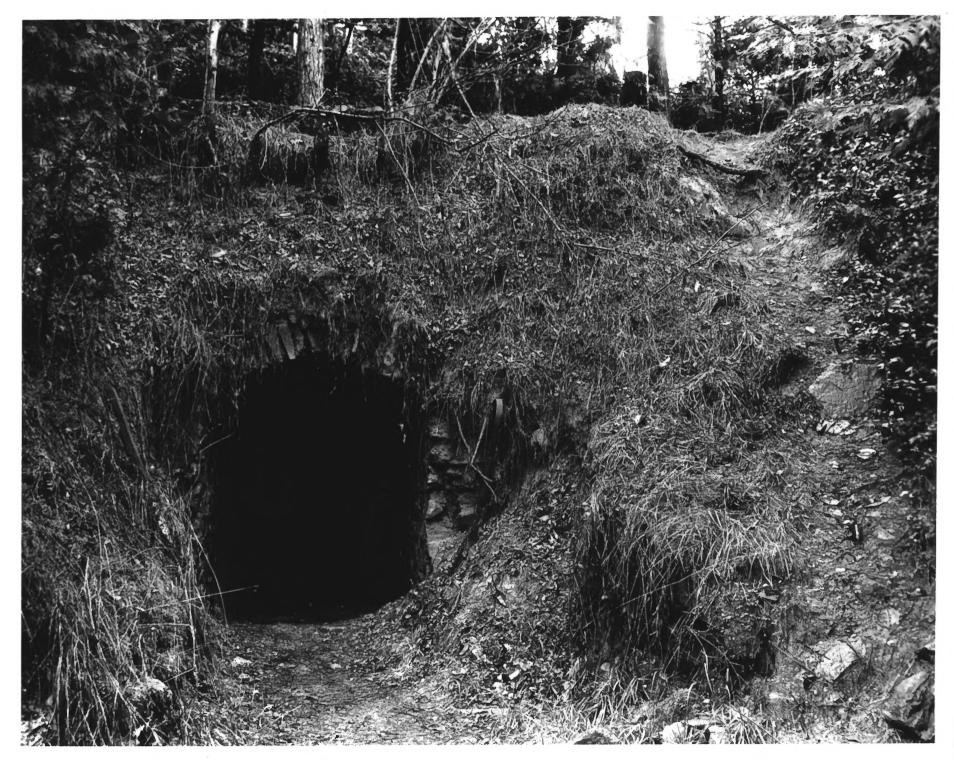
Entrance to beer cooling/storage cave in hillside at rear of Brewery. Path to right leads up to Rough and Ready Ditch, a mining flume which runs above and perpendicular, south of the Brewery.

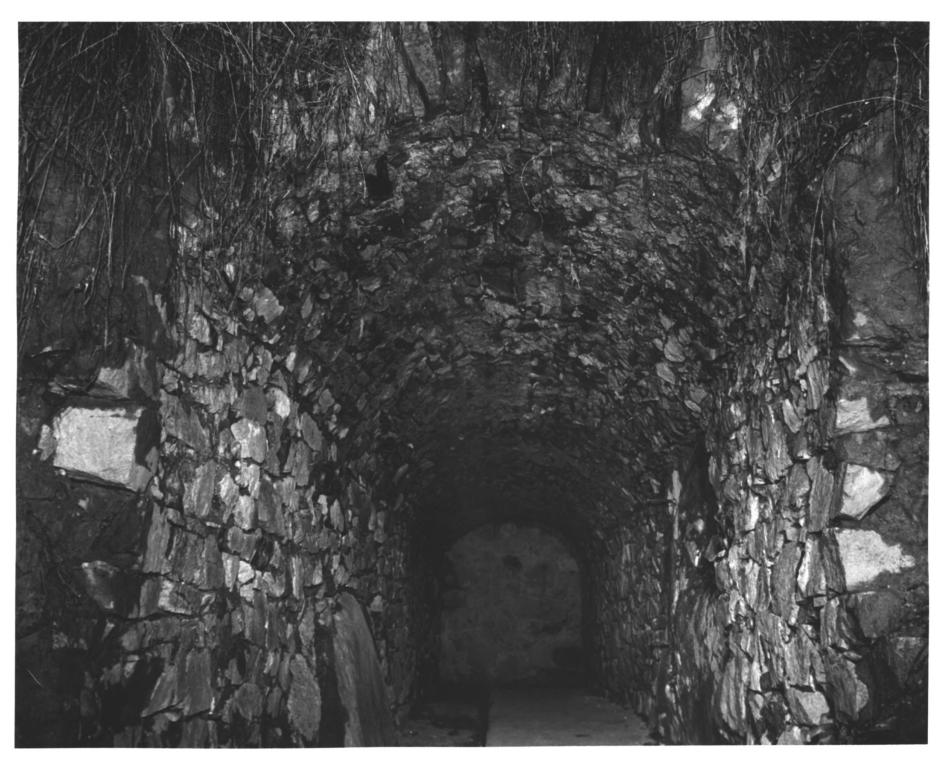
Interior of granite-lined tunnel to beer cooling/storage cave. At rear of tunnel, cave branches to right and left approximately 15' in both directions before being blocked off.

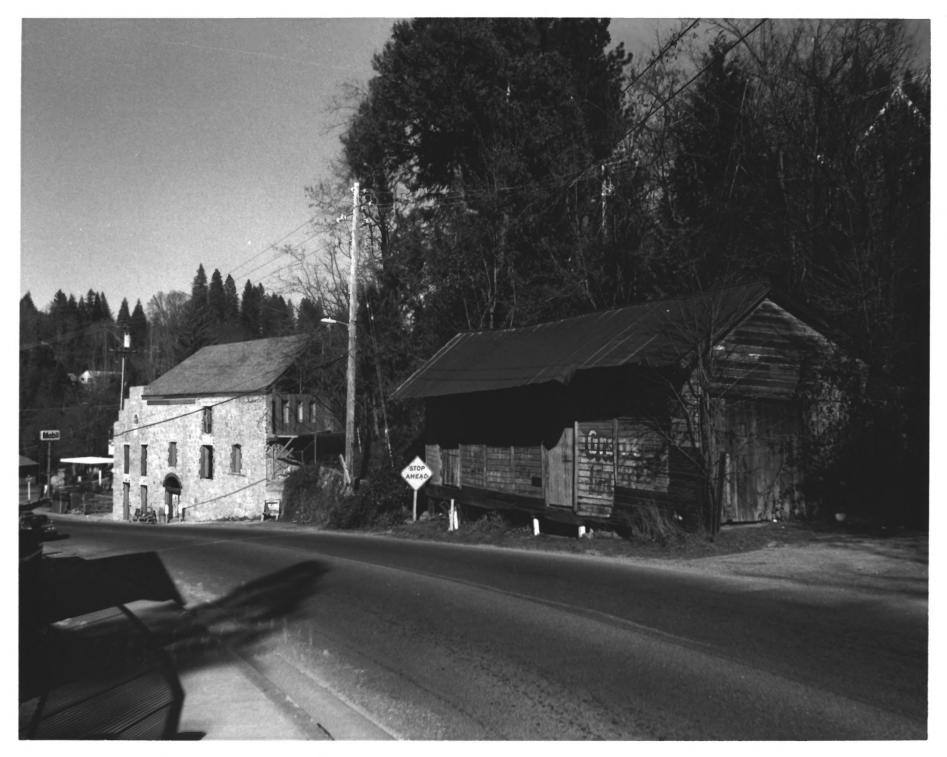
P.O. Box 1284, Nevada City, CA February 1985 View looking northeast along Sacramento St. showing restoration of roof.

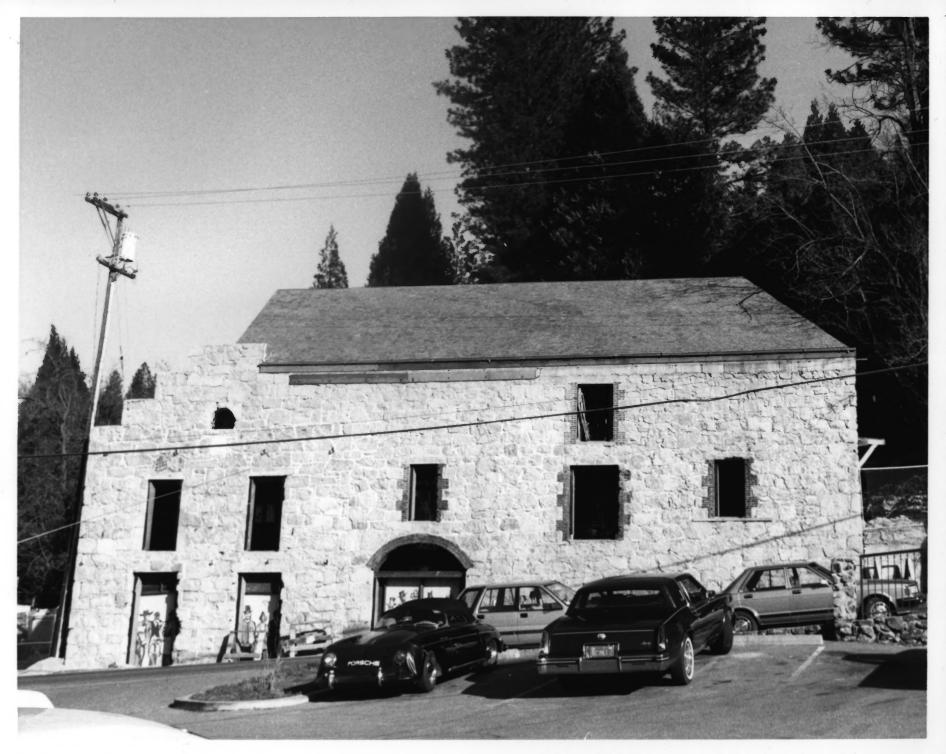
View looking east showing roof restoration.
