Exterior Stucco Condition Assessment and Treatment Recommendations

Building 38 – Tearney Building
at
Harpers Ferry National Historical Park
Harpers Ferry, WV

September 2019

Prepared by:
Lindy Gulick
NCR Architectural Conservator

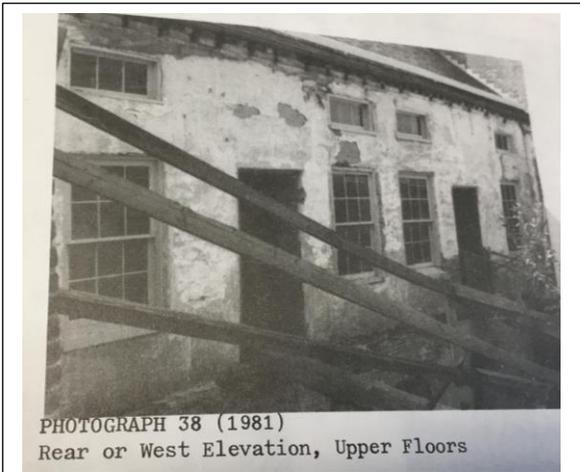
For comparison purposes, two photographs showing the upper rear floor are shown side by side from 1981 and 2019. These photographs show the deteriorated condition of the exterior stucco as seen in the 1981 photograph and evidenced by the exposed brown coat, flaking paint, and uneven and bowing appearance of the stucco. The 2019 photograph of the same location shows areas that appear to be in similar to condition to that of the 1981 photograph (exposed brown coat, flaking paint, and detached or bowed stucco) but also smooth sections that appear to be modern repairs (see red arrows indicating likely repair locations). The repair locations are primarily located above door frames and under windows and appear to be stable.

Figure 1. Photograph from 1982 HSR showing the conditions of the rear upper floors.

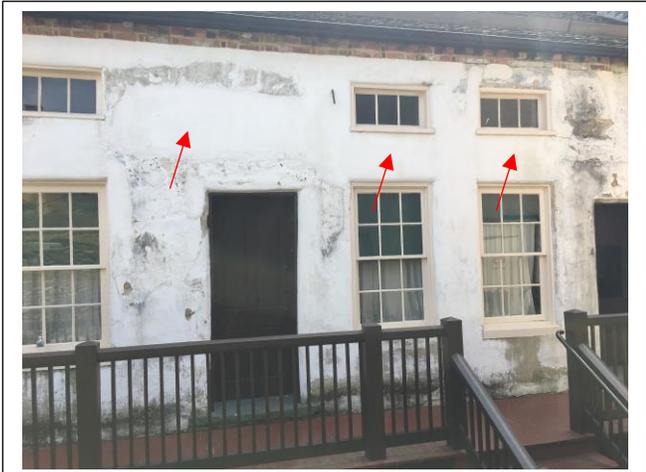
Figure 2. Photograph from the May 2019 assessment showing the condition of the rear upper floors.

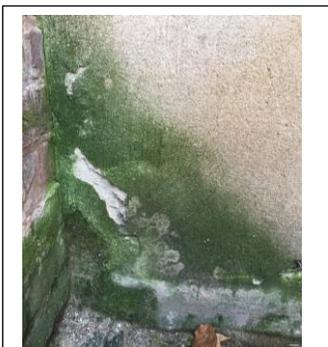
Figure 3. Biological growth on the rear lower section.

- General cleaning should be performed to remove surface soiling and biological growth. Only hose pressurized water should be used for the cleaning along with natural bristle brushes and a biocide (quaternary ammonium compound). Care should be taken to avoid cleaning where material is extremely friable. A pressure washer should NOT be used to clean the historic material.

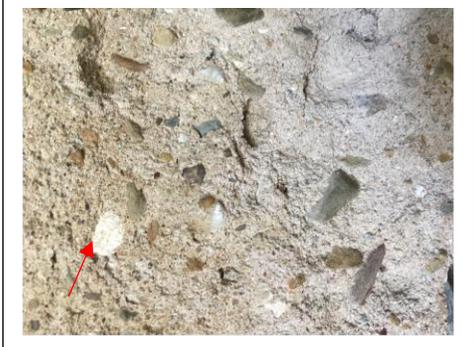
Figure 4. Detail photograph of the scratch coat showing lime blebs (red arrow), shells, and well sorted aggregate.

roughly 25% of the surface and is more concentrated at the top of the wall. The brown scratch coat is very friable and crumbles when touched. Lime blebs, small shells, and coarse to fine aggregate are visible to the naked eye in the brown coat.

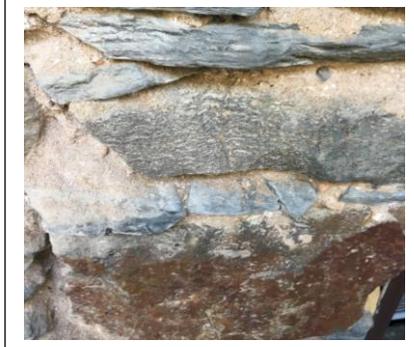
Figure 5. Detail photograph of the friable crumbling condition of the scratch coat and run down on adjacent stone.

- Remove friable, bowing, and crumbling stucco and consolidate around stable edges with a solution of Paraloid B-72 or B-67.
- Consolidate the existing brown coat with consolidation materials (test the consolidation products first). The crumbling/friable stucco or brown coat should be consolidated with the appropriate products (Paraloid B-72, Paraloid B-67, Rhoplex MC-76, OH100) that will be tested to determine the best solvent to use that will not stain the adjacent surfaces. The consolidant will be applied with either a plastic pipette or a needle and syringe to the affected area.

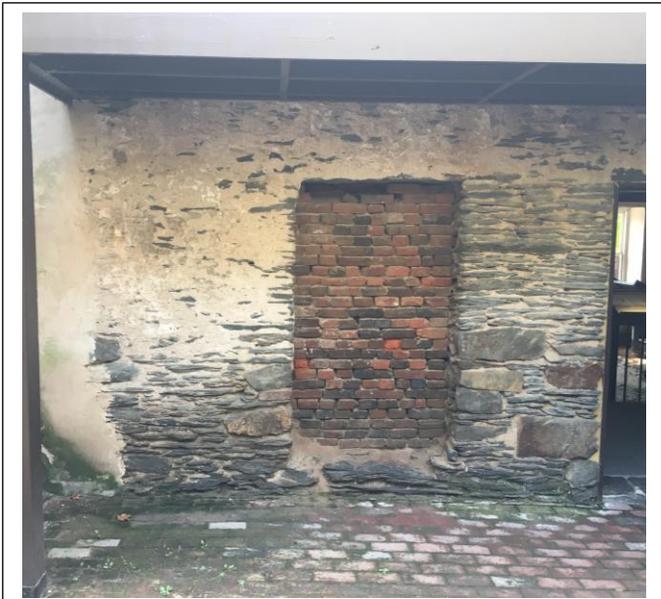
Figure 6. Overall photograph of the first floor, showing the exposed rubble stone, bricked in opening, and remnants of the stucco and brown coat.

General recommendations- First Floor: Stabilize the existing material that remains and re-apply the stucco and whitewash on the entire first floor level. The original intent of the building was to have a stucco exterior and therefore the stucco should be reinstalled to protect building materials that were never meant to be exposed to water.

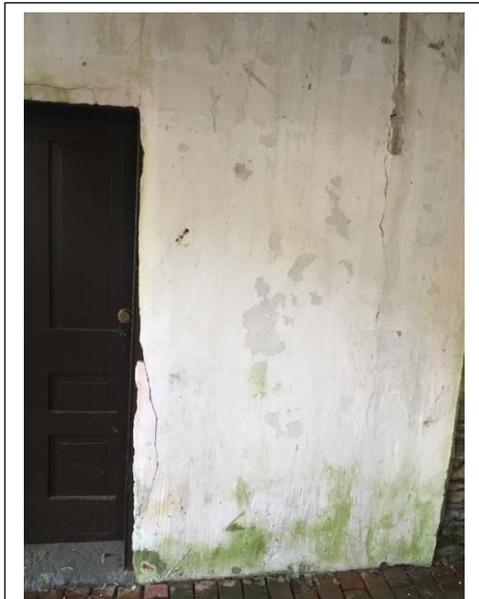
Figure 7. Overall photograph of the first floor showing current conditions. Cracks, biogrowth, and the current condition of the exterior stucco.

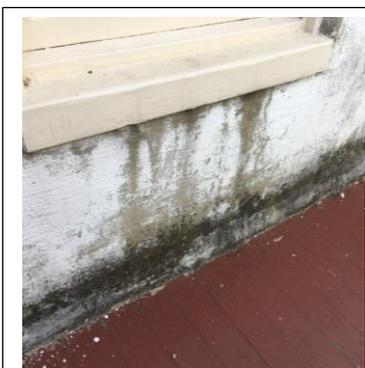
Figure 8. Dark biological soiling at the bottom of the upper level section. Also note the exposed stucco where the whitewash/coating is gone.

- General cleaning should be performed to remove surface soiling and biological growth. Only hose pressurized water should be used for the cleaning along with natural bristle brushes and a biocide (quaternary ammonium compound). Care should be taken to avoid cleaning where material is extremely friable. A pressure washer should NOT be used to clean the historic material.

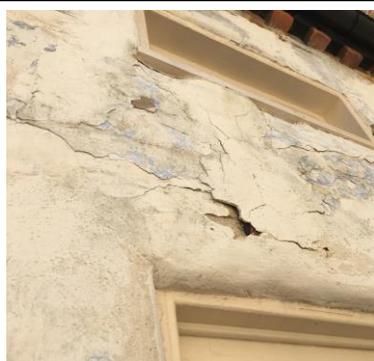
Figure 9. Crumbling and friable plaster and coating under a window. Note how the stucco has deteriorated and is detached.

- Remove friable, bowing, and crumbling stucco and consolidate around stable edges with a solution of Paraloid B-72 or B-67.
- Consolidate the existing brown coat with consolidation materials (test the consolidation products first). The crumbling/friable stucco or brown coat should be consolidated with the appropriate products (Paraloid B-72, Paraloid B-67, Rhoplex MC-76, OH100) that will be tested to determine the best solvent to use that will not stain the adjacent surfaces. The consolidant will be applied with either a plastic pipette or a needle and syringe to the affected area.

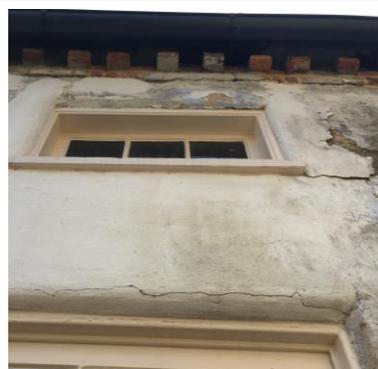
Figure 10. Large horizontal cracks located above the door frame and areas of stucco loss adjacent to the window.

There are also several horizontal and vertical cracks that appear in the stucco along the door frames in the non-historic repairs. There are some instances of material loss that appears in areas that have cracks or detached stucco. A majority of the original fabric is in poor condition.

- It is recommended that the cracks be injected with either the finish plaster mix or an acrylic or lime based grout to prevent further deterioration and potential water ingress.

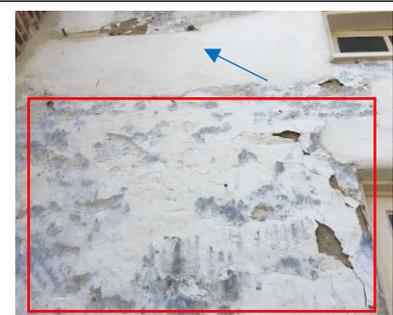
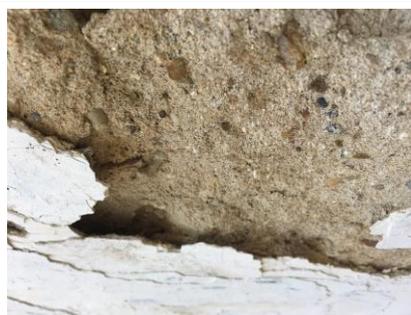
Figures 11 & 12. A section of the original historic stucco (red box) and the overlapping area of the non-historic repair (blue arrow). Figure 10. Note the layers of paint and how far the paint/top layer of stucco has detached from the brown coat.

Without performing material analysis it is unknown if the non-historic repairs to the stucco are Portland cement based but it is assumed due to the appearance and strength of the repairs that a combination of Portland cement and lime was used.

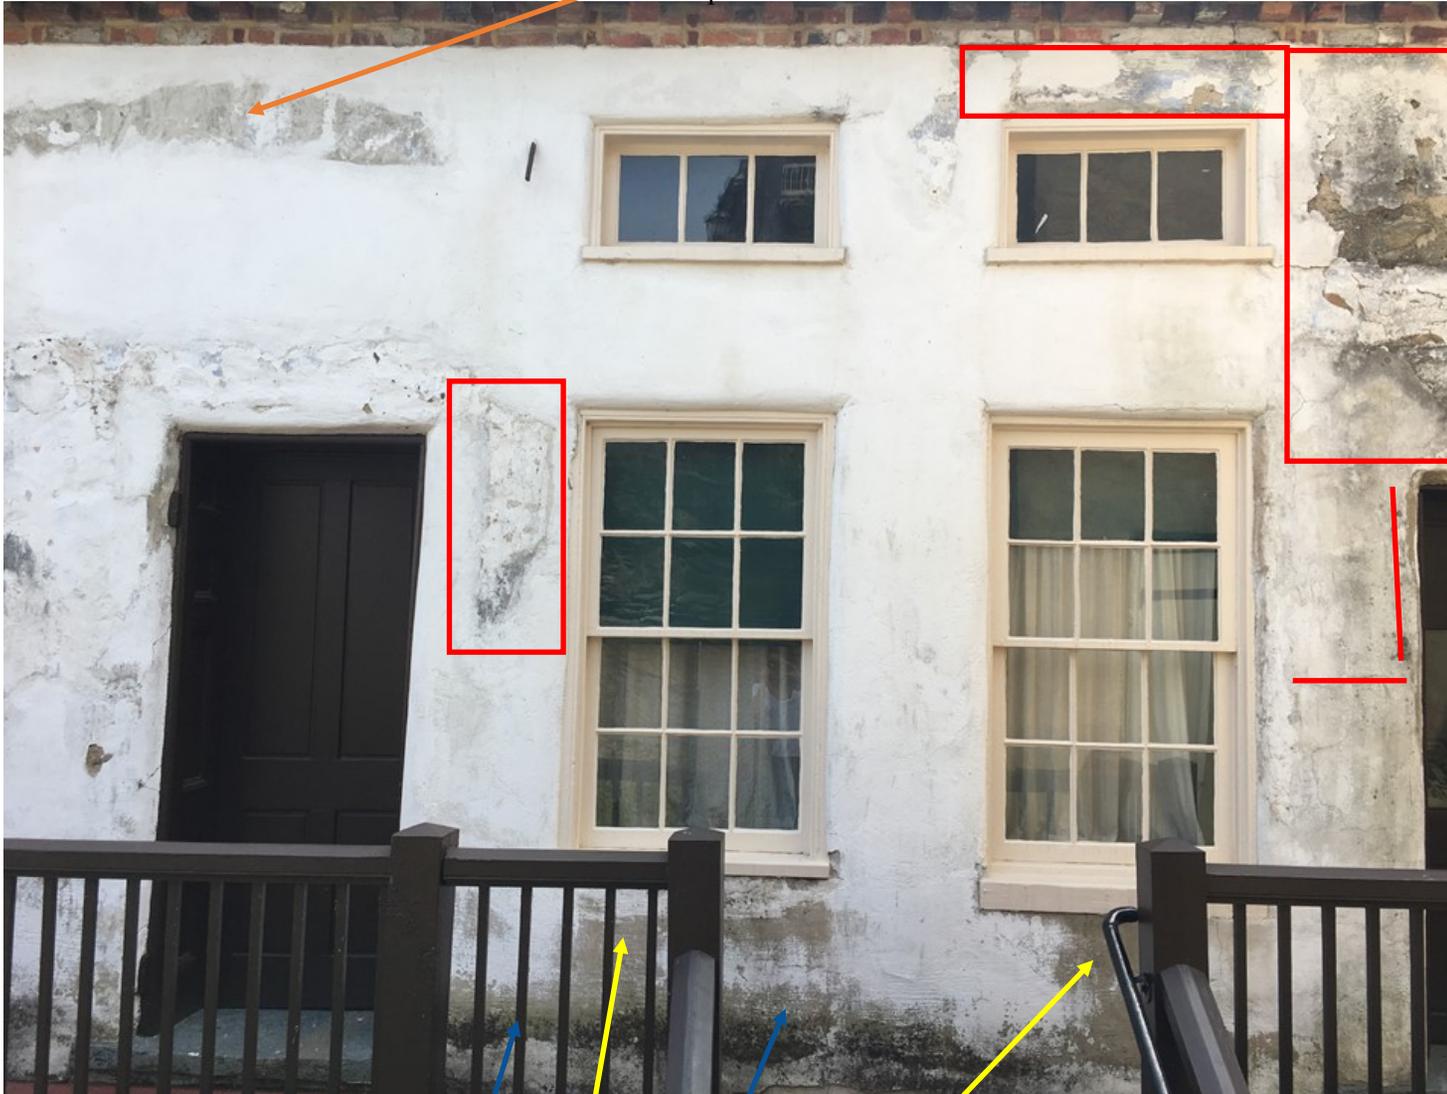
SECOND FLOOR CONDITIONS

This section appears to be stable but was not accessed during the investigation so it should be closely inspected to determine the treatment needed.

BLUE ARROWS: Remove biological growth with a biocide, hose, and natural bristle brushes (pressure washer should not be used on friable stucco). Bio-growth is present on the lower section of the stucco.

YELLOW ARROWS: Renew whitewash coating as needed.

RED BOXES/LINES: These locations indicate areas that are extremely friable and need to be either consolidated or removed and replaced with in kind material. Treatment will vary based on the conditions. Inject cracks as needed around window and door frames.
