NEW JERSEY TRANSIT RAILROAD STATION SURVEY

FACILITY NAME: Millington

Station: Millington

Surveyed October, 1978

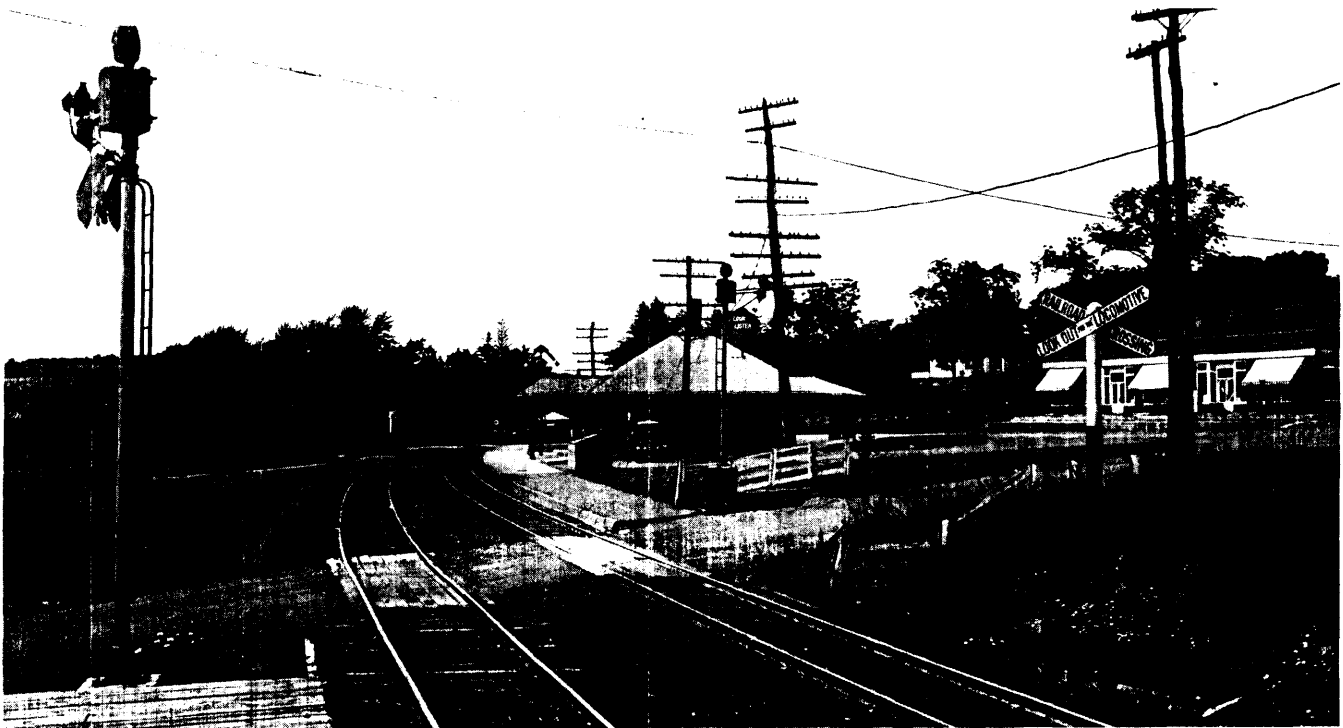
The Murray Hill passenger station and freight house at about 1915. This station is actually located in New Providence. Note the chewed ties in the foreground where a car ran off the track when the derail was open.
