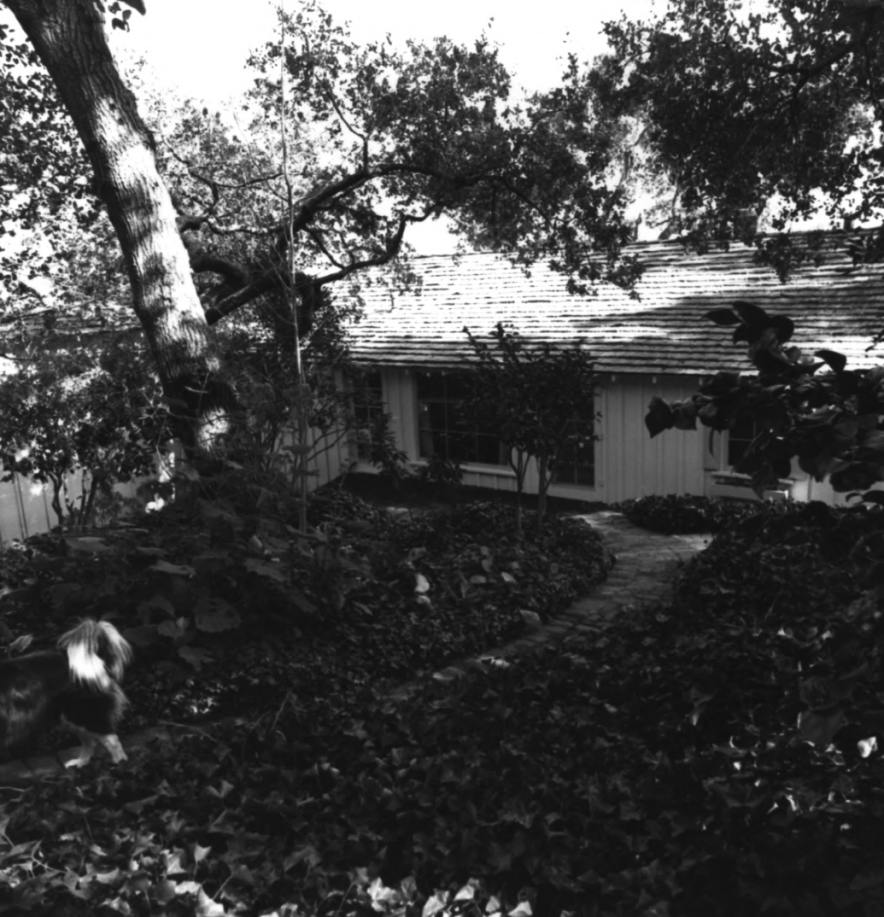
H-1

From Entry

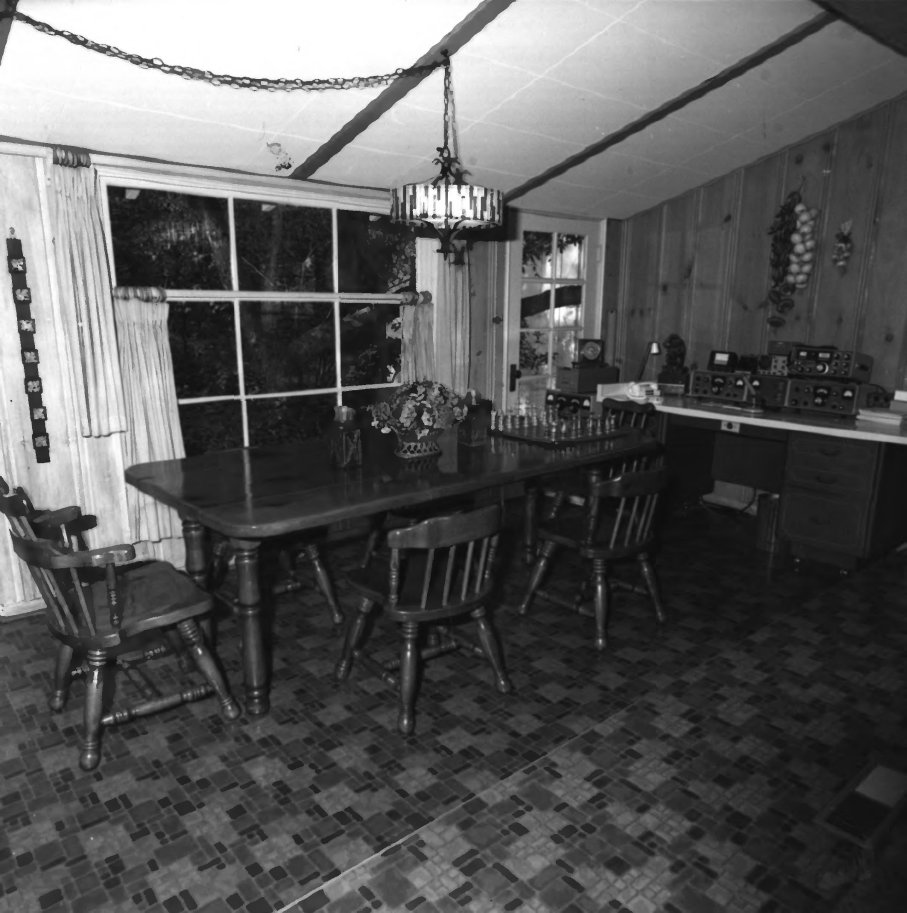
H-2 Dining space

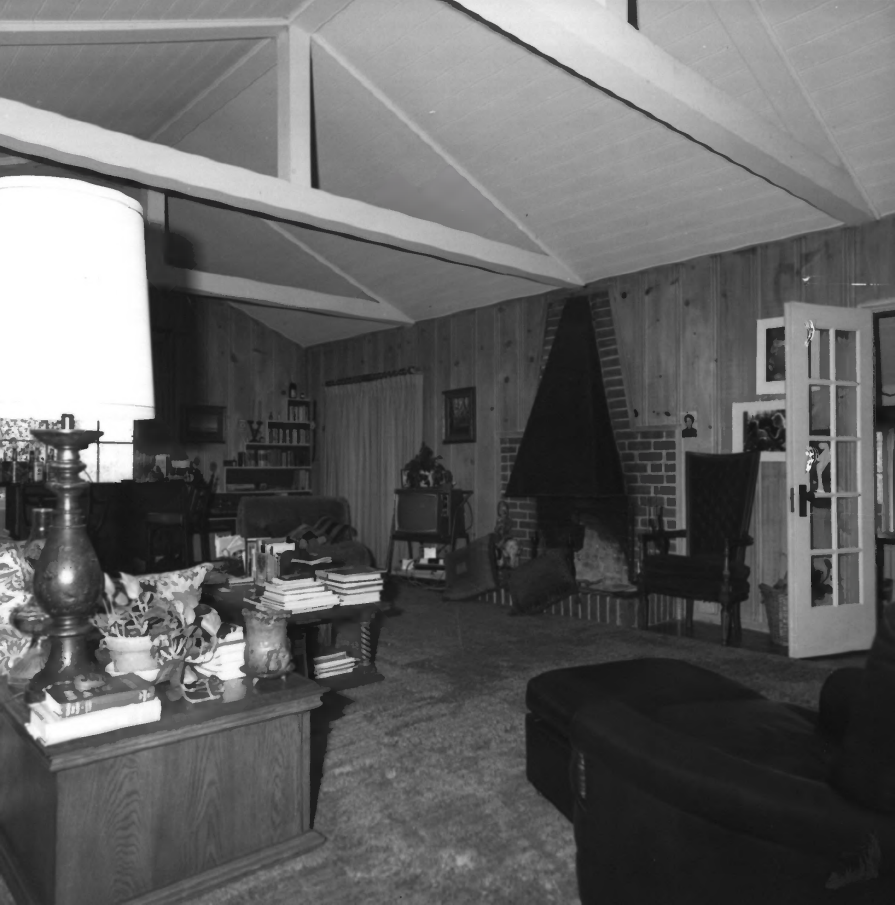
H-3 Dining Room, east
wall - NE SM#5

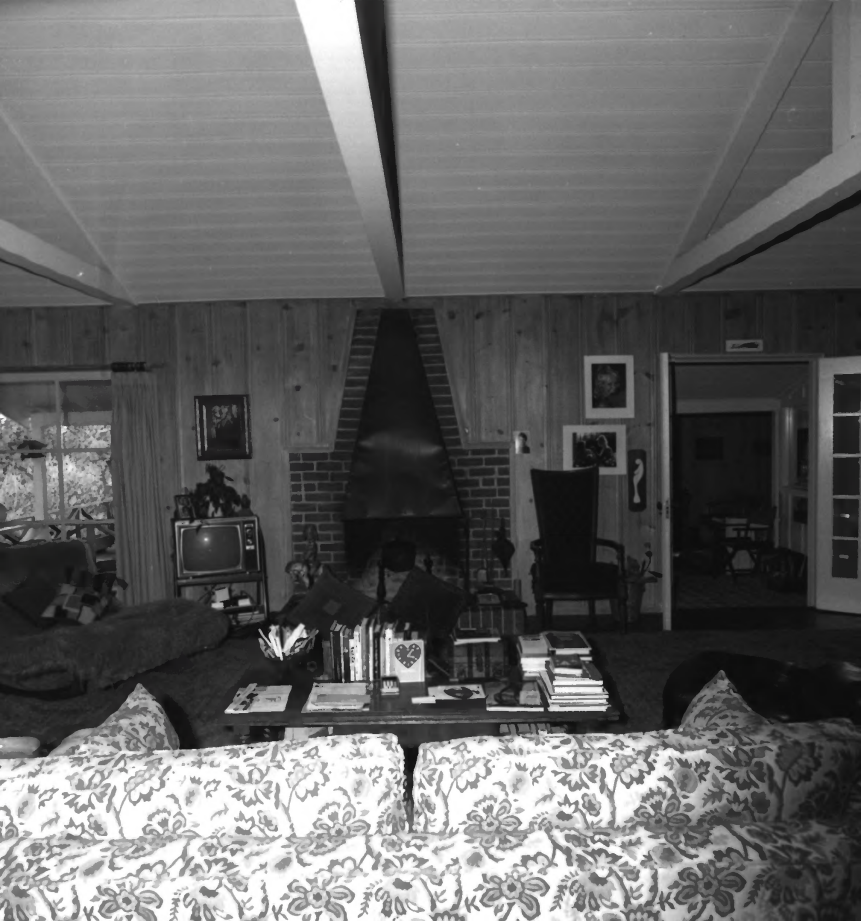
H-4 dining room,
east wall - E - SM#5

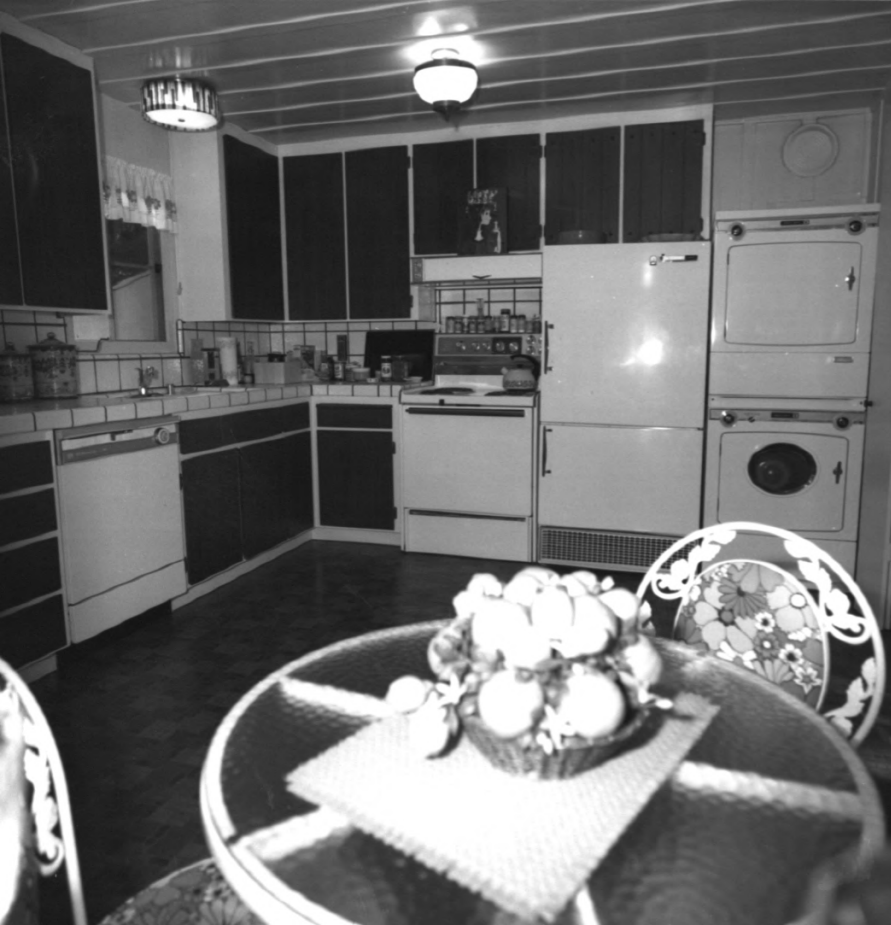
4-5 Remodeled kitchen

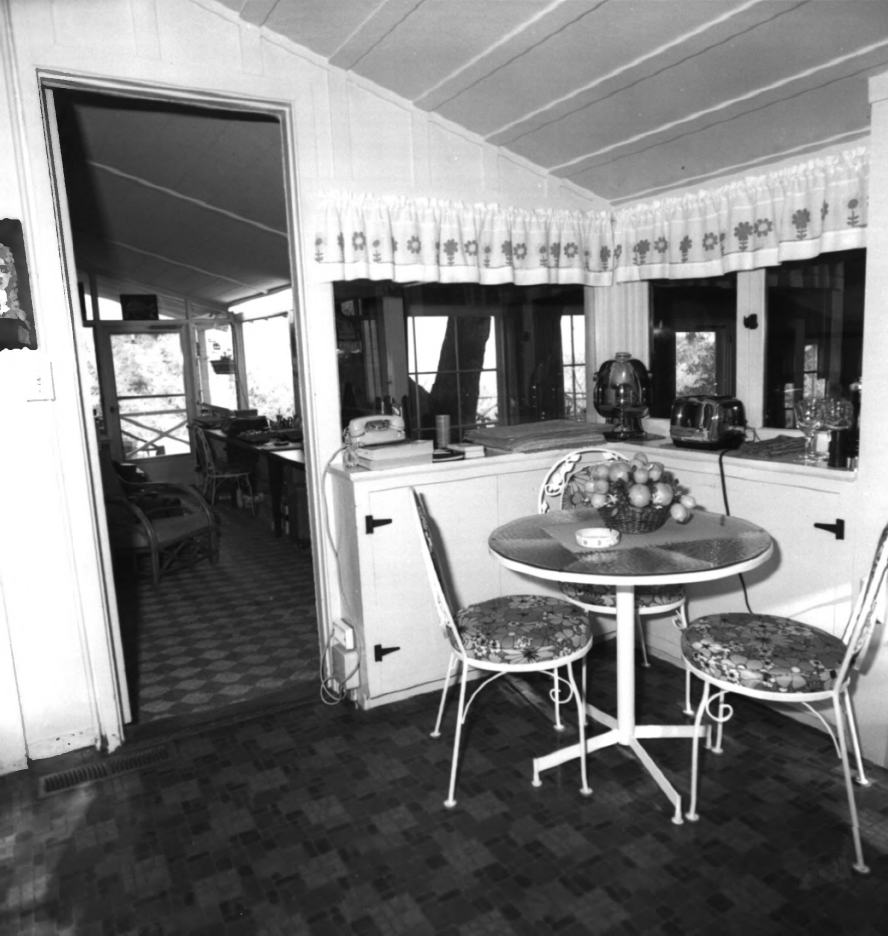
H-6 Parach - internal
screen enclosure

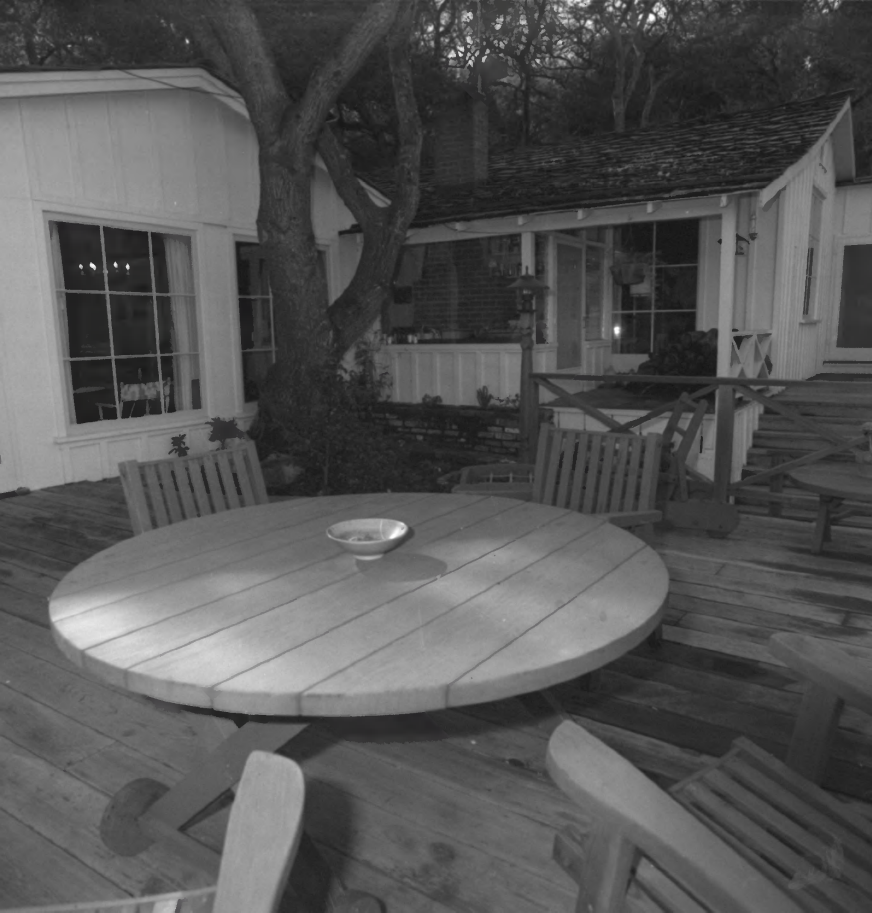
H-7 Porch, external
screen enclosure - W-

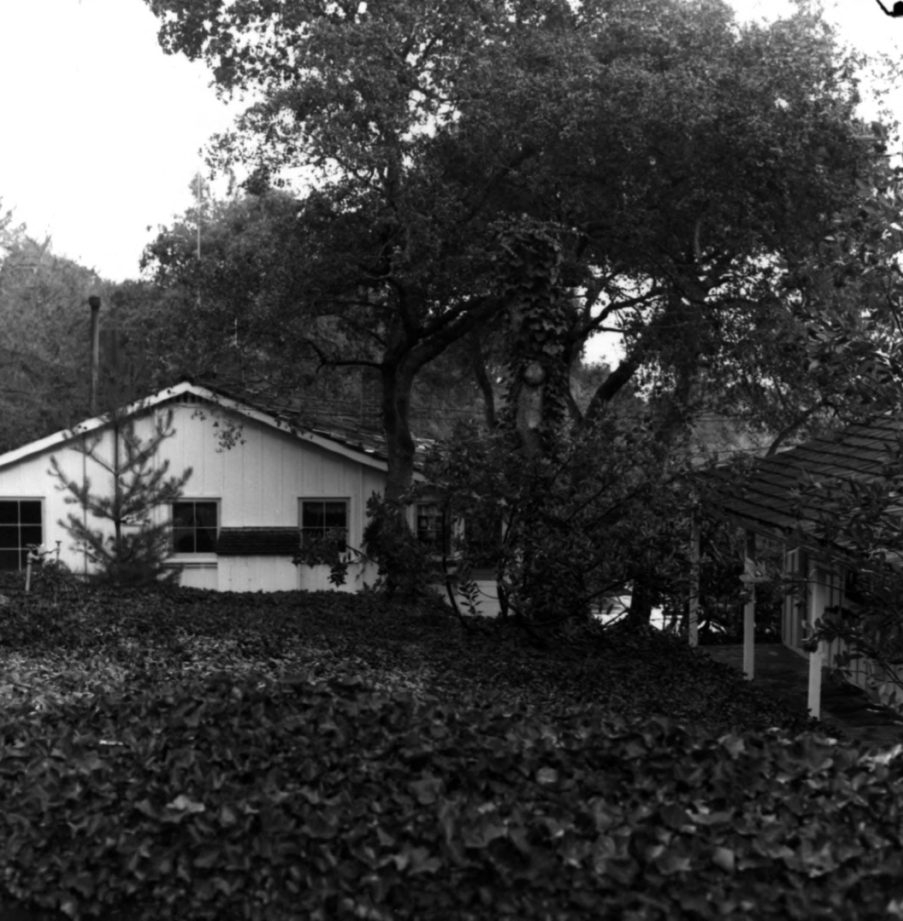
A-8 Main house
Orientation to guest house

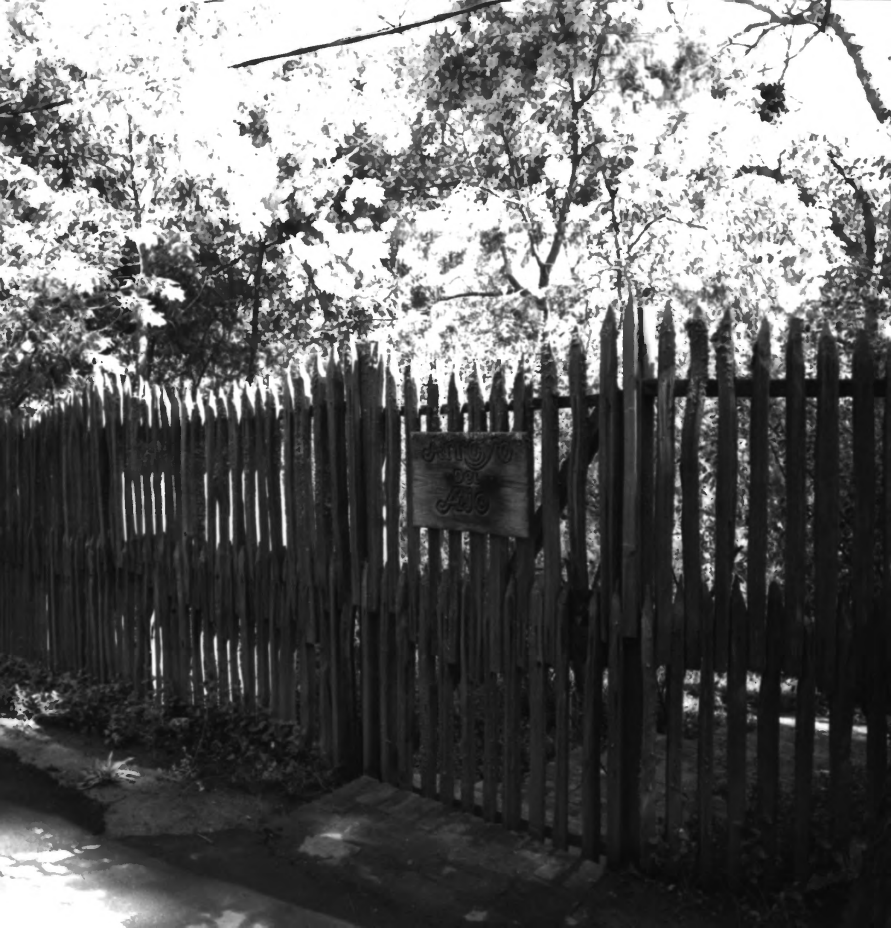
H-9 Entry gate with
sign - NE - SM#11

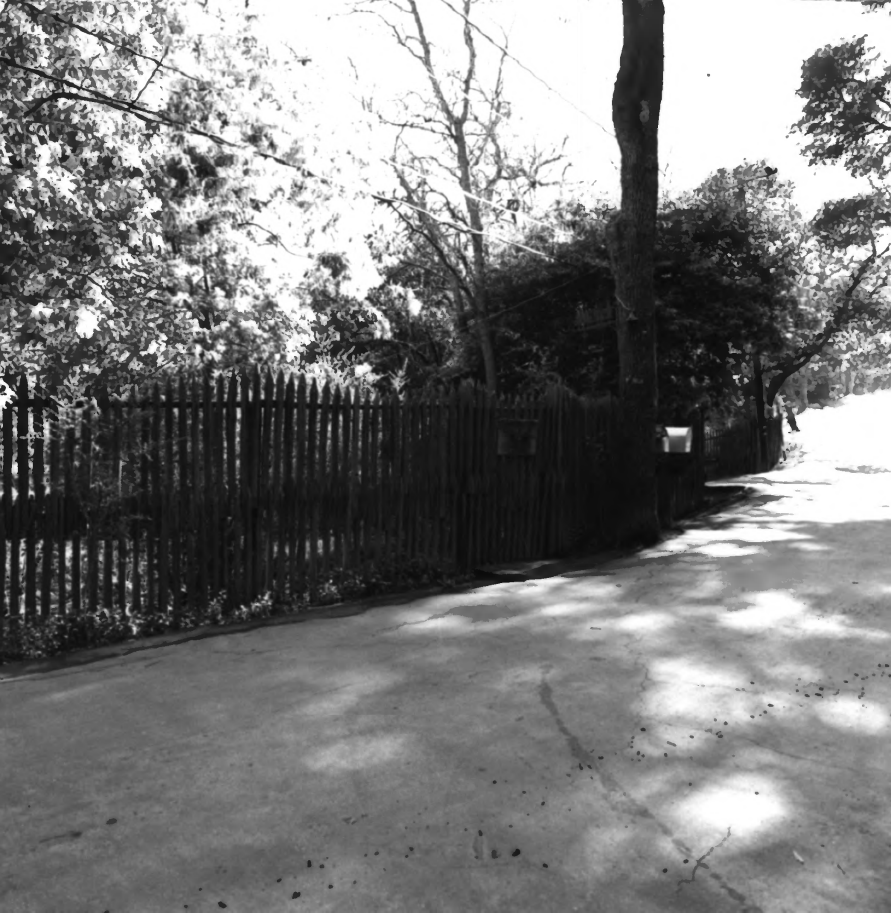
A-11 grape stake fence
bordering Greenwood Lane

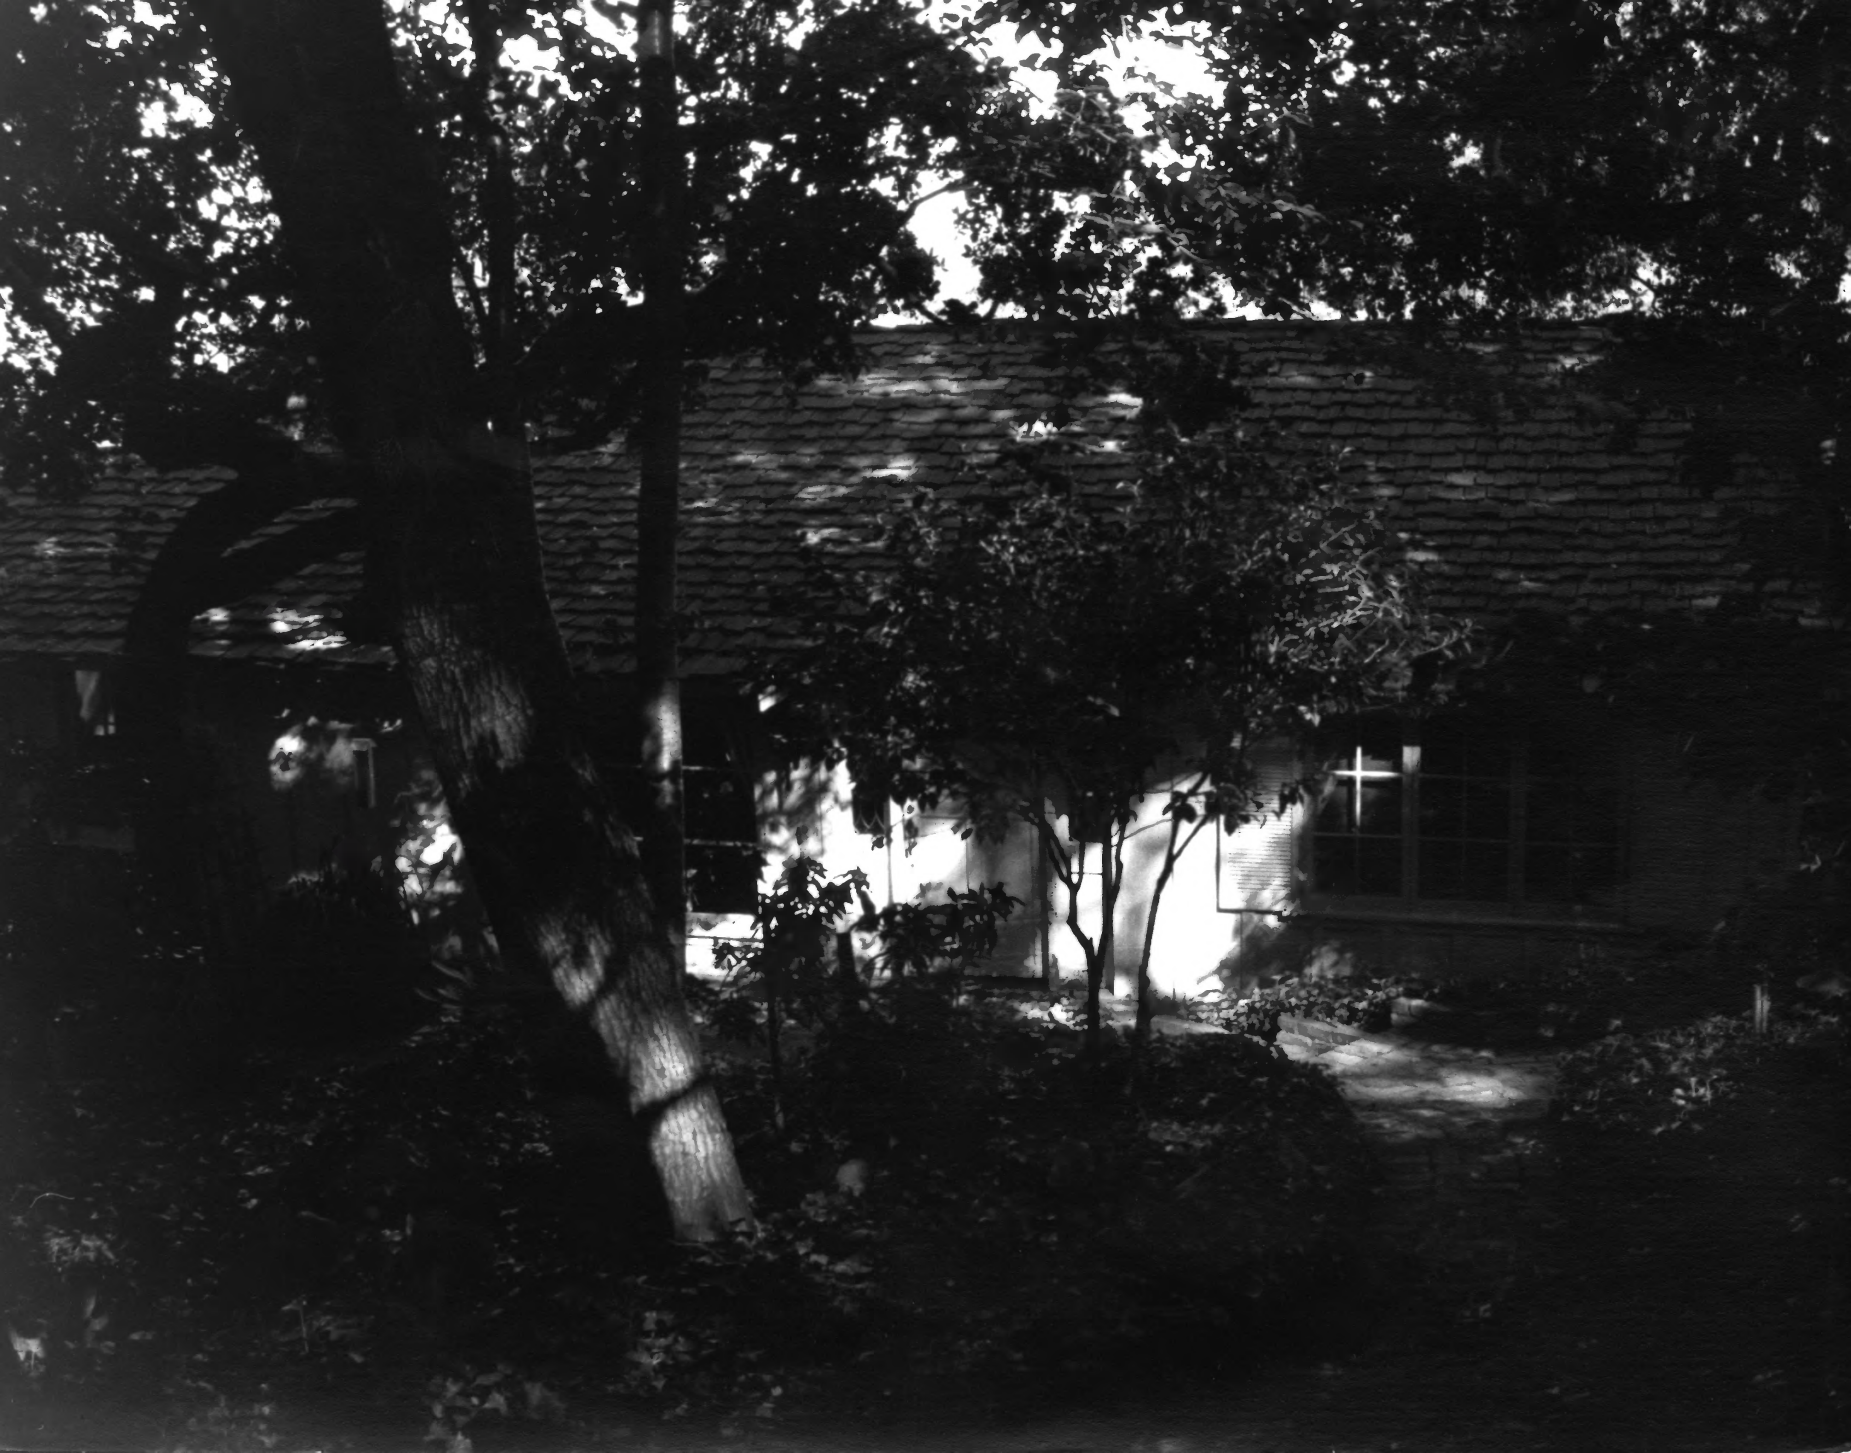
#1 front entry - E - SM #1

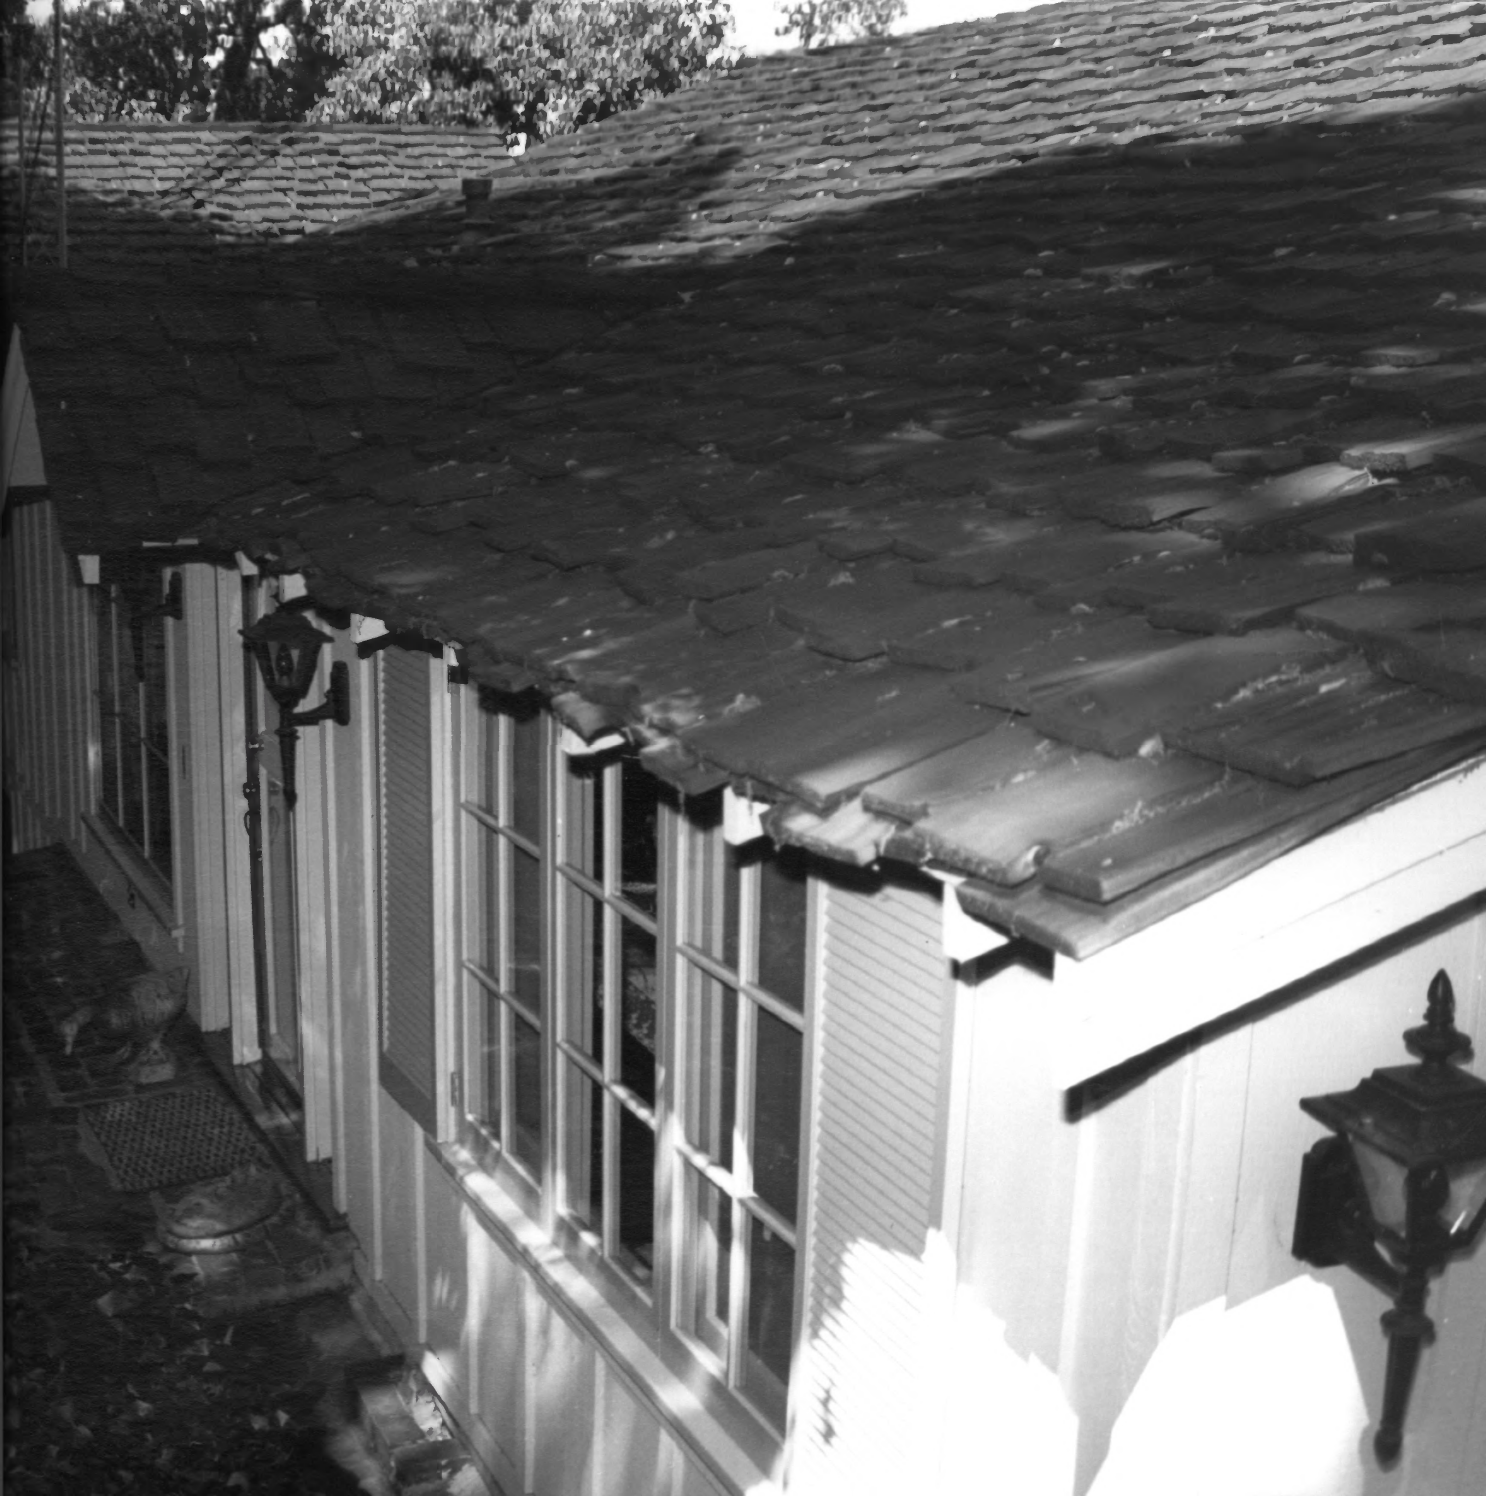
2 front entry - NW - SM # 1

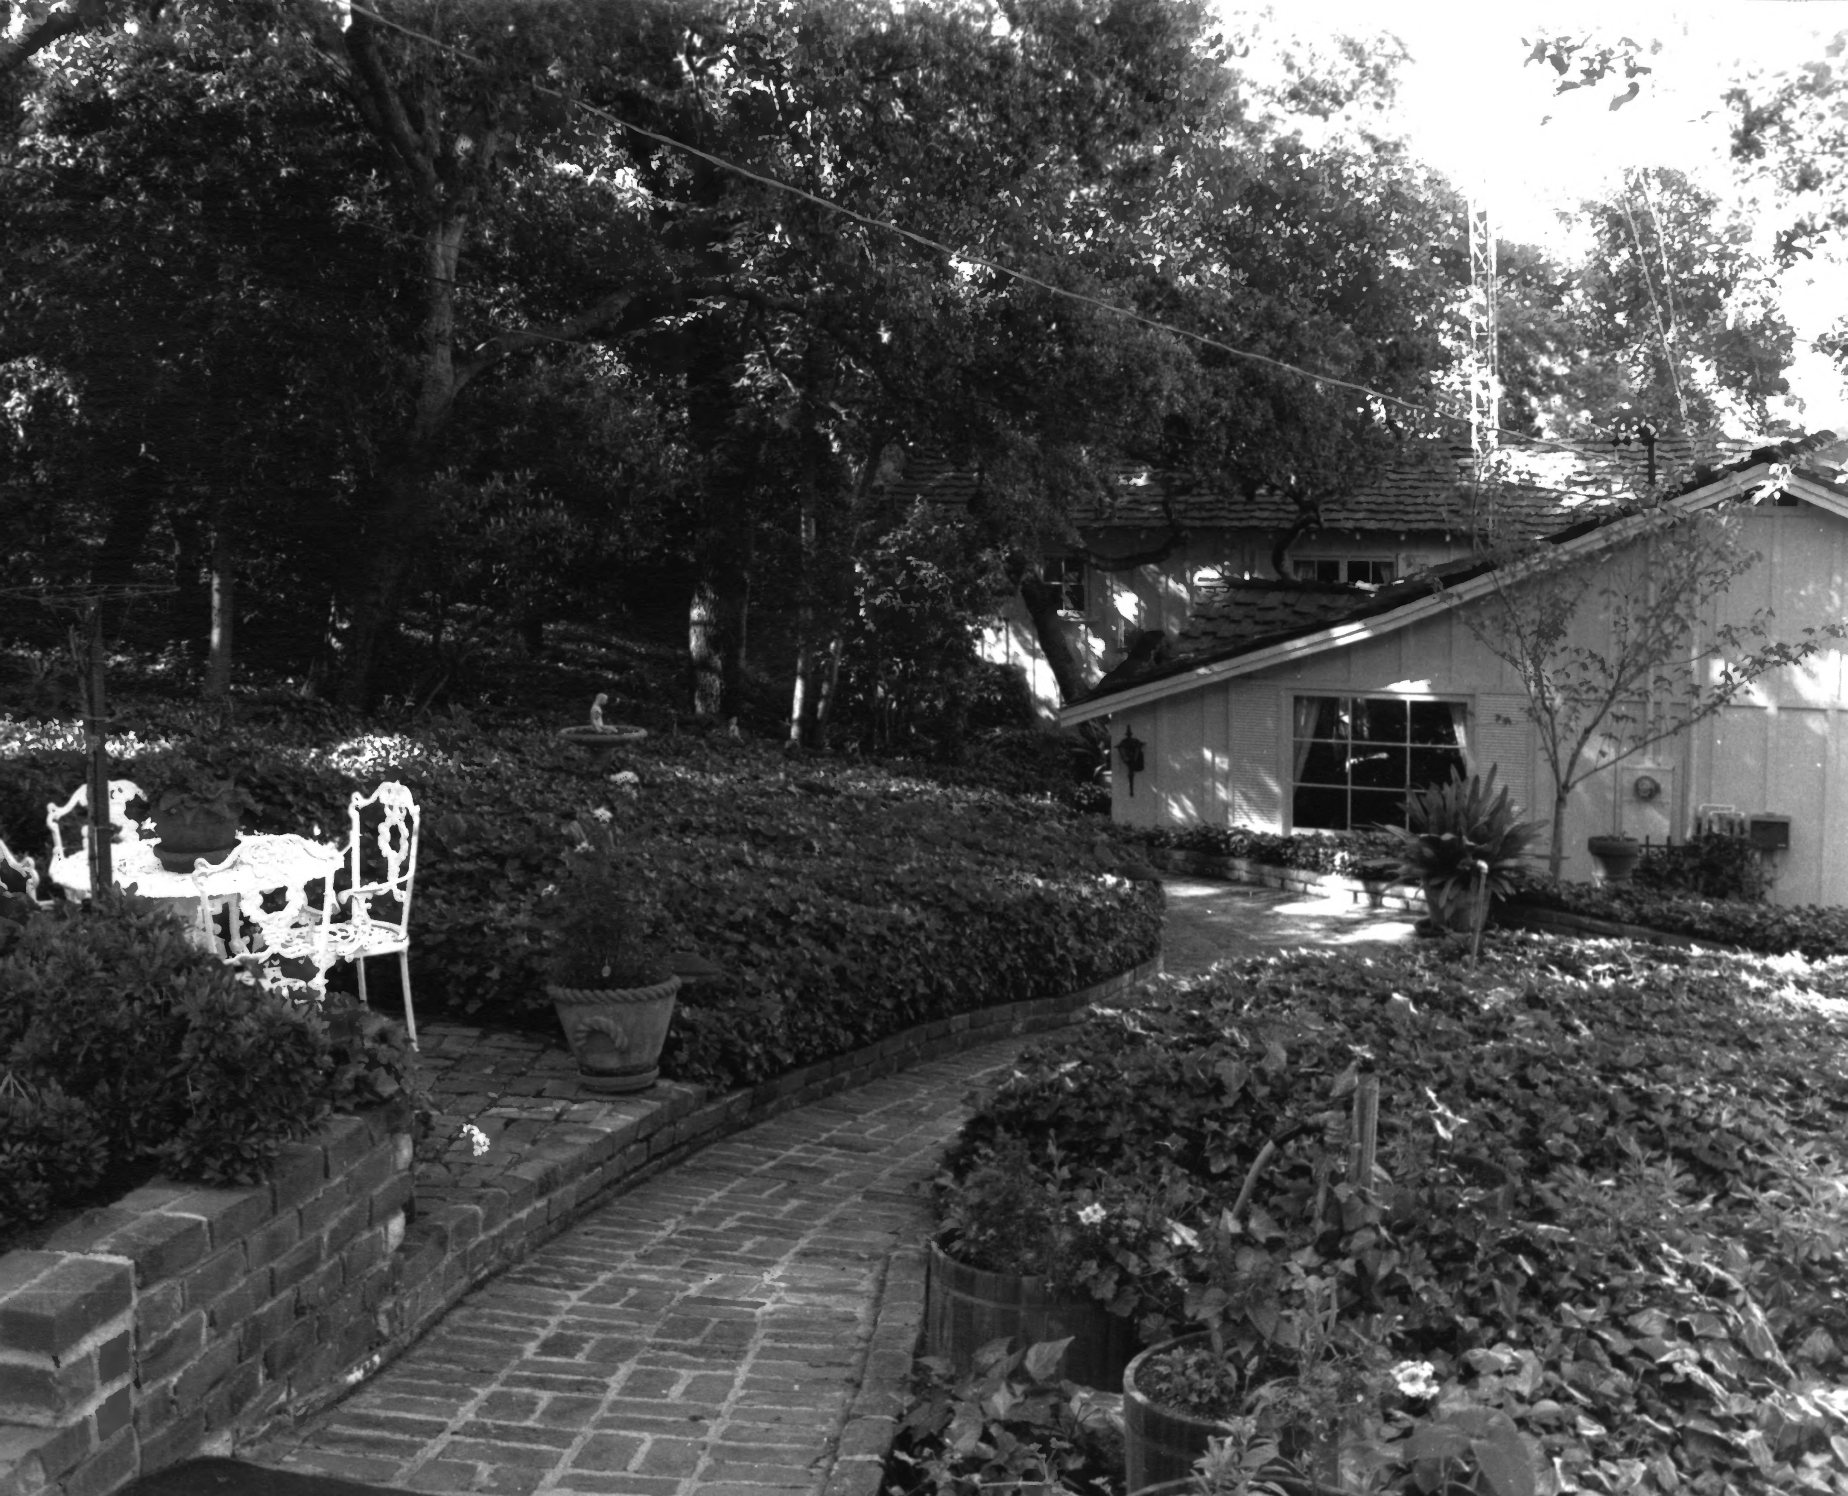
#3 brick path: bedroom, south wall - NW - SM#2

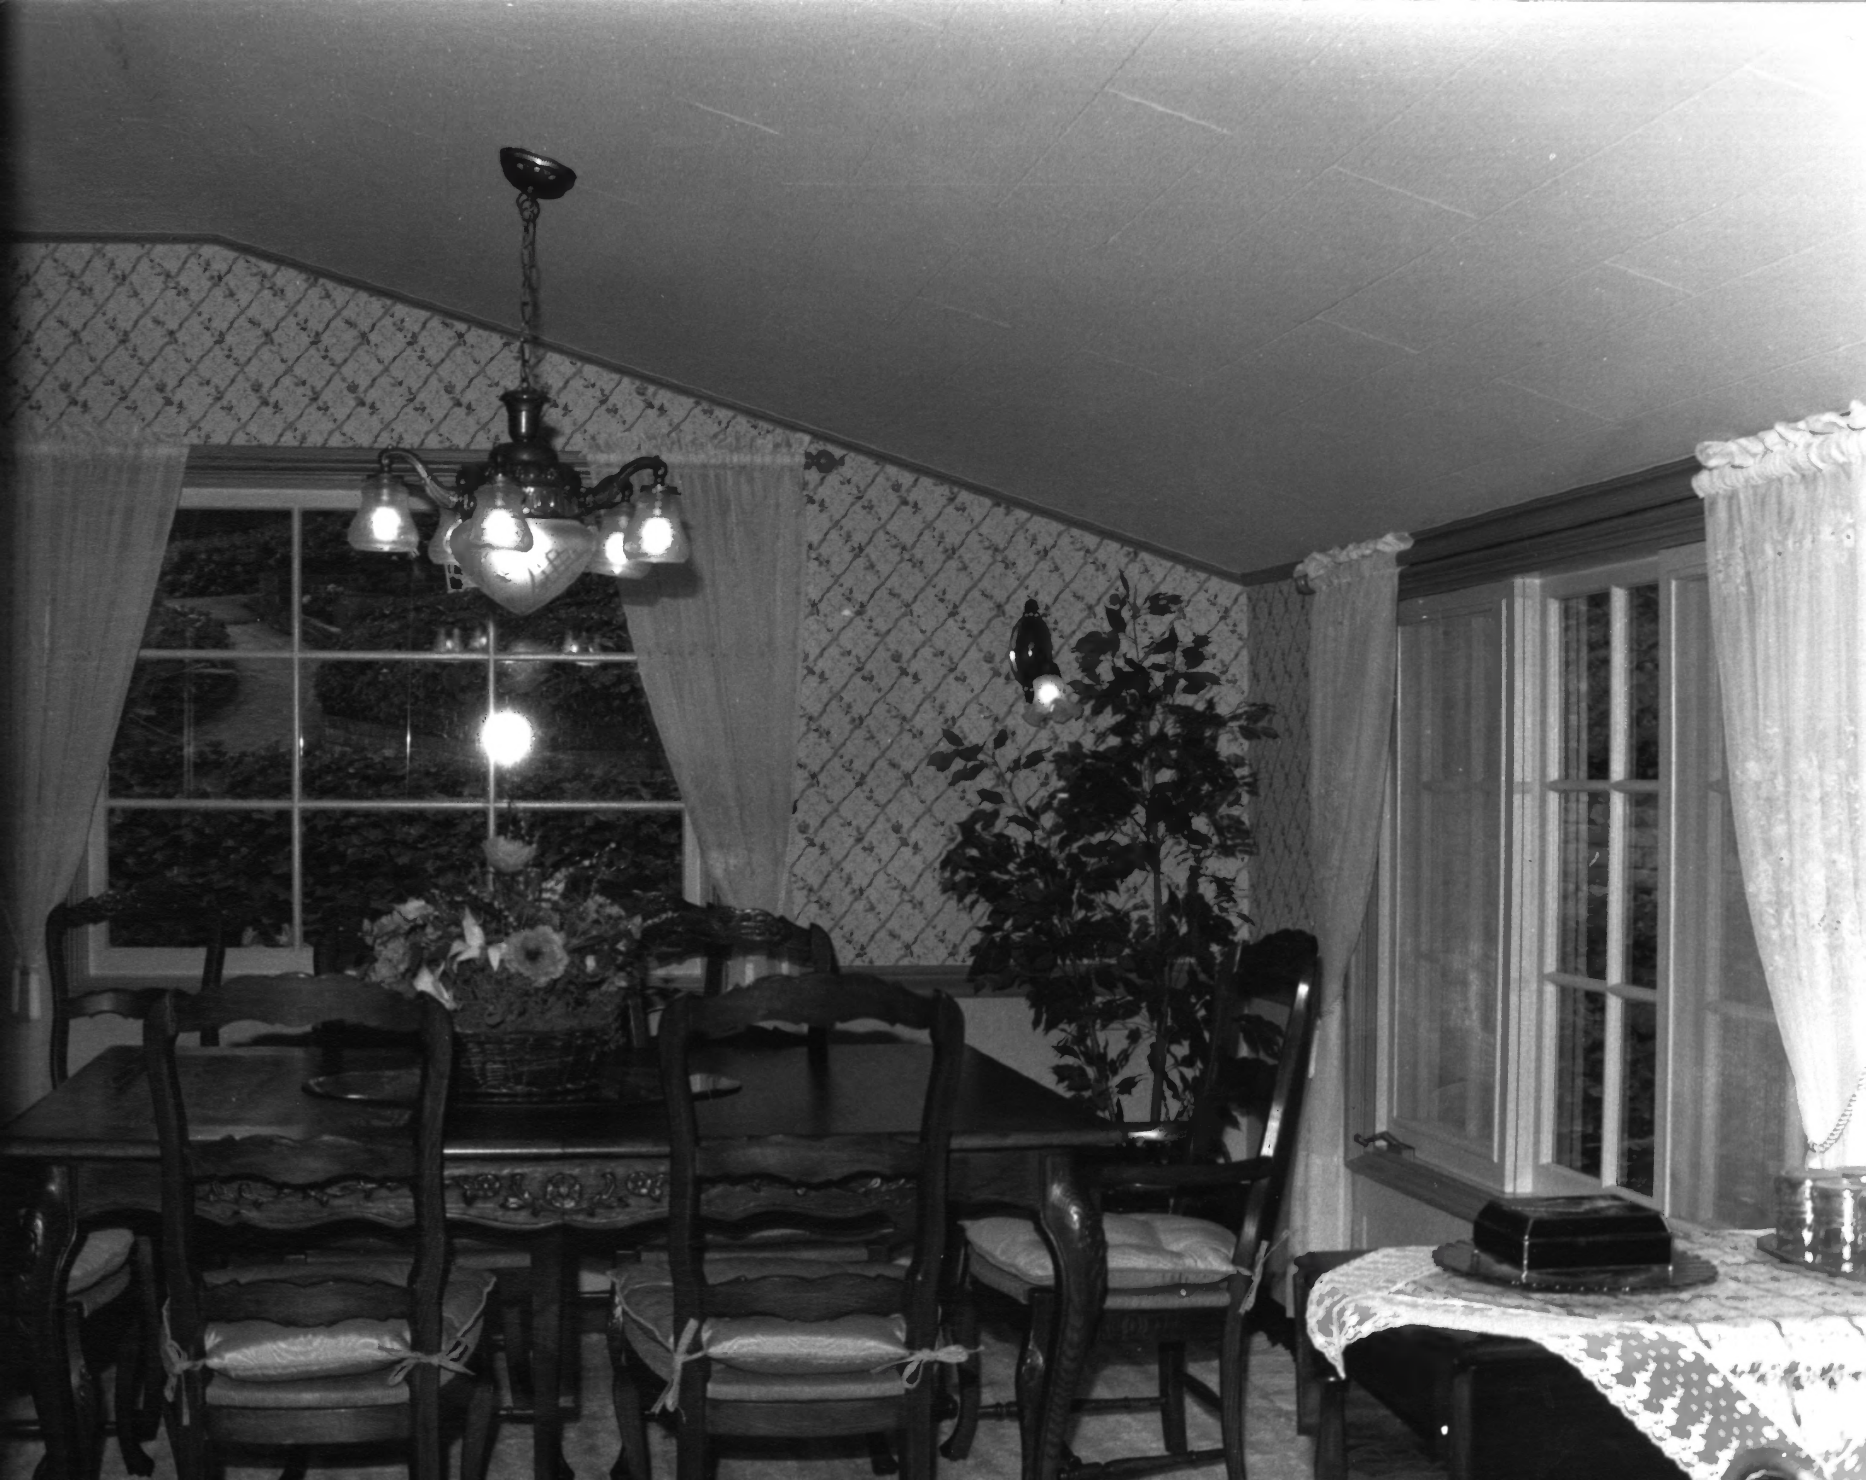
* * bedroom converted to dining room - S - SM#2

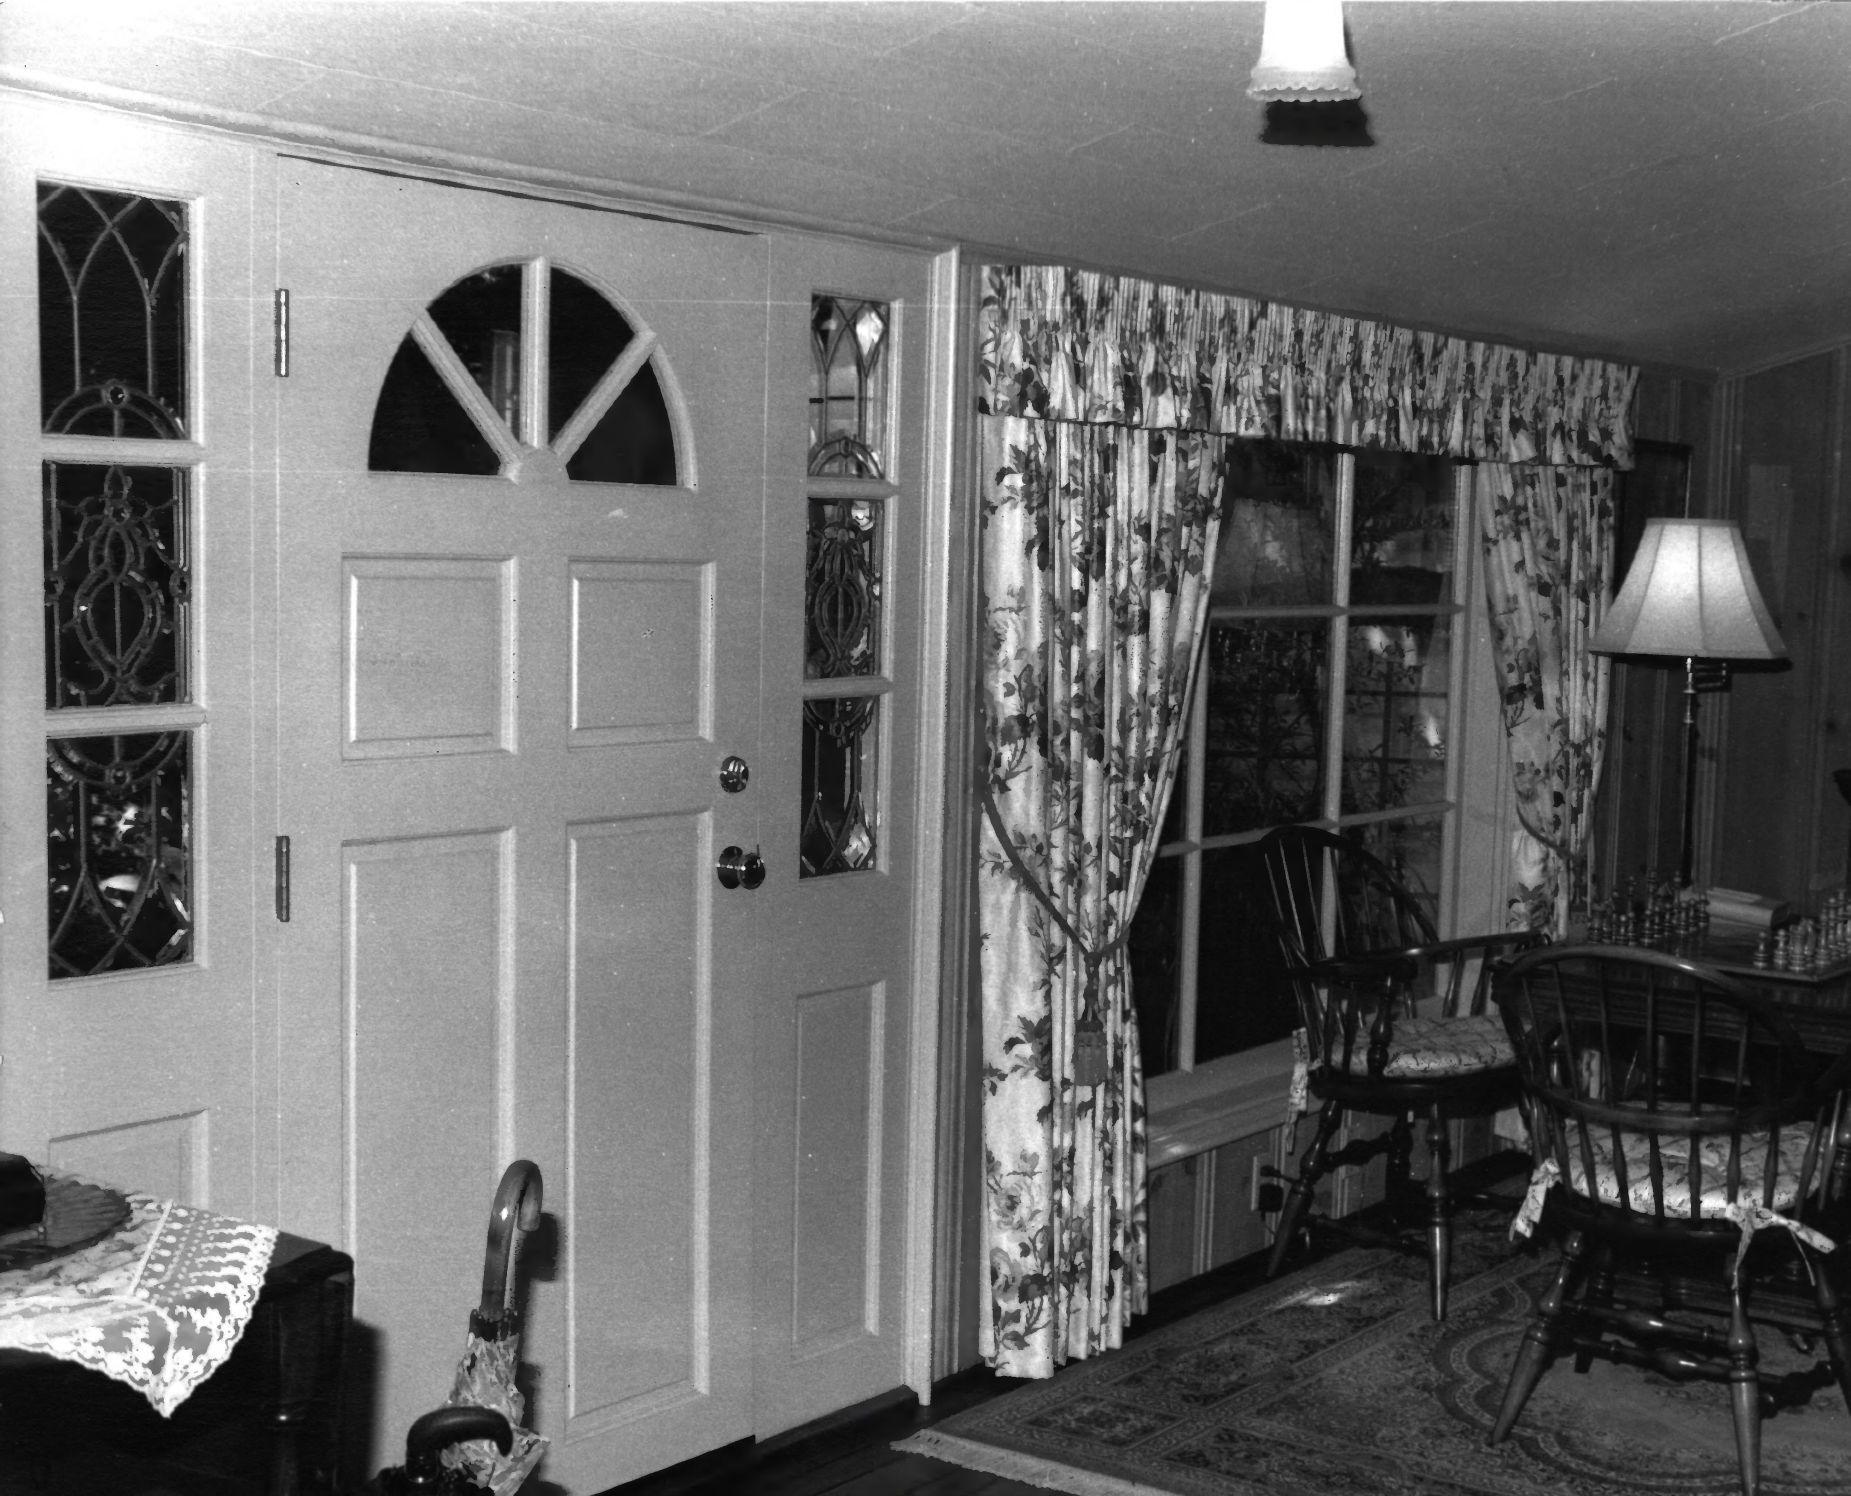
#5 dining space: entry - NW - SM #3
