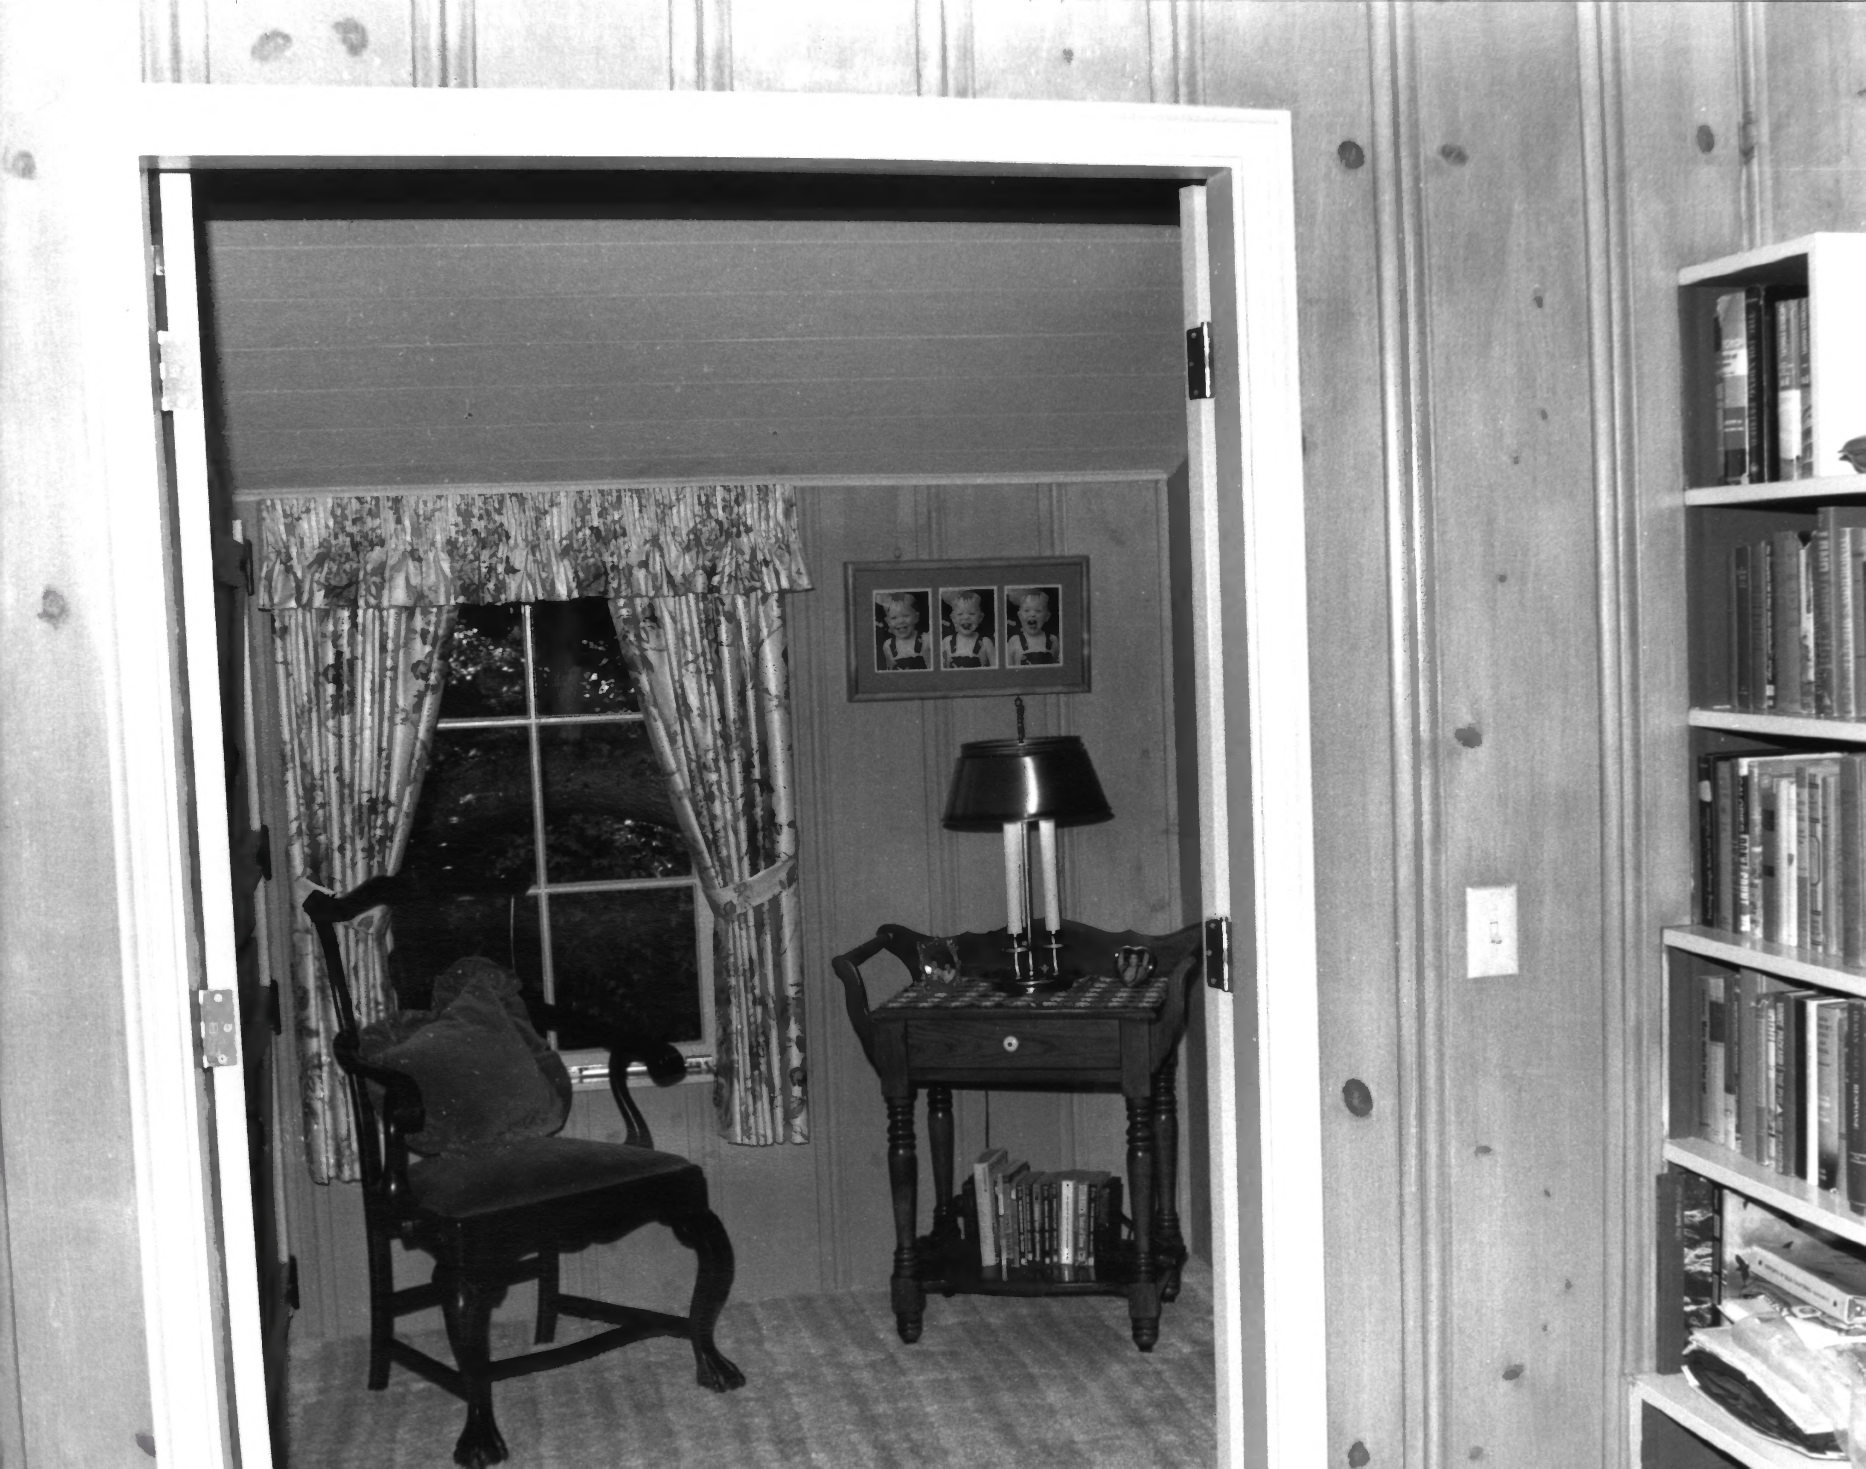
#6 workroom - W - SM #4

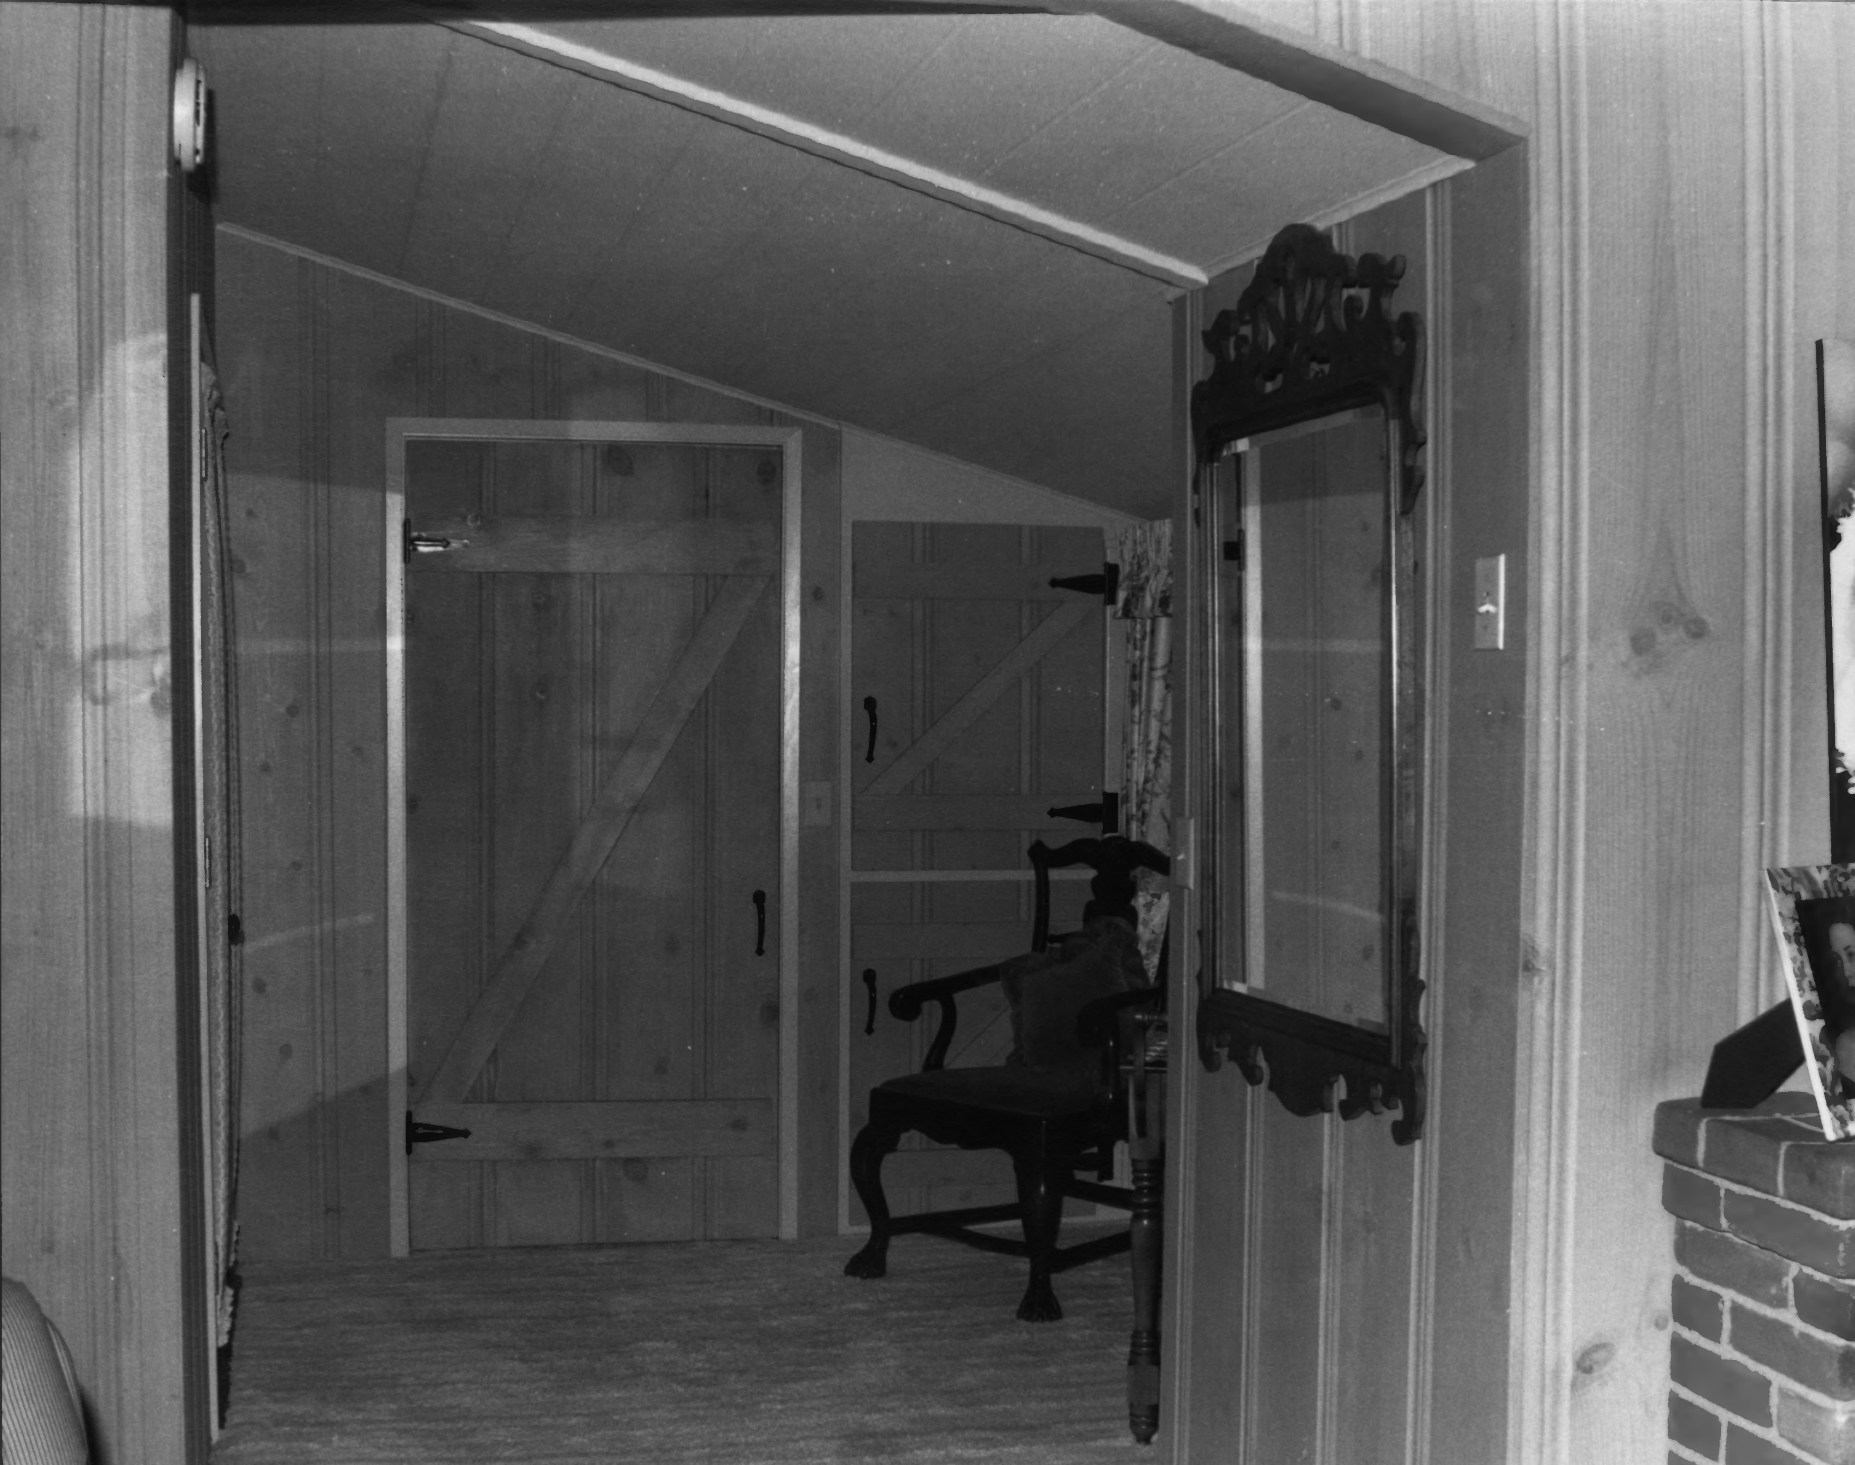
#7

WORKROOM

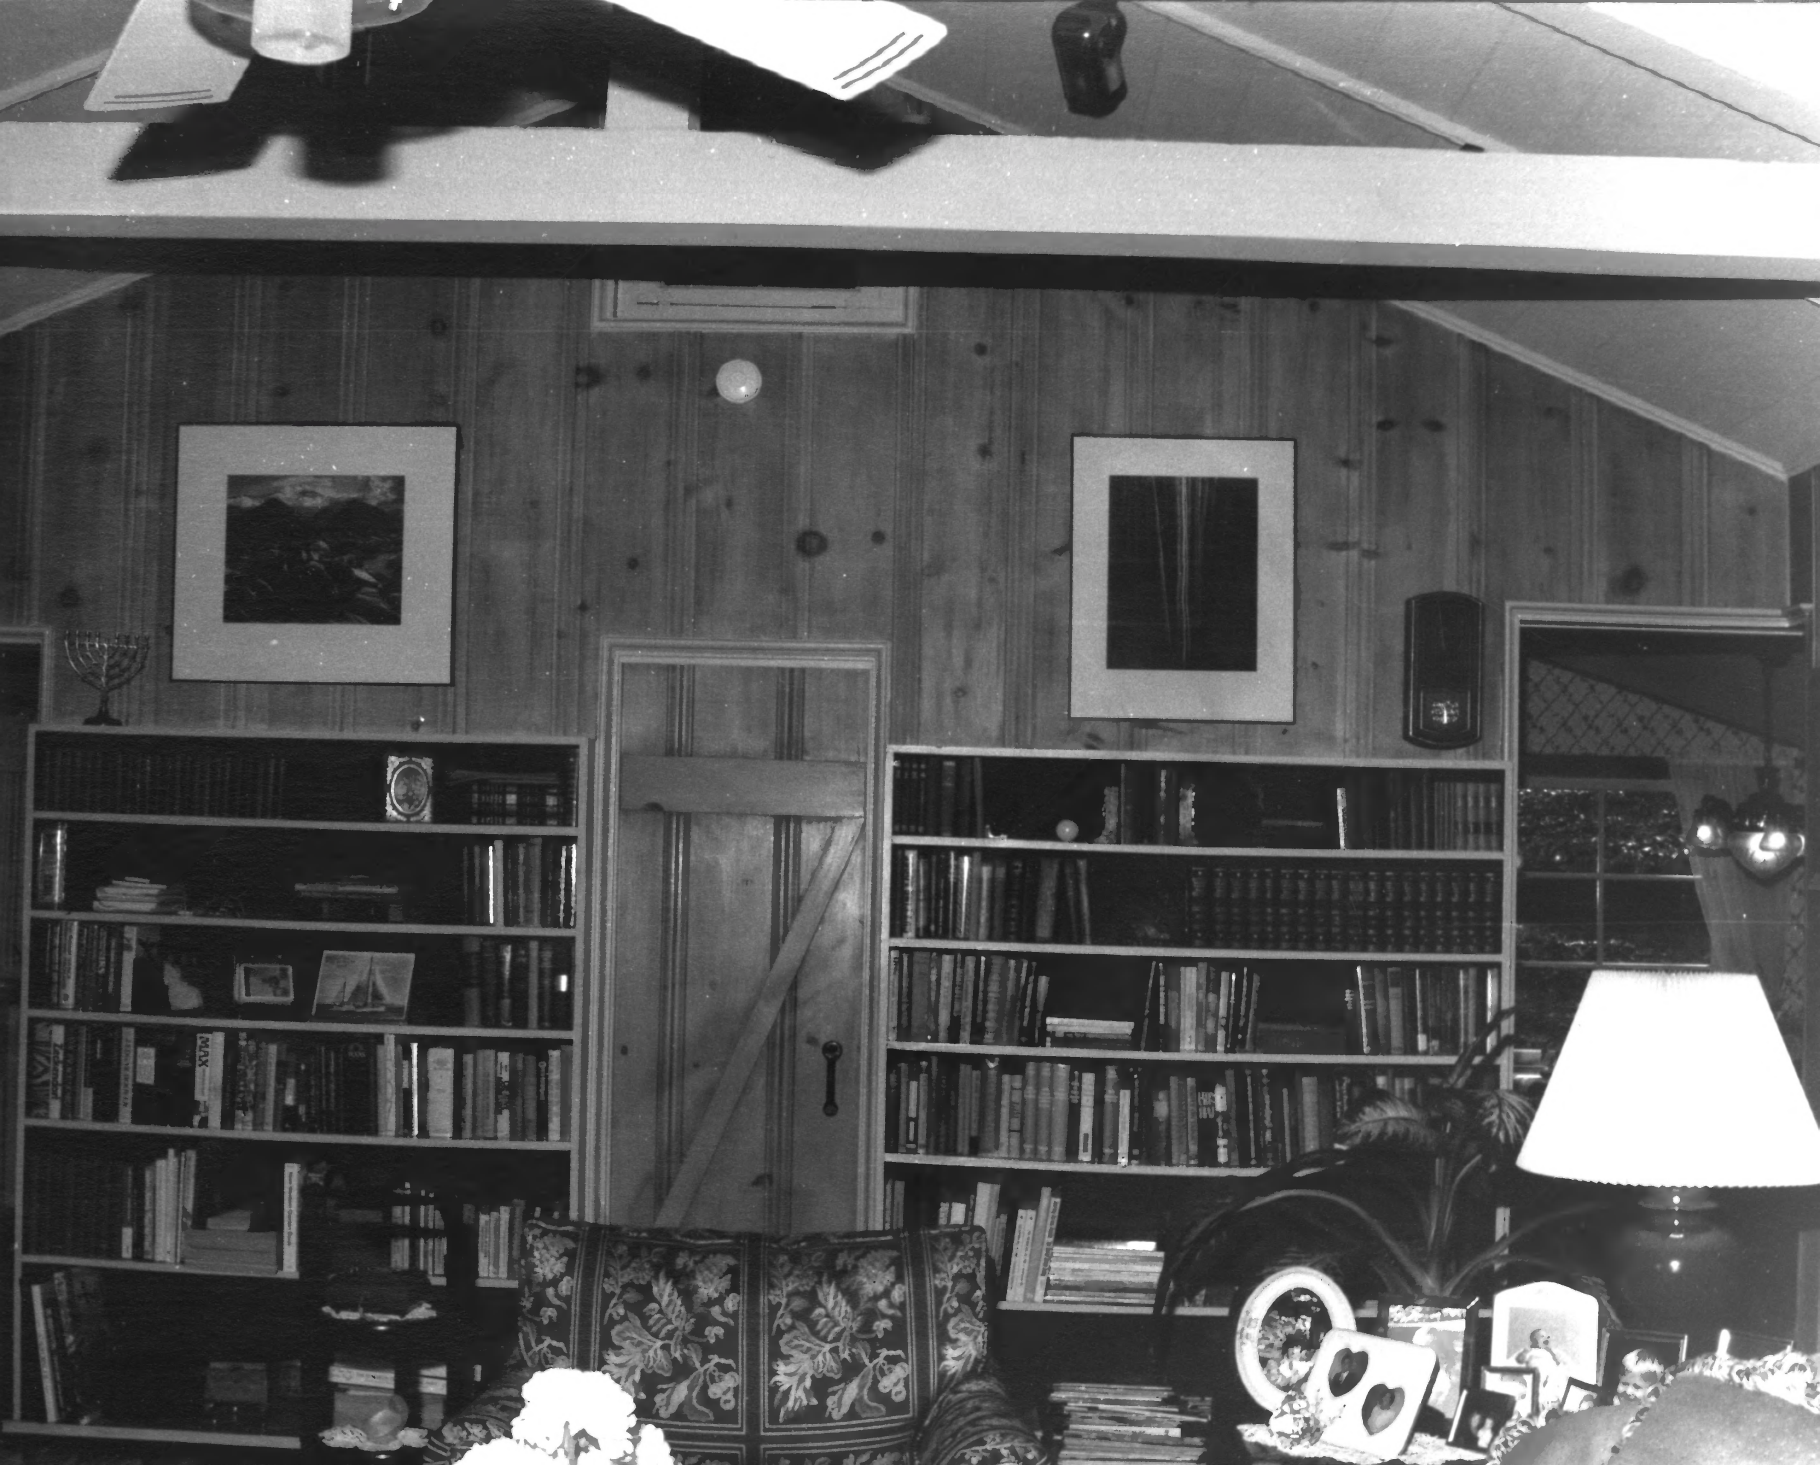
#8 living room, south wall - S - SM#5

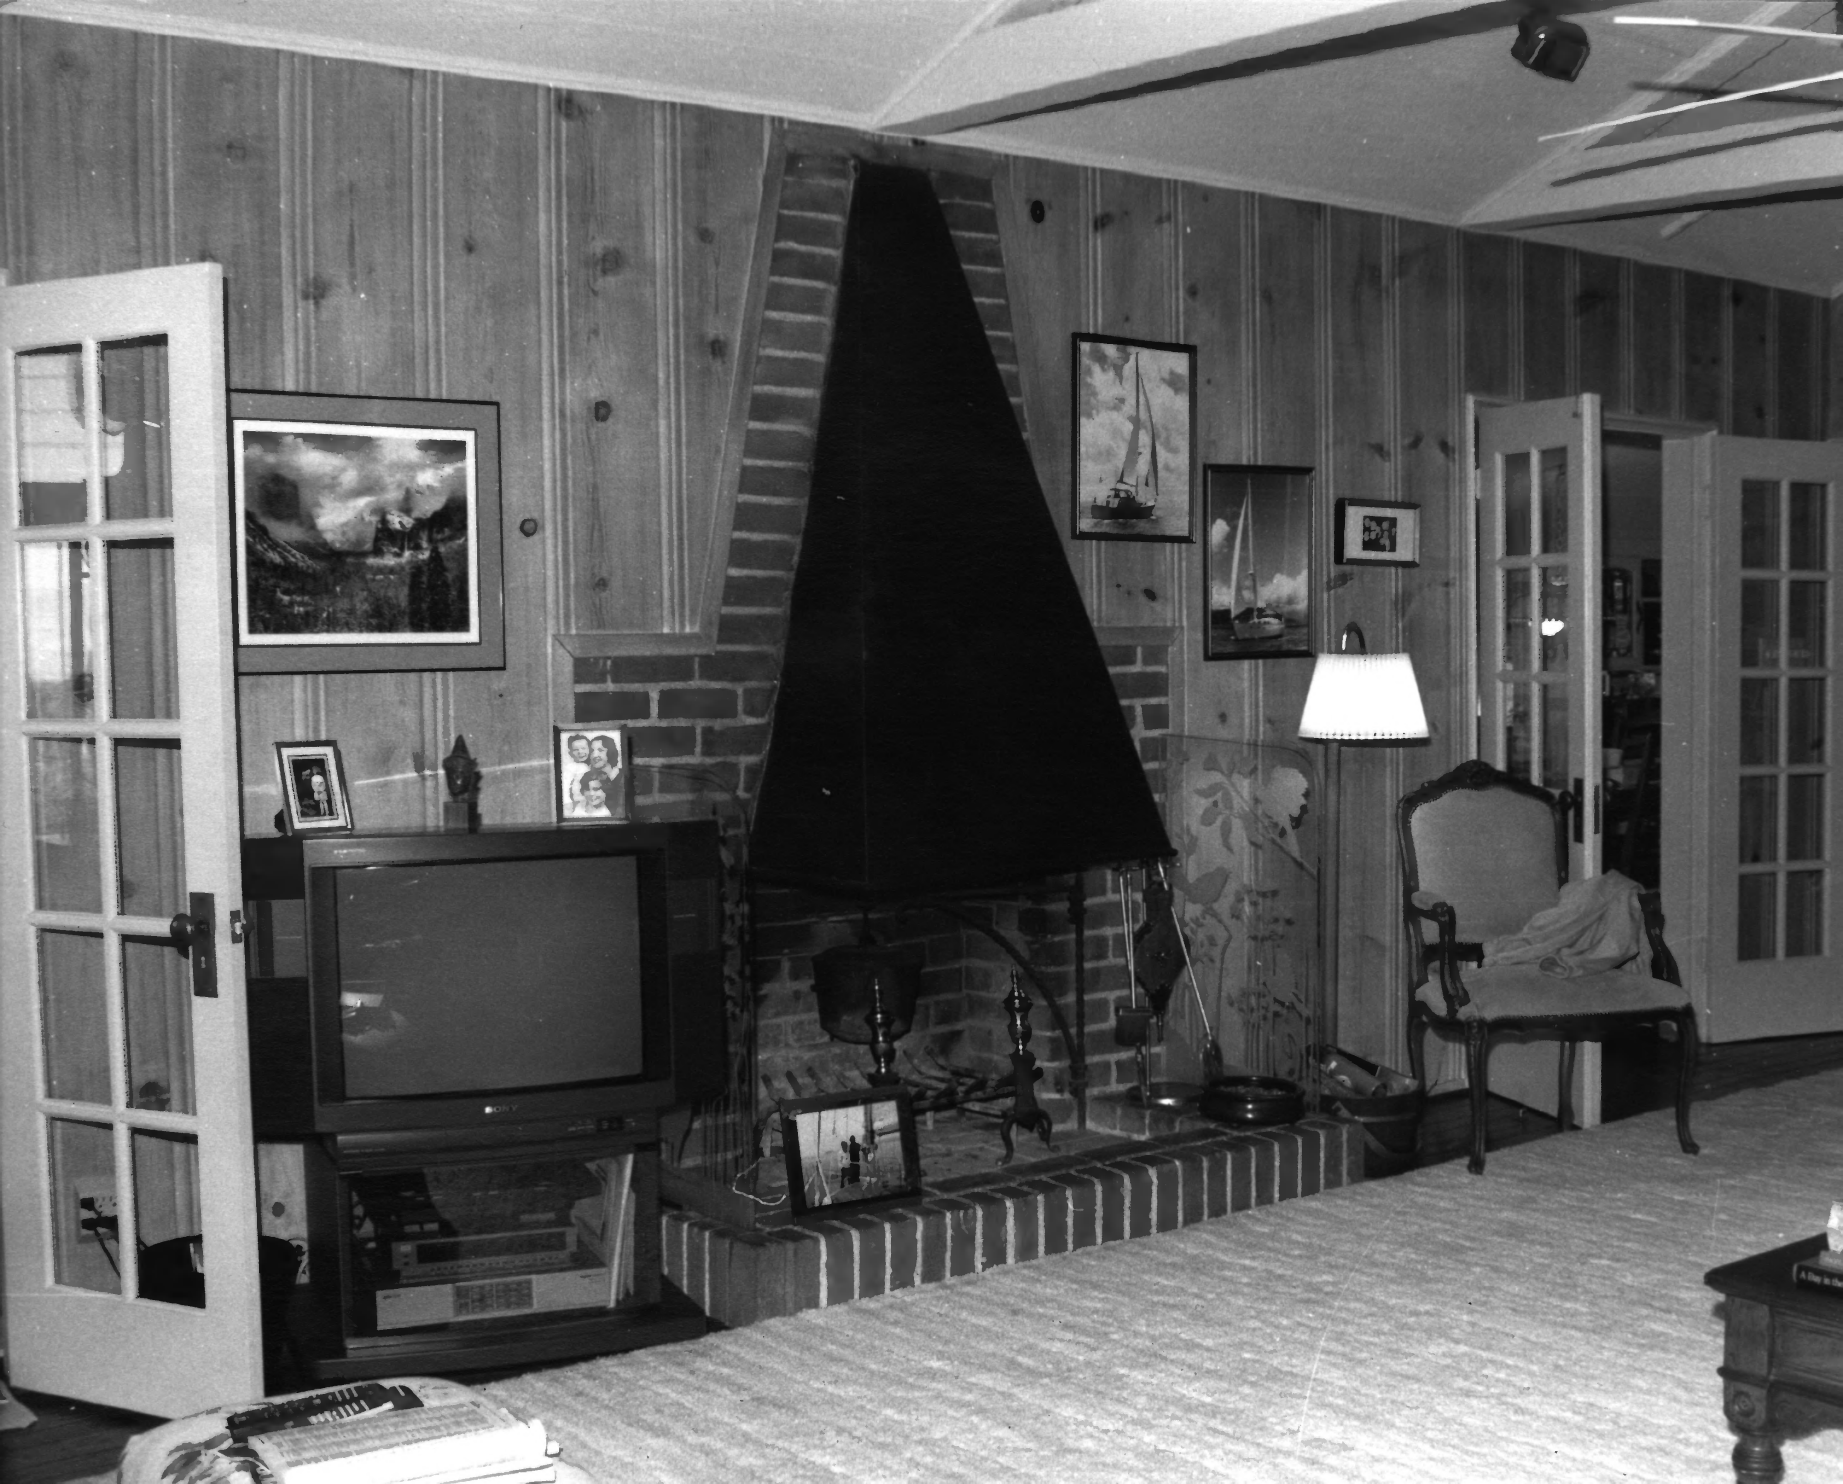
#9 living room, east wall - SE - SM#5

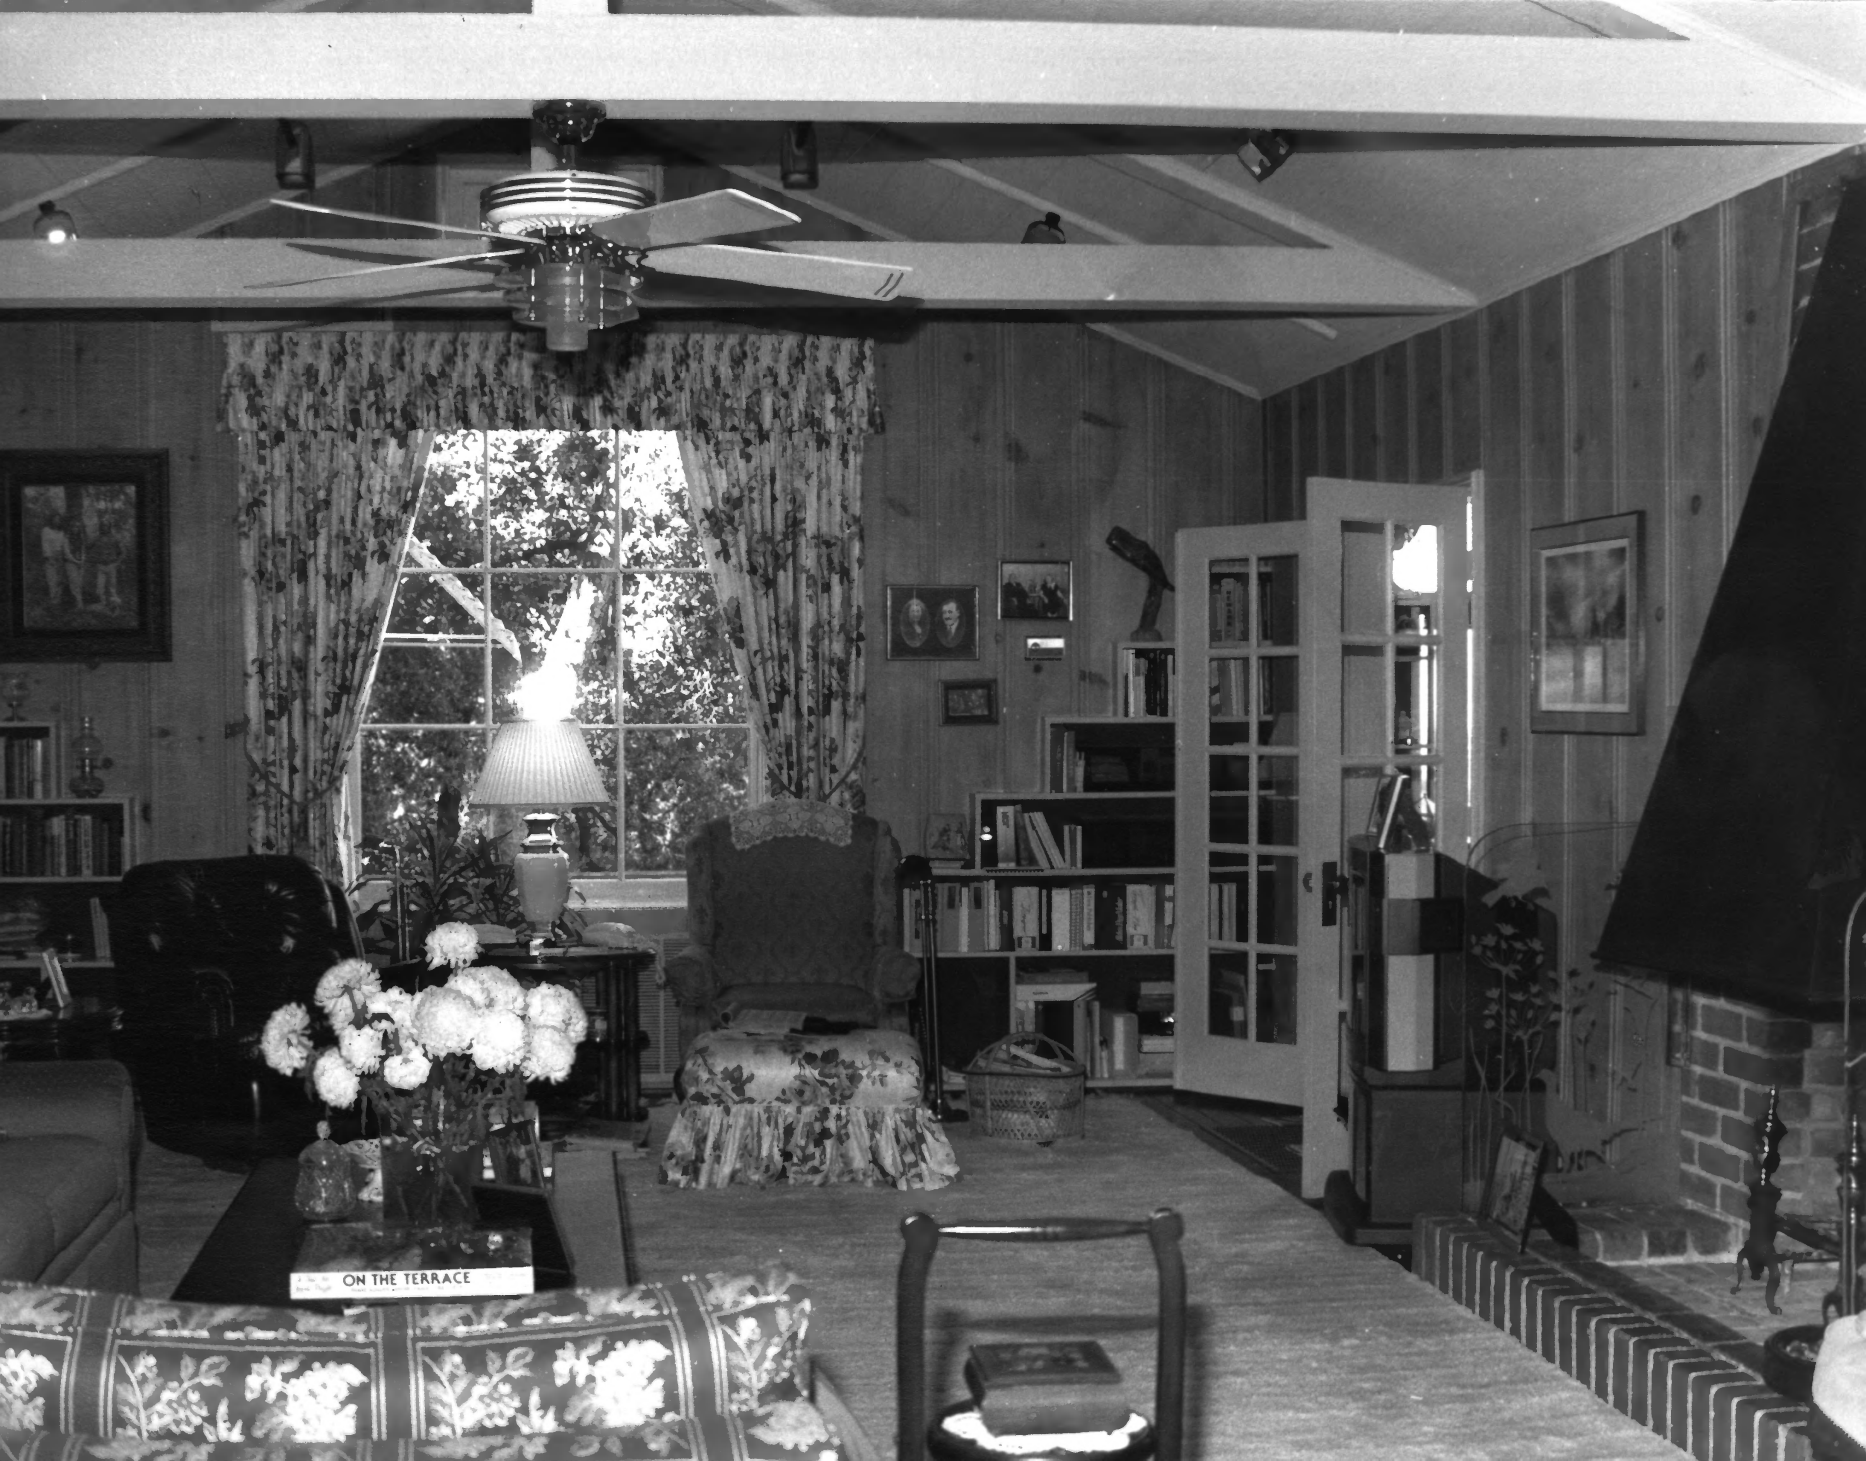
#10 living room, north wall - N - SM # 5

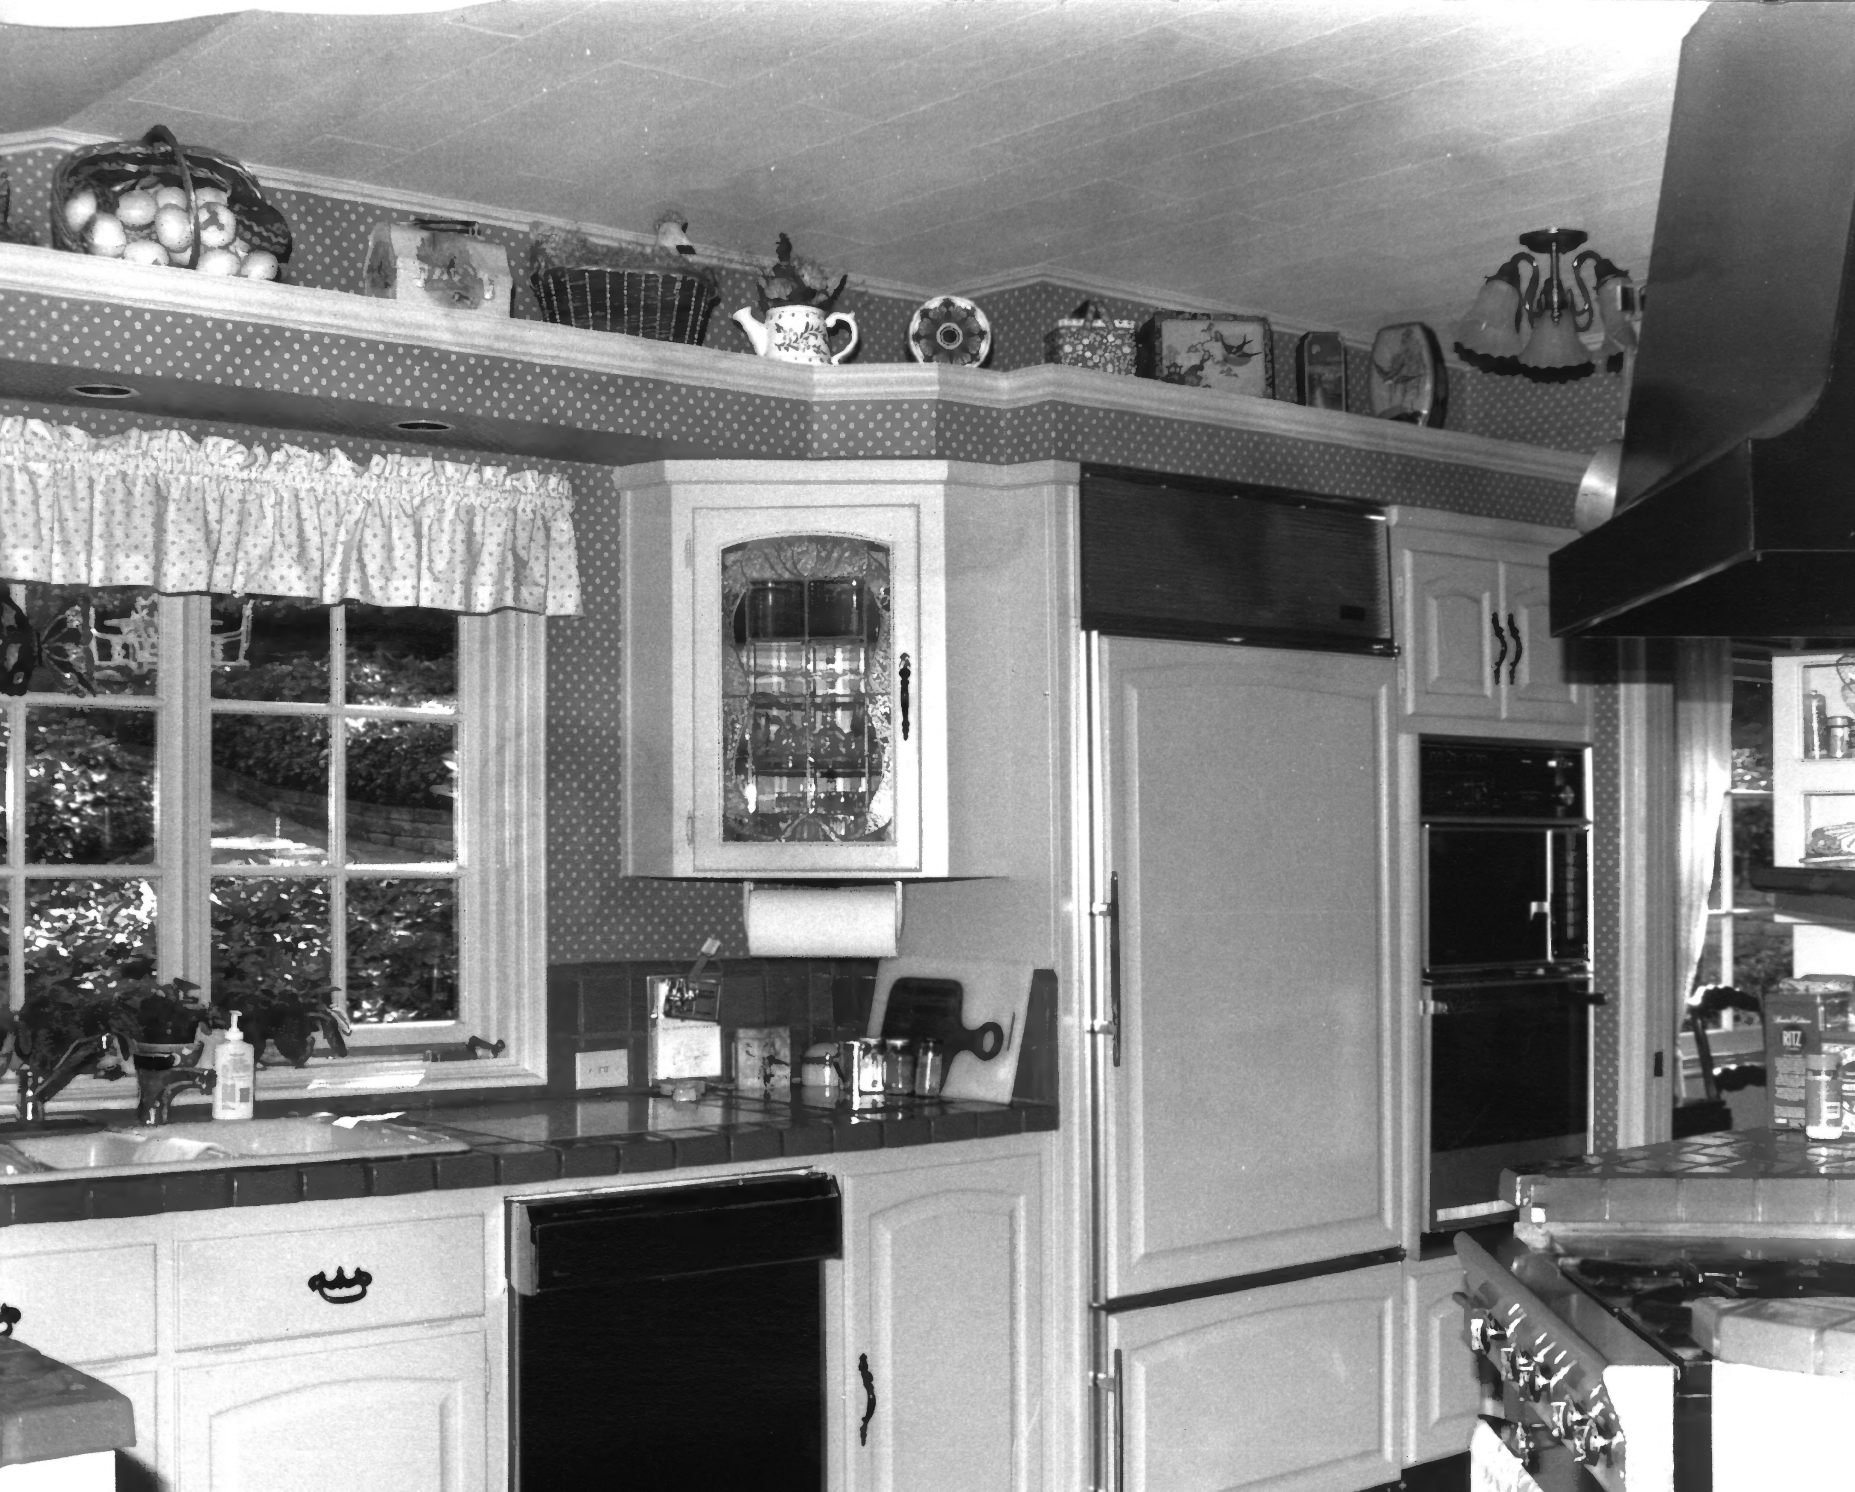
#11 Kitchen, looking toward former bathroom - SW - SM#6

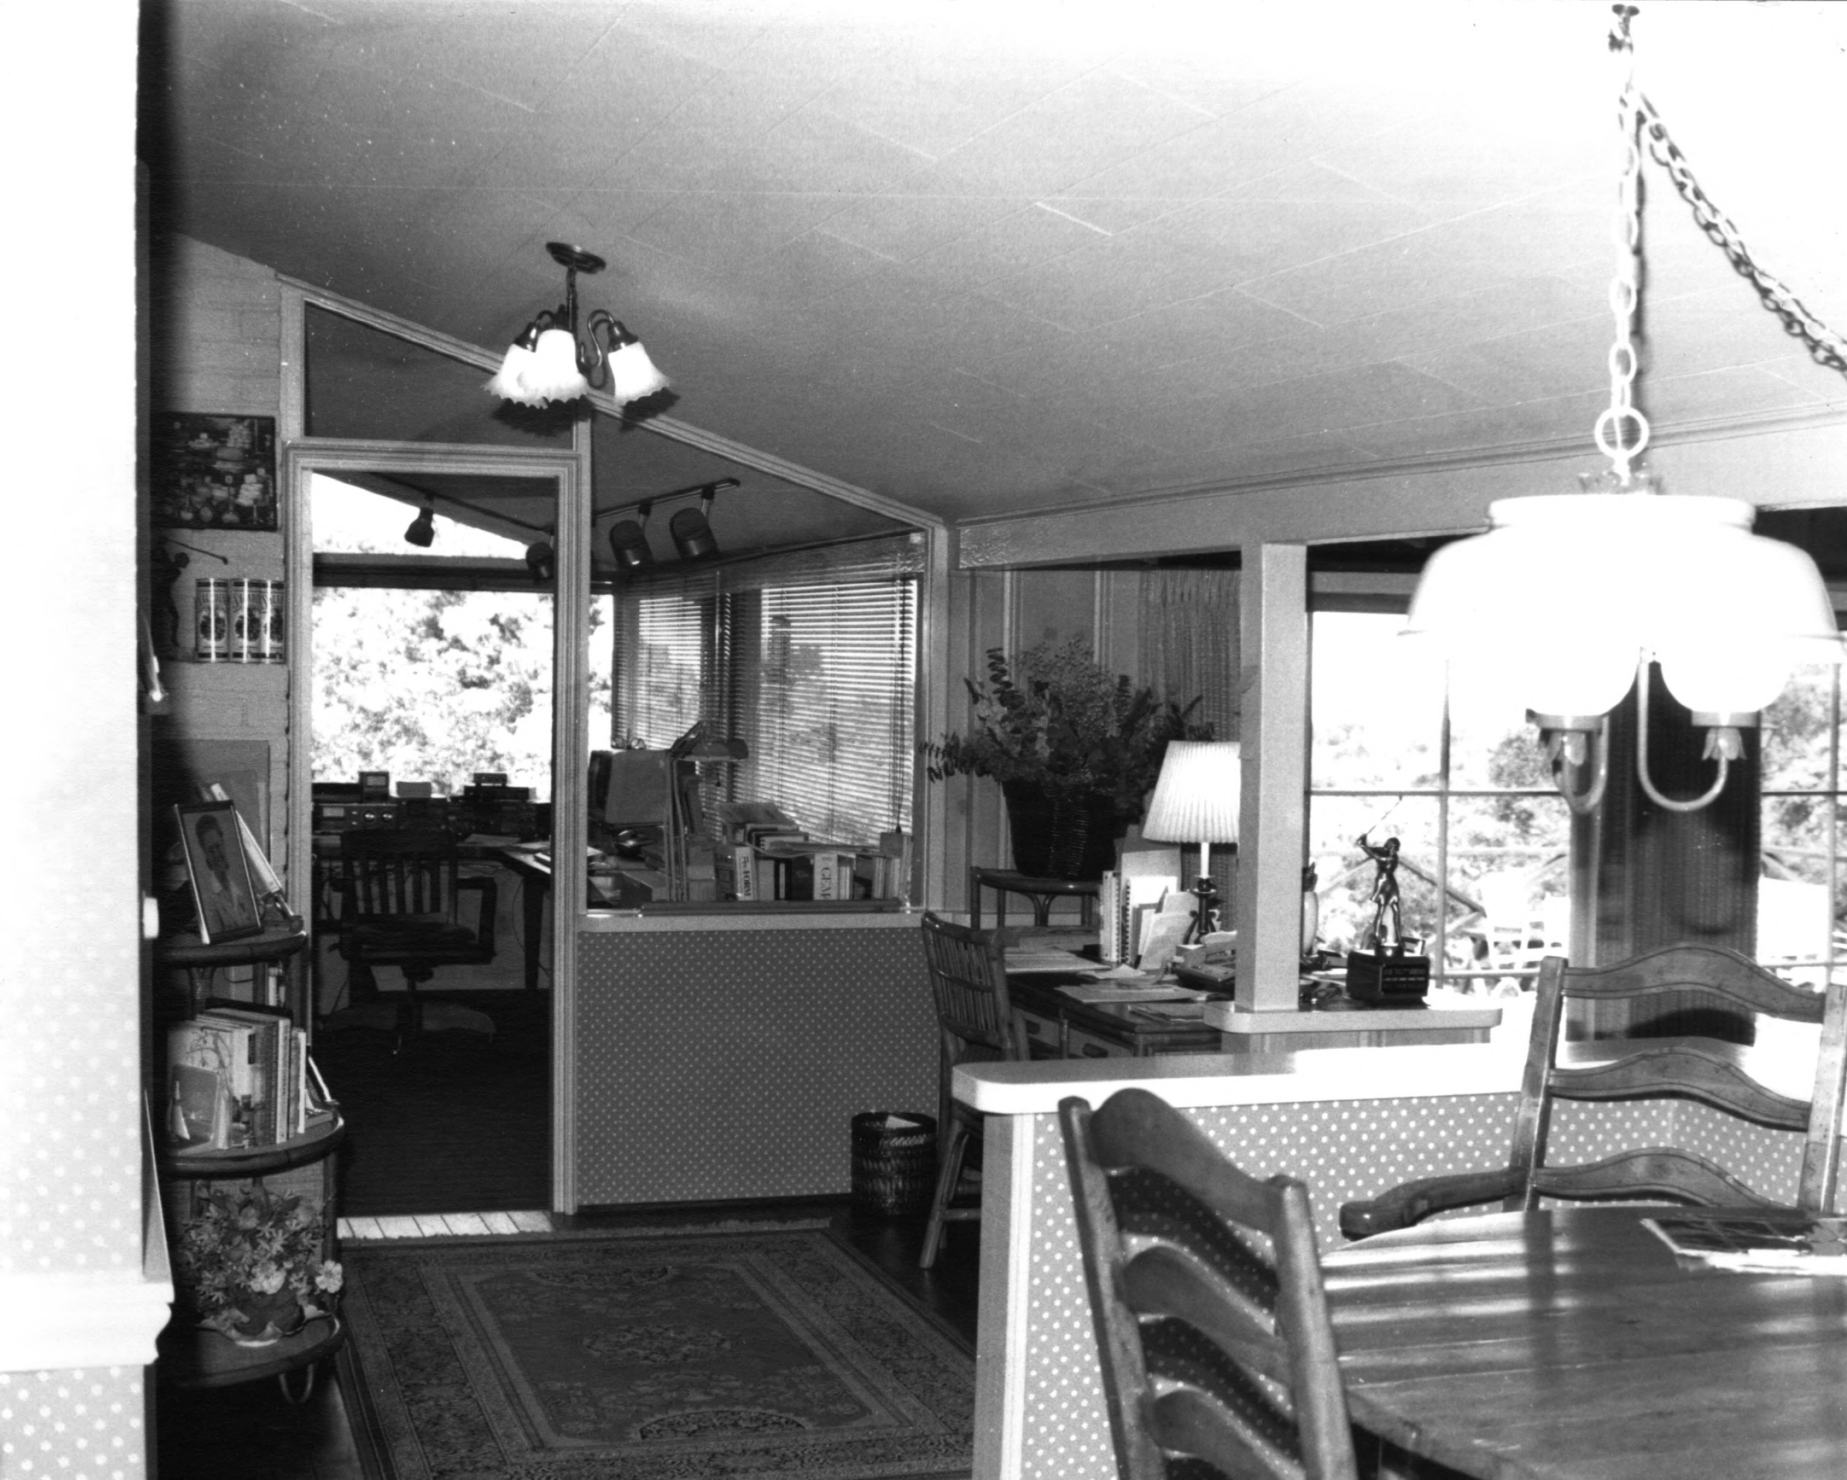
#12 porch, interior glass enclosure - NE - SM#7

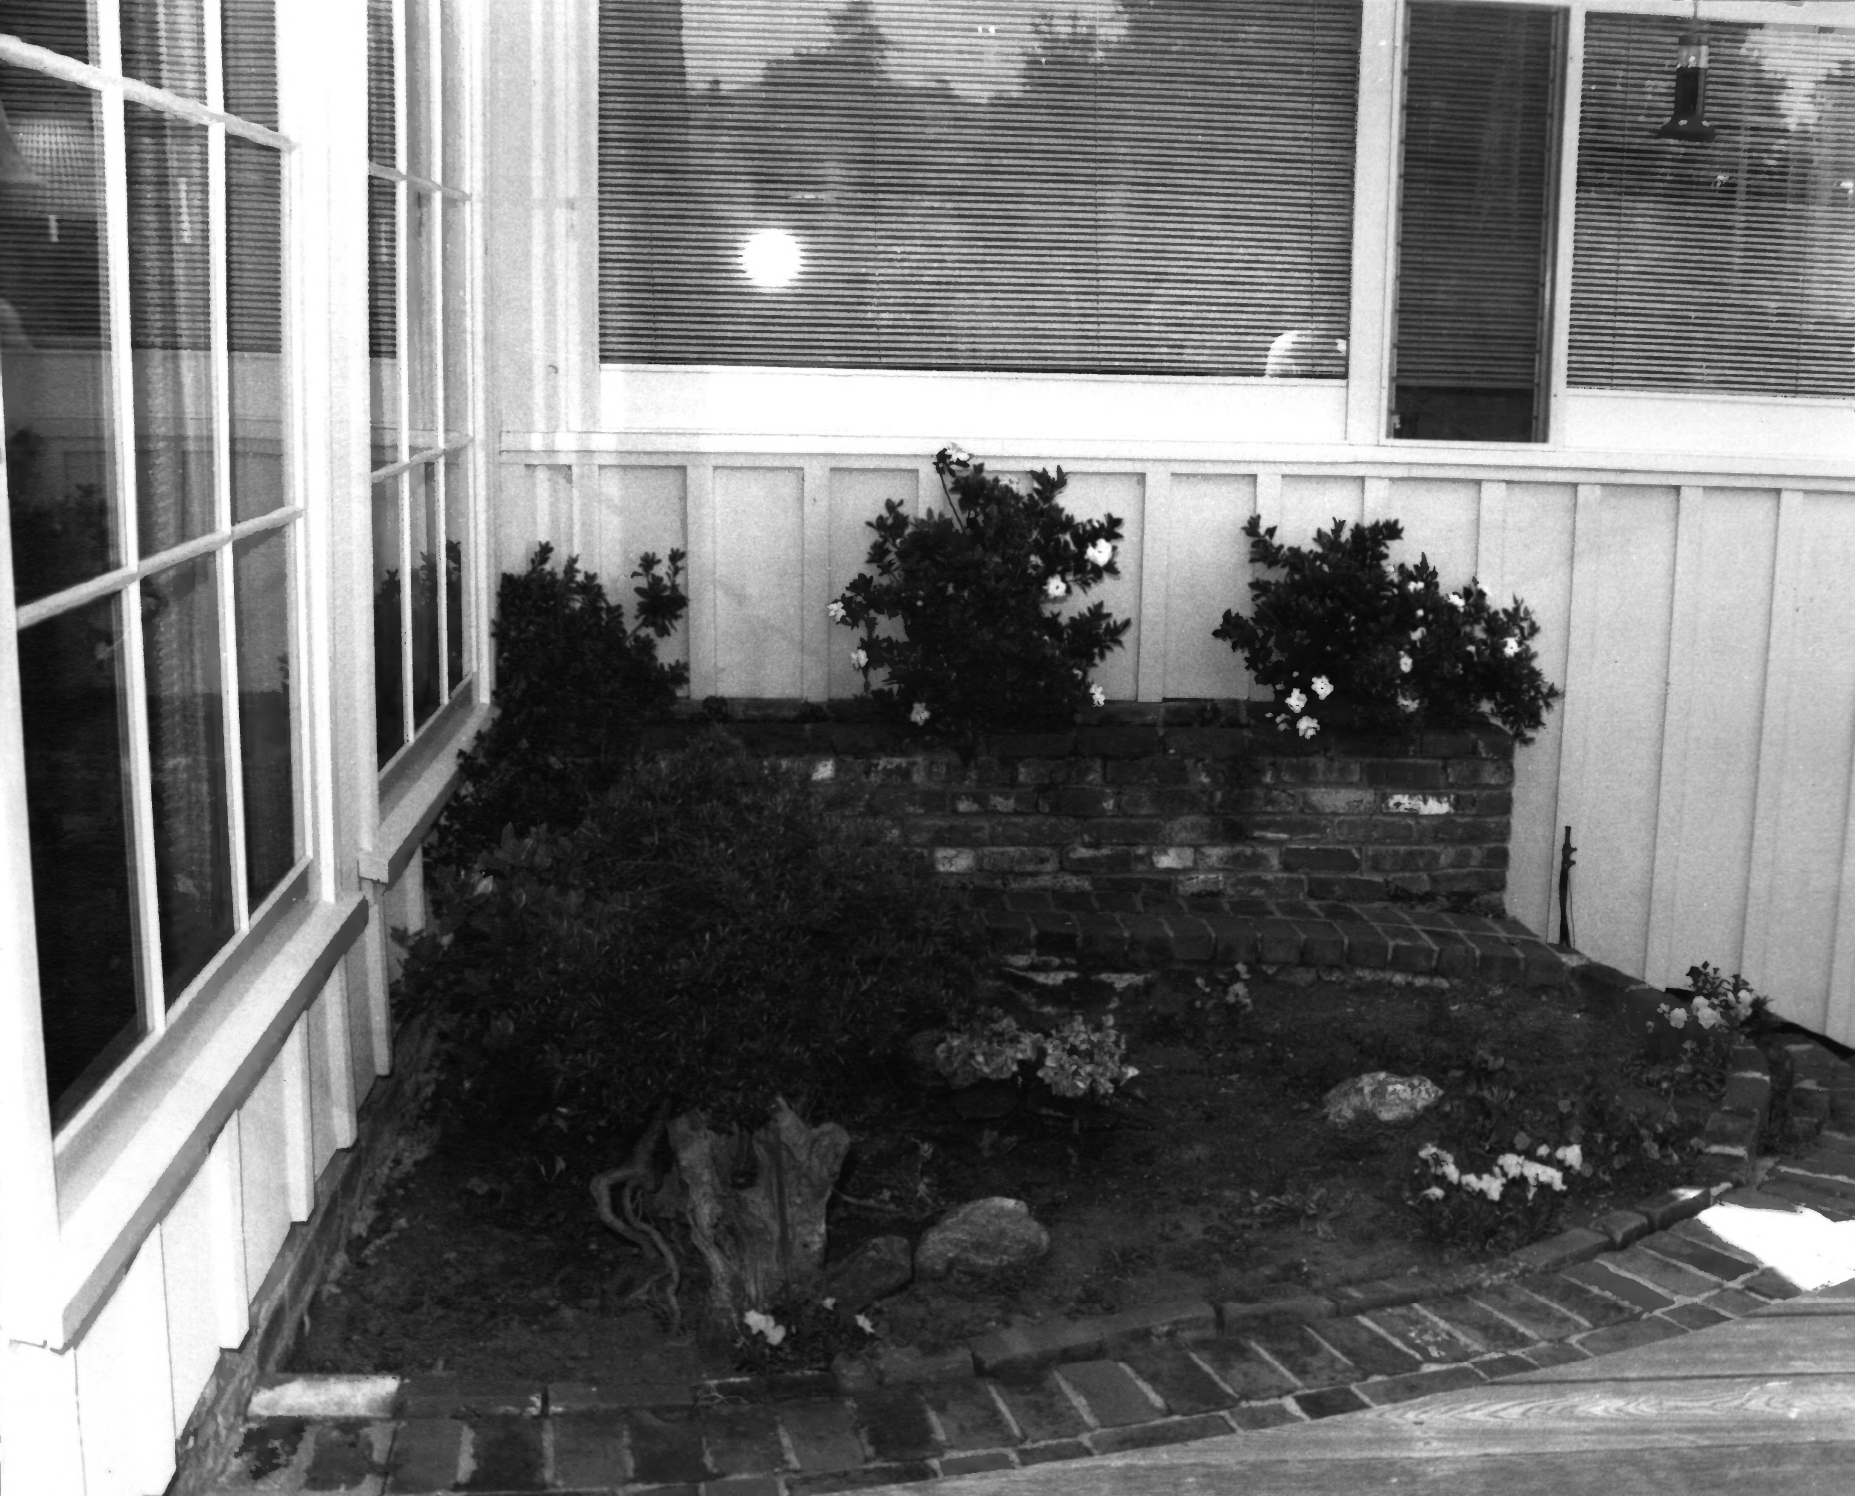
#13 porch, exterior glass enclosure - W - SM#7
