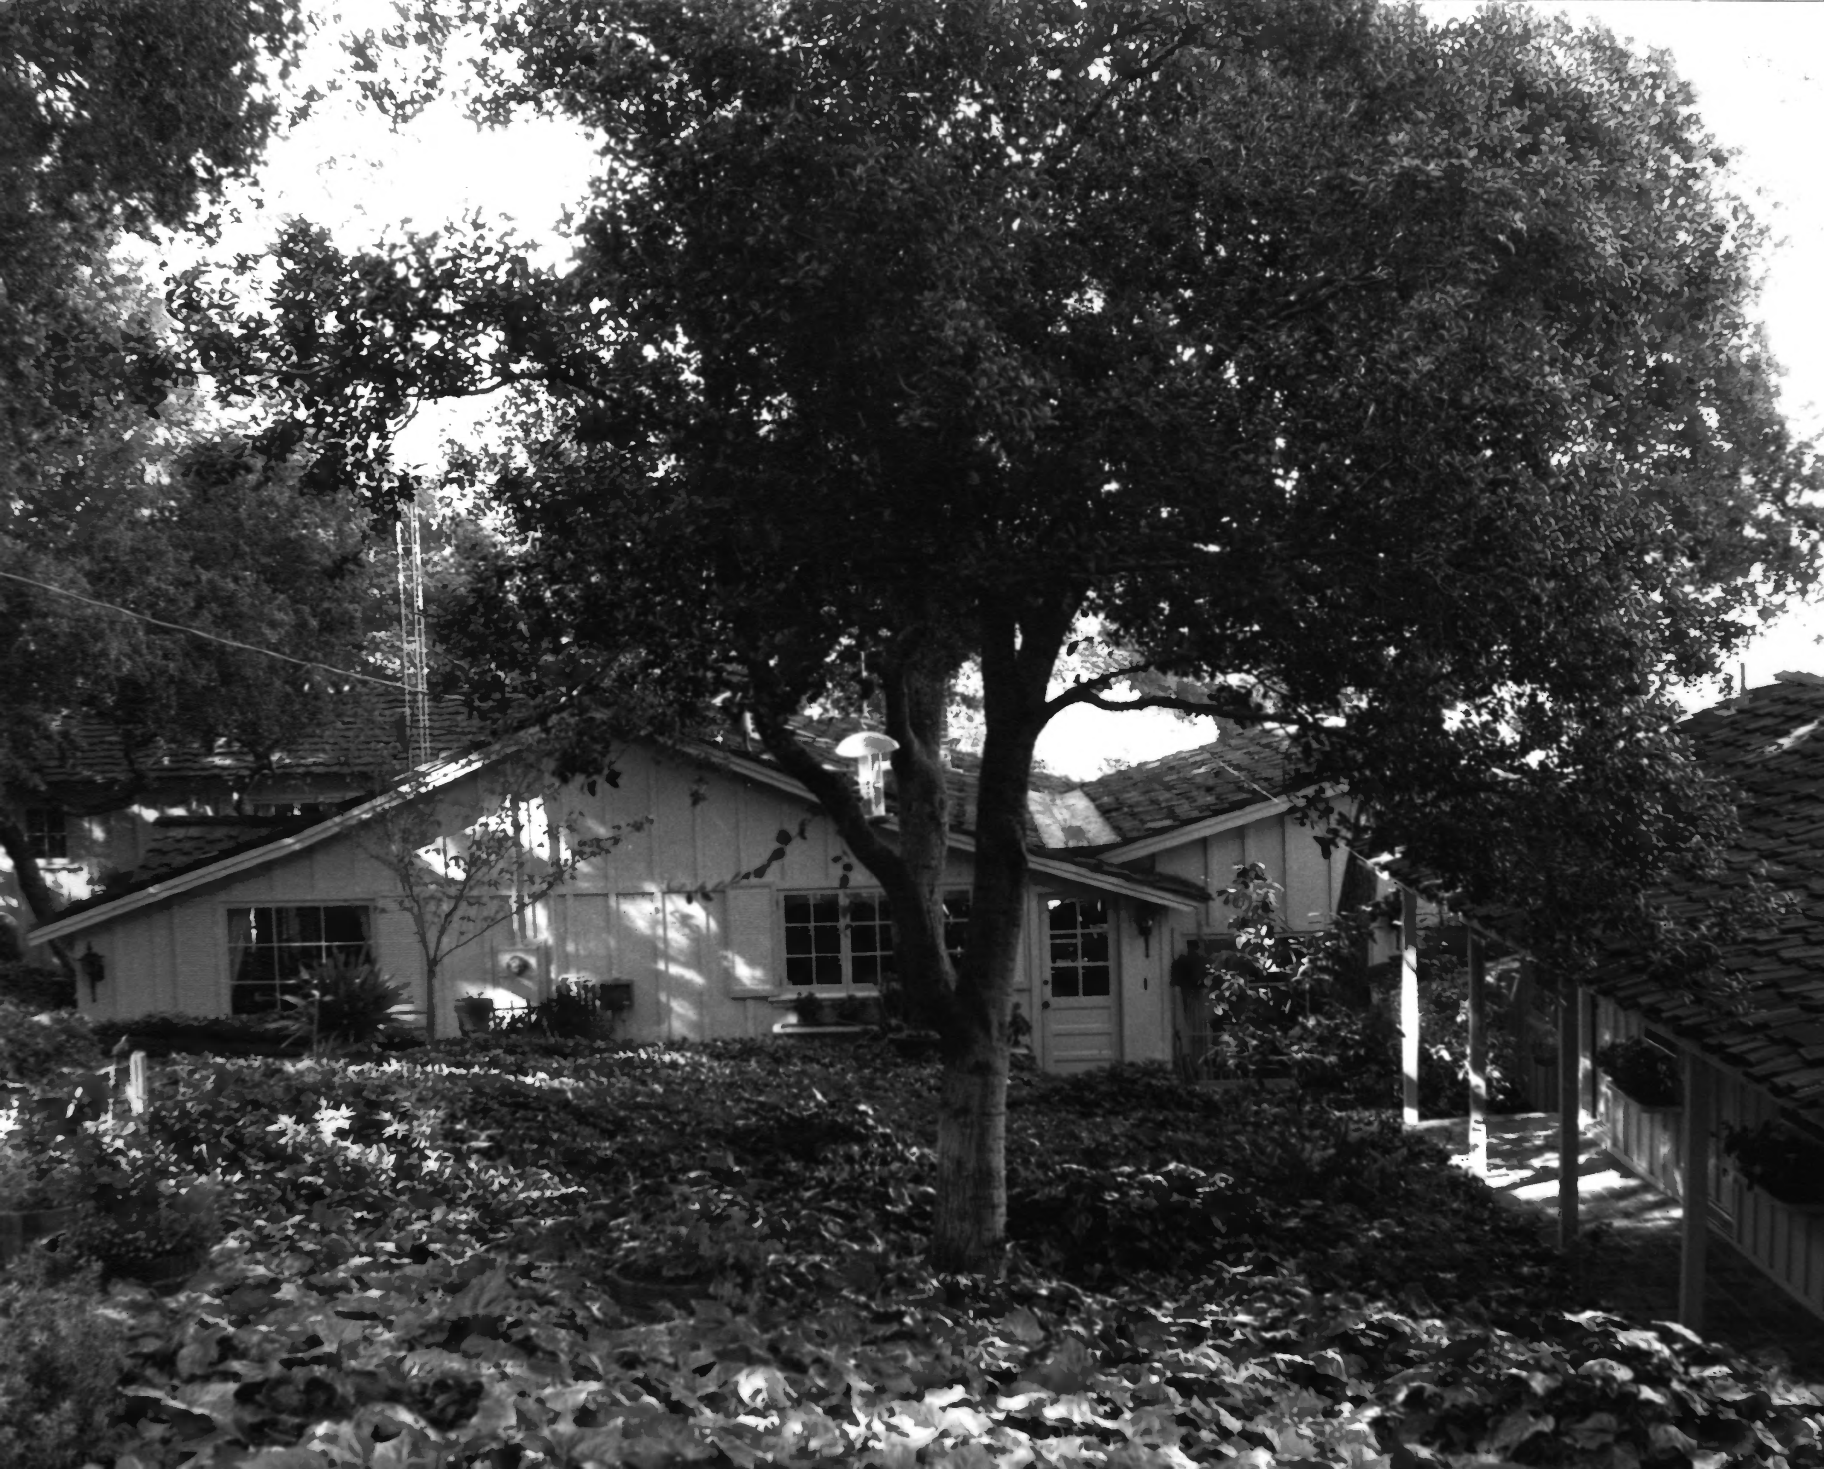
#14 main house orientation to guest house - N - SM #8

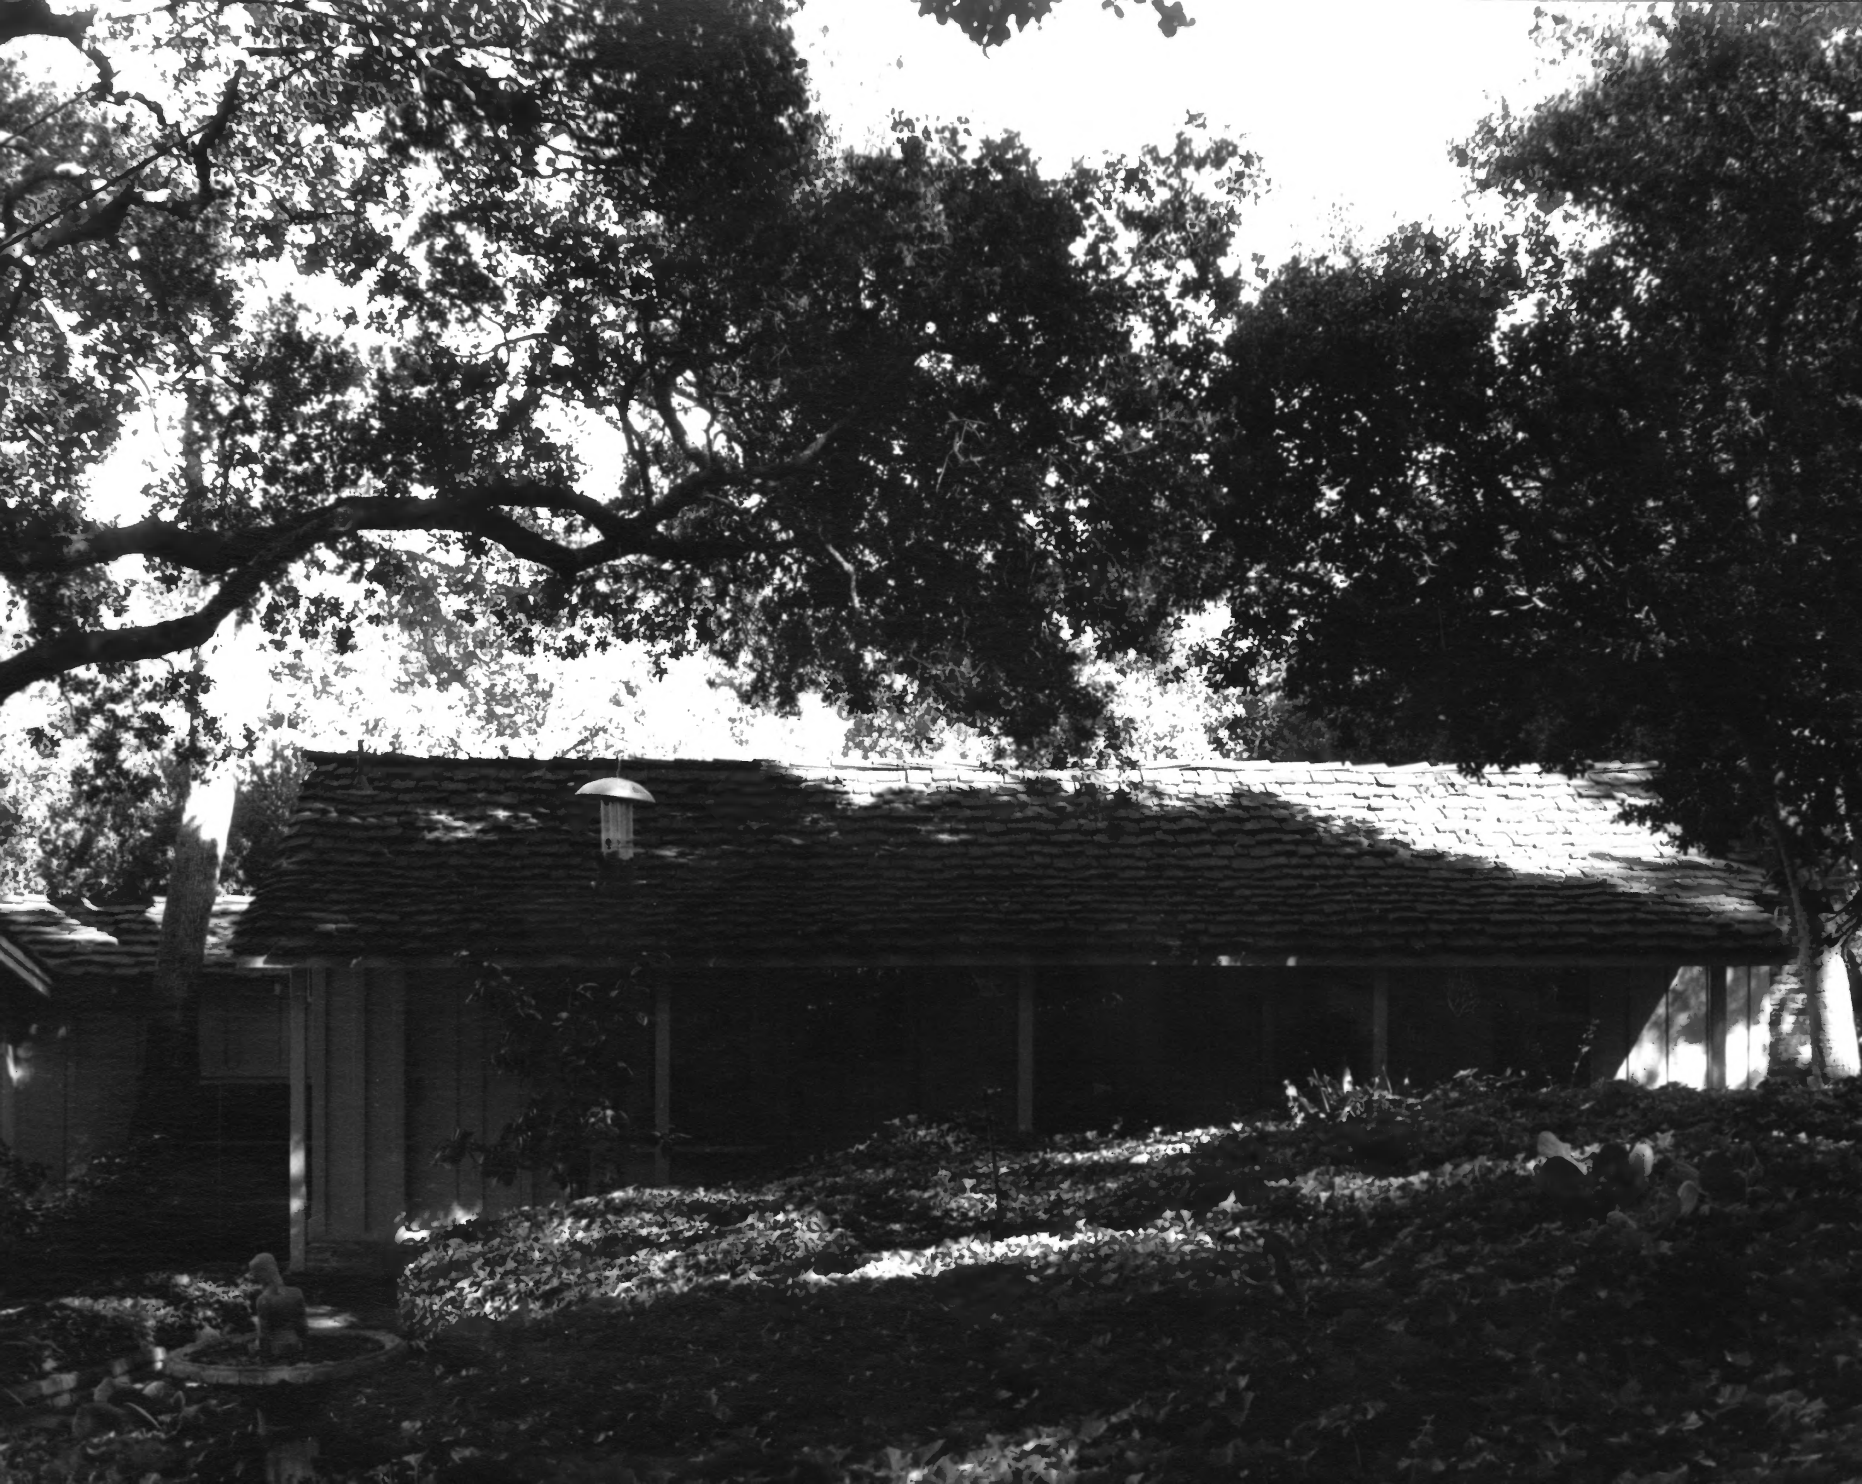
#15 guest house - E - SM # 8

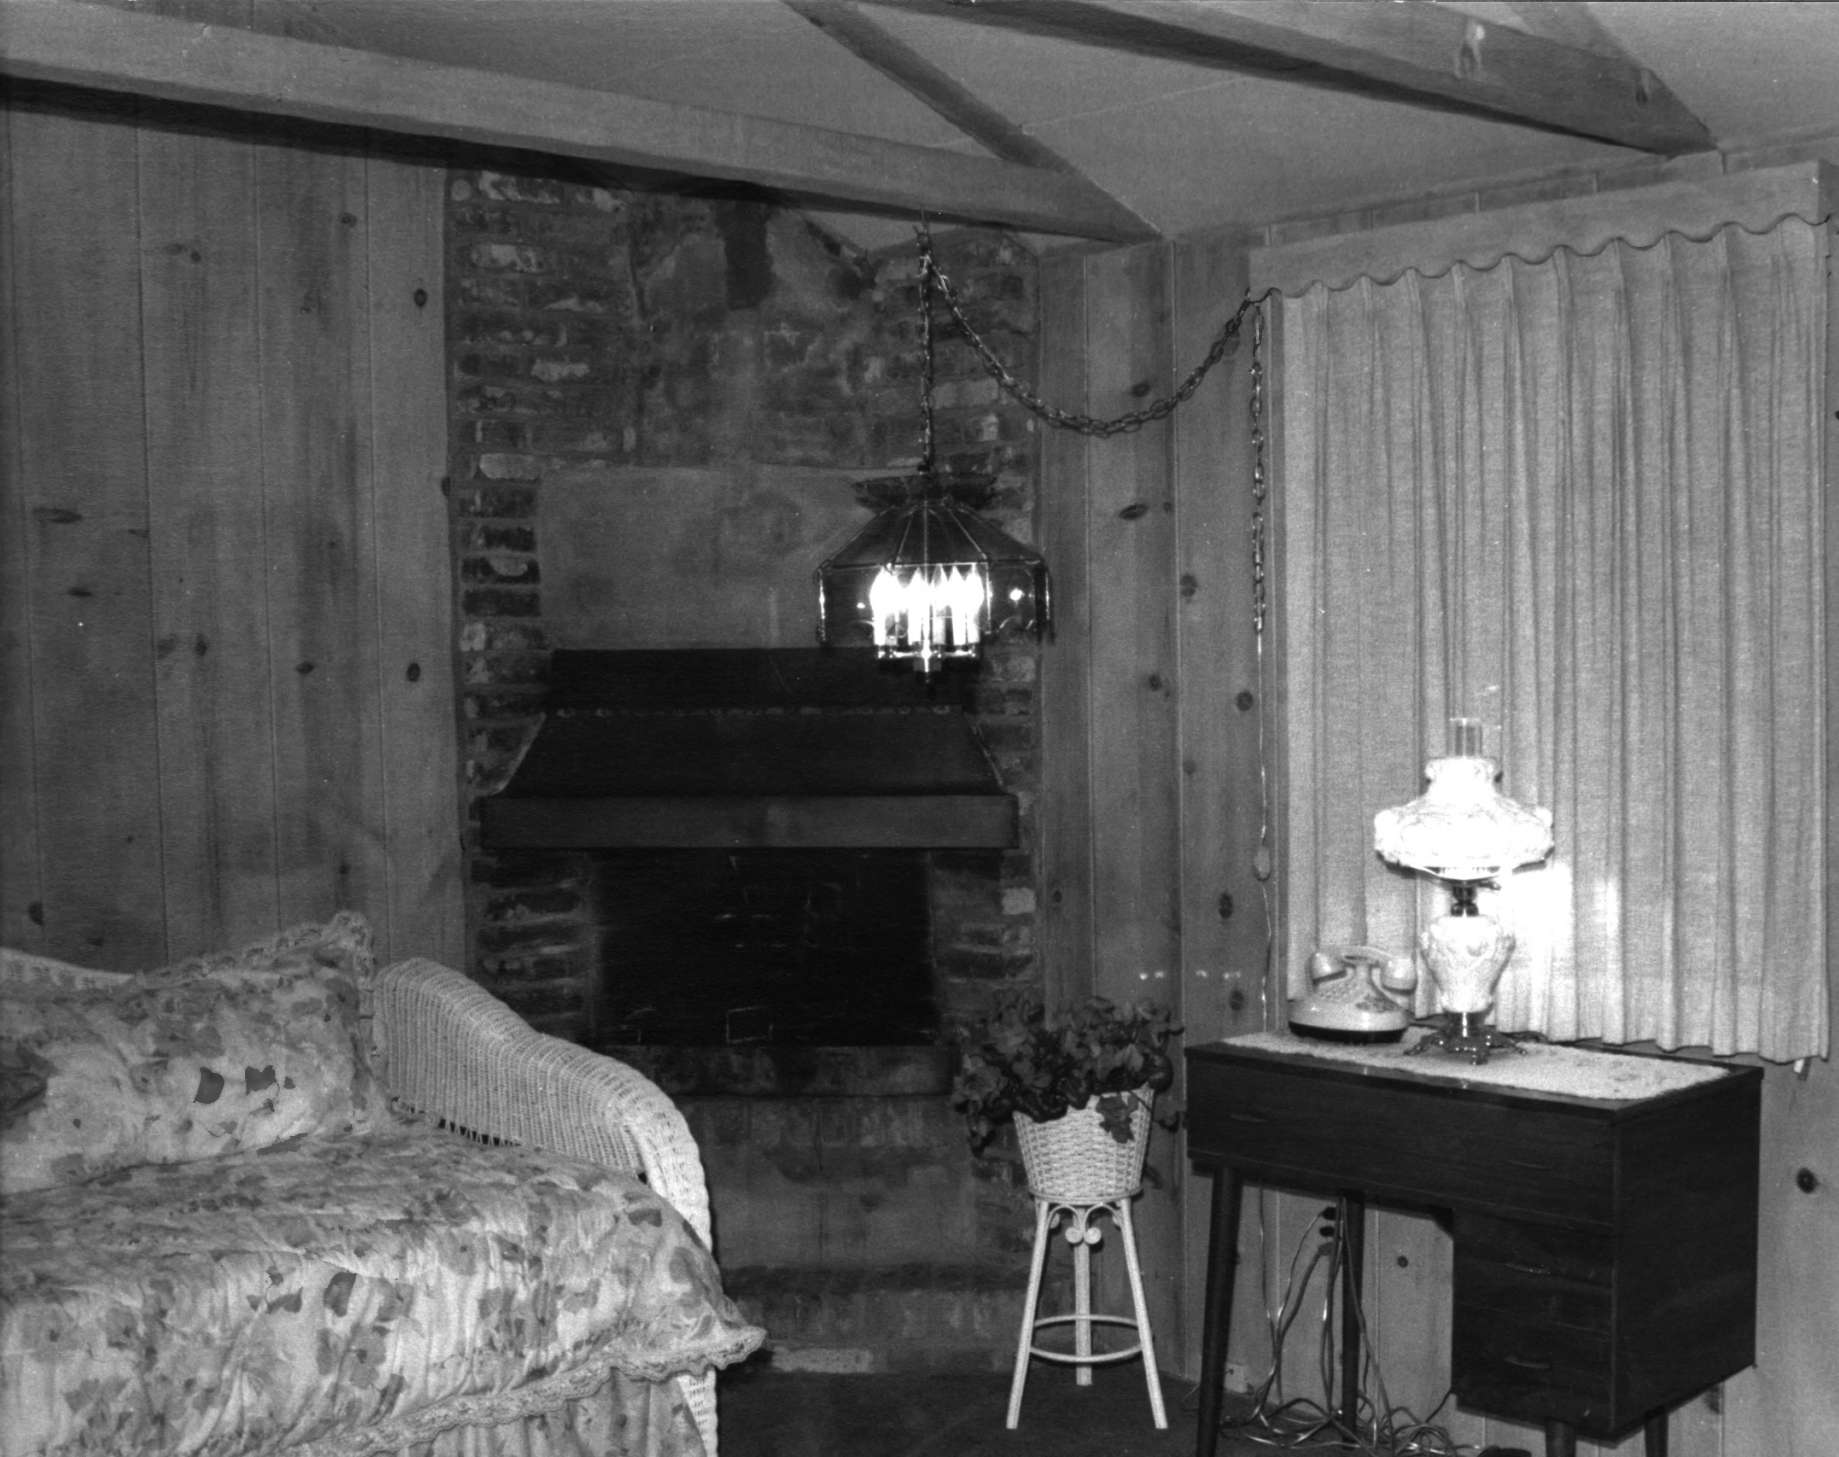
#16 guest house, bedroom #1 - SW - SM# 2a

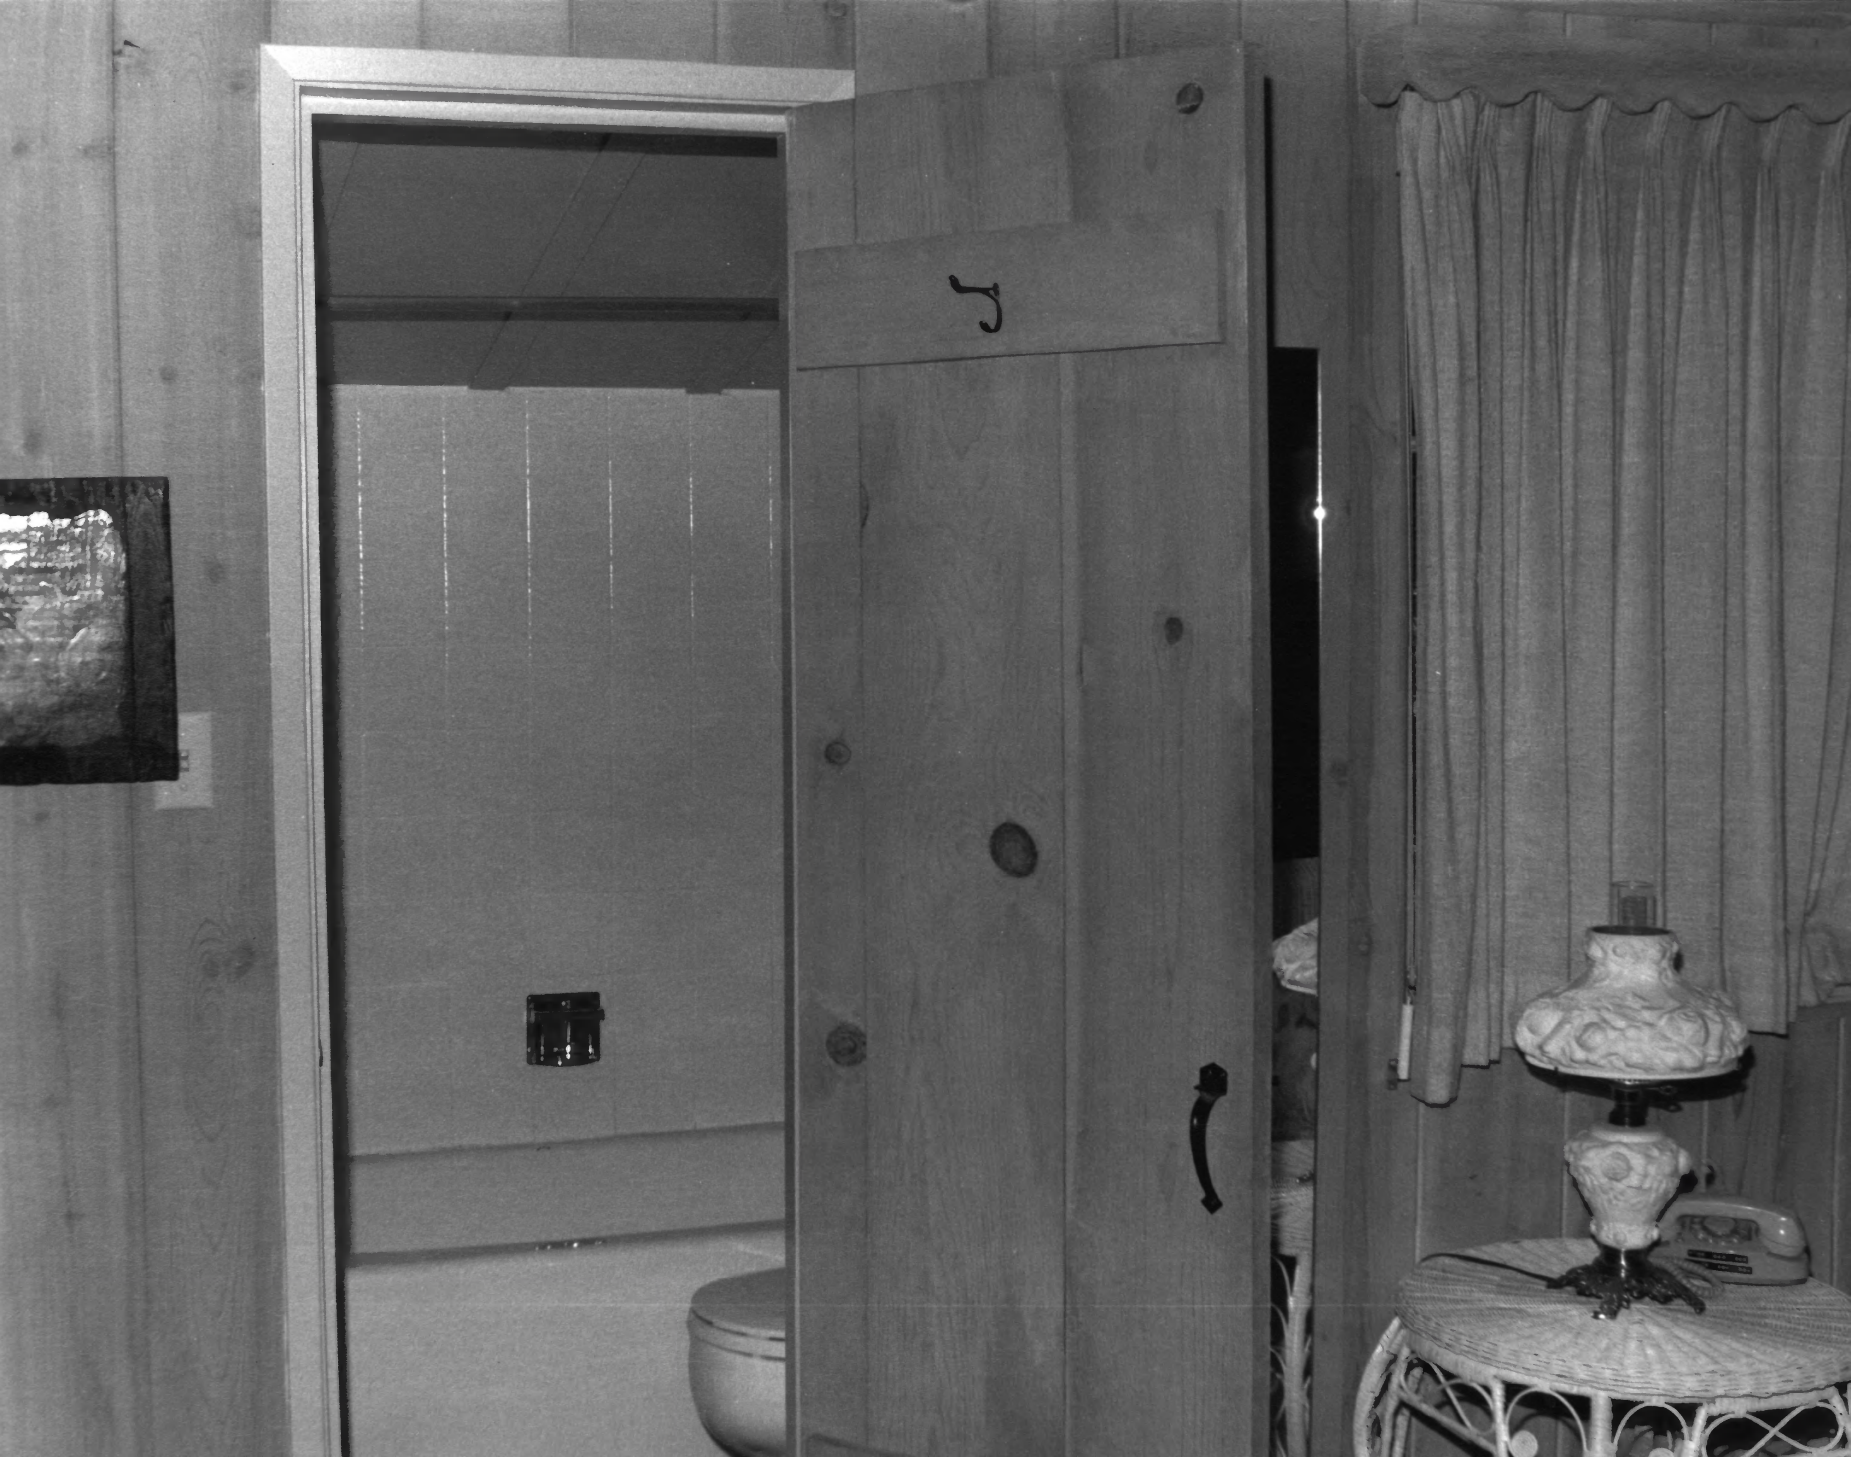
#17 guest house. kitchen converted to bathroom - SE - SMM# 86

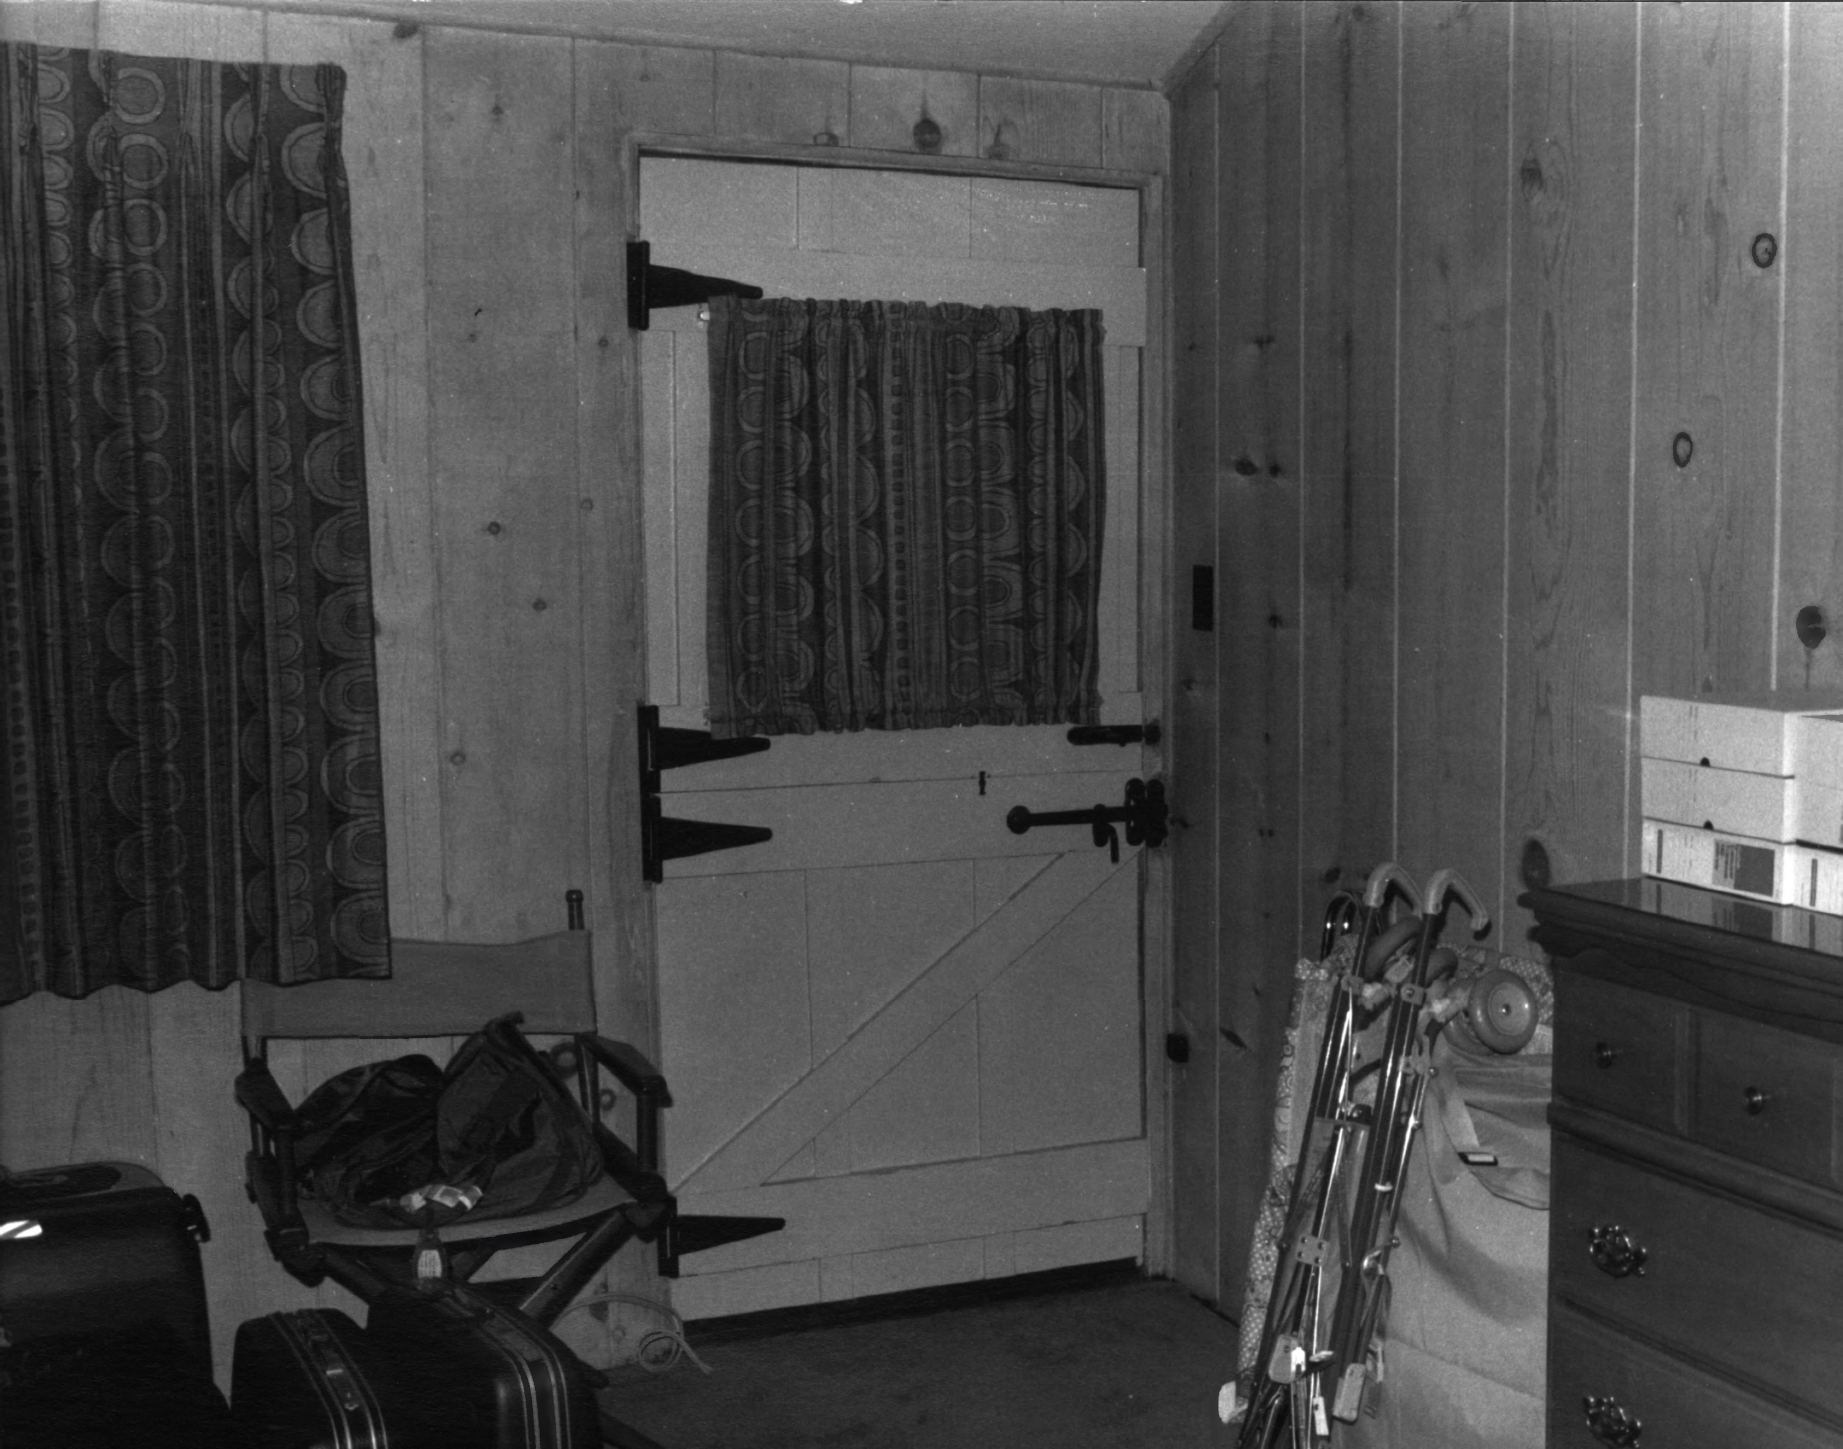
#18 guest house, bedroom #2 - NW - SM# 8c

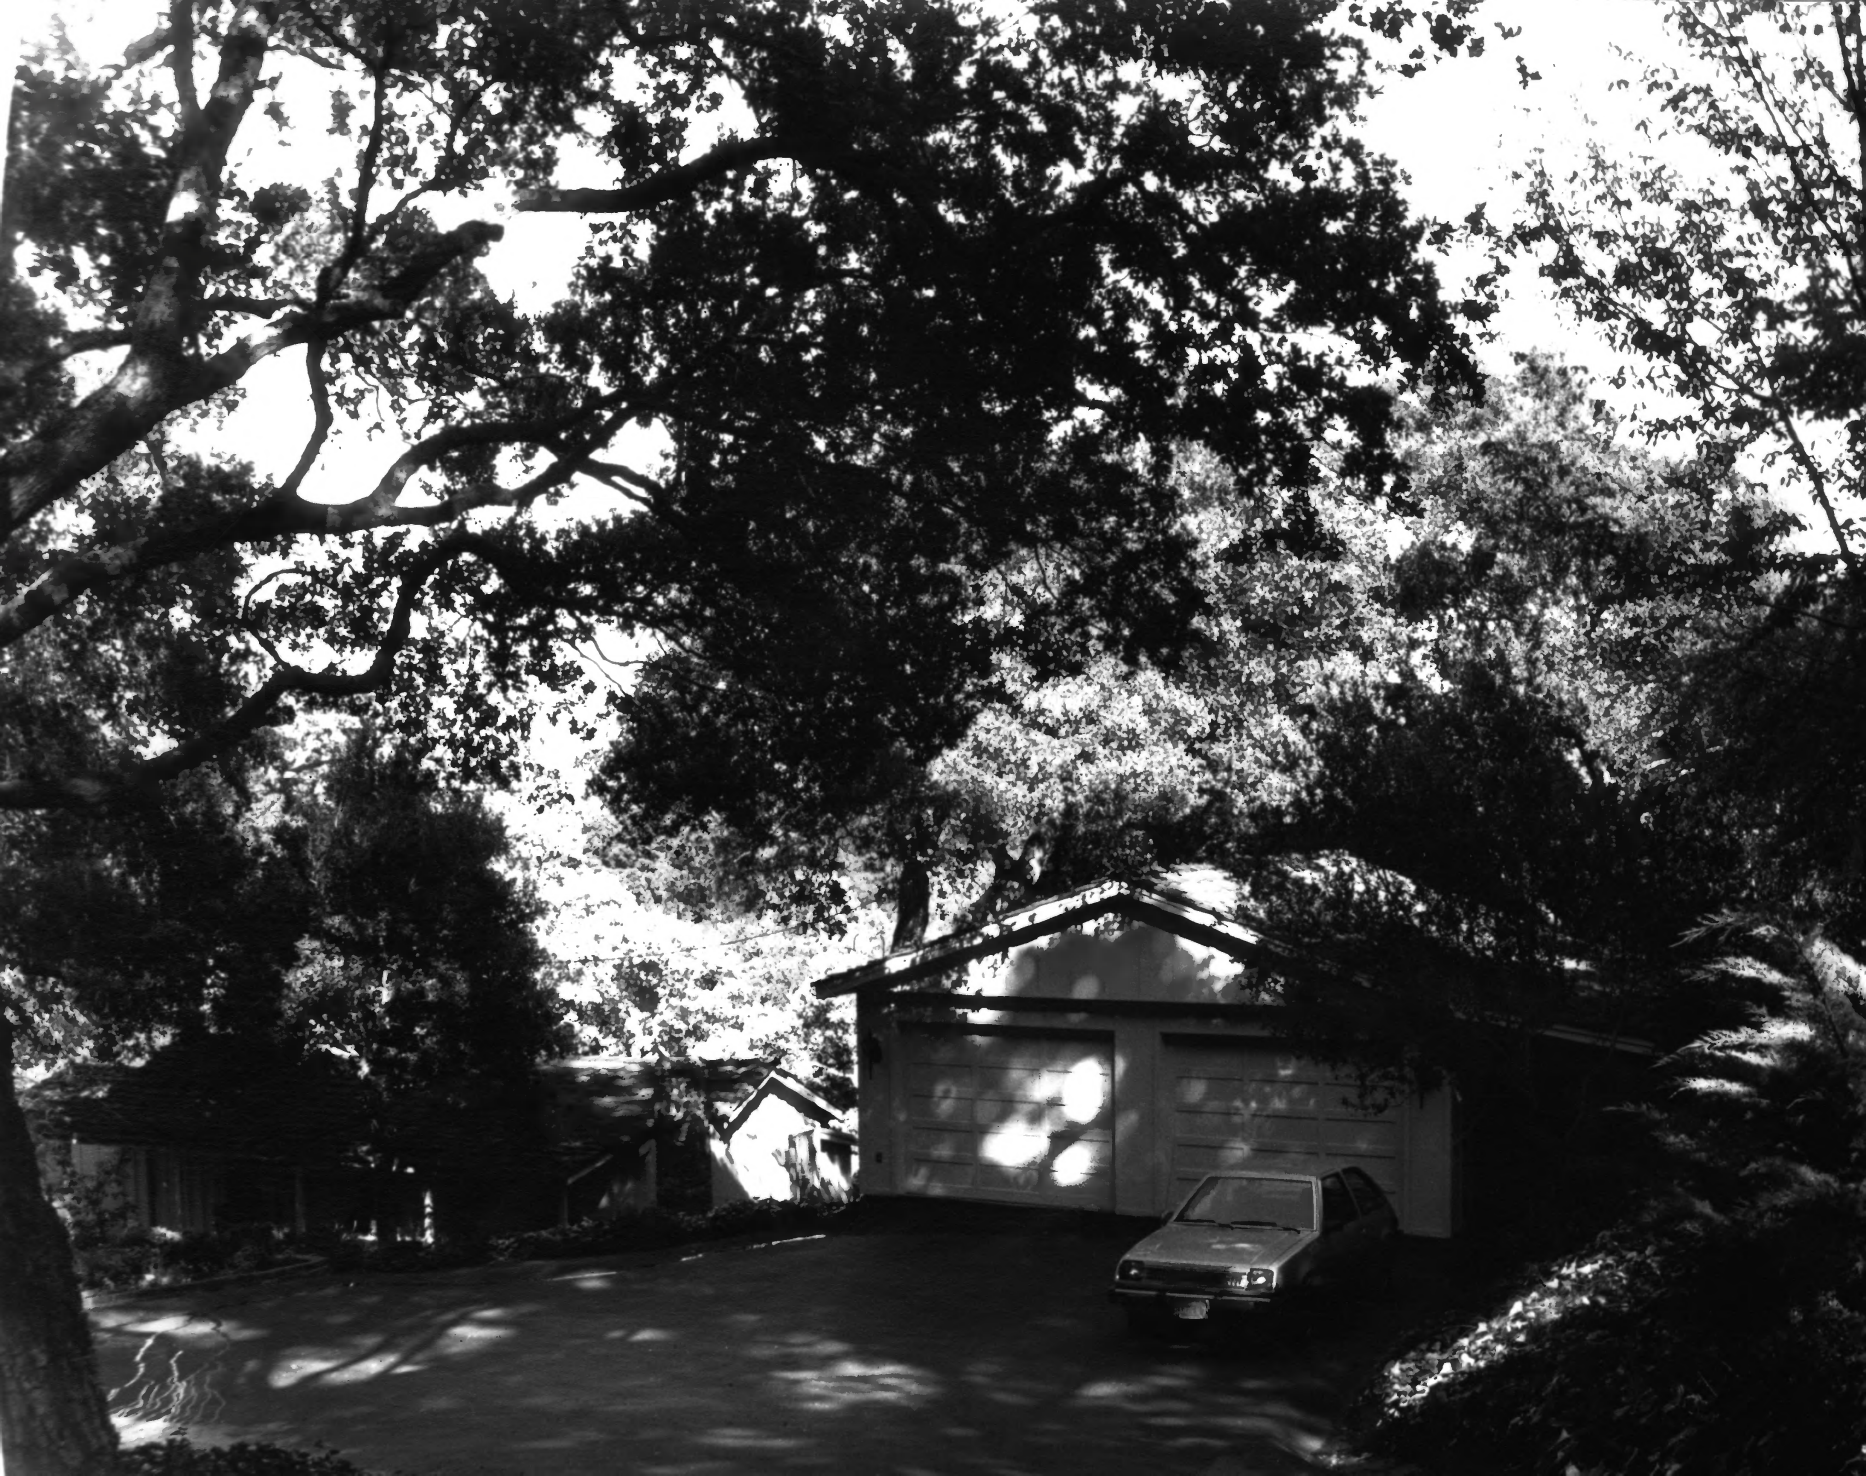
#19 carport converted to garage - NE - SM#9

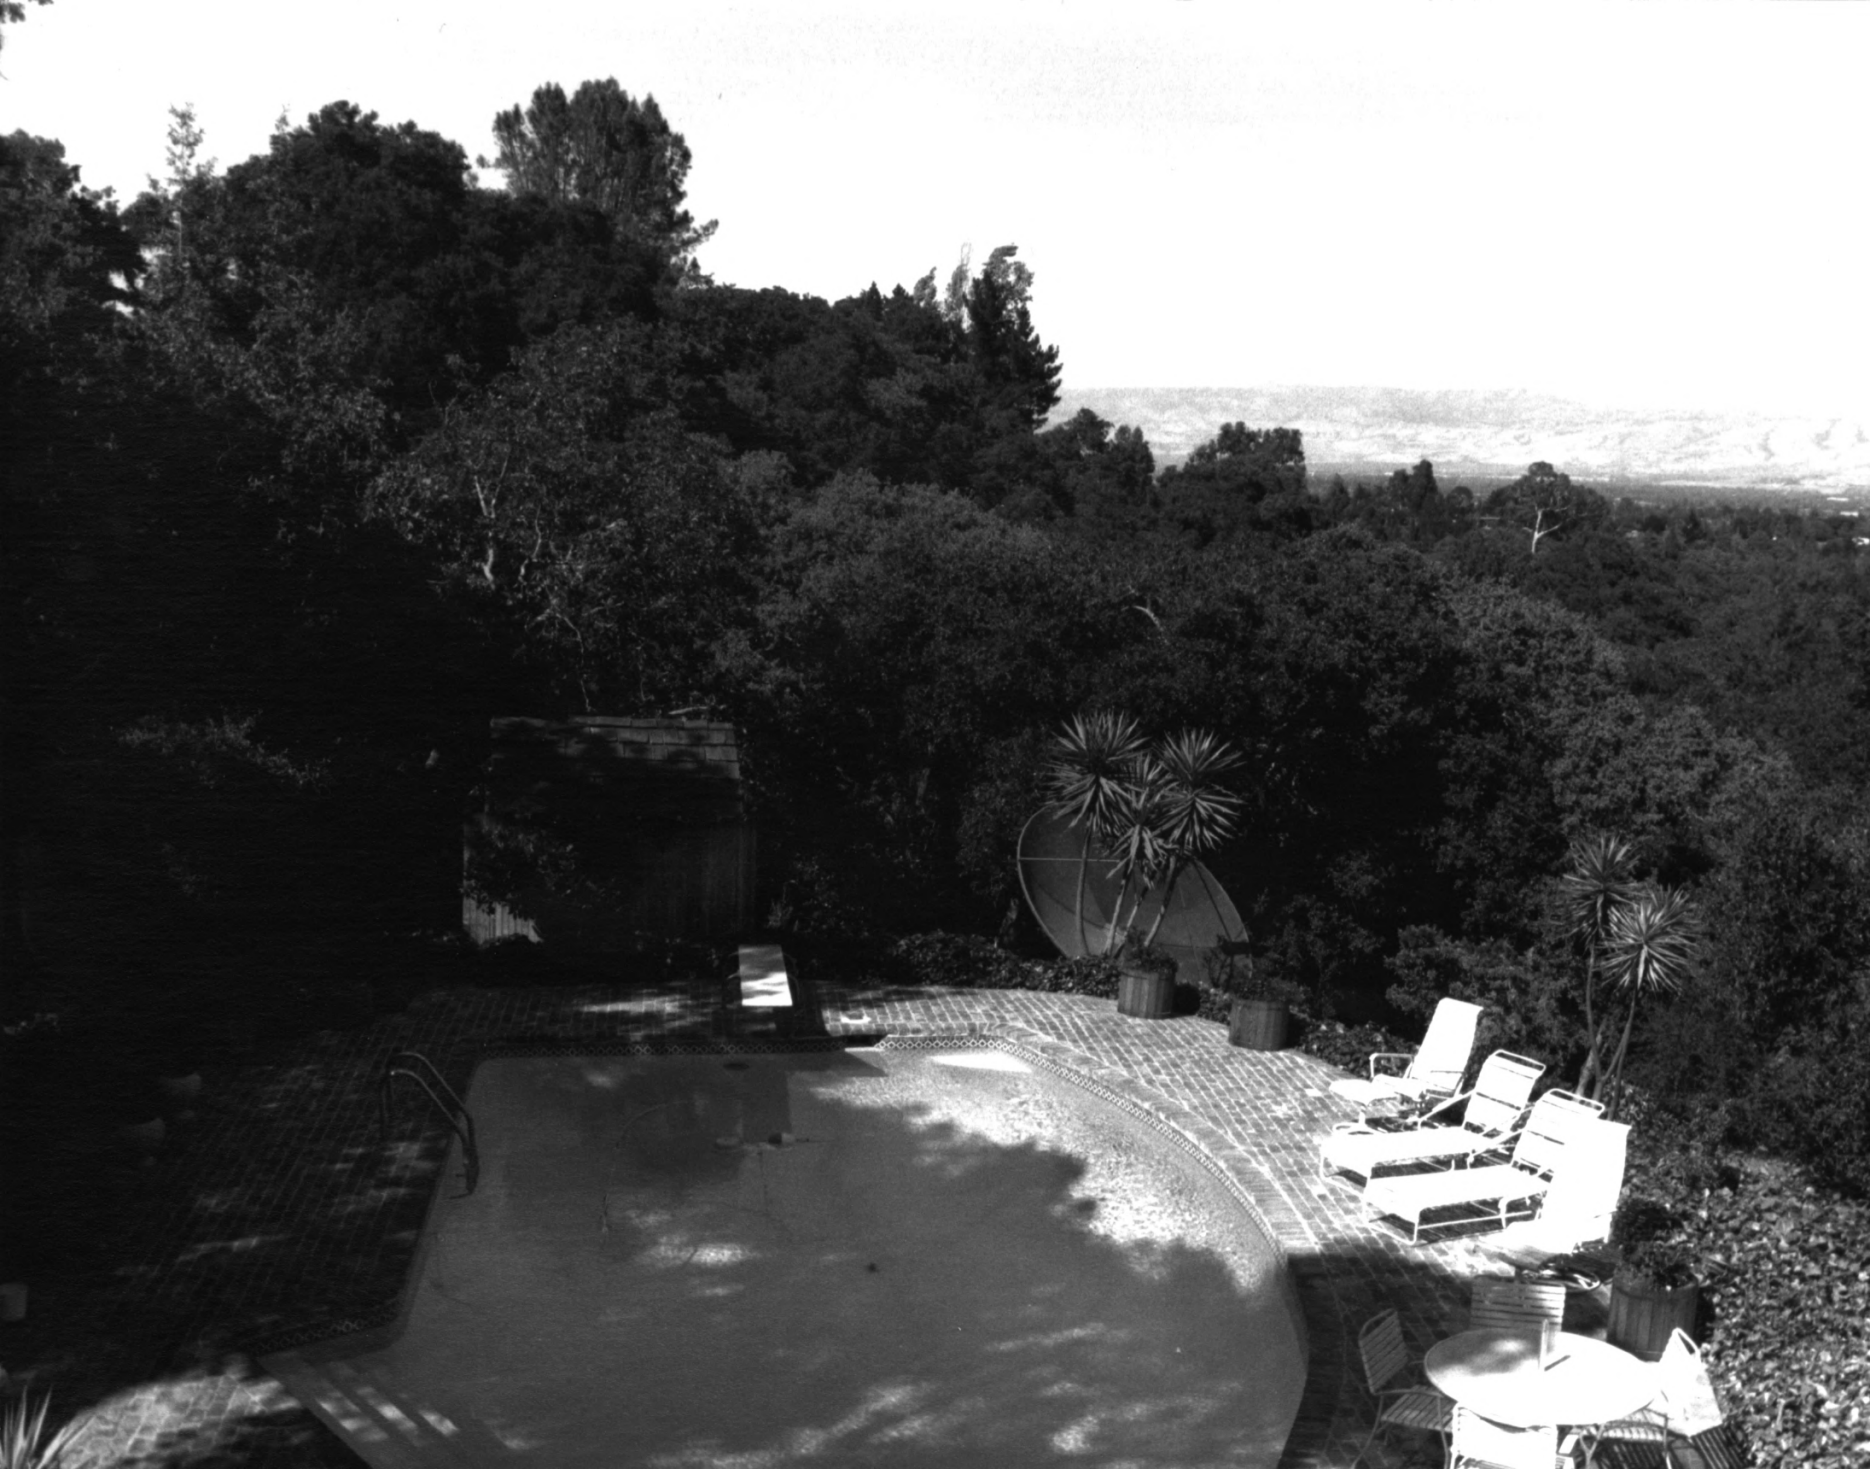
#20 gazebo converted to pool equipment enclosure - NW - SM# 10

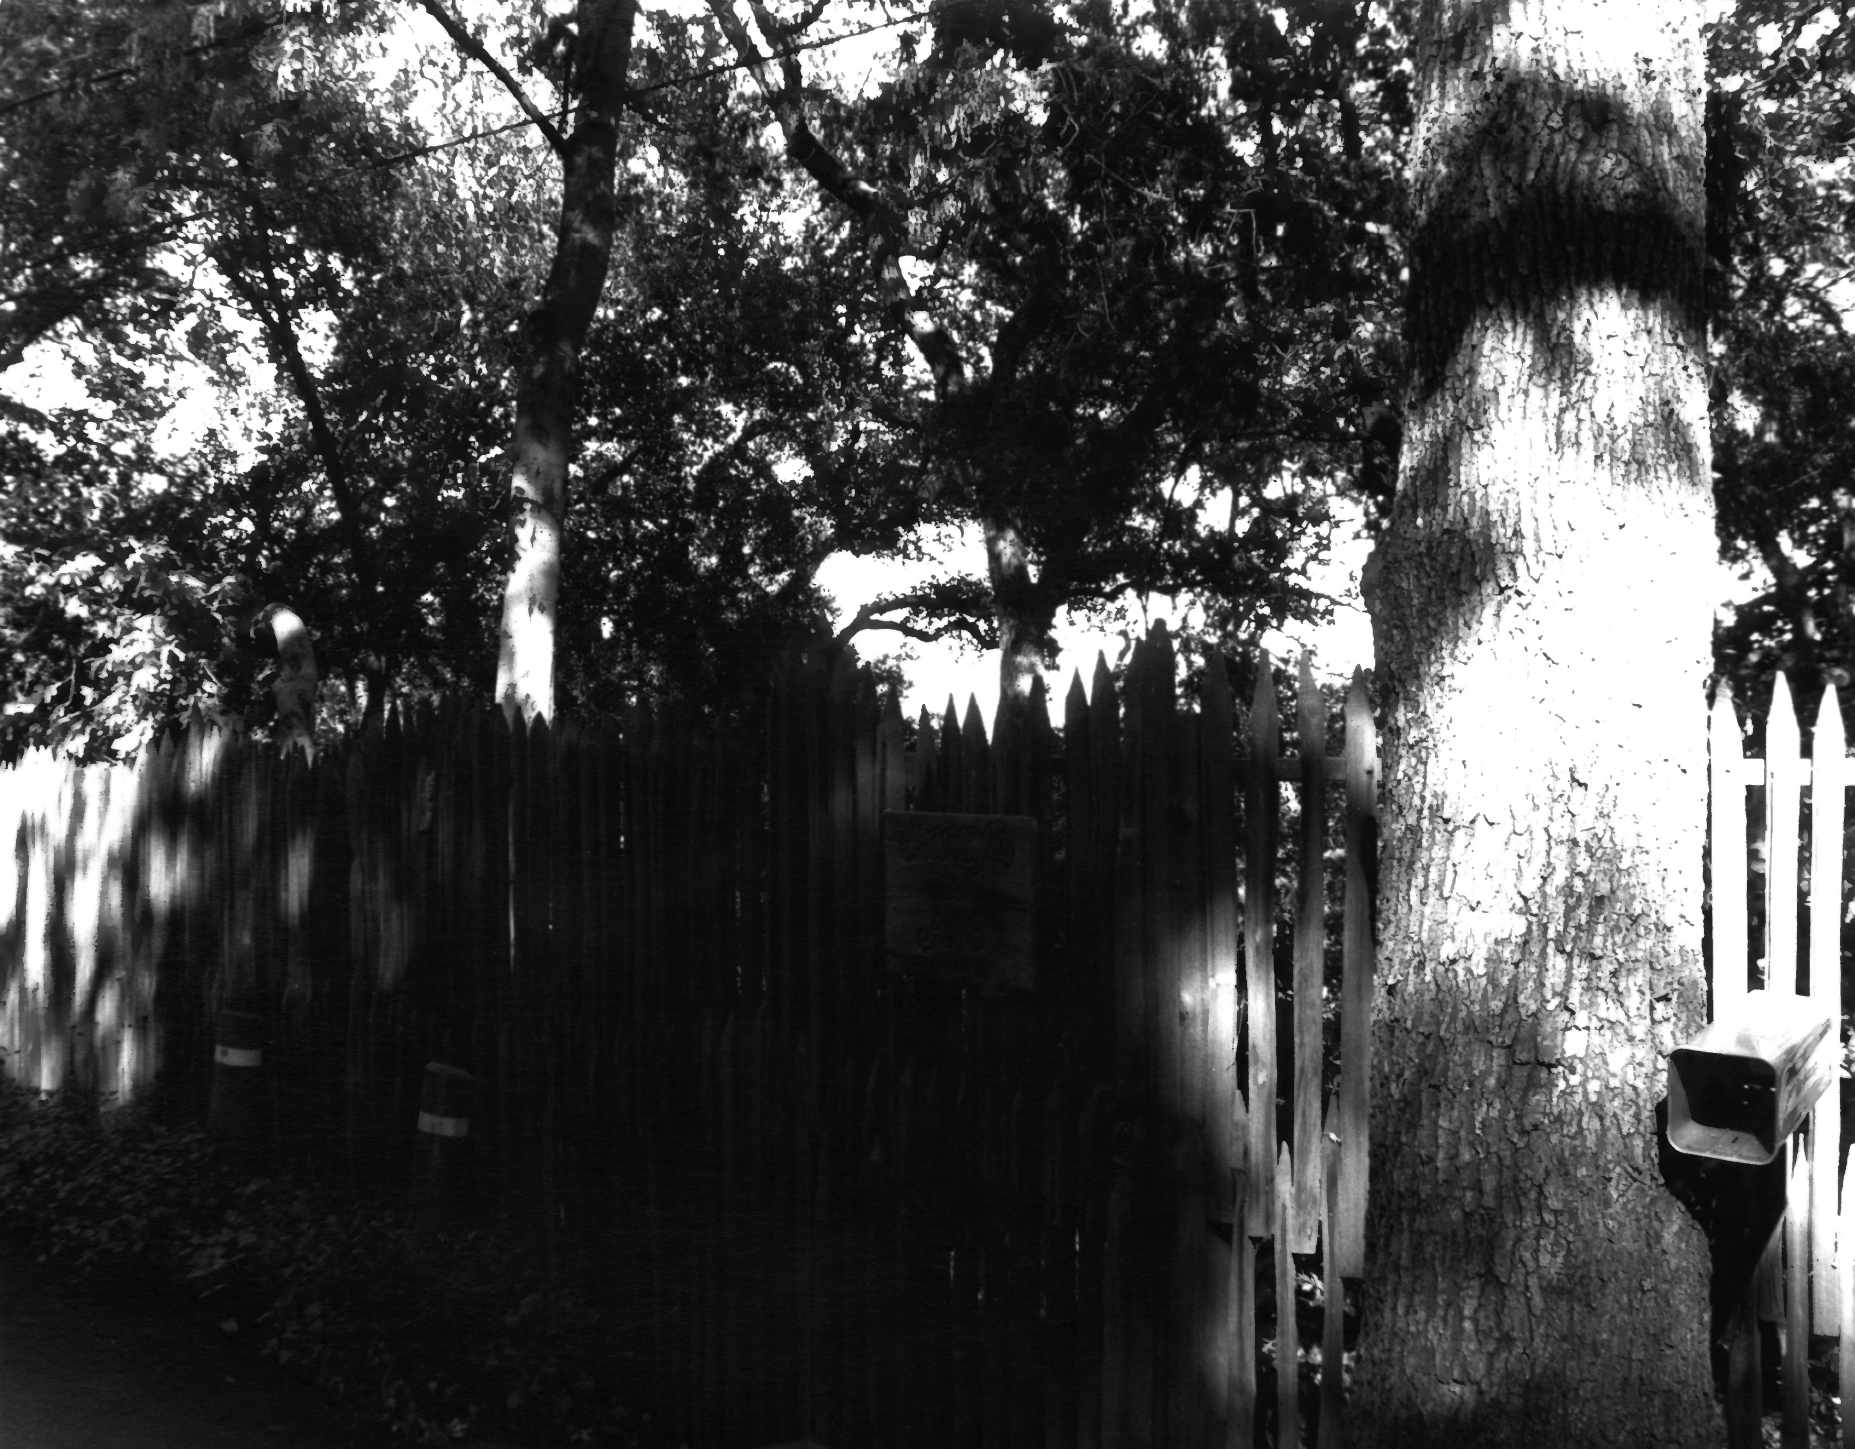
#21 entry gate with sign - NE - SM # L1
