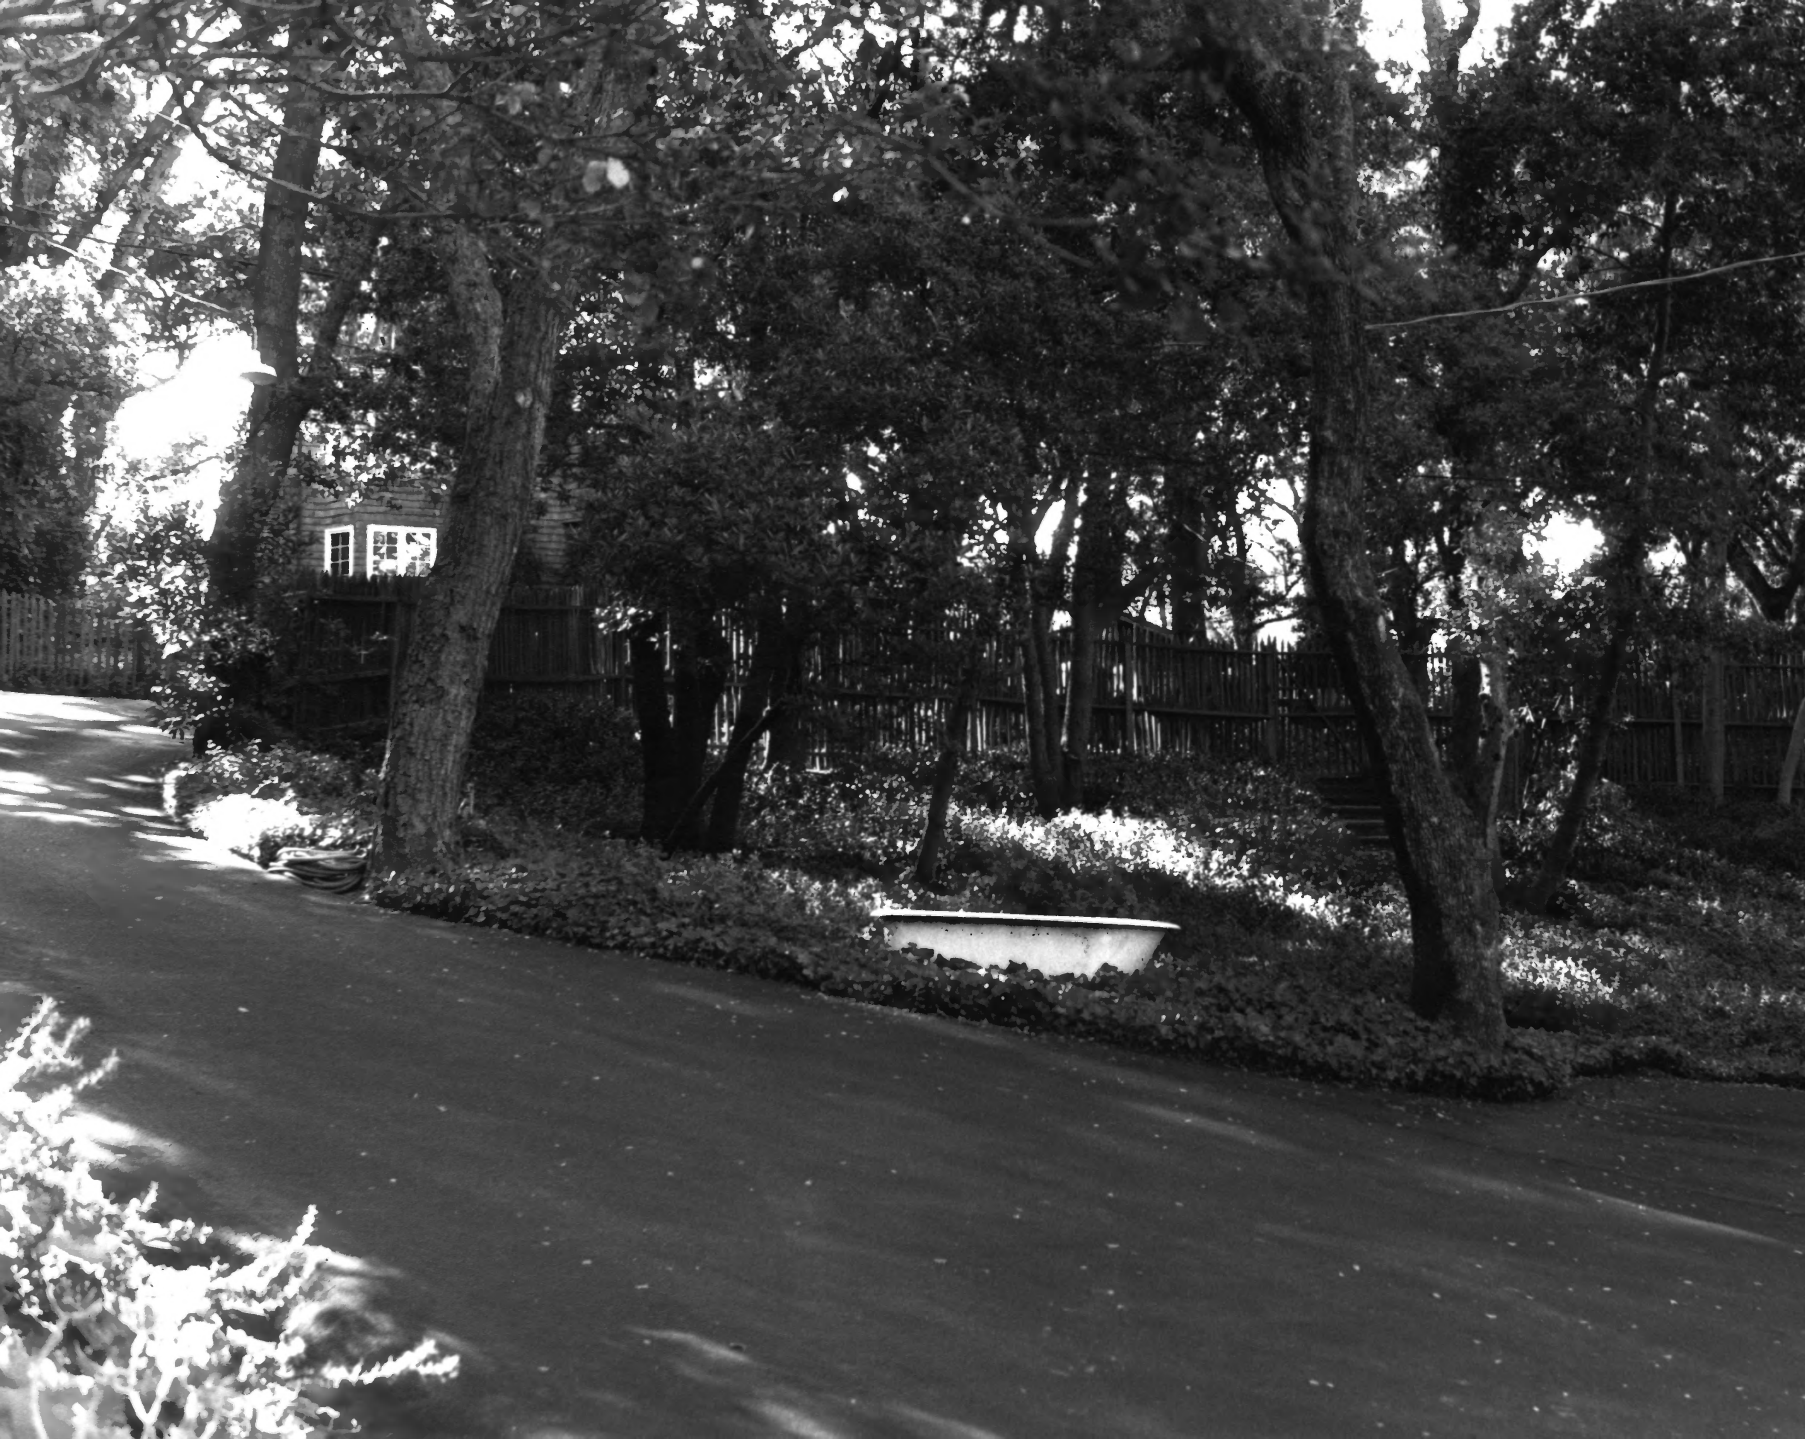
#23 grape stake fence: garage driveway - E - SM# L2
