NATIONAL REGISTER OF HISTORIC PLACES PROPERTY PHOTOGRAPH FORM

HISTORIC Hollenburg Pony Express Station

Cottonwood Station (Hollenberg Ranch Pony Express Station), Hanover, Kansas, Landmark Inspection, June 21, 1977

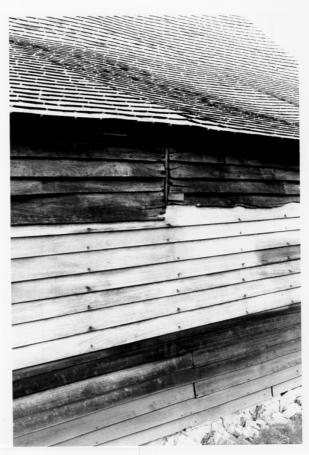
W exposure - Note variety of siding - cedar (?) lower, redwood - middle, original walnut - upper. Note deterioration of original siding as well as a sagging roof. This wall was apparently damaged in a hail storm a few years ago

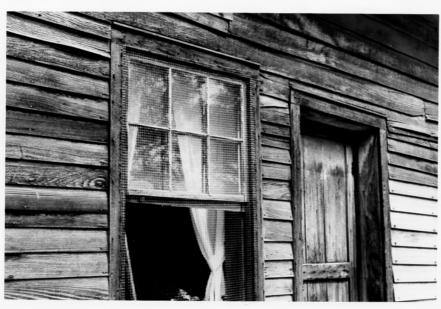
E exposure - detail of siding, window and door condition
