# PRE-PLANNING FOR THE MAJOR RENOVATION OF BUILDING 210

ASSET CONDITIONS  
ASSESSMENT AND ANALYSIS

PMIS #310907A

December 1, 2021

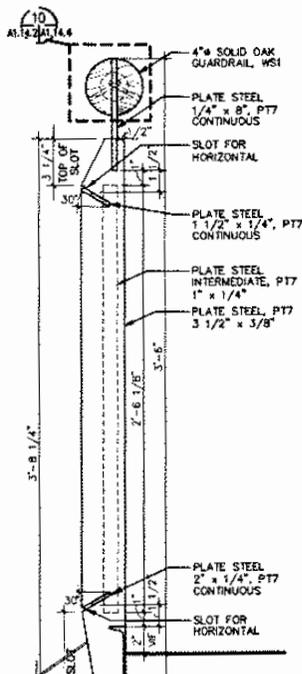
Components of the interior stairs are mostly in compliance with adopted local and DSC codes. However, the age of the building and loose construction tolerances can affect the tread and riser dimensions. Drawings of the stairs from the mid-1990s note the risers as 7-1/2 inches (+/-) and the treads as 10-12 inches (+/-). Both of these dimensions can be flagged as code violations, but are likely permissible because they are original to the building.<sup>5</sup> Guardrails were designed and documented at 42 inches in the 1990s drawings, but some were observed to be slightly less during the survey [Figures C-5 and C-6]. While guardrails are provided at the landings, only handrails are installed along the stair runs; guards are also required.<sup>6</sup>

[C-5] Typical guard at egress stair

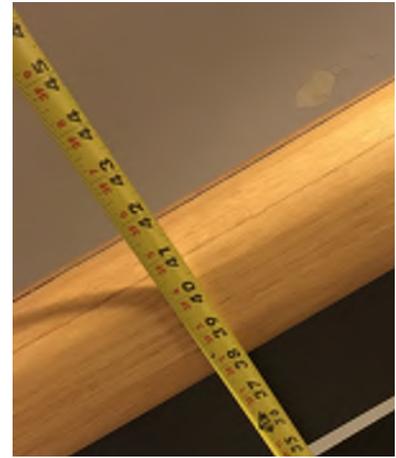
Guard height at upper level landing [C-6]

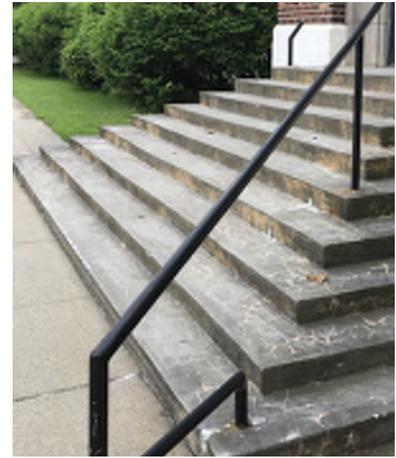
- Handrails are provided at the steps leading to the entry door. The treads and risers are non-compliant.<sup>11</sup> A similar condition exists at the rear Park Police entrance.

Loose and missing handrails [AC-4]

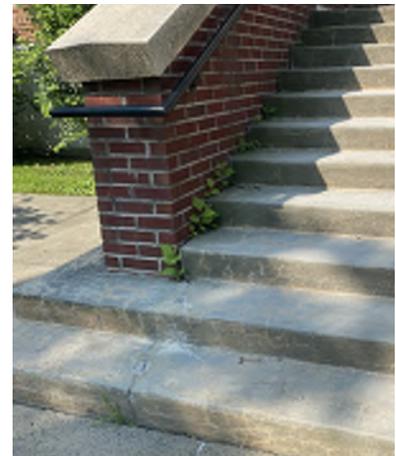
Handrail terminates above base landing [AC-5]

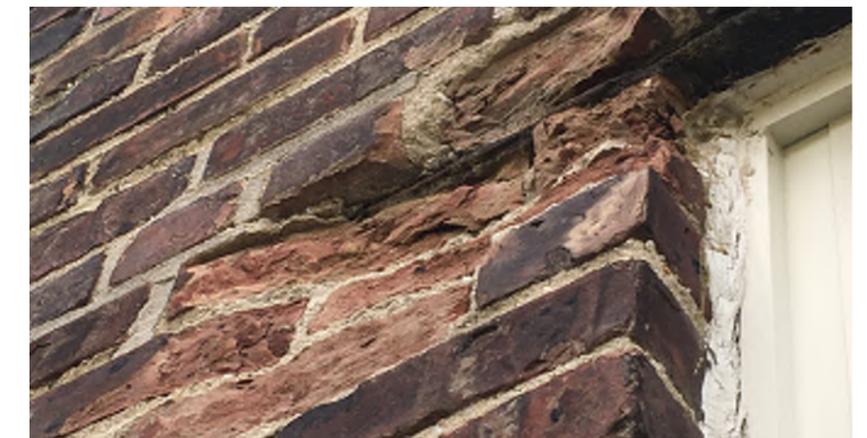
[A-3] Split and spalled exterior brick

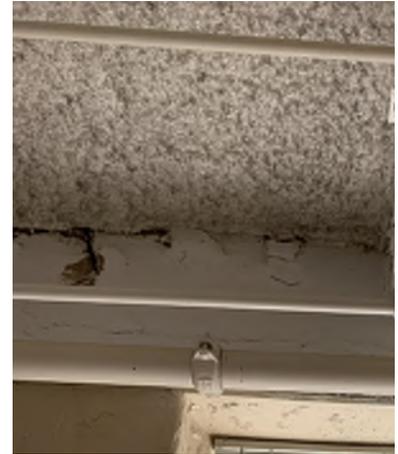
Spray insulation at underside of roof [A-4]

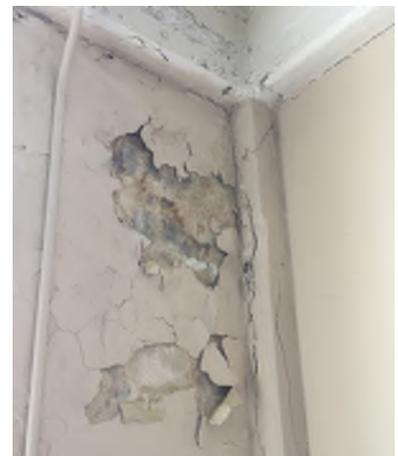
Damaged cementitious parging [A-6]

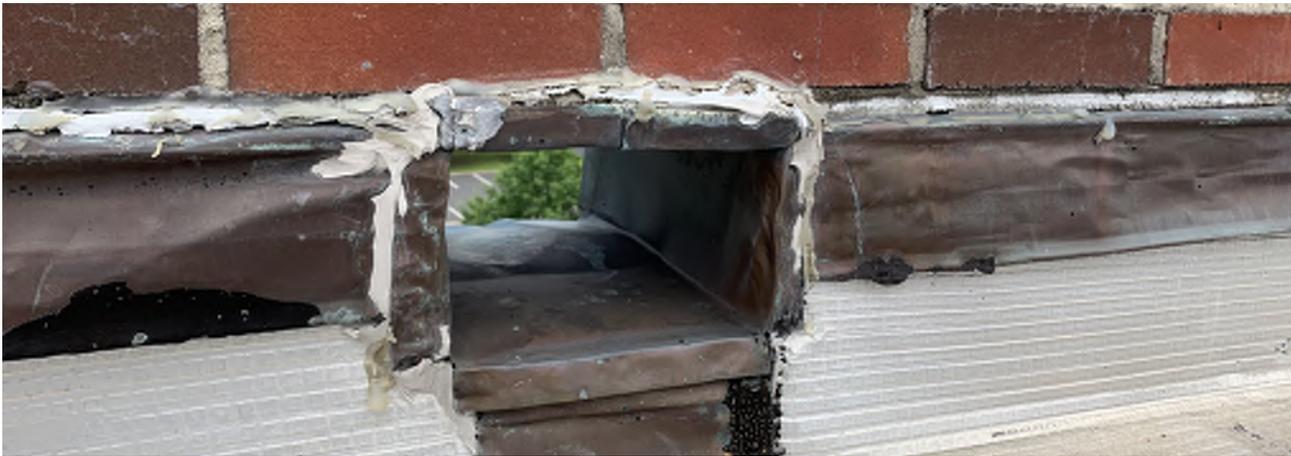
[A-7] Attempted repair at damaged through-wall scupper

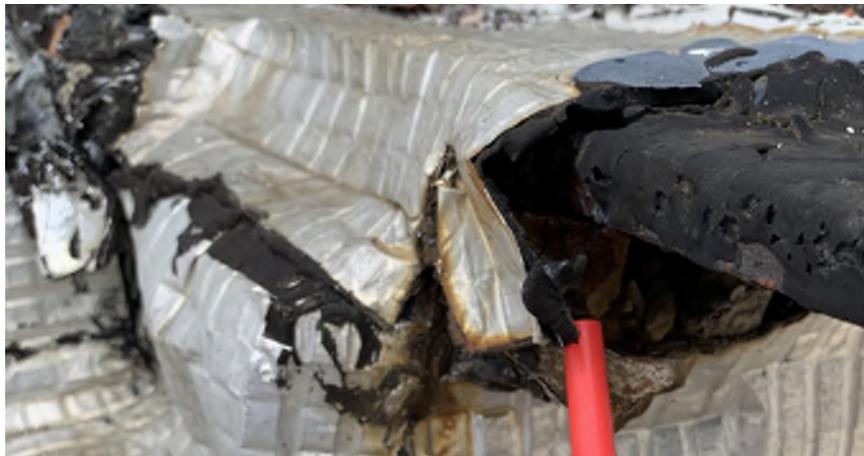
[A-9] Failed transition wrap at roof penetration flashing

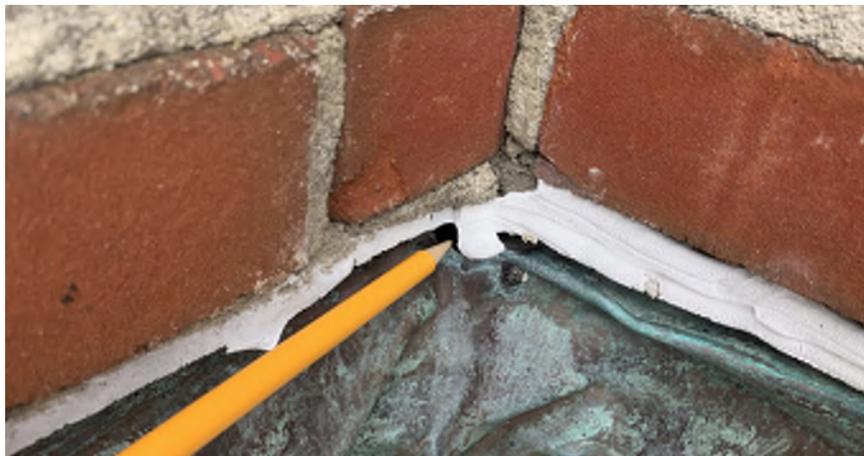
[A-11] Failed sealant joint atop counterflashing

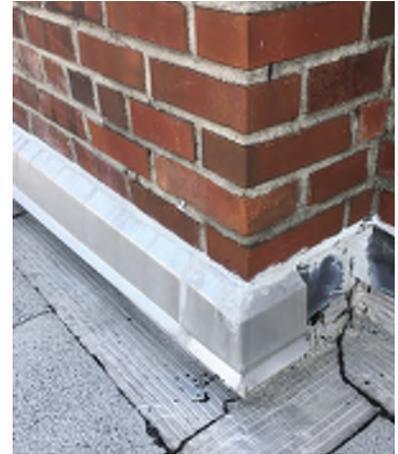
Where the roof finish turns upward onto the interior side of the parapet walls, a copper counterflashing is provided as a termination. The counterflashing has a patina and is punctured at several outside corner conditions [Figures A-8 to A-11]. Details in the parapet reconstruction drawings from the 1990s show a through-wall flashing integrated into the counterflashing and extending to the exterior wall face. Unfortunately, because of the compromised counterflashing conditions, the through-wall piece is not preventing infiltration. Segments of flashing along the northeast, north, and northwest parapet walls have been replaced with what appears to be aluminum [Figure A-12].

Aluminum counterflashing [A-12]

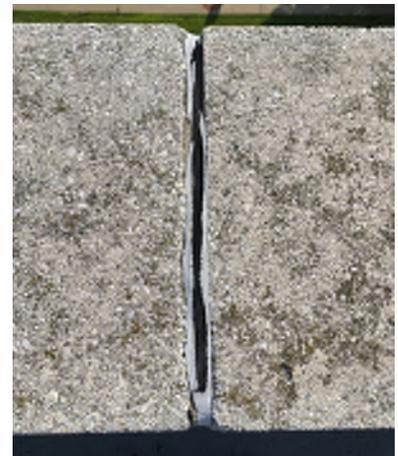
Further up the parapet walls sit cast stone copings. Where the parapets are still of original construction, there is no bond break or flashing below the caps. Flashing was added to those segments repaired in the 1990s. Because brick is clay-based and cast stone is cement-based, the two (2) materials have different expansion and contraction properties. The differential movement causes the bonding mortar to crack and delaminate. Sealant joints between cap segments have failed, so water is flowing into the failed joints, bypassing the cracked mortar, and then absorbing into the wall below [Figure A-13]. From here, the freeze/thaw cycles lead to the deterioration discussed previously.

Failed sealant at coping stones [A-13]

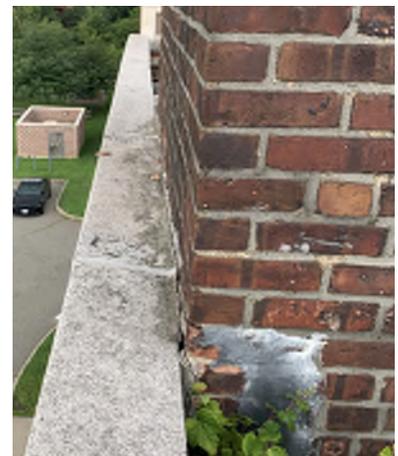
Damaged cementitious parging [A-14]

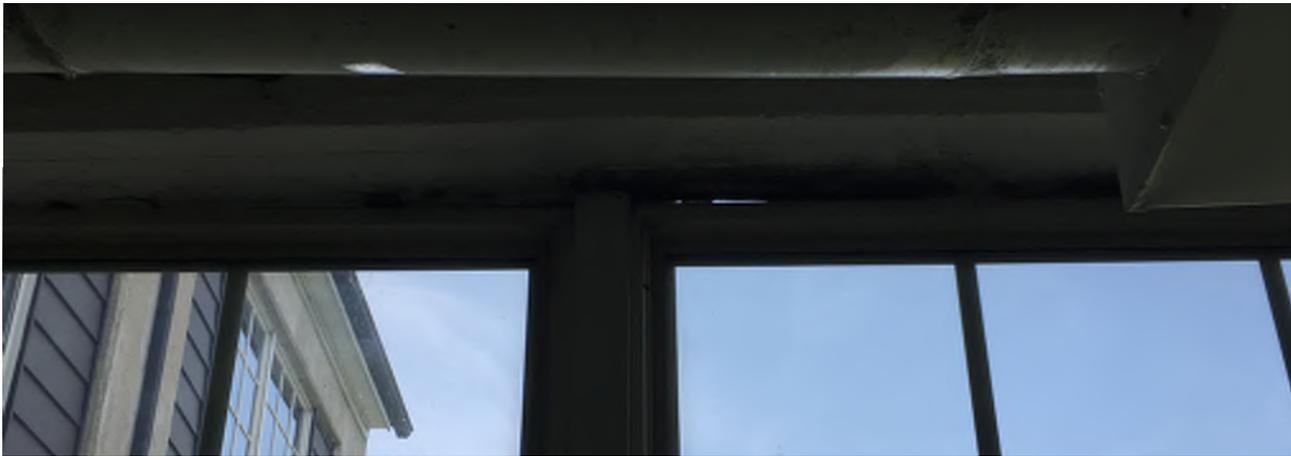
At Levels 2 and 3, the wood-framed infill at the west-facing “porches” is failing in several locations. Two (2) specific locations at Level 2 are of primary concern:

[A-15] Visible daylight and wood-framed infill

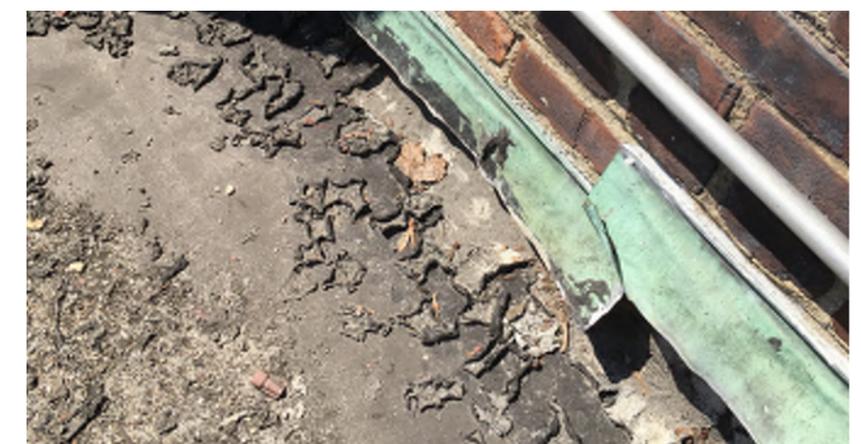
[A-20] Compromised built-up roof finish

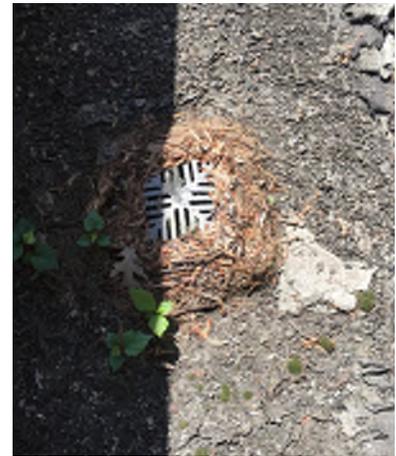
Obstructed roof drain [A-21]

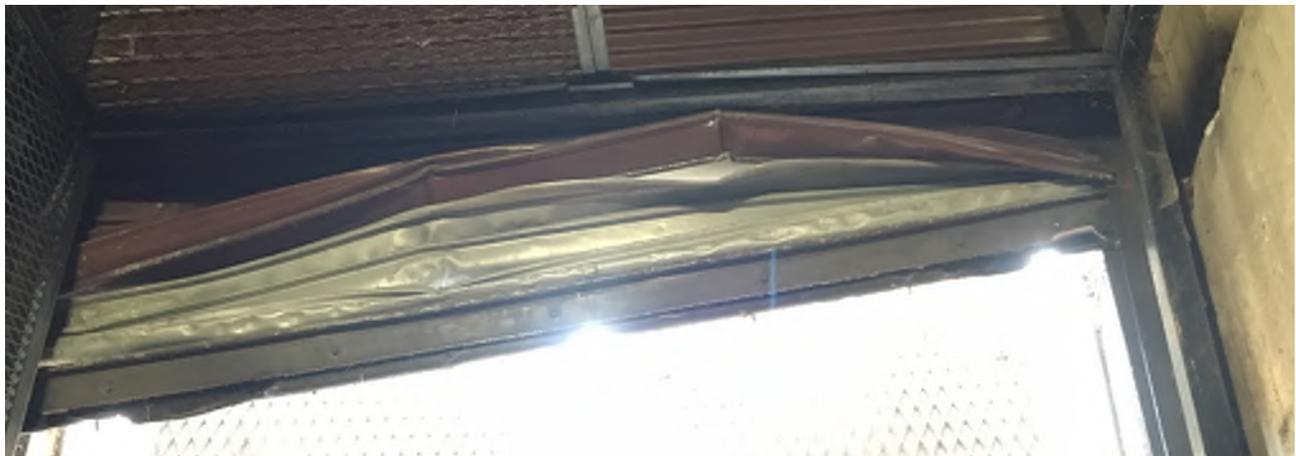
Damaged elevator shutter [A-23]

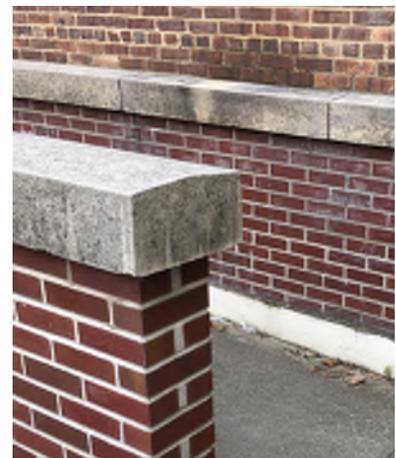
Dissimilar brick color [A-27]

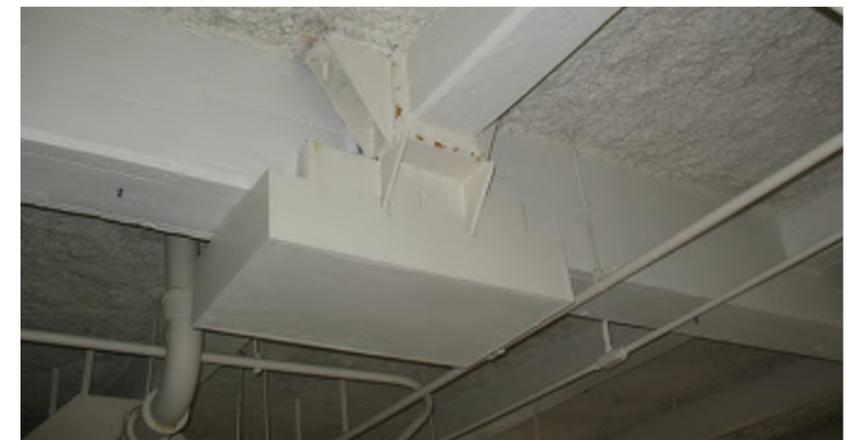
[S-5] Hanger assembly, Level 3

In 1977, eight (8) columns between Level 3 and the roof were removed. Structural steel wide-flange girders, exposed to the elements, were installed to support the roof from above. They are supported by bearings over existing columns, or bear directly on the exterior brick walls above perimeter columns. Threaded steel rod hangers attached to the bottom flanges of the girders extend down through pitch pockets and the roof slab to steel saddles which support the roof beams and girders where columns were removed. The girders are nominally 24 to 26-inches deep and their bottom flanges are approximately 8 to 16-inches above the roof surface. Supplementary wide-flange beam and steel angle framing provides lateral bracing for the girders [*Figures S-3 to S-7*].

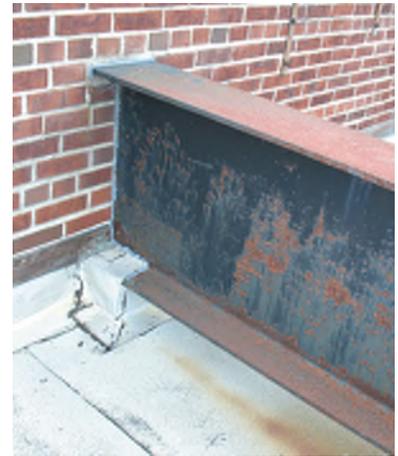
*Steel bearing condition and corrosion [S-6]*

The original coating on the steel framing installed in 1977, and on the mechanical equipment platforms, has mostly or completely failed. Surface rust with moderate pitting and flaking was observed at all locations. The loss of coating and corrosion is most pronounced on the horizontal surfaces of member flanges where rainwater ponds [Figures S-6 to S-9]. Note that the corrosion process is active and ongoing.

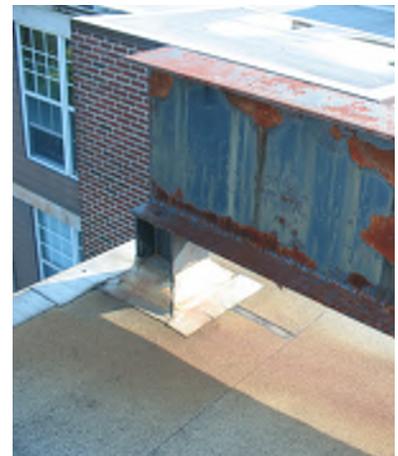
*Steel bearing condition and corrosion [S-7]*

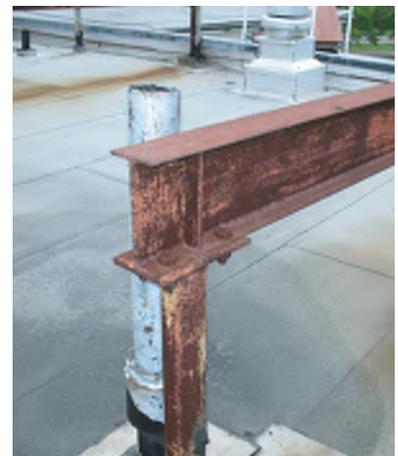
*Equipment structure corrosion [S-9]*

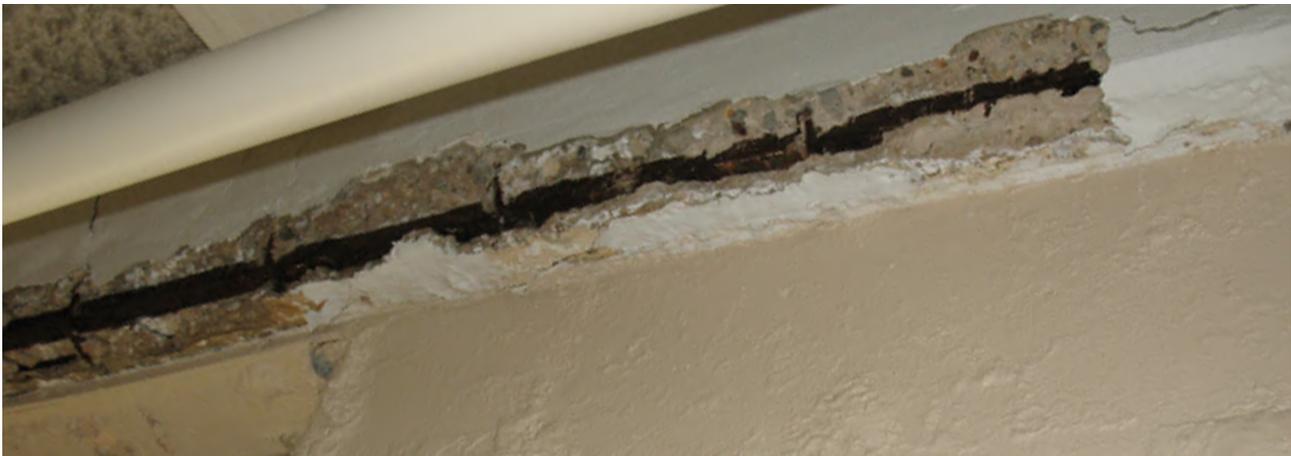
[S-11] Concrete girder deterioration at C/D, grid 1

- Roof Girders along grid line “1,” between grid lines “B” and “D”
  - Steel corrosion noted on the girder between lines “B” and “C” has advanced to the point of delamination and partial loss of cross section [Figure S-10].
  - Cracks observed along the bottoms of these members may also indicate a partial loss of concrete bond along the reinforcing bars [Figure S-11].
- Roof Beam along grid line “B,” between grid lines “5” and “6” [Figure S-12]

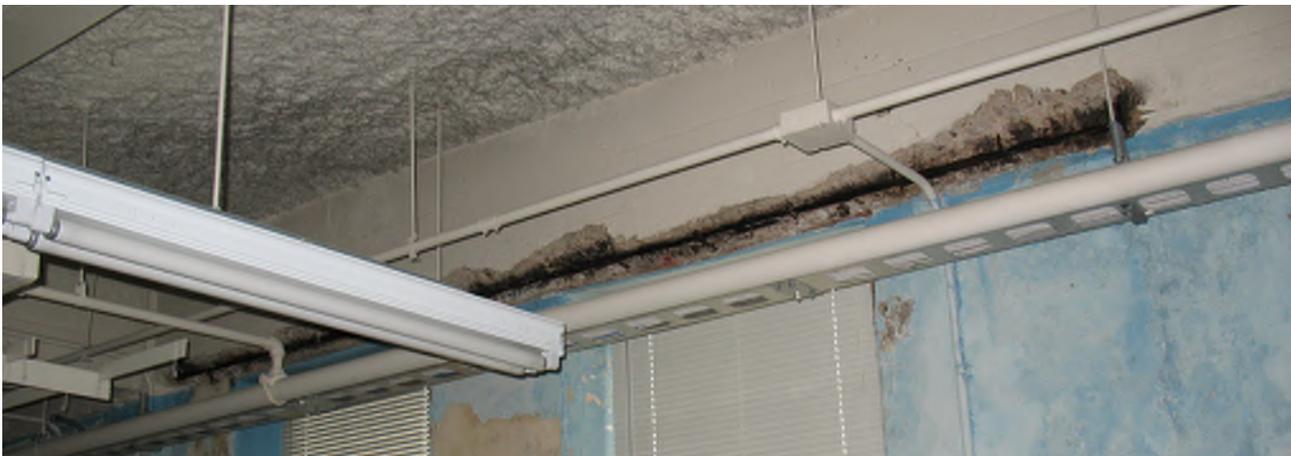
[S-12] Concrete beam deterioration at 5/6, grid B

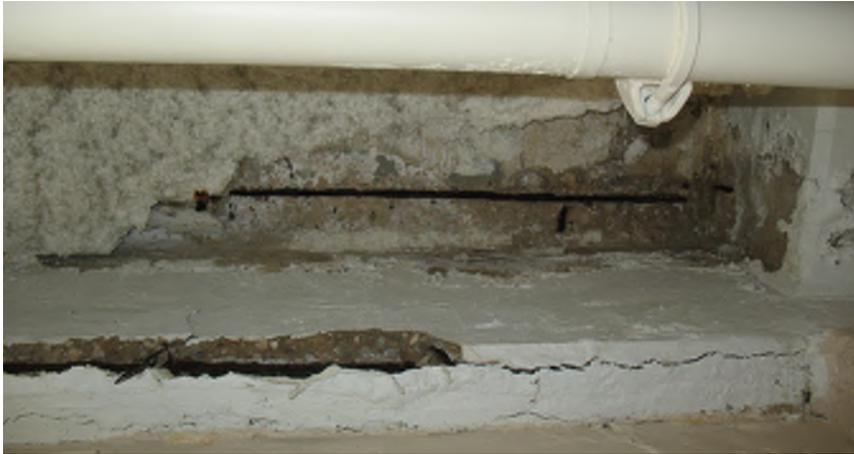
Concrete roof slab spall, corroded reinforcement, and beam cracks [S-13]

- Spalling with exposed and corroded reinforcing steel were noted at several locations
  - Roof slab [Figure S-13]

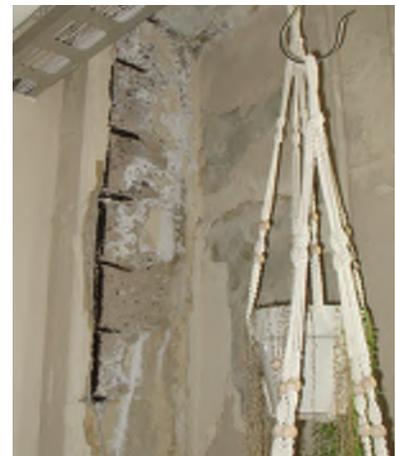
Spall with exposed and corroded reinforcement [S-15]

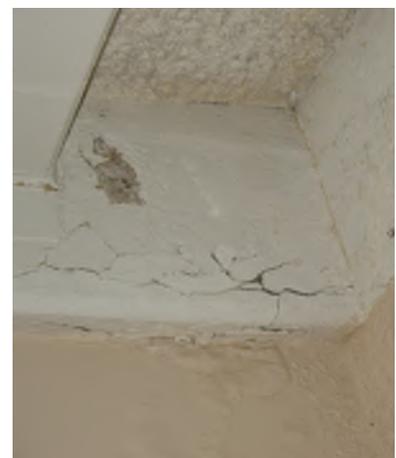
Concrete beam cracks at 2/3, grid G [S-16]

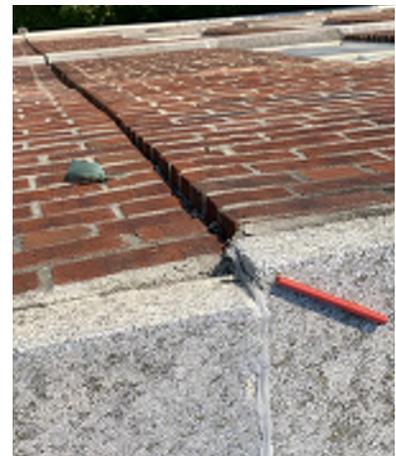
[S-34]

At the interior, building expansion joints have been filled with cementitious parging at column faces, or fabricated joint covers that do not appear to allow for adequate movement were installed. Besides visual observation, this issue is evidenced by out-of-plane differential wall movement at the east elevation parapet wall. Plus, there are east-west cracks observed at Levels 1 and 3 extending through the slabs and beams of the respective floors, crossing several building bays. Previously installed crack monitors were observed along the cracking at Level 3. It is also possible that the expansion joints, as originally located, and previous reconstruction of the east parapet wall, have contributed to the cracking and out-of-plane conditions [Figures S-33 to S-34].

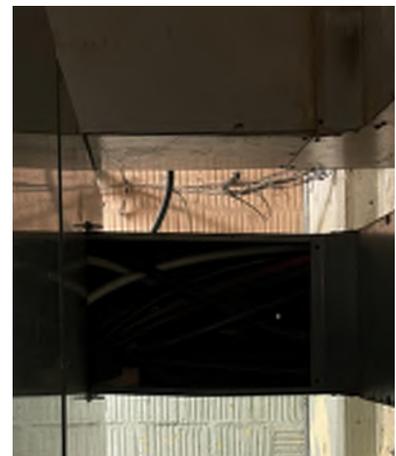
Exposed service wiring [E-8]

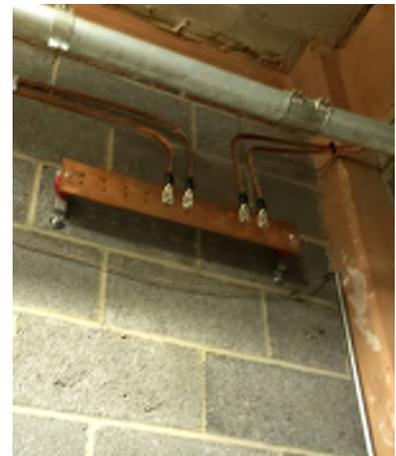
Main grounding bar [E-11]

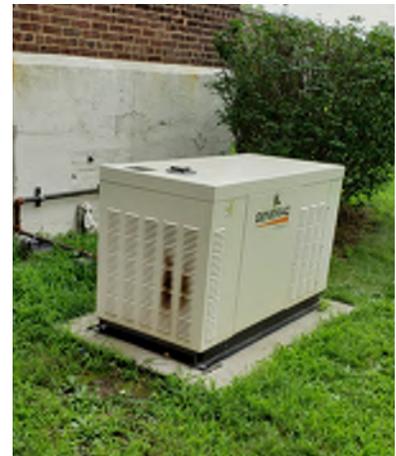
Only the panelboard serving Park Police and Dispatch is backed up by emergency power [Figure E-13]. A small, natural gas-powered Generac generator is located at the west wide of the building [Figure E-14]. Conduits are routed inside through the Basement boiler room to a small automatic transfer switch located adjacent to Panelboard NDP4. The normal feed to Panel IP-4 was intercepted and connected to the transfer switch. Installation time frame for the generator is unknown, but it appears to be in fair condition.

Park Police generator [E-14]

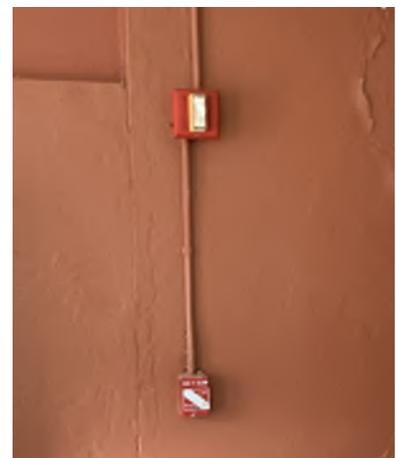
Edwards #2452 appliance [FP-11]

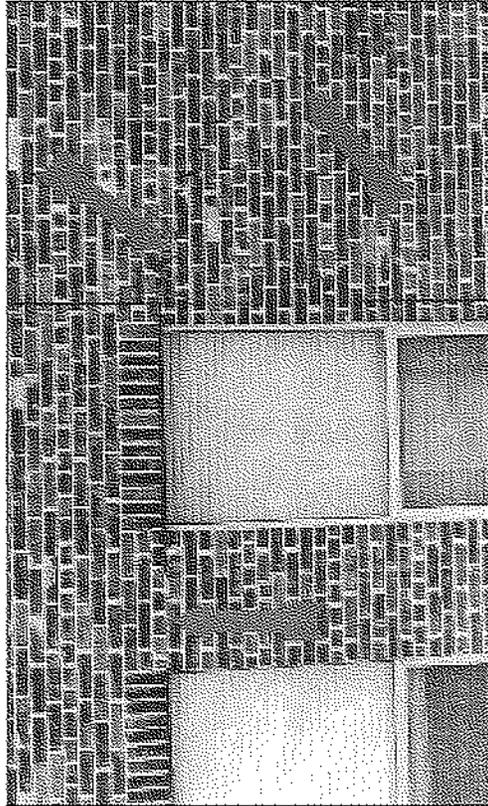
**Figure 6:150**  
Detail of northeast corner,  
showing major cracking  
(arrow). Brickwork is  
beginning to spall.
