SEISMIC EVALUATION OF SELECTED BUILDINGS AND STRUCTURES AT SCOTTY'S CASTLE

Death Valley National Park, Death Valley, California

DeSimone Consulting Engineers, P.L.L.C.

January 19, 2006

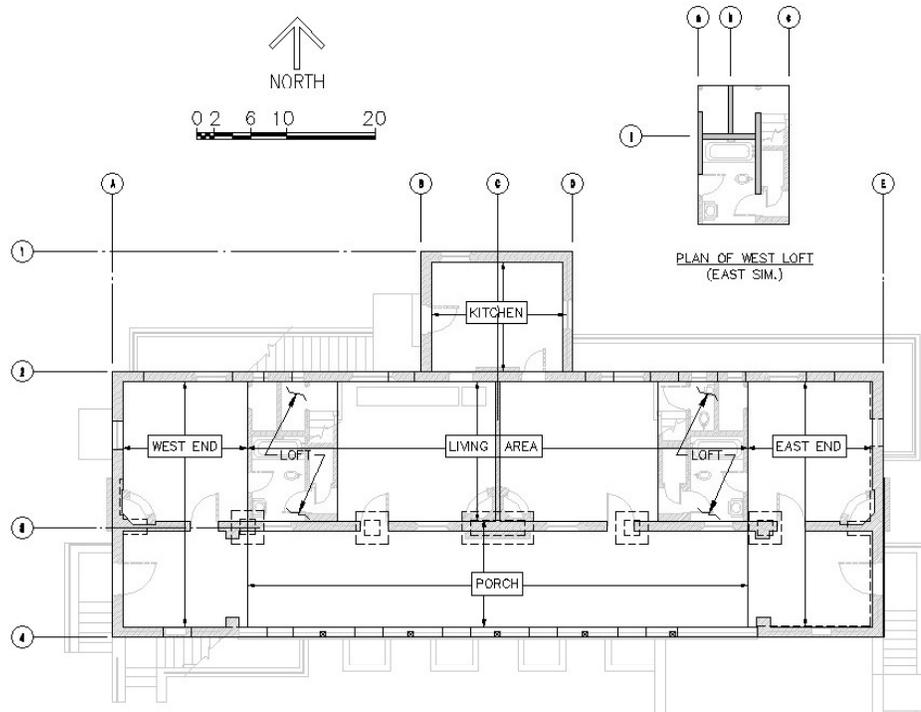
Figure 3.2: Guest House Floor Layout Plan

Figure 3.2 shows the Guest House floor plan with grid lines for easy reference. Note that there is no lateral force-resisting element for the porch roof diaphragm in the north-south direction. The force is thus considered to be resisted by the walls in the east and west ends of the building, which would require connection of the roofs over these areas. In keeping with the spirit of the Secretary of Interior's Standards and to keep the changes to the historic structure to a minimum, we are adopting the results of UCBC for our retrofit recommendations.

The evaluation criteria for FEMA 356 are more stringent and hence more walls are found to have inadequate lateral load-carrying capacity. All main walls, except those along grid 4 in the east and west ends of the building, have DCRs much greater than 1.0, with values ranging from 1.55 to 6.39, and hence require strengthening. However, as in the UCBC analysis, the partition walls were found to be adequate for supporting the loft areas, with a relatively low DCR of 0.67 in the east-west direction and 0.23 in the north-south direction.

FEMA 356 Based on the more stringent FEMA 356 criteria, all roof diaphragms were found to be inadequate for this building, with DCRs ranging from 2.48 to as high as 11.98. The heavy weight of the hollow clay tiles, coupled with the perimeter walls having minimal shear resisting capacity, is a very important factor in contributing to the poor seismic performance of this building.

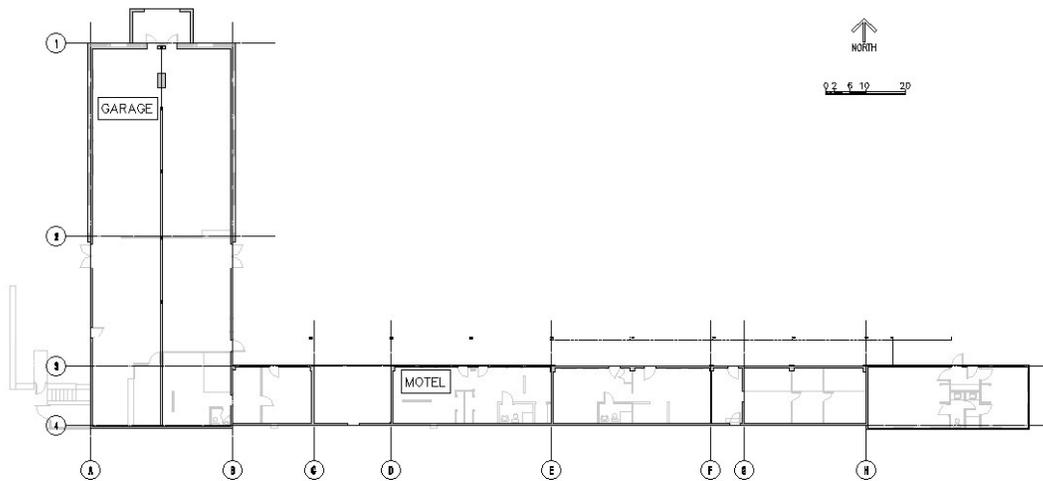
Figure 3.3: Long Shed Floor Layout Plan

Figure 3.3 shows the Long Shed floor plan with grid lines for easy reference. The porch area is only framed by wood posts and has no lateral force-resisting capacity in either direction. Along grid line 1, the wall has many large openings and thus cannot be considered effective to resist seismic forces. For similar reasons, the wall on the east face of the Motel is also considered ineffective. Along grid line 2, as can be seen in photo B.8 in Appendix B, one side of the plaster of the partition wall is discontinuous above the ceiling, and hence for analysis purposes only one side is considered effective. Given the simplicity of this building, it is our recommendation to adopt the UCBC criteria for this building over the more stringent requirements of FEMA 356. The results of the FEMA 356 analysis are provided here for comparison purposes only.

FEMA 356 As with the analysis for the Guest House, under the FEMA 356 criteria several walls were found to have inadequate lateral load carrying capacity. All walls in the north-south direction, as well as walls along grid lines 2 and 4 for the Garage, and along grid line 3 for the Long Shed in the east-west direction, have DCRs well above 1.0, with typical values ranging from 1.14 to 2.90. The highest DCR value was found to be 12.30 for the wall along grid line 2 for the Garage. Under FEMA 356 guidelines, all of these walls will require strengthening.

FEMA 356 Based on FEMA 356 criteria, however, all diaphragms, with a minor exception of an 8 ft. x 15 ft. area between grid lines F-G, are inadequate. However, inadequacy of the diaphragm strength at such DCR values corresponds to an exceedance of only the serviceability criteria. Yielding of diaphragms in light frame wall buildings does not present a collapse hazard, as inherently, such buildings are able to deform substantially and therefore absorb energy.

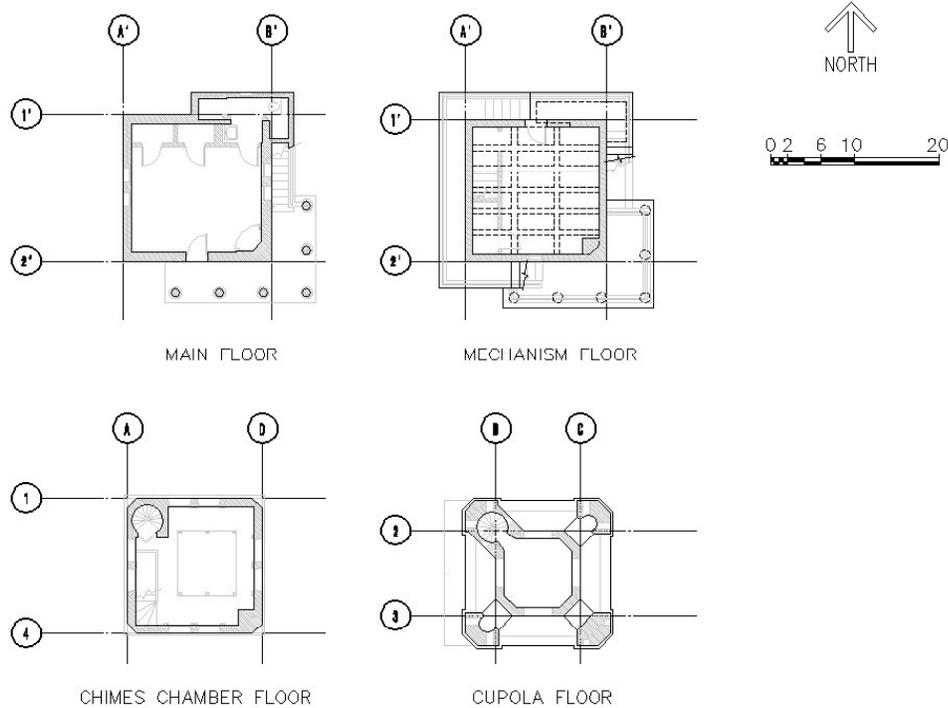
Figure 3.4: Chimes Tower Floor Layout Plan

Figure 3.4 shows the different level floor plans for the Chimes Tower for easy reference. The Chimes Tower has three stories and is comprised of a mix of construction materials. The Main Floor and the Mechanism Floor are constructed of concrete, whereas the levels above, namely the Chimes Chamber Floor and the Cupola Floor, are constructed of wood.

The seismic evaluation summary for the Chimes Tower shear walls is presented in Table 3.6. The walls supporting the Cupola Floor have big openings on all four sides of the structure, and are considered not effective in resisting lateral forces due to their high aspect ratios.

For this particular structure, guidelines from UCBC and FEMA 356 give comparable results; hence discussion is included herein based on numeric values from the FEMA 356 analysis. For the walls that qualify as shear walls, all but two walls have capacities greater than the shear demand, with DCRs ranging from 0.47 to 0.83 per FEMA 356 criteria. The walls supporting the roof along grid lines 2 and B are the only walls that have inadequate capacities, with a DCR of 1.42 per FEMA 356 criteria. However, inadequacy of strength in walls comprised of wood studs and diagonal lumber sheathing at such DCR levels corresponds only to an exceedance of the serviceability criteria. Excessive deformation is expected to occur, but it would not induce collapse in the structure. It is our conclusion that these walls are adequate for the Collapse Prevention performance level, as discussed earlier in this section.

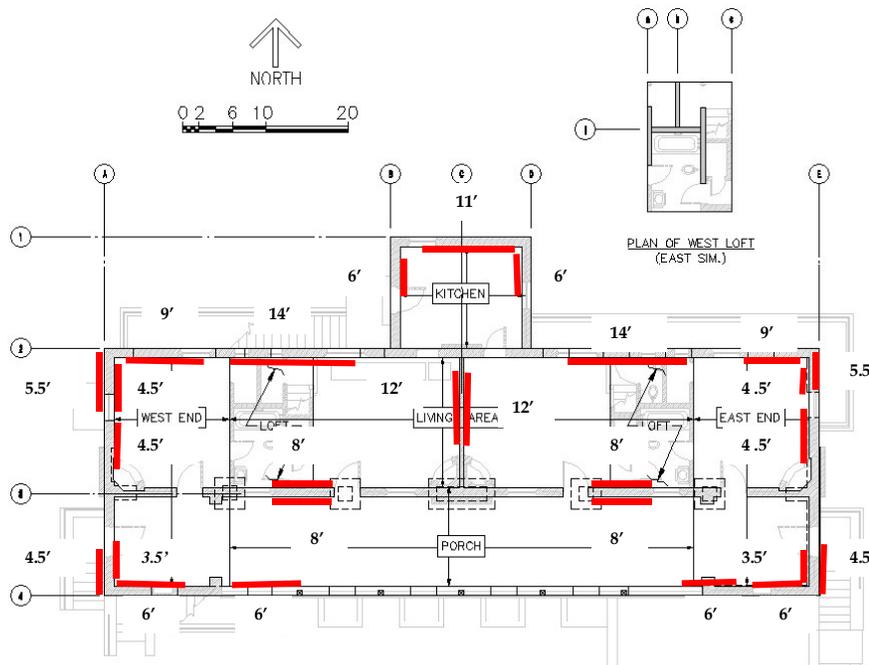
**Figure 3.4: Guest House – Conceptual Seismic Rehabilitation Recommendation
Addition of Plywood Sheathing**

1. Increase the lateral load-resisting capacities of the existing stucco/ metal lath and plaster shear walls by either adding plywood shear panels (Figure 3.4), or replacing the hollow clay tile walls by 4-in.-thick shotcrete at select locations (Figure 3.5).
2. Provide roof diaphragm connection between the porch area and the east and west ends.
3. Strengthen existing wood roof diaphragms by adding plywood sheathing to the underside of the roof.
4. Provide positive anchorage of existing walls to the wood roof diaphragm for out-of-plane loads.
5. Repair hairline cracks in the basement walls to minimize moisture penetration into the structure.

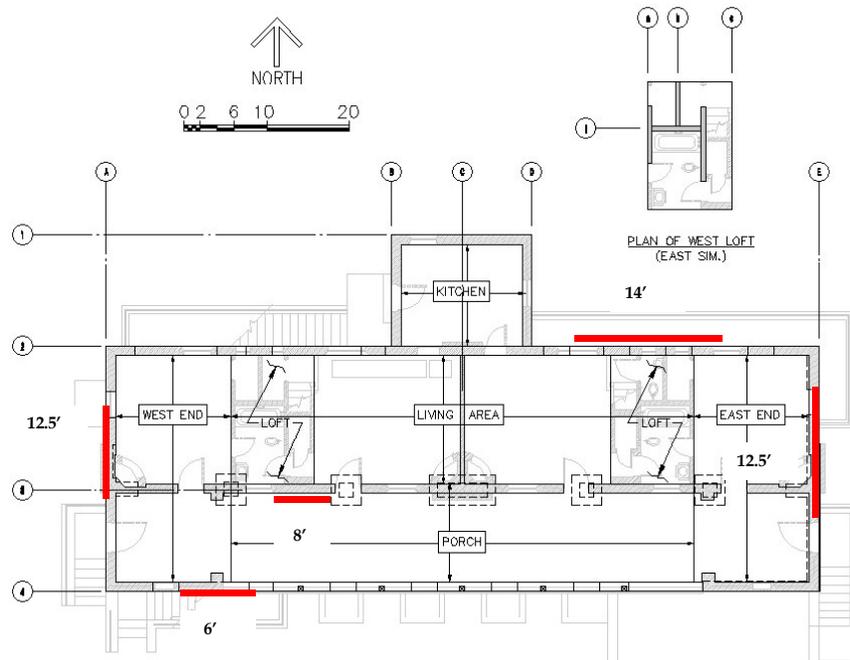
Figure 3.5: Guest House – Conceptual Seismic Rehabilitation Recommendation
Replacement of Hollow Clay Tile Walls with Shotcrete Walls

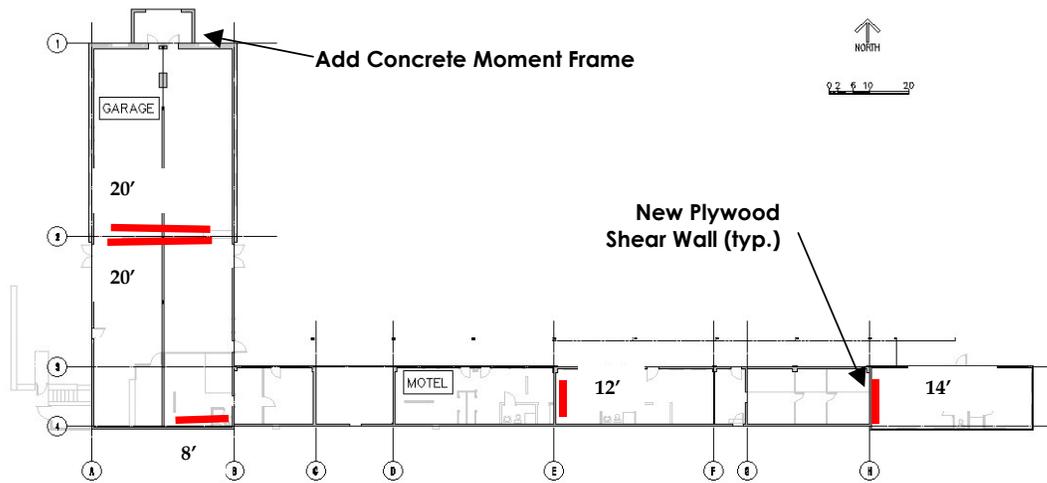
Figure 3.6: Long Shed – Conceptual Seismic Rehabilitation Recommendation for Shear Walls

1. Increase the lateral load-resisting capacities of the existing metal lath and plaster shear walls by adding plywood shear panels at select locations (Figure 3.6).
2. Introduce a concrete frame along grid line 1 in the Garage.
3. Provide a positive roof diaphragm connection between the porch and the main area of the Garage.
4. Provide positive anchorage of existing walls to the wood roof diaphragm for out-of-plane loads.
5. Repair holes and cracks in the plaster walls to minimize moisture penetration into the structure.

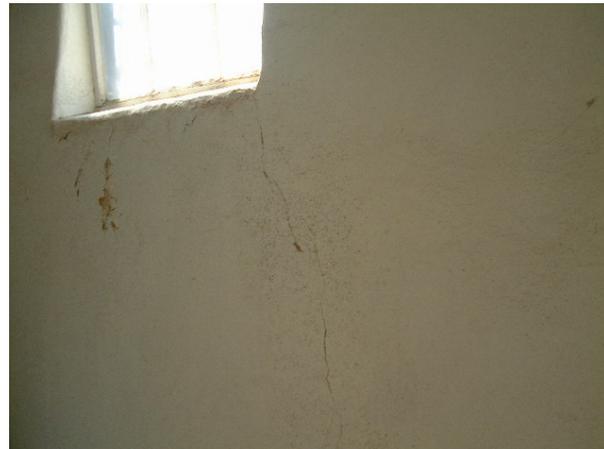
1. The structure appears to be in good condition overall and very well maintained. The gravity framing of the structure, where exposed, was also found to be in good condition. Member sizes and connections of the roof trusses appear appropriate and adequate for their respective loadings.
2. The existing drawings provide adequate and accurate information for the as-built condition of the structure. The information provided in the existing drawings was confirmed during the site visit by visual inspection.
3. There was no sign of any major damage to the structure, and no sign of water seepage in the basement.
4. There are many hairline cracks in the concrete basement walls, which may suggest settlement of the structure.

Photo A.8: Cracks in Basement Wall, Guest House

1. Increase the lateral load-resisting capacities of the existing stucco/ metal lath and plaster shear walls by either adding plywood shear panels, or replacing the hollow clay tiles by 4-in.-thick shotcrete at select locations.
2. Provide a positive roof diaphragm connection between the porch area and the east and west ends.
3. Provide positive anchorage of the existing walls to the wood roof diaphragm for resisting out-of-plane loads.
4. Repair hairline cracks in the basement walls to minimize moisture penetration into the structure.

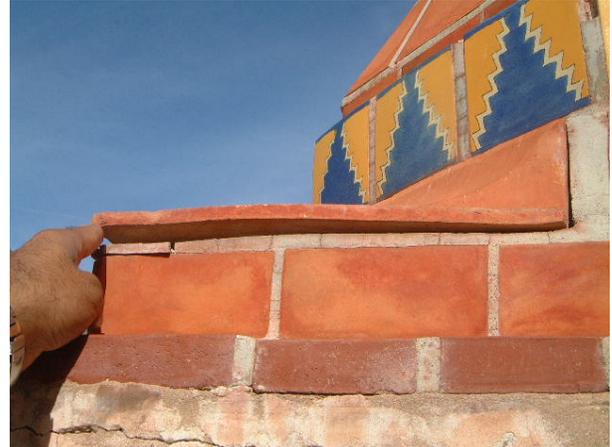
Photo C.2: Loose Tile at Finial, Chimes Tower

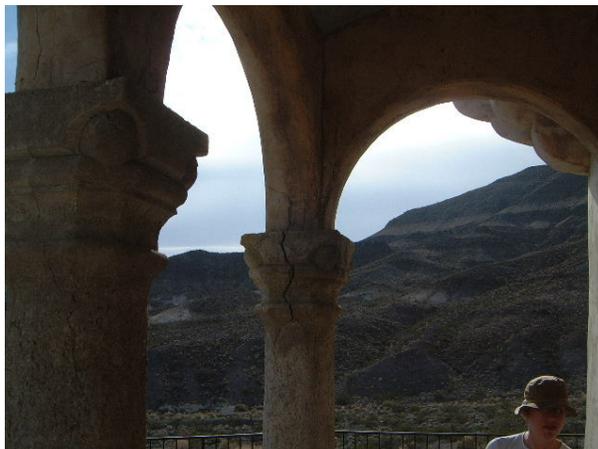
1. The concrete columns of the structure are deteriorating and have extensive cracks. The columns appeared to be not finished and the concrete was of poor quality.
2. There are many cracks on the exterior of the structure.
3. Tiles on the finial areas are loose and present a life-safety hazard to passers-by and visitors to this building.
4. Member sizes and connections appear appropriate and adequate for their respective loadings.

Photo C.3: Cracks in Columns at Chimes Tower

1. Repair deteriorating columns by epoxy injecting the cracks to create a sound concrete finish.
2. Strengthen walls supporting the Cupola level by adding ½-in. plywood sheathing on the inside face of the walls and adding straps around openings to stiffen the wall elements.
3. Repair loose tiles on the finial areas.
4. Repair cracks on the exterior walls to minimize moisture penetration into the structure.

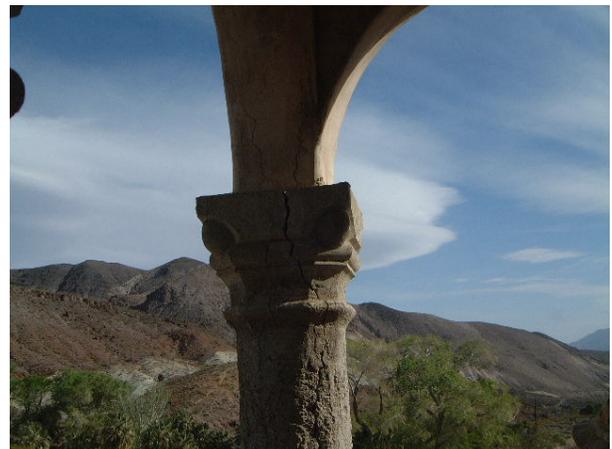
Photo C.4: Cracks in Column at Chimes Tower

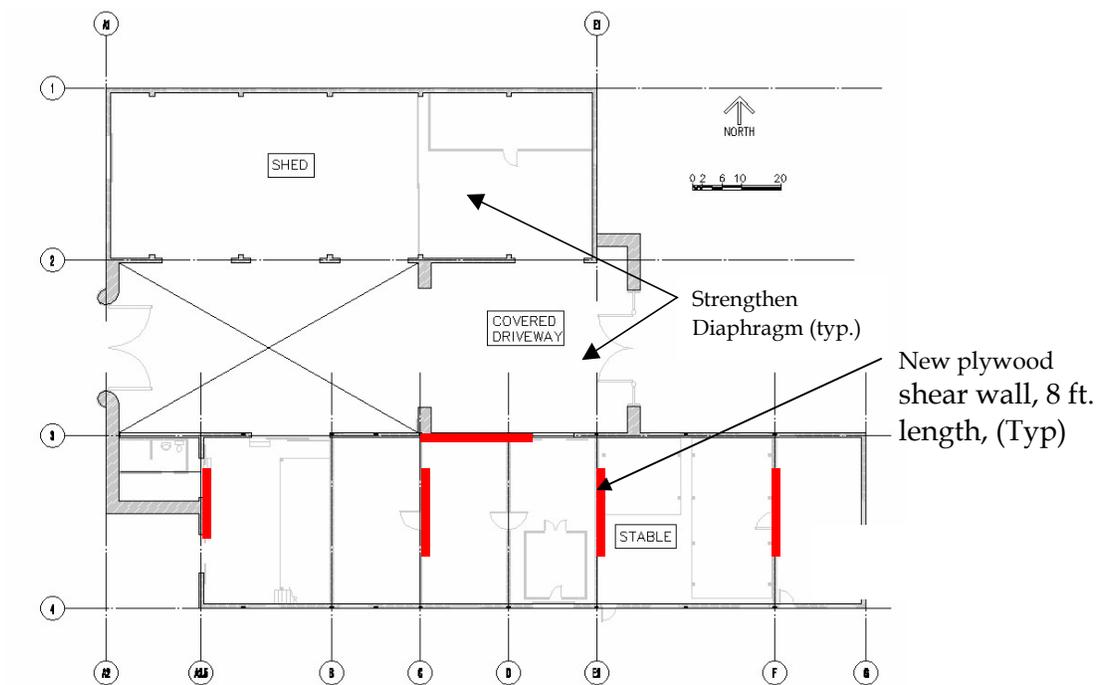
Figure 3.3: Conceptual Seismic Rehabilitation Recommendation

1. To strengthen shear walls, remove plaster on lath on selected walls and add ½” plywood sheathing to increase the shear capacity of the walls. Once the addition is made plaster can be applied to the plywood to match existing architecture.
2. To increase diaphragm capacity, add ½” plywood at the bottom of roof trusses. This method eliminates the need of removing the tiles on the roof and thus retains the original architecture.
3. Provide positive in-plane and out-of-plane wall to roof diaphragm anchorage.

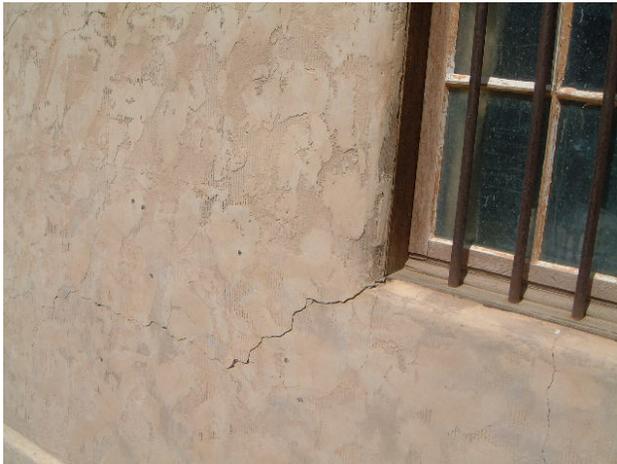
Photo-3: Crack around Window, Stable

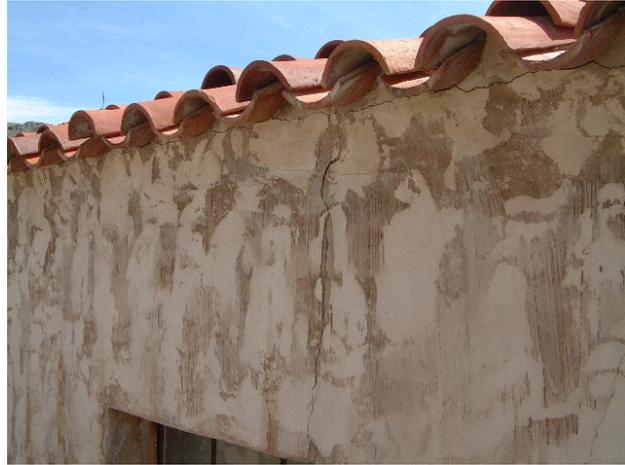
Photo-10: Crack under Roof, Shed

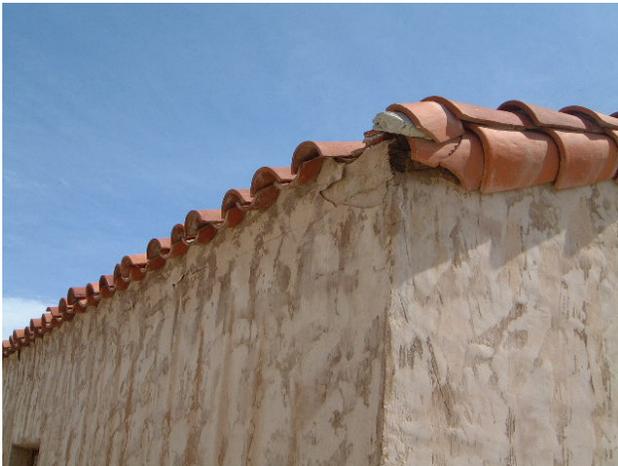
Photo-11: Damaged Tiles, Shed
