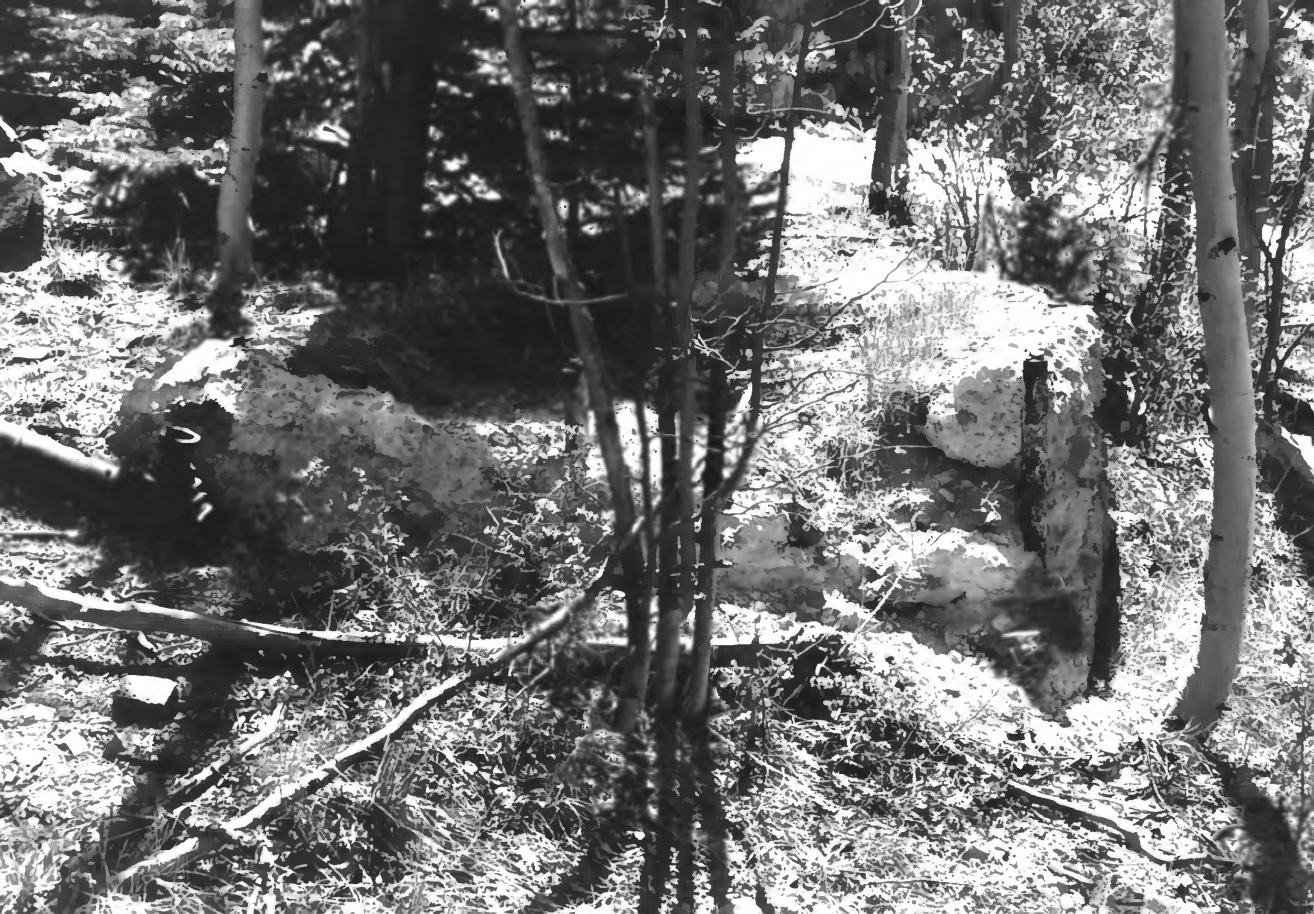
Figure 1: Feature 1, the concrete foundation. This view is taken from near the southwest corner of the foundation, looking toward the northeast. This feature was apparently the location of the boiler.

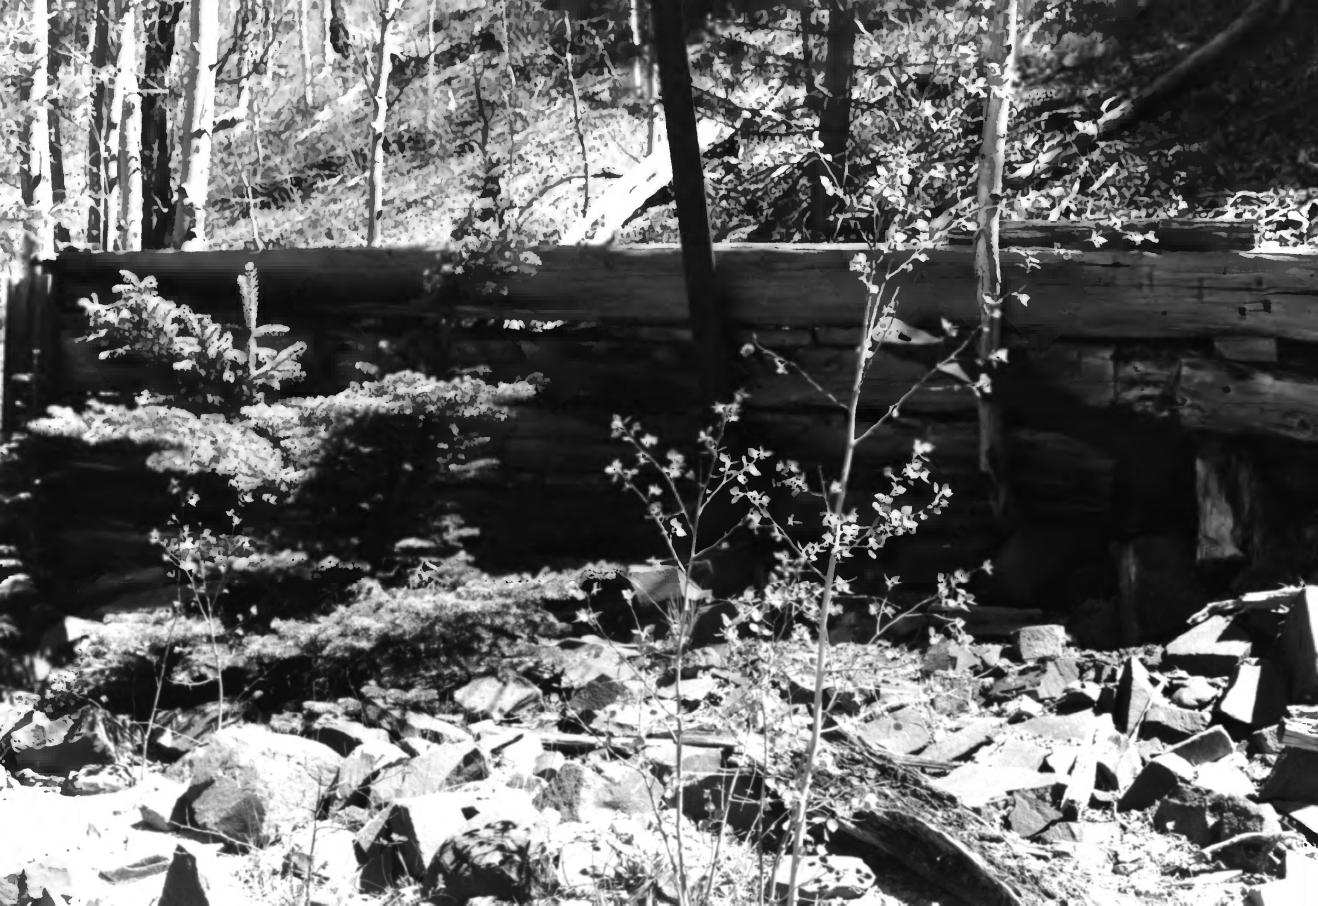
Figure 2: Feature 2, the wood retaining wall. This view was made south of the wall looking north. In the foreground is a portion of the rock foundation.

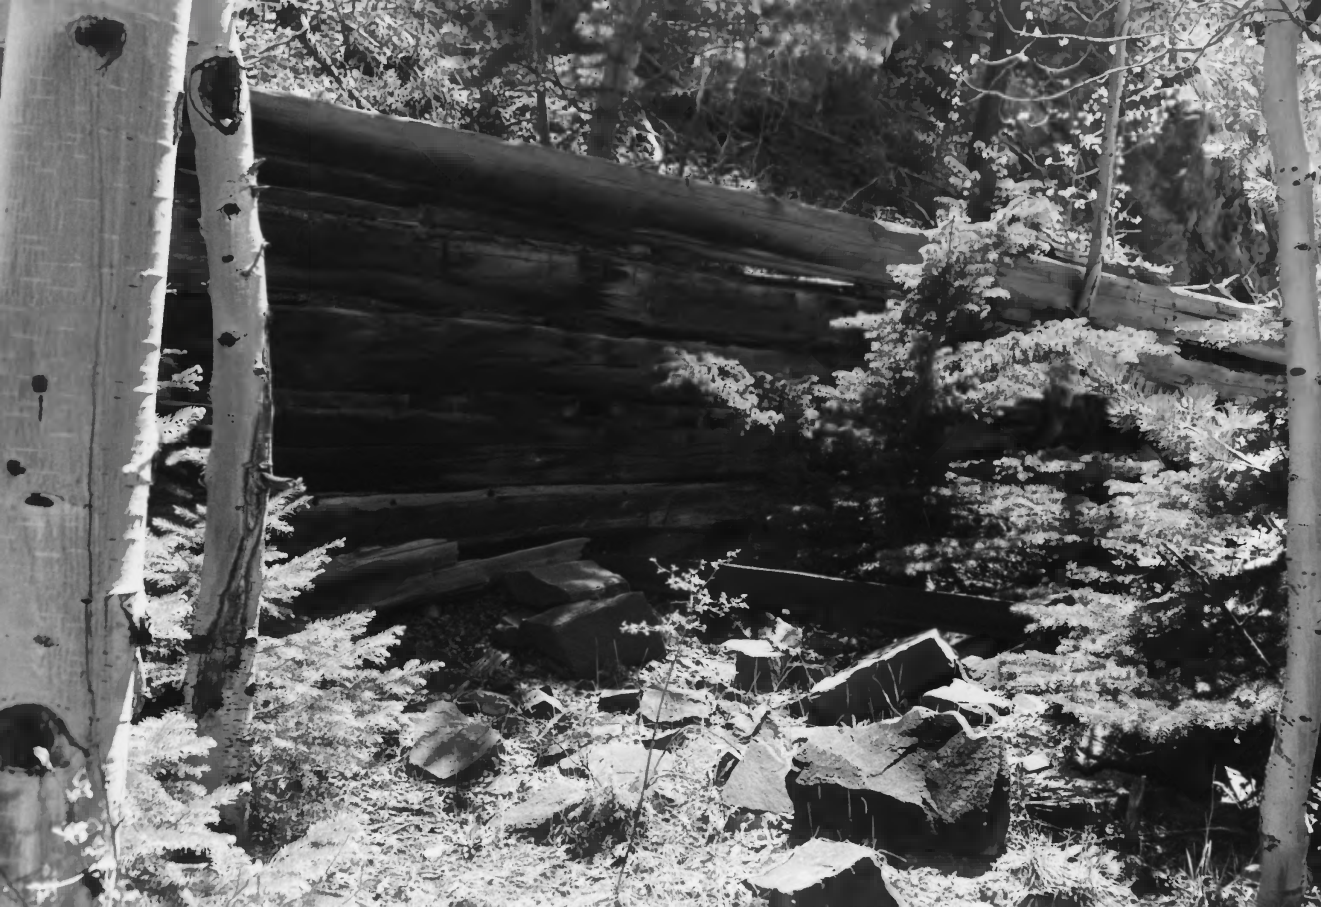
Figure 3: Feature 3, another view showing the rock foundation and the retaining wall in the background. This view is looking to the northeast.

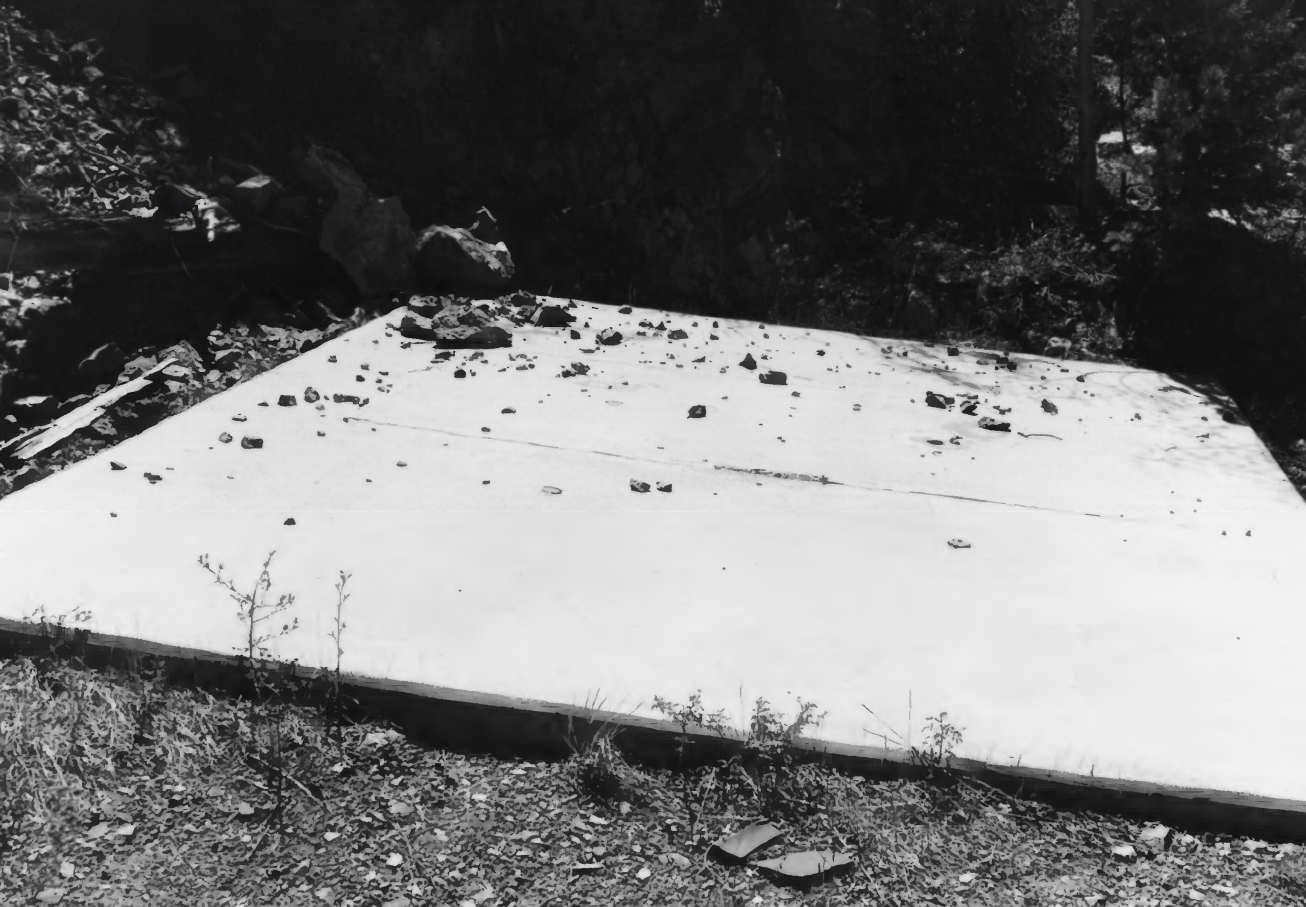
Figure 4: Feature 4, the location of the shaft which is now covered with a concrete slab. The picture was taken a few feet west of the slab, looking east.

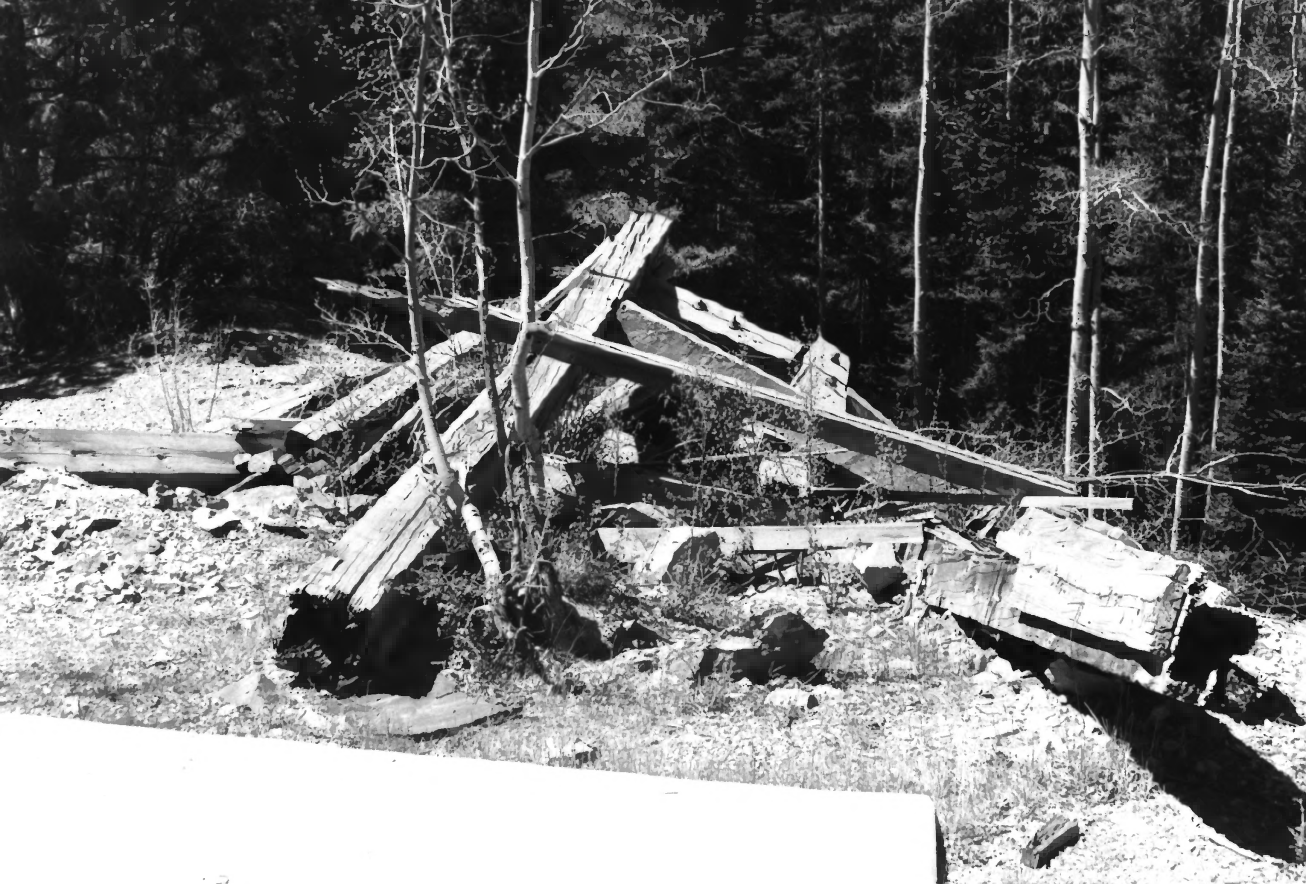
Figure 5: Feature 5, the collapsed hoist tower. At the far end of the long beam is the pulley and cable which cannot be seen in this picture. The view was made on top of the tailings pile, looking south with part of the slab over the shaft seen in the foreground.

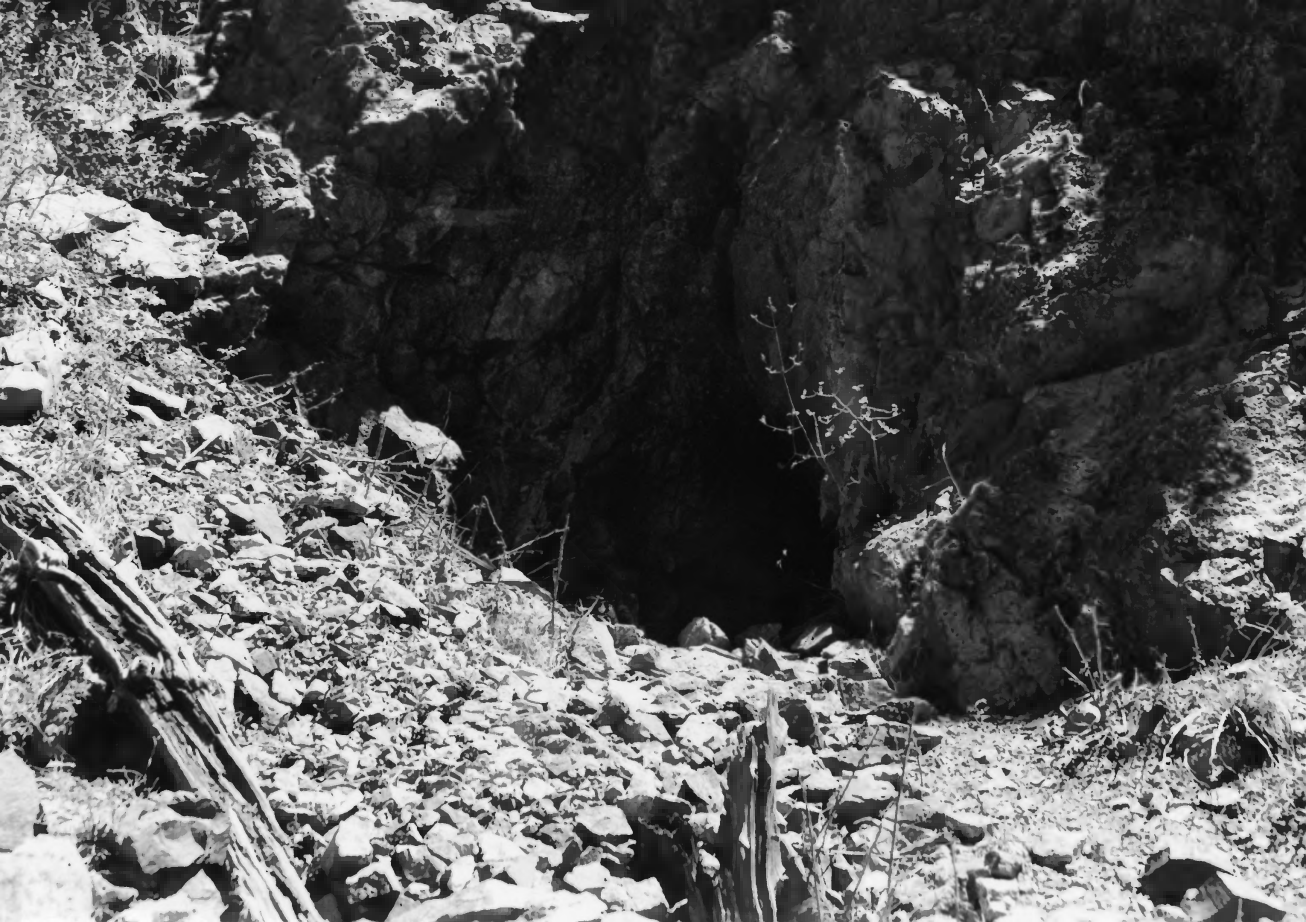
Figure 6: Feature 6, the discovery adit. The picture was taken from just east of the shaft location looking to the northeast.

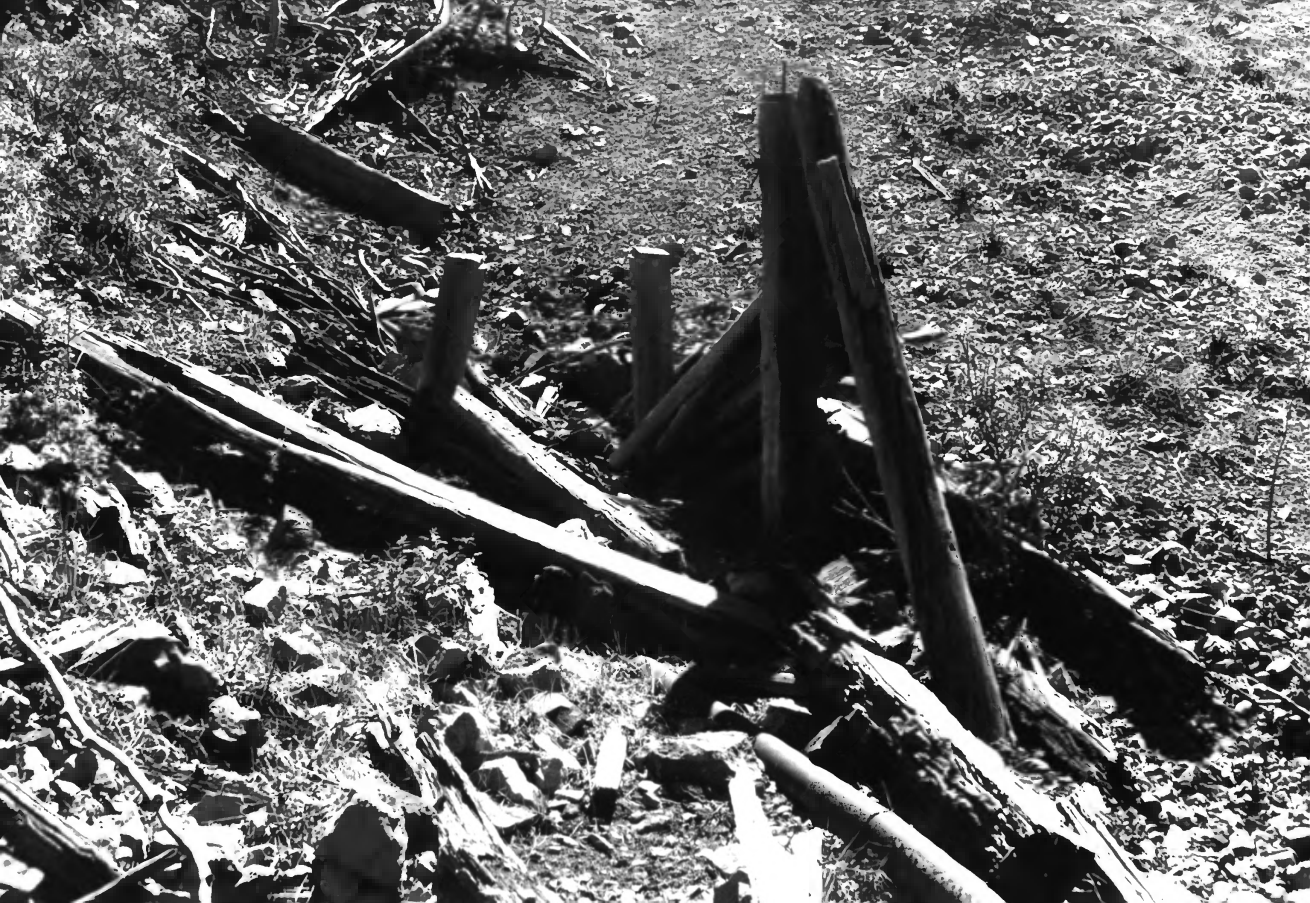
Figure 7: Feature 7, the Black Copper adit. This is now collapsed. The view is directly east with the tailings pile in the background.

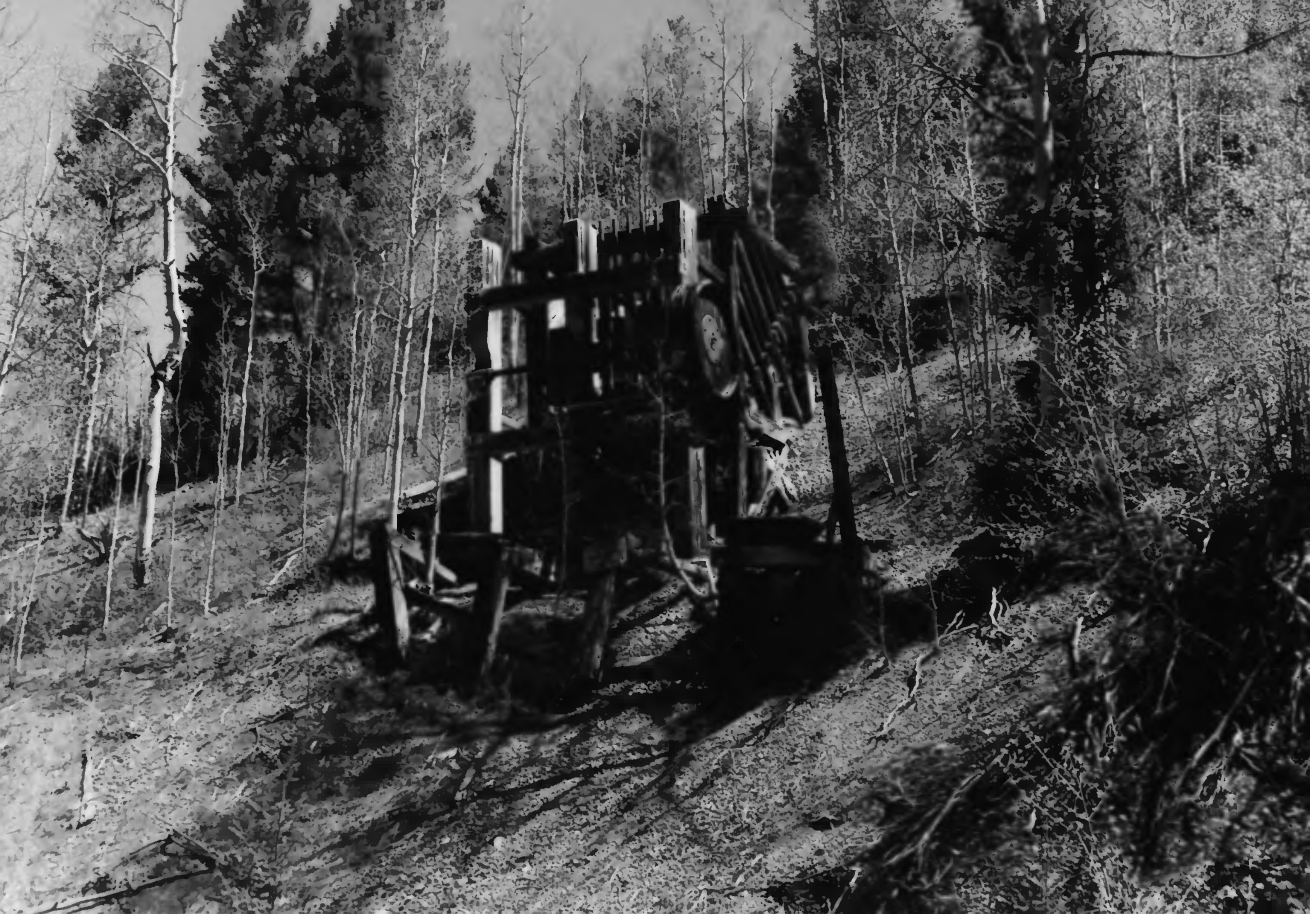
Figure 8: Feature 8, the Black Copper stamp mill. This photograph was taken from the road below and south of the mill looking upslope toward the north.

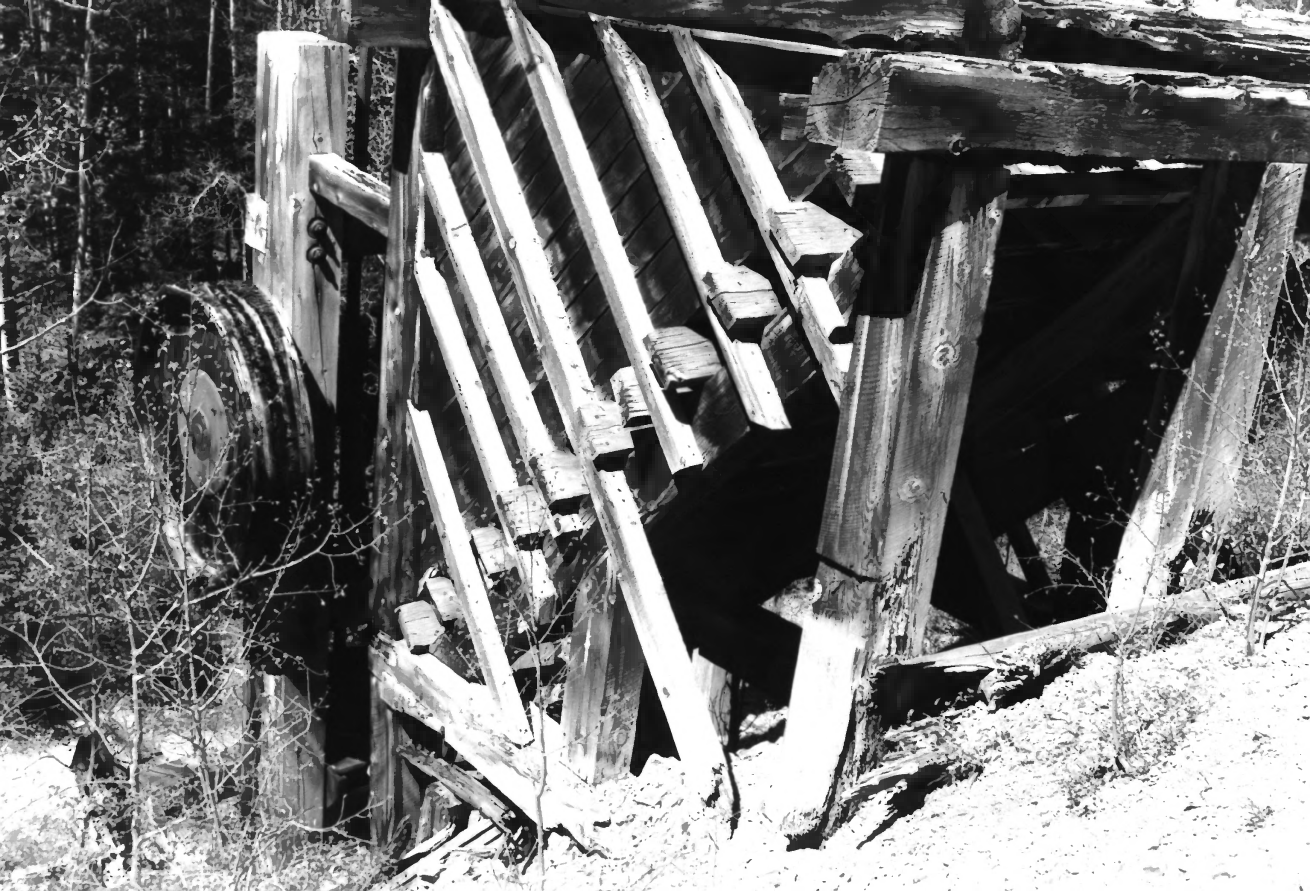
Figure 9: Feature 8, the stamp mill, as seen from the road above the mill. This shows the large hopper which stands above the machinery. The large wheel on the east side of the mill is seen and above and to the right of the wheel are the long iron rods to which the pistons are attached. This view is looking in a southeasterly direction.

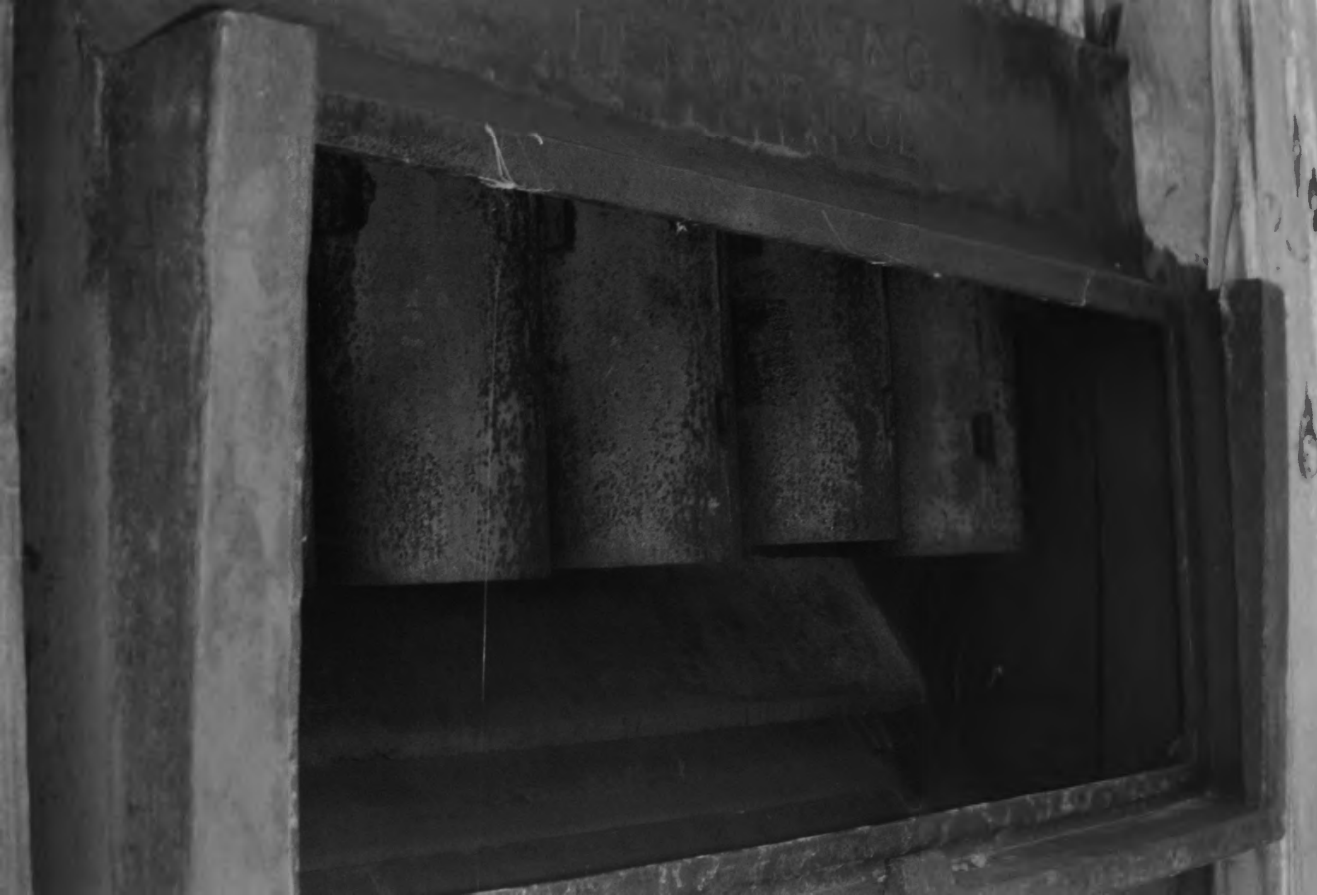
Figure 10: Feature 8, the stamps. This photograph was taken from the west side of the mill looking directly into the machinery. Only four of the five stamps are visible in this view. The trough is directly below the stamps.

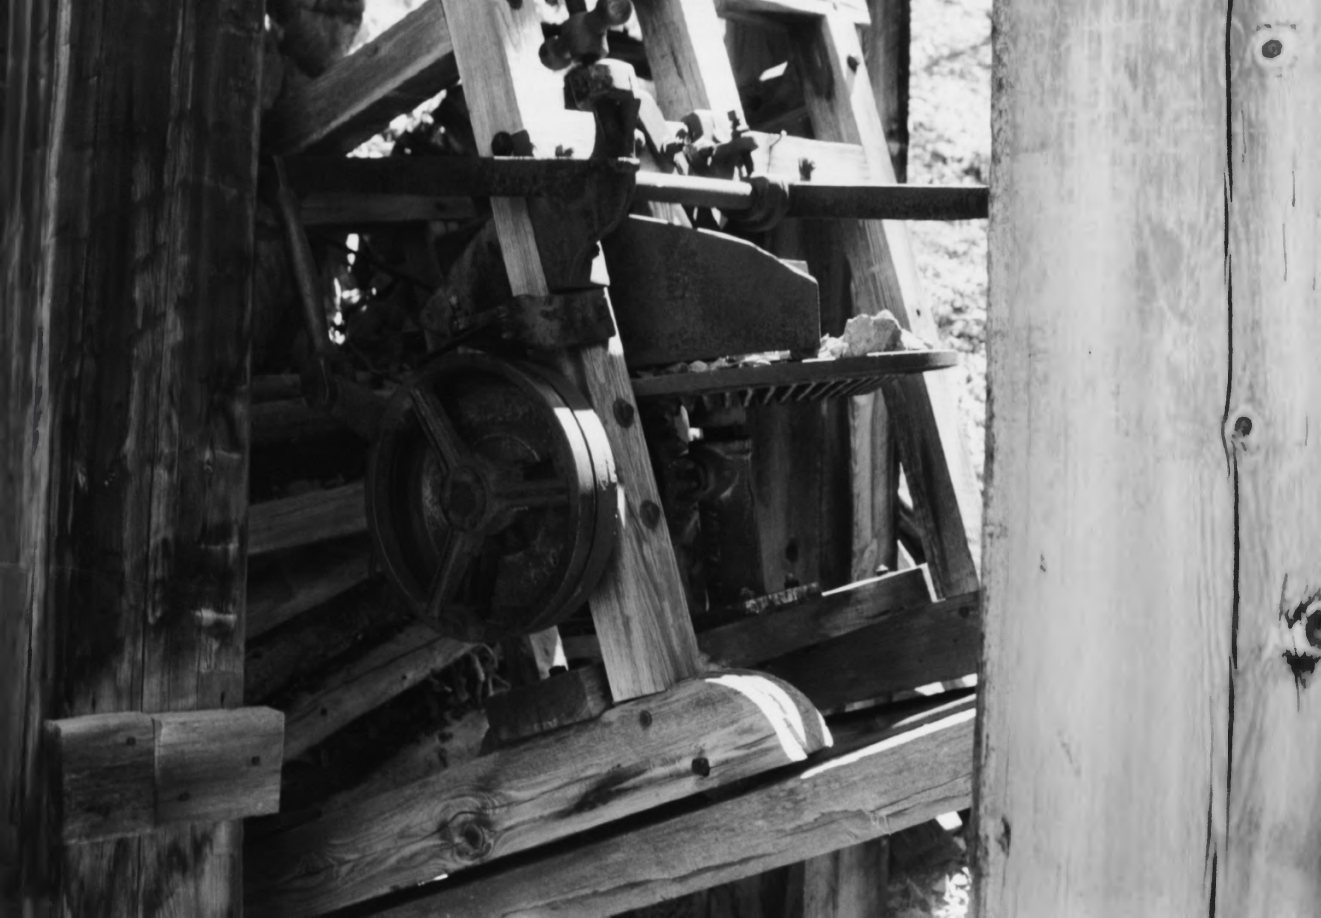
Figure 11: Feature 8, the gear mechanism which fed the ore from the hopper into the trough below the stamps. The picture was made from the east side of the mill looking into the machinery.

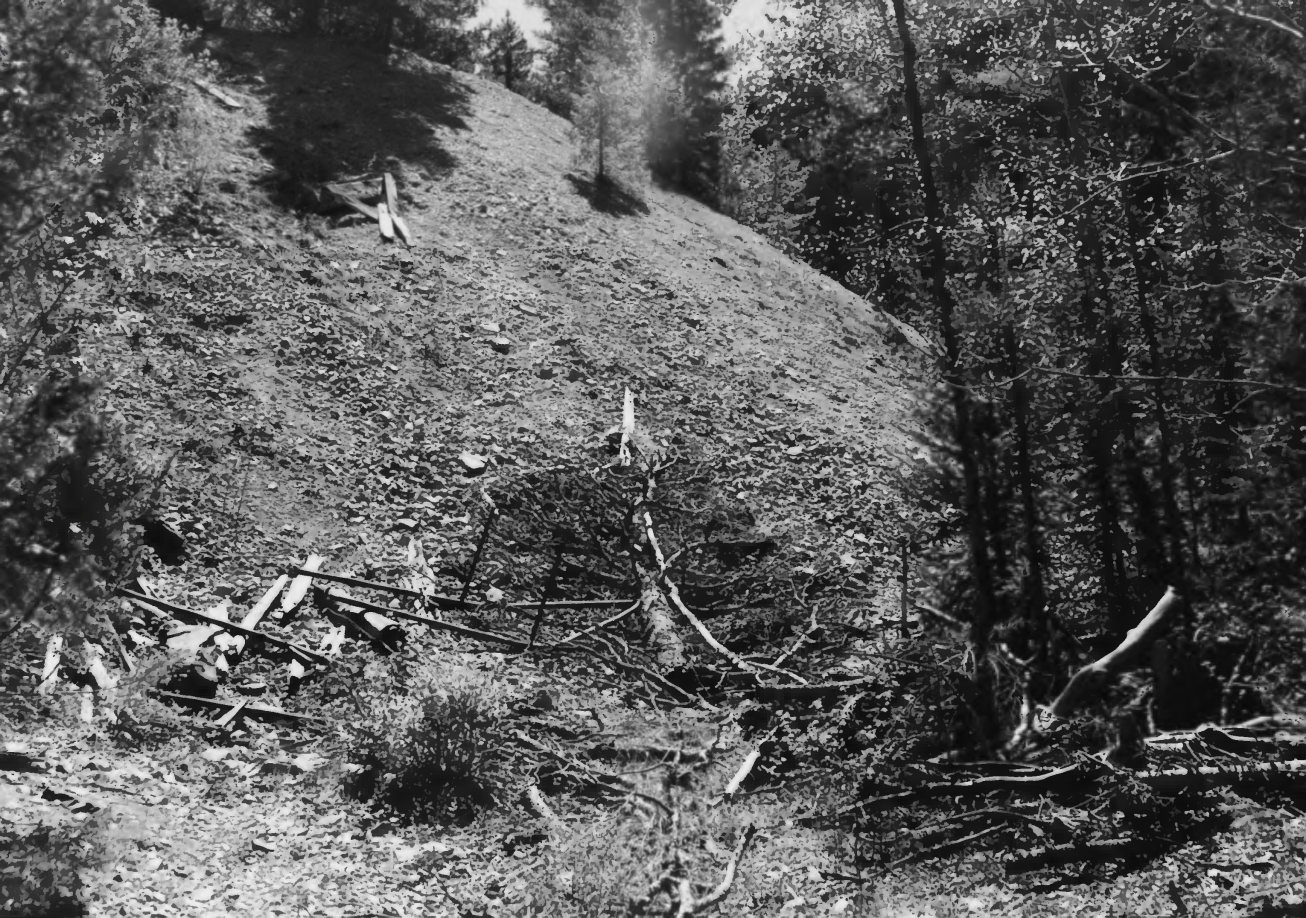
Figure 13: The tailings pile, as viewed from near Black Copper Creek, looking eastward.
