CONDITION ASSESSMENT AND TREATMENT RECOMMENDATIONS

GRANDVIEW SCHOOL MONUMENTAL LIMESTONE ENTRANCE

HARPERS FERRY NATIONAL HISTORICAL PARK  
HARPERS FERRY, WEST VIRGINIA

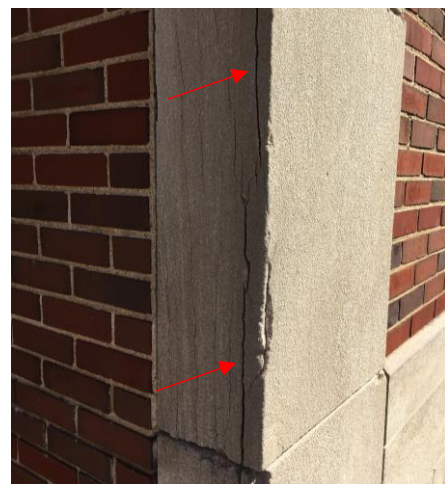
The hairline cracks appear mainly on the faces of the stone while most of the larger cracks appear on the stone return. The larger cracks that appear on the stone return are mainly located on the east elevation of the entrance. There are several cracks that run the entire vertical length of the stone. Smaller hairline cracks appear alongside the larger, deeper cracks. In addition to the cracks on the stone return, there are also cracks that will need to be injected on the lower section of the stone pier on the west elevation. These cracks on the lower sections of the stone pier do not typically run the entire length of the stone block.

Figure 1. East Side of the Entrance showing the cracks in the limestone blocks on the stone pier. The red arrow indicates that the larger cracks will be injected.

There are several large cracks ranging from 1/8"-1/4" wide in several locations on the stone piers and stone pier bases. These cracks should be filled with injection mortar to prevent additional deterioration. The cracks should be filled as deep as possible and flush to the stone. The cracks should first be injected with a 50/50 solution of denatured alcohol and water to flush out any dirt or debris and ensure that the crack injection material is able to seep as deep into the crack as possible. A color mixed injection grout (such as Cathedral Stone Products, Jahn M-30 #31, #32, Voidspan or approved equal) should be matched to the repair location with mineral pigments and injected until the repair is flush with the stone. Excess grout and overruns should be cleaned up immediately with a clean sponge and fresh water to prevent staining.

The four limestone stones that make up the east elevation of the stone pier have massive cracks that will need to be injected and reattached to the brick substrate. In order to anchor the limestone to the brick, holes will be drilled through the front face of the stone to take stainless steel dowels. The holes will be drilled to reach a depth greater than the deepest internal delamination (or to the brick substrate). The masonry drill bit should be slightly wider than the stainless steel dowel. The depth of the hole should be measured and the dowel cut to finish at least 1" below the outer surface. The drilled holes should be flushed with a 50/50 solution of water and denatured alcohol. A syringe will be used to inject the grout until the hole is no more than two thirds filled. The dowel is then pushed into the hole as far as it will go, and any seepage is cleaned away. When the grout has set, the tops of the dowel holes will be filled with a color matched restoration mortar mixed to match the surrounding stone. OR the Voidspan Cintec product can be used to re-anchor the limestone to the brick substrate. The process is very similar. The crack injection locations are illustrated on the annotated photographs in Appendix B.

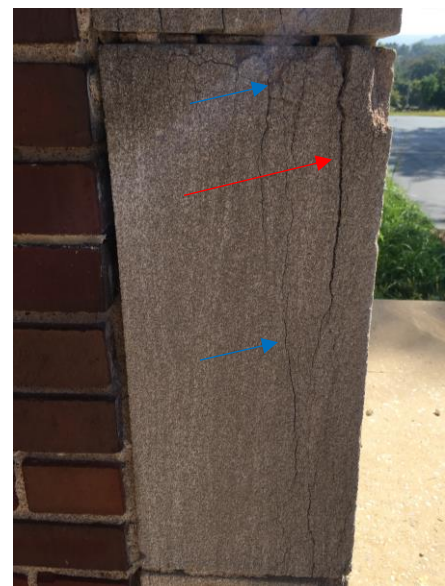
Figure 2. East Side of the Entrance showing the cracks in the limestone blocks on the stone pier. The red arrow indicates that the larger cracks will be injected and the blue arrow shows smaller hairline cracks and fissures.

A mock-up to treat the hairline cracks should be performed in order to determine the appropriate means and methods for treatment. If the cracks appear to be wide enough to take crack injection grout then they should be grouted (Jahn M-30 injection grout, or approved equal). If the cracks are too fine and grout is not able to be injected then the hairline cracks should be stabilized with a dilute lime putty that is color matched with mineral pigments to match the existing stone. If the dilute lime putty does not consolidate the hairline cracks then the entire limestone block should be consolidated with an ethyl silicate consolidant (the pre-treatment Conservare HCT (hydroxylating conversion treatment) with OH100, distributed by Prosoco, Inc. should be tested). A mock-up should be performed not on the limestone entrance but on a separate block of stone that closely resembles the texture and porosity of the original material. If the ethyl silicate consolidation is successful after a mock-up is performed, then all the stone blocks on the stone piers and stone pier bases should be consolidated 100% due to the deteriorated condition of the limestone. The ethyl silicate consolidation should be performed first before any repointing and patching or injecting repairs.

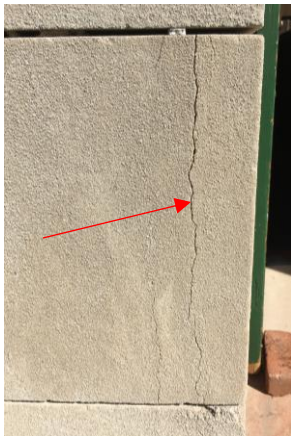
Figure 3. Example of cracking on the stone pier base on the west elevation (red arrow).

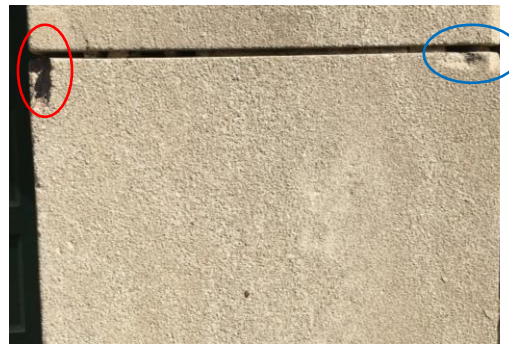
There are several areas of stone loss/voids on the face and return of the limestone panels. These stone losses appear mainly on the east side of the entrance on the corners or front faces of the limestone pier stones. Most of the losses are small, ranging from 2"- 4" of loss primarily on the corners. Small stone losses, 1" or smaller or small spalls will not be considered for patching repairs.

Figure 4. Example of an area to be patched on the east elevation of the stone pier base as indicated by a red circle. The blue circle indicates a spall that would not be repaired through patching. Note there is little to no mortar in the joint above.

A sample of the existing stone should be sent to the manufacturer's lab to be color matched. The areas where patching will occur should be prepped and the material applied according to the manufacturer's specifications. The US Heritage HL60 Limestone Repair mortar can be used in areas where small repairs are needed because the product can be feathered to the edge. In other instances where deteriorated stone will need to be removed before patching can occur, other restoration products such as Conproco or Jahn restoration mortars can be used. The patches should be compatible to each individual repair location in color, texture, and finishing. This may require a few color matched samples of the approved material for custom mixing at each patch location. The patch locations are illustrated on the annotated photographs in Appendix B.

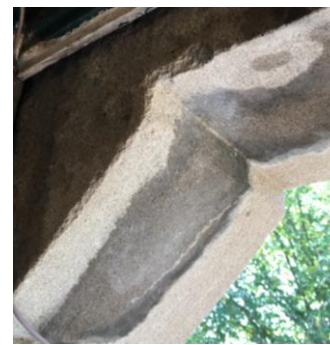
Figure 5. Gypsum soiling on the underside of the stone pier canopy. The black sulfate crust is visible on the entire underside of the protected area.

There is gypsum soiling on the underside of the limestone pier canopy stone. The black sulfate crusts are caused by pollution and atmospheric soiling. A black sulfate crust builds up on the sheltered and protected areas that are not consistently rinsed with rain water.

The gypsum soiling on the underside of the stone pier canopy should be removed through either chemical or mechanical removal processes. A chemical to remove carbon crusts should be tested in a small discrete location (766 Limestone and Masonry Prewash, 942 Limestone and Marble Cleaner, Limestone and Masonry Afterwash, manufactured by Prosoco, could all be tested) to determine the effectiveness of chemical cleaning. If the chemical cleaning is not effective, mechanical cleaning can be used to remove the sulfate crusts. A micro-abrasive cleaning machine using finely crushed milled glass (IBIX H2O micro-abrasive cleaning machine) can be used to remove the sulfate crusts. The micro-abrasive cleaning procedure should be tested before large-scale treatment implementation.

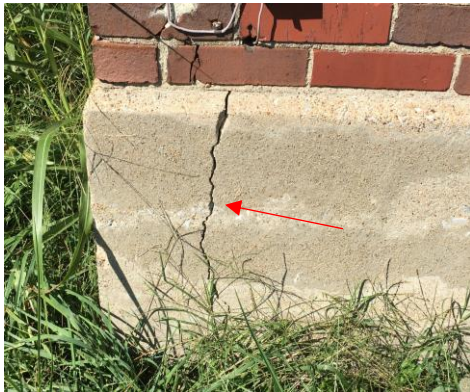
Figure 8. Example of cracking that is typical on the concrete foundation, on all elevations.

There are roughly about 13 cracks along the concrete foundation. The cracks range in width from 1/8" to 1/4" and larger. There are some cracks with stone spall losses. Most of the cracks span the entire height of the concrete foundation which is about 2' high and appear on all elevations of the building.

The cracks in the concrete foundation around the building should be injected with a crack and void injection grout (Jahn M-40, Crack and Void Injection Grout by Cathedral Stone, Inc., Voidspan product, or approved equal). The injection sites should be flushed with a 50/50 solution of denatured alcohol and water prior to crack injection. The injection grout should be color matched with mineral pigments to match the adjacent concrete color. The injection grout should be filled flush to the surface of the stone. If there are any voids or areas of losses not filled with the injection grout they should be patched with a concrete restoration material (Jahn M-90, Concrete Restoration Mortar, Cathedral Stone, Inc. or approved equal). The restoration patching material should be color matched with mineral pigments to match the adjacent stone. Because the patching repairs are minimal in scope and quantity, it is not recommended that matching aggregate be used in the restoration mix for these types of patches.

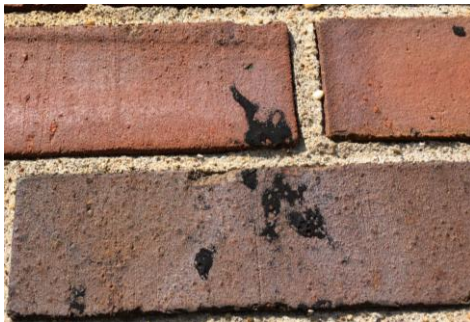
**Tar Stains and Splatters-** On the east elevation there is a section of the brick wall and concrete foundation that has tar stains and splatters. This is the only noted occurrence of tar staining on the building.

Figure 9. Surface condition of the tar on the brick. Only visible on the east elevation.

**Tar Stains and Splatters-** The tar should be removed from the brick and concrete through a variety of methods. Each method should be tested in a small inconspicuous location before implementing large-scale cleaning. The areas of tar that are thick should be removed first with scalpels and blades taking care to not scratch or scrape the brick. The thick tar buildup should be removed as best as possible and then dissolved with a chemical product. Sure Klean Asphalt and Tar Remover distributed by Prosoco could be tested along with a variety of solvents.

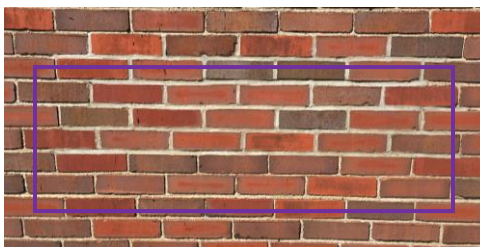
**Brick Mortar Joint Repairs-** There is a 2' x 4' section of Portland repointing mortar on the east elevation completed during a previous restoration campaign. This section of gray portland cement mortar does not match the 1930s exposed aggregate buff-colored mortar that was originally used on the building. There are also other sections of brick mortar on the east elevation where the mortar does not match the original mortar. These areas are much smaller and range from a few square feet to a few inches of repointing mortar.

Figure 10. Previously installed portland cement mortar joints that are not compatible with the original mortar. See the purple box with the portland cement pointing mortar.

**Brick Mortar Joint Repairs-** There are several locations where inappropriate materials and colors were used to repoint select mortar joints. There is one location on the east elevation that was repointed with a gray Portland cement mortar. Since the Portland cement mortar is much harder than the adjacent bricks, it is recommended that the Portland cement mortar be left in place to prevent damaging the bricks further with removal procedures. In order to blend the existing repair with the surrounding brick and mortar it is recommended that the Portland repointing mortar be retooled to match the profile of the original mortar. This can be accomplished a few different ways. The Portland cement mortar can be scaled back using a scalpel or with a Dremel tool. The goal of the retooling is to remove the surface mortar so that the repair appears to have the same profile original mortar joints. The retooled surface can also be in-painted with stains or potassium silicate paints to match the original mortar if determined necessary.

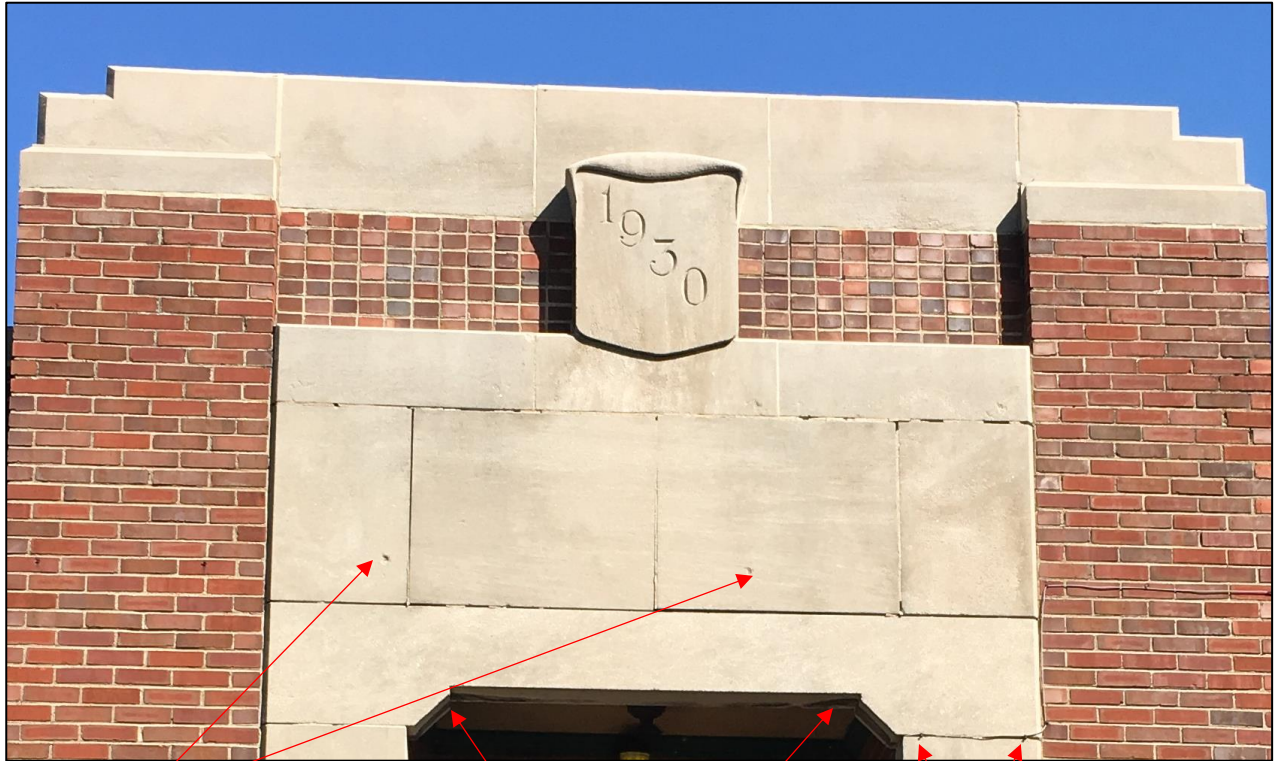
**Stone Cornice, Stone Pilaster Cap, 1930 Emblem, Stone Pier Canopy**

Condition: Embedded plastic anchor. Treatment: remove plastic anchor and patch void with a color matched restoration

Condition: Gypsum soiling (typical on underside). Treatment: chemical or micro-abrasive cleaning

Condition: Existing ferrous anchors holding wire in place in mortar joint. Treatment: If wire is being removed, patch limestone if needed, repoint.

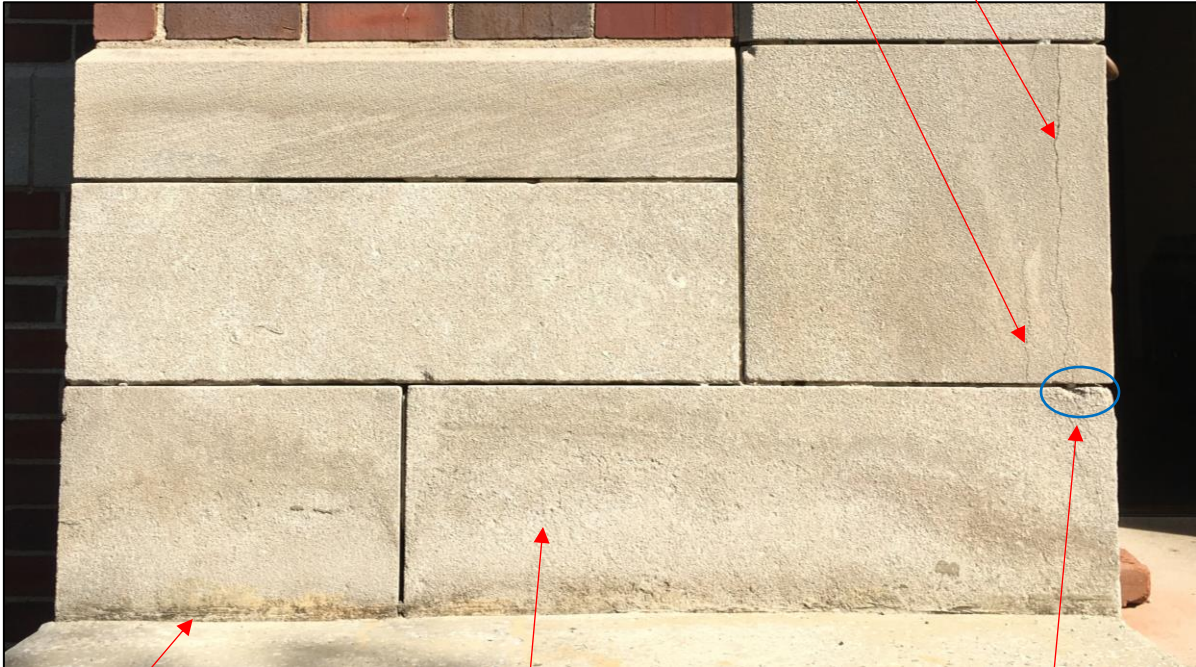
## Stone Pier Base- West Elevation

Condition: Open vertical crack/potential spall on stone face (2). Treatment: inject crack with color matched injection grout

Condition: No mortar remaining in joint between limestone and concrete. Treatment: Fill with backer rod if needed and repoint with compatible mortar.

Condition: Stone loss, deterioration. Treatment: Remove deteriorated stone and patch with compatible restoration mortar.

Condition: Eroded stone surface. Treatment: no treatment recommendation other than reduce the amount of salt products used on the concrete

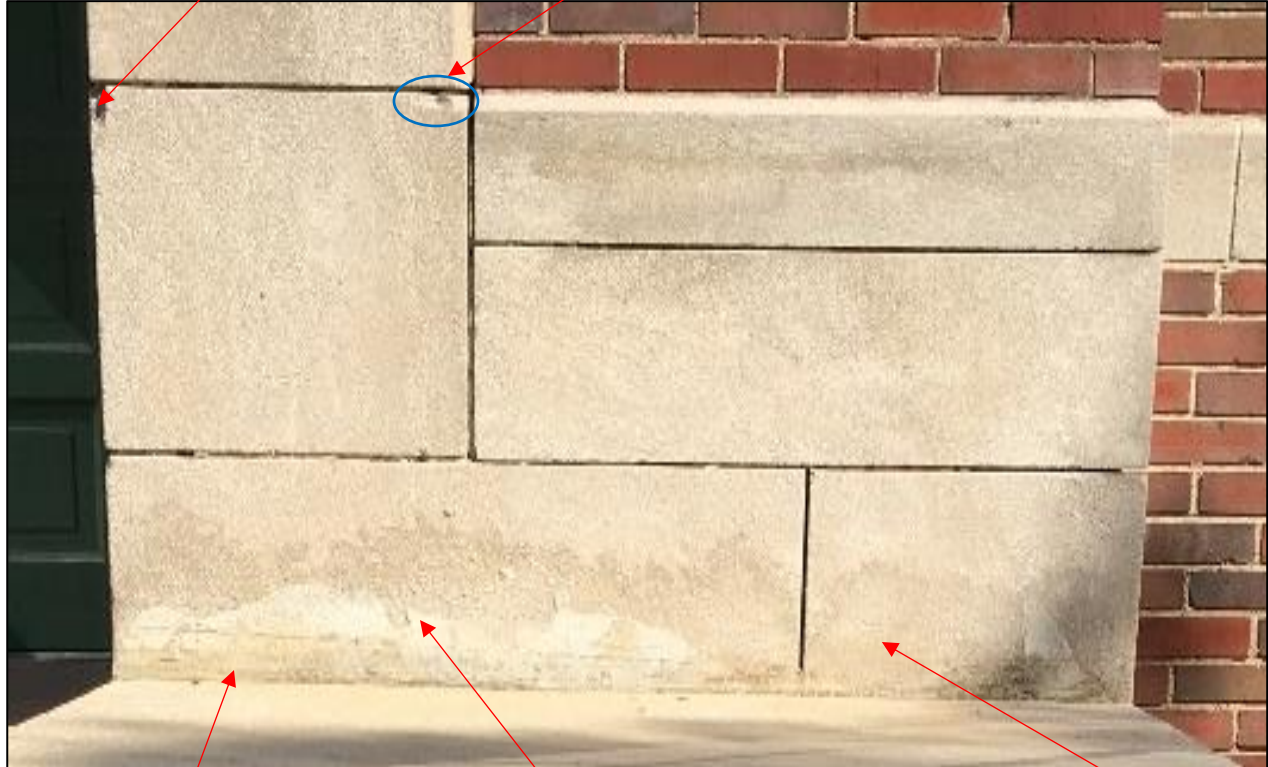
## Stone Pier Base – East Elevation

Condition: Stone loss, deterioration, open cracks (1) and hairline cracks (on stone return). Treatment: Remove deteriorated stone and patch with compatible restoration mortar, inject crack with injection grout.

Condition: Stone loss. Treatment: No treatment recommended for such a small loss.

Condition: No mortar remaining in joint between limestone and concrete. Treatment: Fill with backer rod if needed and repoint with compatible mortar.

Condition: Concrete or cementitious material on the surface of the bottom stones on the stone pier base. No treatment recommendation to remove concrete smears

Condition: Eroded stone surface. Treatment: no treatment recommendation other than reduce the amount of salt products used on the concrete for future maintenance or use another de-icing product

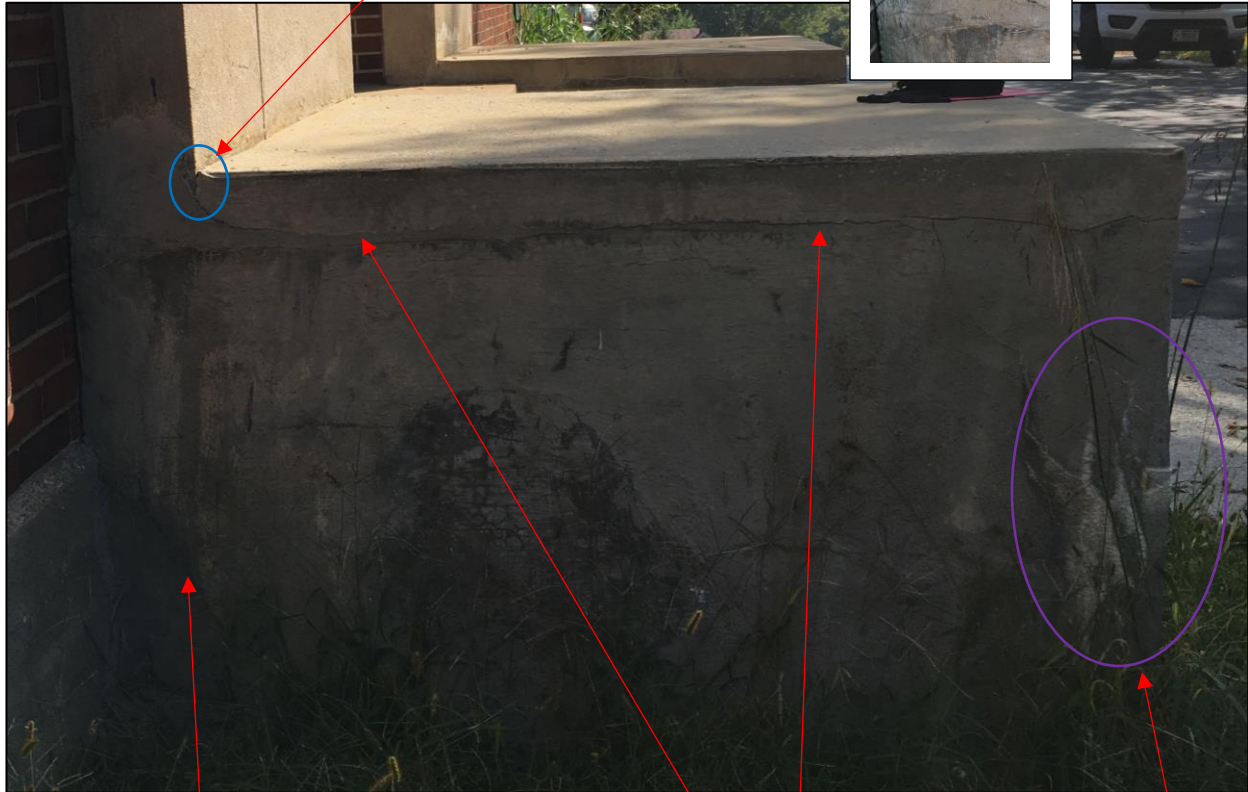
## Concrete Plinth Base- West Elevation (Side)

Condition: Stone loss, failed patch. Treatment: Remove deteriorated stone and patch with compatible restoration mortar.

Condition: Open crack around previous repair. Treatment: inject crack with color matched injection grout

Condition: Open crack around previous repair. Treatment: inject crack with color matched injection

Condition: Calcite/mineral deposits leaching from open joints/cracks. Treatment: Manually remove calcite/mineral deposits with scrapers, or a micro-abrasion system

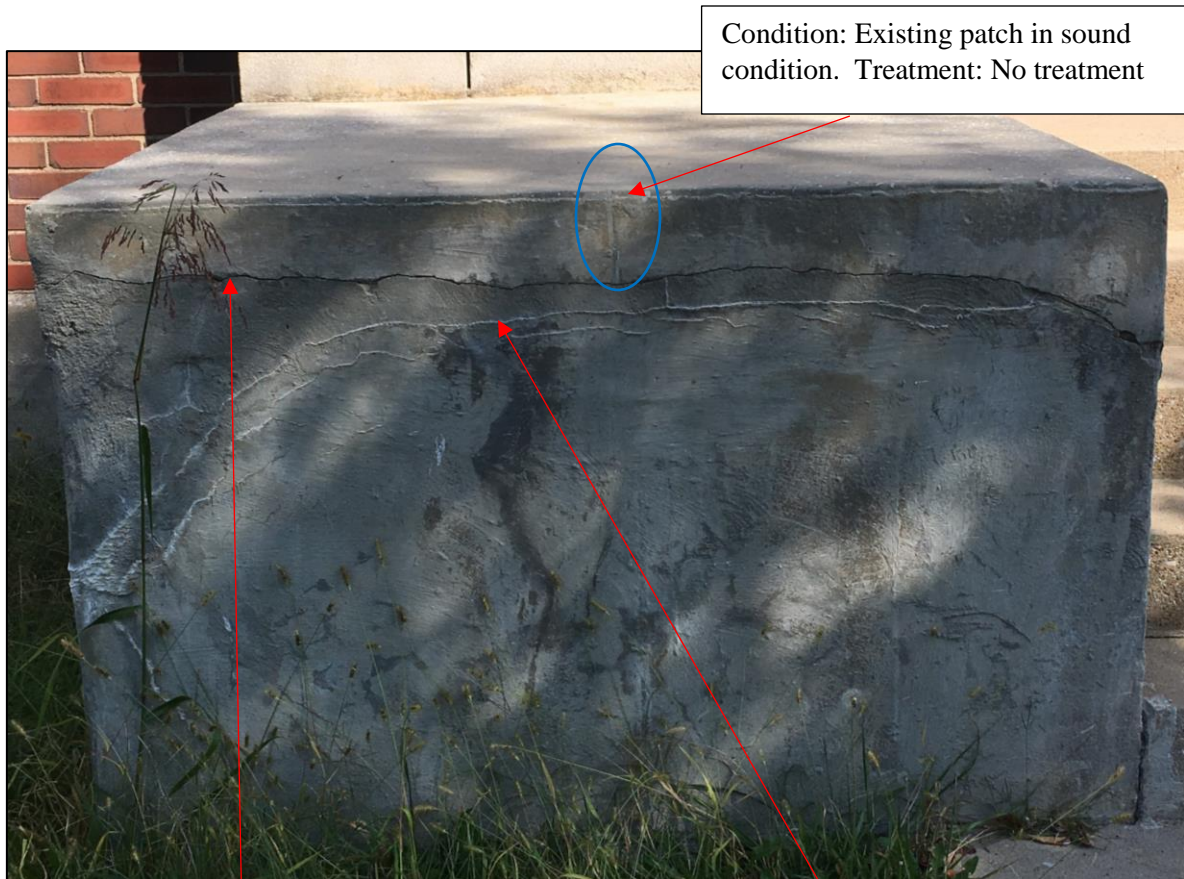
## Concrete Plinth Base- West Elevation (Front)

Condition: Existing patch in sound condition. Treatment: No treatment

Condition: Open crack around previous repair (runs the length of the plinth base). Treatment: inject crack with color matched injection grout

Condition: Calcite/mineral deposits leaching from open joints/cracks. Treatment: Manually remove calcite/mineral deposits with scrapers, or a micro-abrasion system

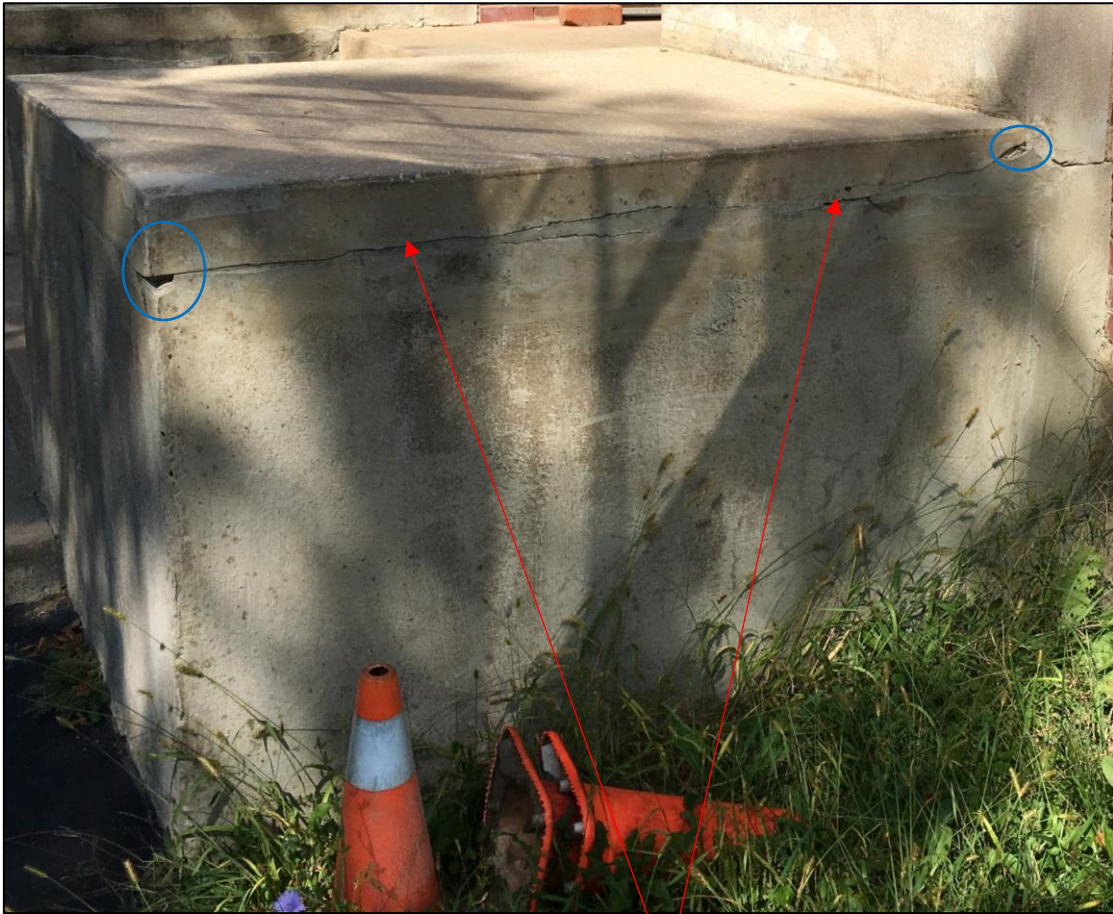
## Concrete Plinth Base- East Elevation (Side)

Condition: Open crack around previous repair (runs the length of the plinth base to the front), previous repair may not be sound. Treatment: inject crack with color matched injection grout OR remove existing repair and install new patch with compatible restoration mortar. Red arrow shows crack along repair, blue circle shows voids/losses in the previous repair.

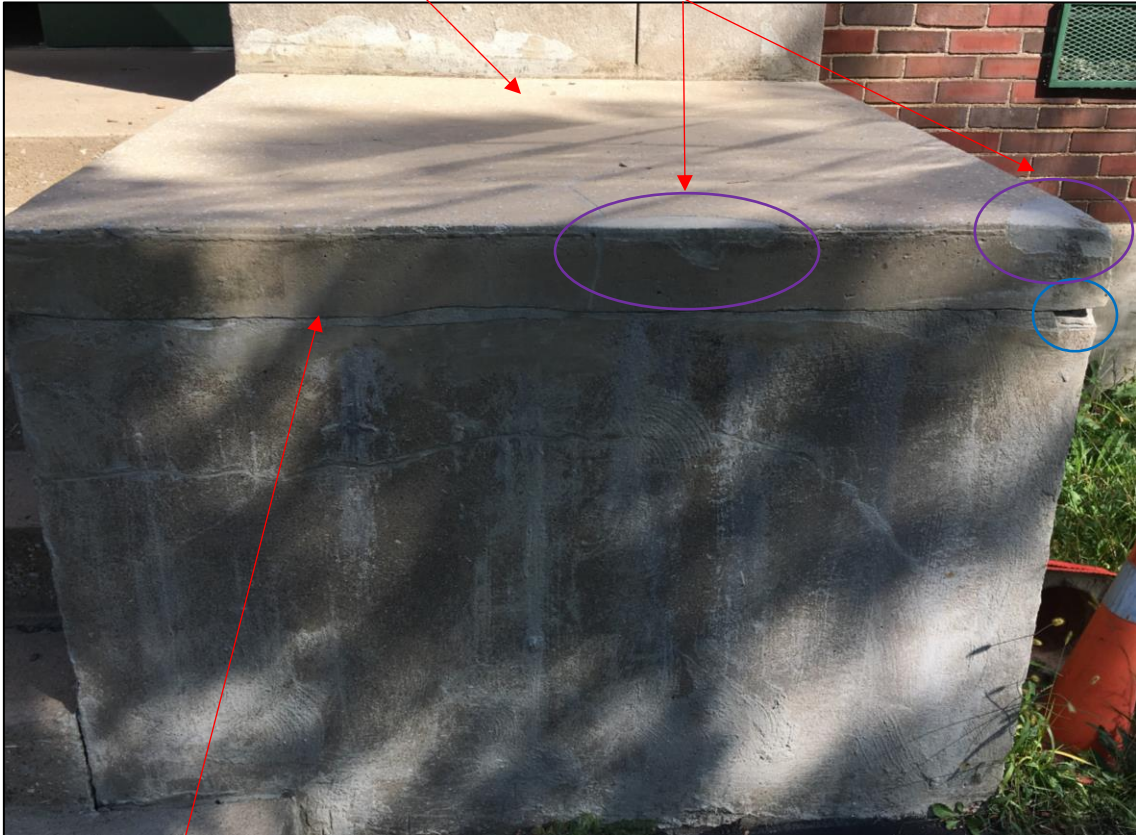
## Concrete Plinth Base- East Elevation (Front & Top)

Condition: Open crack. Treatment: inject crack with color matched injection grout

Condition: Existing patch in sound condition. Treatment: No treatment, in-paint if necessary

Condition: Open crack around previous repair (runs the length of the plinth base from the front to the side), previous repair may not be sound. Treatment: inject crack with color matched injection grout OR remove existing repair and install new patch with compatible restoration mortar. Red arrow shows crack along repair, blue circle shows voids/losses in the previous repair.

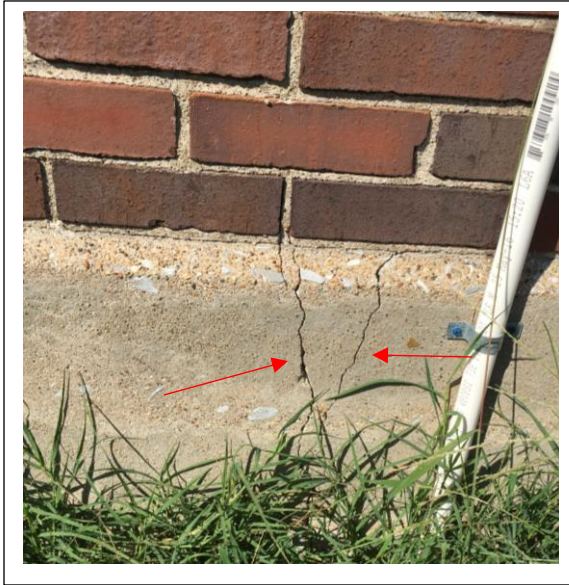
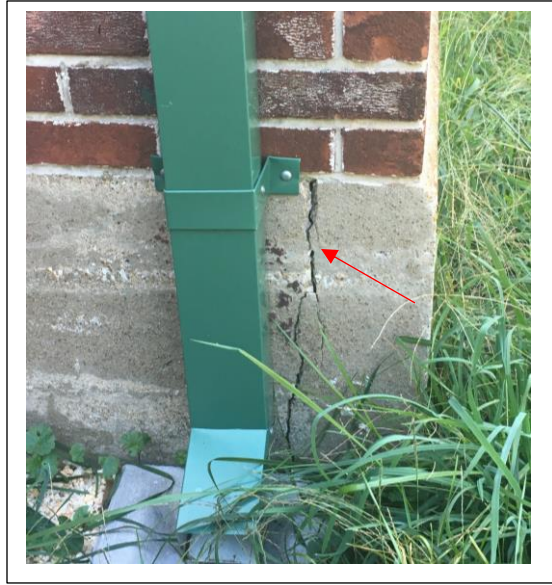
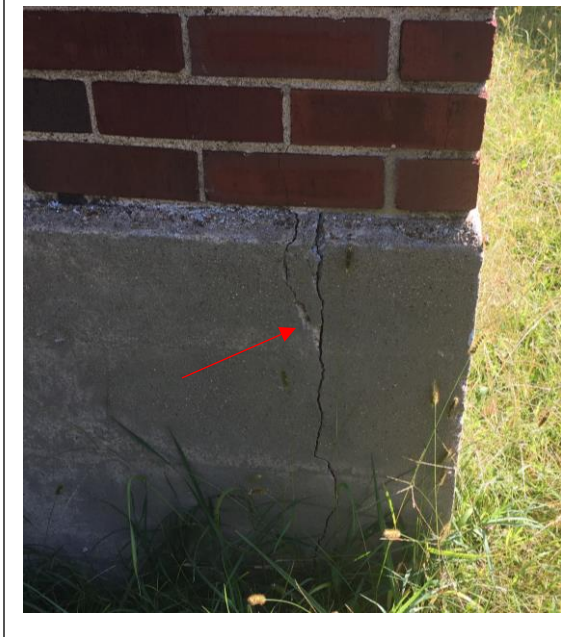
## Concrete Foundation

Condition: Cracks along concrete foundation (typical on elevations).  
Treatment: Inject cracks with color matched injection mortar, patch larger areas not filled with injection grout with color matched restoration mortar (see red arrows indicating typical cracks in the foundation)
