PMIS 187452 --- Restoring Larry Damm Creek
Site Condition Photos

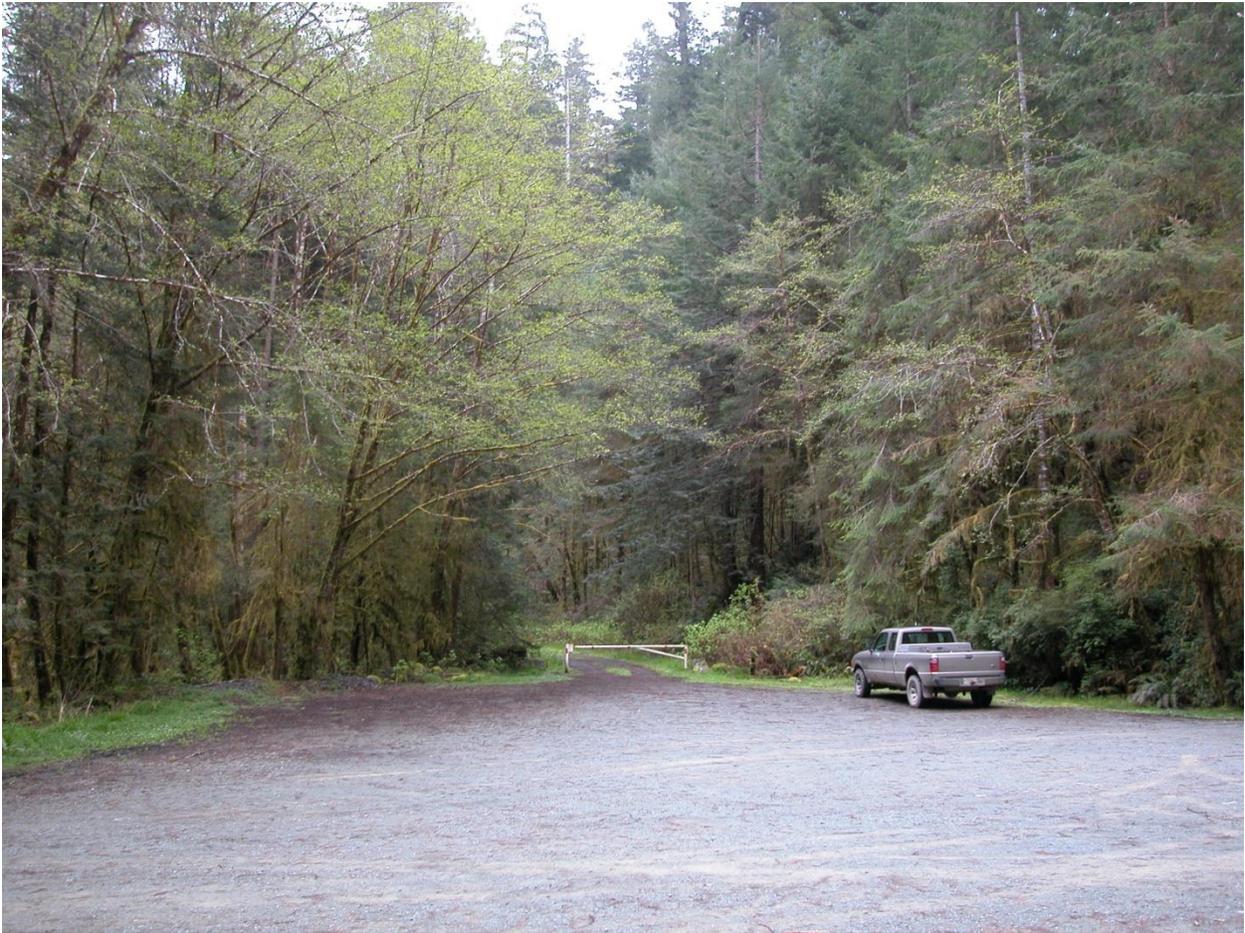
Figure 1: Entrance to the Lower B500 from the Lost Man Creek picnic area.

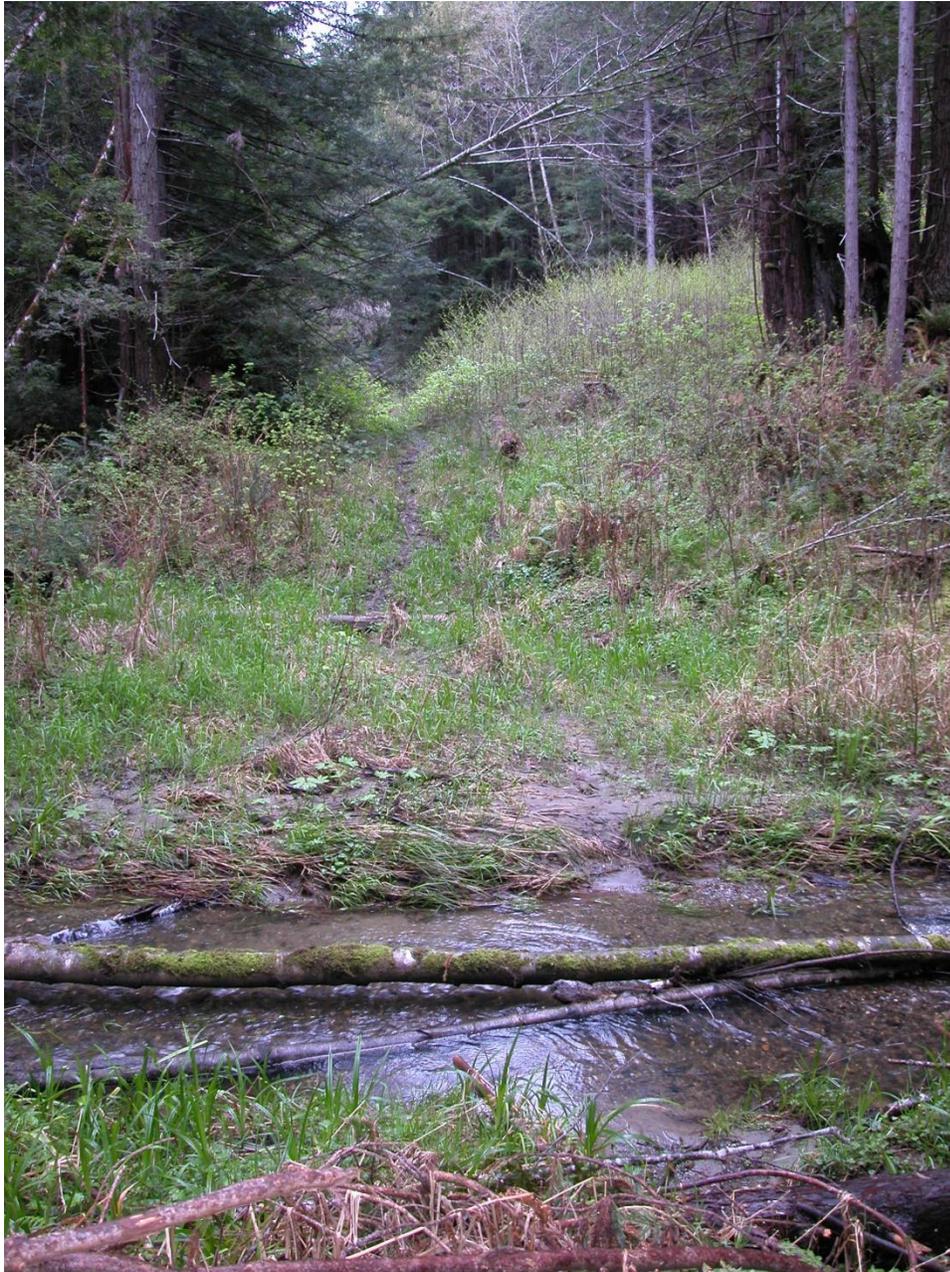
Figure 2: Example of the removed portion of the Lower B500 and Larry Damm Creek. Site was excavated in 2004.

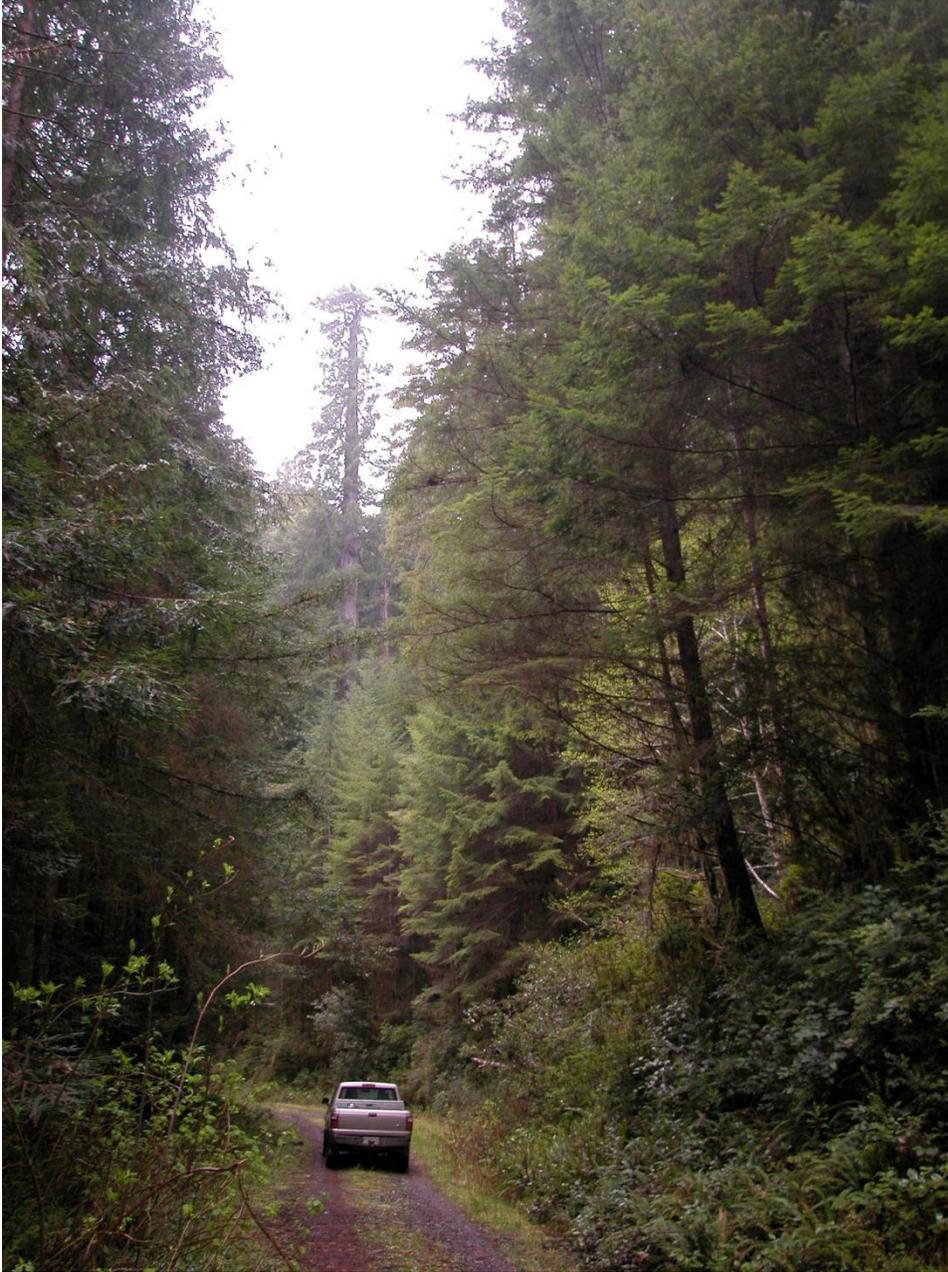
Figure 3: Corridor of the Lower B500 through surrounding old growth forest.

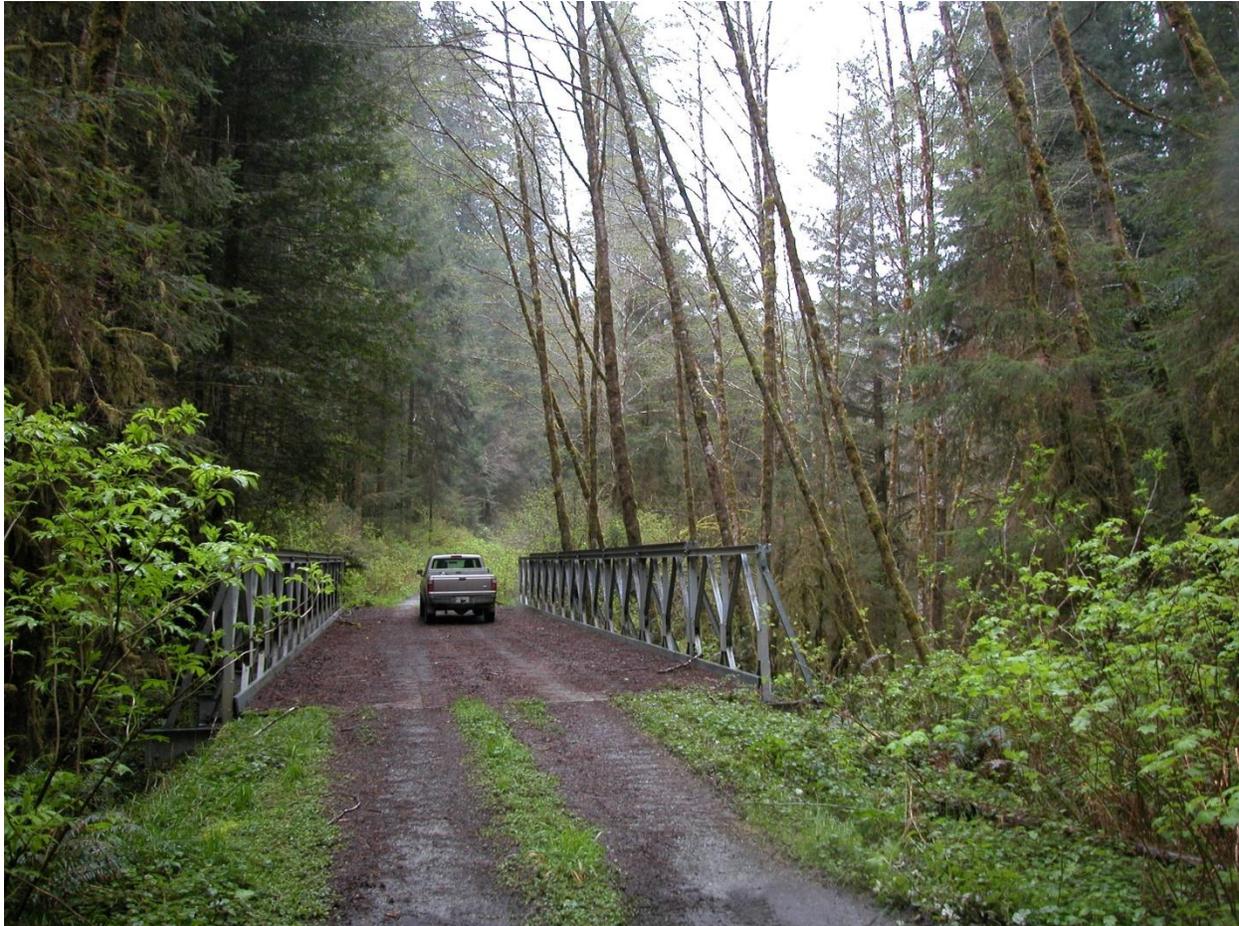
Figure 4: Modular steel bridge installed to enable equipment to access upper portion of the Larry Damm watershed for restoration work. Bridge was installed in 1999 to cross a failing log stringer bridge. (See Figure 5.) Bridge will be removed and staged for use in other locations within the park of region.

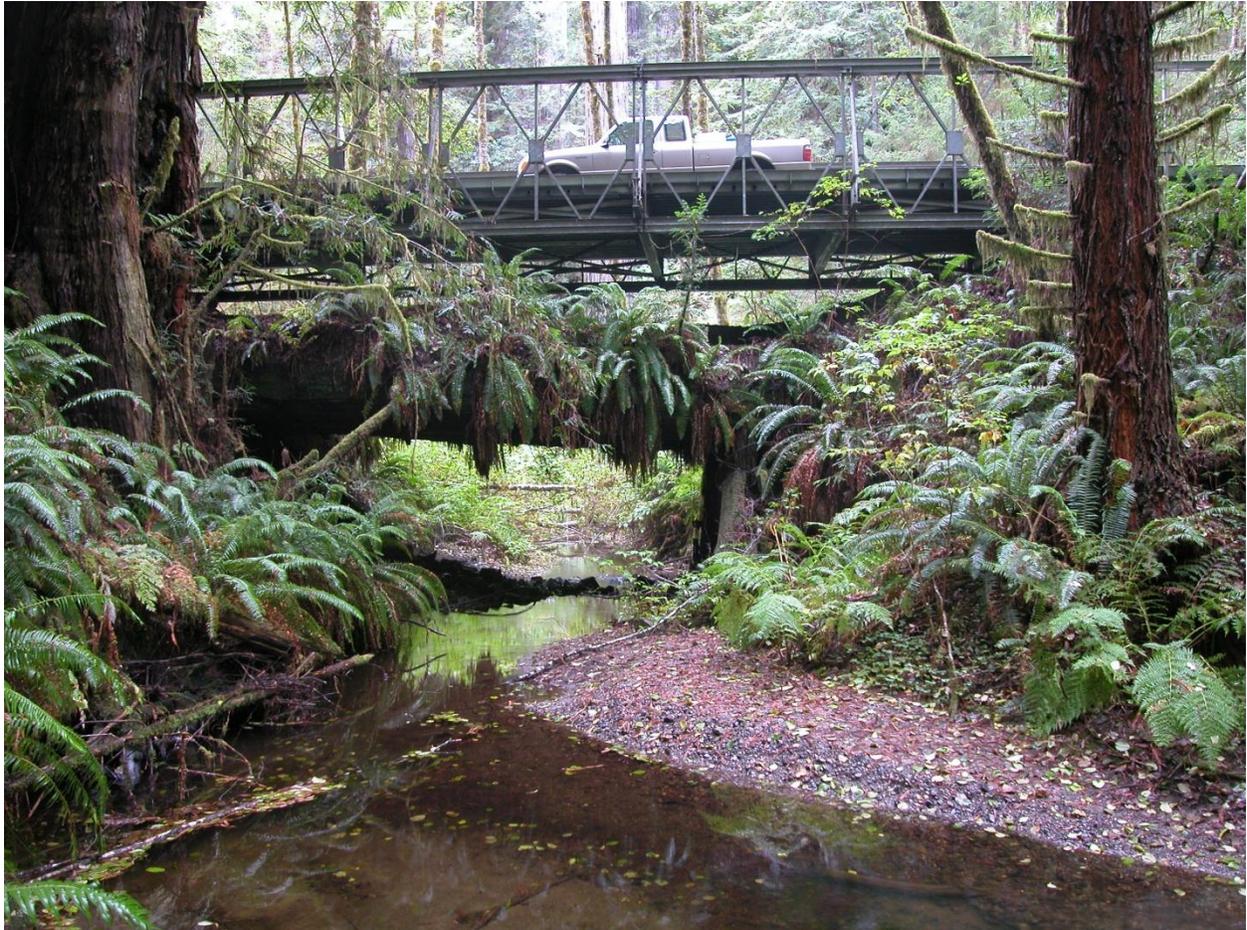
Figure 5: Side photo of modular bridge and failing log stringer bridge crossing the main stem of Larry Damm Creek. Original surface of the log bridge was at the base of the modular bridge but the right abutment has been gradually failing. Collapse of the existing log stringers poses a threat to fish passage to upstream portion of Larry Damm Creek.
