NAME
Historic Joshua Sears Building (Rehabilitated Land + Improvement Co. TR)
Common _____ Site No. _____

Number & Street 701 Market Street Not for Publication _____
City or Town Kirkland Zip 98033
Incorporated Unincorporated _____ Community name Kirkland
Congressional District 2 Community Planning District Market
State Legislative District 45 Zoning Community Business
County Council District 3 Shoreline Environment Urban

FORM PREPARED BY (PRINT) Loel Kuhl
Signature *Loel Kuhl* Date 10/26/77
Organization King County Historic Sites Survey
Address 1955 6th Avenue W., Seattle, Wa. 98119 Phone 284-8556

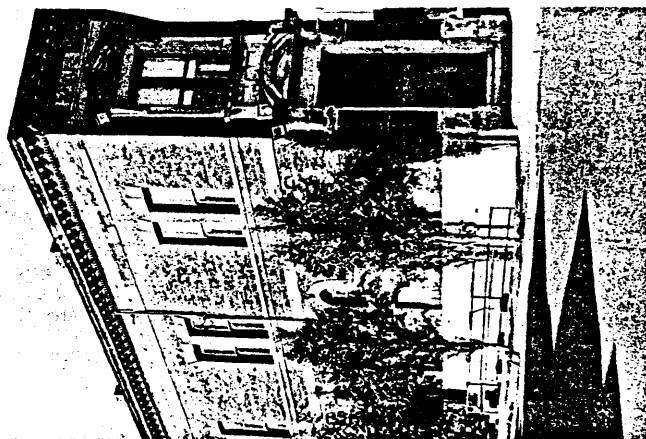
The Sears Building stands on its original site. The lot only slightly exceeds the size of the building, and is situated on a gentle southern slope. The structure is sound but detailing and decorative features are deteriorating. The metal is rusting and the cast ornamental concrete is falling away in places. There have been doorways added to accommodate the change from commercial use to apartments and some window openings have been bricked in.
