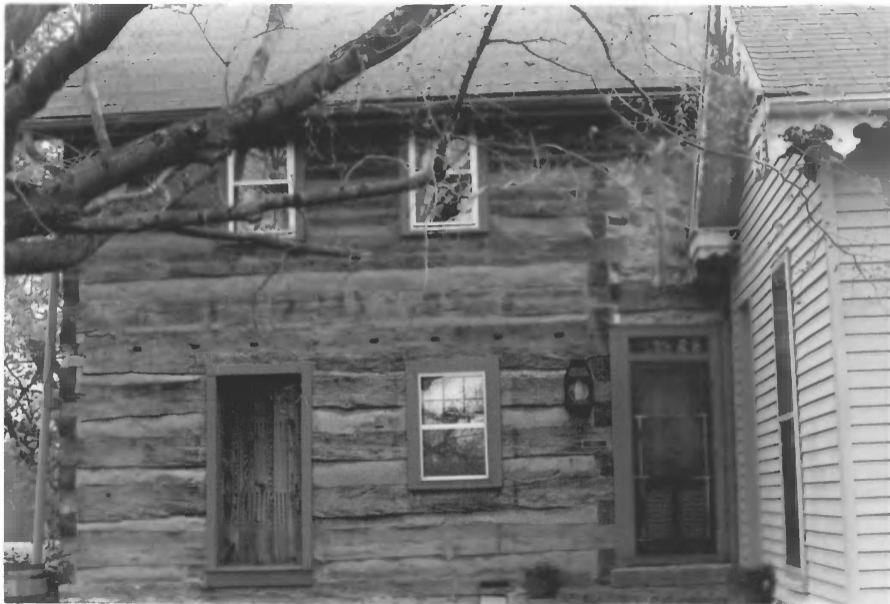
④

NOTE: OVAL HOLES IN LOGS
ABOUT 1/2 WAY UP - PROBABLY
ANCHOR HOLES FOR EARLY
PORCH ROOF.

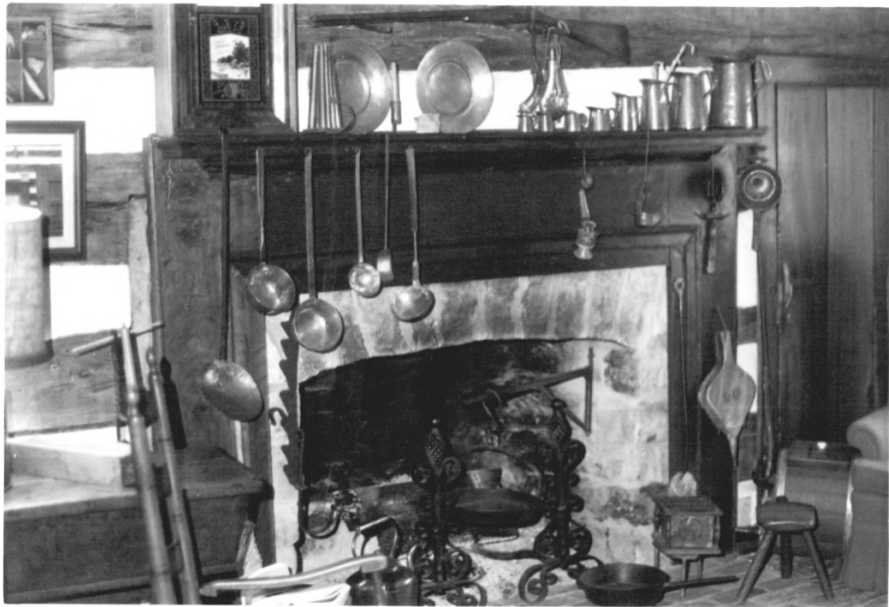
6

ORIGINAL MANTEL.

FIRE PLACE ALSO HAS
ORIGINAL WARMING OVEN

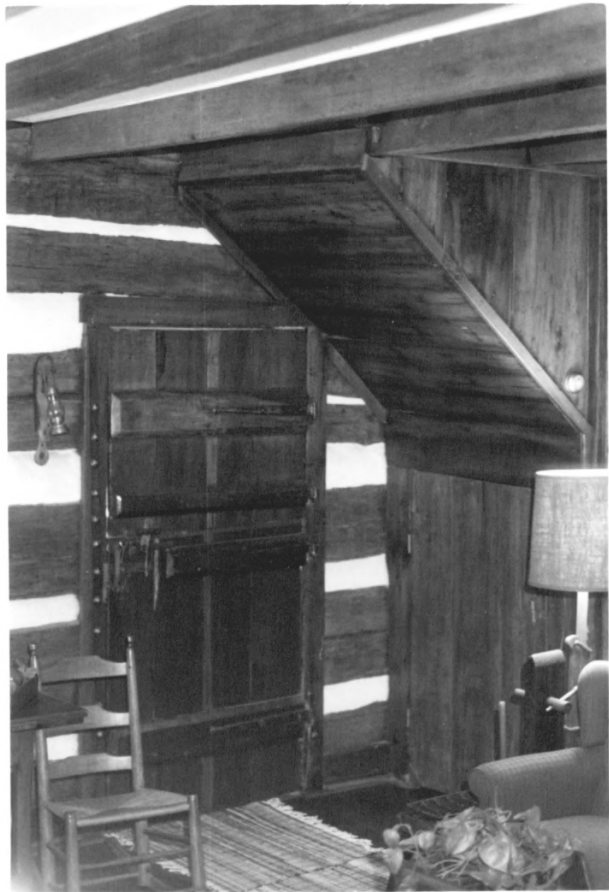
⑦

ORIGINAL PANELING —
" DOOR & STRAP
Hinges - (see 7A)

NOTE MORTISE & TENON
CONSTRUCTION (see 7B)

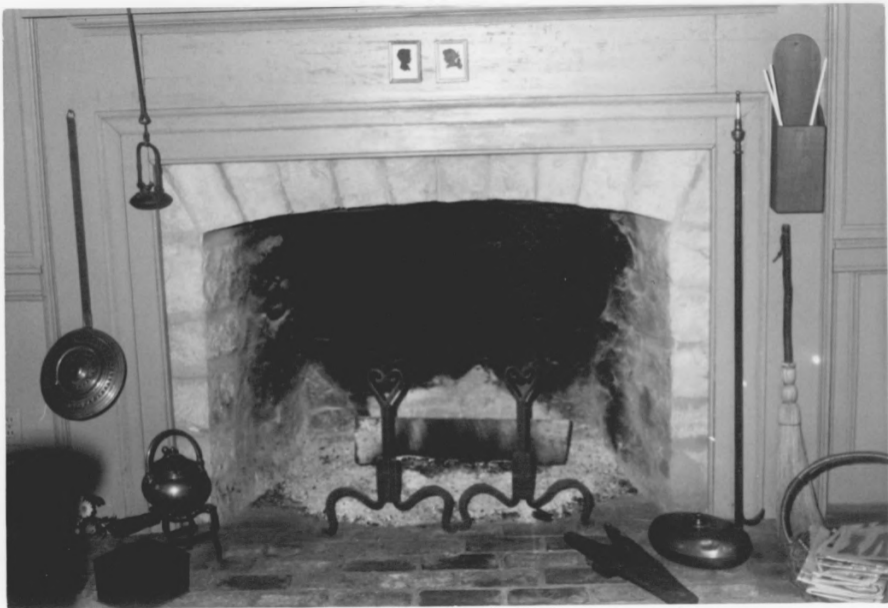
(11)

ORIGINAL MANTEL
& STONE in FIREPLACE
