REGIONAL OFFICE Memorandum

TRIP REPORT

DATE: Nov. 17, 2020
FROM: Kim Sykes, Regions 8, 9, 10 & 12 Architect
SUBJECT: Trip Report – LAVO November 10-11, 2020
TO: For the Record

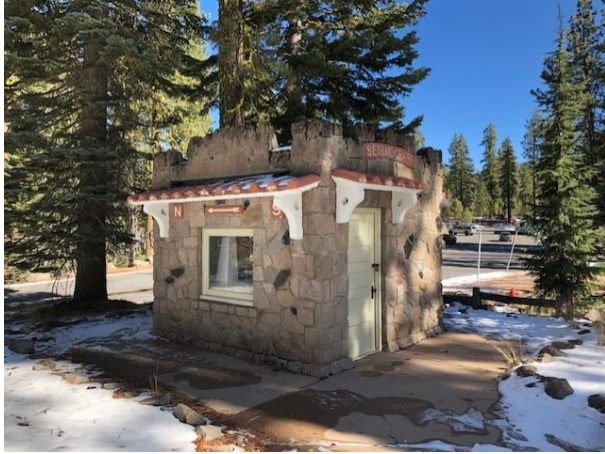
Wednesday on the Veteran's holiday I explored the Manzanita Lake area, NW quadrant of the park. Gary had mentioned a stone parapet detail on the seismograph building that he wanted me to review for damage and safety and encouraged me to take in the postcard views within the park. I reviewed the detail at the seismograph building and the exposed rebar and missing concrete mortar to keep the stone in place is concerning. I suggested the park limit access to that side of the small building where visitors can see seismograph equipment through a window. I encouraged he create a PMIS to address the repair need and work with a historical architect to address the detail repair scope. The same detail is also extant at the Loomis Museum building where cracking and missing mortar was also observed. The thaw and freeze cycle is challenging for concrete mortar repair and a special mix is needed and work conditions need to be optimal.

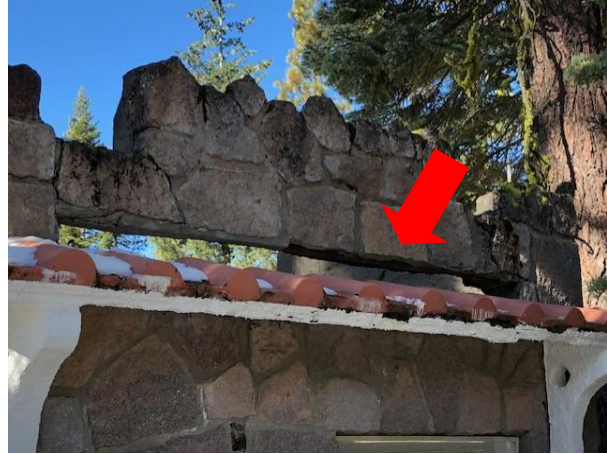
Previous repairs on the eave details have failed. Cyclic funding (PMIS 131854 and PMIS 83322) funded 2 projects over 10 years ago. The stone and concrete details are failing again. Right photo below with red arrow shows missing mortar and exposed rebar with a lot of cracks in the mortar at future failure points. For safety, this needs to be addressed sooner than later to prevent the entire stone detail to fail and fall to the ground.

Seismograph Building – Right Photo - East Elevation Detail showing rebar exposure

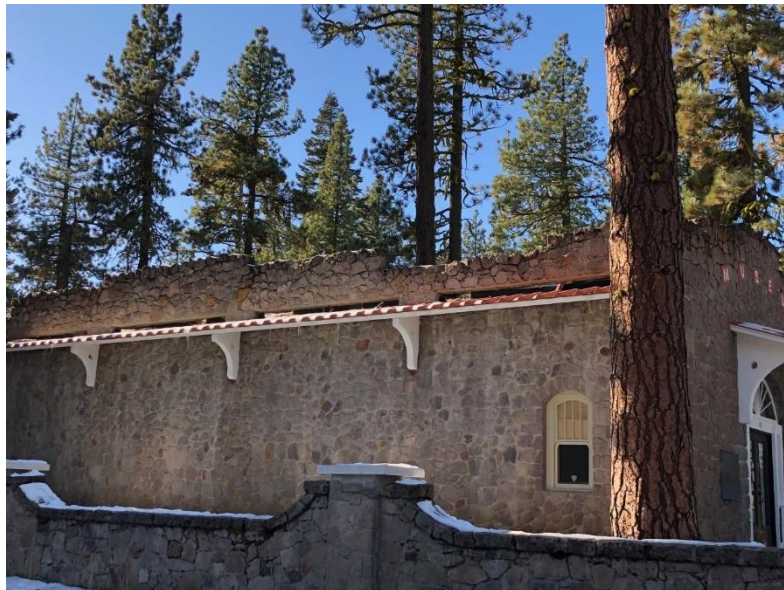
Loomis Museum has nearly same detail

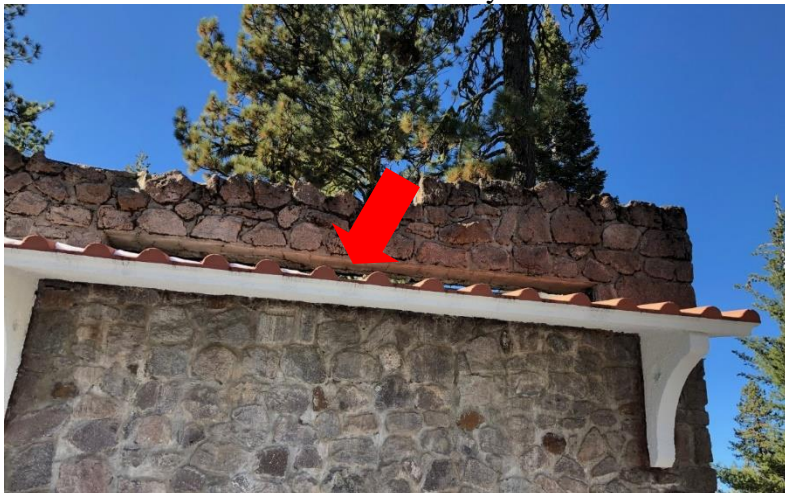
Loomis Museum – SW corner detail appears to have exposed rebar.
Other signs of cracking, missing mortar at other Museum roof locations.
