**BERGEN COUNTY STONE HOUSE SURVEY**  
**INDIVIDUAL STRUCTURE SURVEY FORM**

HISTORIC NAME: (G.V.H.) Berdan House  
 COMMON NAME:  
 LOCATION: 1219 River Road.  
 (Block 5611, Lot 51/53)  
 MUNICIPALITY: Fair Lawn  
 OWNERSHIP:  Public  Private  
 OWNER/ADDRESS: Frank Bruno

BERGEN COUNTY STONE HOUSE SURVEY  
HISTORIC NAME: G. V. H. Berdan House  
LOCATION: 1219 River Road, Fair Lawn

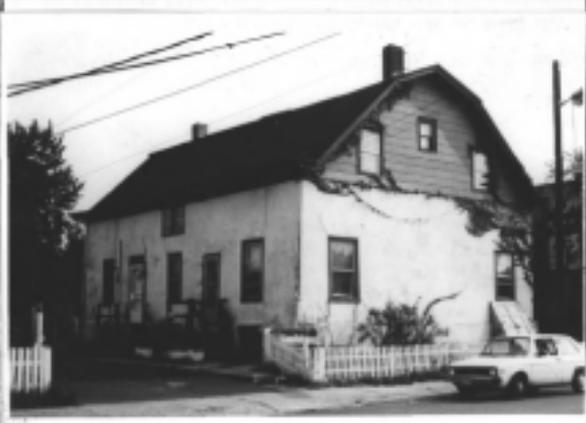
**PHOTO**

The house has been converted into a 2-family house and has had several interior changes: additional partitions, fireplace closed up and general modernizations. The former entrance has been blocked up, although the lines of its 6'0" opening with fan light transom show through. The rear door has been completely filled in and two windows were changed into doors. The exterior has been stuccoed over.

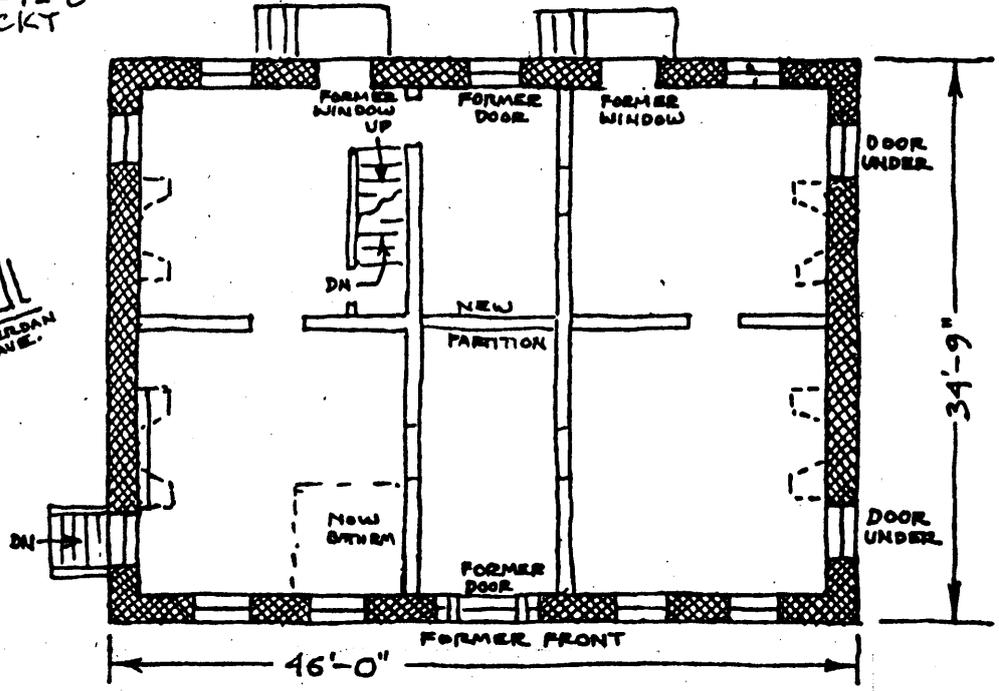
PRESENT 2-FAMILY ENTRANCES
