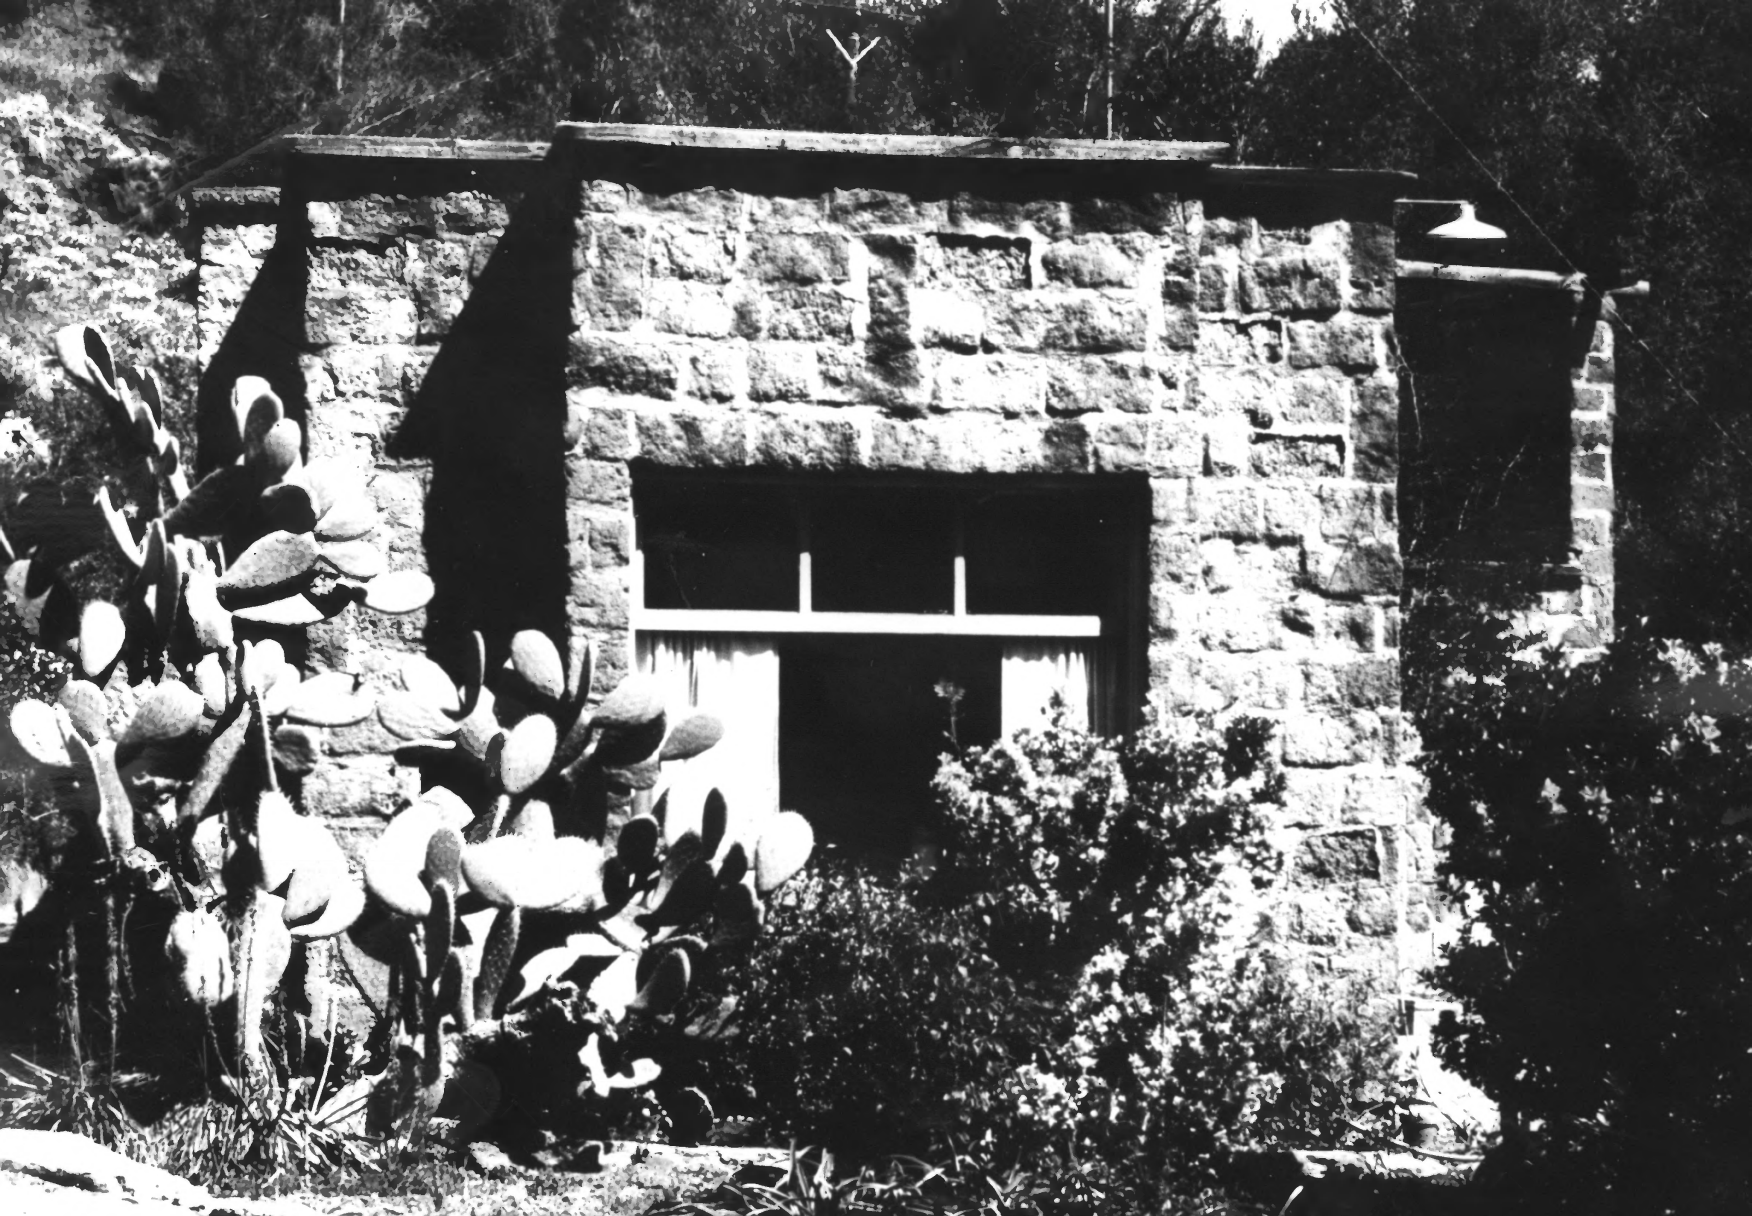
A. Woodhills. View of the south end of the studio and pool house. Walls are veneered with salvaged oven-fired thick adobe terrace or patio tile. The old rose garden and swimming pool are to the right, out of the picture.
Photo taken late Fall 1976.

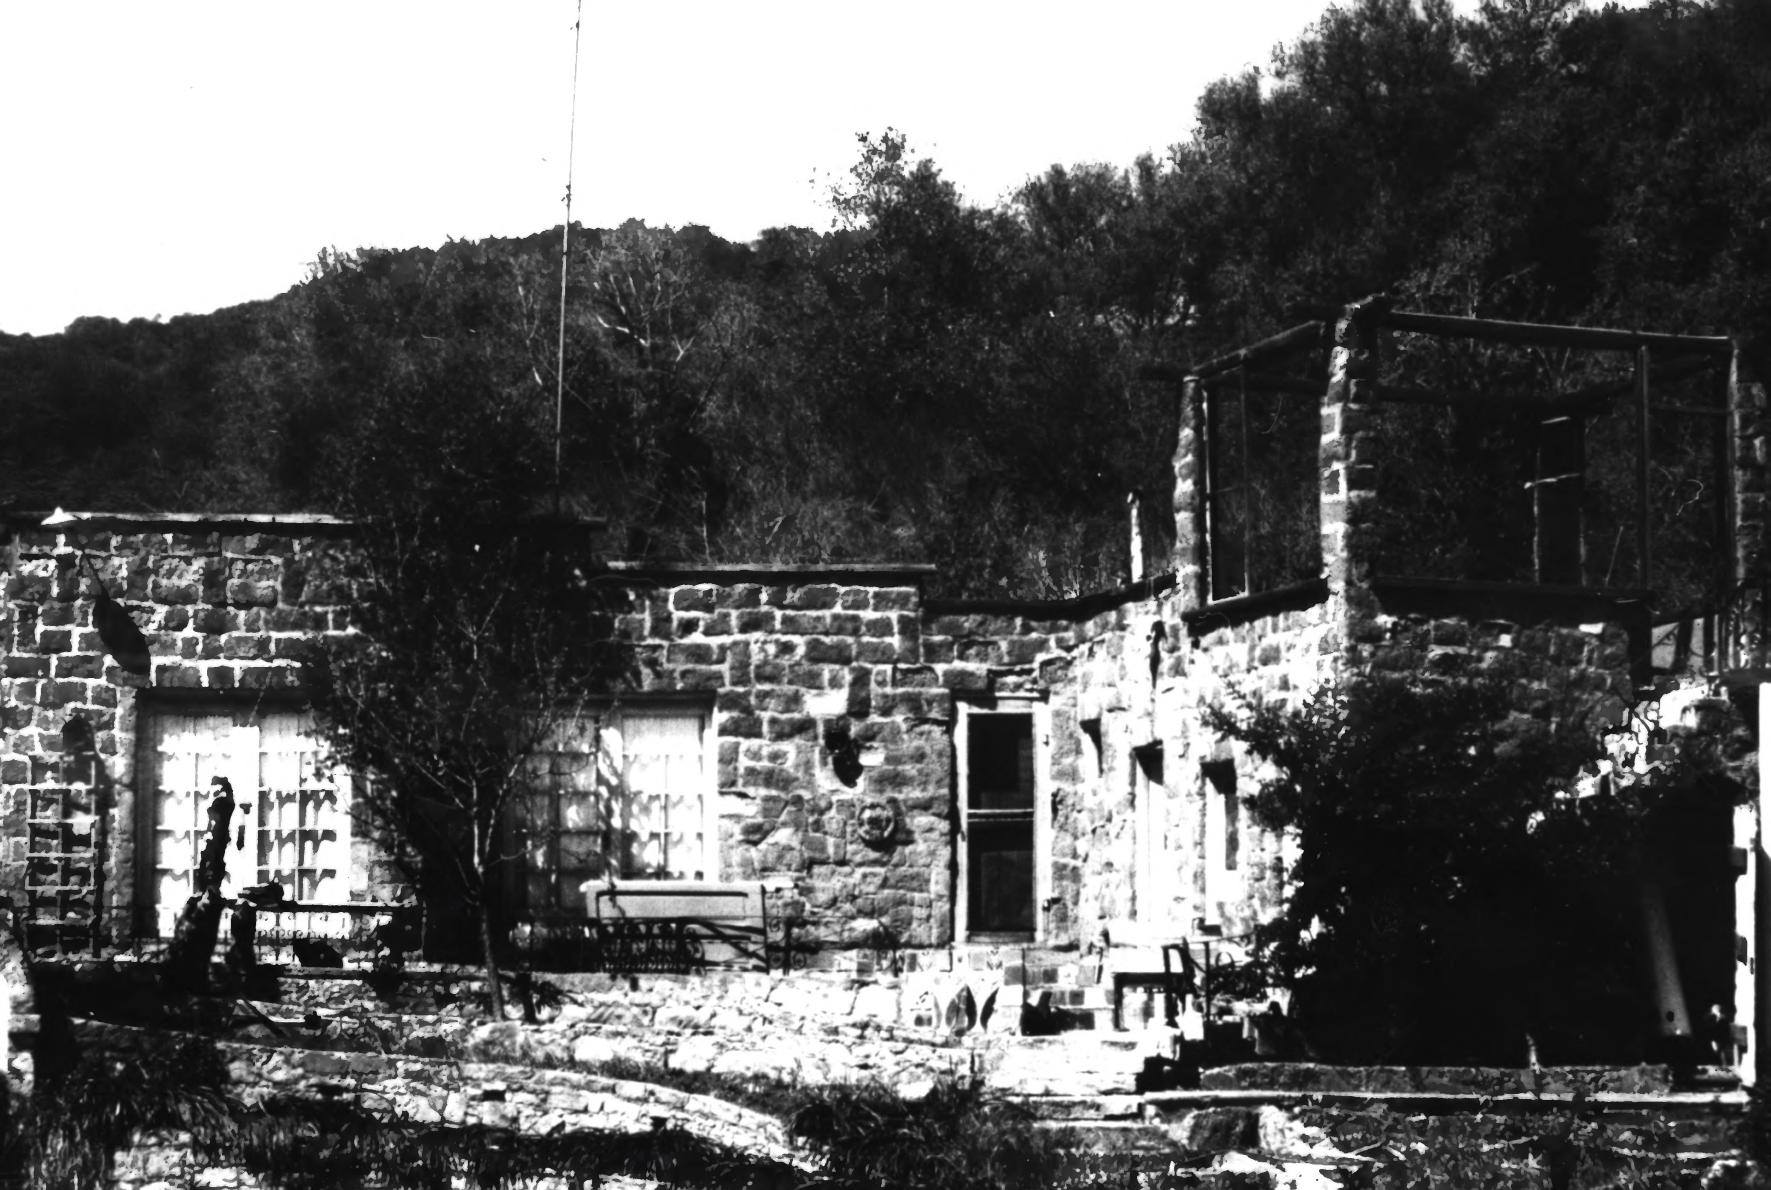
B. Woodhills. View of the fired adobe tile veneered studio and pool house from the old rose garden. The second floor solarium framing held stained glass panels and opened to the sky.

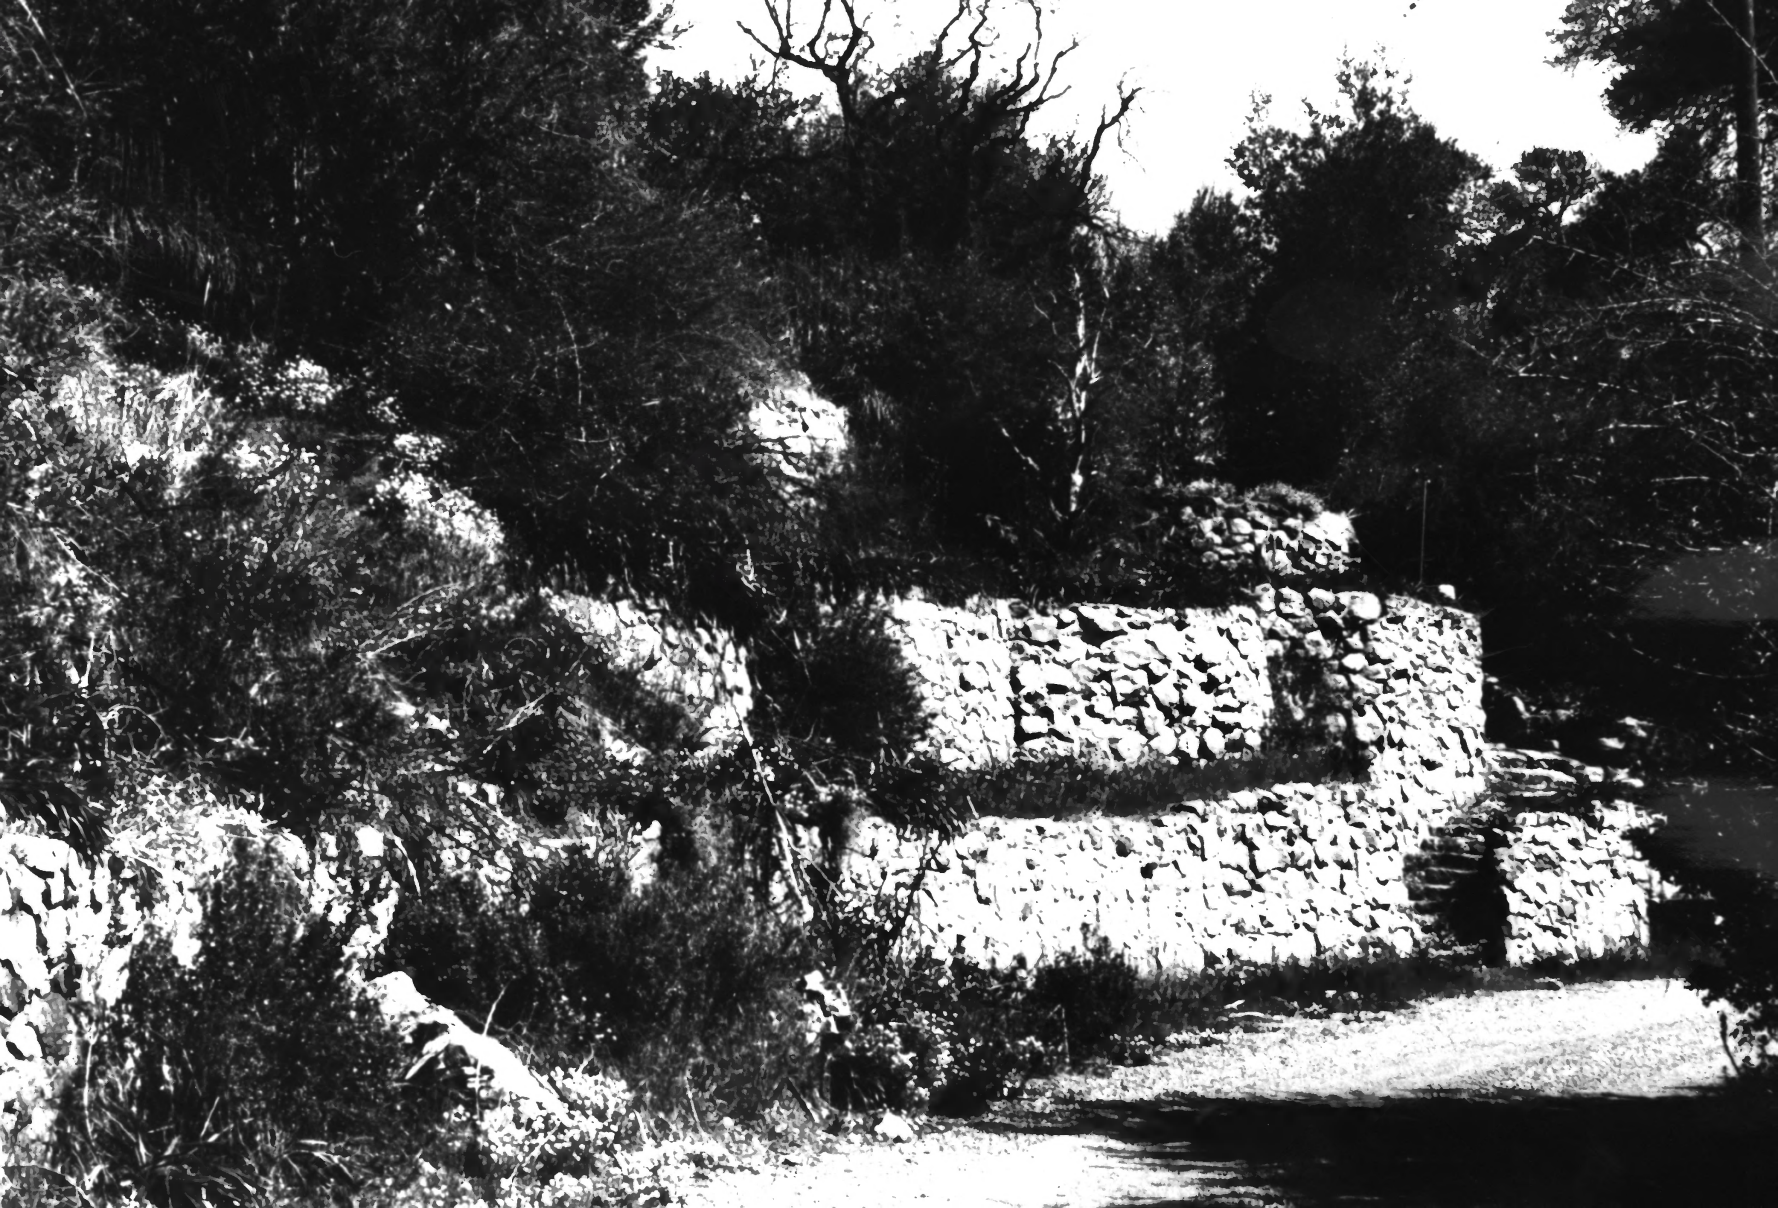
C. Woodhills. Photo on the driveway between the studio and the main house above and to the left. Part of the ornamental stone retaining walls and stairs are shown. The landscaping has been neglected for a number of years. Photo taken late Fall 1976.

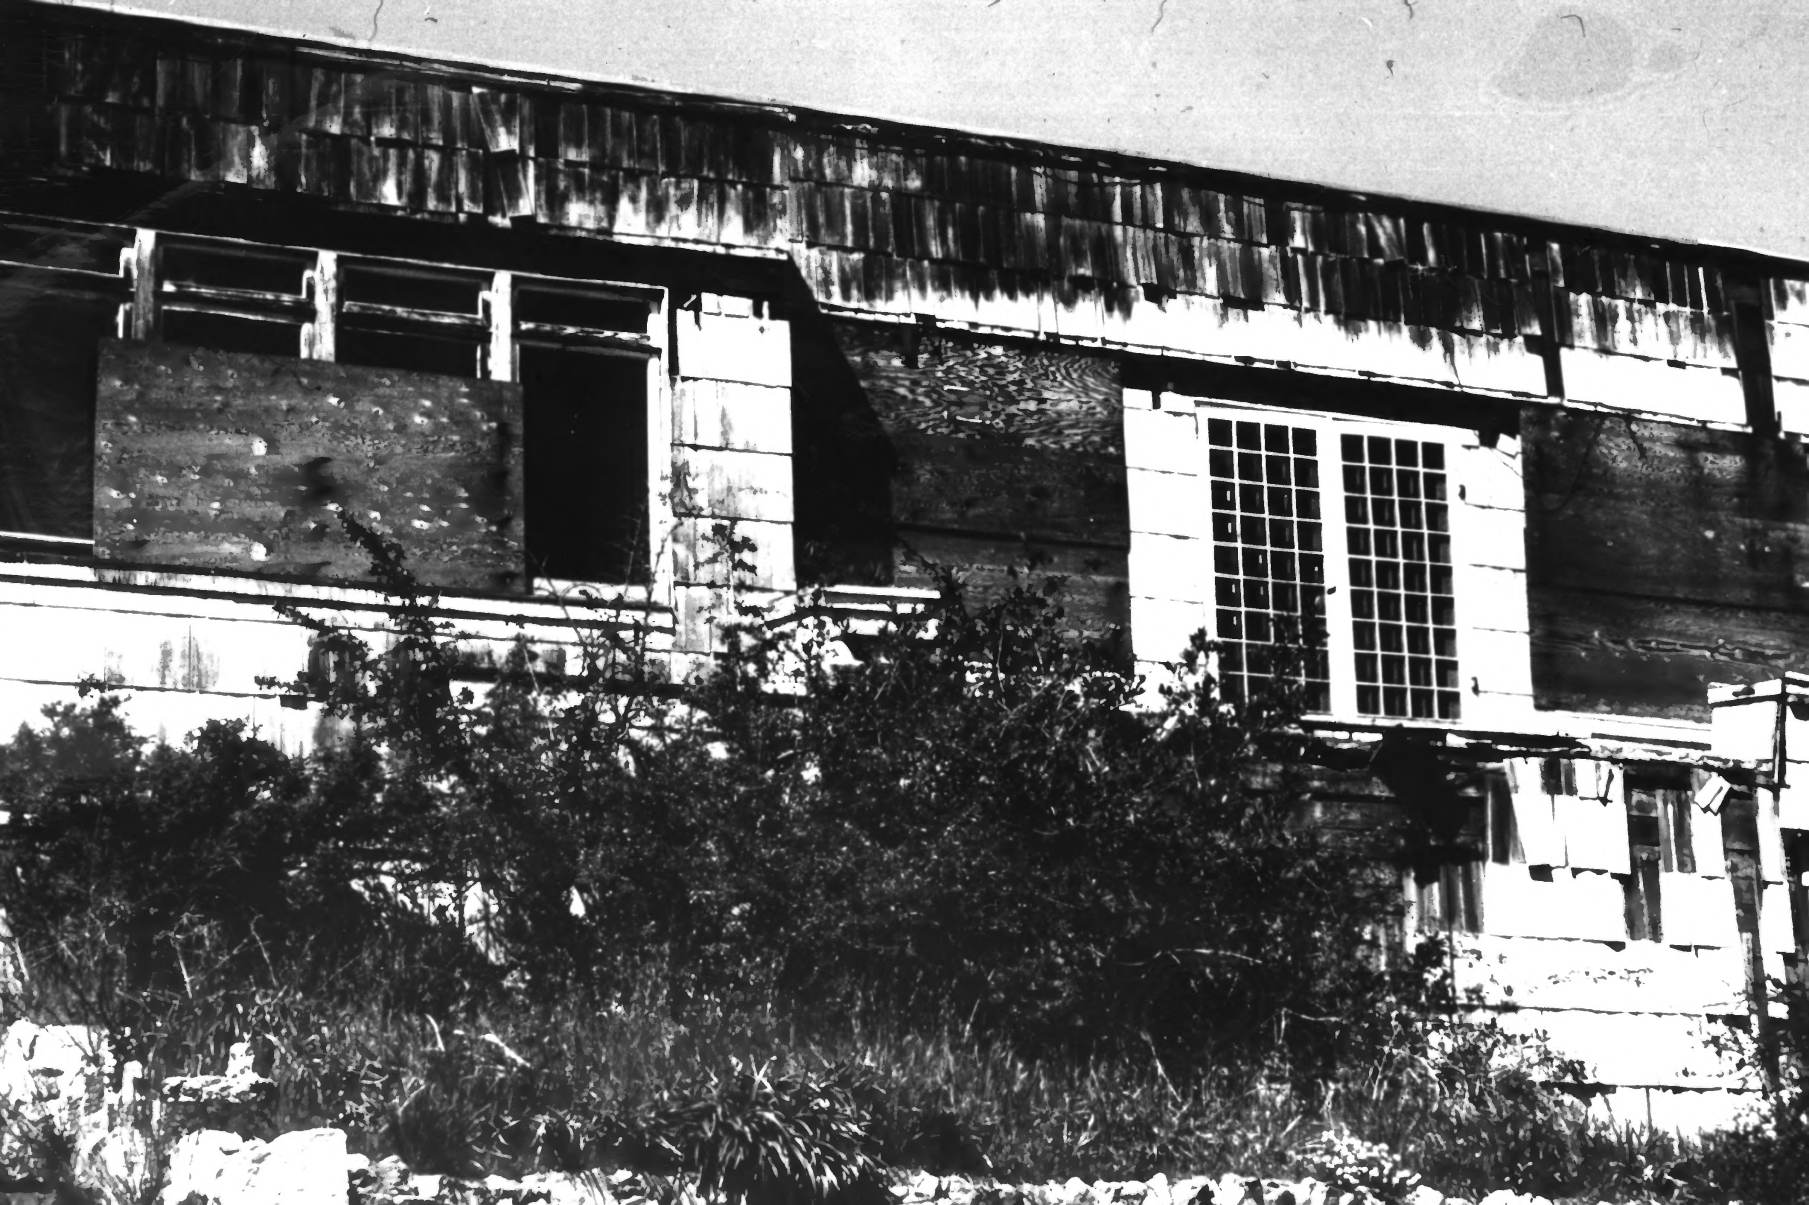
D. Woodhills. Photo shows part of the front of the main house, neglect, deliberate spiteful damage by the previous owner (a New Jersey speculator developer) followed by numerous acts of vandalism detracts from its former simple beauty.

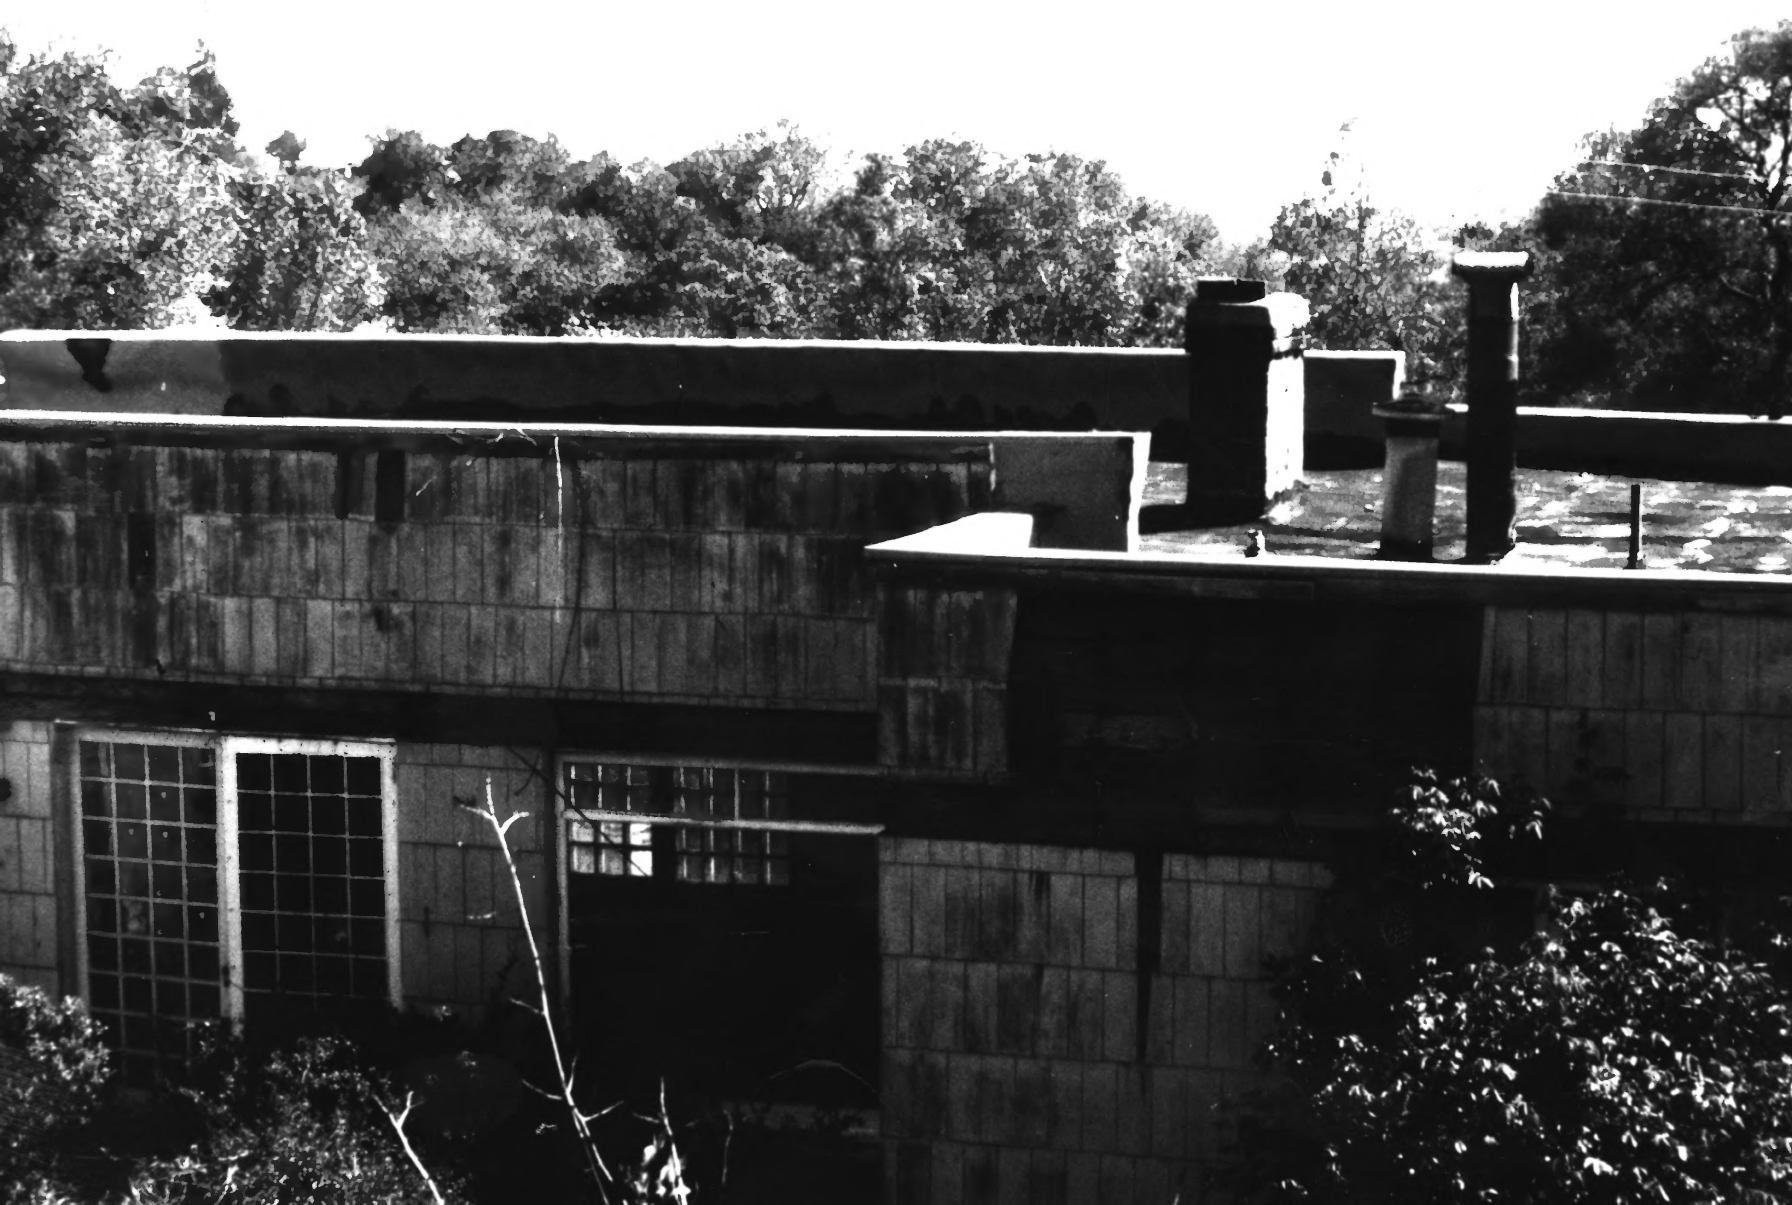
E. Woodhills. Photo shows a part of
the rear exterior of the main house and
the tops of brush in the overgrown patio

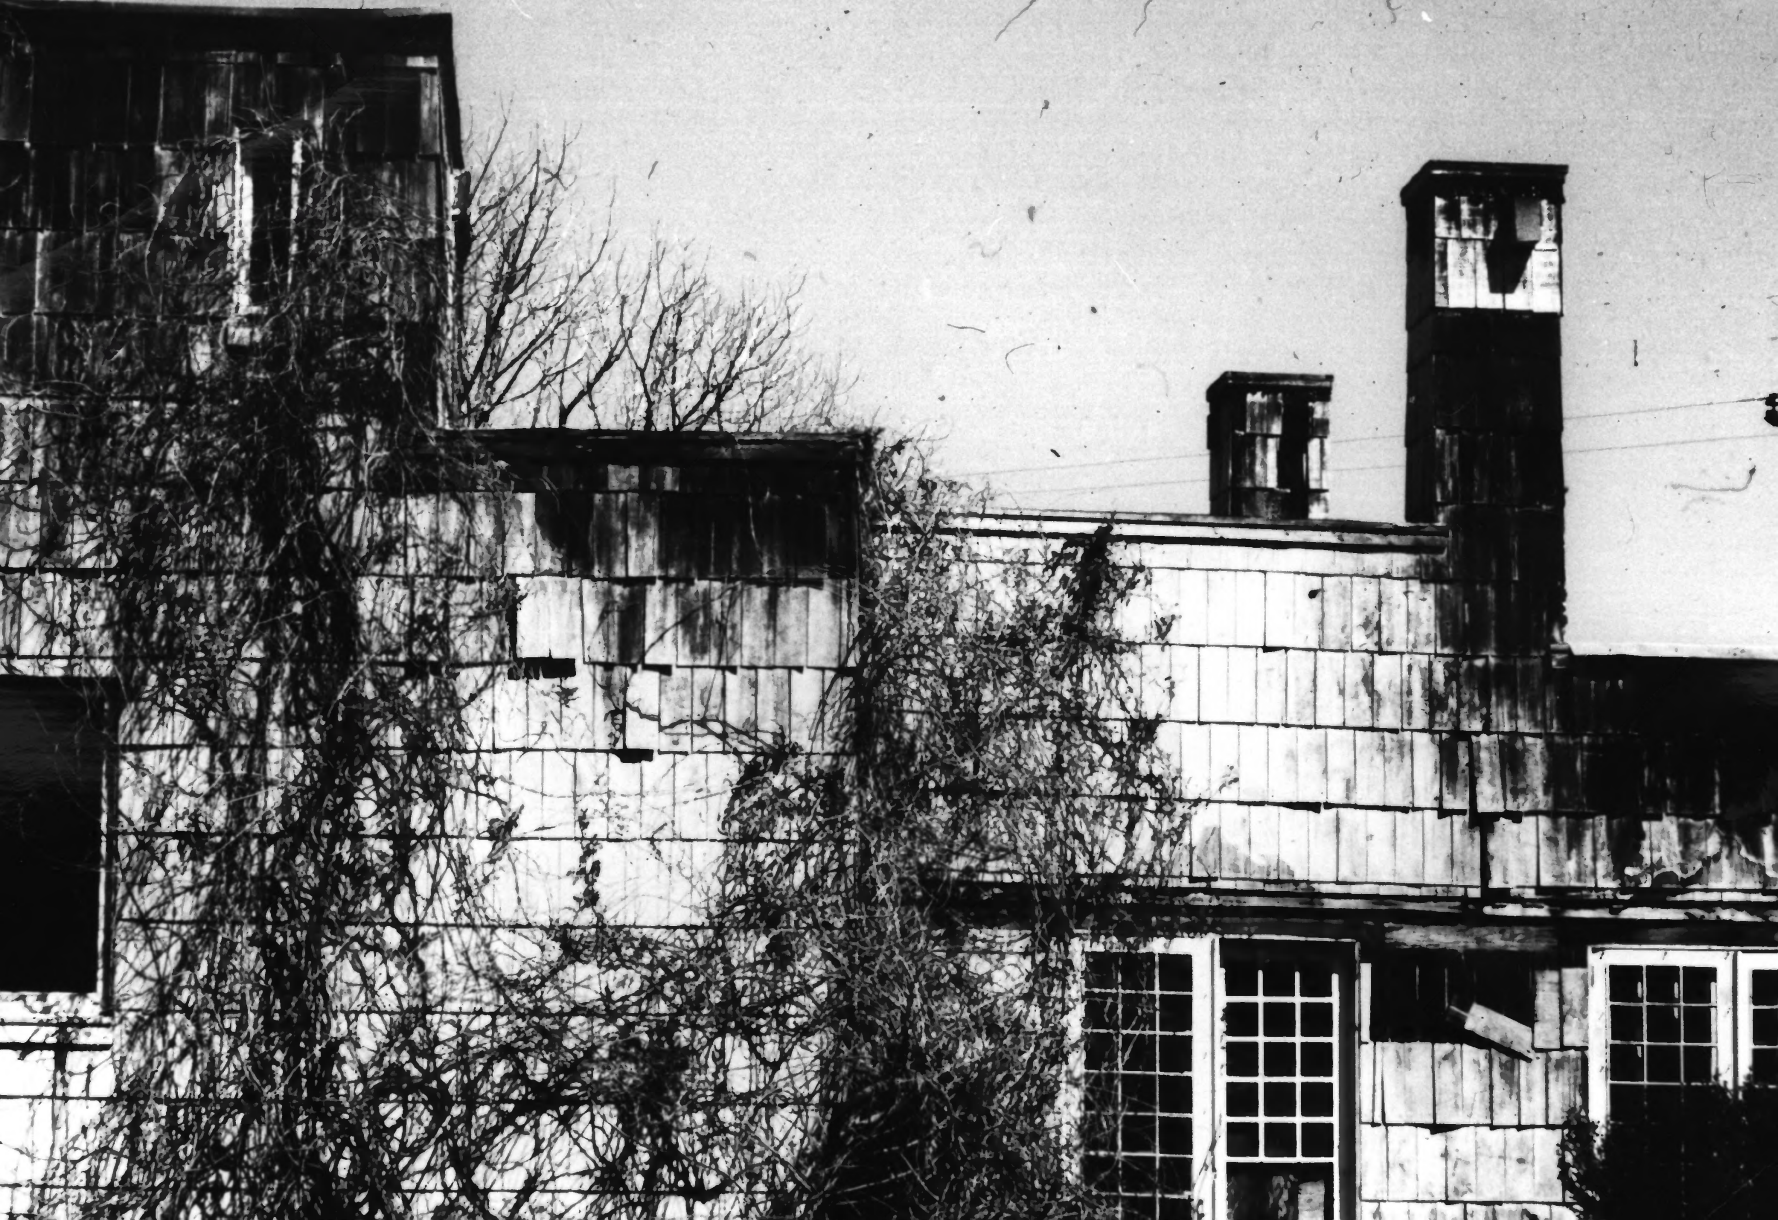
F. Woodhills. Photo of the side wing of the main house from the overgrown patio. The original Cedar shingles are 3 ft. long! The horizontal timbers which spanned between the vertical architectural elements were sawed out and removed by vandals (note the four exposed ends). Large Wisteria Vines and Climbing Roses lent relief and beauty to horizontal and vertical lines.
