# Klinar Engineering Structural Consulting

## Photographs:

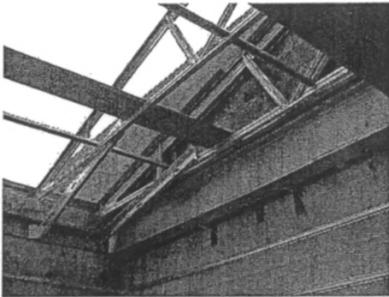
Figure 7 Missing connection  
angle – See Item 2

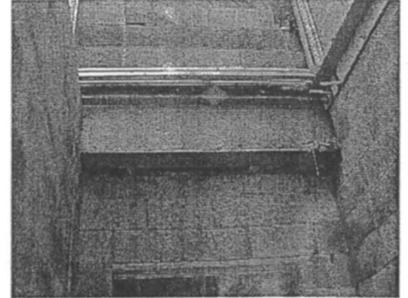
Figure 8 Missing connection  
angle – See Item 2

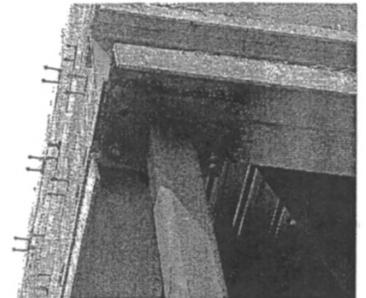
Figure 9 Missing bolts at cap  
plate – See item 4

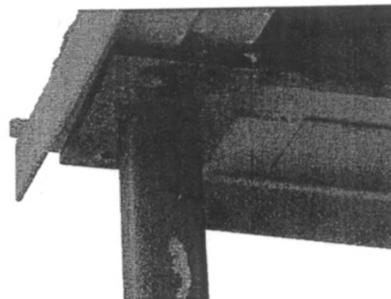
Figure 18 Missing bolt at cap plate – See item 4

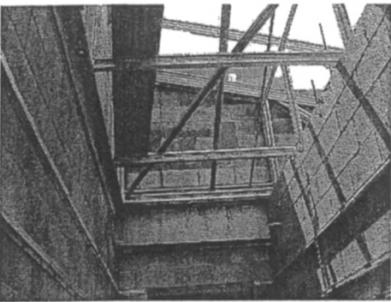
Figure 24 Missing connection angle – See Item 2

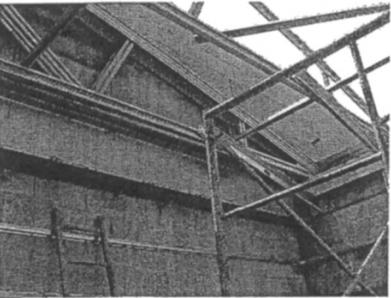
Figure 25 Missing connection angle – See Item 2

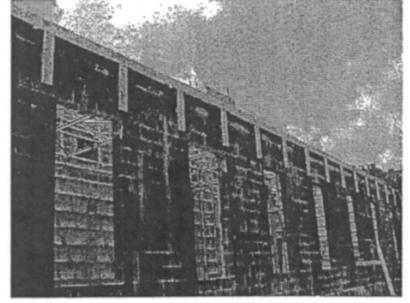
Figure 31 Steel tube supports for precast at low roof

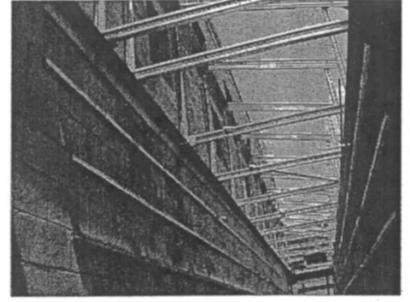
Figure 32 Low roof bearing at inside wall – See item 9

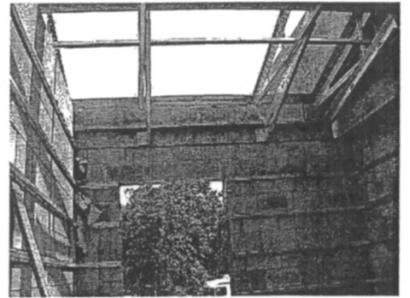
Figure 33 Low roof truss bearing at exterior wall – see item 8

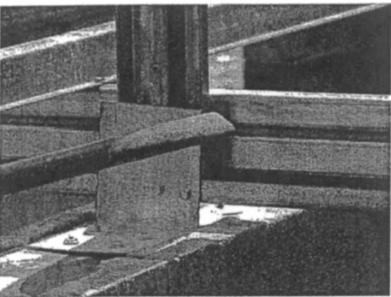
Figure 37 Low roof truss bearing condition at intermediate support – See item 11

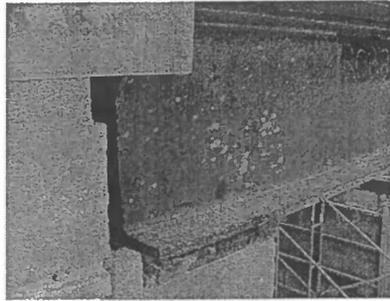
Figure 38 Bearing plate at W16 – See item 12

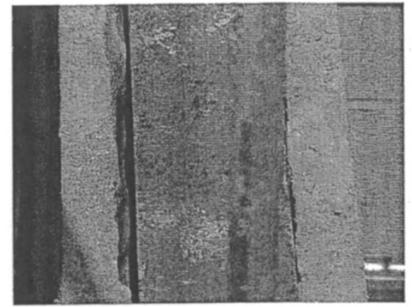
Figure 51 Typical embed plate at interior wall at low roof. Void between grout and plate – See item 15

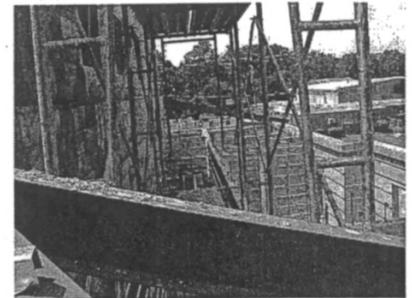
Figure 52 Low wall framing at judges chamber in rear of building – See item 20

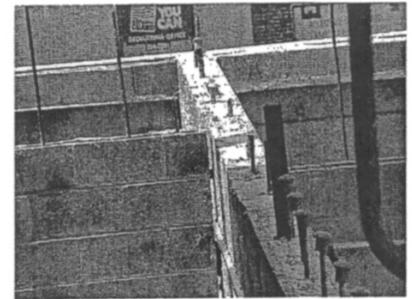
Figure 53 Low wall framing at judges chamber in rear of building – See item 20

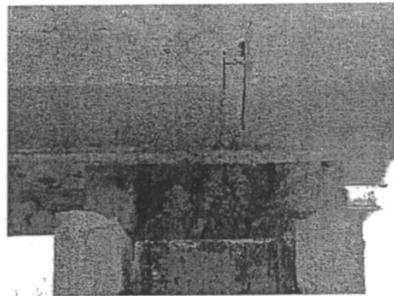
Figure 59 Bond beam missing at intersections - See item 23

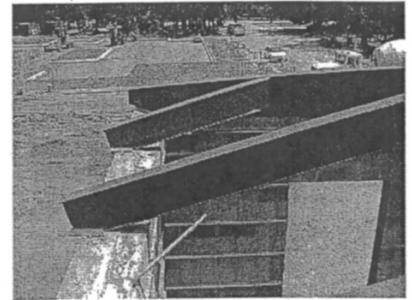
Figure 60 Low roof steel hip framing - See items 10, 16, 18

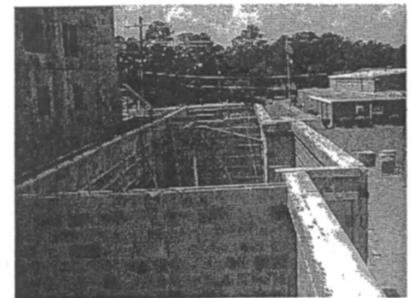
Figure 61 CMU bearing walls at judges chambers - roof framing not installed

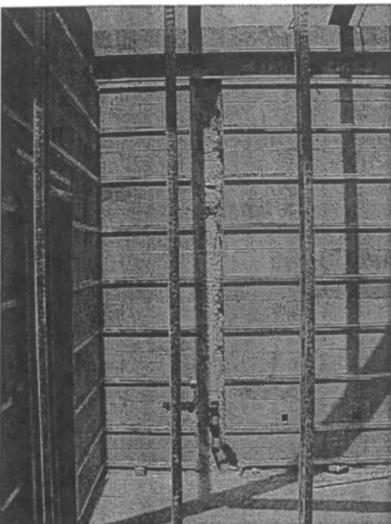
Figure 64 Trenched wall – See item 21

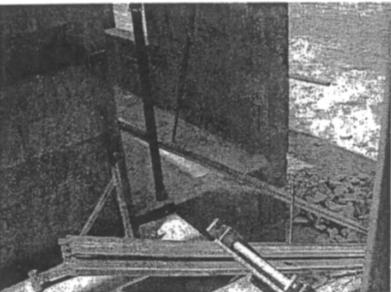
Figure 65 Missing wall section – See item 22

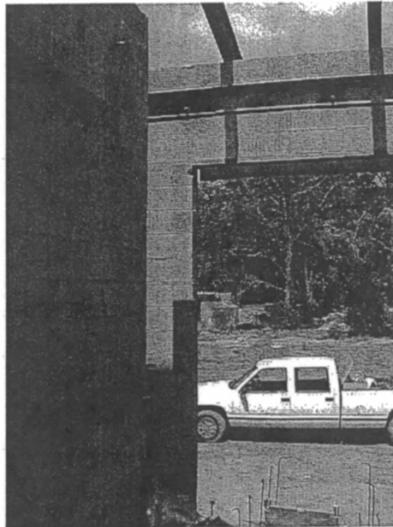
Figure 66 Missing wall section – See item 22

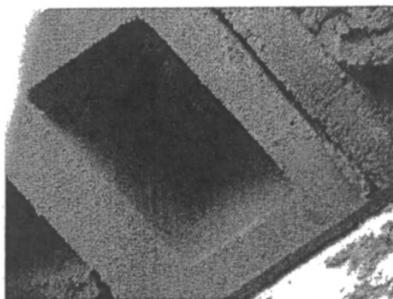
Figure 67 UngROUTED lintel over louver opening – See item 24

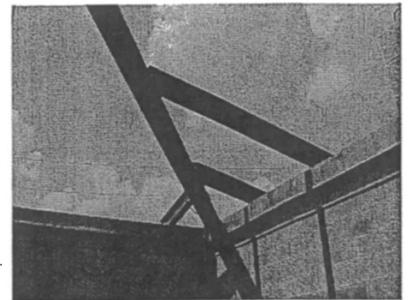
Figure 69 Unfinished steel framing at low hip roof in corner – See items 10, 16, 17, 18

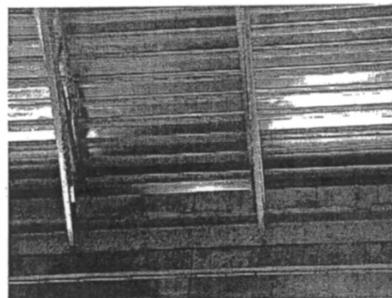
Figure 88 Missing through bolts at top of wall at high roof of courtroom – See item 25

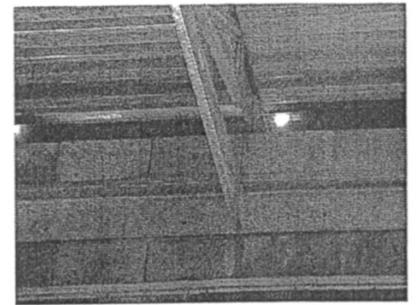
Figure 89 Missing through bolts at top of wall at high roof of courtroom – See item 25

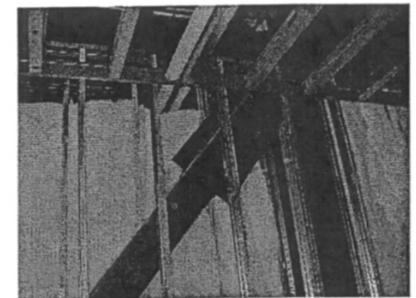
Figure 91 Braced frames in existing building – See item A

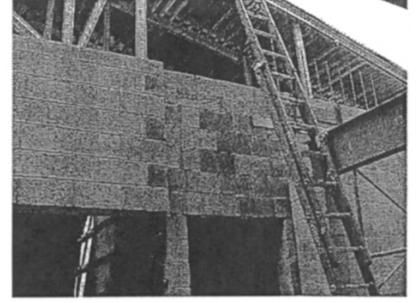
Figure 99 Lintel L16 over second floor opening in new wall at addition – See item 27

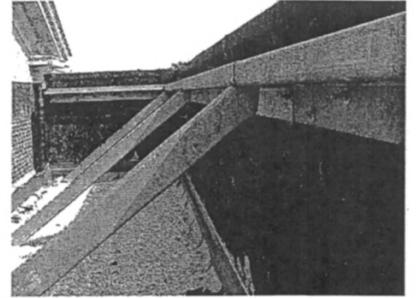
Figure 100 Parapet braces at portico roof – See item C

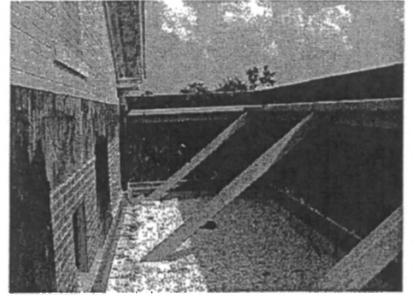
Figure 101 Parapet braces at portico roof – See item C

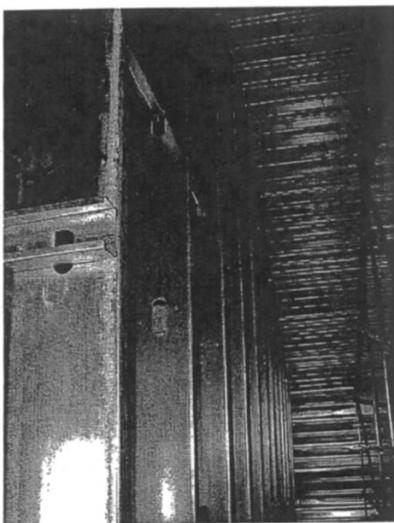
Figure 104 8" stud gable end wall bracing – See item E

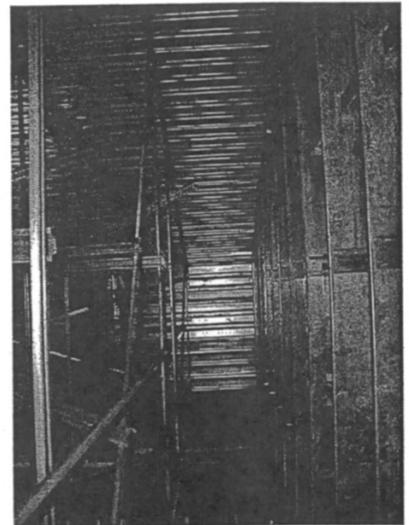
Figure 108 8" stud gable end wall bracing – See item E
