STRATFORD HALL PLANTATION

Robert E. Lee Memorial Association, Inc.

STRATFORD GREAT HOUSE AND FLANKING OUT HOUSES

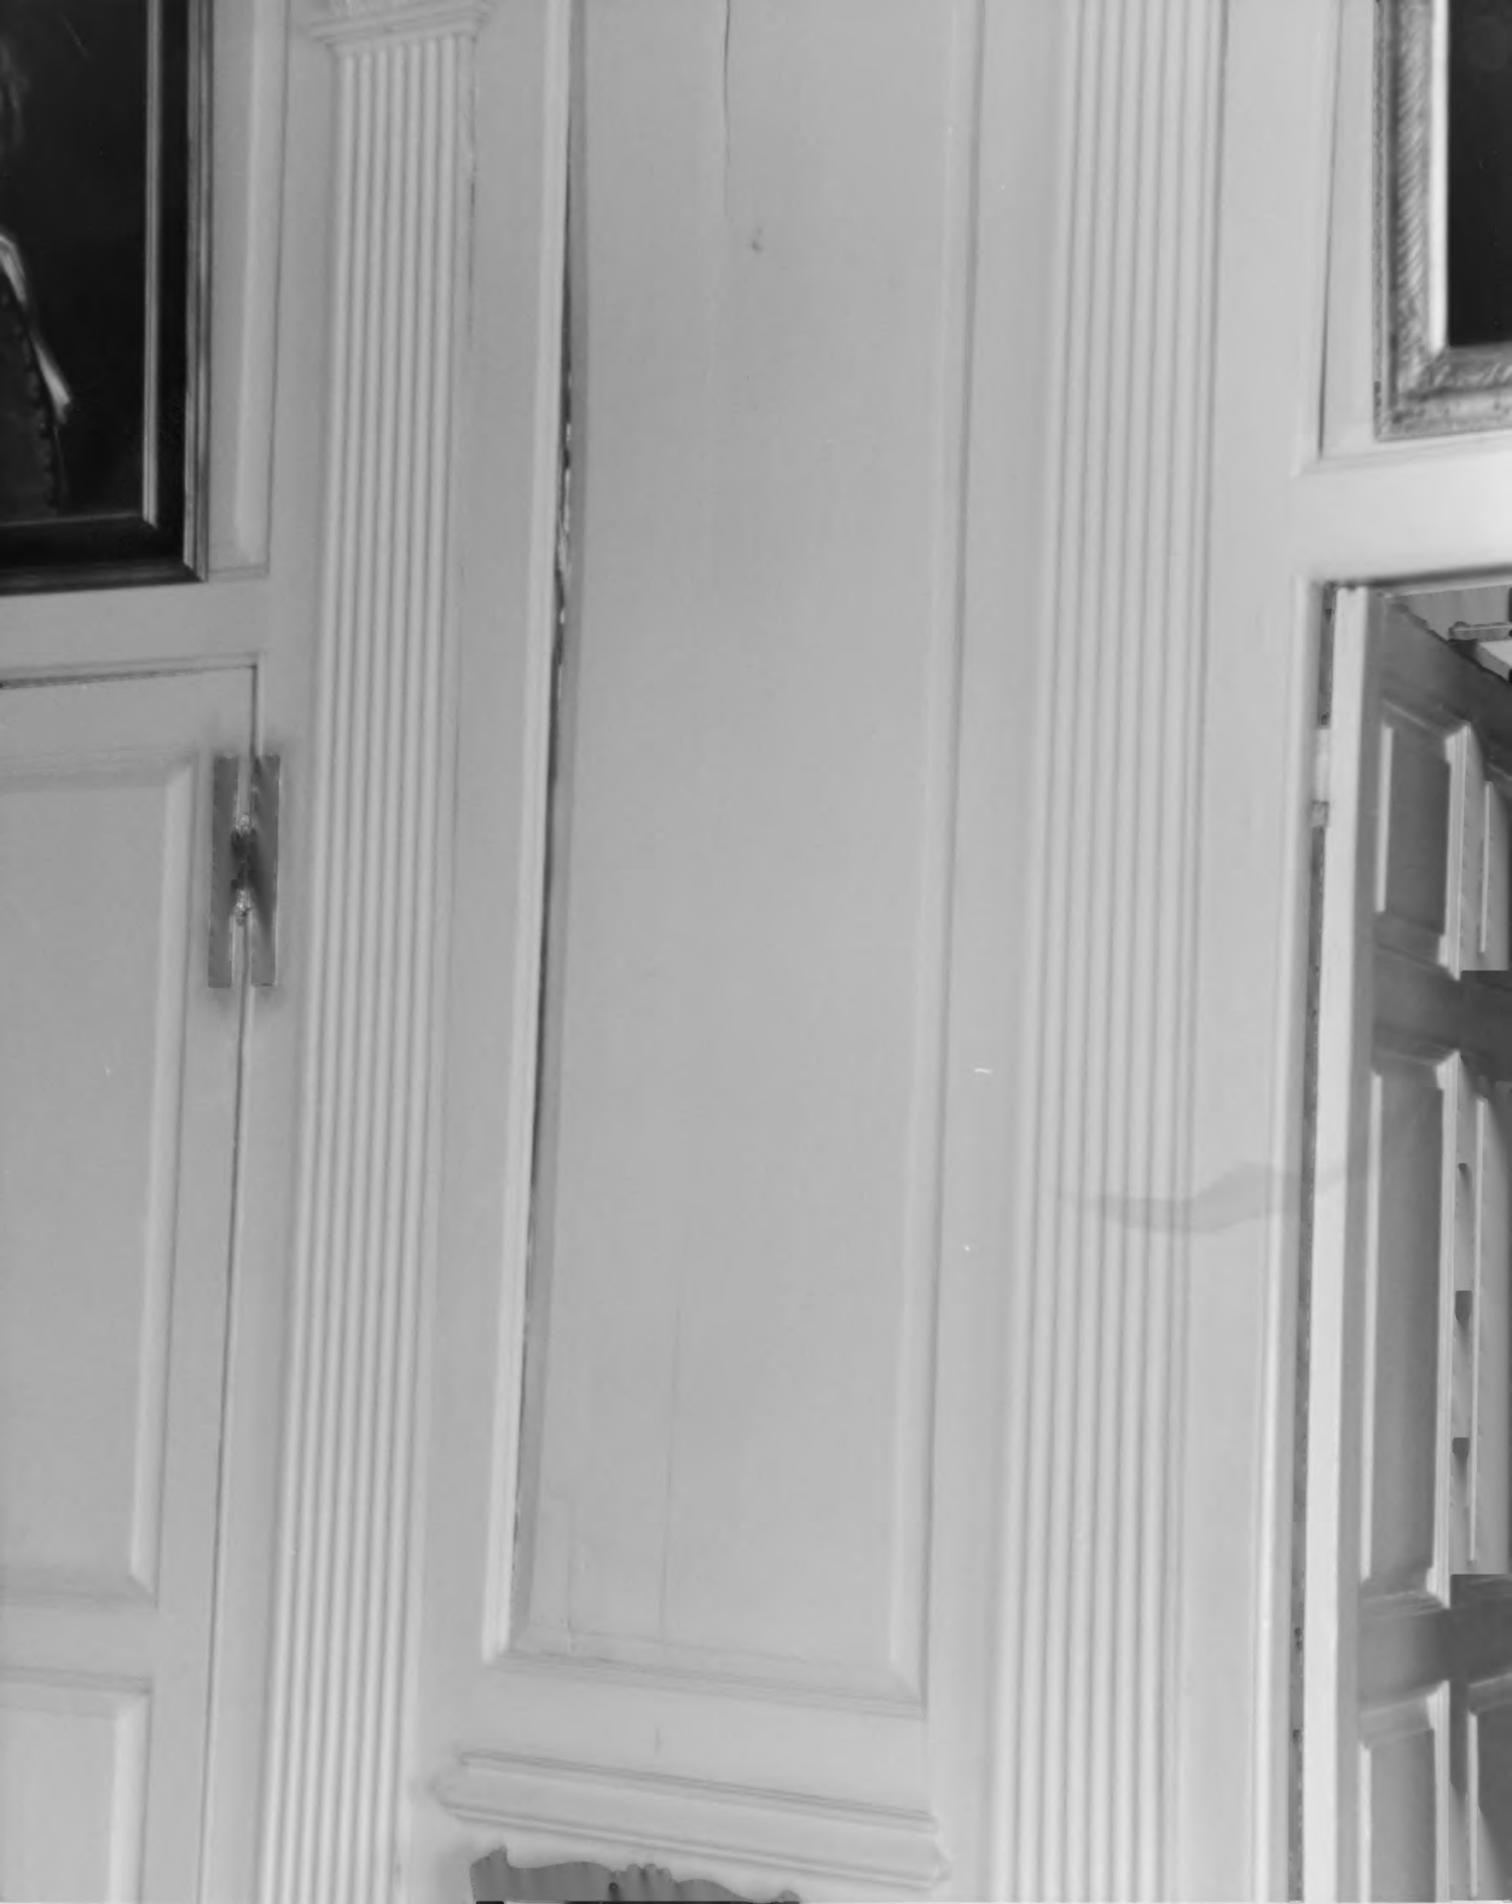
WARPED AND SPLIT WOODEN PANELS IN THE GREAT HALL

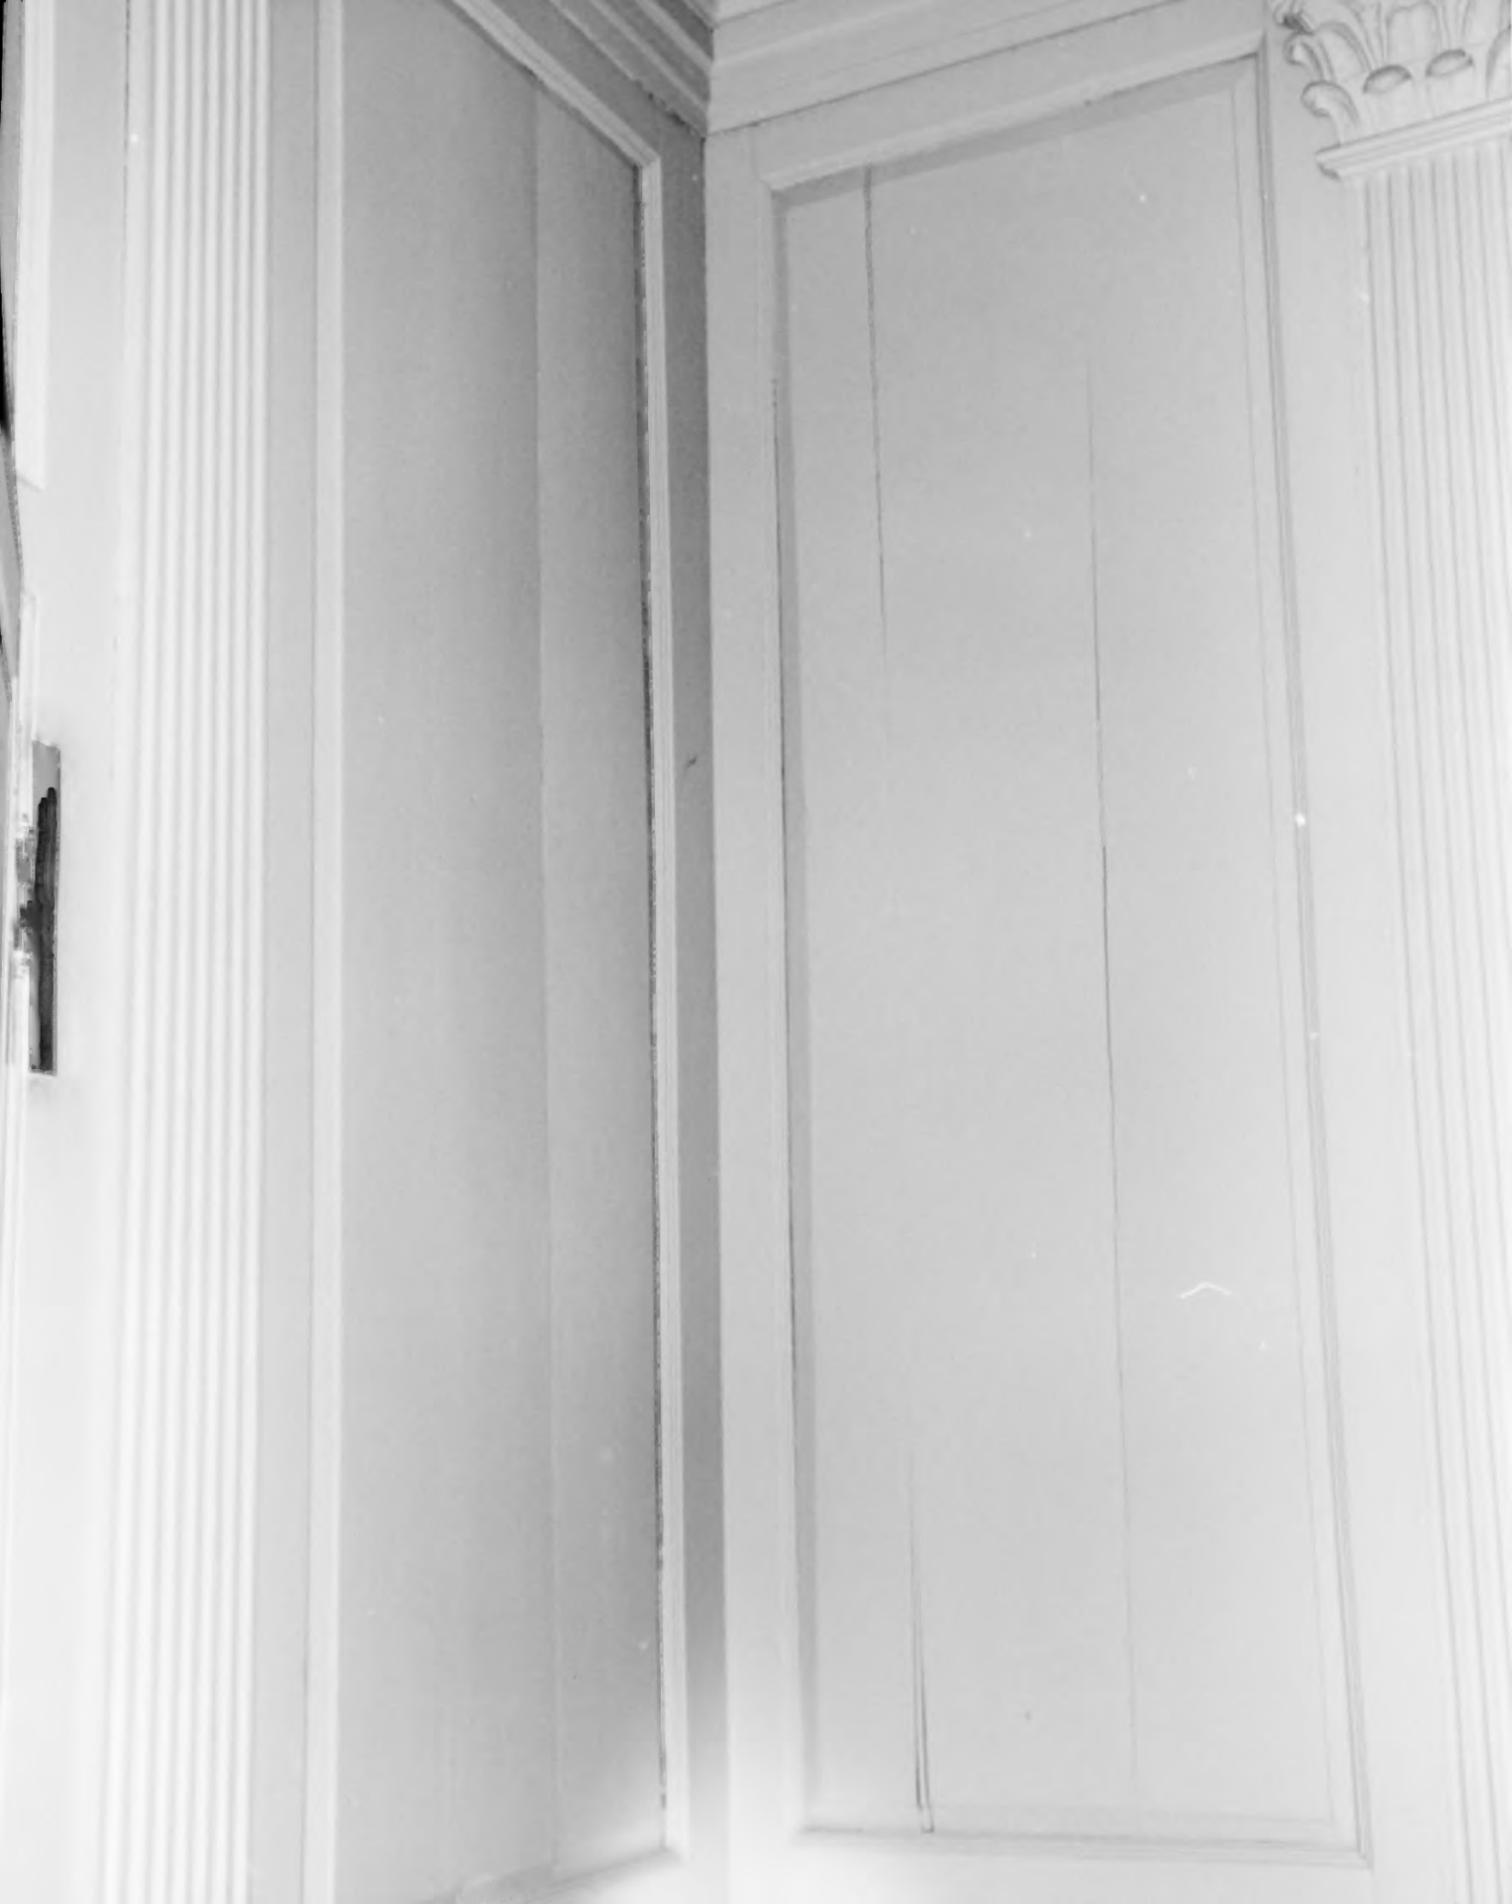
**WARPED AND SPLIT WOODEN PANELING
IN THE NORTHWEST CORNER OF THE
GREAT HALL - CONDITION TYPICAL**

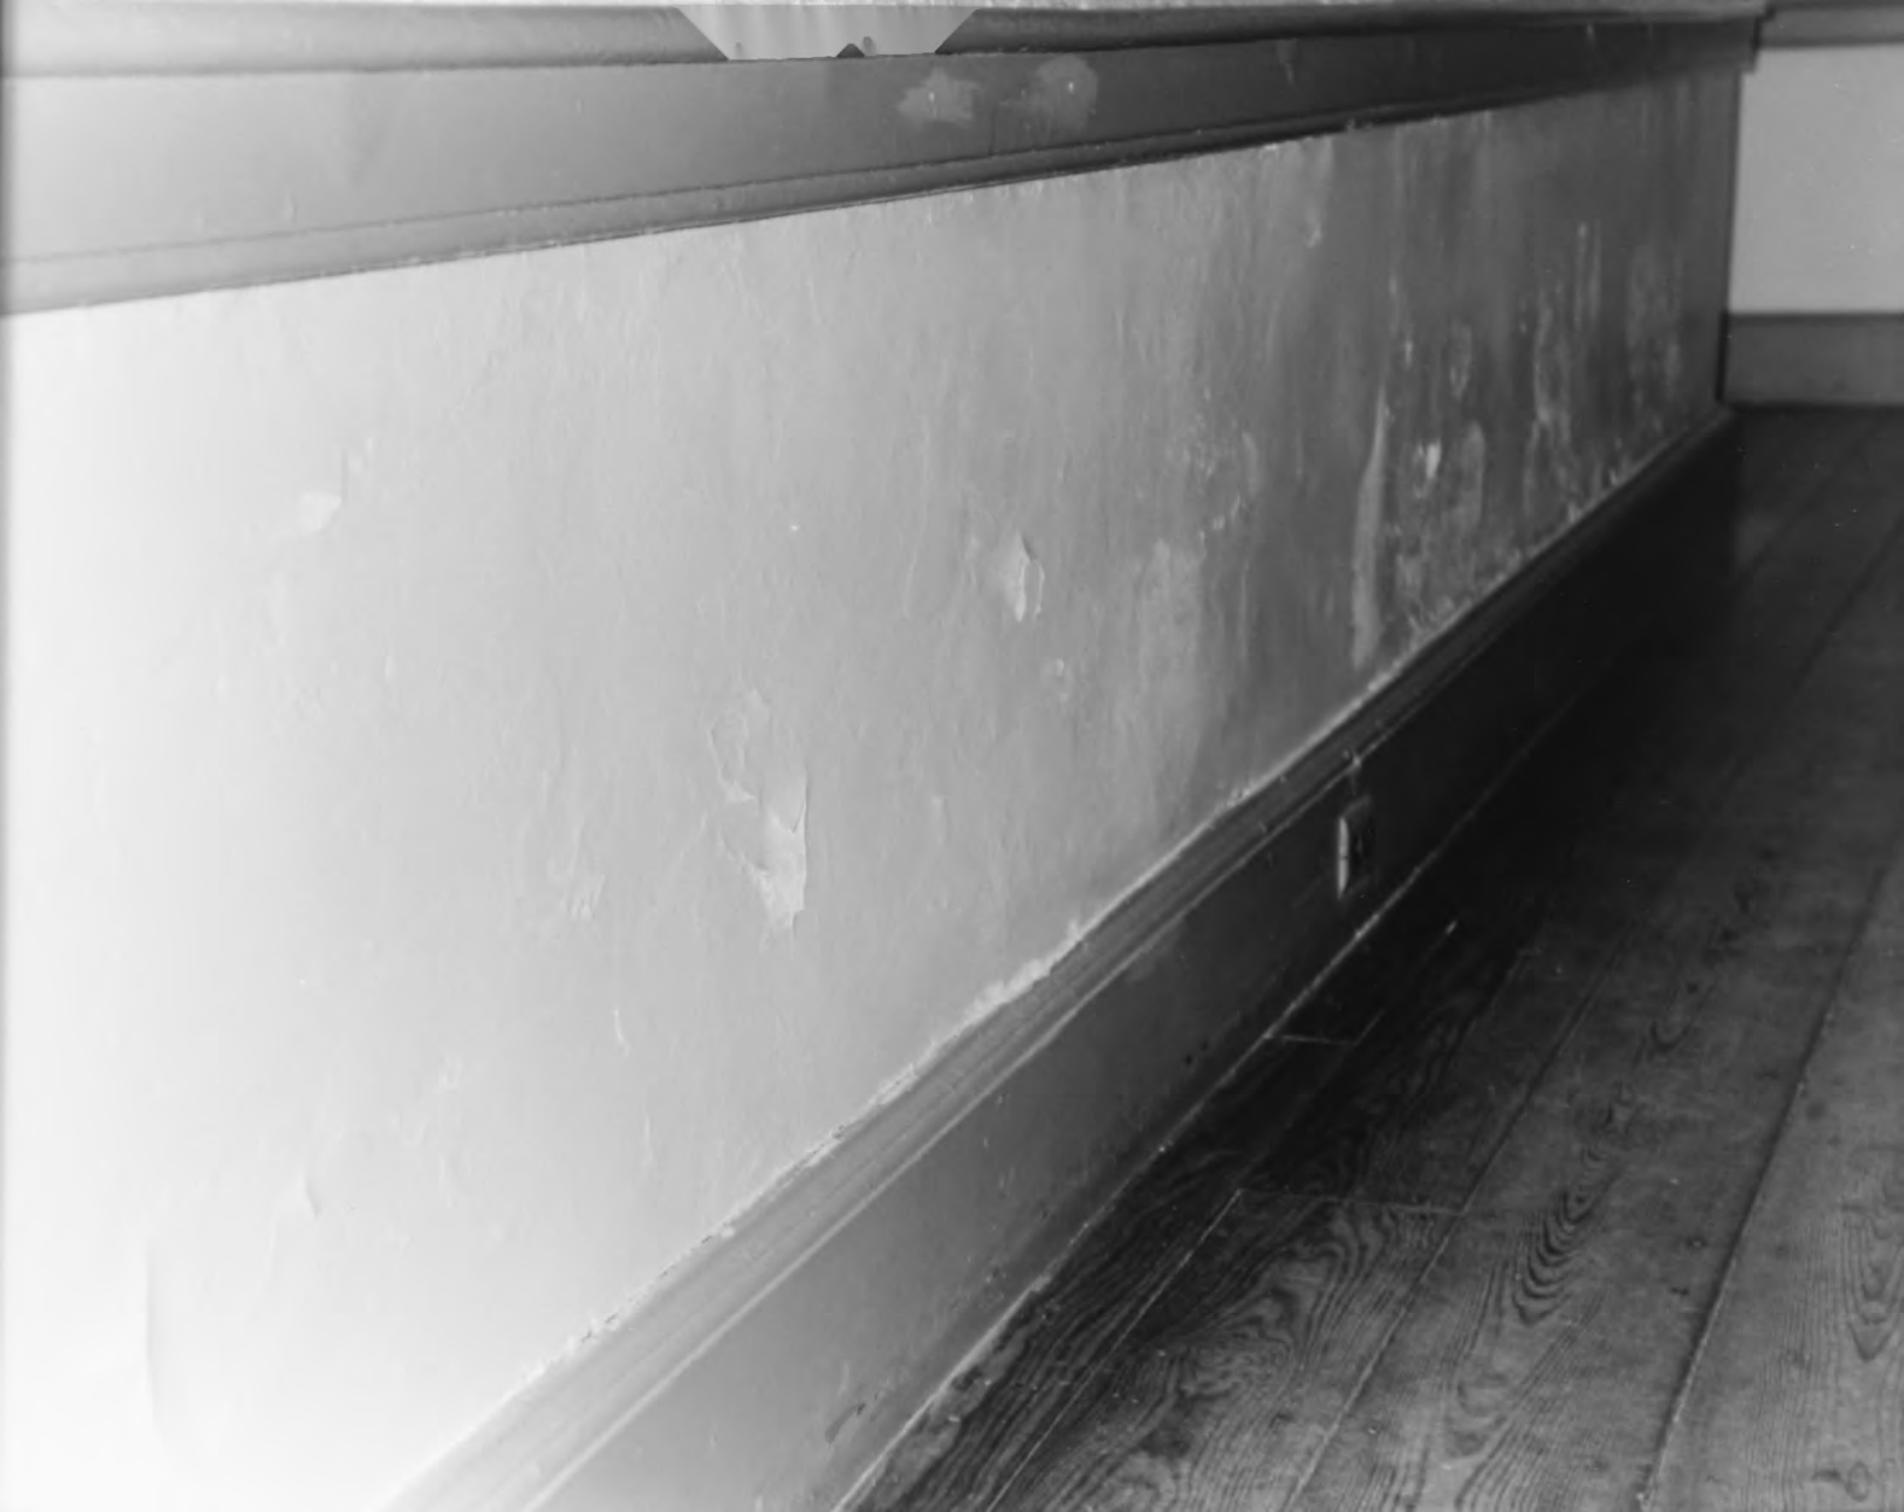
TYPICAL SPALLING PAINT AND PLASTER ON MASONRY WALL IN GREAT HOUSE

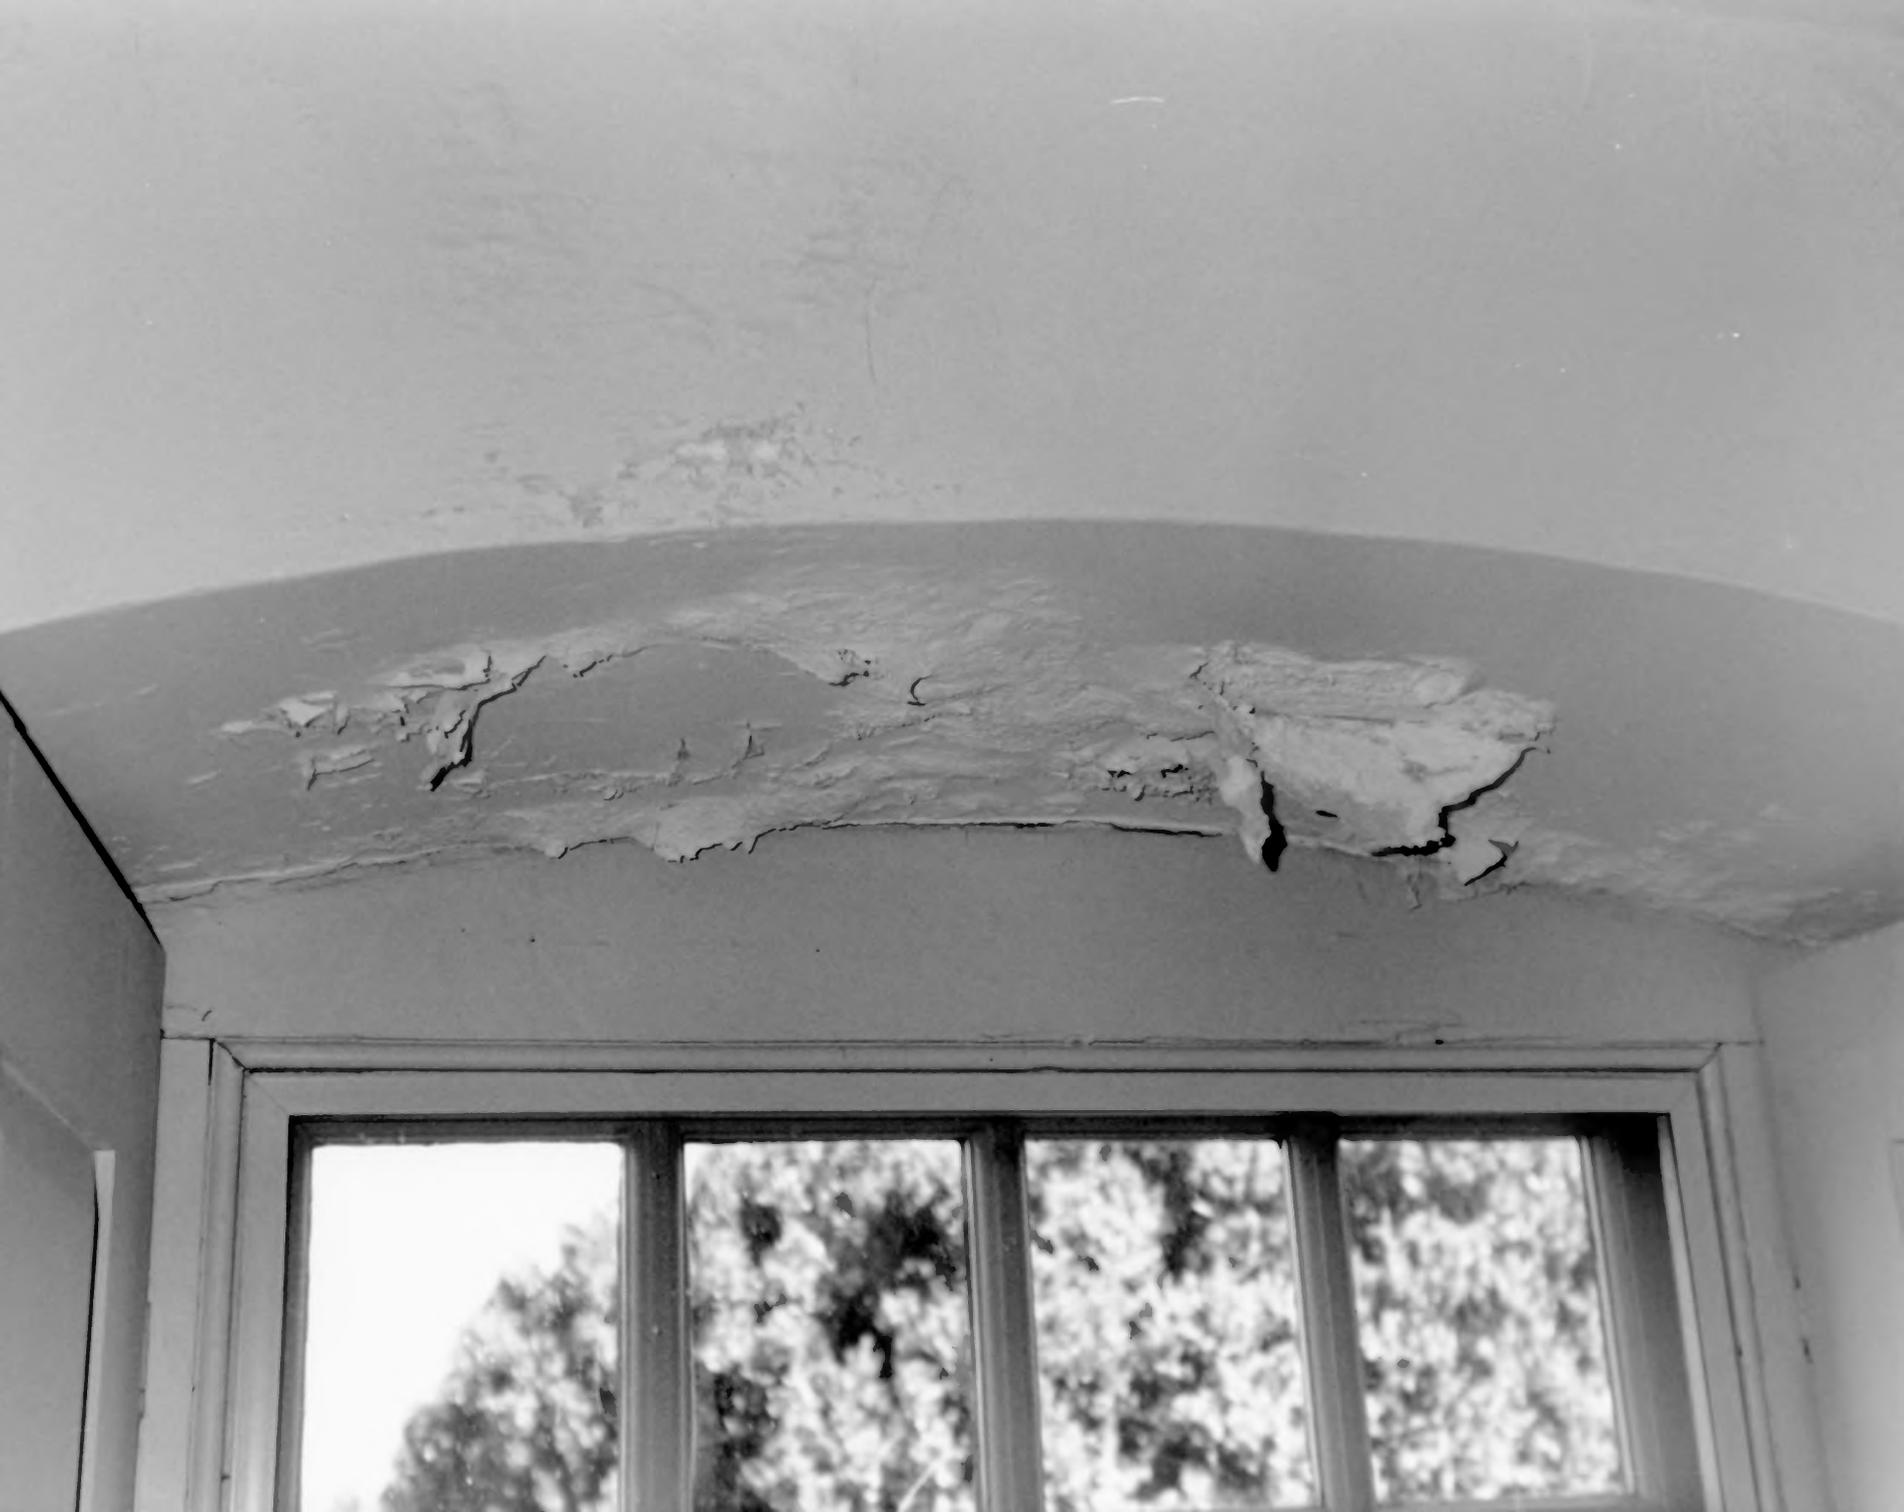
TYPICAL EXFOLIATION OF PLASTER ON EXTERIOR MASONRY WALL OF GREAT HOUSE

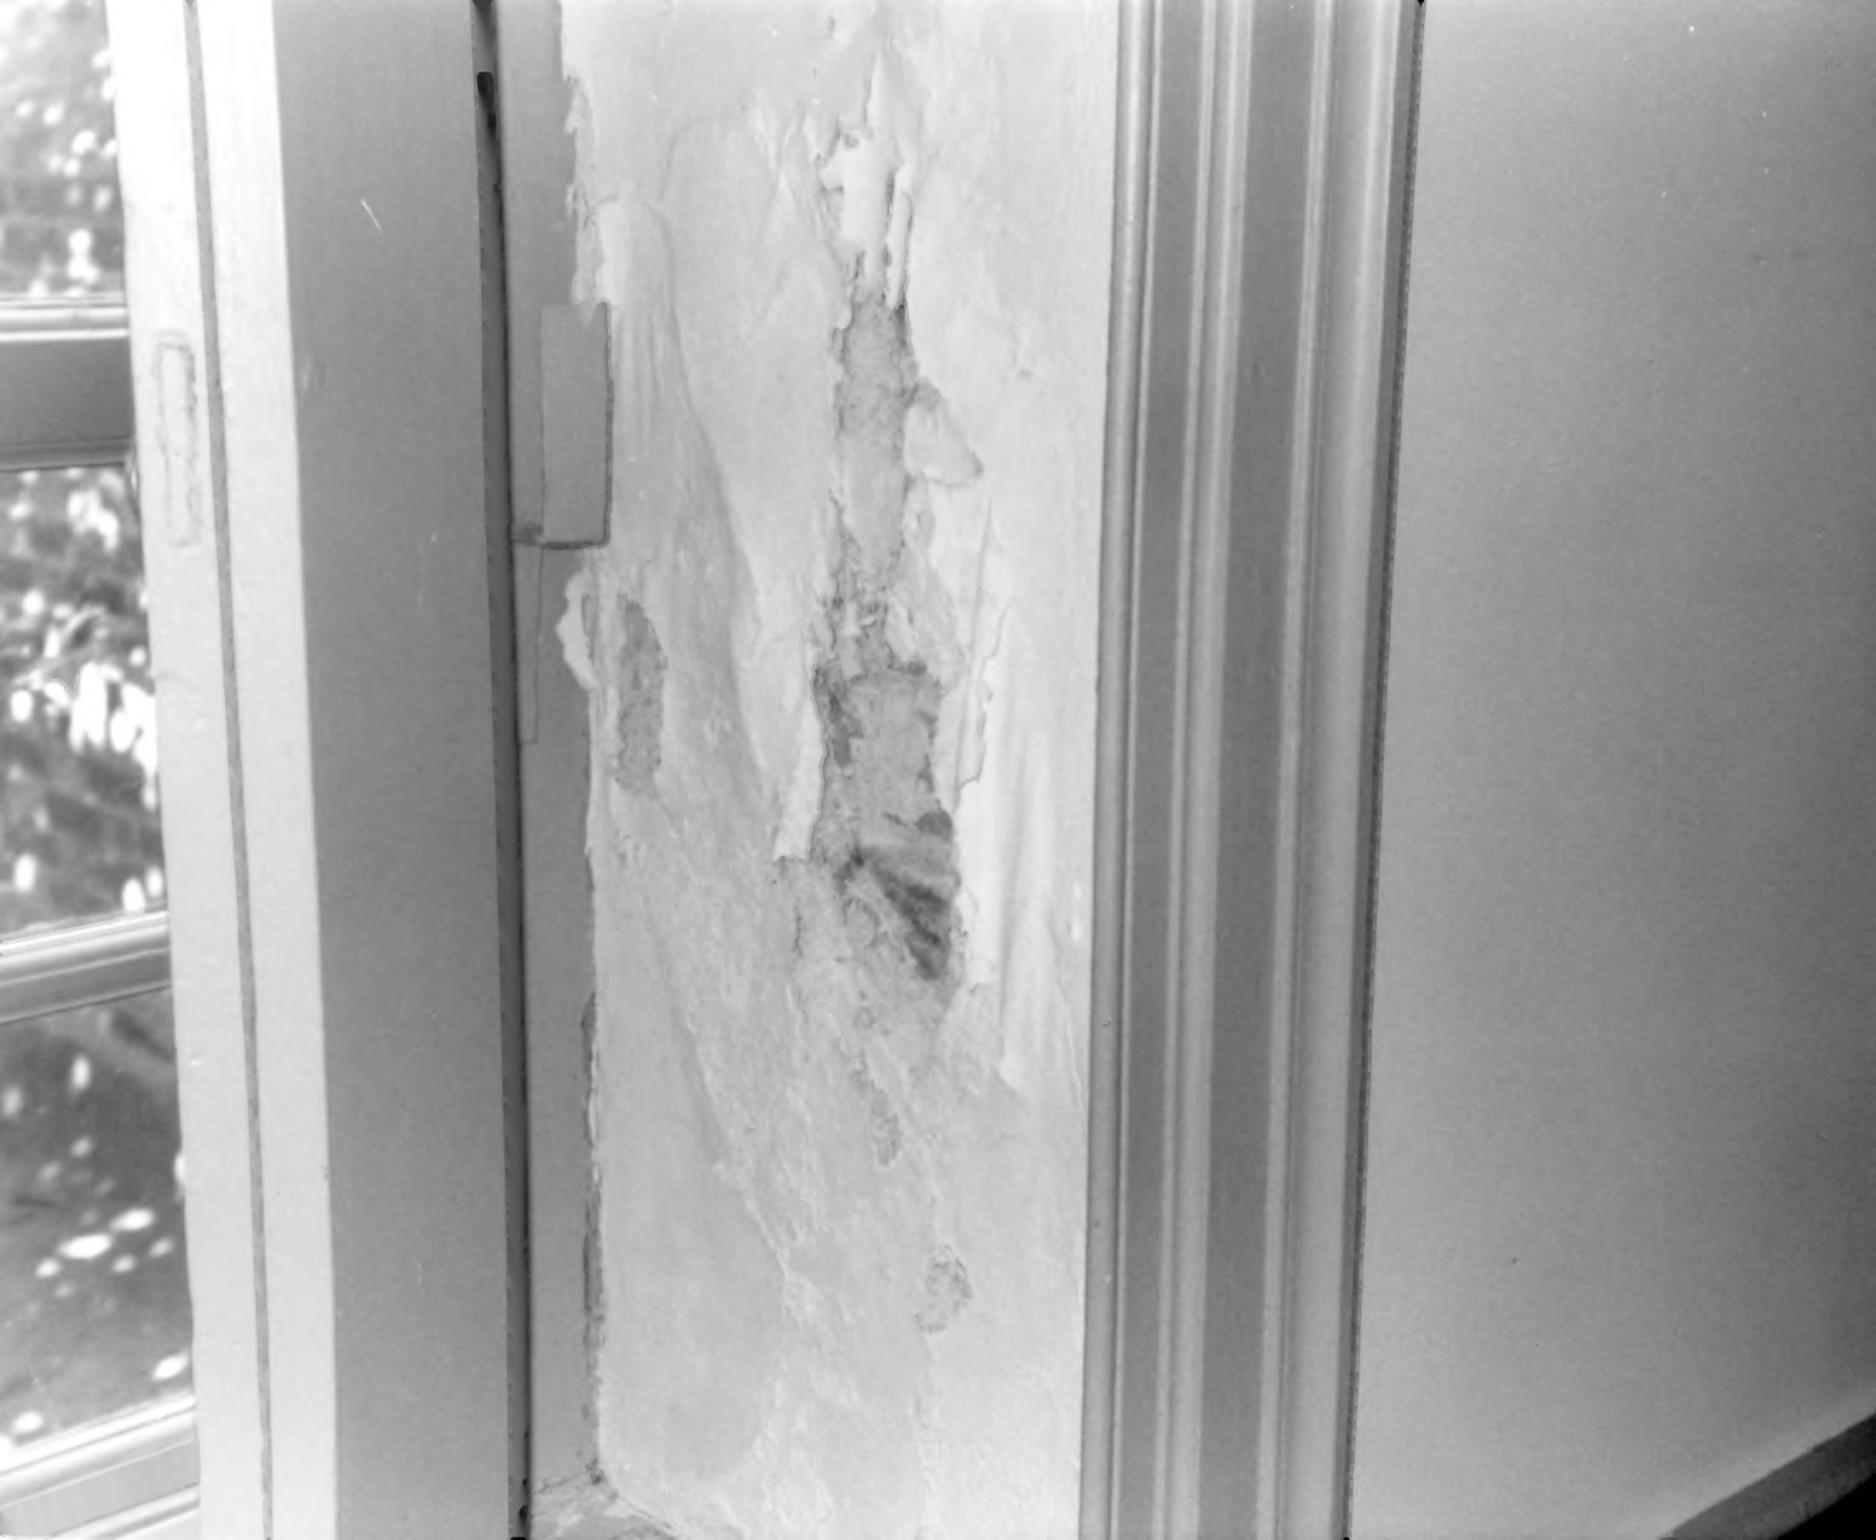
**TYPICAL SPALLING PLASTER IN EXTERIOR
MASONRY WALL FOUND AT ALL
GREAT HOUSE WINDOWS**

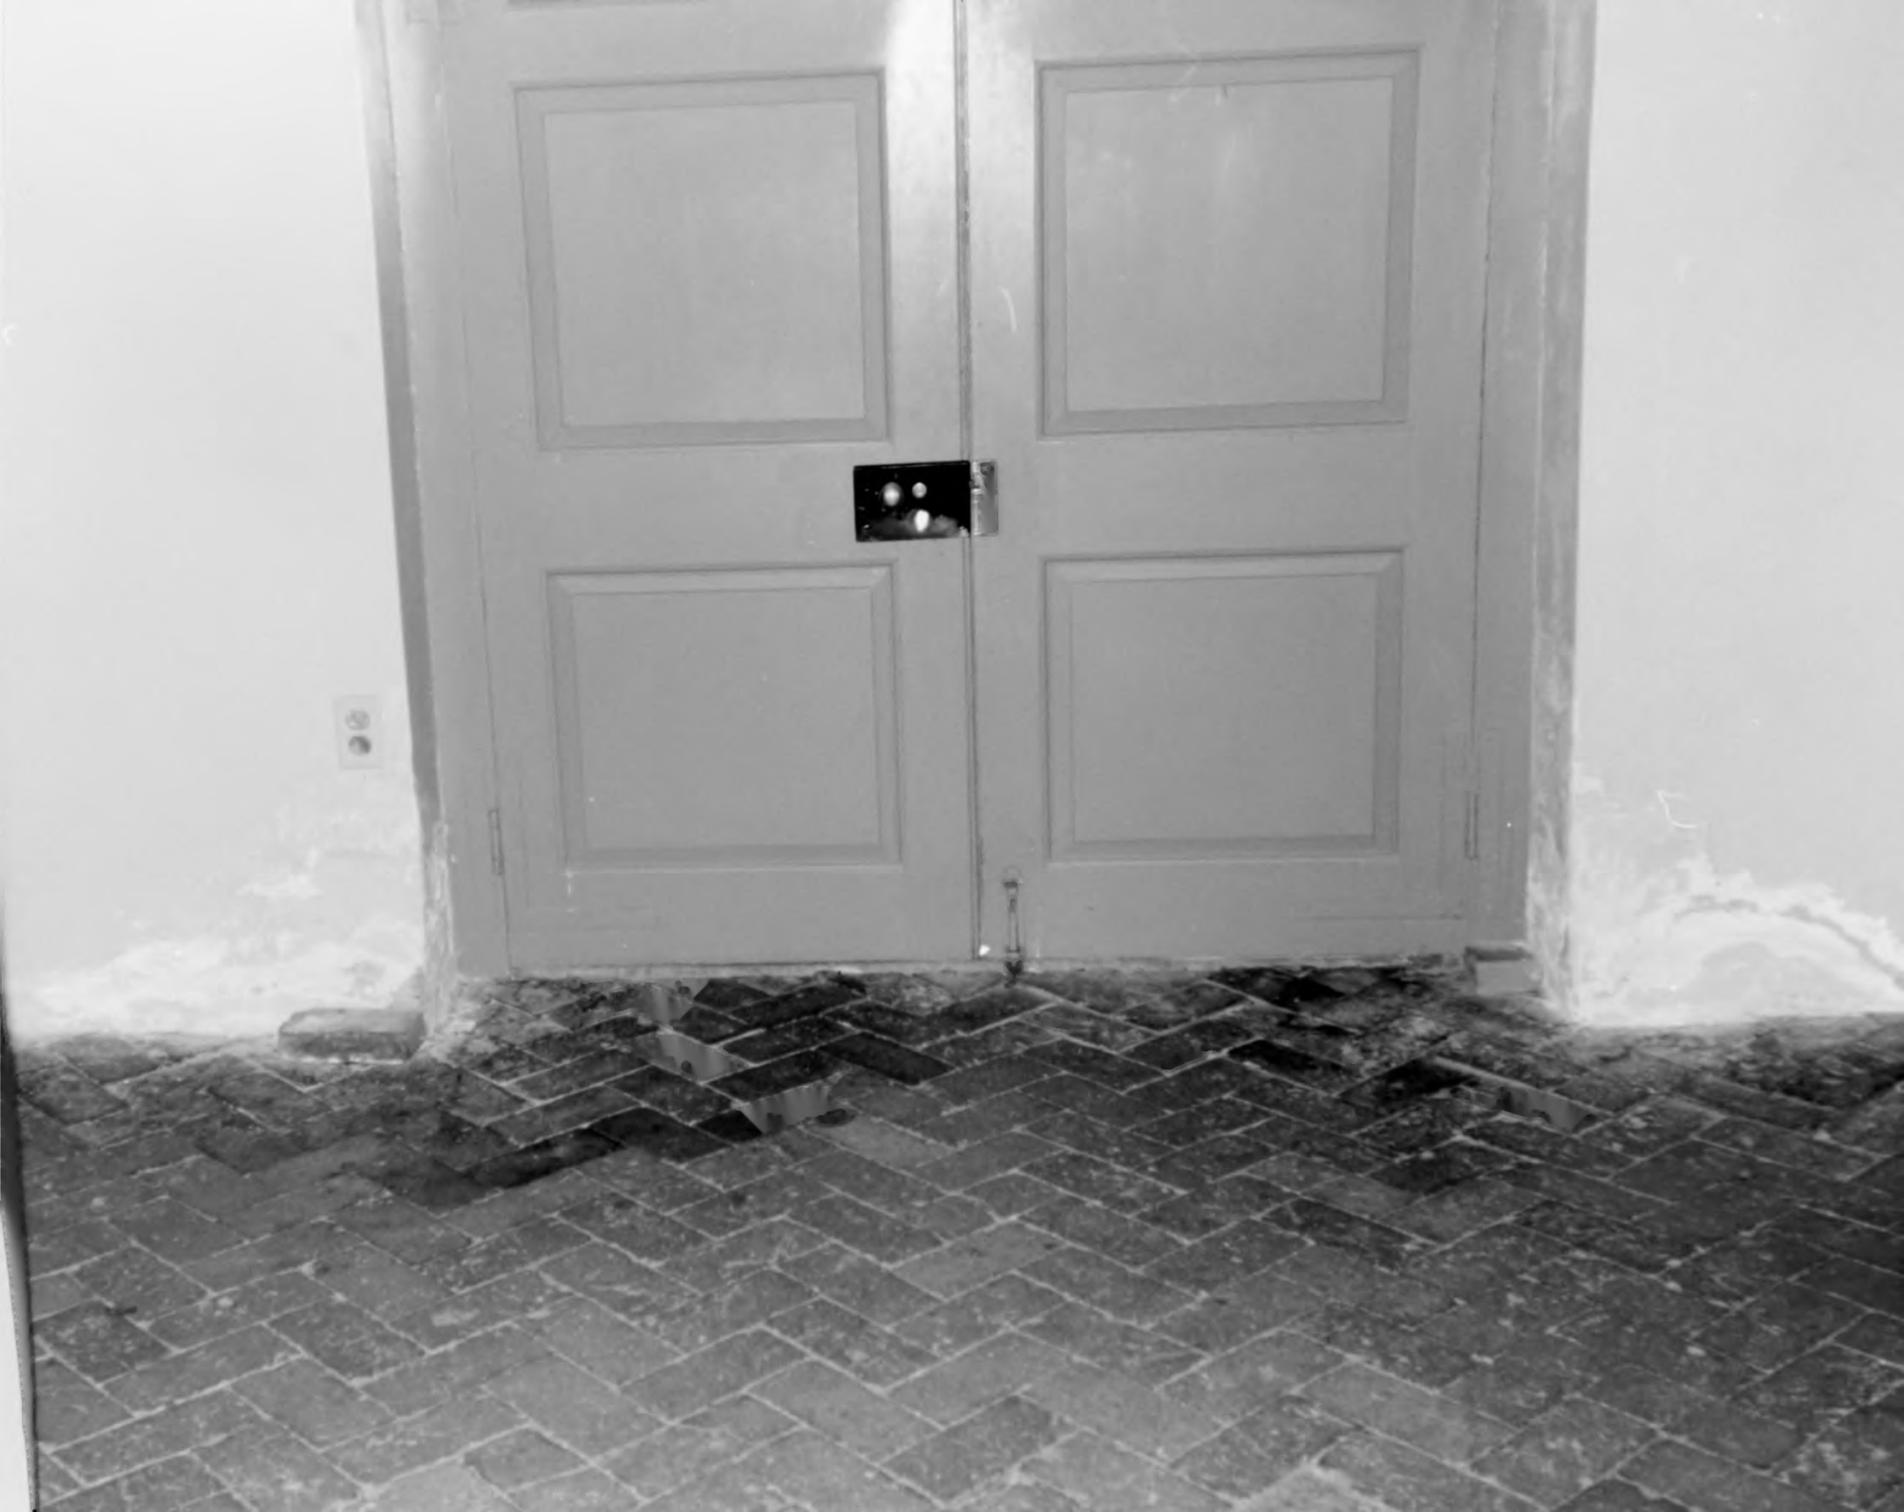
PLASTER DAMAGE CAUSED BY MOISTURE INFILTRATION AND CONDENSATION, TYPICAL IN GREAT HOUSE
