BANK OF WOODBURN BUILDING
CORNER OF ARTHUR & FRONT STREETS.
WOODBURN, MARION COUNTY, OREGON

NORA FIVES, PHOTOGRAPHER
FEBRUARY 20, 1996

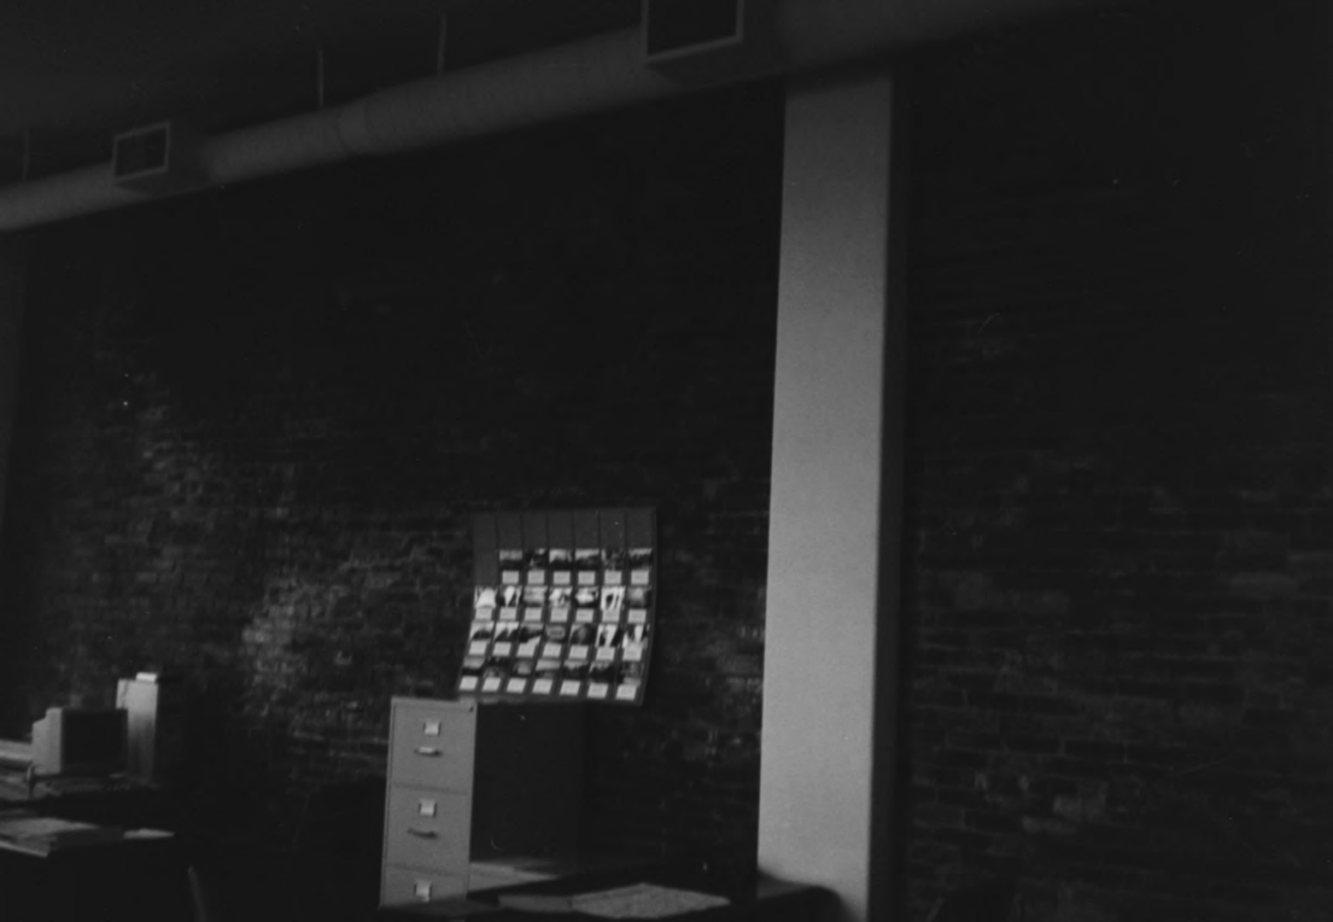
2 of 21

LOOKING SOUTH AT EXPOSED ORIGINAL BRICK WALL.
CIRCULAR DUCT WORK - NEW FURNACE
FIRST FLOOR LEVEL, INTERIOR VIEW

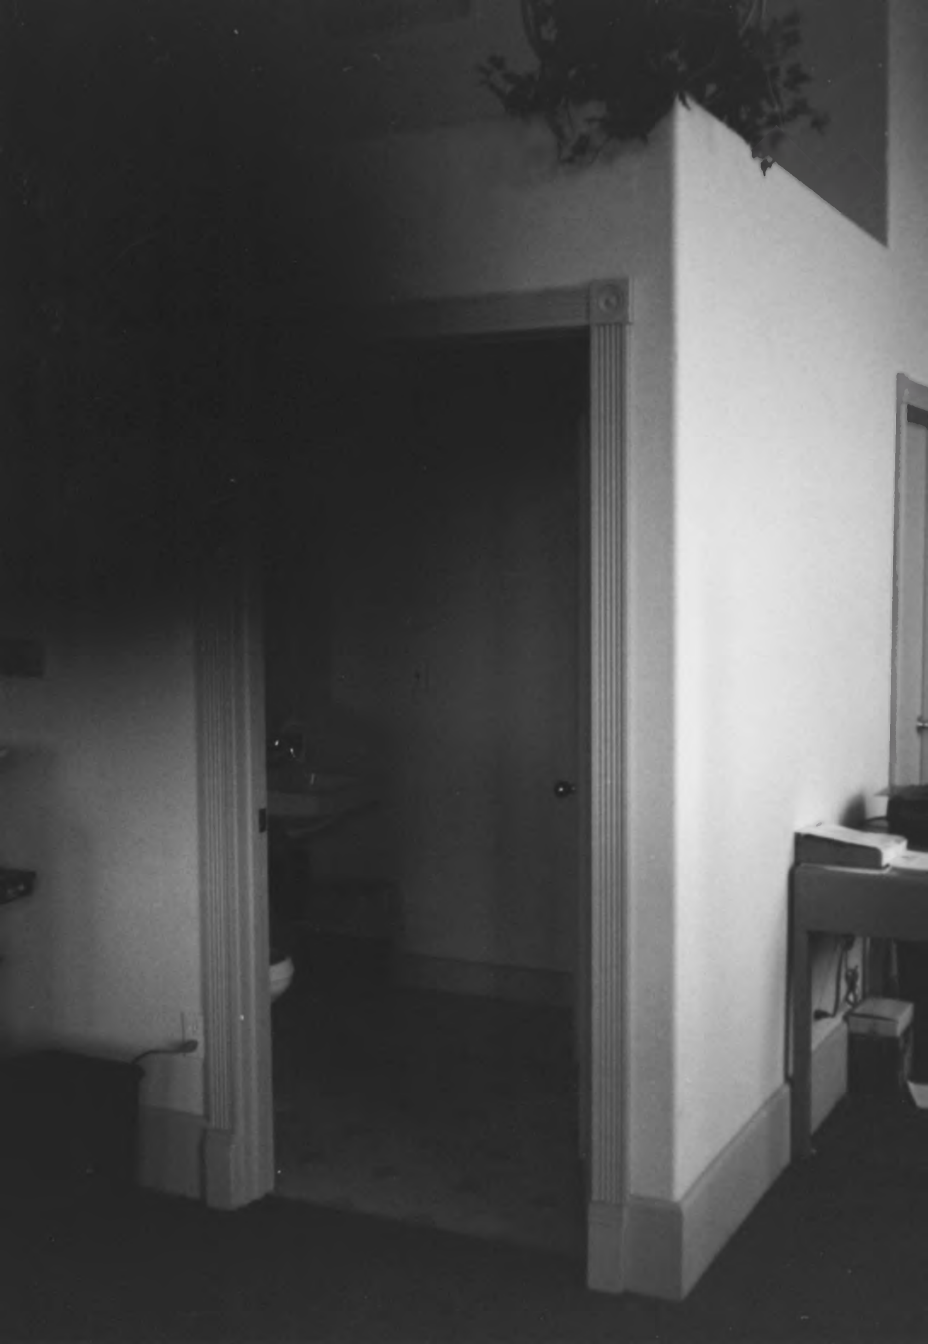
3 of 21

LOOKING WEST. NEWLY INSTALLED BATHROOM,
REPRODUCED ORIGINAL TRIM & MOLDING.
FIRST FLOOR LEVEL, INTERIOR VIEW.

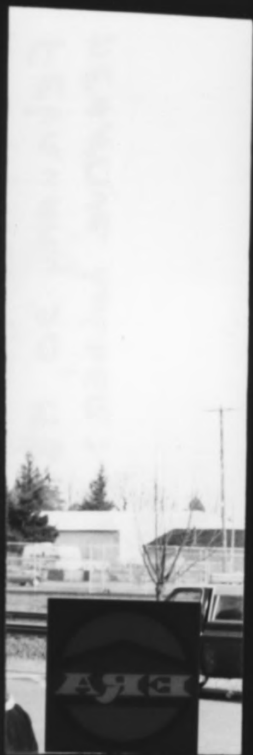
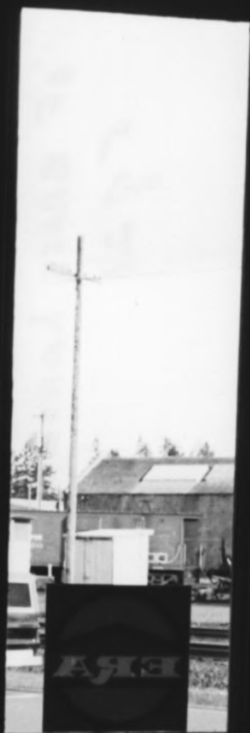
5 of 21

LOOKING NORTH EAST. DOOR ON ANGLE FRONT & ARTHUR.
FIRST FLOOR LEVEL, INTERIOR VIEW.

RESTORATION OF ORIGINAL TRIM. REPRODUCTION
OF BRASS HARDWARE. SINGLE PANE GLASS REPLACED.

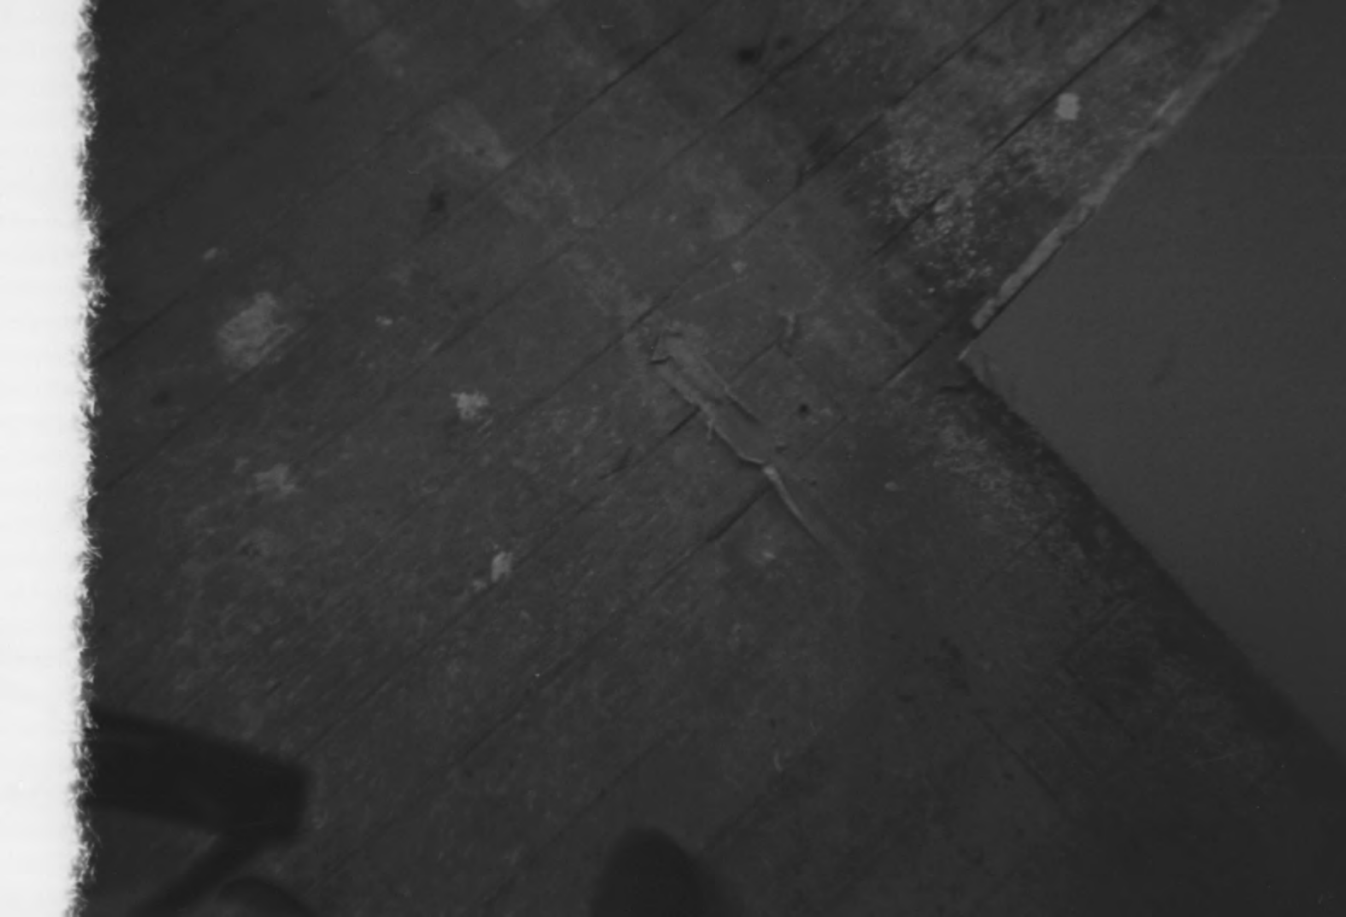
6 of 21

ORIGINAL CEDAR PLANK FLOORS. UPPER LEVEL

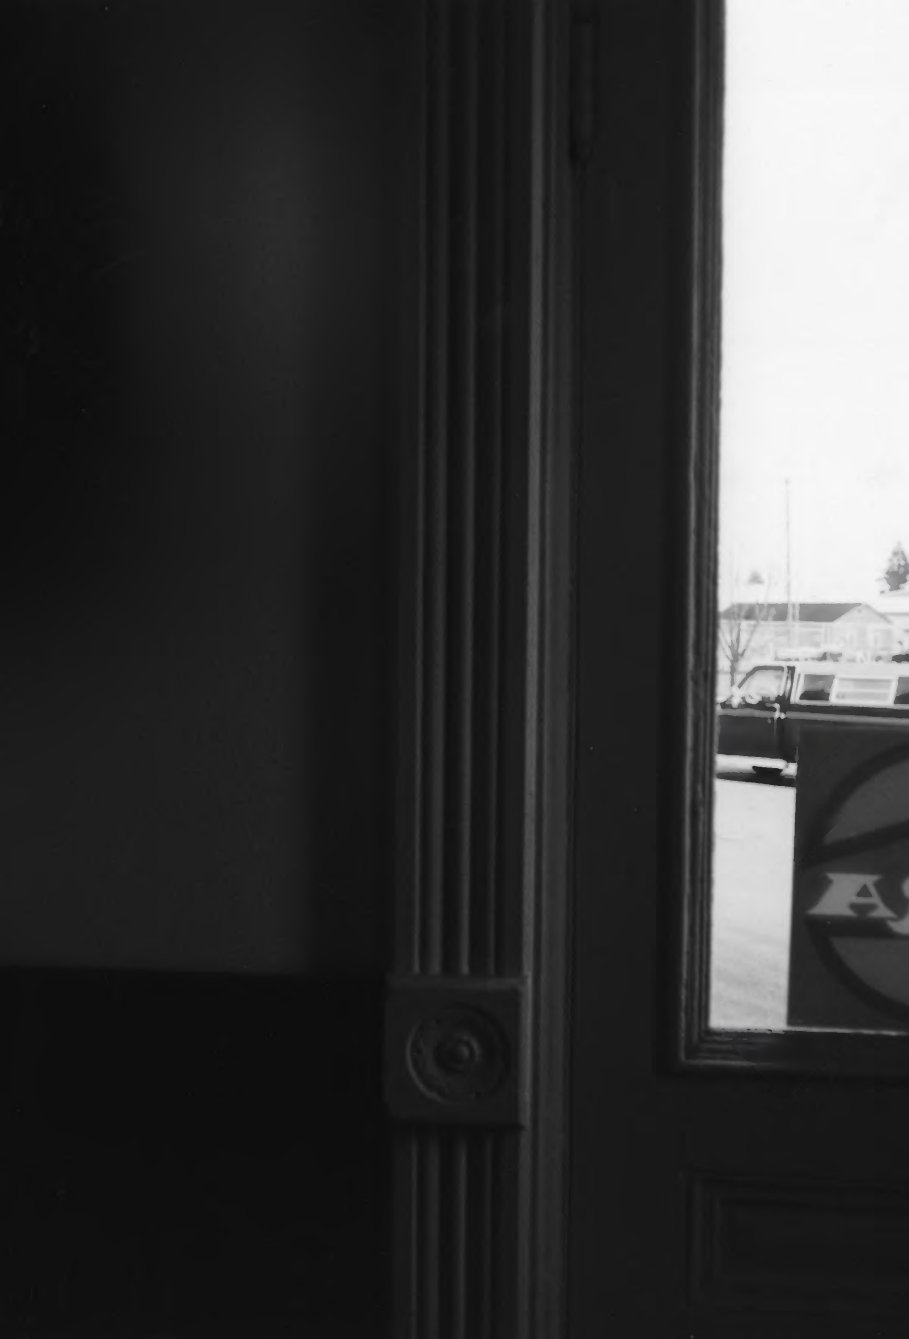
LOOKING NORTH, FIRST FLOOR LEVEL INTERIOR VIEW.
RESTORED ORIGINAL WINDOW TRIM. DOUBLE HUNG
WINDOWS RETAIN ORIGINAL WAVY GLASS. ORIGINAL
HARDWARE RETAINED.

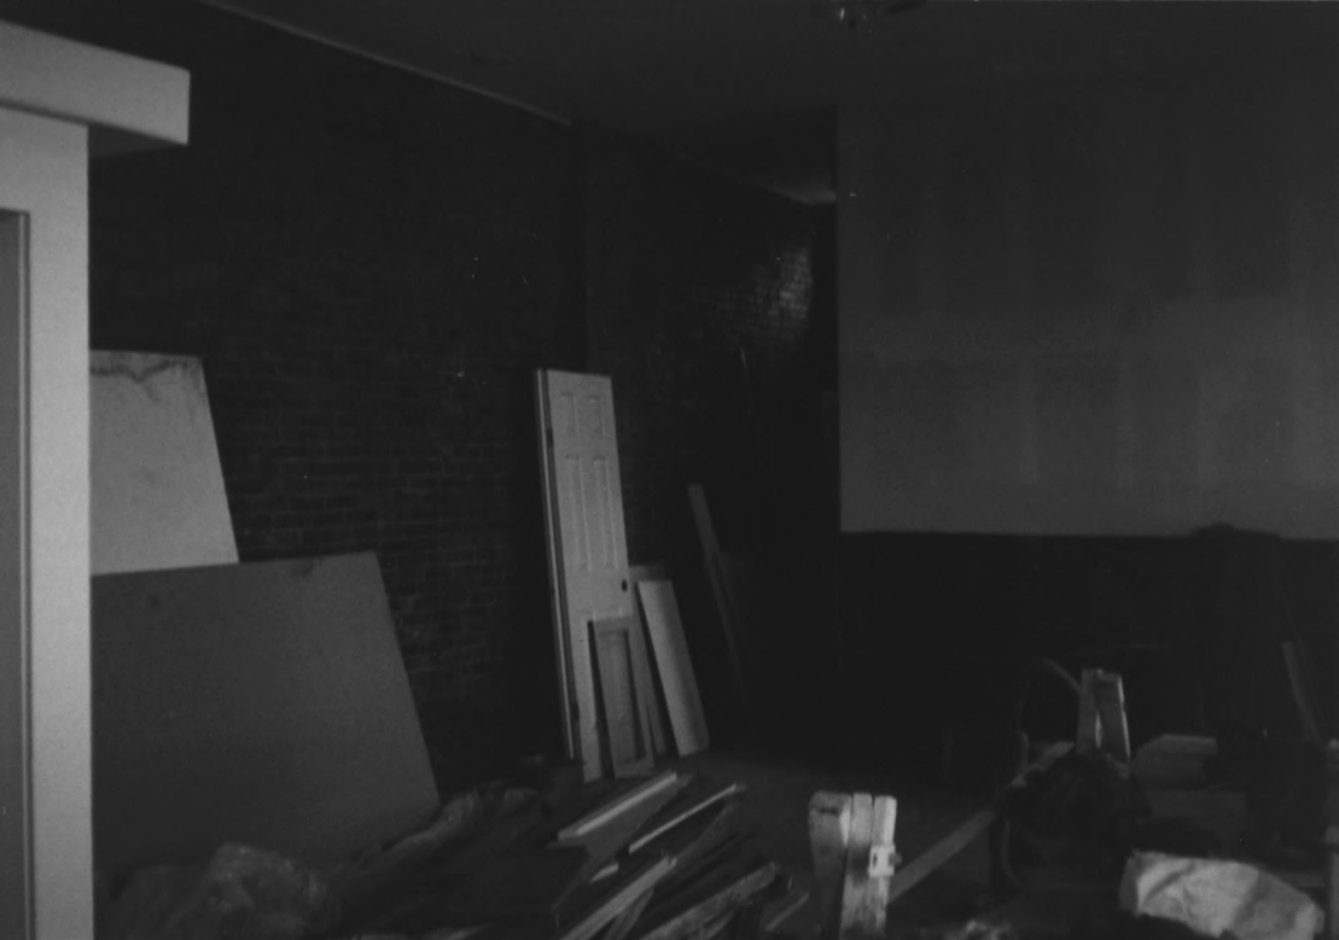
10 of 21

LOOKING NORTH, FIRST FLOOR LEVEL, INTERIOR VIEW.
REPRODUCED ORIGINAL WINDOW TRIM & CORNER
BLOCKS. WALL WAINSCOTTING INSTALLED BELOW.

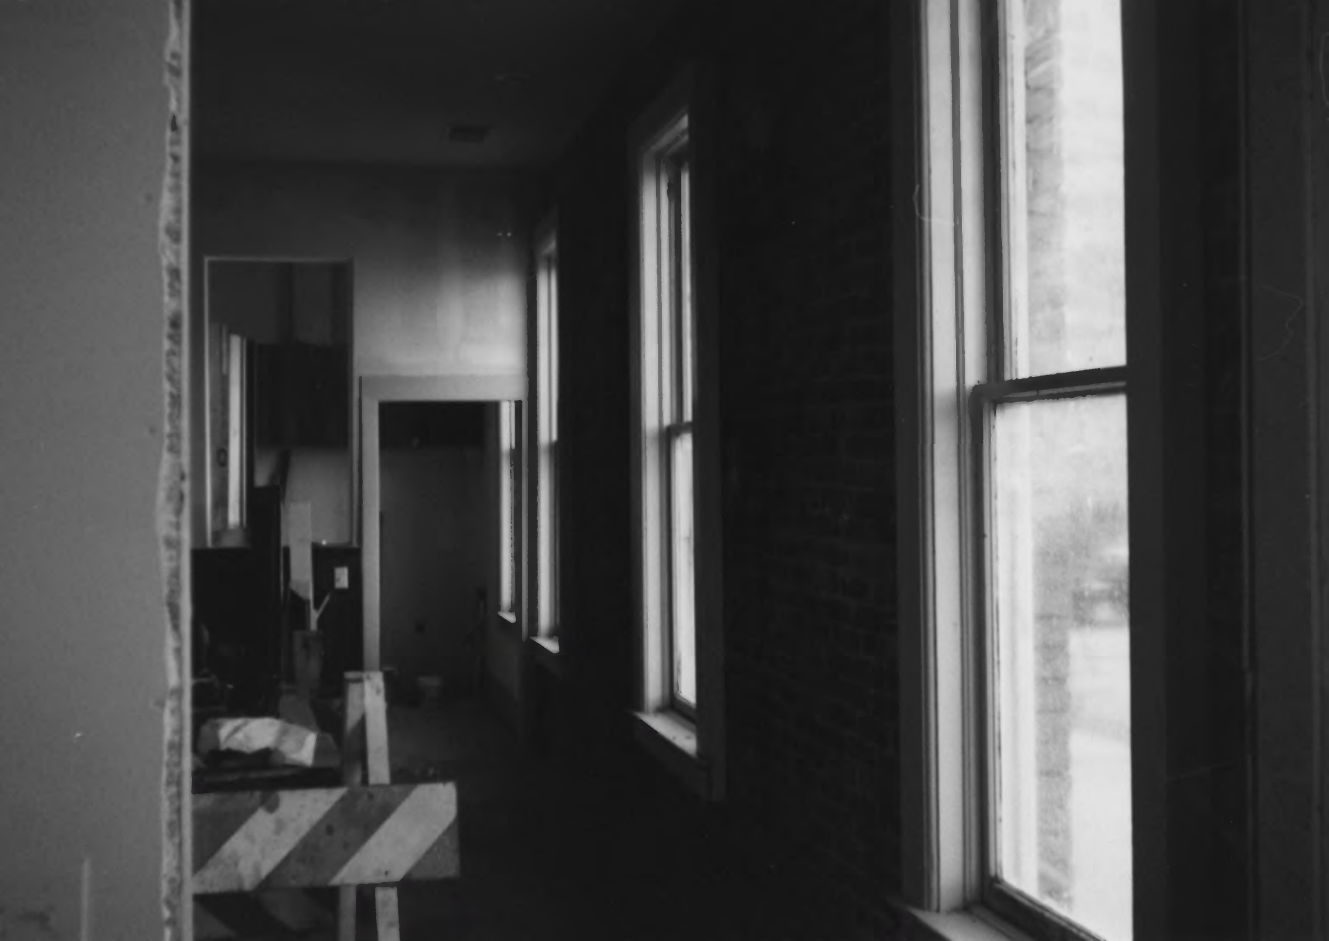
11 of 21

LOOKING SOUTH EAST, UPPER LEVEL, INTERIOR VIEW.
EXPOSED BRICK WALL, WAINSCOTTING.
WORK IN PROGRESS.

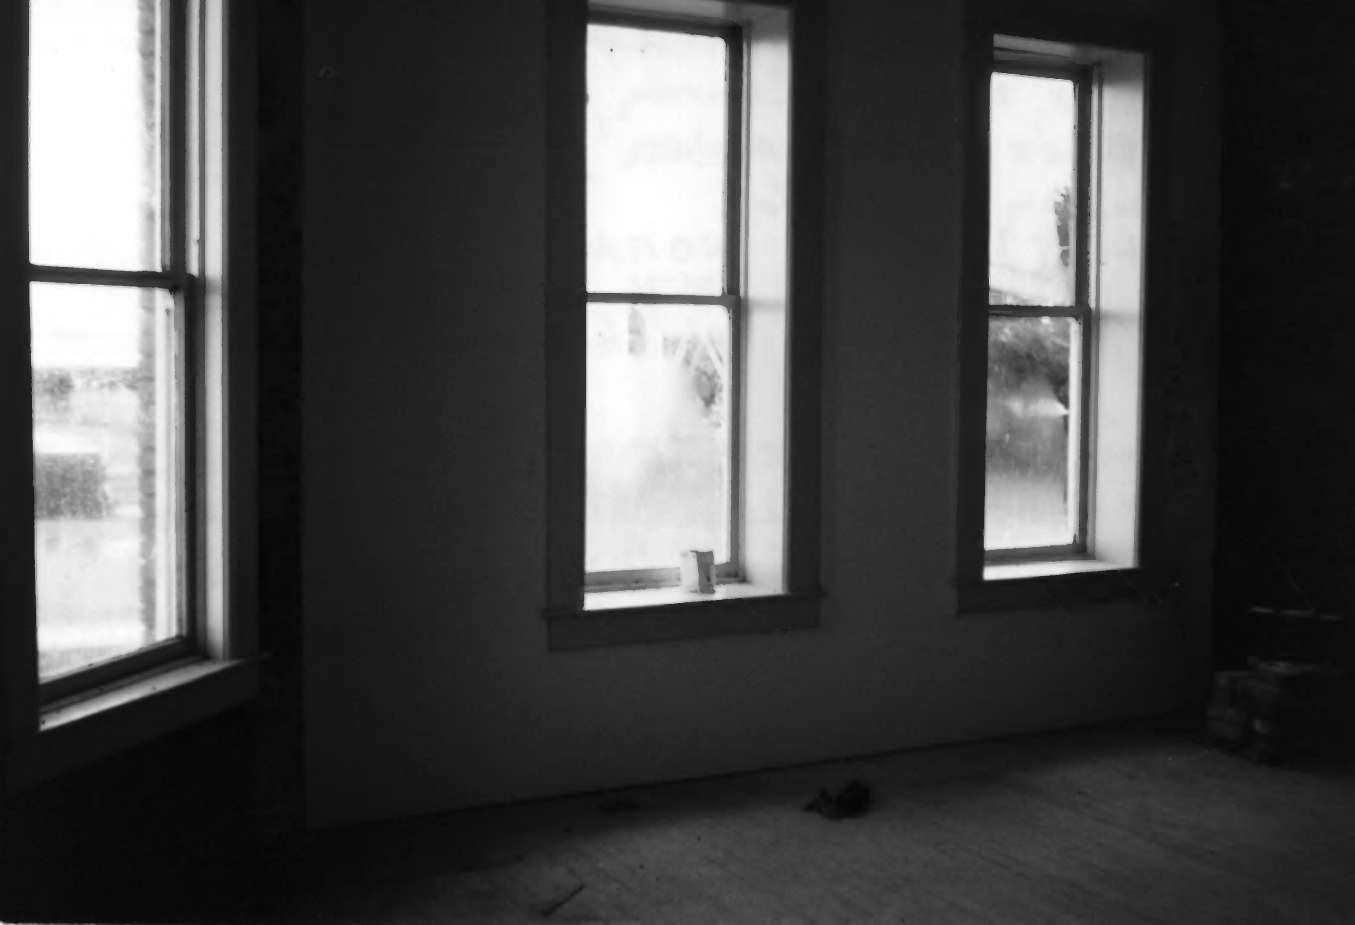
LOOKING WEST UPPER LEVEL, INTERIOR VIEW, NORTH
WALL DOUBLE HUNG WINDOWS, ORIGINAL WAVY GLASS
& TRIM. EXPOSED BRICK WALL SHOWS ARCHES OVER
WINDOWS.

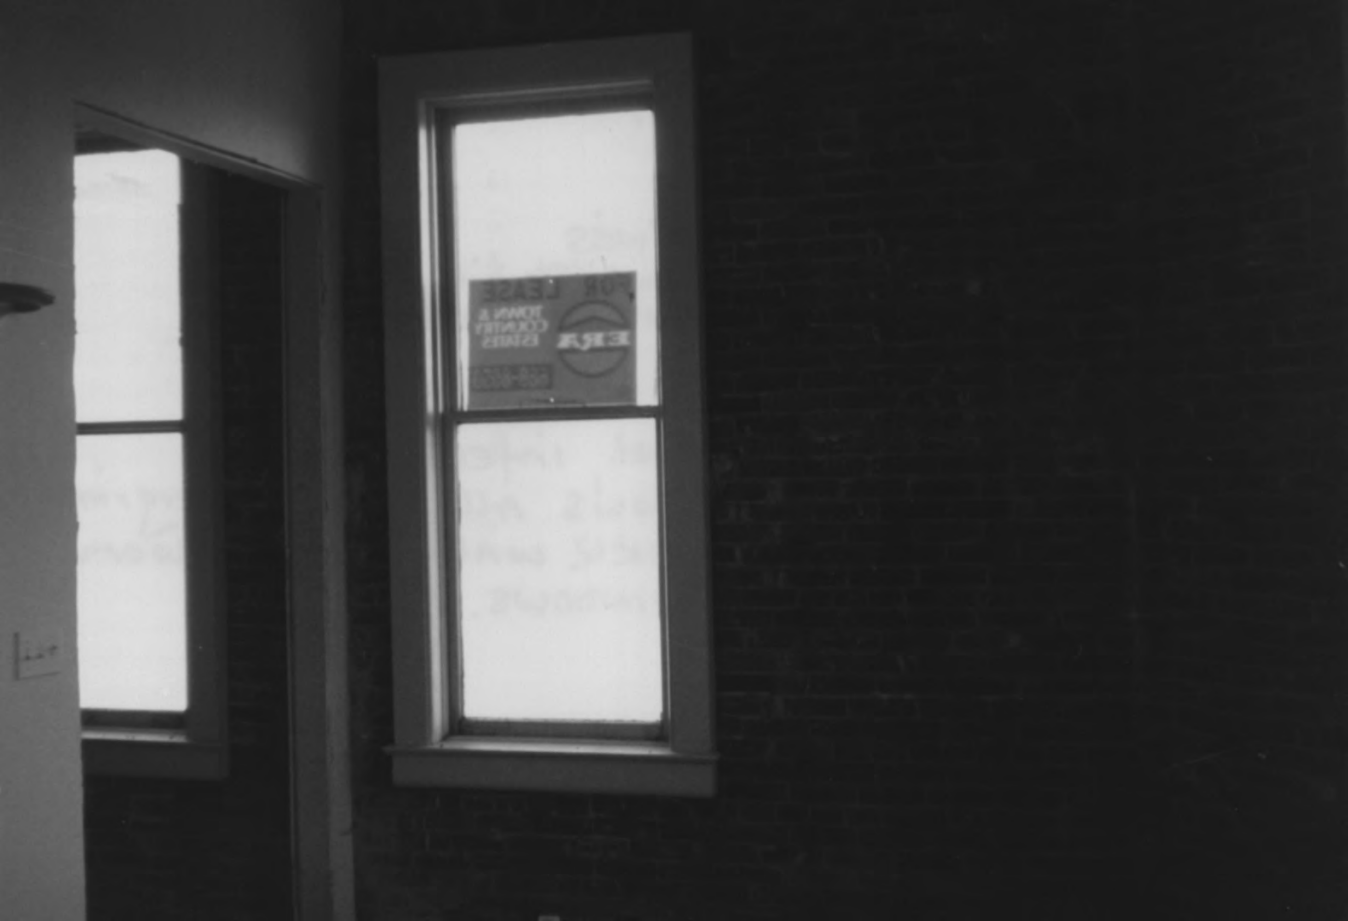
13 of 21

LOOKING EAST, UPPER LEVEL, INTERIOR VIEW.
FRONT ROOM, WALL REBUILT DUE TO EARTH-
QUAKE DAMAGE (RECESSED WINDOWS.)
ORIGINAL FRAMES, GLASS, AND TRIM RETAINED.

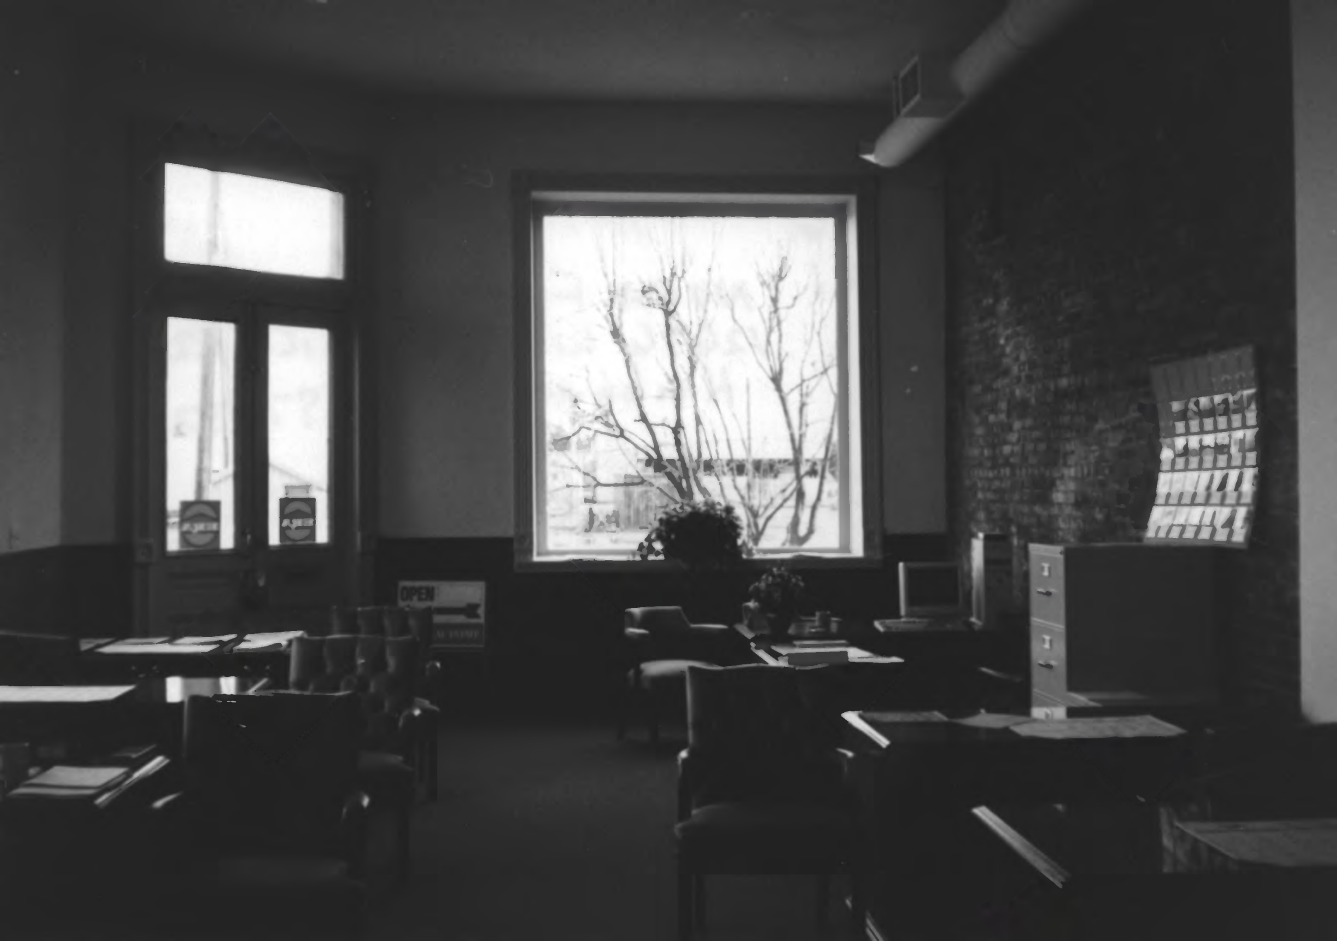
LOOKING NORTH EAST, FIRST FLOOR LEVEL, INTERIOR
VIEW. REPRODUCED TRIM ON WINDOW, ORIGINAL
DOORS AND GLASS, RESTORED DOOR TRIM &
REPRODUCED HARDWARE ON DOORS. WAINSCOTTING
15 721 ADDED BELOW.

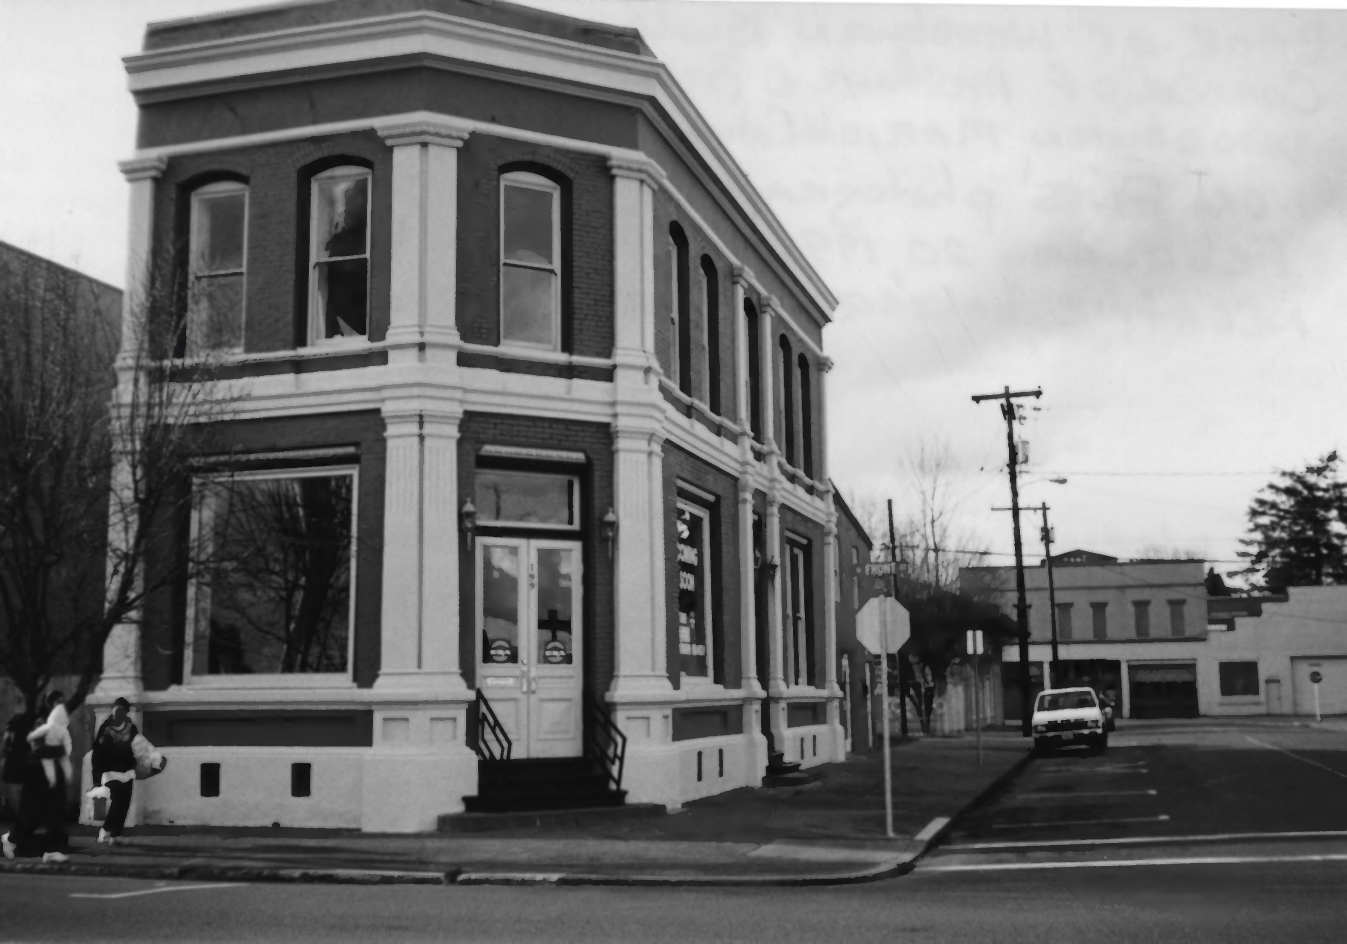
17 of 21

EXTERIOR VIEW EAST FACING WEST. Bldg.
REPAINTED MATCHING ORIGINAL PAINT COLORS.
REPRODUCED COLUMN TOPS, BANDING AND
CORNICE PIECE. ORIGINAL ~~DOORS~~ DOORS & STEPS.

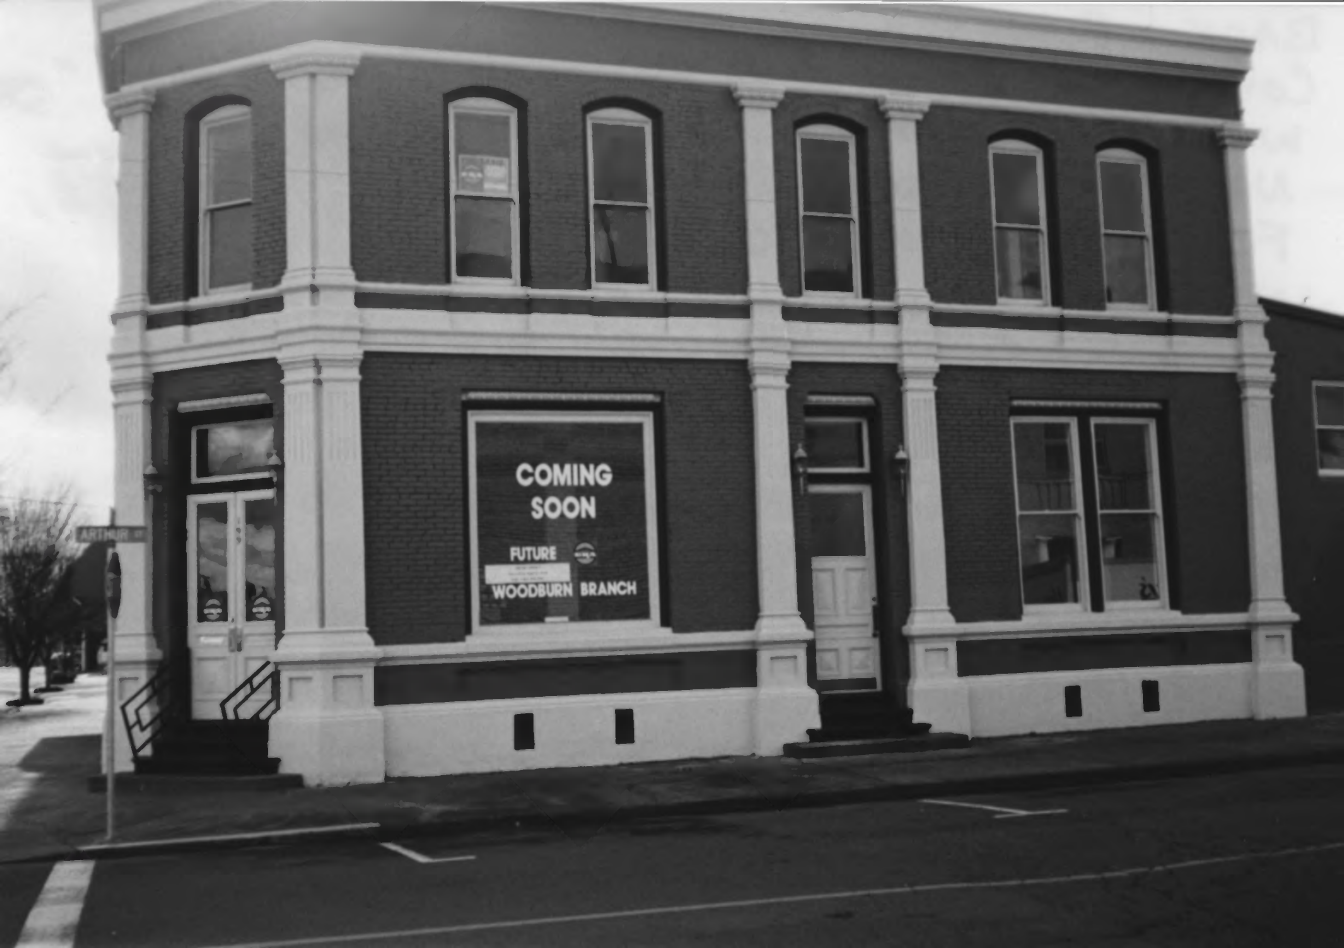
EXTERIOR VIEW EAST FACING WEST.

REPRODUCED COLUMN TOPS, BANDING, & CORNICE.

REPAINT, MATCHING ORIGINAL COLORS.

18 x 21' ORIGINAL DOORS & STEPS
