East or principal facade of La Fortaleza.

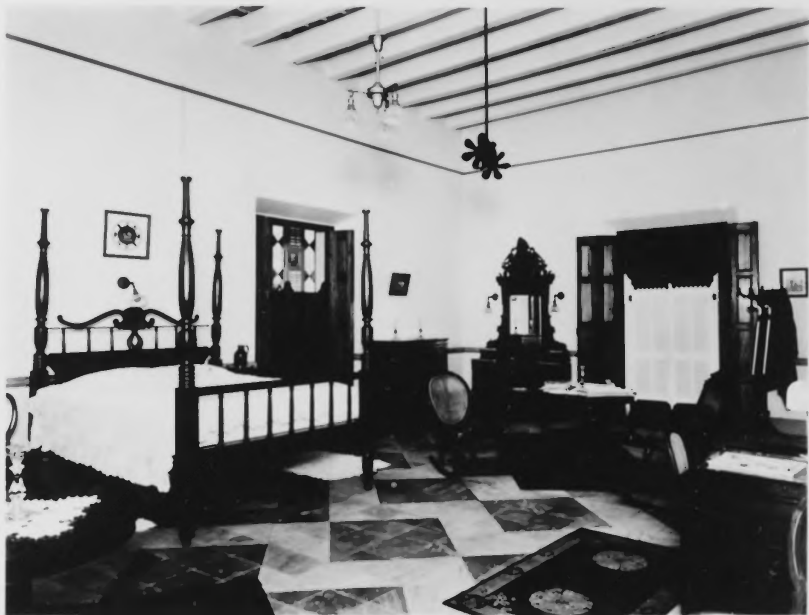
Bedroom in La Fortaleza showing type of ceiling construction being replaced with reinforced concrete
