OLD TAVERN *2801 Capitol Avenue*  
Sacramento, CA *Sacramento County*  
Photographer: Unknown  
circa 1880 or earlier  
Negative: Bob McCabe, Sacramento  
Looking east x northeast

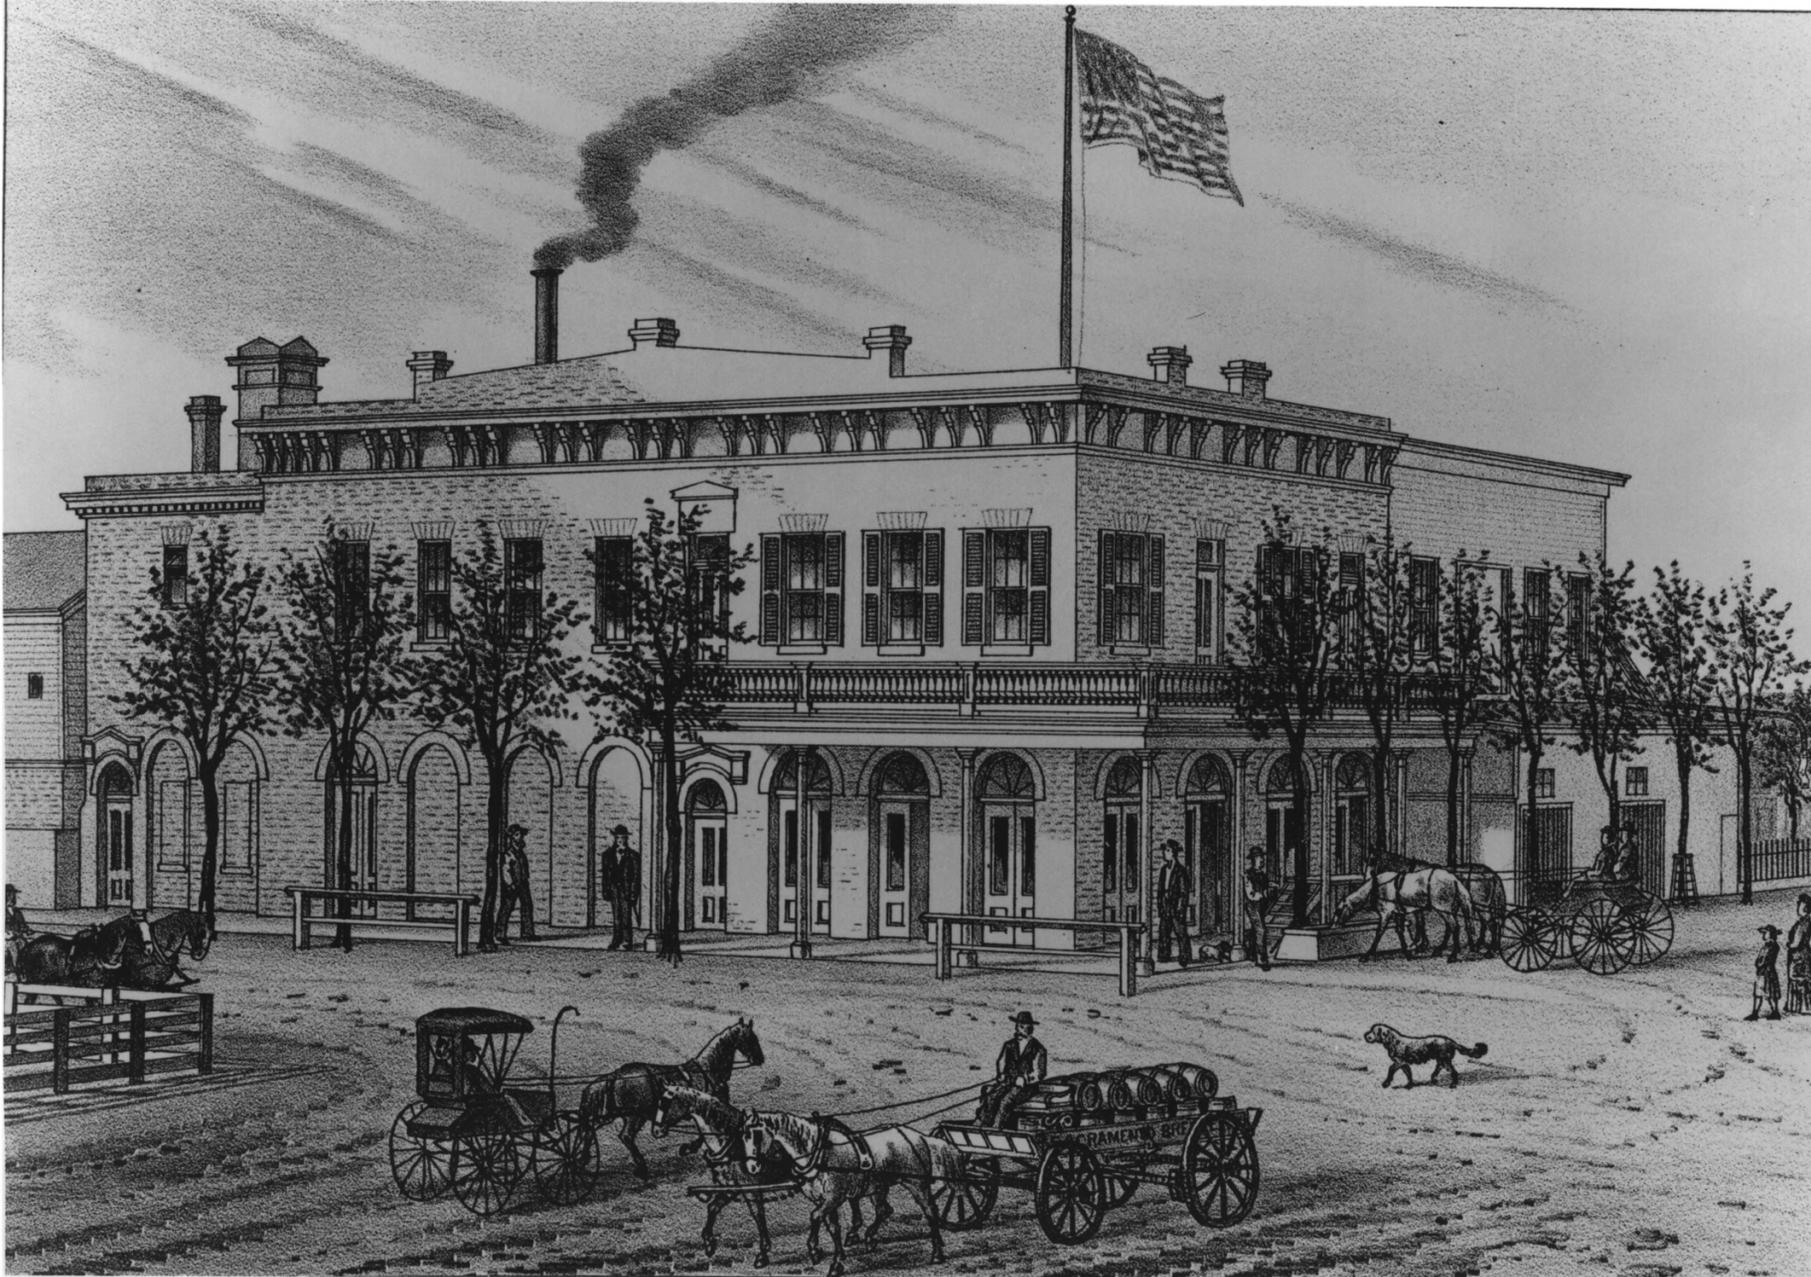
#1 of 29

This is a copy of the earliest printed document known at this time of the old Sacramento Brewery building, found in Thompson & West's History of Sacramento County, 1880. Note the turned balcony handrail at the second level which does not show in any later graphics. At this period, the building was a two story brick structure.

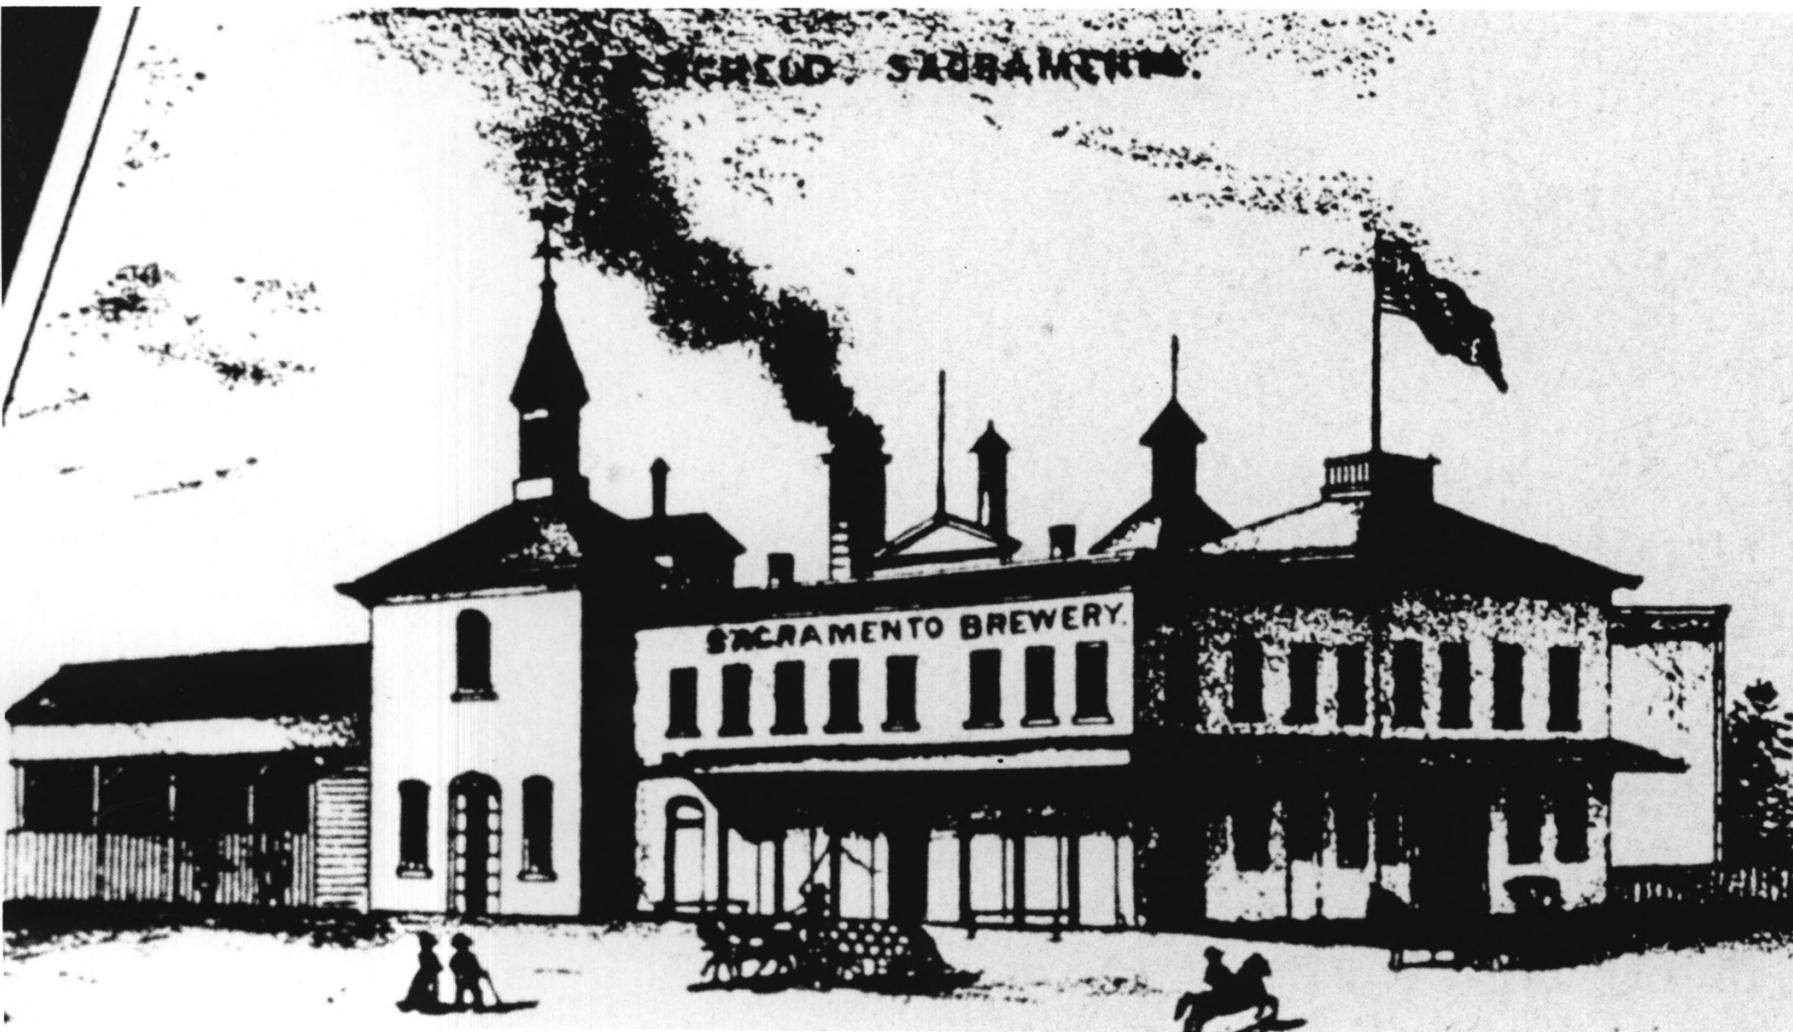
#2 of 29

This illustration was found in the California Room, State Library, in an 1886 composite published in the 1948-1949 issue of Western Brewing and Distributing magazine. Differences in this photograph include turned balcony rail now missing, parapet wall showing a very classical frieze, and the adjacent building to the east has a new roof and relocated flag pole. Adjacent building to the north now protrudes forward at street facade and displays a very large cupola. Trees along both streets are missing, but hitching rails remain.

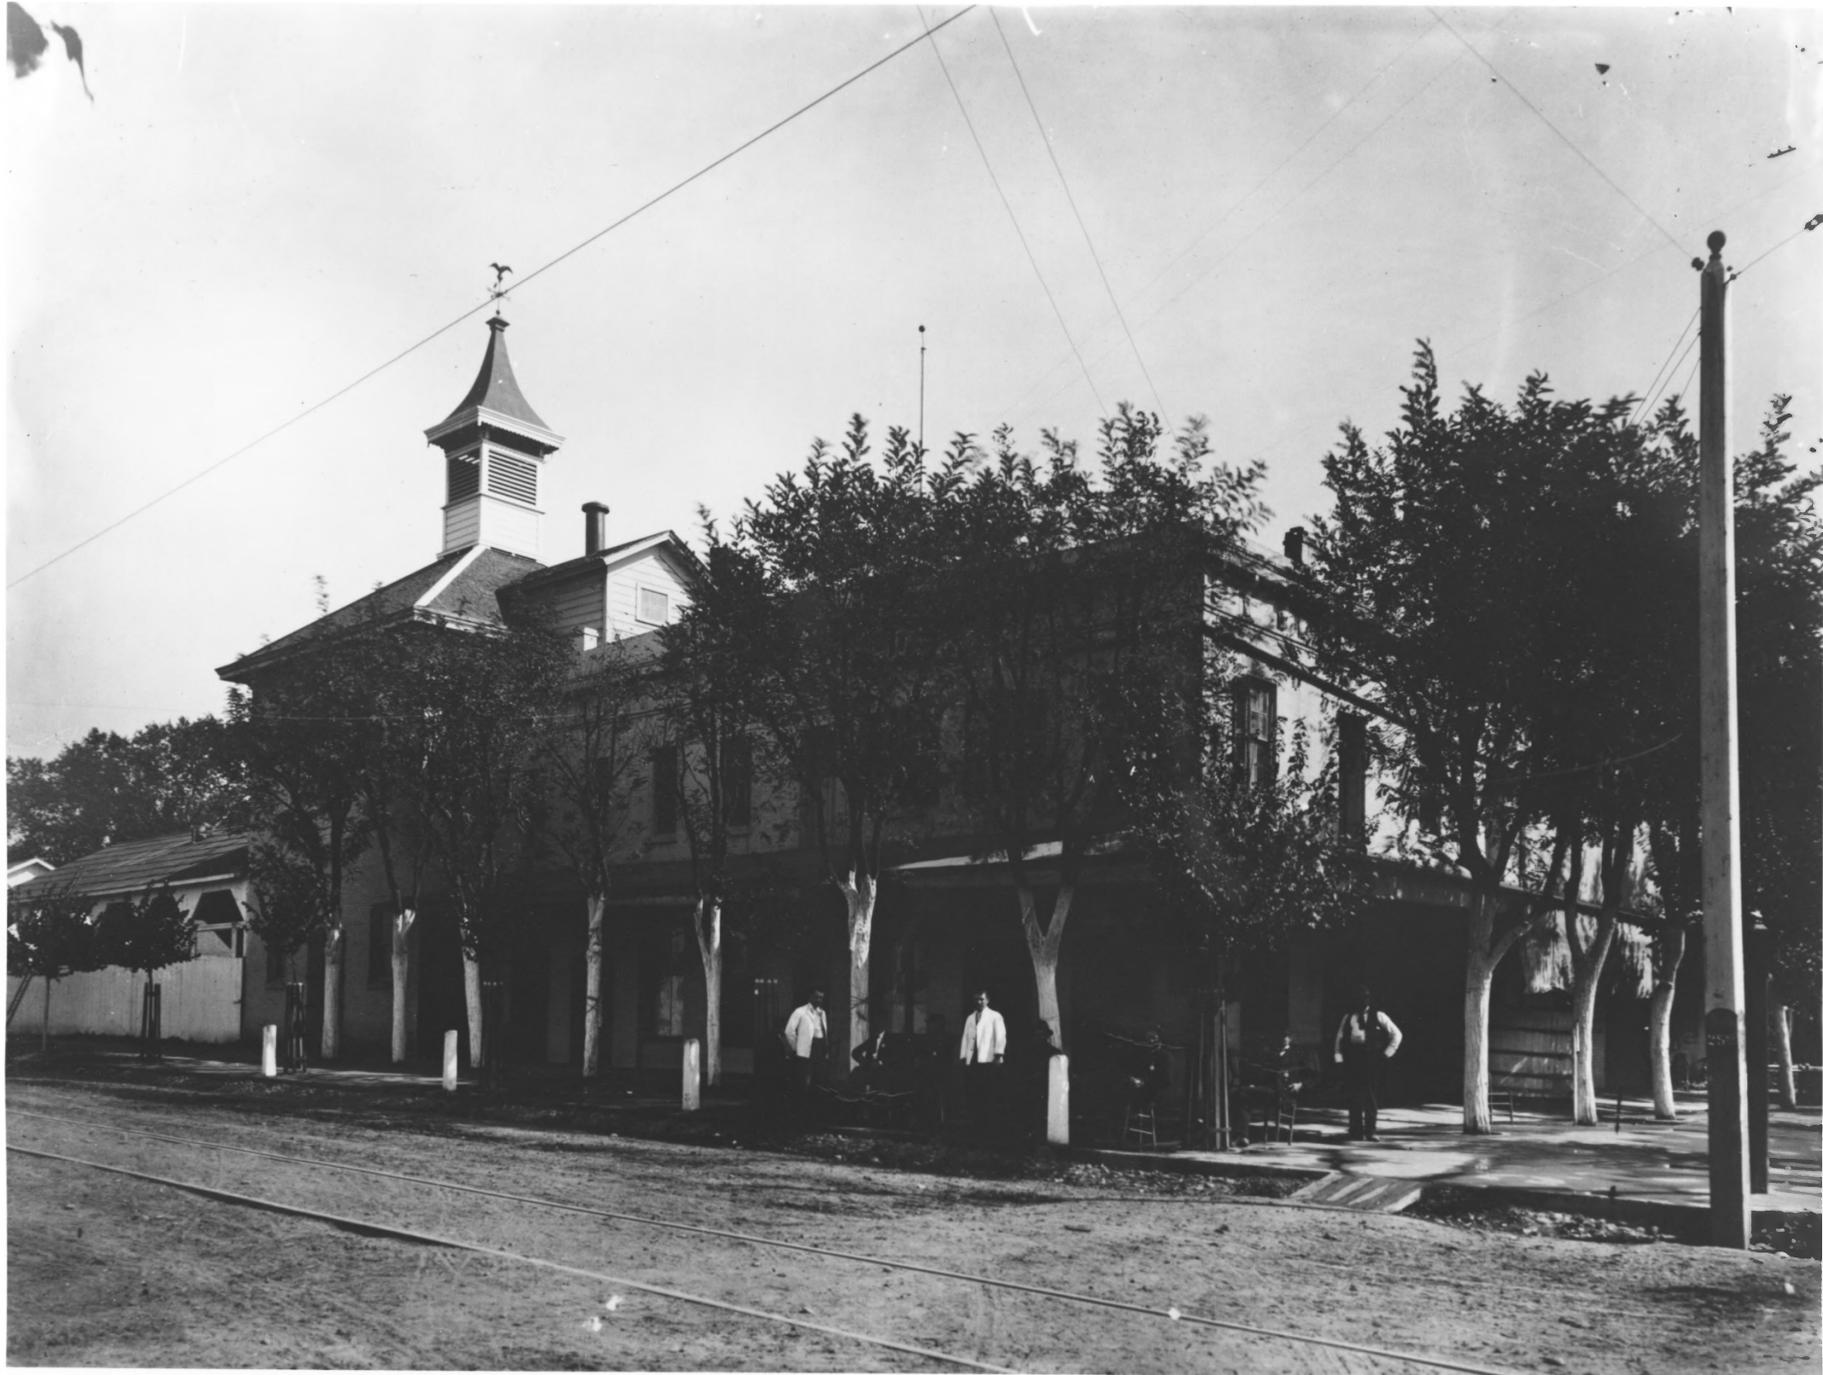
#3 of 29

In this photograph found in the California Room, State Library, the parapet behind the trees appears to be very similar to the Thompson & West rendering (#1). Porch roof is sloped and no longer has columns showing, suggesting the possibility of a diagonal brace supporting members. Wood louver shutters on the second floor windows also indicates the accuracy of the Thompson & West drawing. Note trolley track running up 28th Street, as well as overhead electric power. This version of the building remained until approximately 1922.

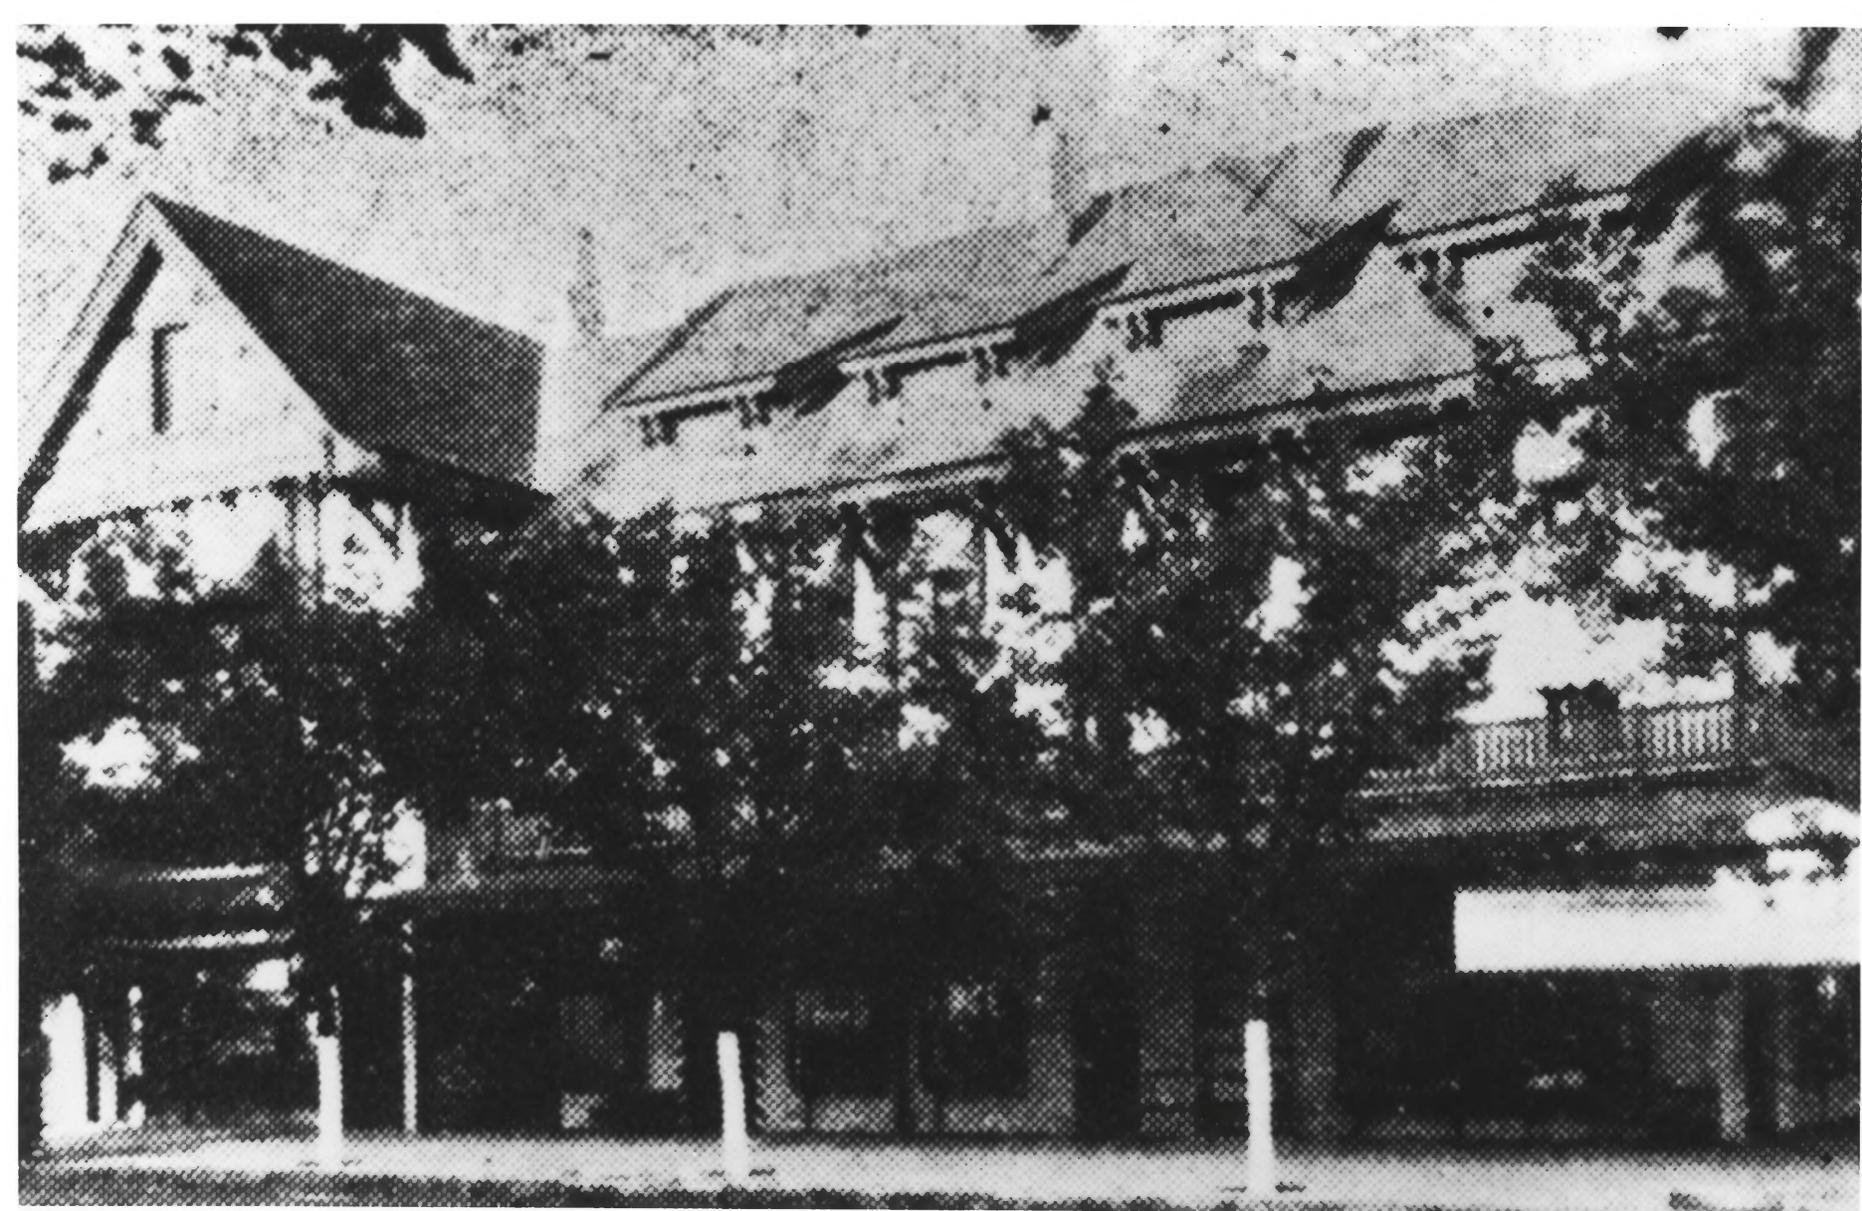
#4 of 29

Earliest photograph found of the conversion from two story brick classical architecture to a three story half timber structure with a very steep pitched roof over large attic space. This major remodeling occurred about 1922 and was the beginning of the era when the building became known as the Old Tavern.

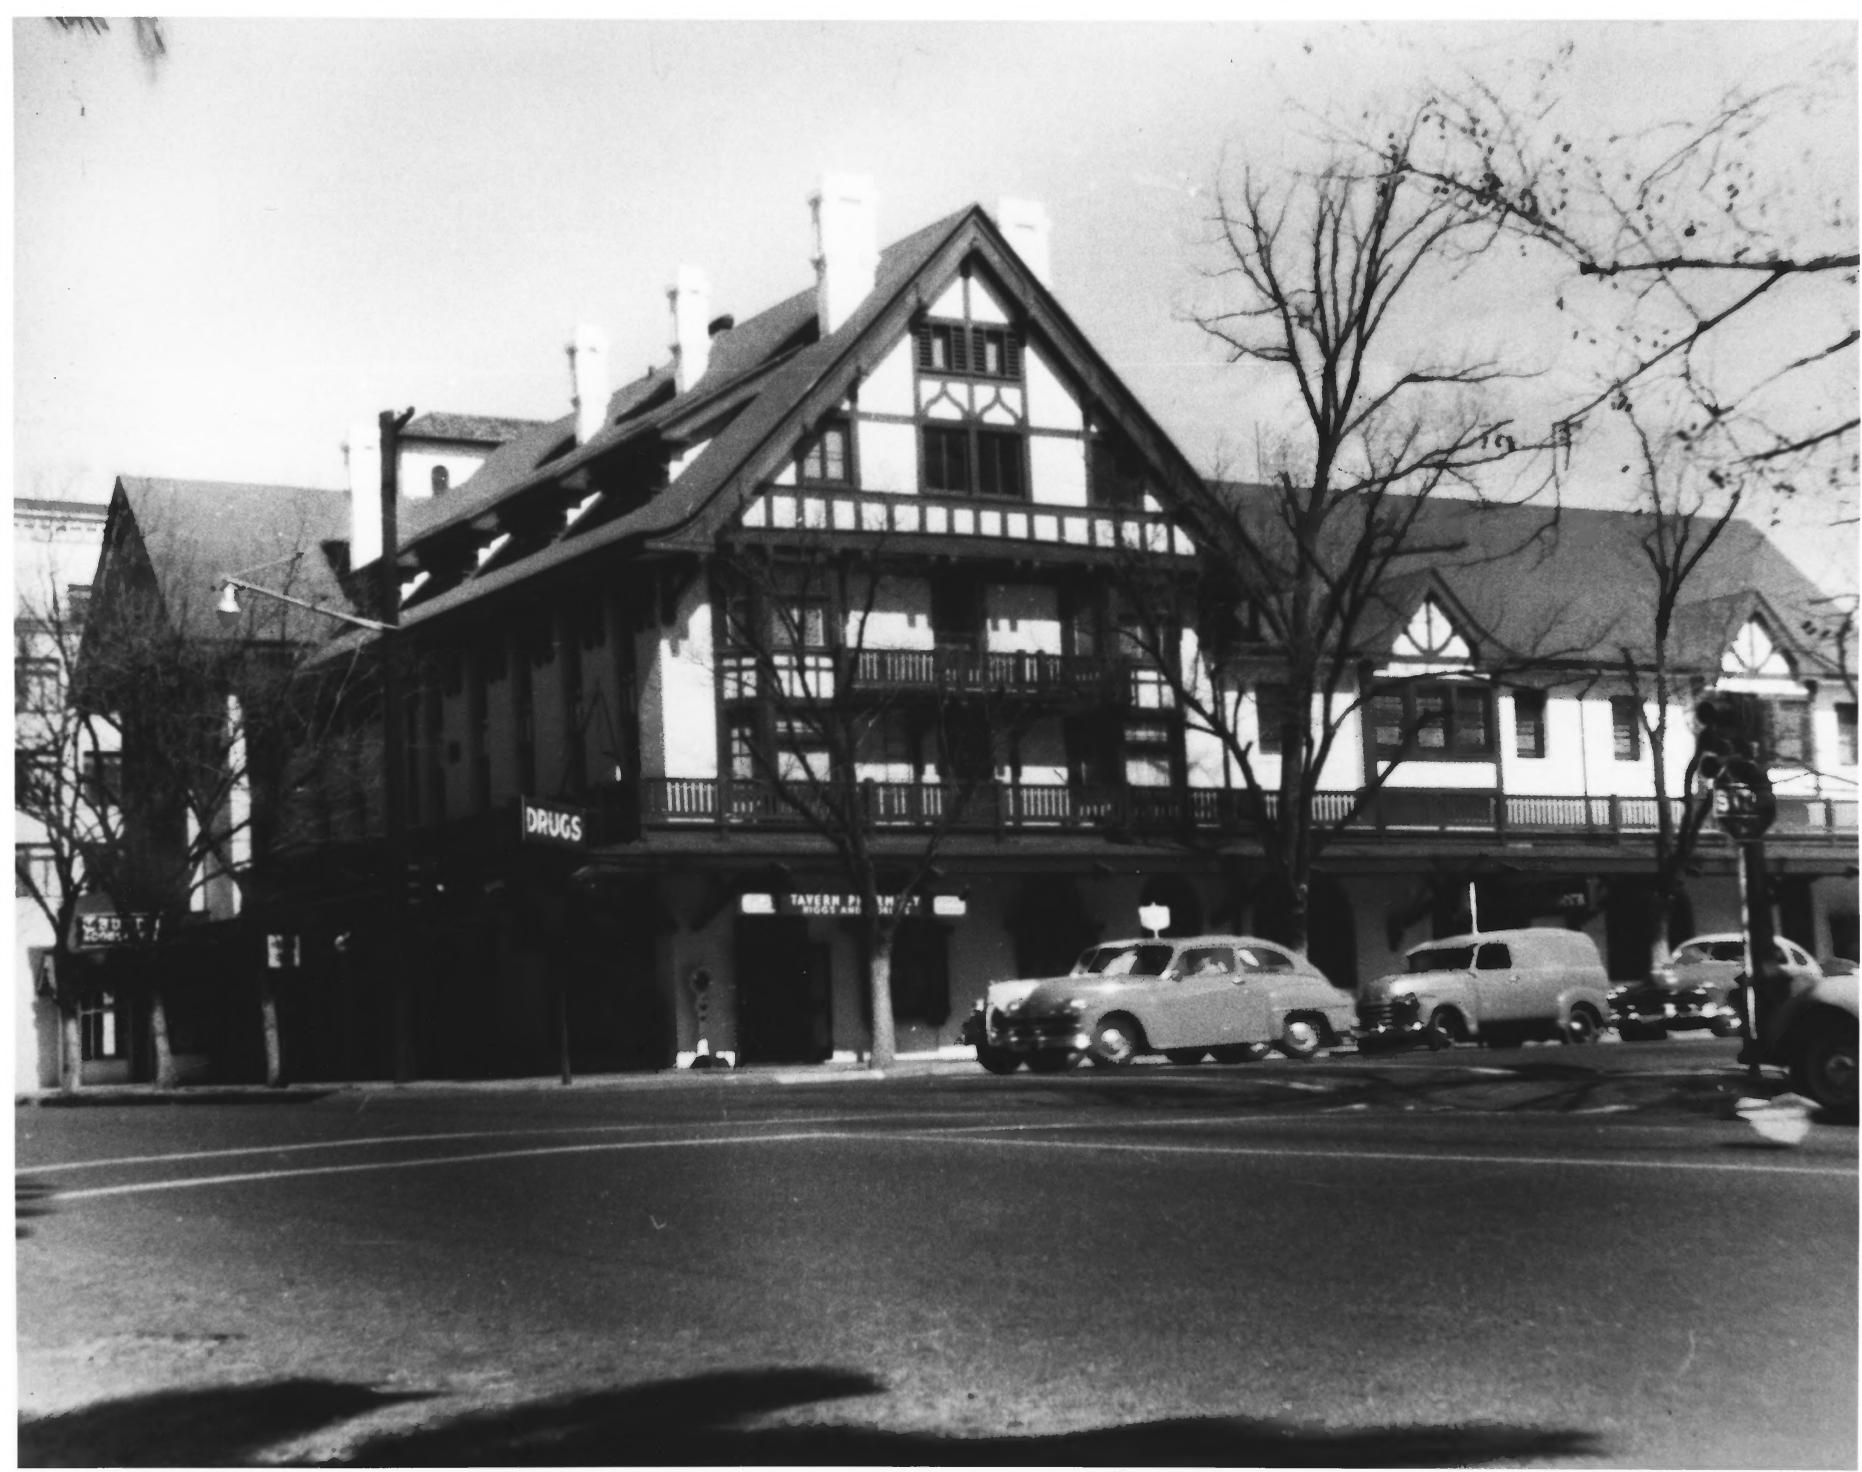
#5 of 29

Unfortunately, we have not been able to locate any photographs of the Old Tavern building between the 1924 photograph (#4) and this 1951 scene. Although the exterior physical appearance has remained nearly the same from 1922 to date, a great deal of history, as well as interior modifications, has taken place over those years.

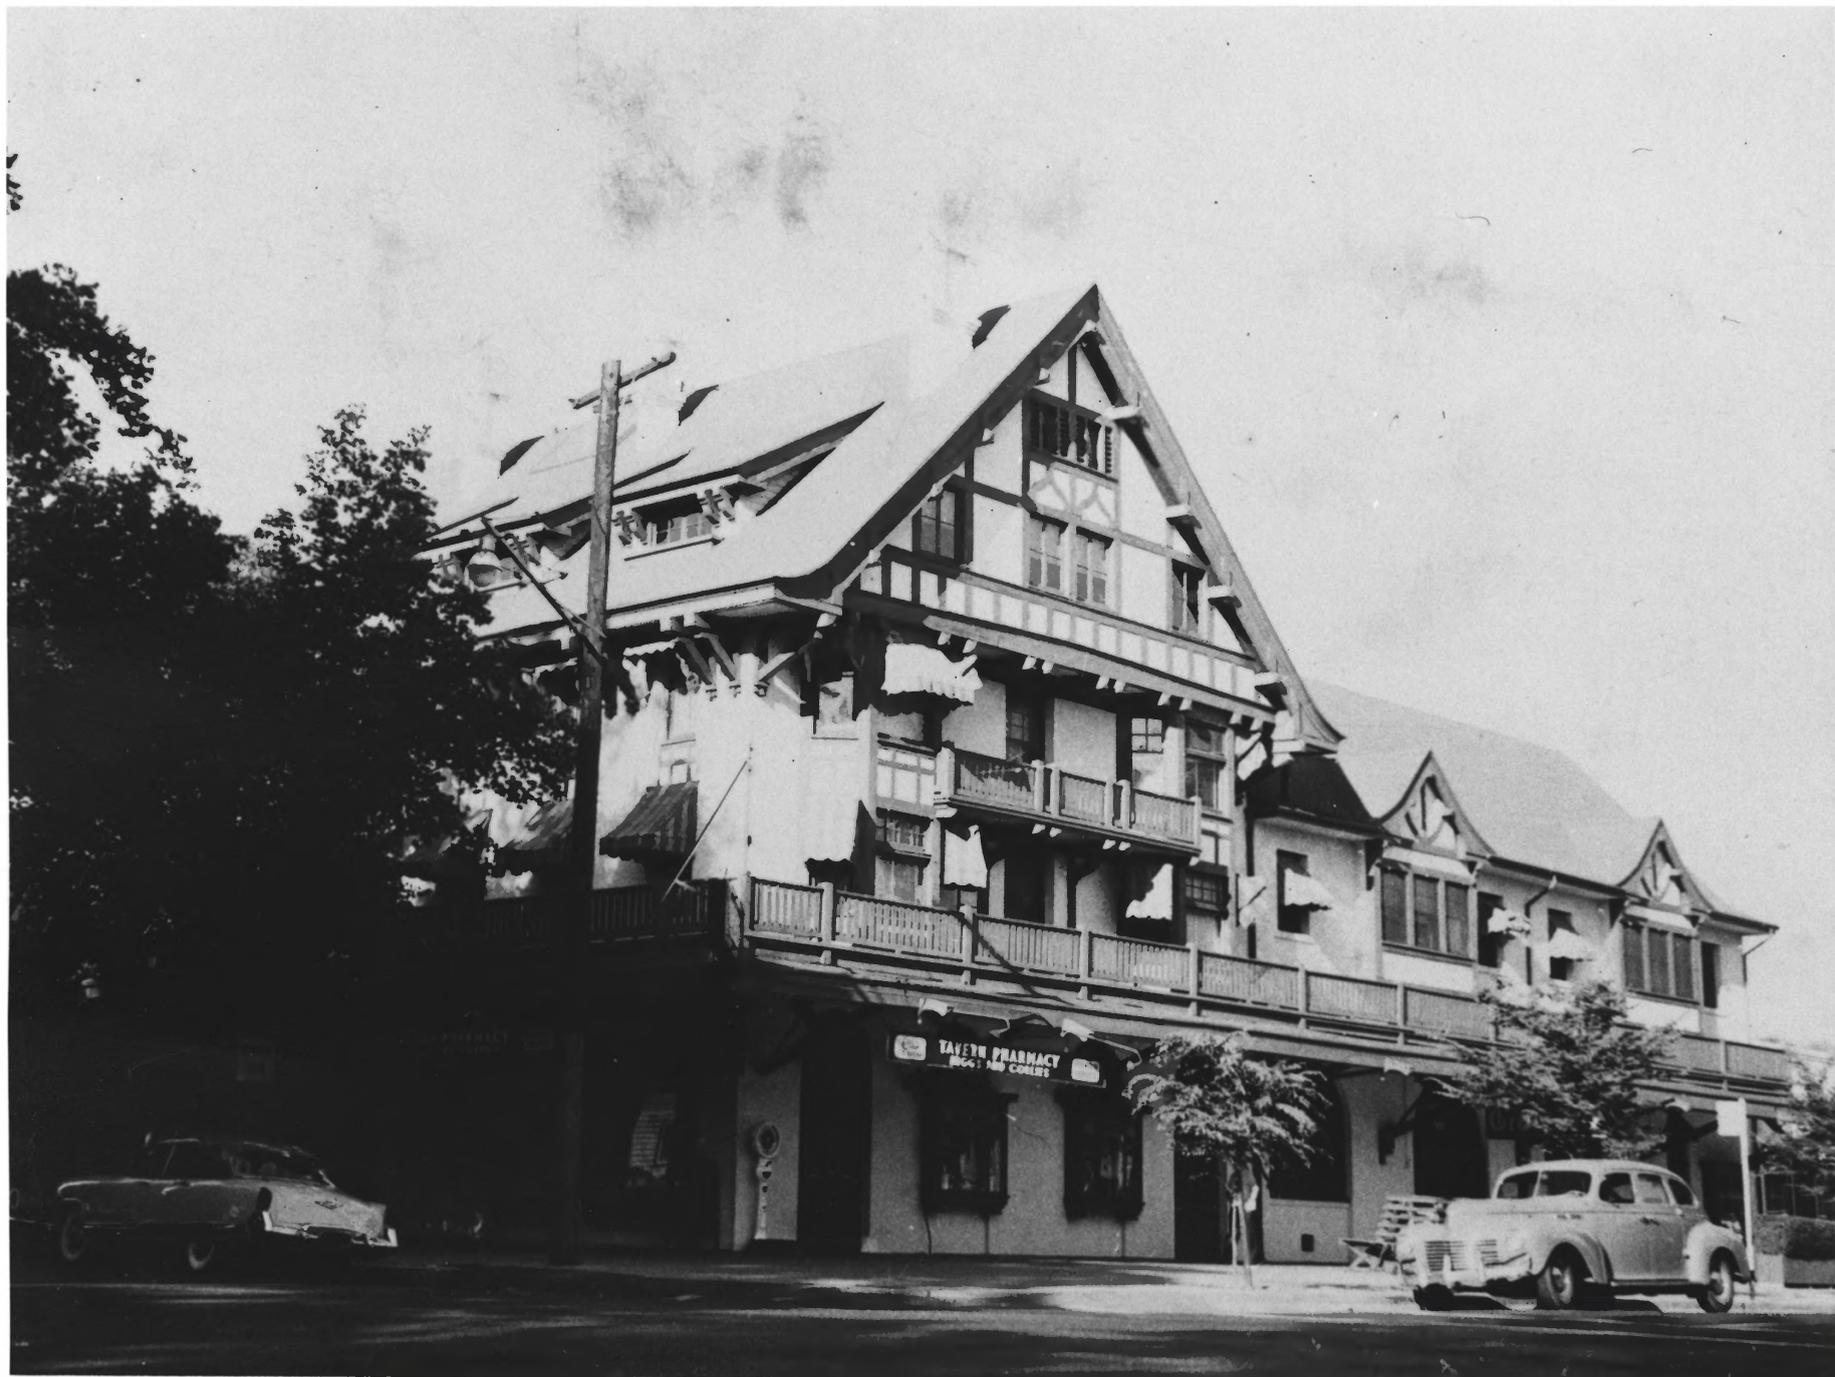
#6 of 29

This photograph was found in the California Room, State Library, in the Frederick Miers album. Several things occurred in a period of a few years. The large trees along Capitol Avenue ("M" Street) have been removed and replaced with new young trees. Again canvas awnings appear on the upper levels of the Old Tavern Building.

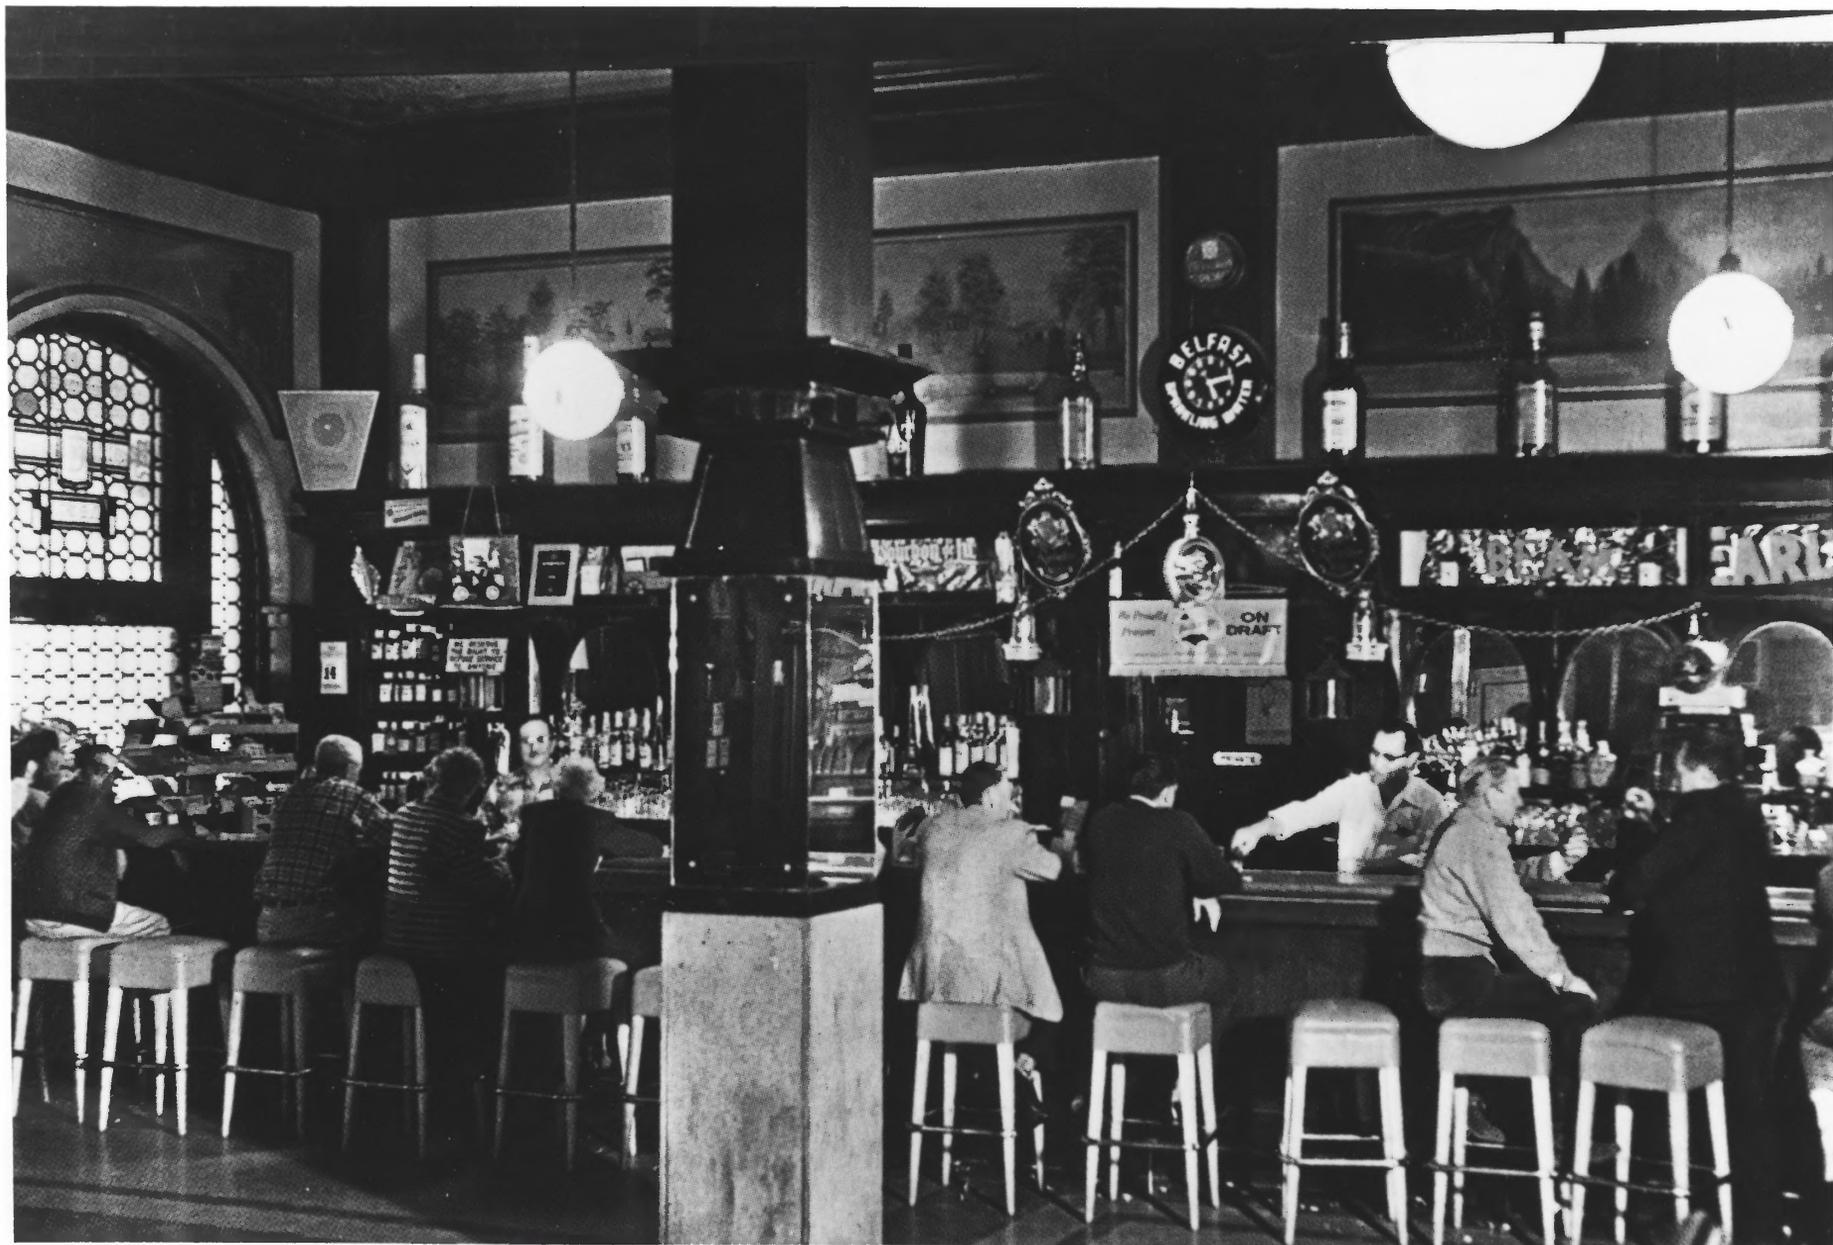
#7 of 29

This is the only interior photograph available of the Old Tavern as it was, taken from a colored photograph produced for postcards. It is our understanding that murals shown above the bar still exist behind new partition walls. Because of present occupancy, we have not been able to verify this information.

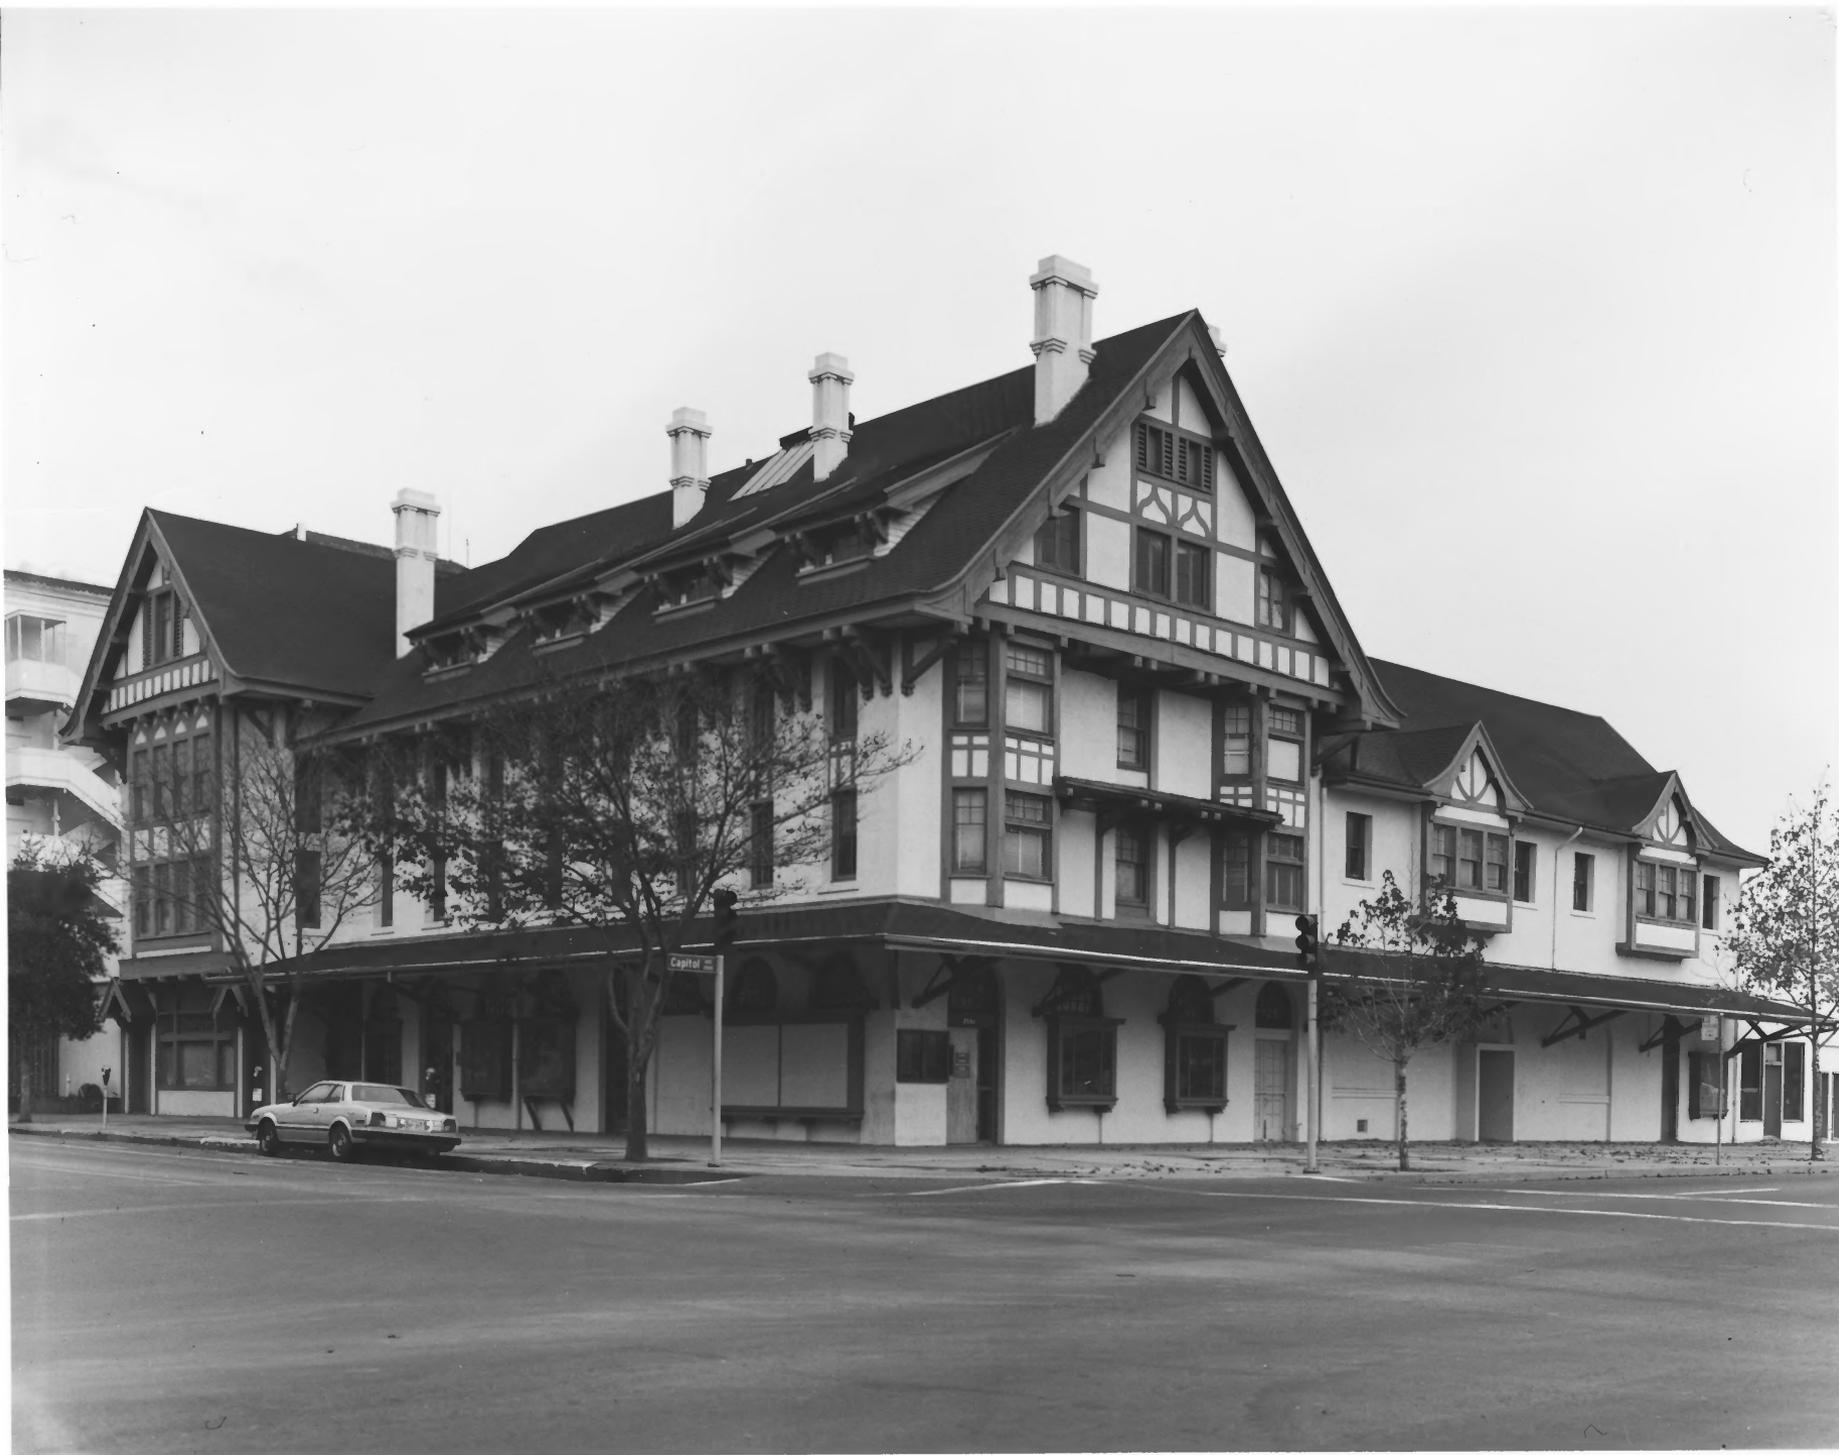
#8 of 29

Sometime between the mid 1950's and now, the canvas awnings have disappeared, as well as the balcony rails. Offices of Sutter Hospital now occupy the entire main floor, as well as the majority of the basement. The entire second and third floors are vacant.

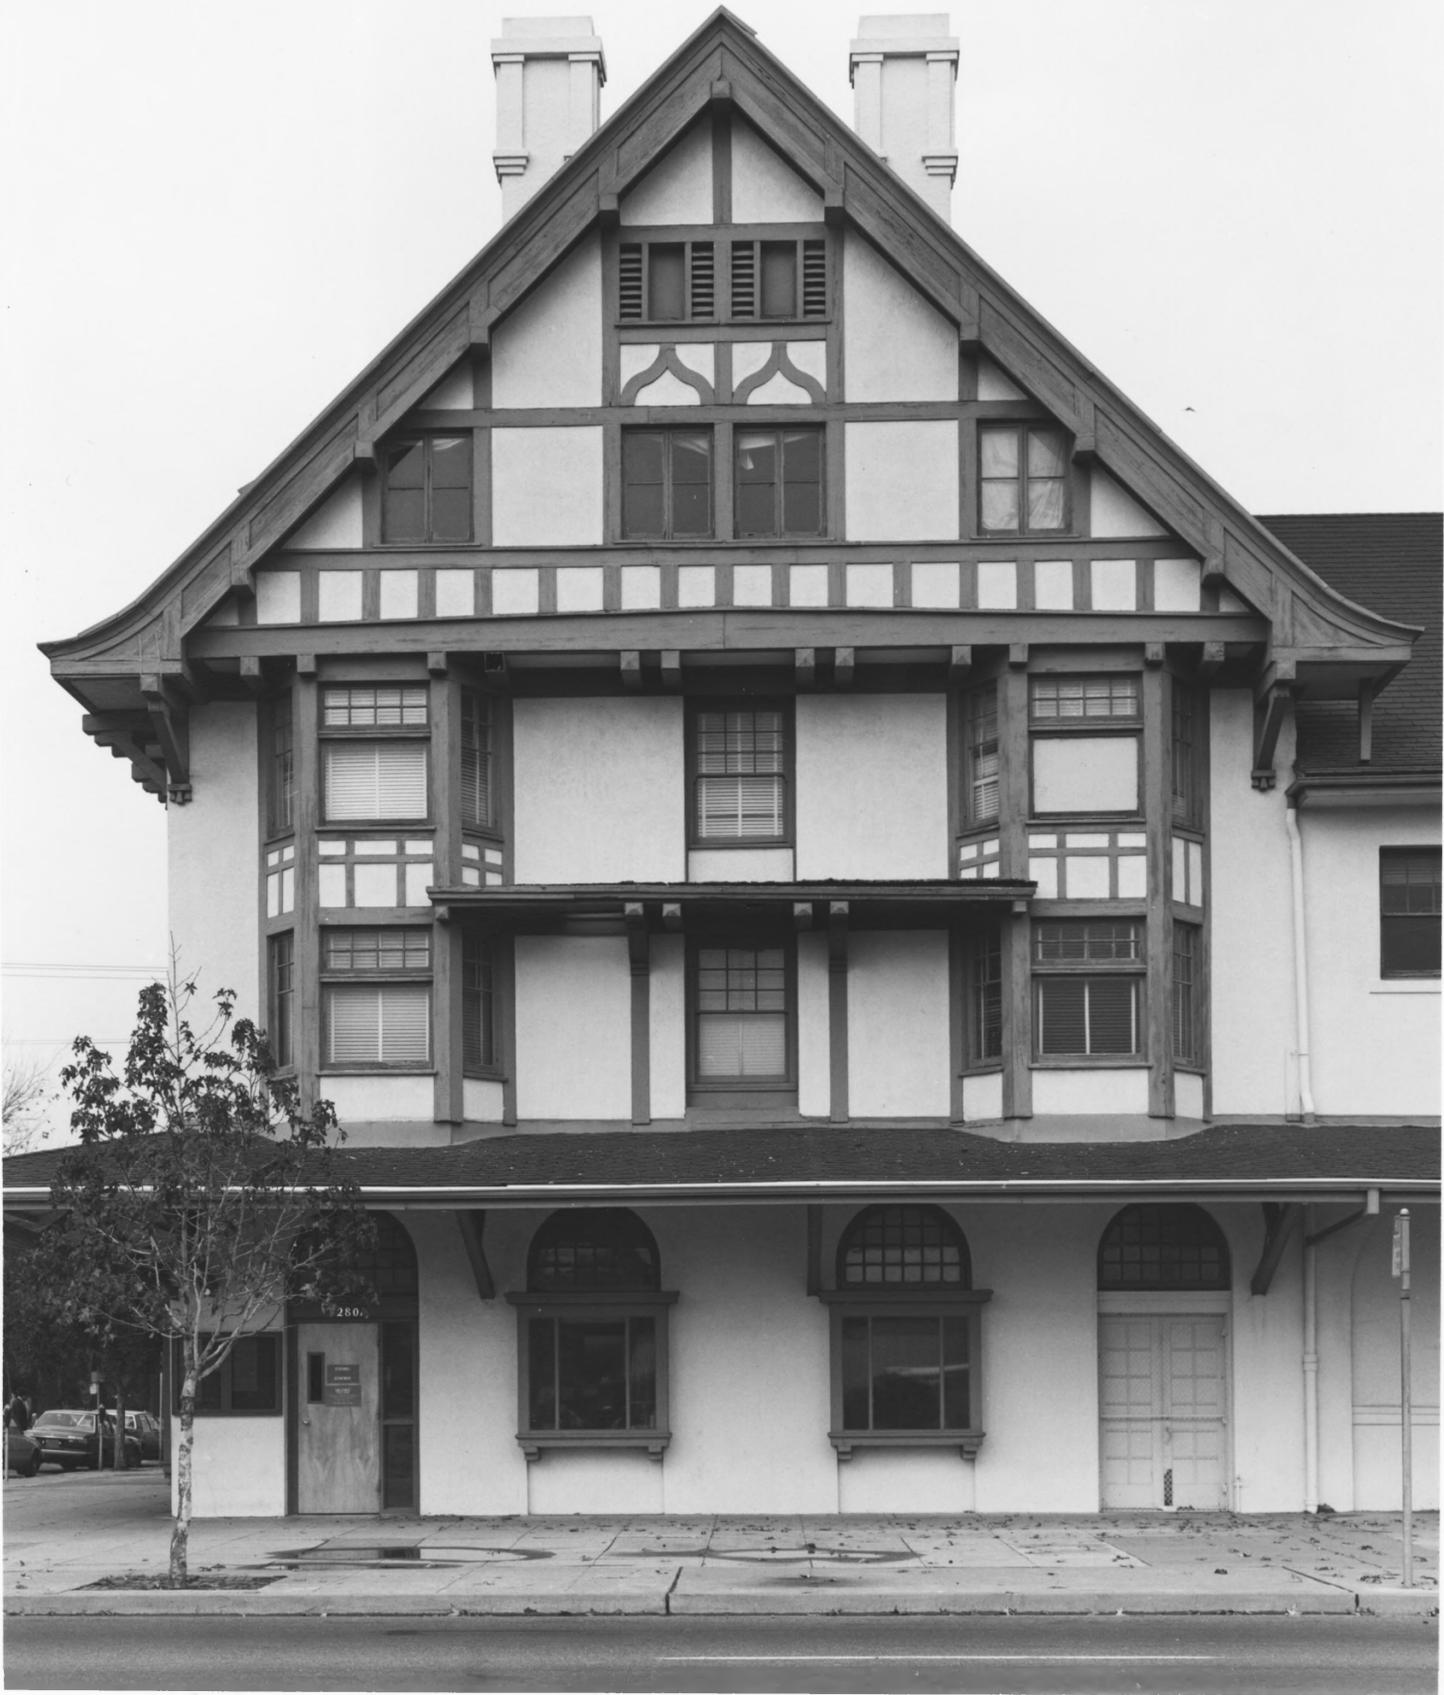
#9 of 29

This photograph shows details of the  
south elevation.
