OLD TAVERN *2801 Capitol Avenue*  
Sacramento, CA *Sacramento County*  
Photographer: Unknown  
circa 1880 or earlier  
Negative: Bob McCabe, Sacramento  
Looking east x northeast

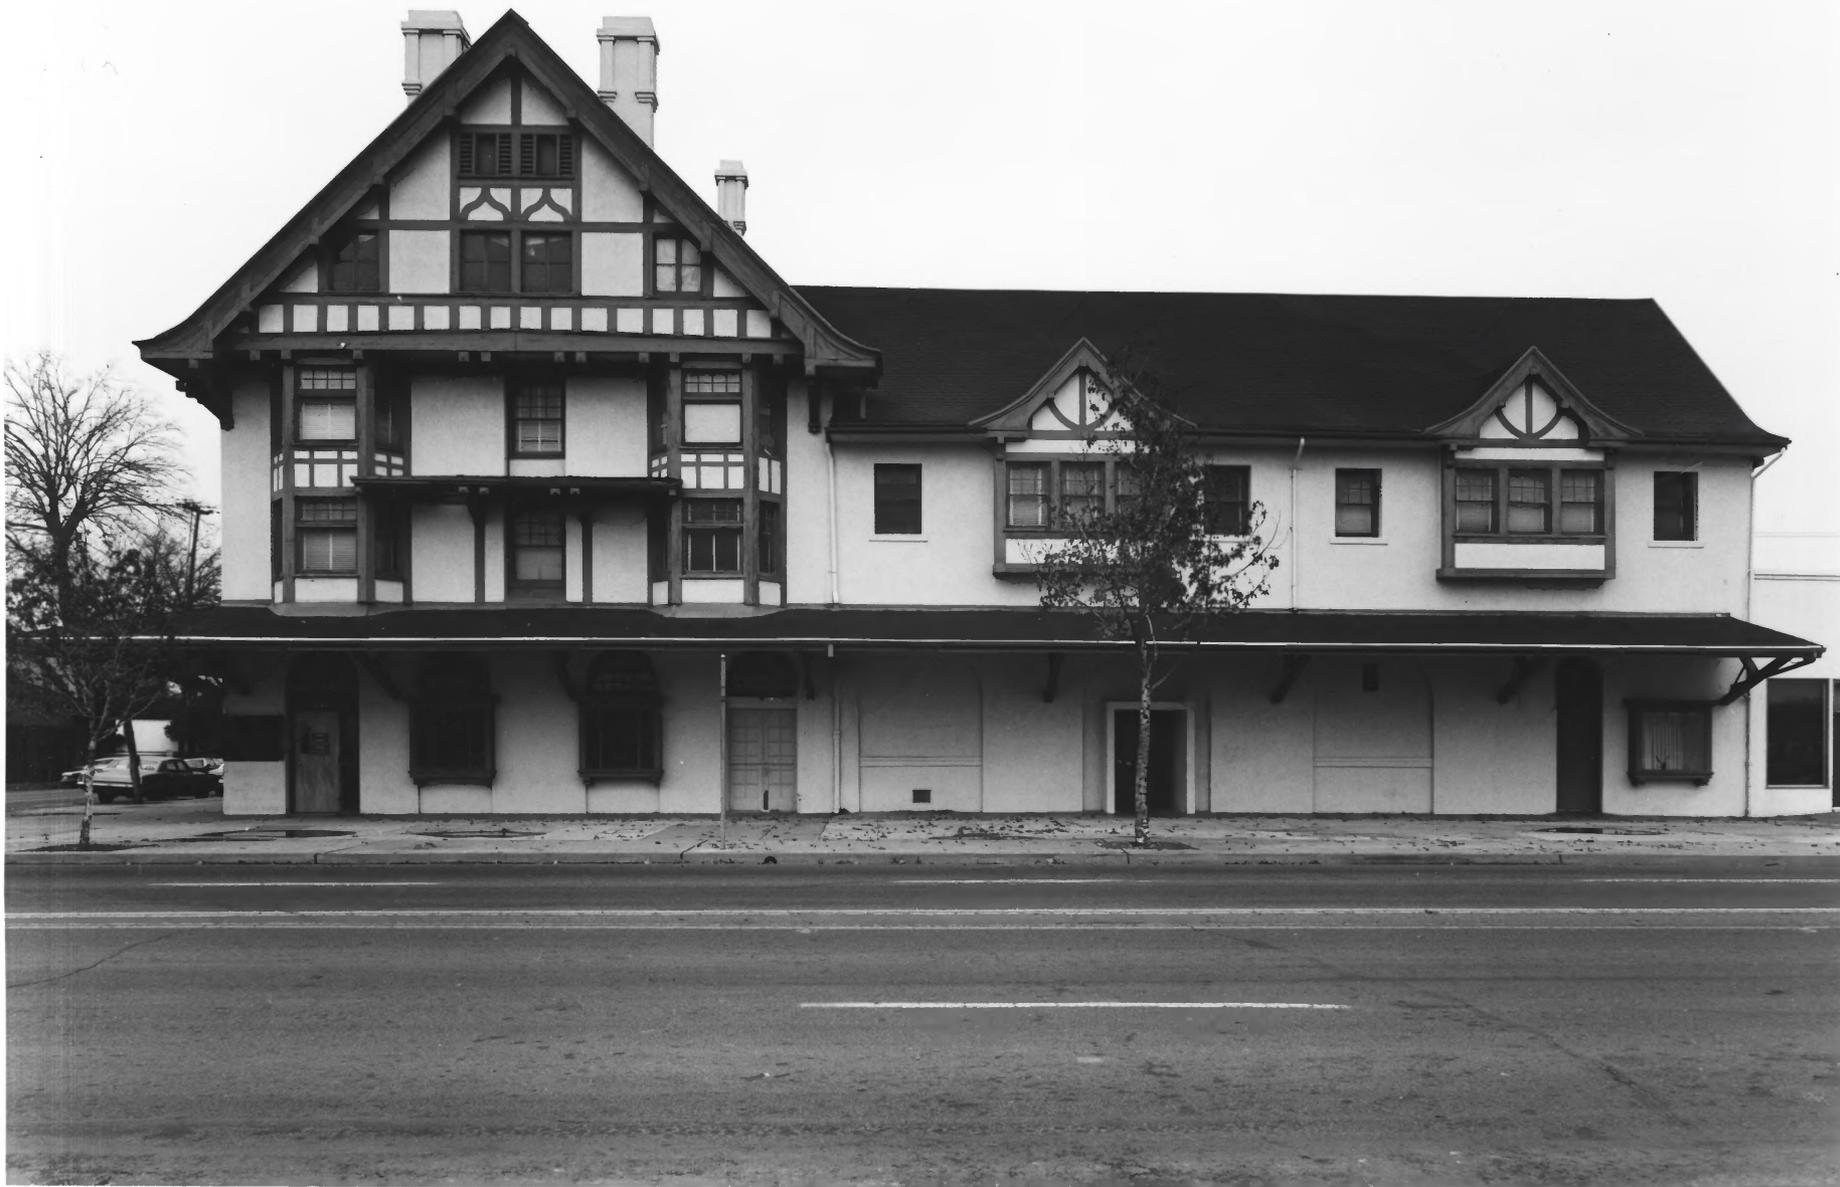
#10 of 29

This photograph shows the full south elevation of the Old Tavern building.

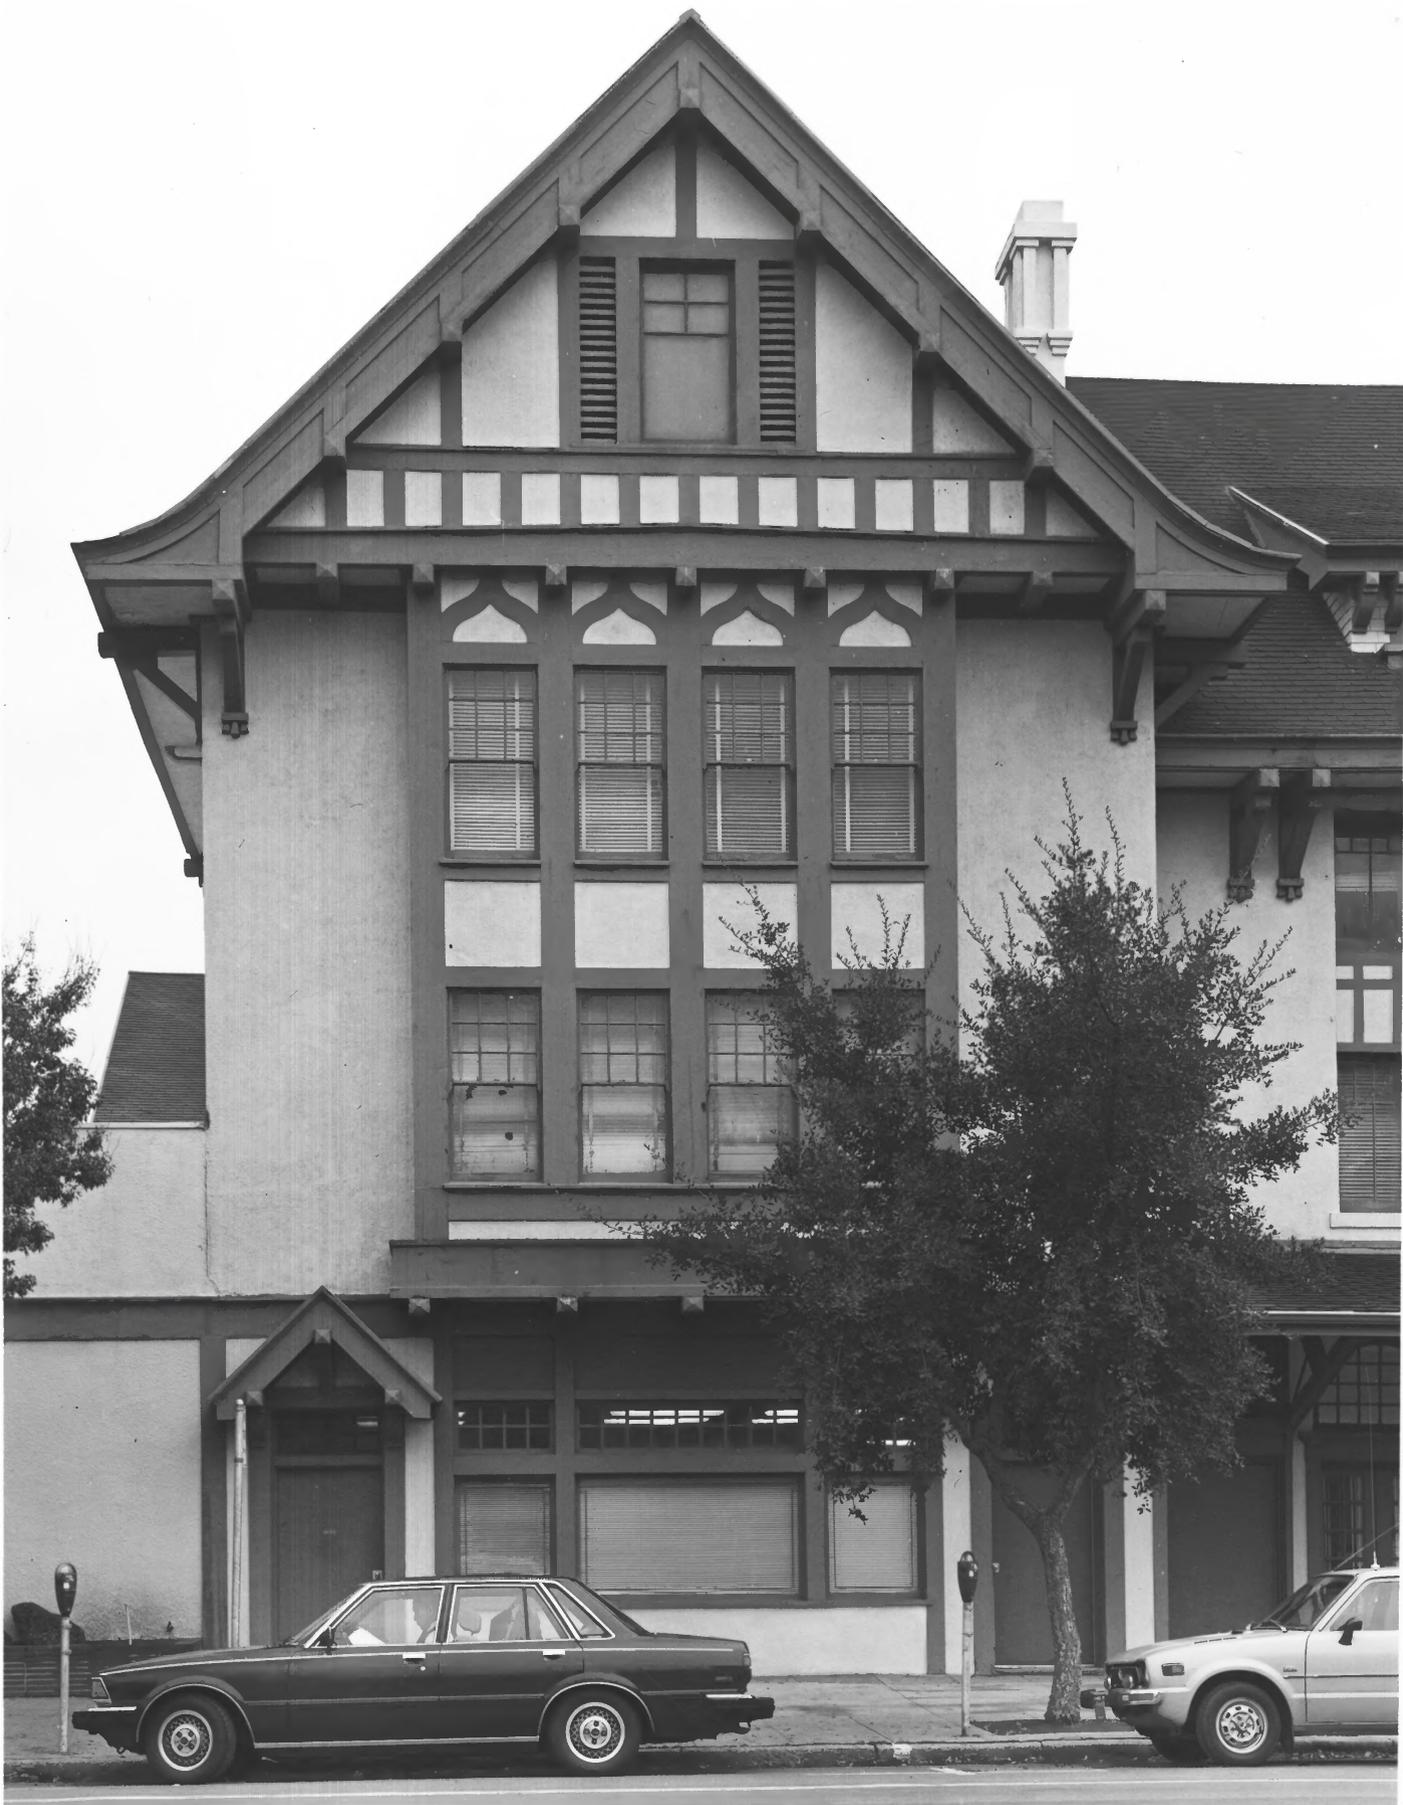
#11 of 29

This photograph shows a detailed west elevation at the northwest end of the Old Tavern building.

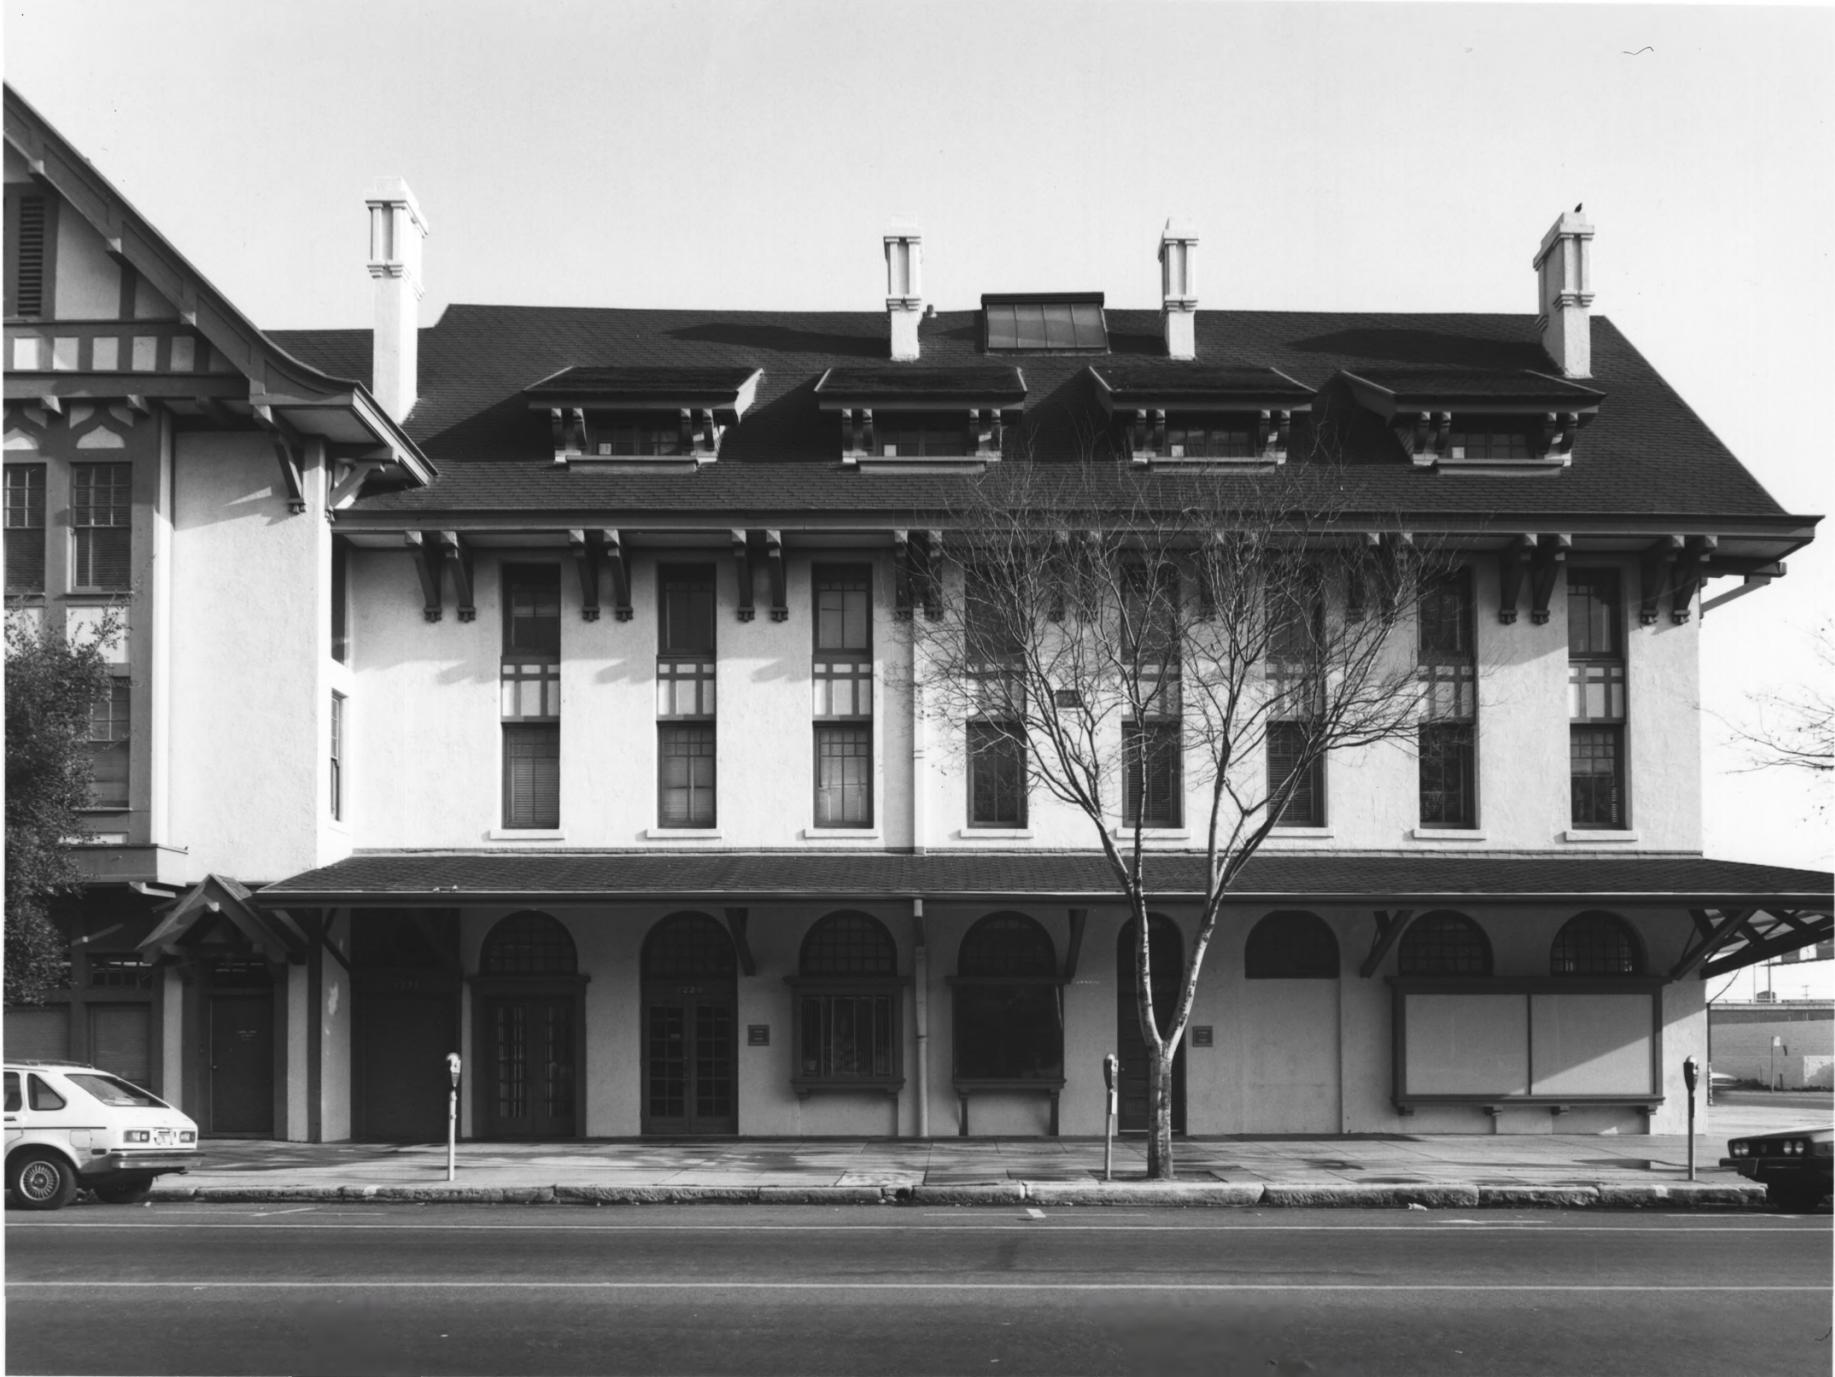
#12 of 29

West elevation, including main entry to the upper level (behind first parking meter from left) with special square header above door.

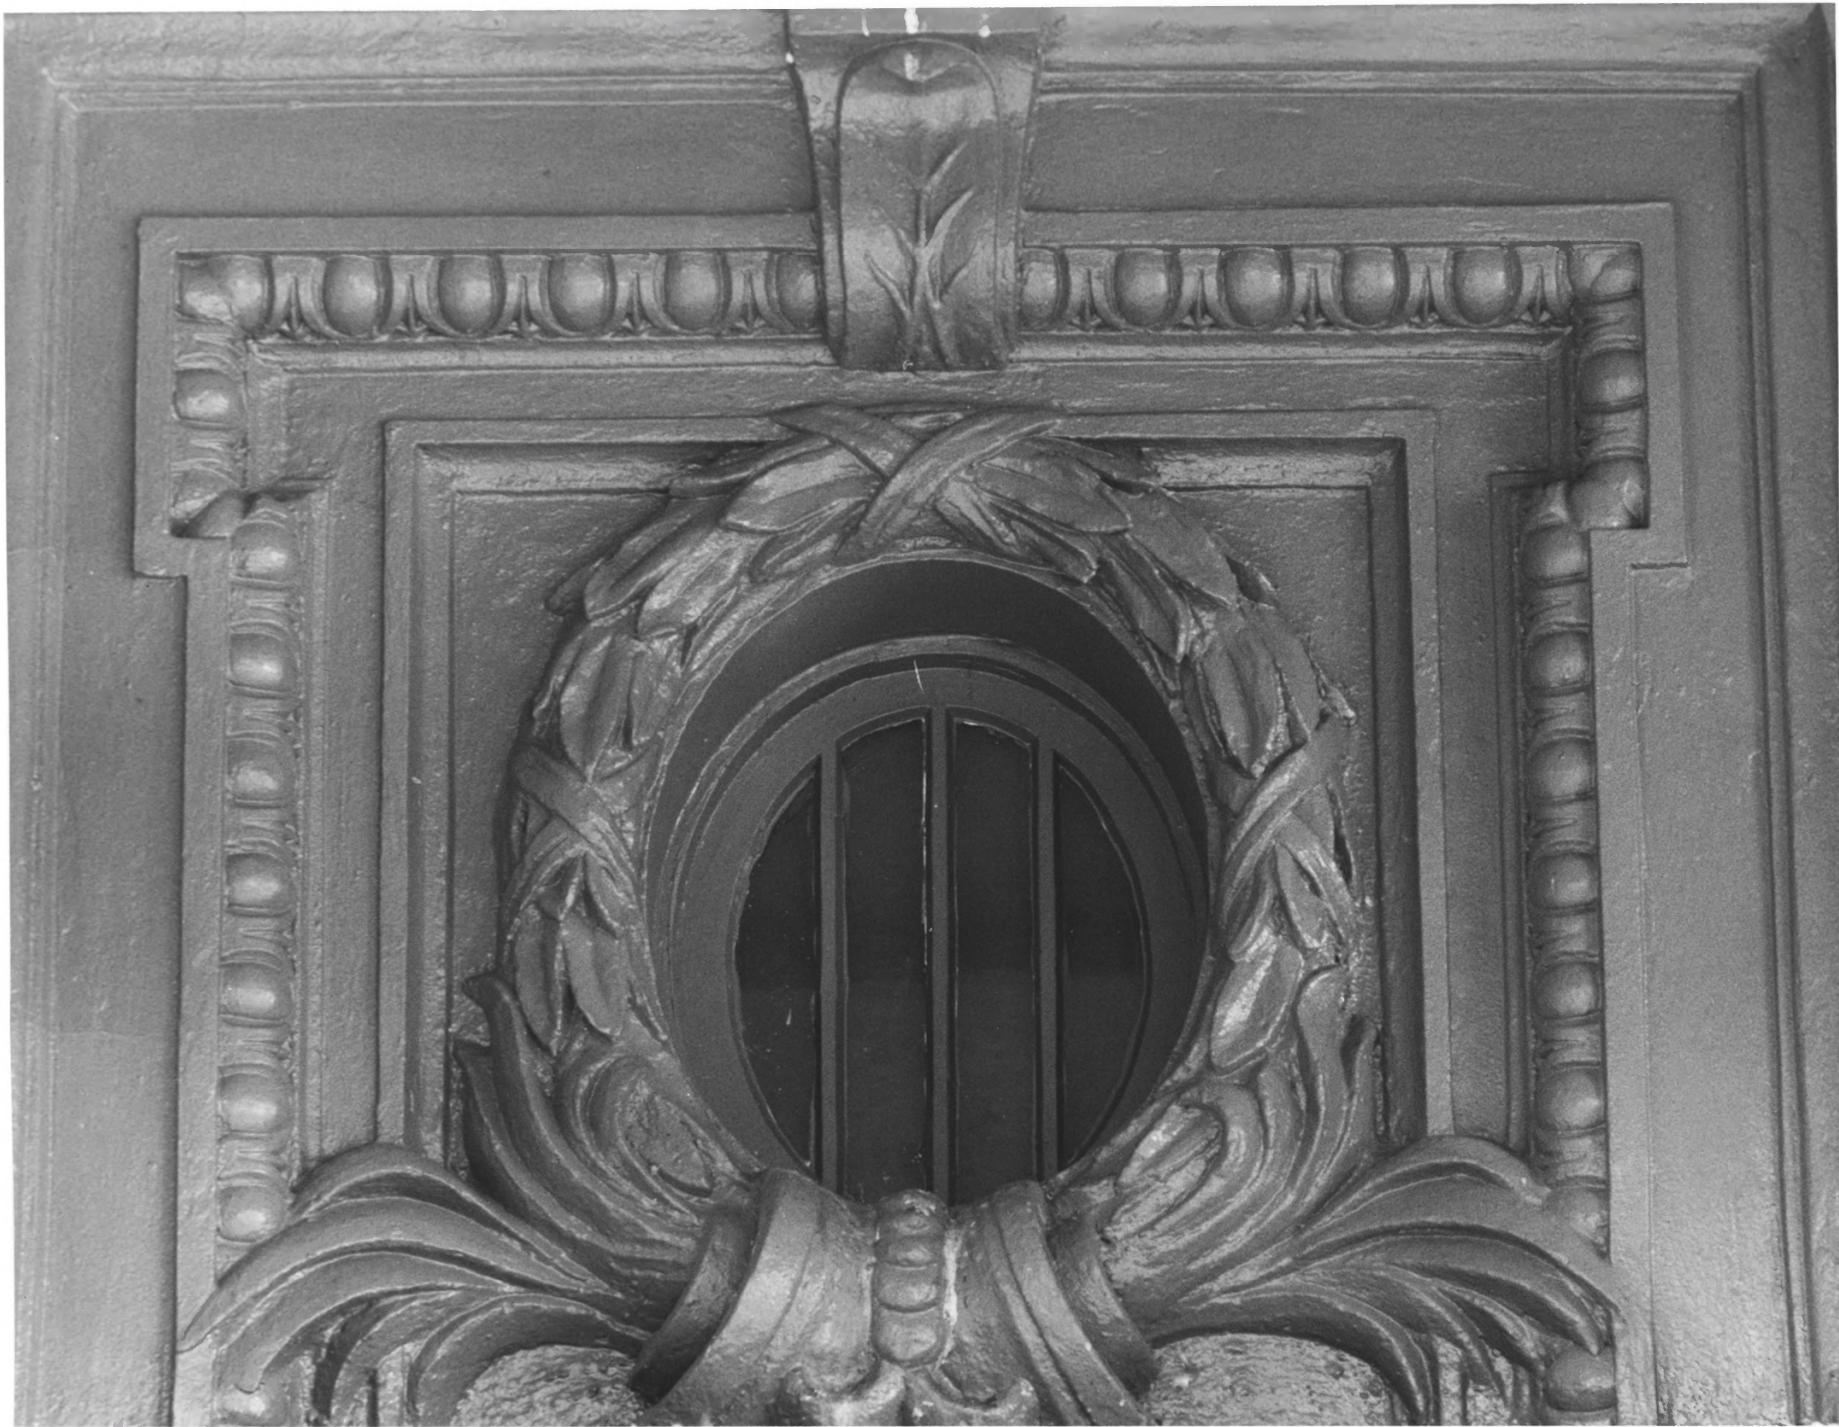
#13 of 29

Looking at header detail with small oval transom window above main entry door to upper levels.

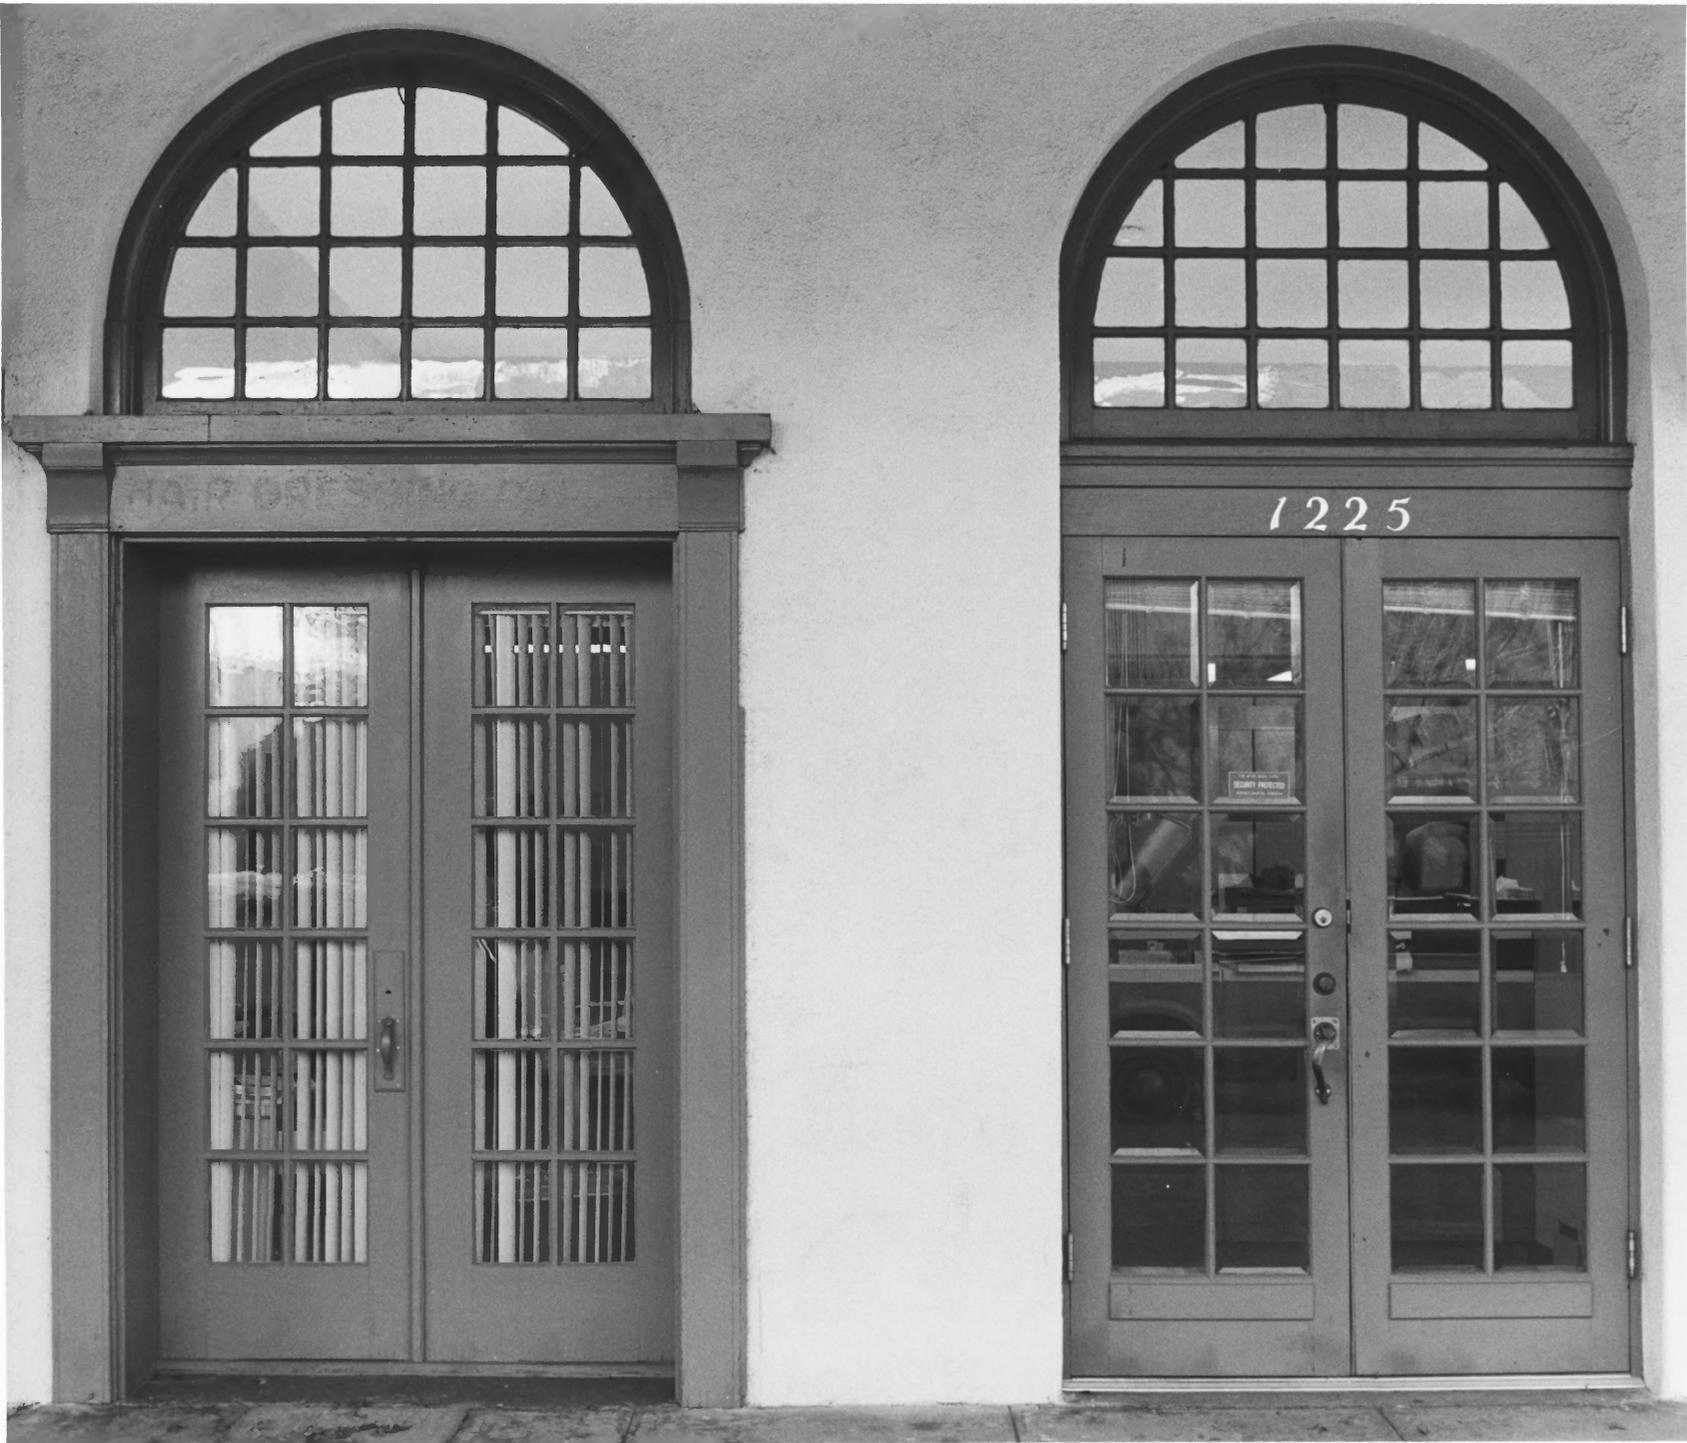
#14 of 29

Looking at west elevation, showing  
two different handlings of the  
arched transom windows above french  
style entry doors with beveled glass.

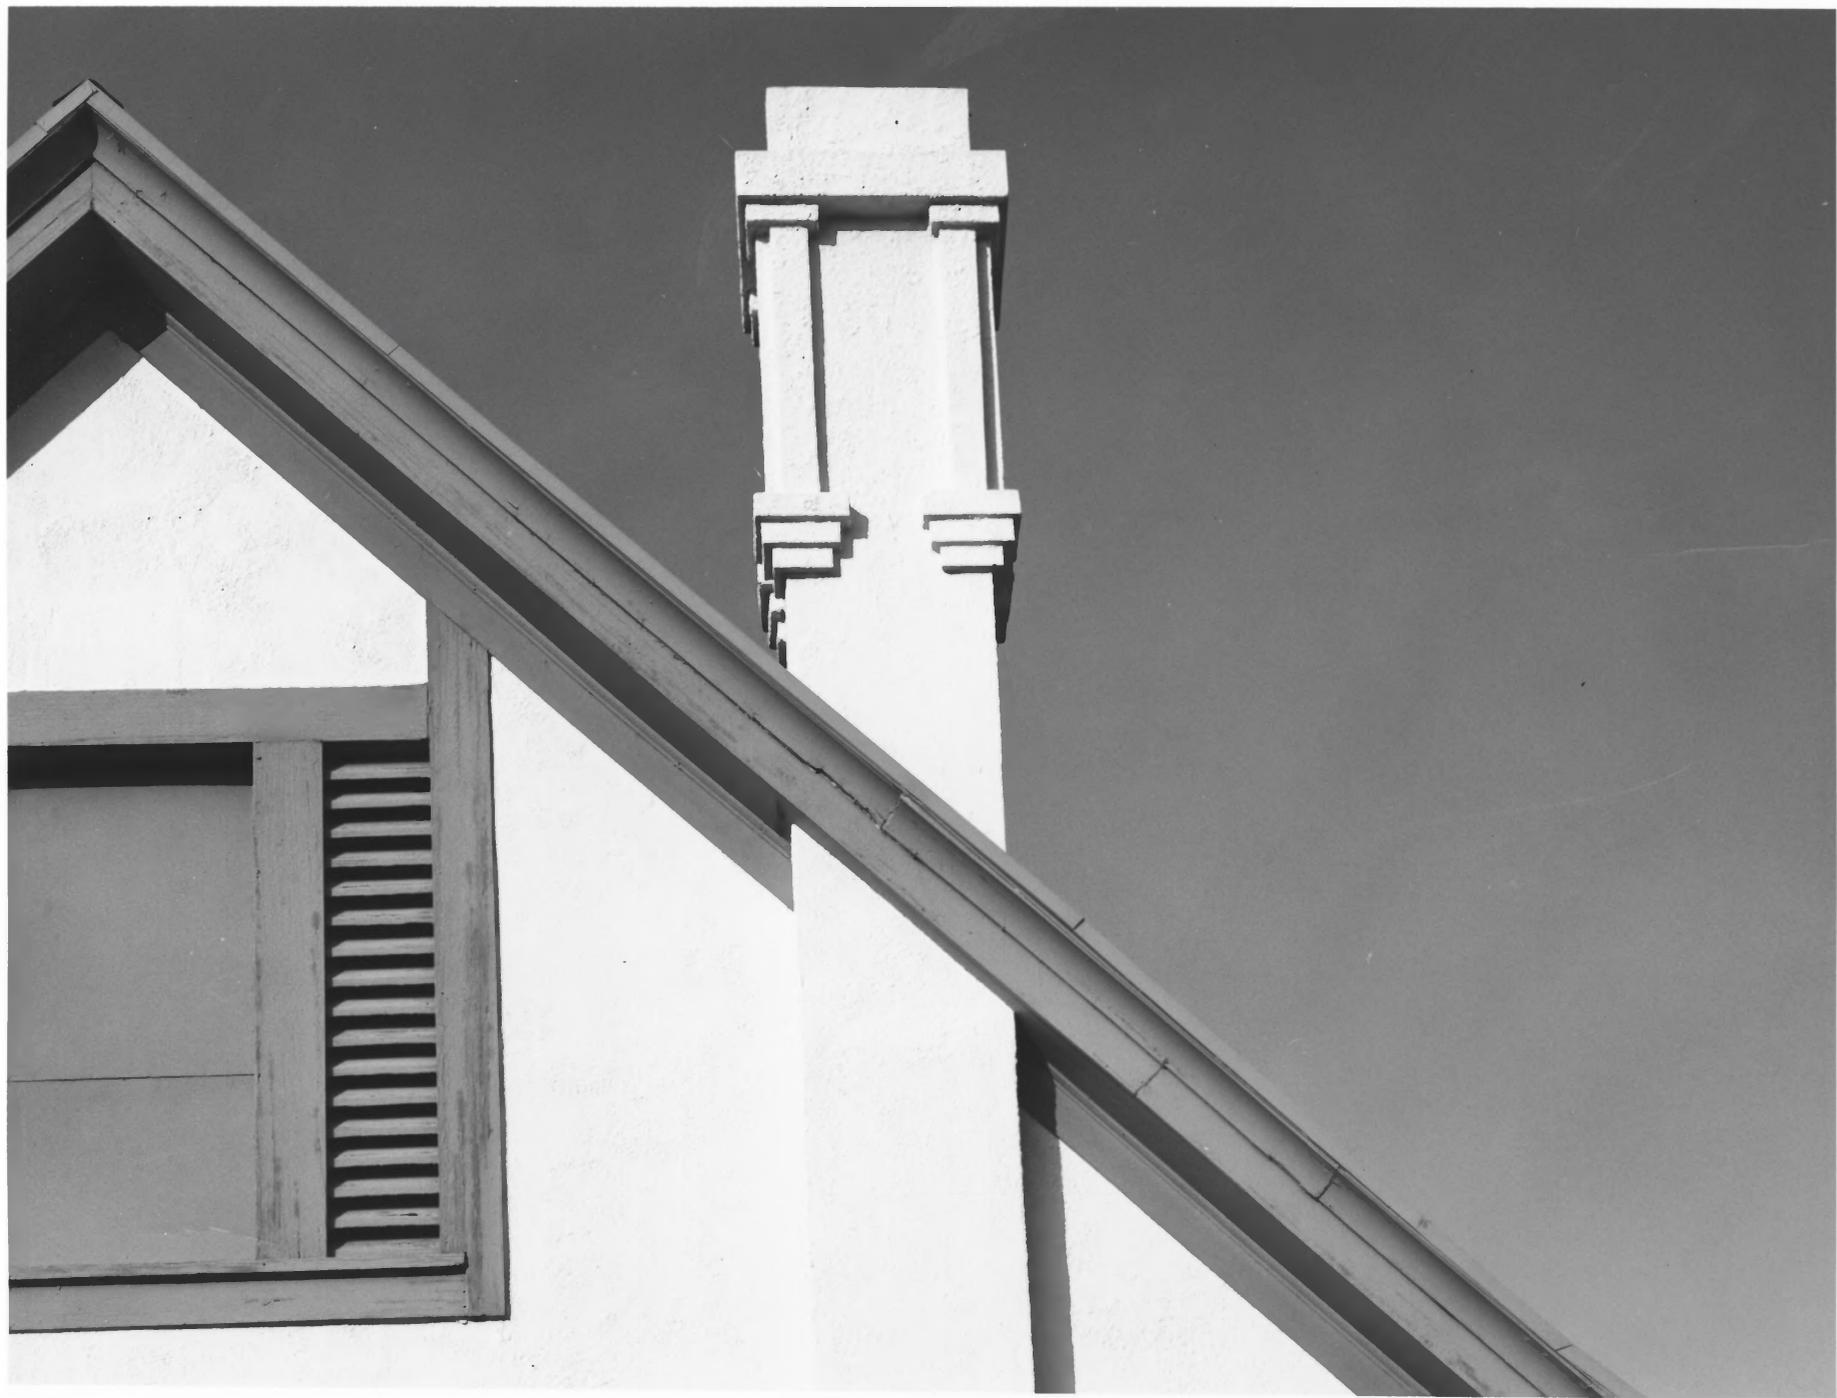
#15 of 29

Looking at east elevation chimney  
detail, along with attic ventilation  
louvers.

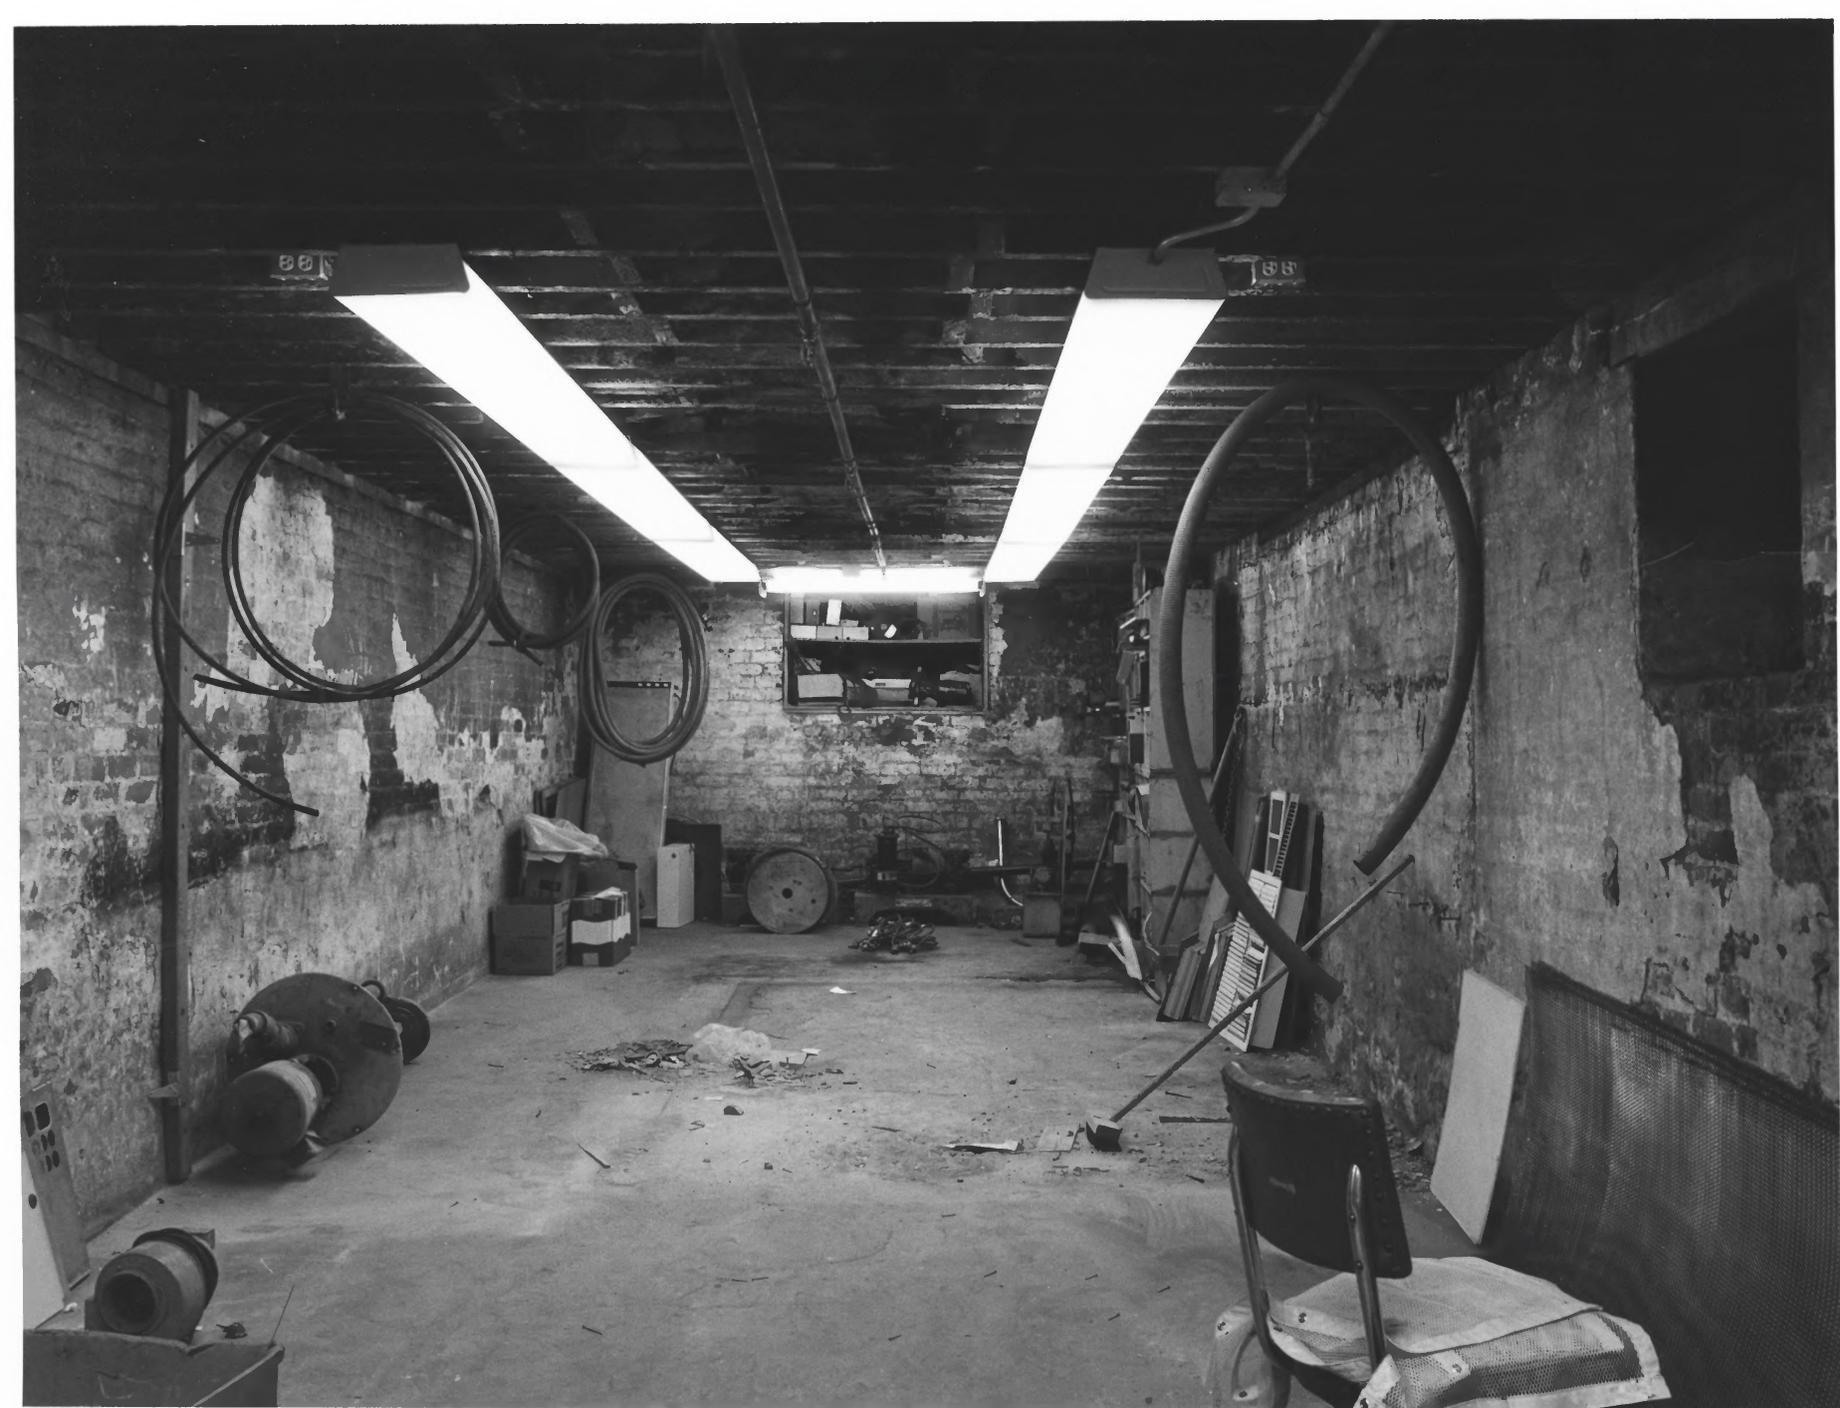
#16 of 29

In the basement, this photograph shows an end brick wall at the middle of the building on the south side. The end brick wall would support part of the exterior south elevation wall.

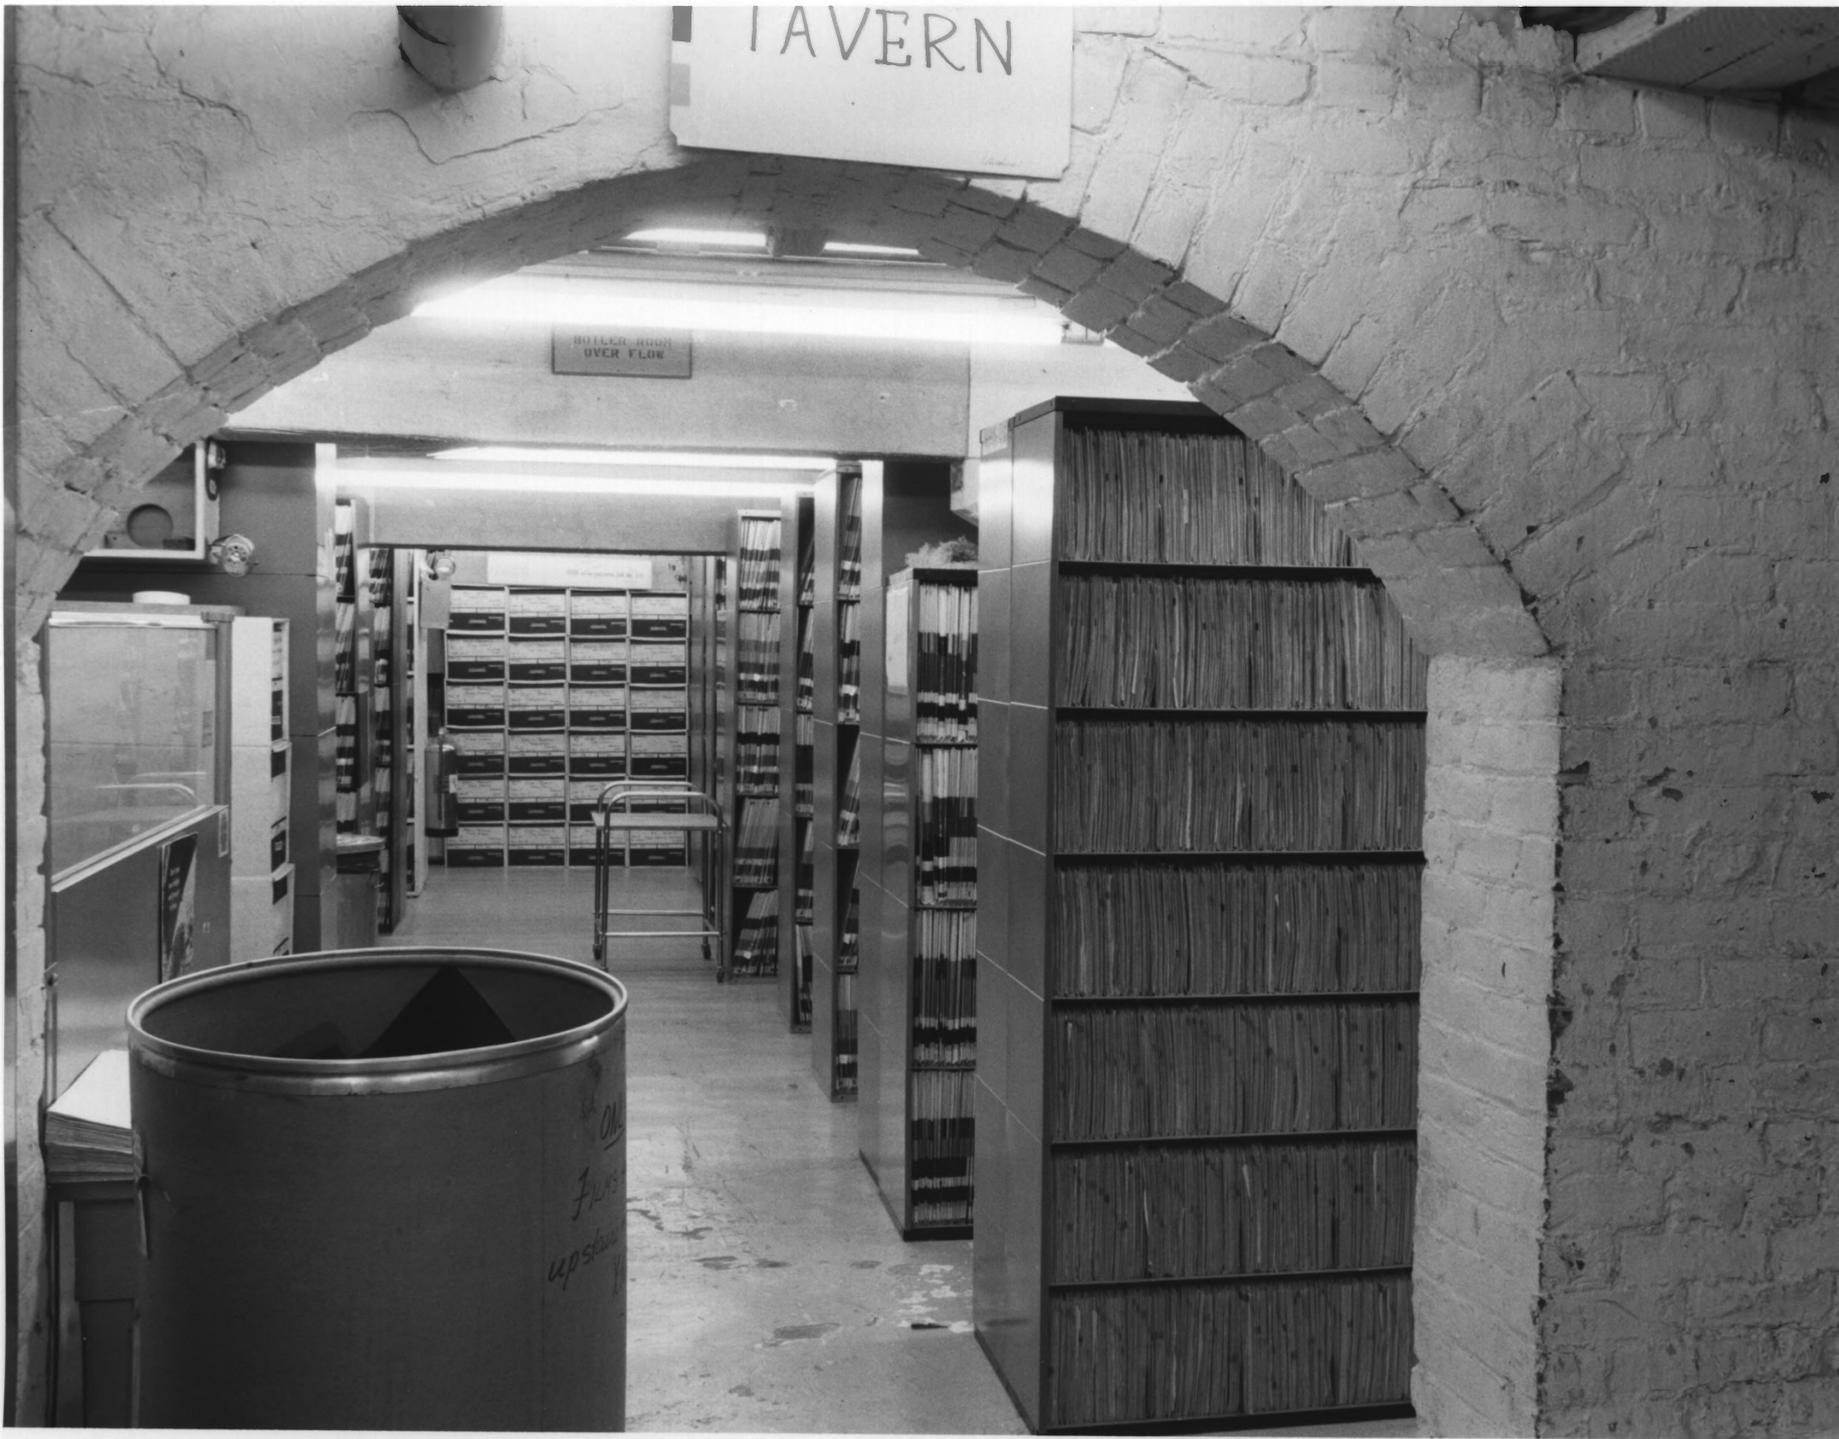
#17 of 29

This basement photograph shows the brick arched opening in one of the original main bearing walls. Currently, this area is being used to store hospital medical records.

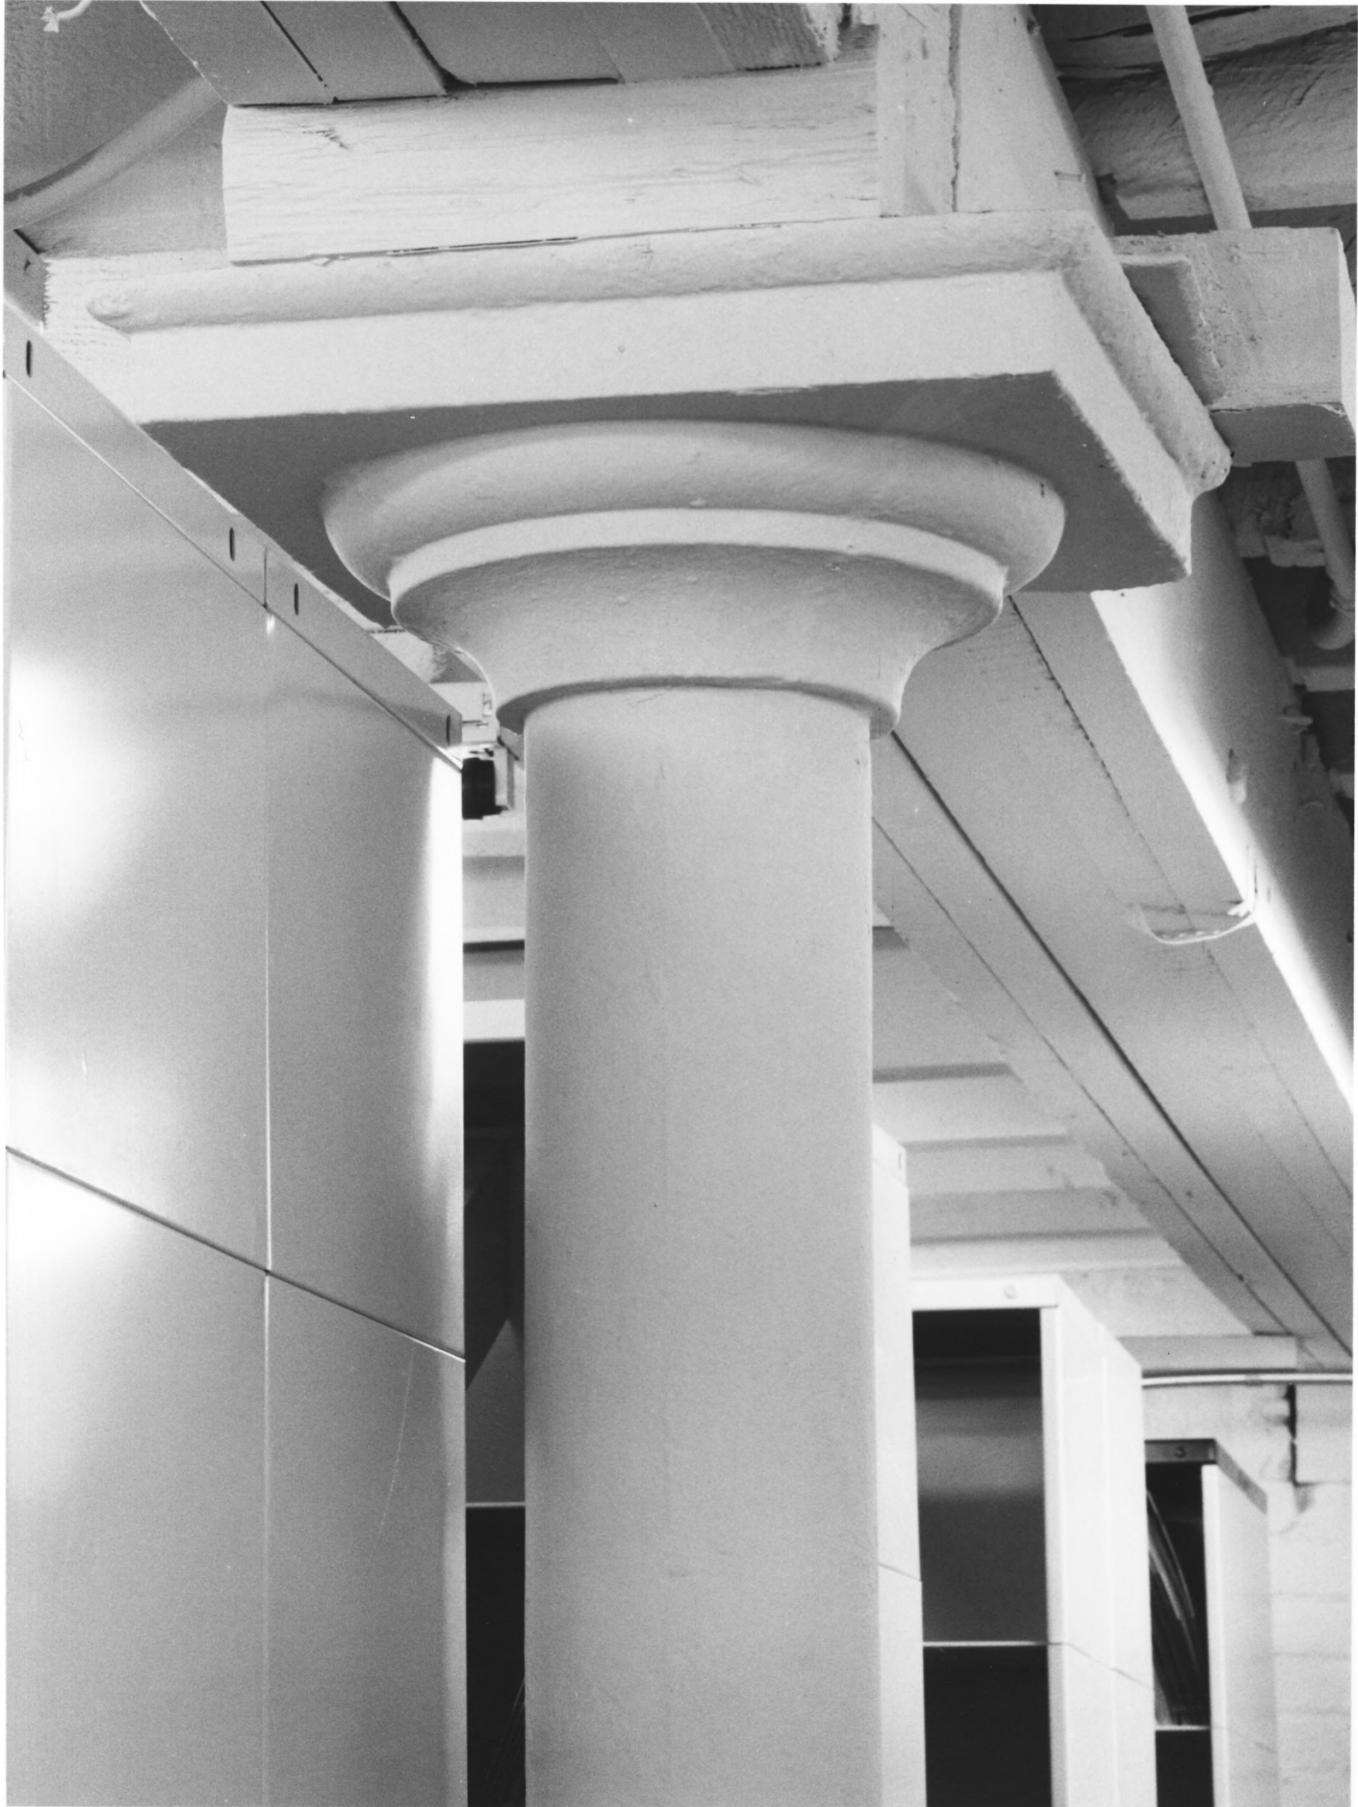
#18 of 29

At basement level in the eastern wing, directly behind the area shown in #17, is a row of neo-Doric cast iron columns, supporting laminated timber beams. Floor joists of street level run perpendicular to the center beam and bear on exterior brick walls.
