OLD TAVERN *2801 Capitol Avenue*  
Sacramento, CA *Sacramento County*  
Photographer: Unknown  
circa 1880 or earlier  
Negative: Bob McCabe, Sacramento  
Looking east x northeast

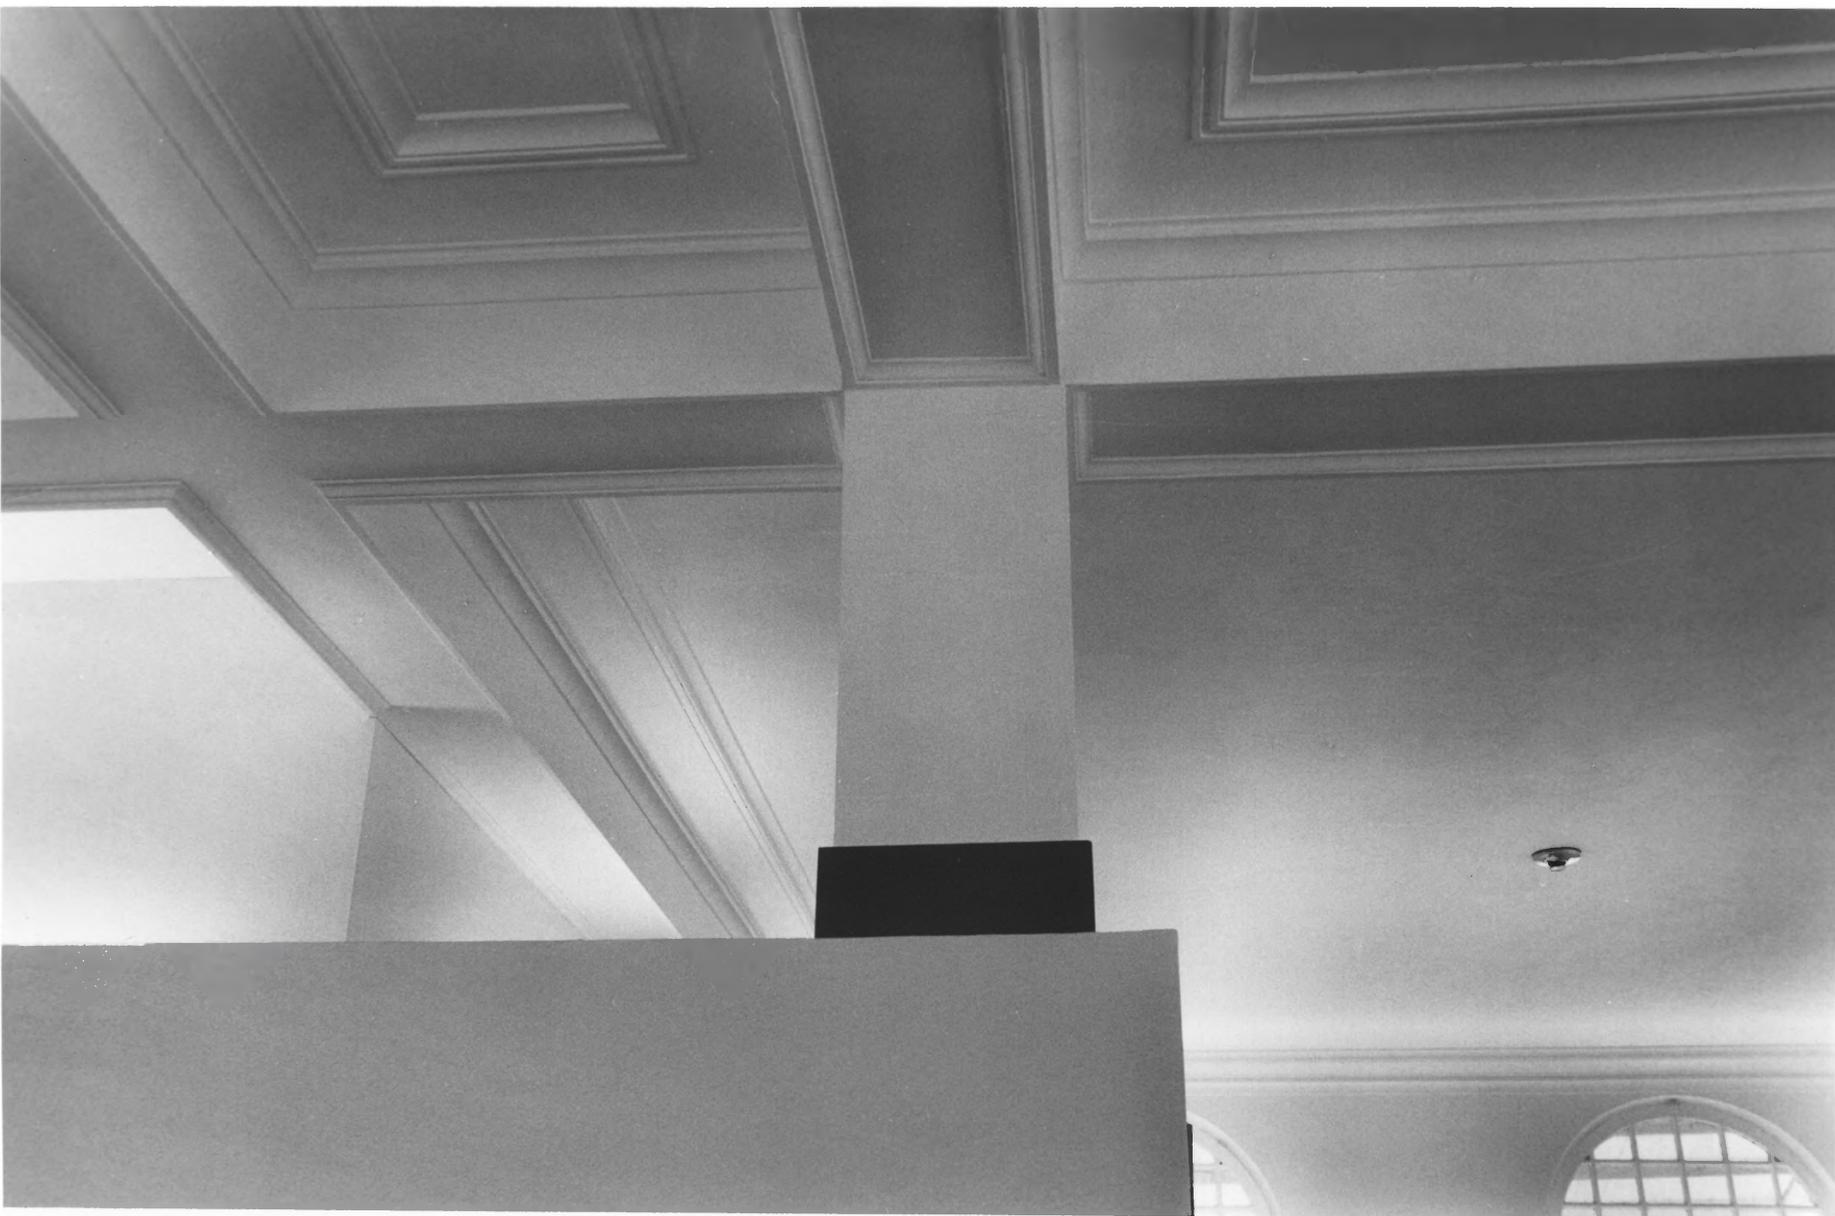
#19 of 29

Main street level at southwest corner. Interior photograph of unusual ceiling beam and column design. This appears to be the original ceiling as shown earlier in the interior photograph of the bar (#7).

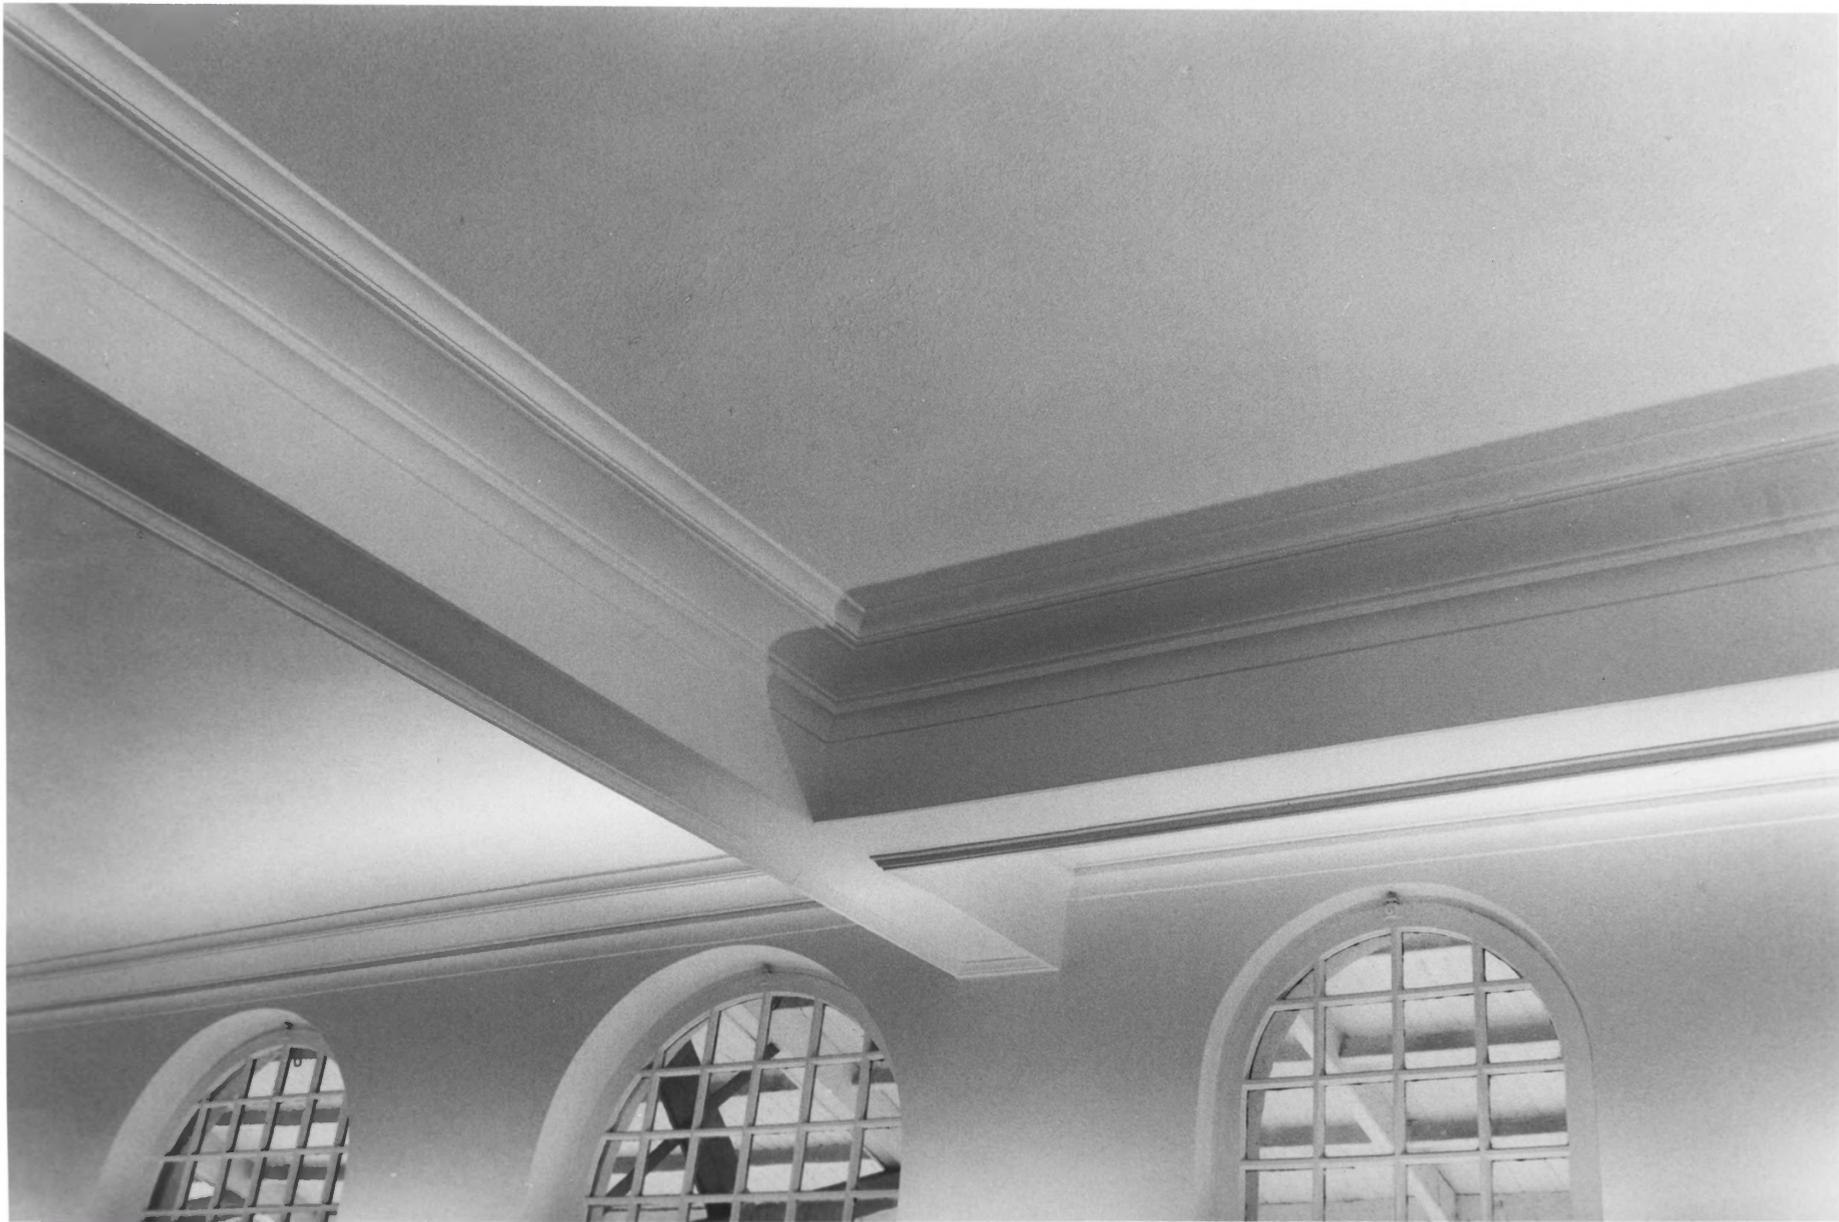
#20 of 29

Main street level at southwest corner. This photograph shows another unusual beam and ceiling condition which again appears to be a part of the early bar ceiling. Note interior detailing of the arched windows. The right hand window is the interior of the transom door (the exterior shown in #14).

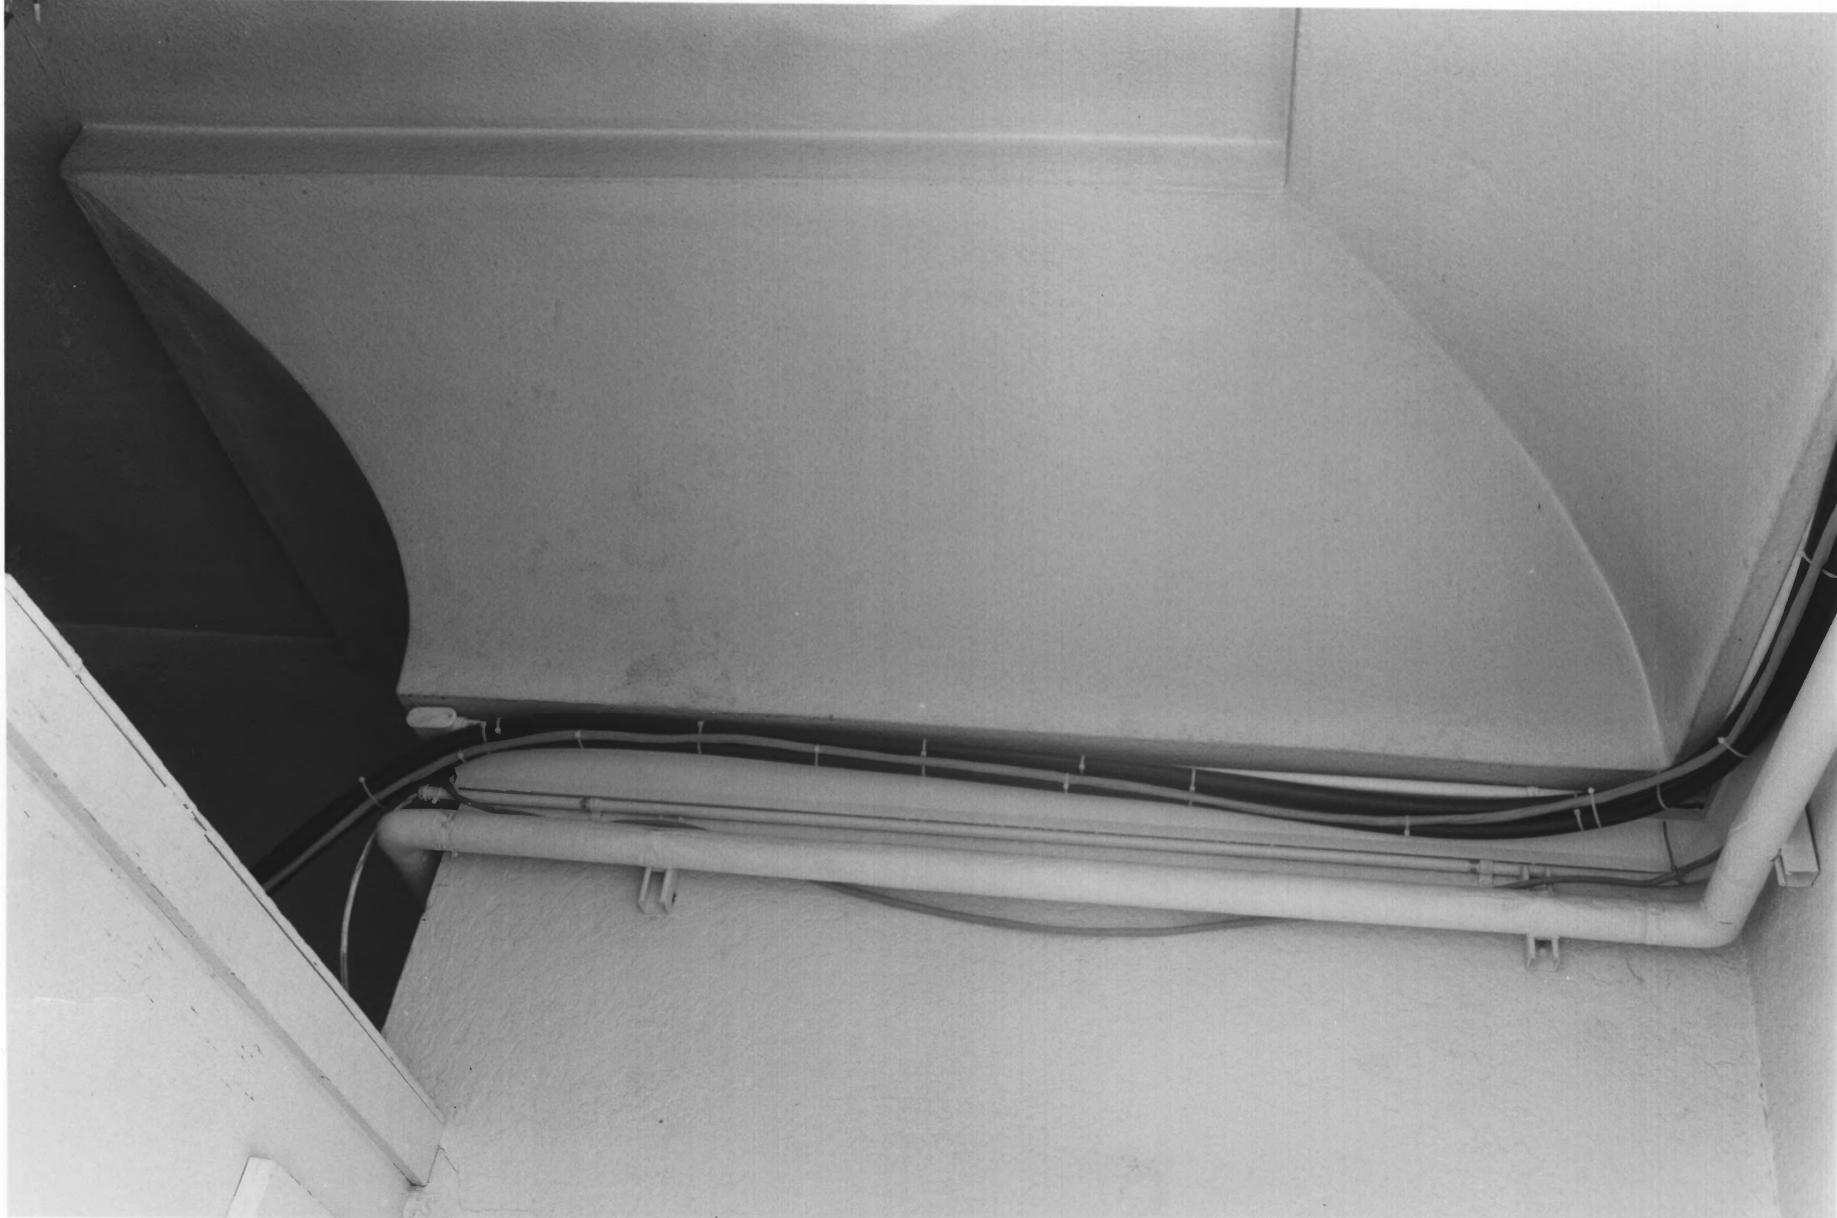
#21 of 29

This photograph shows the heavy plaster ceiling cove, east wing, main floor. Most of the remaining part of this ceiling is located in the area now being used for storage and work-rooms, but enough of the plaster cove remains to cut accurate new templates.

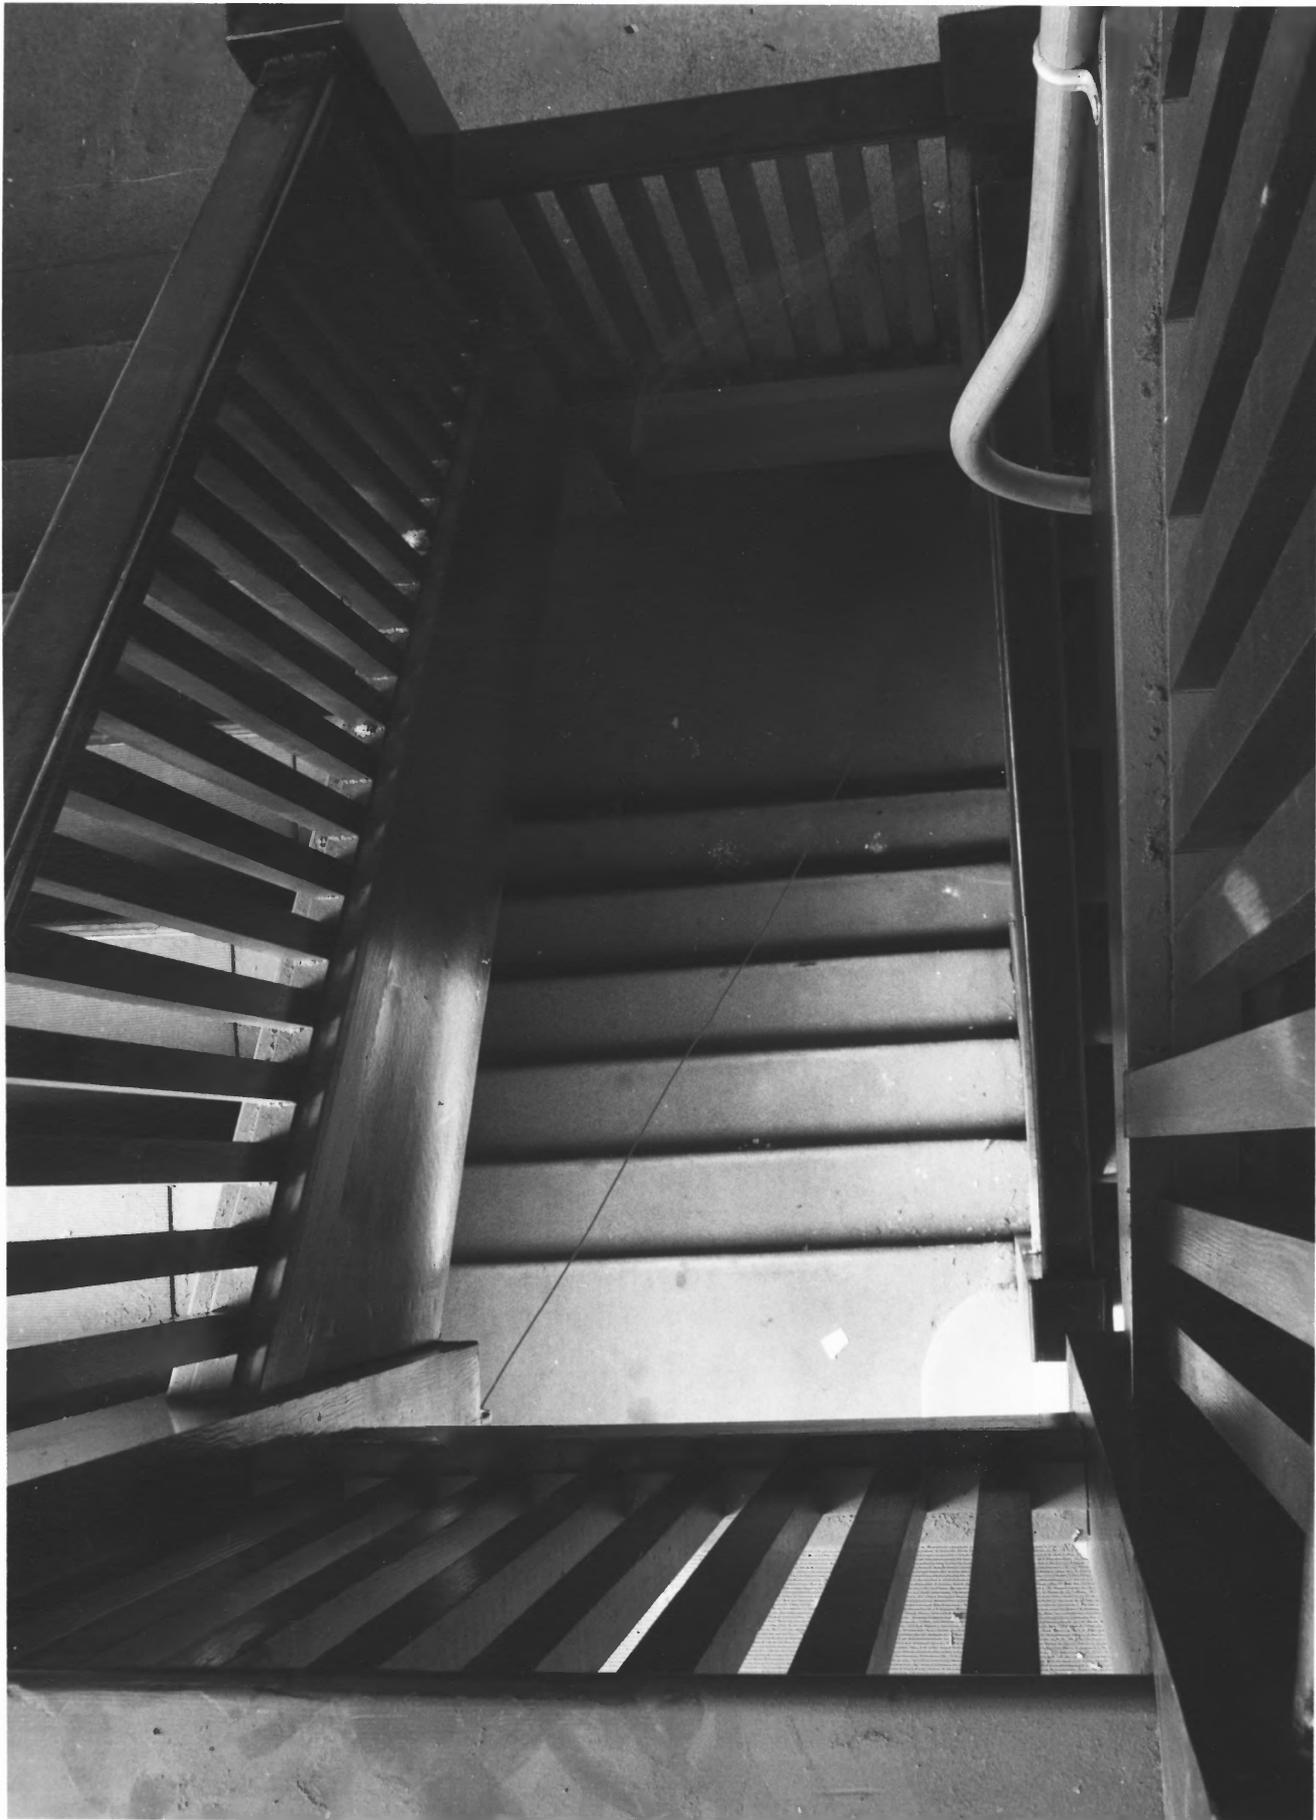
#22 of 29

The stairway and handrails are of  
redwood and pine, typical California  
design from the 1920's. Condition  
is good.

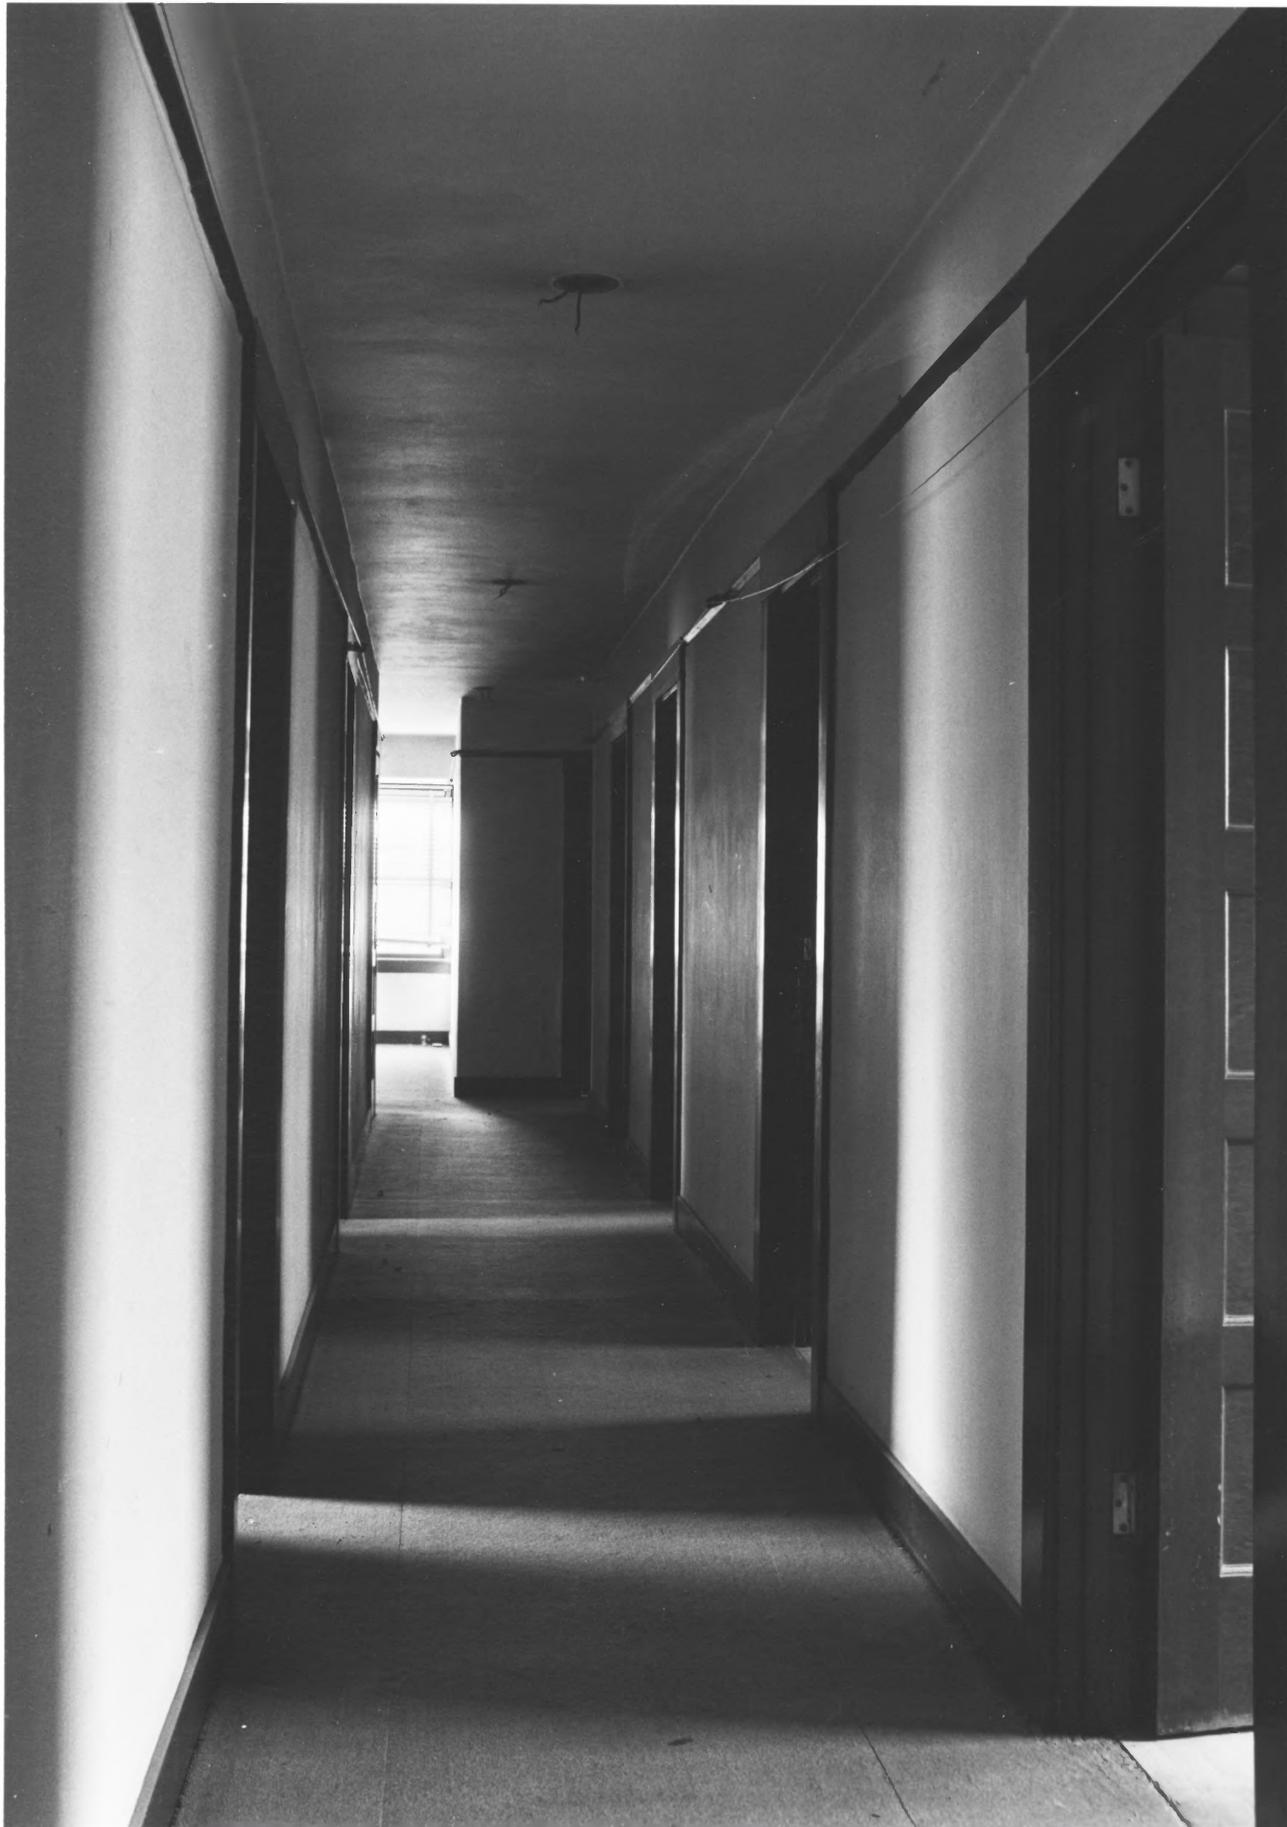
#23 of 29

This photograph is typical of most of the second and third story hallways, with horizontal panel doors and simple door moldings. Walls are plastered throughout and floors were originally carpeted.

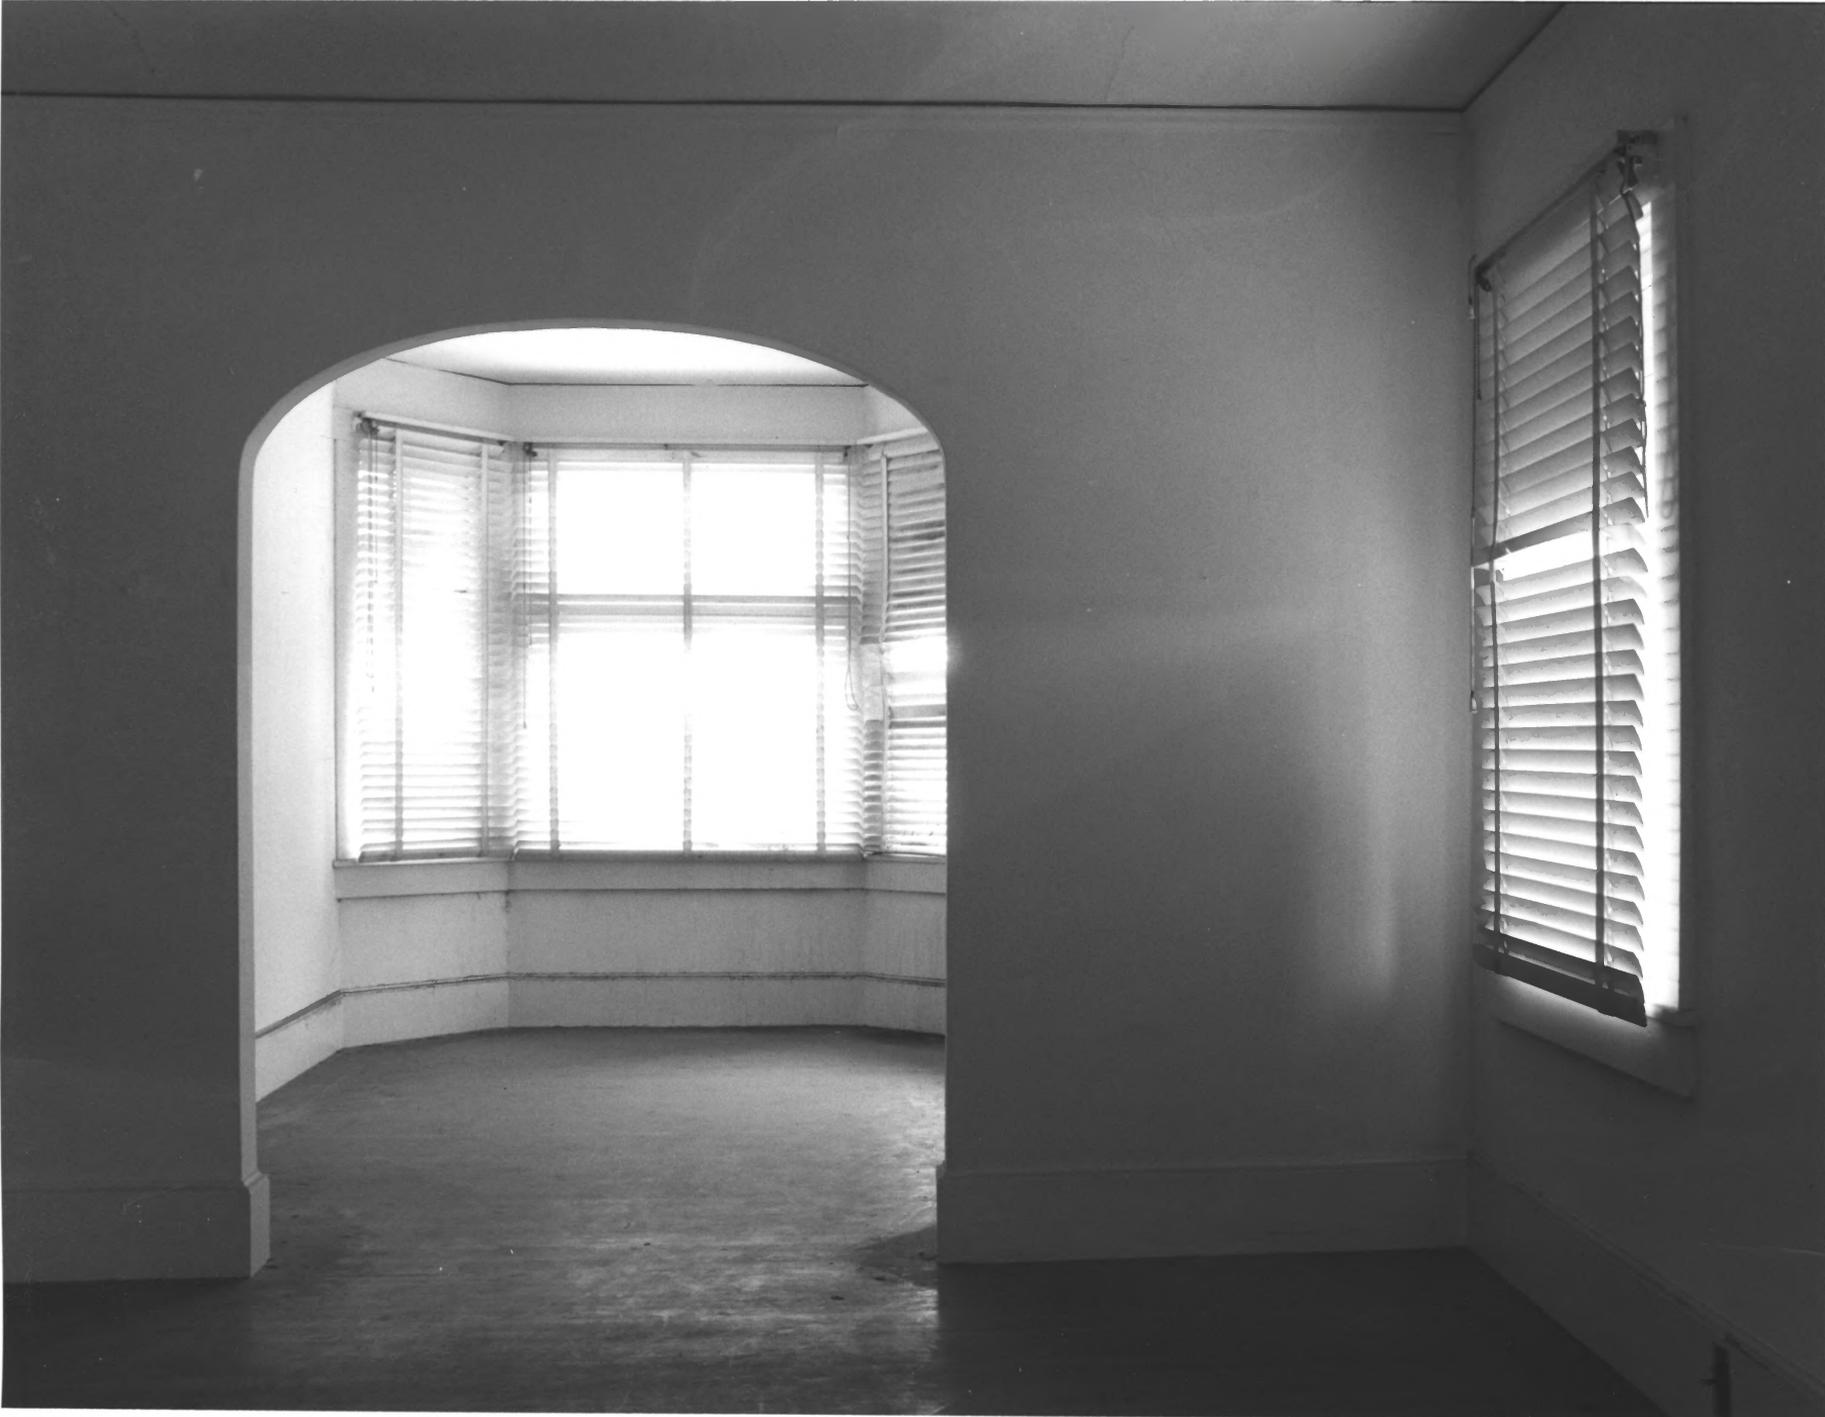
#24 of 29

Photograph shows one of the bay windows in the living room/study of one of the larger apartments. Walls and ceilings were plastered, with simple window and door moldings. Floors are inlaid oak with mahogany trim strips.

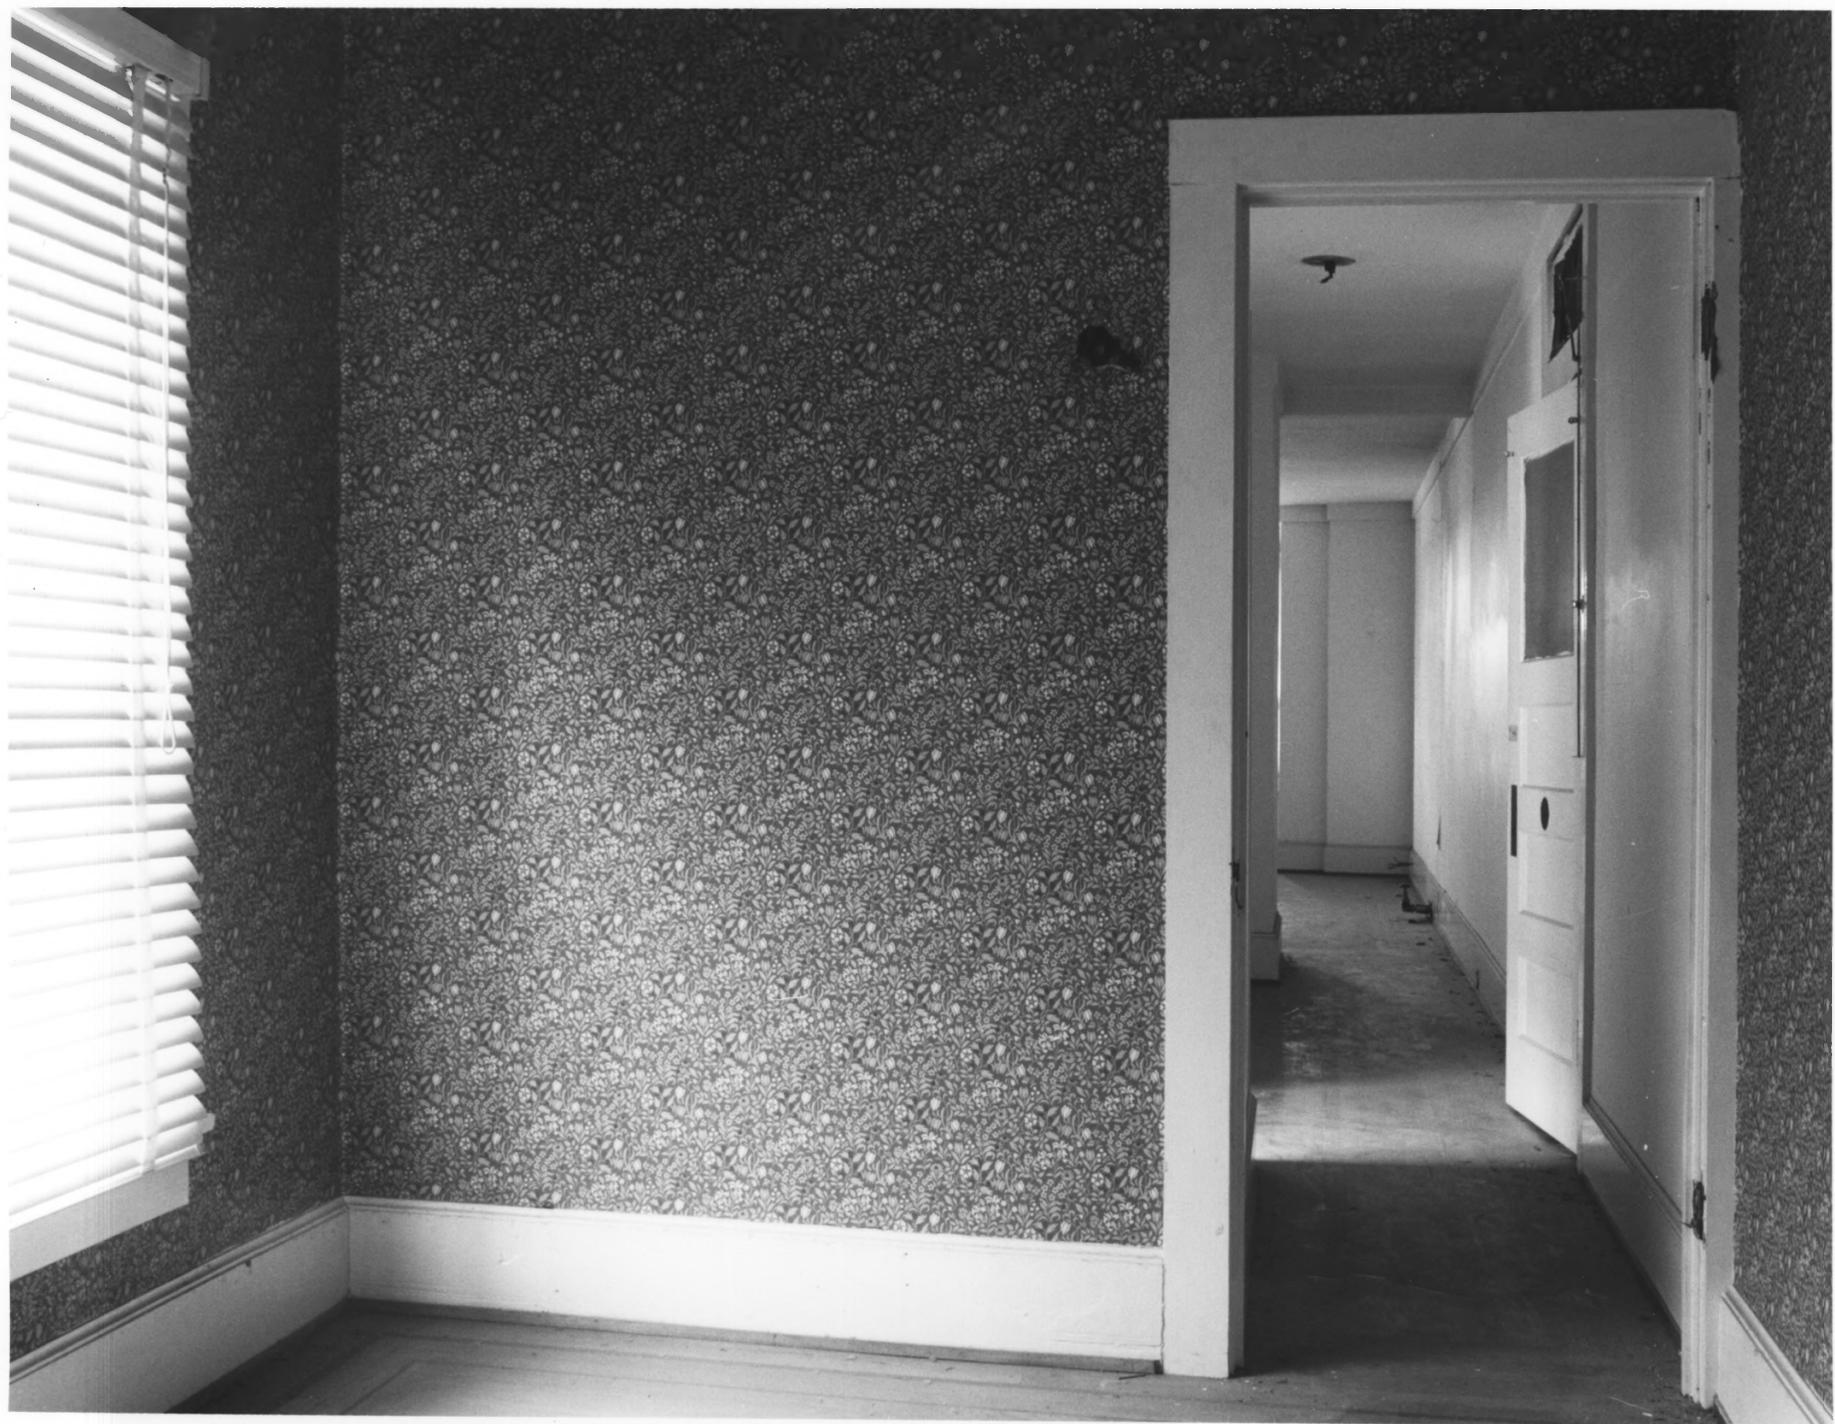
#25 of 29

This southeast apartment next to the area way, third level, shows the bedroom windowed onto the area way. The living room is at the far end of the hall. Right hand door is apartment entry, with bathroom door directly opposite. Walls and ceilings are plastered. Simple window and door trim. Floor is oak with inlaid mahogany. Note transom window over entry door (typical for west wing).

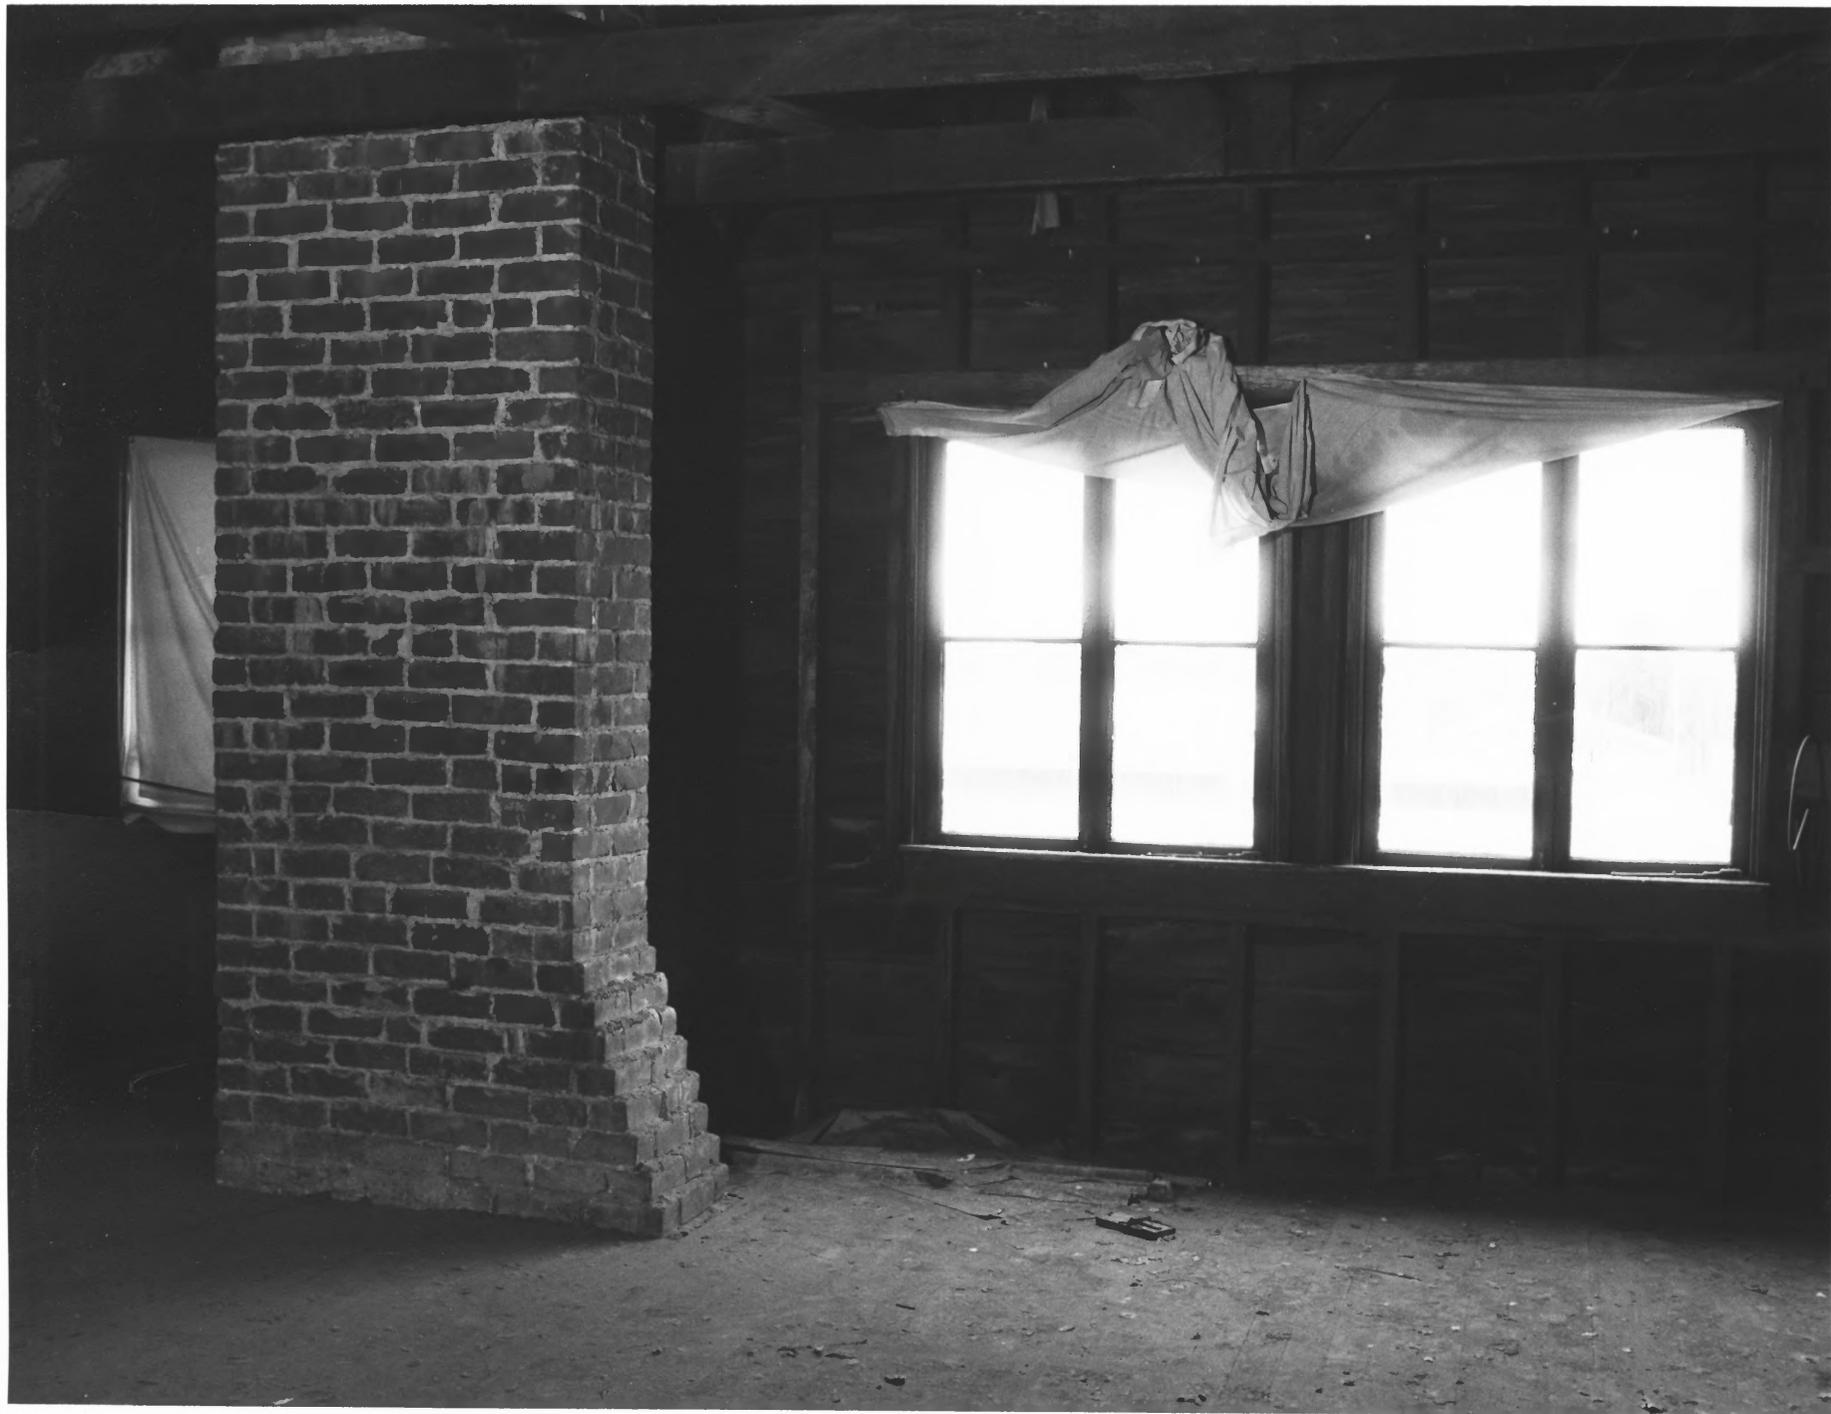
#26 of 29

Neither of the attic areas have ever been finished, except for the floor which is vertical grain T&G Douglas Fir. Evidence of both plumbing and wiring "rough-in" indicate plans had been made to make these areas into inhabitable space.

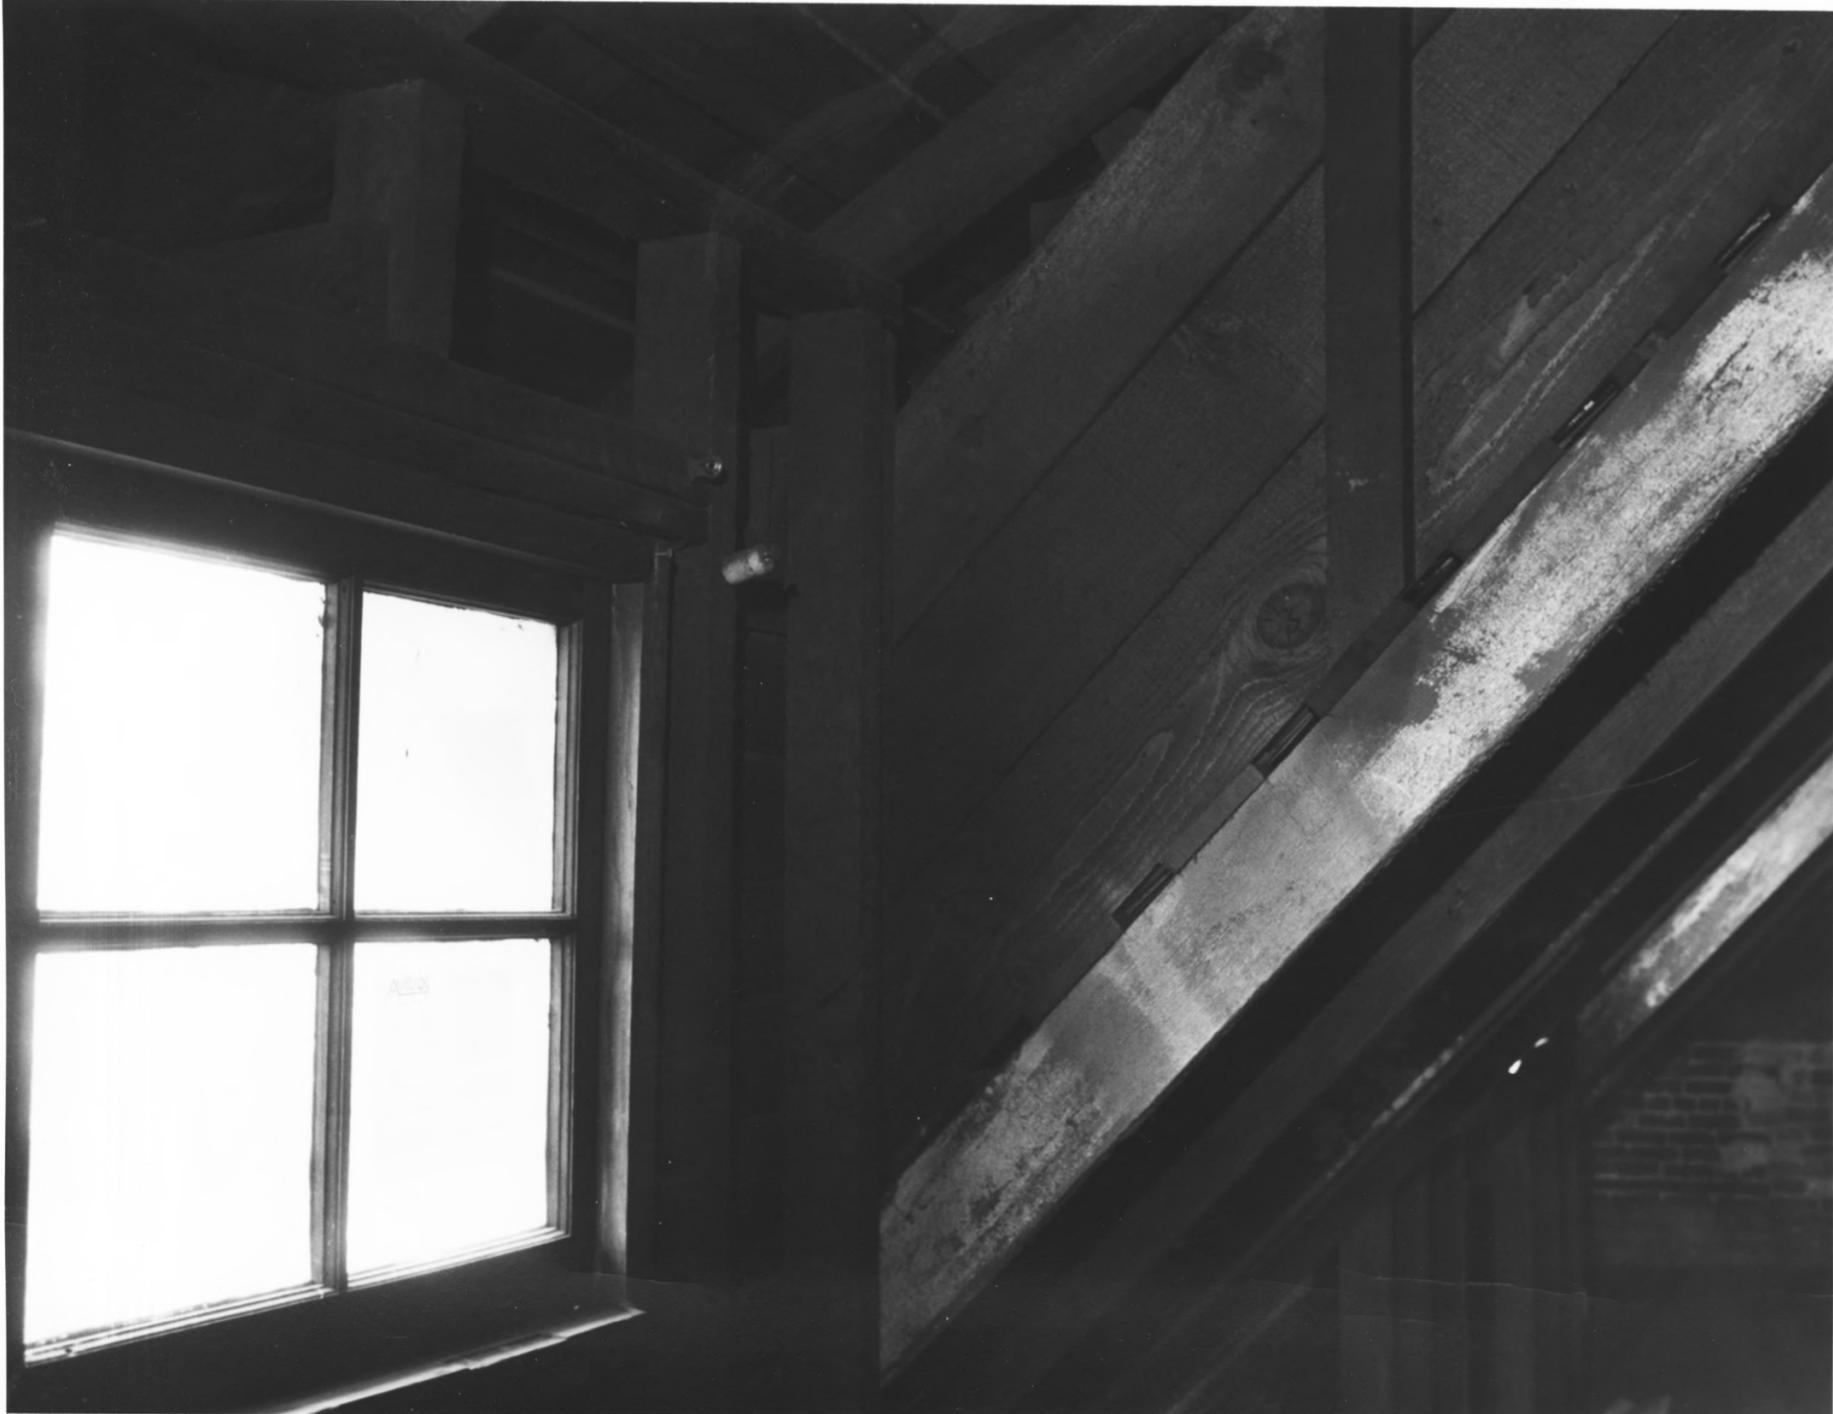
#27 of 29

This photograph shows interior framing of a typical dormer window on the west elevation (refer to #13). From this picture, we are able to determine the slope of both the main roof and the dormers.
