OLD TAVERN *2801 Capitol Avenue*  
Sacramento, CA *Sacramento County*  
Photographer: Unknown  
circa 1880 or earlier  
Negative: Bob McCabe, Sacramento  
Looking east x northeast

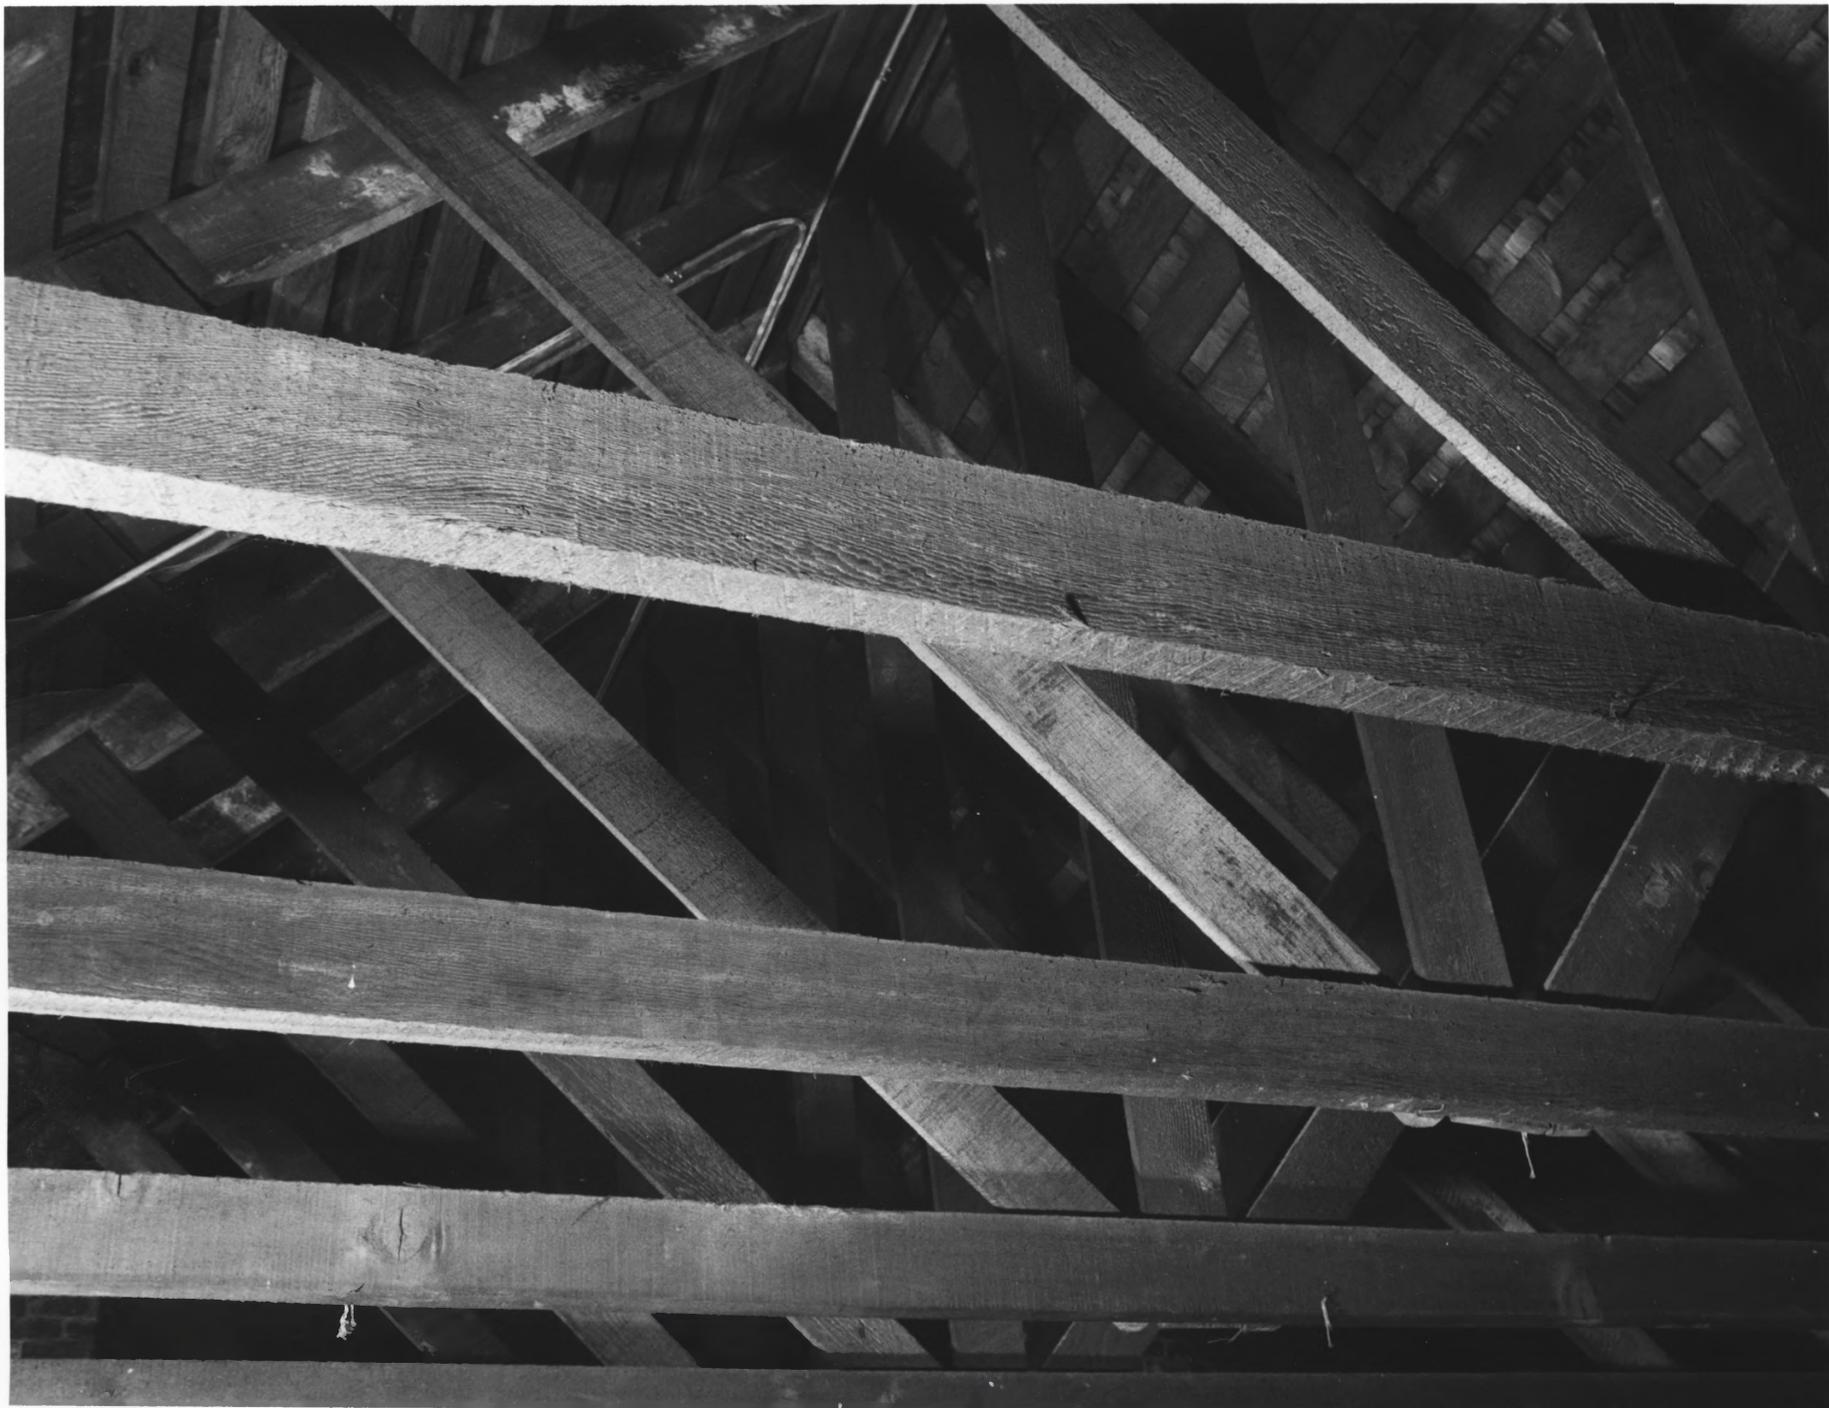
#28 of 29

Roof framing is typical "carpenter" truss with spaced sheathing and wood shingle roof. This system can be made to calculate by additional nailing and plate tie downs, so that the total system could remain.

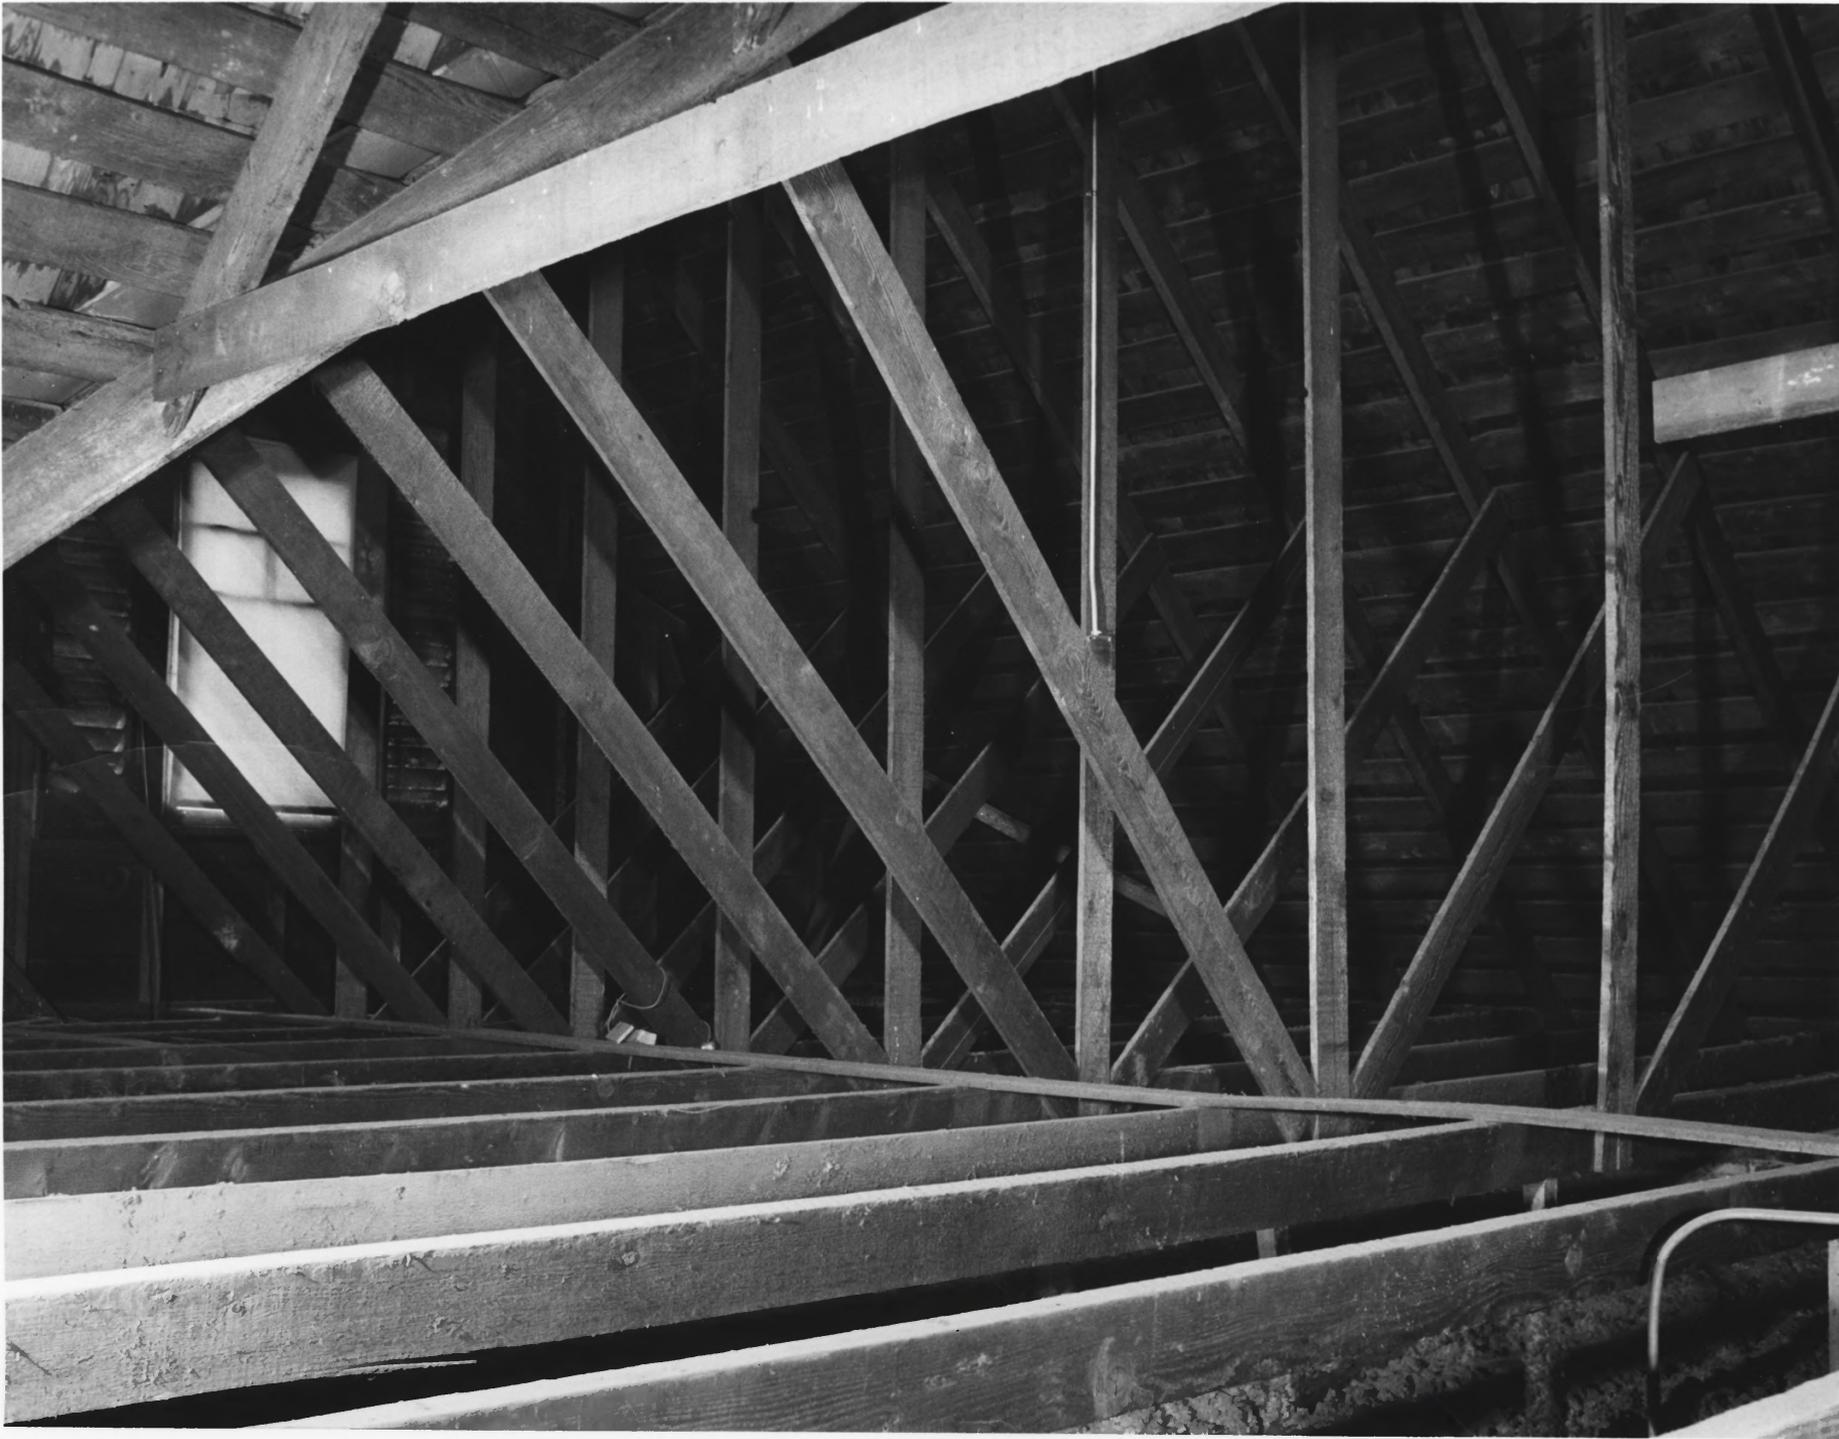
#29 of 29

This photograph shows the interior of the window in the gable end (exterior of this window is shown in #11).

Note roof valley framing in upper left corner of the photograph. Minimum structural stabilization will be required.
