RR 0227 ~
Survey # 6-7

NEW JERSEY TRANSIT RAILROAD STATION SURVEY

FACILITY NAME: Hillsdale

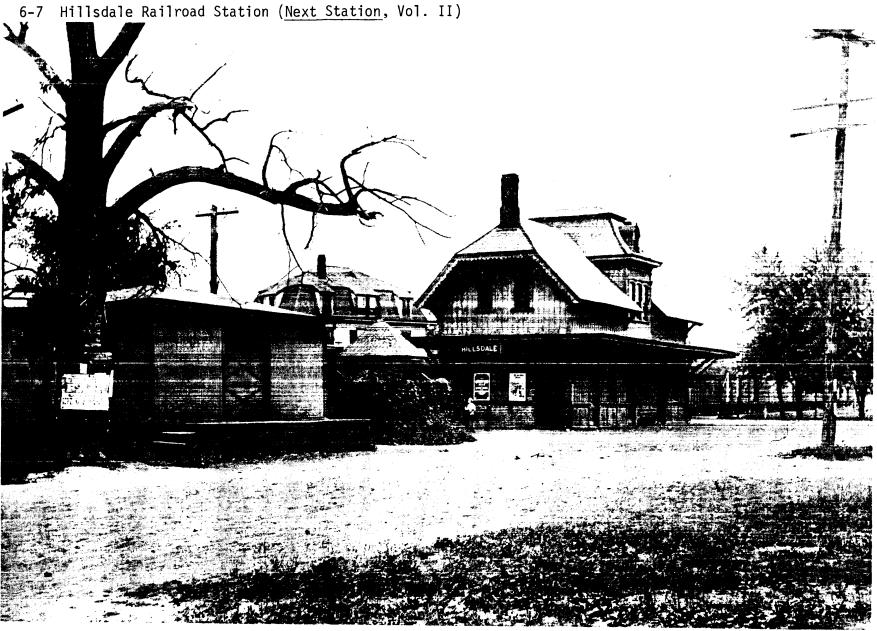
M.P.-21.5

Looking northwest to the Hillsdale station. The neat little FREIGHT HOUSE and a tastefully decorated outhouse will be noticed in both pictures.

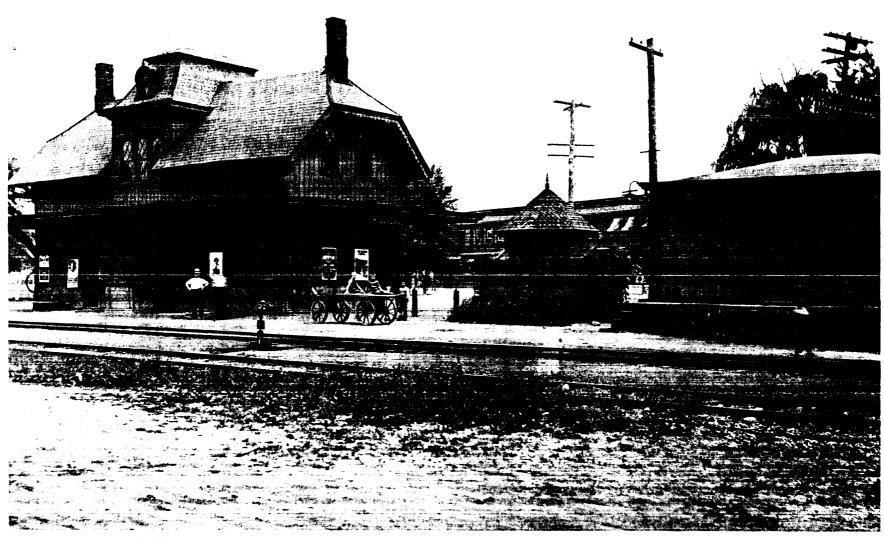
M.P.-21.5
When the railroad was finished to HILLSDALE in 1869, offices of the company were located on the second floor of this new station and remained there for many years. There were complete shop facilities and an engine house situated just behind the photographer.
