**HISTORIC RESOURCES INVENTORY
BUILDING AND STRUCTURES**

IDENTIFICATION	1. BUILDING NAME (Common) (Historic)		ELISHA SEYMOUR, JR.	
	2. TOWN/CITY	West Hartford	VILLAGE	COUNTY Hartford
	3. STREET AND NUMBER (and/or location) 410/412 PARK ROAD

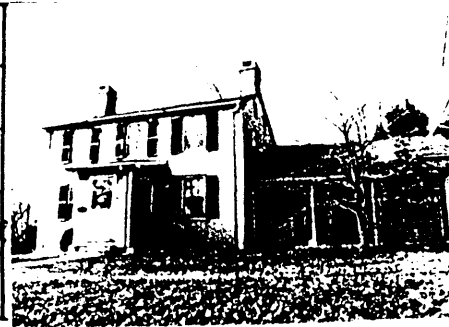
Two story three bay center entrance painted brick house with gable roof. Side gable ends have returns, slight overhang. Paired large chimneys. Windows sash 6/1, louvered shutters. Tops of windows close to roof overhang. One story wing with 4 chamfered posts supporting shed roof. Enclosed shed roof entry porch with large side windows.
