National Register of Historic Places
Inventory—Nomination Form

historic LAWS NARROW GAUGE RAILROAD HISTORIC DISTRICT

and/or common Bishop Station 1883-1890; Laws Station 1890-1960.

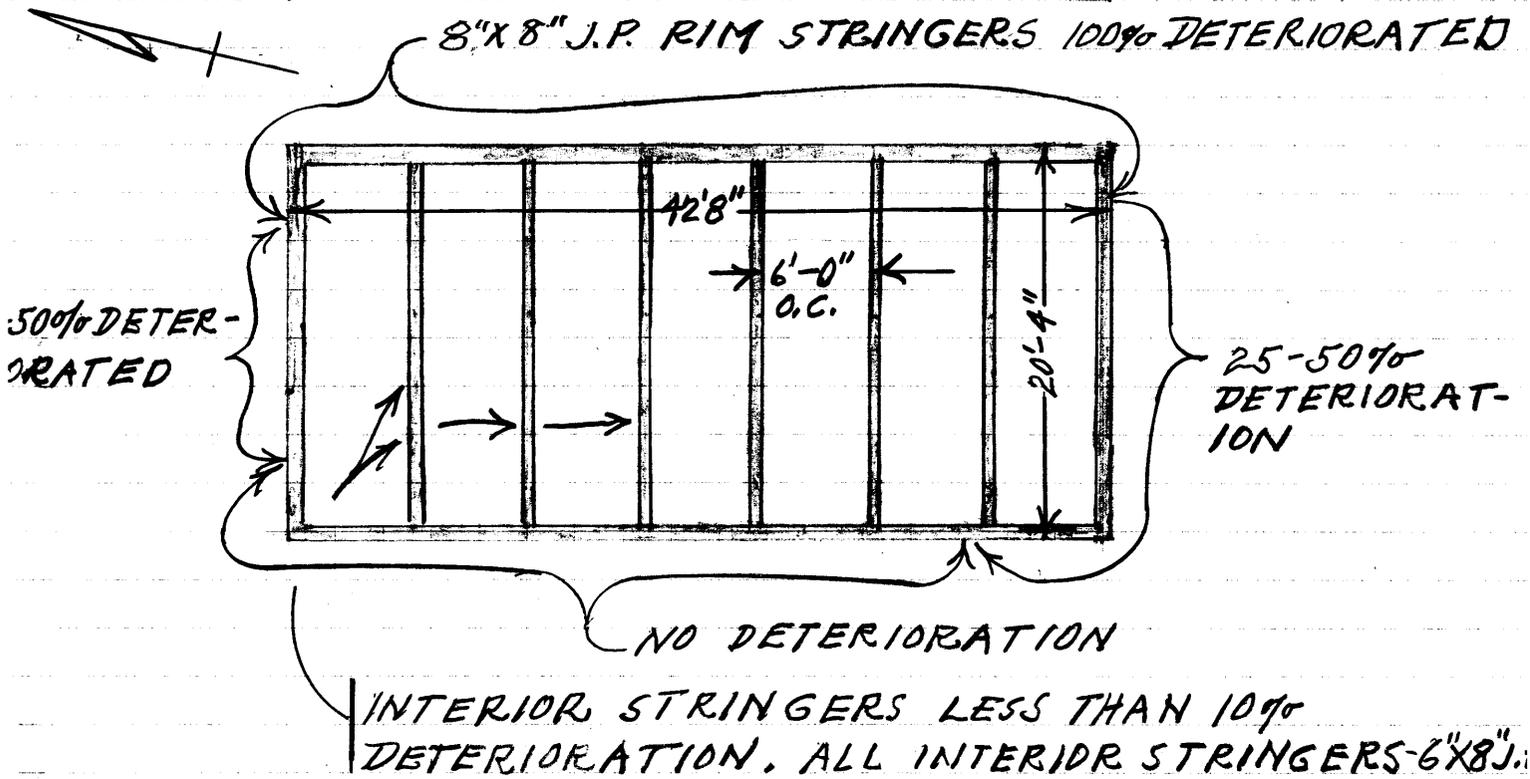
DEPOT FOUNDATION DETAIL

The foundation under the ticket office, waiting room and baggage room consists of 8" x 8" J.P. stringers that rests on the ground. As a result after 97 years, the rim stringers are 100% deteriorated on the east side and are partially deteriorated on the south, north and west sides. The inside stringers are all 6" x 8" J.P. and they also lay on the ground. They are placed on about 6' centers. 2" x 6" J.P. mud sills rest on the rim stringers and inside stringers and no deterioration can be found on any of the mud sills. The mud sills support 2" x 6" J.P. floor joist set on 2' centers.
