**NATIONAL REGISTER OF HISTORIC PLACES
INVENTORY - NOMINATION FORM**

AND/OR HISTORIC:
HOYT FARM HOUSE, BETSEY BARNUM HOUSE

STREET AND NUMBER:
713 Bedford Street

3.0 Conditions Assessment

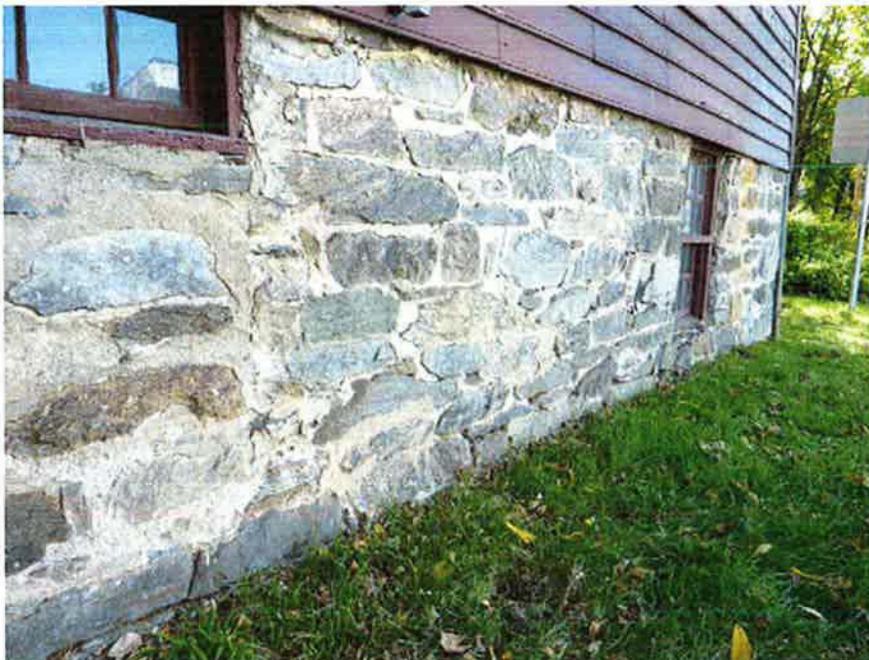
Photo 3 - Cement rich pointing mortar at Southeast corner of North elevation at removed porch

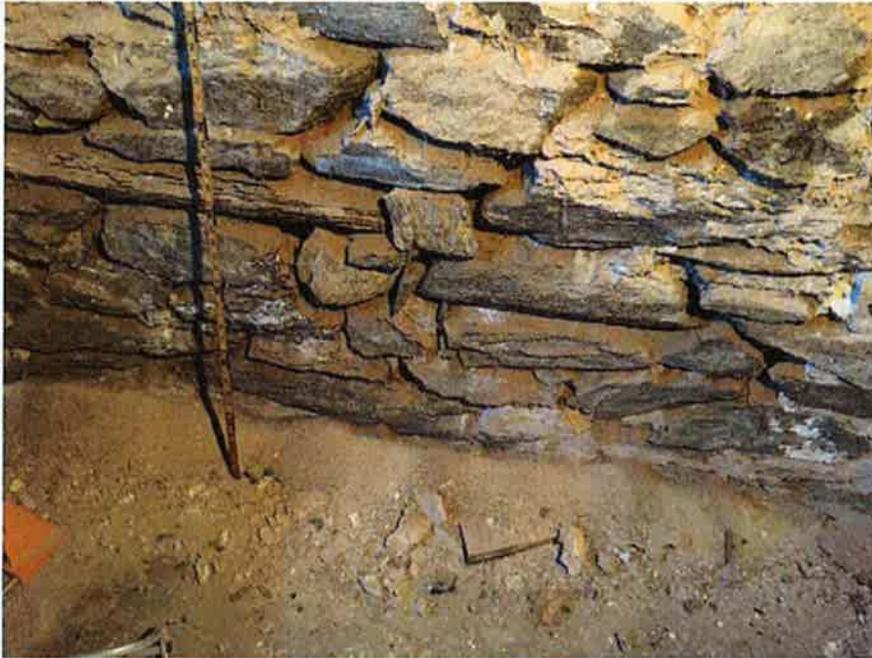
Photo 3a – West foundation. Infilled original window, variety of mortars and pointing techniques

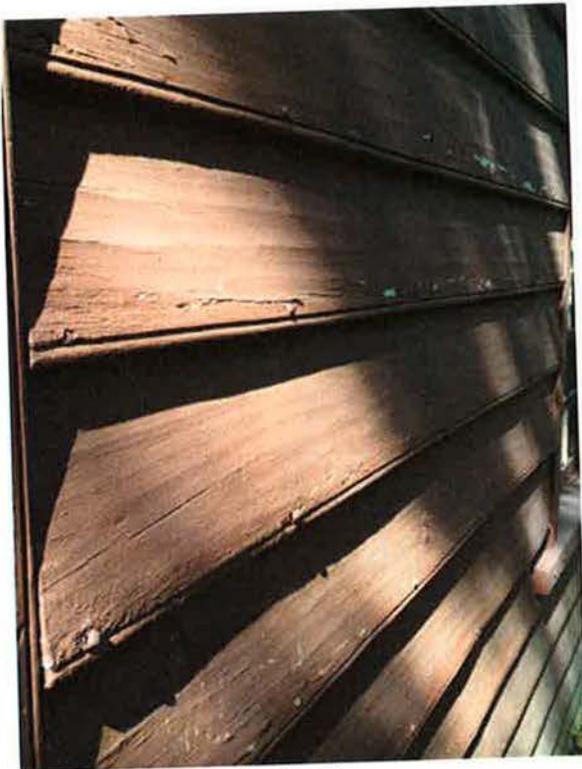
Photo 7 - Typical siding nail, removed (and replaced) without the use of tools.

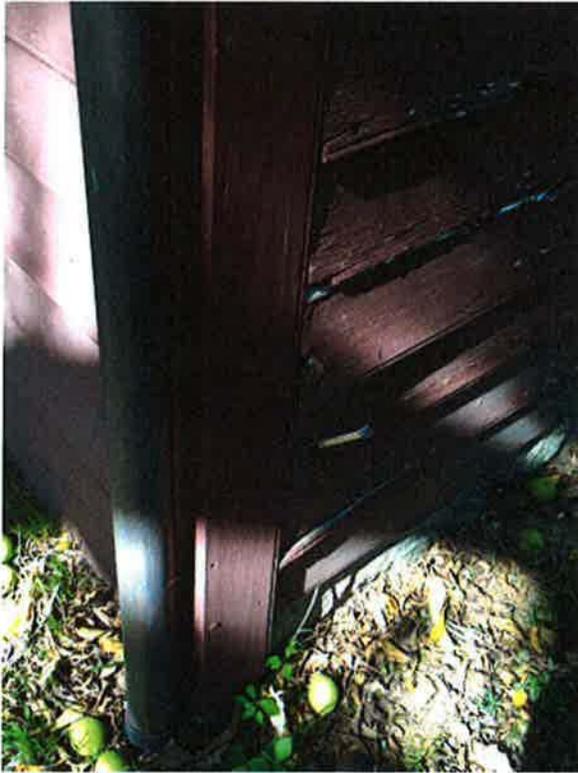
Photo 9b - Siding curling away from East attic window

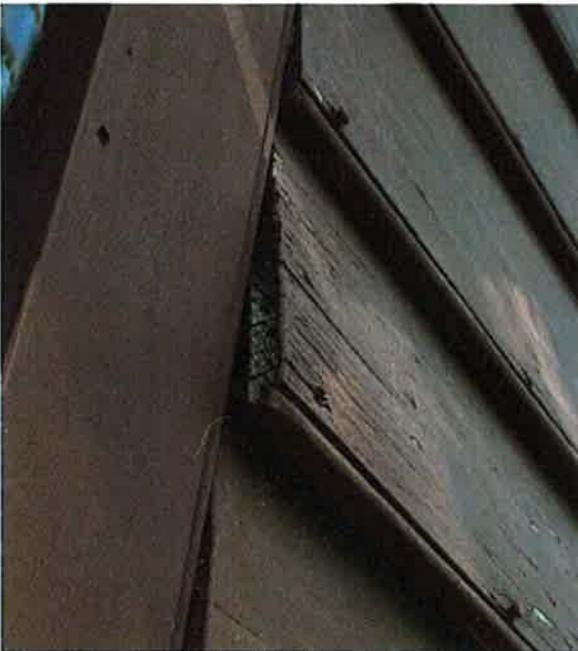
Photo 10 - Probing indicates localized decay; easy knife penetration to 3" depth, SE corner

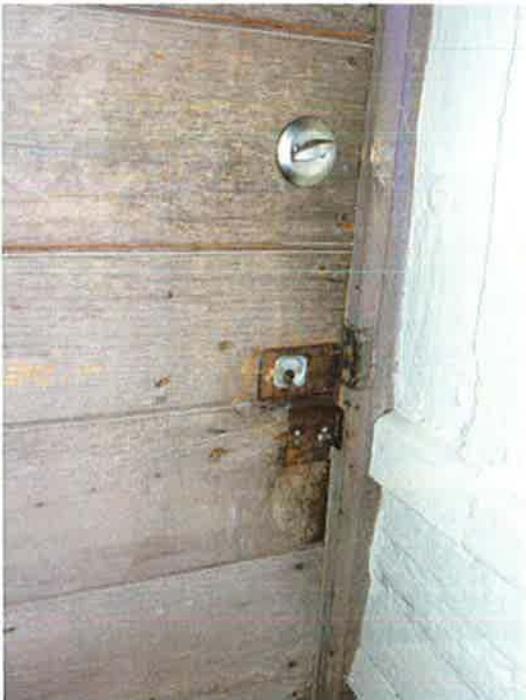
Photo 15c - Kitchen exterior entrance latch, a later interpretive product.

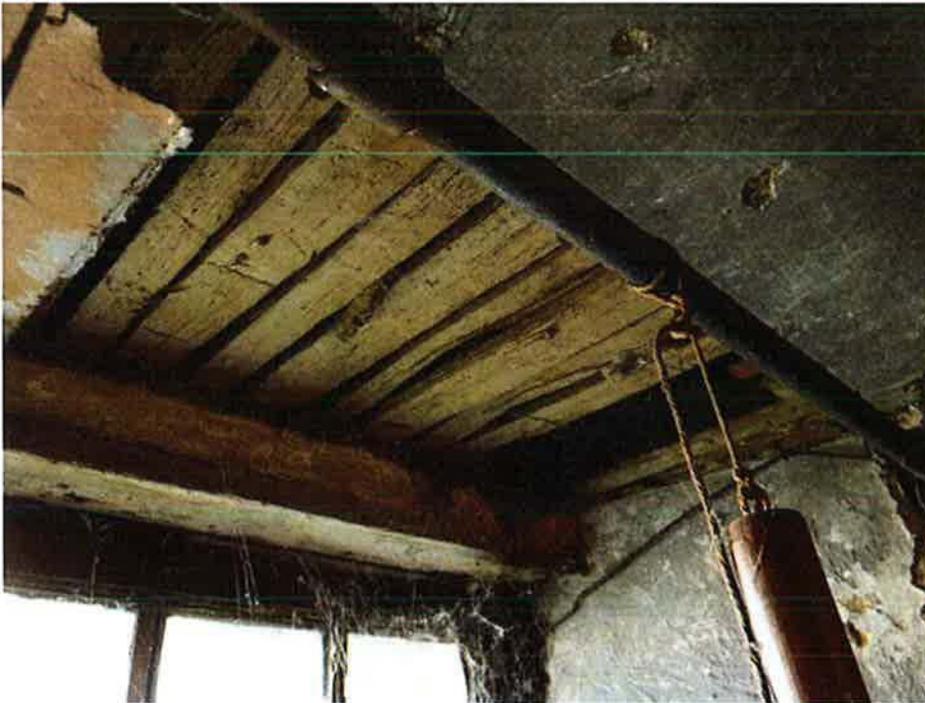
Photo 31 - Chimney cant through attic. Note mortar-wash stain at upper extent.
