**NATIONAL REGISTER OF HISTORIC PLACES
PROPERTY PHOTOGRAPH FORM**

COMMON: **South Finegayan Latte Stone Park**
AND/OR HISTORIC:

STREET AND NUMBER:
at 74 Golden Shower Lane
CITY OR TOWN:
South Finegayan Navy Housing Area
STATE: **Territory of Guam** CODE **066** COUNTY CODE **0400**

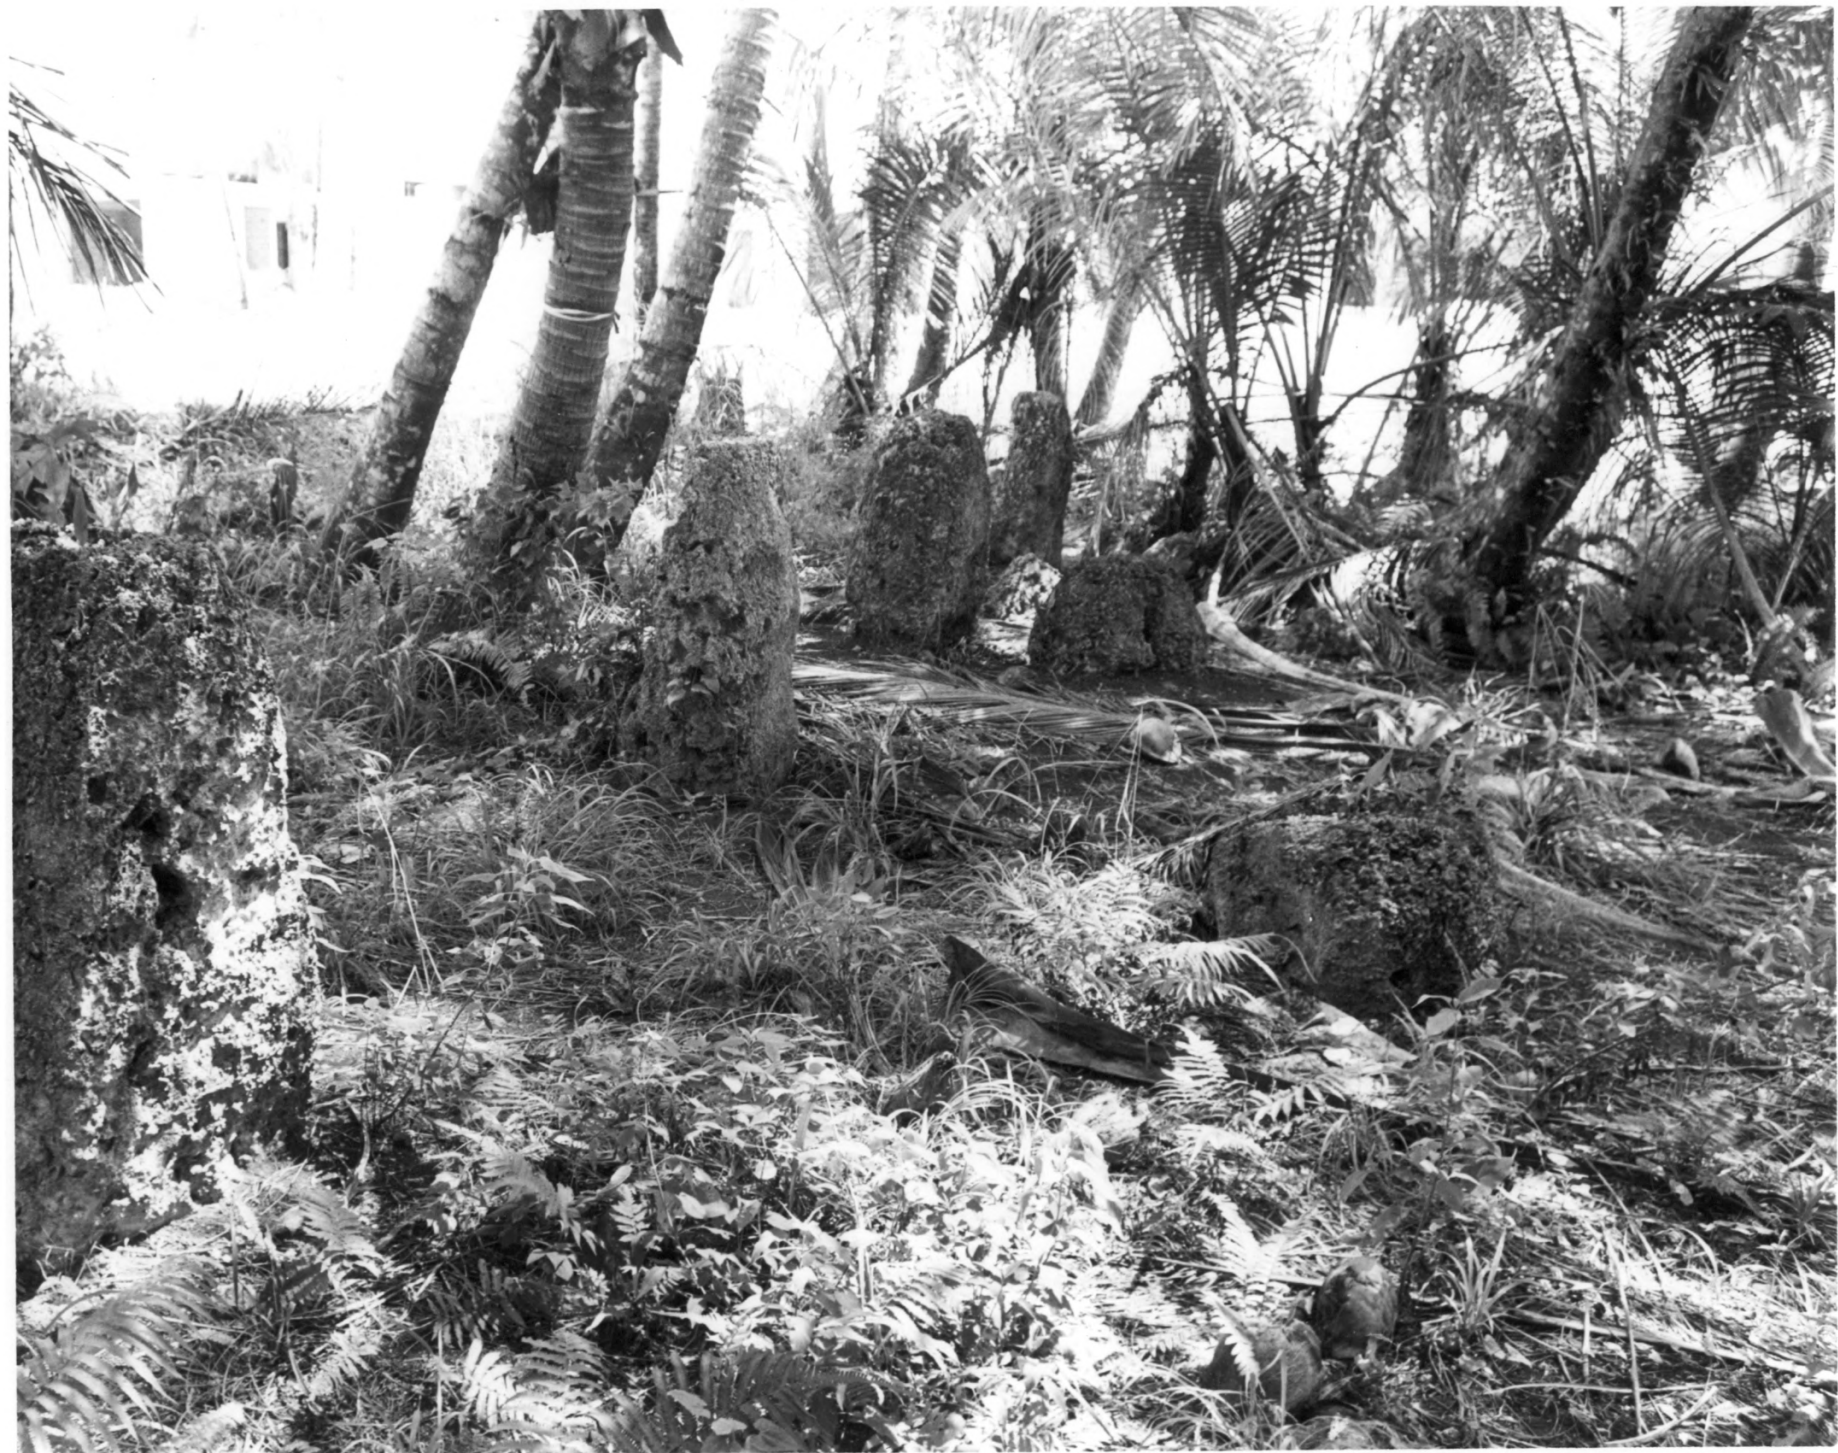
DESCRIBE VIEW, DIRECTION, ETC.
View A indicates natural condition of latte site. Orientation of view is eastward as indicated on Figure 1. Erect shafts are visible with fallen capstones.

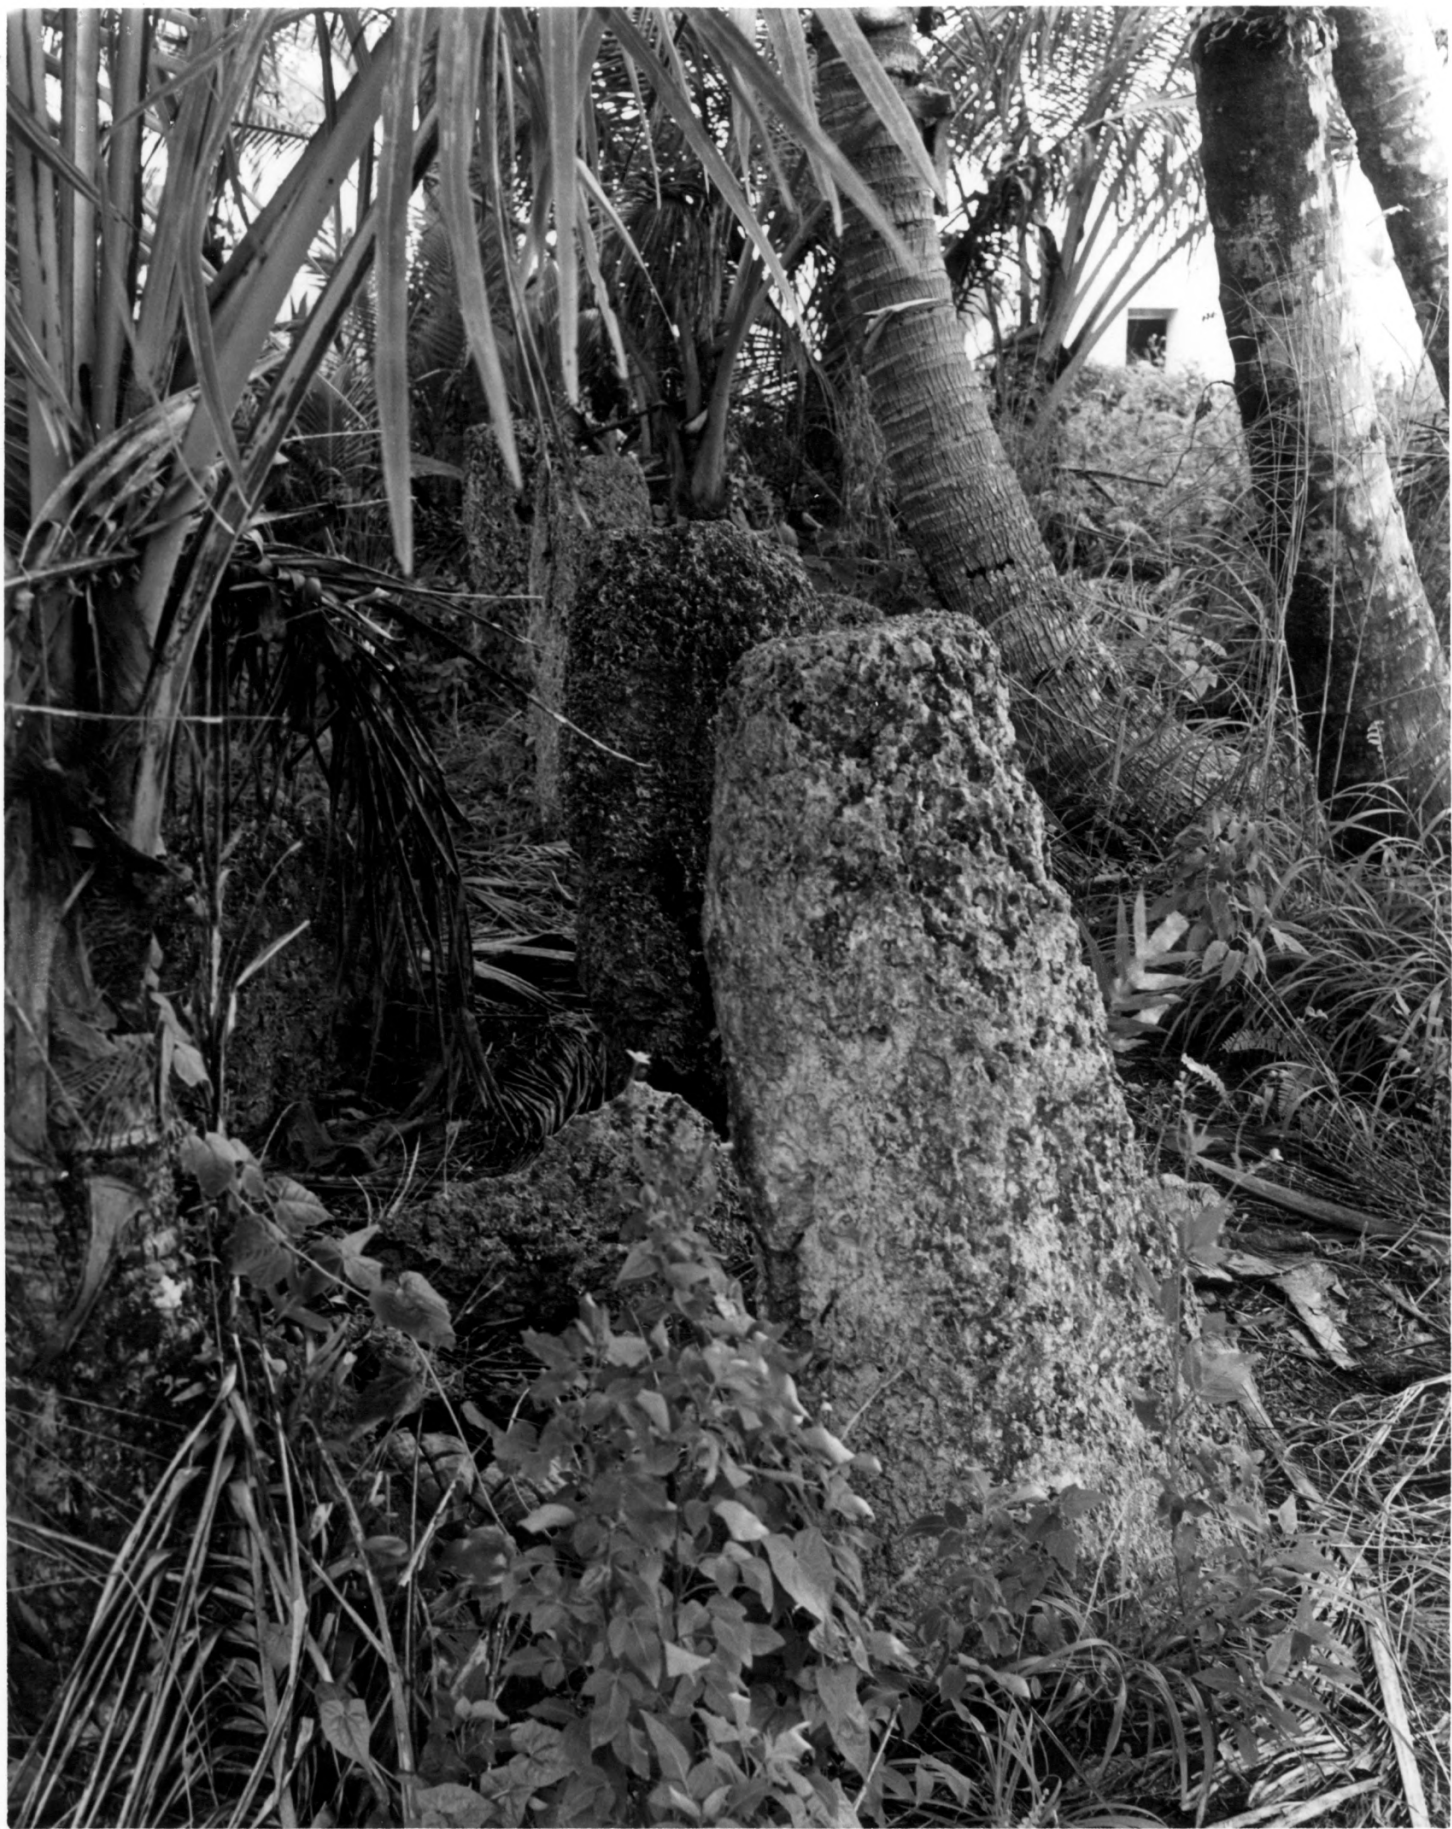
View B shows alignment of best preserved shafts. Orientation of view is west northwest as indicated on Figure 1. Originally the capstones were balanced on the flat tops of the shafts.

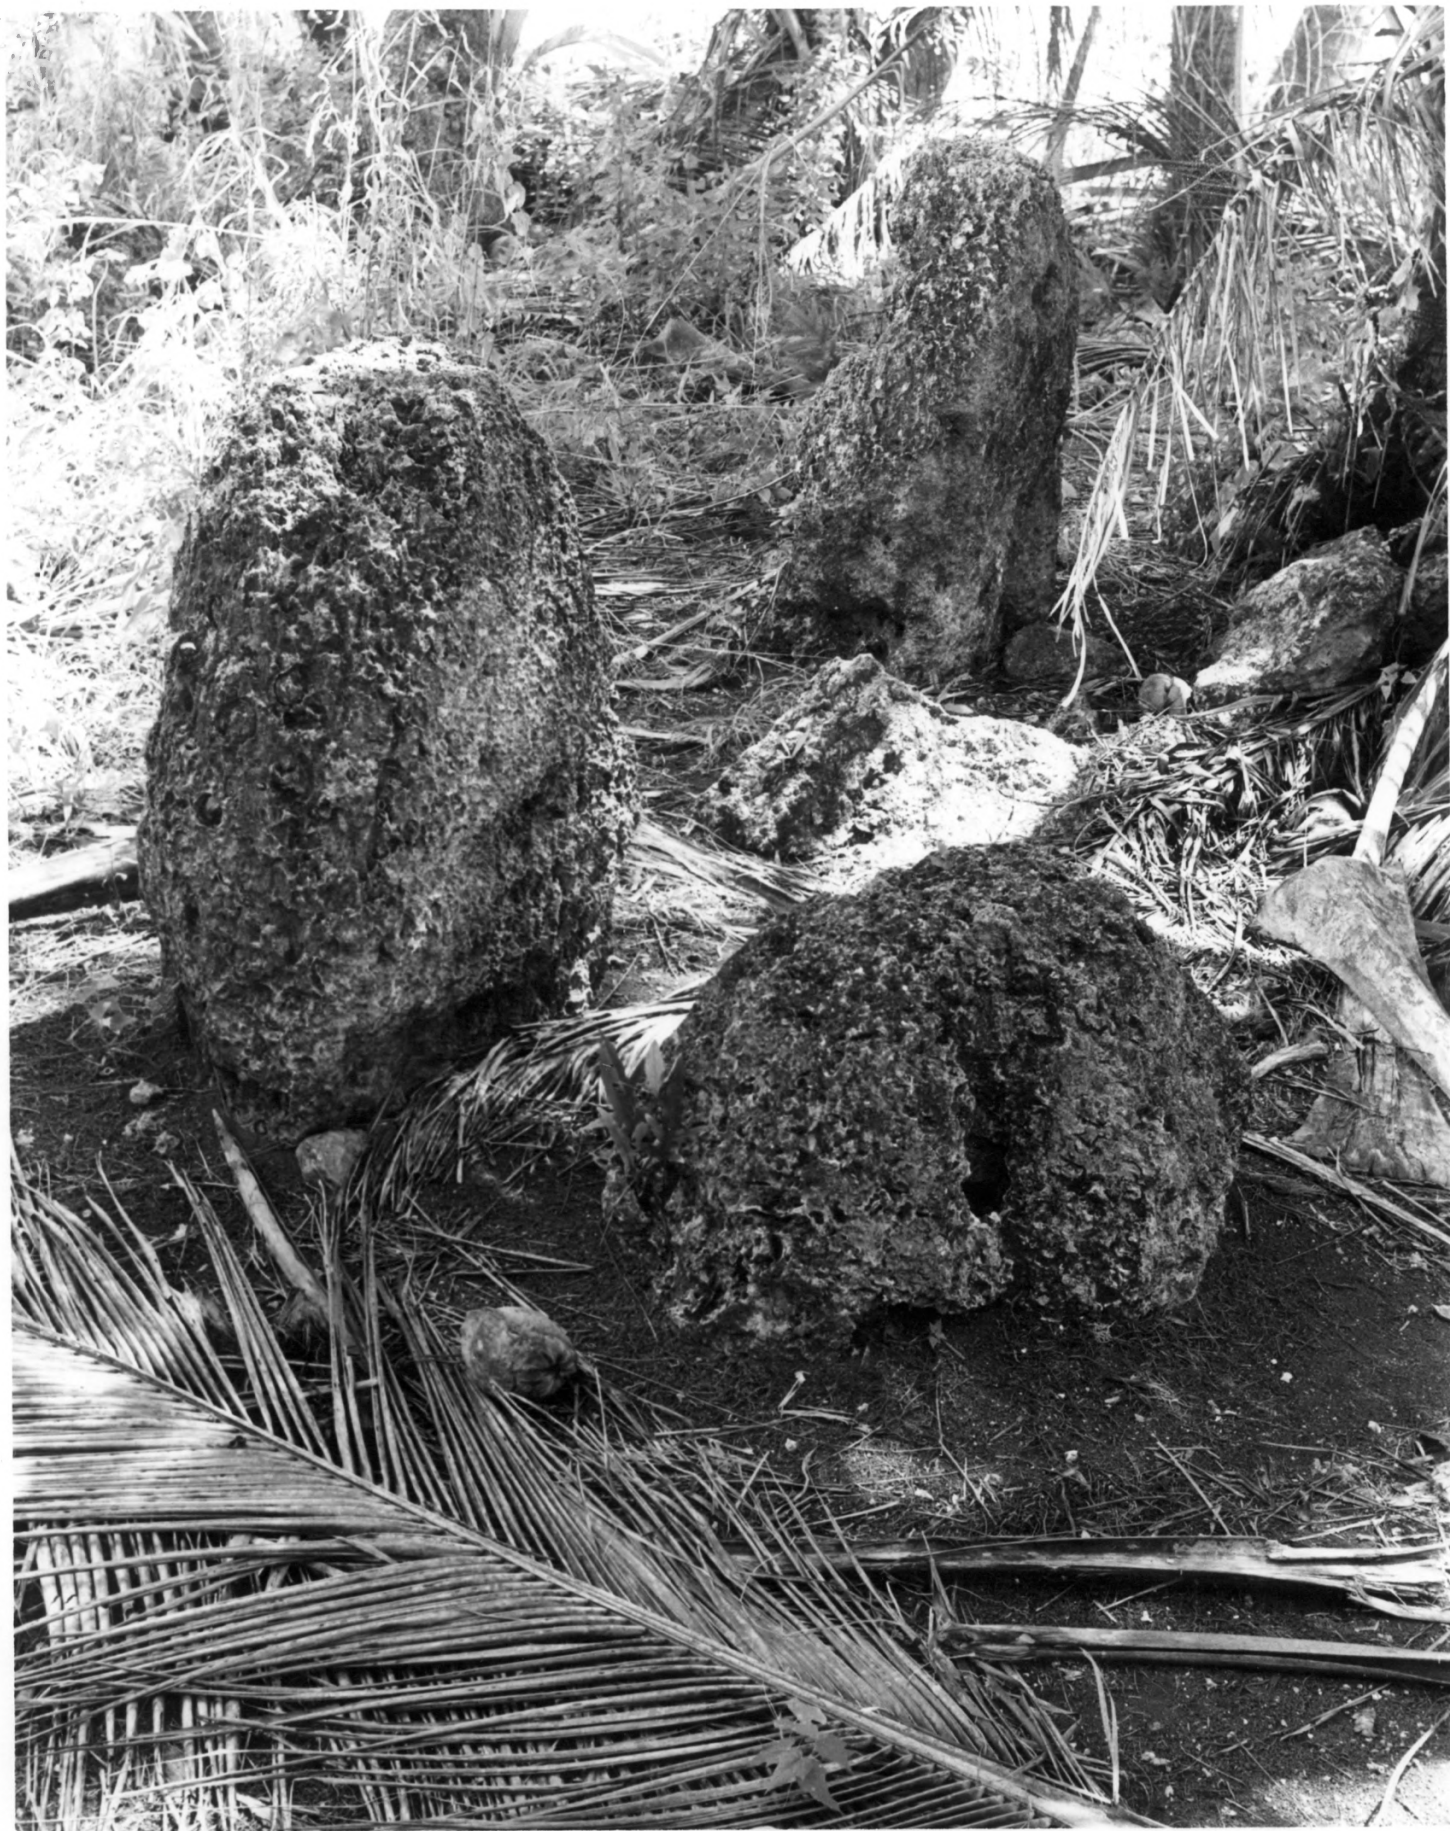
View C shows detail of shaft with fallen capstone in inverted position. Orientation of view is east southeast as indicated on Figure 1. Not visible beyond second shaft is crater of missing shaft and capstone.
