# DATA SHEET

## NATIONAL REGISTER OF HISTORIC PLACES INVENTORY - NOMINATION FORM

COMMON:  
**Leesburg**

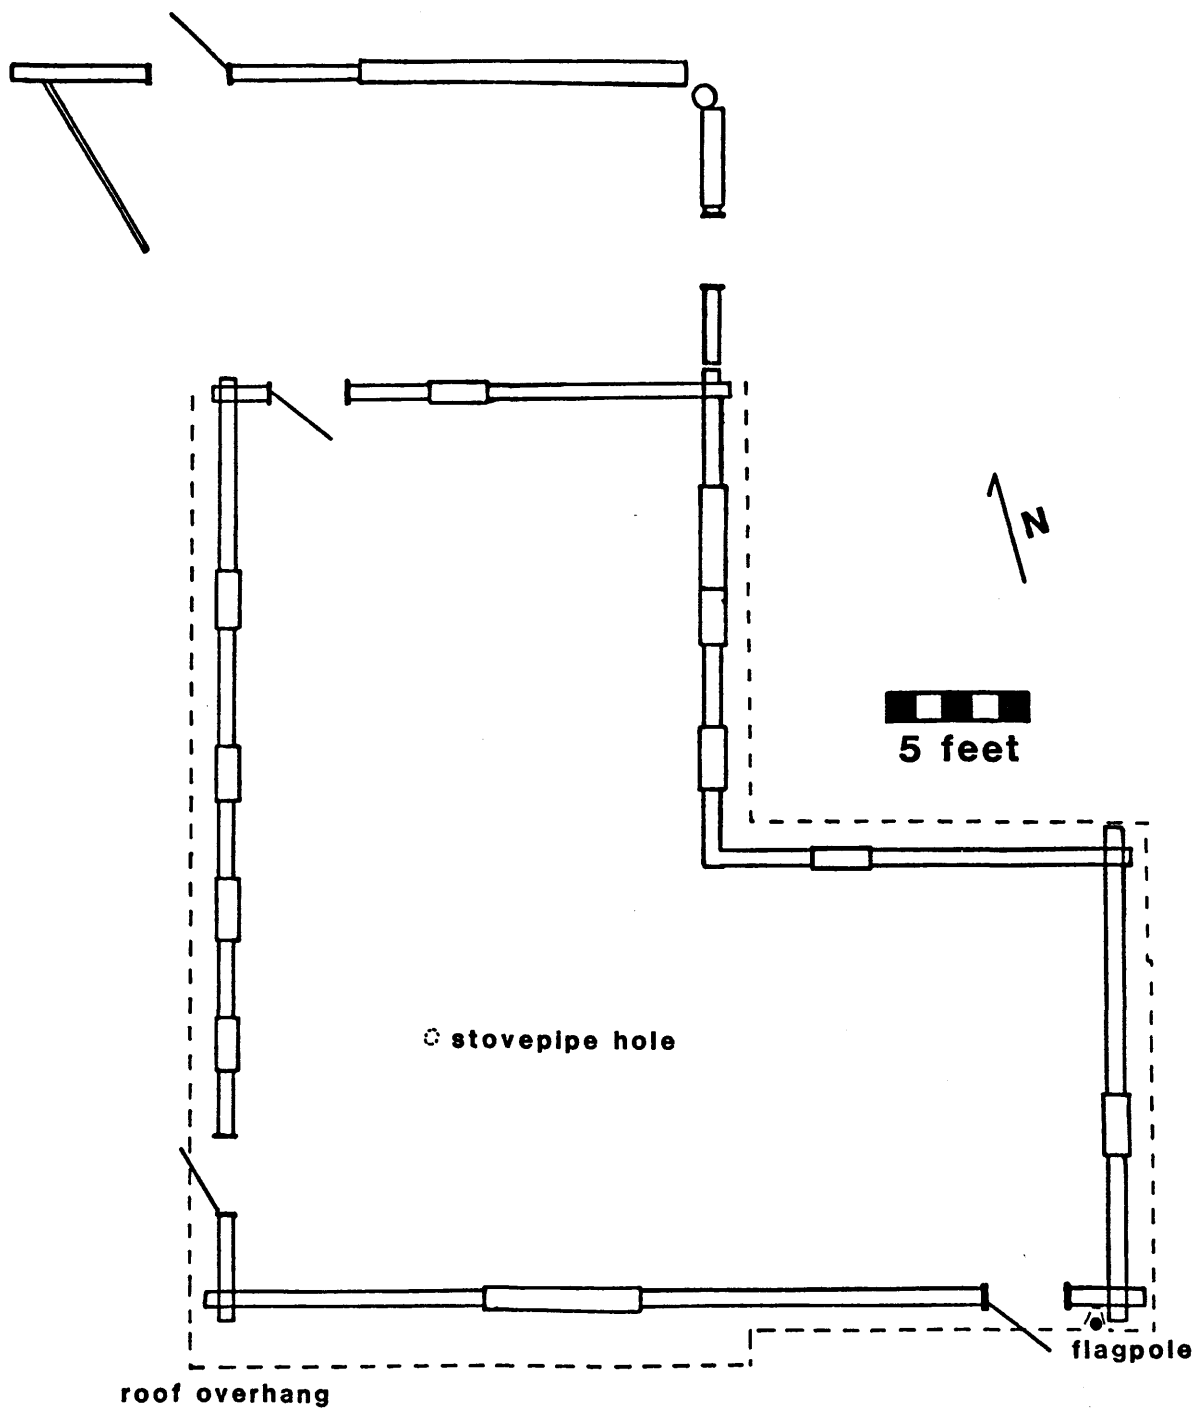
Fig. 4. Example of the type of floor plans drawn for structures at the Leesburg townsite. This is a floor plan for Feature 10.

Feature 10 is a four room, saddle-notched log structure (Fig. 9). It was built in 1937 by Mike and Maude Fraker who used it as a boarding house and post office (Paul Fitzgerald and Marjorie Sims). The building is presently being used by the Napias Mining Company as a cookhouse and boarding house. Feature 10 is in good condition due both to its comparatively recent construction and to fairly continuous maintenance.

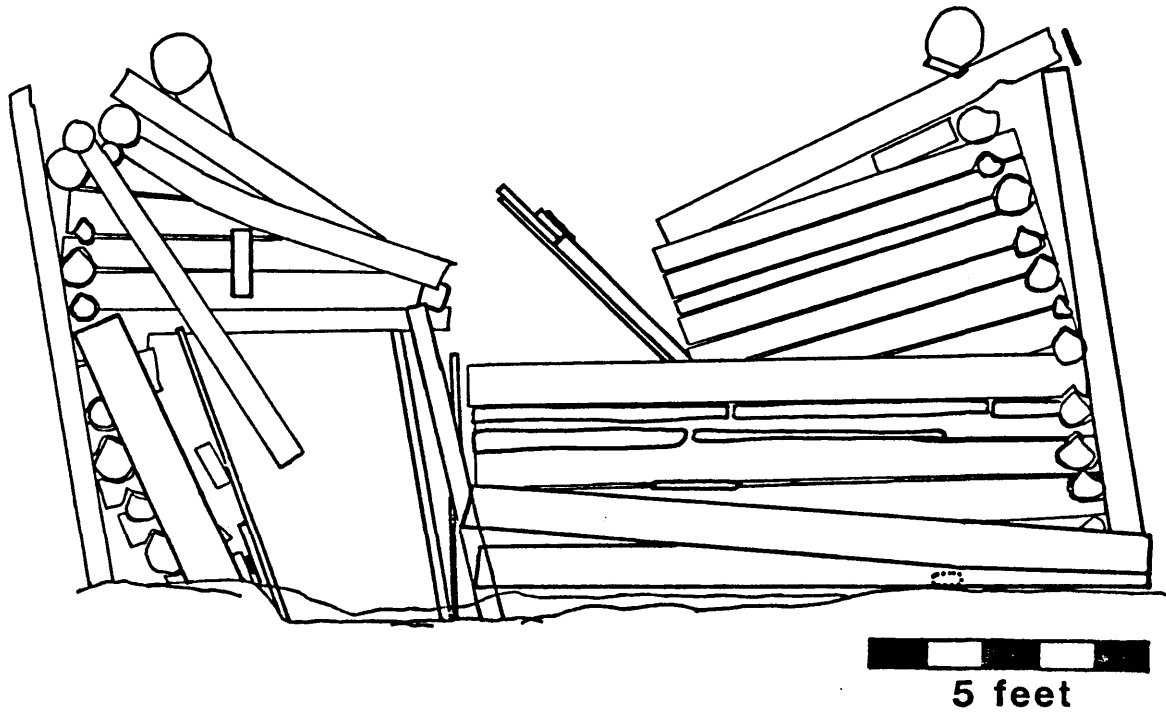
Fig. 5. Elevation of the front (north) wall of Feature 23, illustrating the collapsed condition of the structure.

Feature 23 is a one room, steeple-notched log barn with a hay loft. Dick Shoup claims that it was originally a saloon. The building was built sometime before 1908 (Anonymous 1908). It is in fair to poor condition; the roof is completely collapsed and the east wall is falling down.

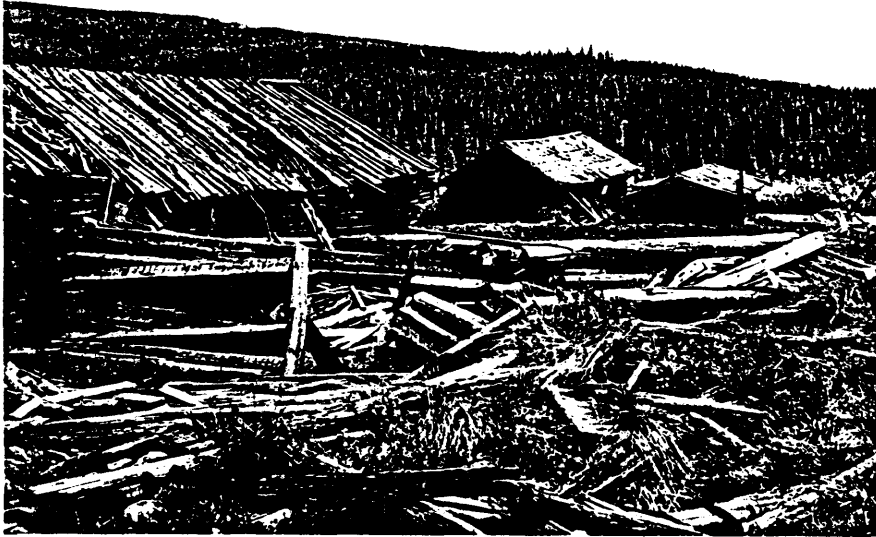
Fig. 7. View of the north and west walls of Feature 6. The building is now a ruin.

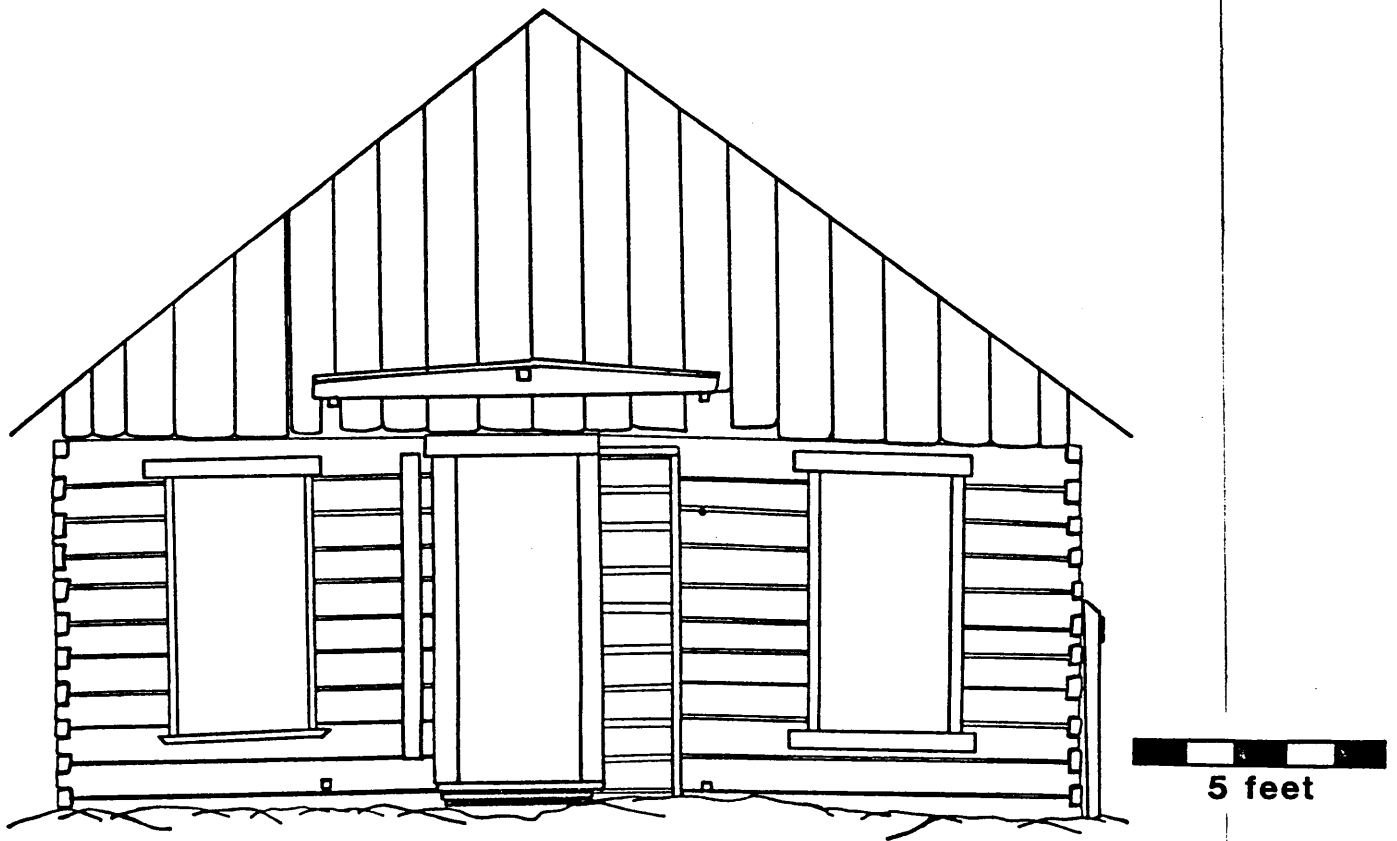
Fig. 8. Elevation of the front exterior wall of Feature 9. This building, still in fairly good condition, once served as Orion Kirkpatrick's freight depot.

The building is in fairly good condition, but about 40% of the roof shingles are missing, the west wall is bowed in, and there is some settling along the north wall.

Buildings in a poor state of repair or in ruins would not be repaired under the proposed stabilization program. Those buildings needing minor repairs to the walls or a new roof would have priority in the program. The buildings that would most benefit from a stabilization program are Feature 3 (roof), Feature 9 (roof and foundation along the north side),

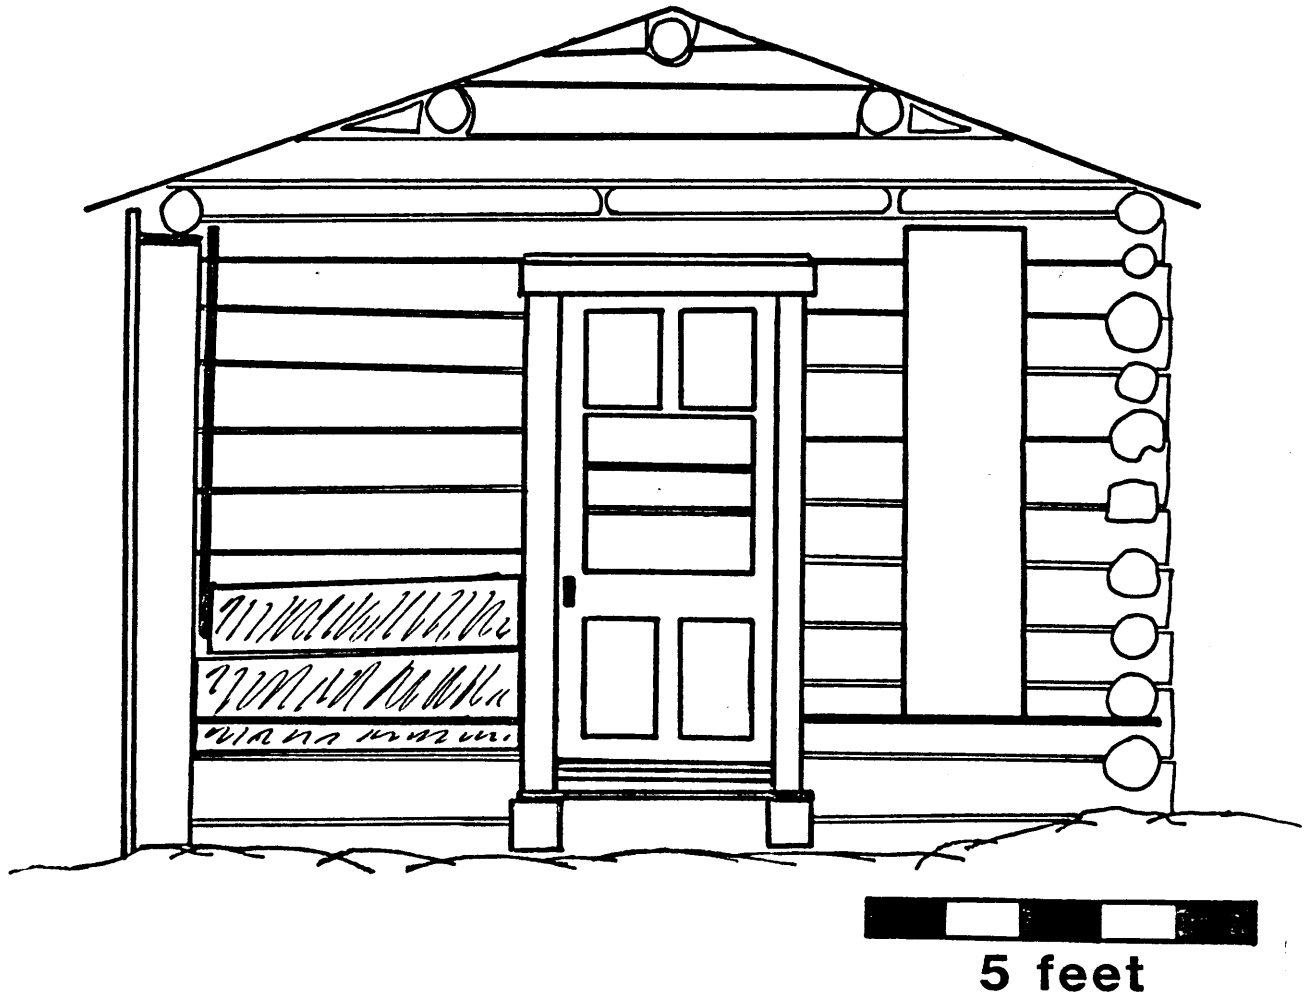
Feature 12 is a two room, saddle-notched log building (Fig. 10). It was built in 1935 by Mr. Fitzgerald and two other men to be used as a schoolhouse (Paul Fitzgerald). Napias currently uses the structure as an office, and occasionally as sleeping quarters. Feature 12 is structurally sound although the bottom wall logs are rotting and the roof and floor are deteriorating.

Fig. 10. Elevation of the front wall at Feature 12. School bench at left of doorway is shaded.

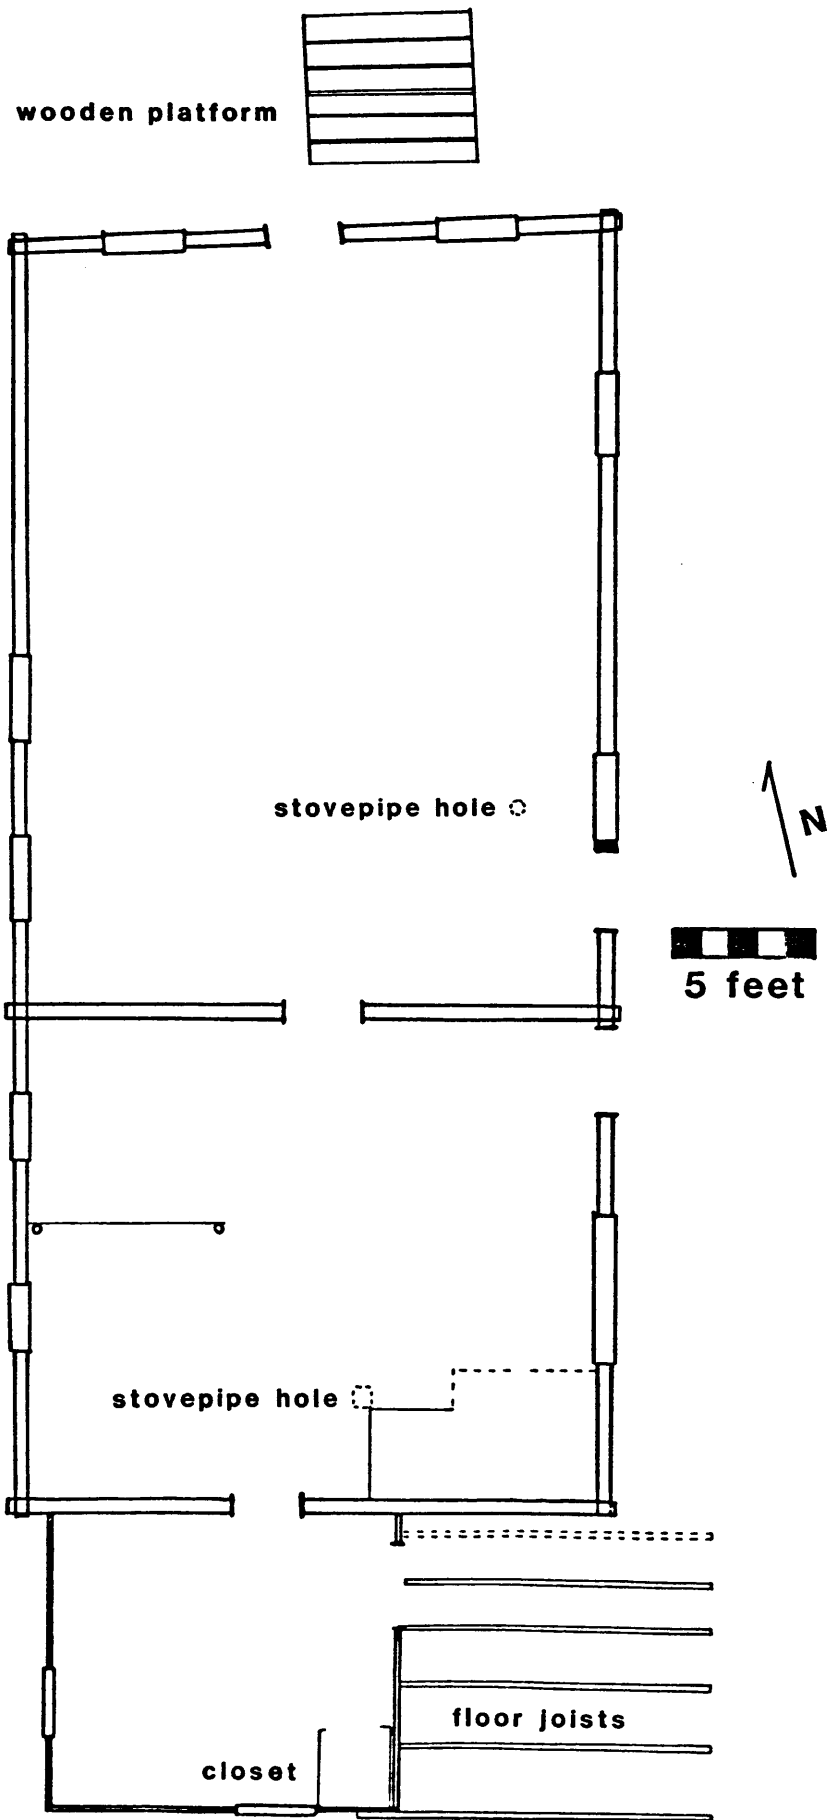
Feature 17 (Fig. 11) is a multi-room, steeple, square and saddle-notched structure used as a hotel between about 1900 and the early 1930's. The main part at the north end of the building was probably constructed in the 1890's, the second part perhaps 5-10 years later, and the third part (a shed) sometime in the twentieth century. Feature 17 is in fair condition with the roof collapsed, some of the walls collapsed, and the floors in very poor repair.

Fig. 11. Floor plan for Feature 17, formerly Alice Mahoney's hotel and post office.

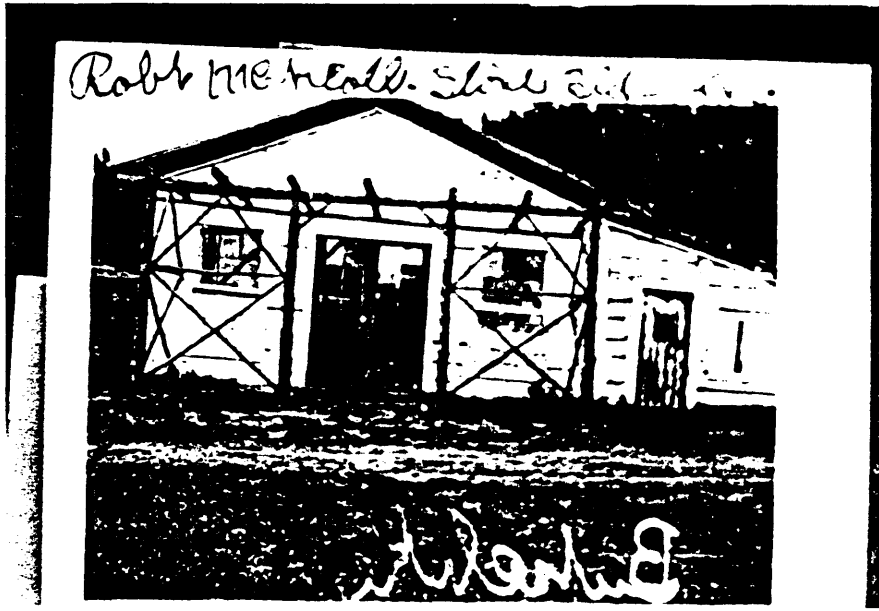
Feature 18 was a two room, square-notched log building used as a boarding house during the early twentieth century (Dick Shoup and Marjorie Simms). It is one of the oldest structures at Leesburg, dating to the 1880's or earlier (Fig. 12). It is in very poor condition with the roof and most of the walls collapsed.

Fig. 12. Historical photograph of a structure that might be Feature 18.  
(Lemhi County Historical Museum, Salmon.)

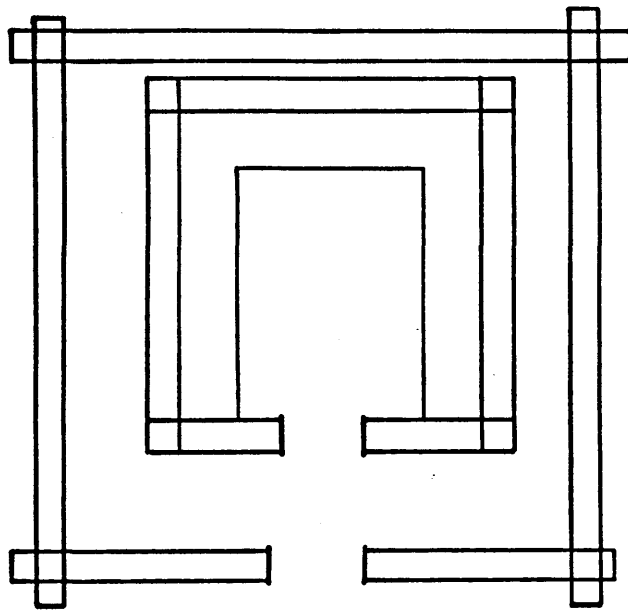
Feature 24 is a small, double walled log building at the west end of the townsite (Fig. 13). The exterior walls have saddle-notched corners, but the interior walls do not interlock in the corners. Feature 24 was built in the 1890's or later and appears to have been used for storage. It is in fair condition because the roofs and two of the exterior walls are collapsed.

Fig. 13. Floor plan for Feature 24, showing double log walls. Shelves line the interior walls.

Feature 14 (roof and back wall), Feature 20 (west wall), and Feature 24 (roof). Building new roofs for the structures is a cost-efficient "stitch-in-time-saves-nine" measure; roofless structures are more exposed to the weather and therefore deteriorate more quickly than do those with roofs.
