NR District

7-Clifton  
Ohio Historic Preservation Office  
Ohio Historical Center  
Columbus, Ohio 43211

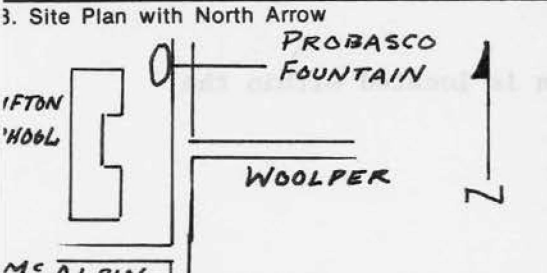
18. Style or Design Function		30. Foundation Material	
1. Coordinates Lat. _____ Long. _____ U.T.M. Reference 16 714440 4336200		19. Architect or Engineer Samuel Hannaford & Sons		31. Wall Construction	
Zone _____ Easting _____ Northing _____		20. Contractor or Builder		32. Roof Type & Material

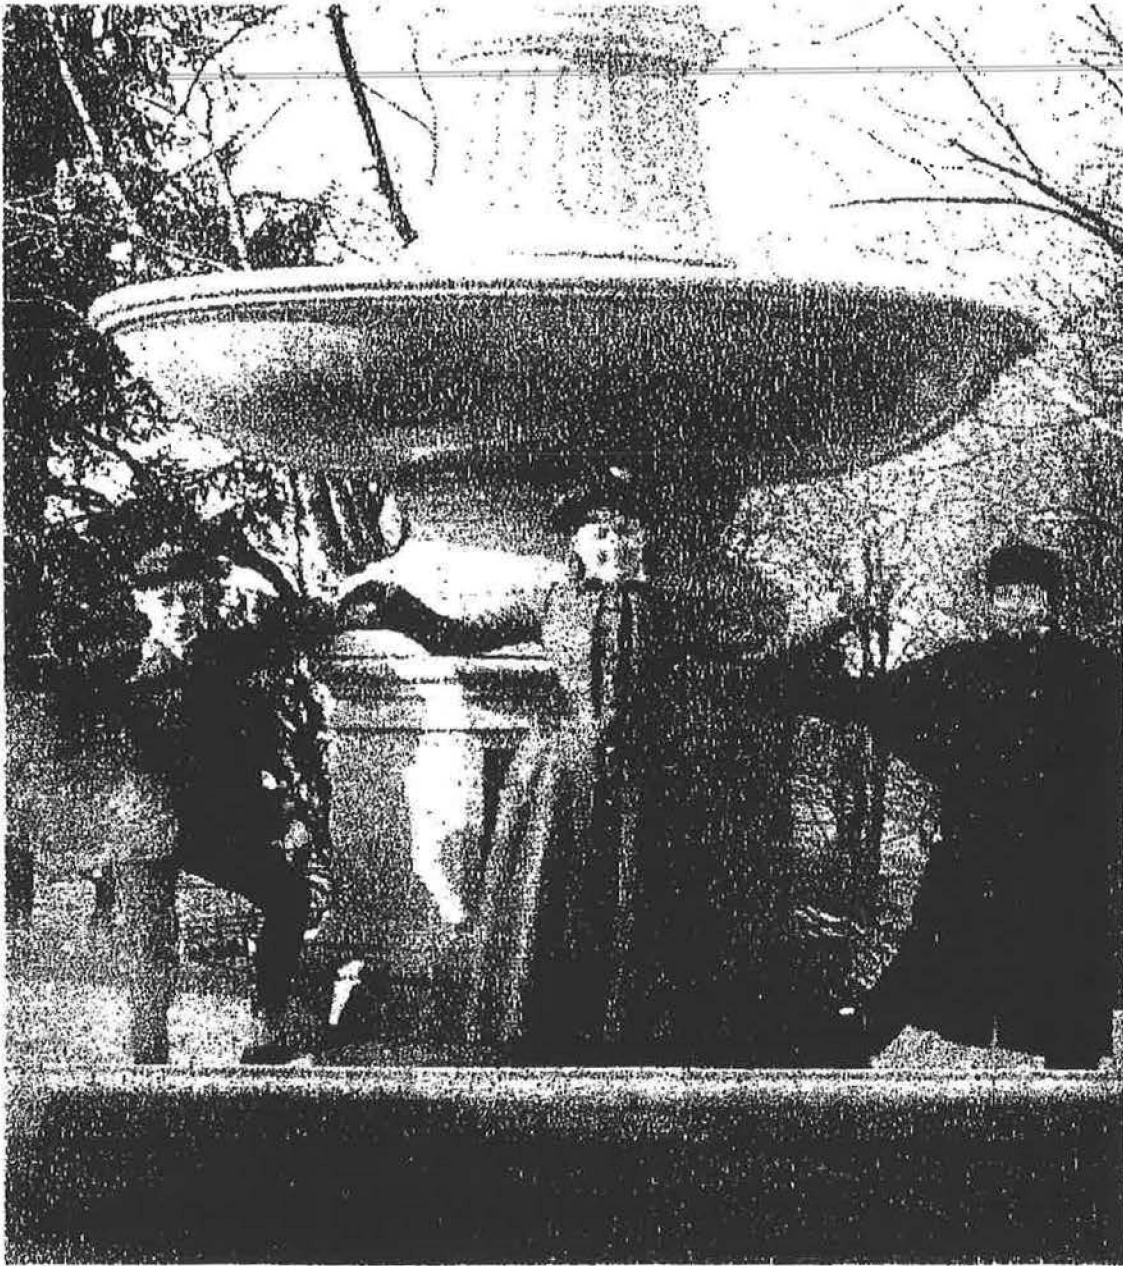
# THE PROBASCO FOUNTAIN

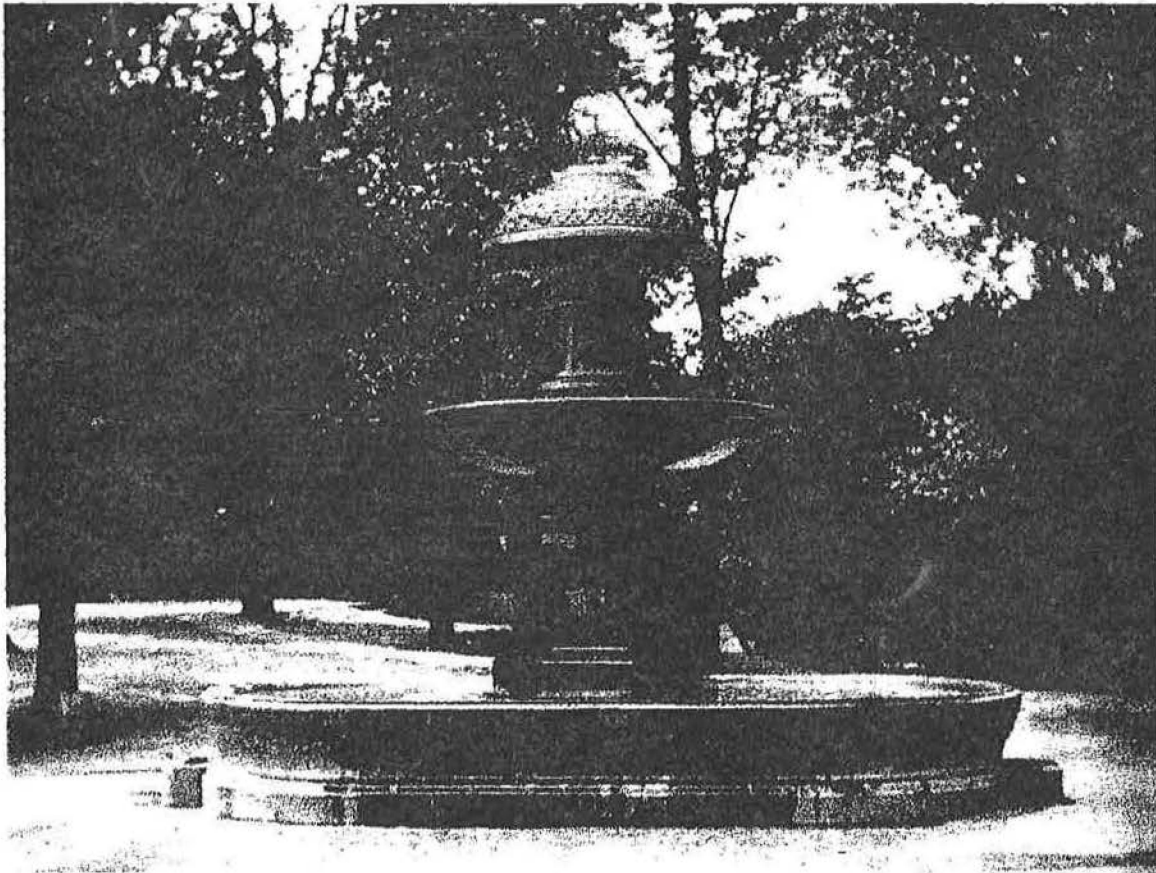
*Figure 1. An early photograph of the Probasco Fountain.*

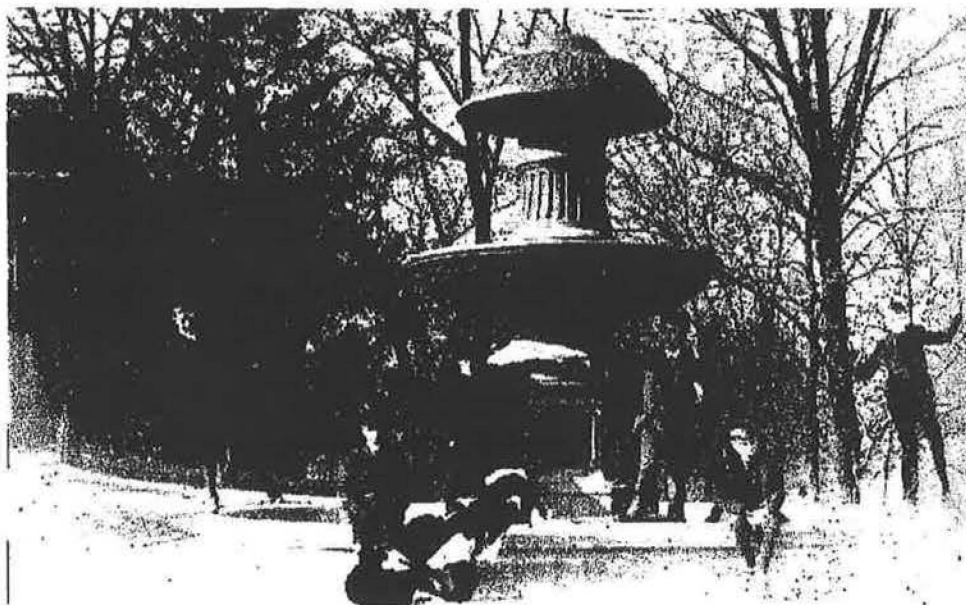
*Figure 2. A pre-1907 picture of the fountain with students from the Resor Academy.*

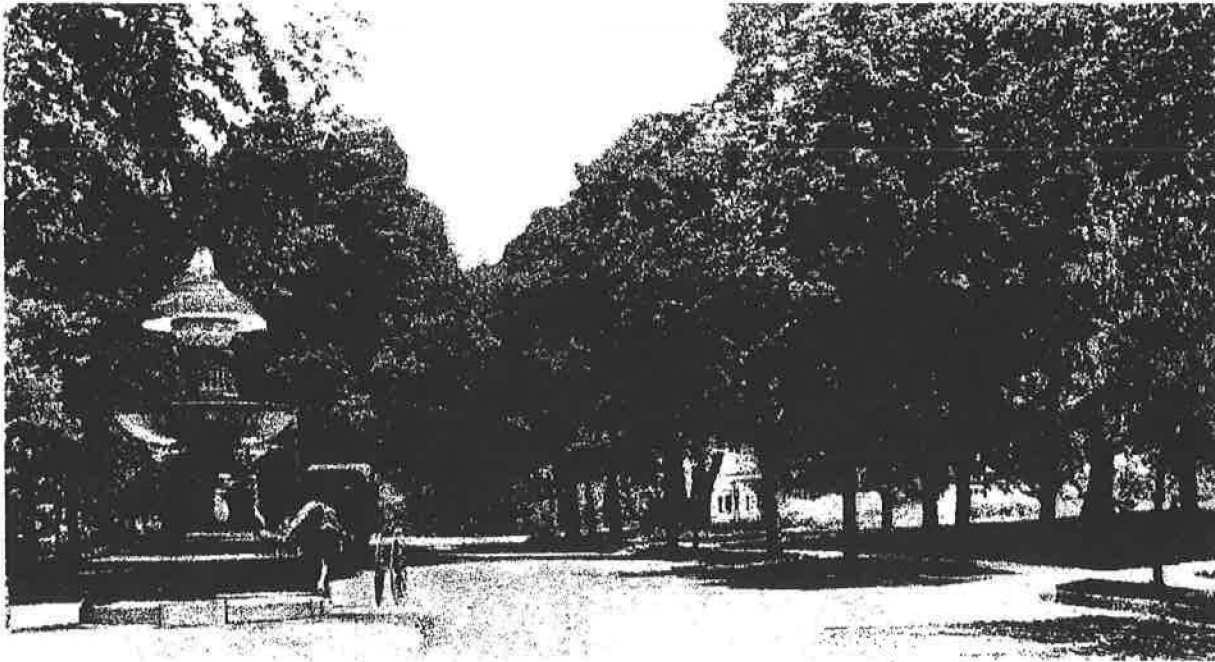
*Figure 5. This photograph is taken from a post card collection in the Cincinnati and Hamilton County Public Library. The setting is almost park-like in its serenity - especially compared to today's busy thoroughfare. Gradually, more and faster vehicles have been funneled into a much narrower roadway. The western curb of Clifton Avenue here was several feet west of the fountain. Today it is on the eastern edge of the fountain. Most of the houses on Clifton Avenue in 1887 are still standing. The character of the neighborhood, aside from the influences of the automobile, is largely intact.*

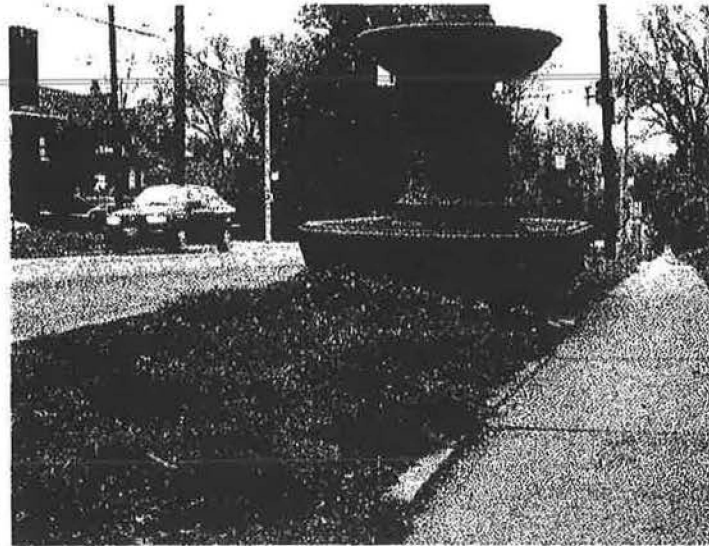
*Figure 6. The present curb is to the left (east) of the fountain. An earlier granite curb can be seen in the foreground, at the left edge of the sidewalk, which was once the edge of the roadway.*

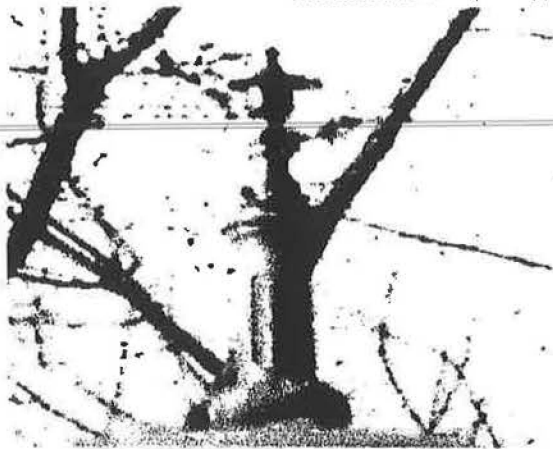
Figure 7. The original bell jet.

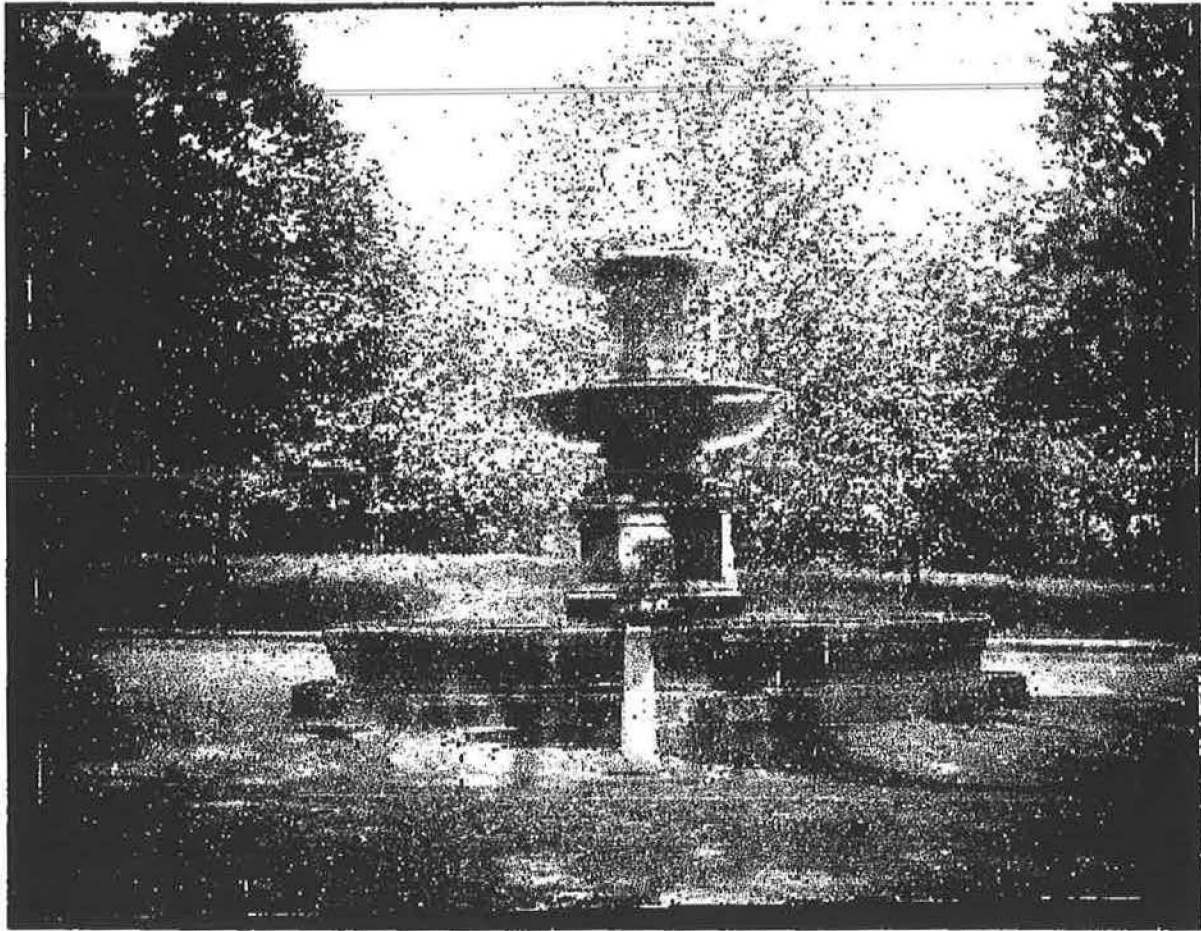
*Figure 10. The only early photograph taken from the west we have found. The stone dipper shelf and the dippers and chains can be seen in the enlargement (Figure 11). Note the curb approximately ten feet west of the fountain, the stone post, and the level grade around the base of the fountain.*

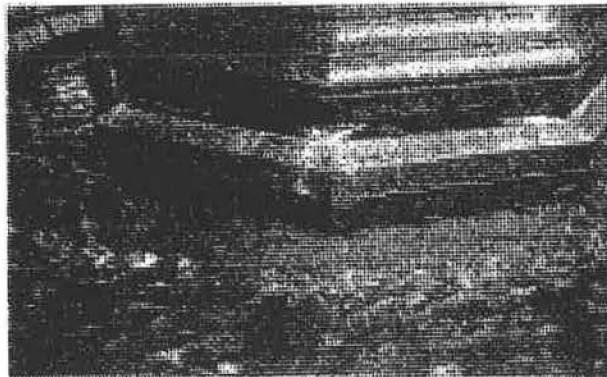
Figure 14. Spalled stone and previous repairs.

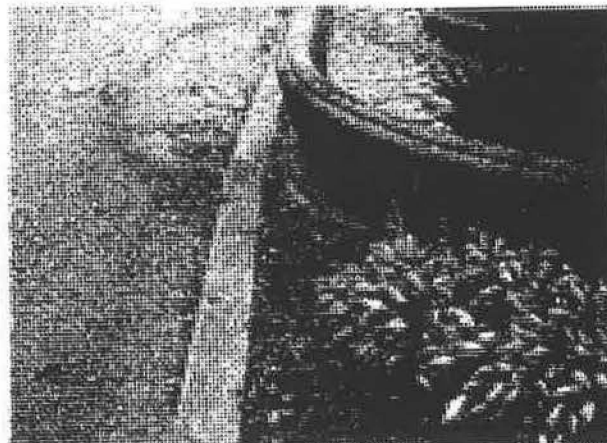
Figure 15. Topsoil covering the north base of fountain.

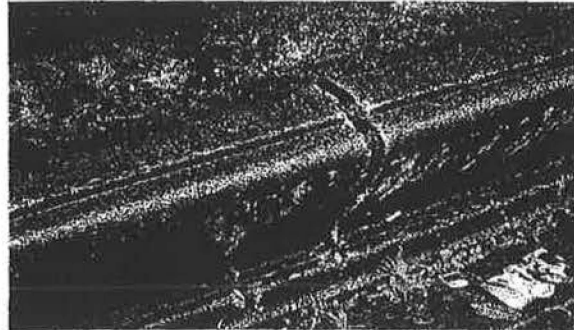
Figure 16. Inappropriate pointing.

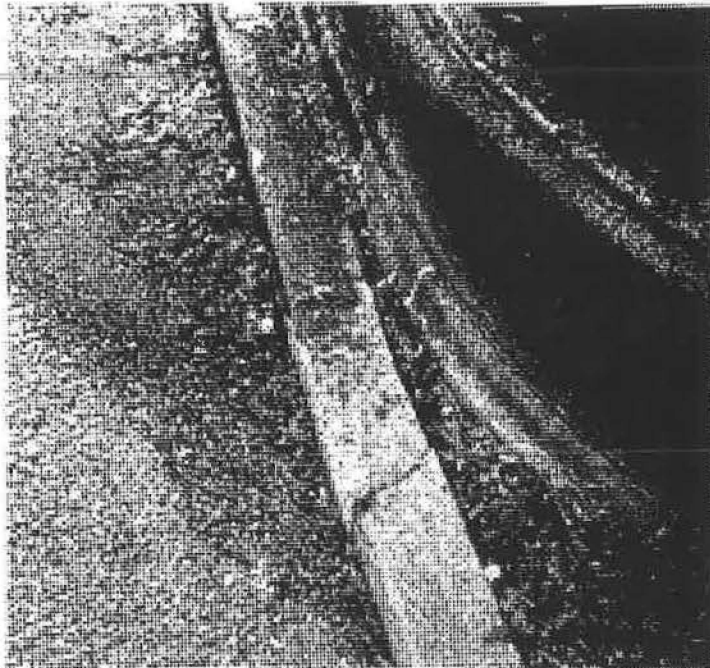
*Figure 18. Curb and topsoil covering the base of the fountain.*

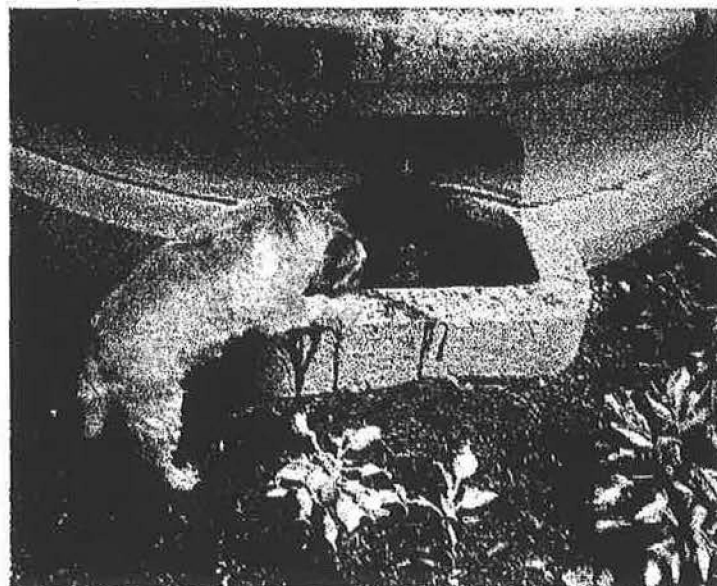
*Figure 19. The dog bowl with plantings.*
