**National Register of Historic Places
Inventory—Nomination Form**

historic Colonel Gustavius A. Palmer House

The following report concerns itself with the present architectural condition and the steps that should be taken to preserve the structure as a useful building; serving as a community meeting center and part of Crystal Lake's heritage.

COL. PALMER HOUSE

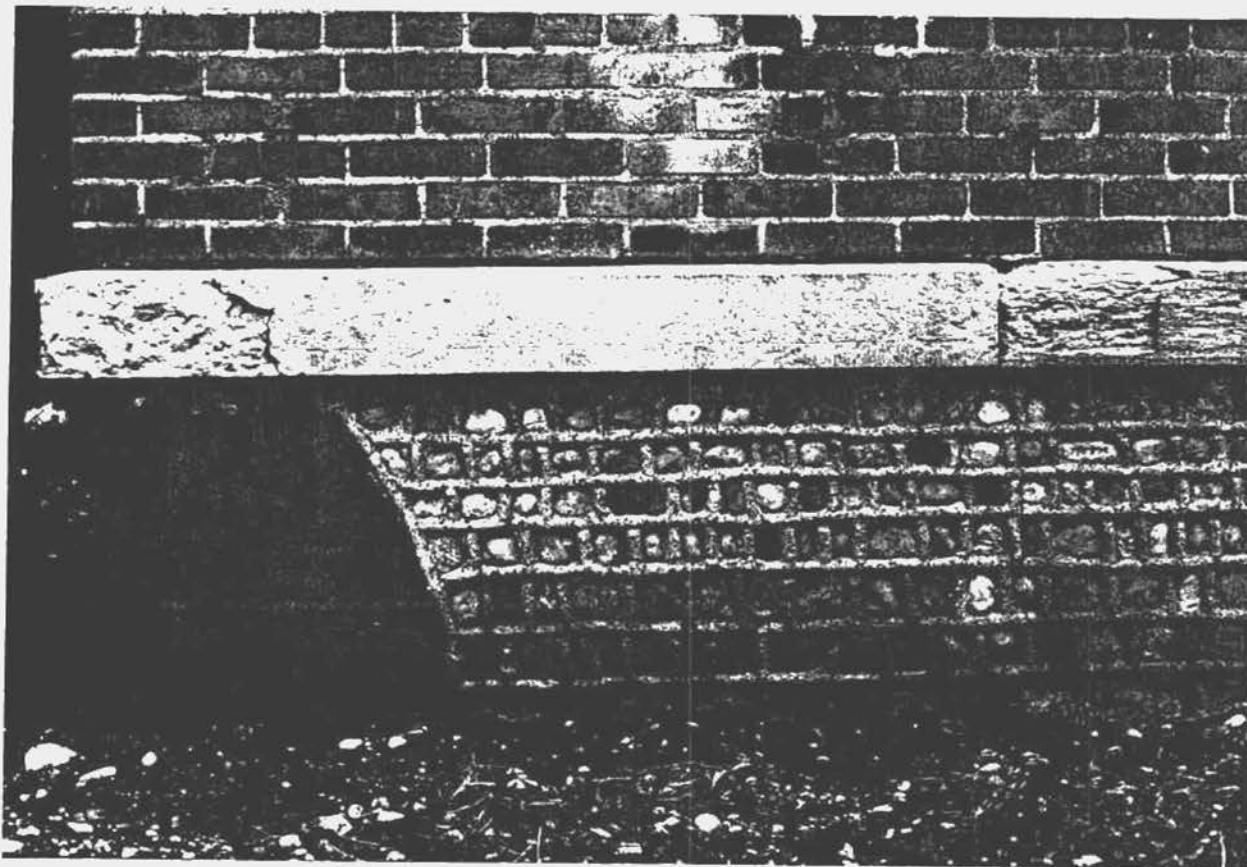
COBBLESTONE MASONRY - SOUTH ELEVATION

The basement foundation is rubble fieldstone with the above grade section on the south and west elevations finished by a veneer of cobblestone masonry. The cobblestones are water-rounded fieldstones of various sizes, shapes and colors, laid six courses to height of the corner quoine. The horizontal and vertical mortar joints are a raised bead giving the appearance of each cobblestone set in a recessed rectangle. The corner quoine is a large rough quartered fieldstone.

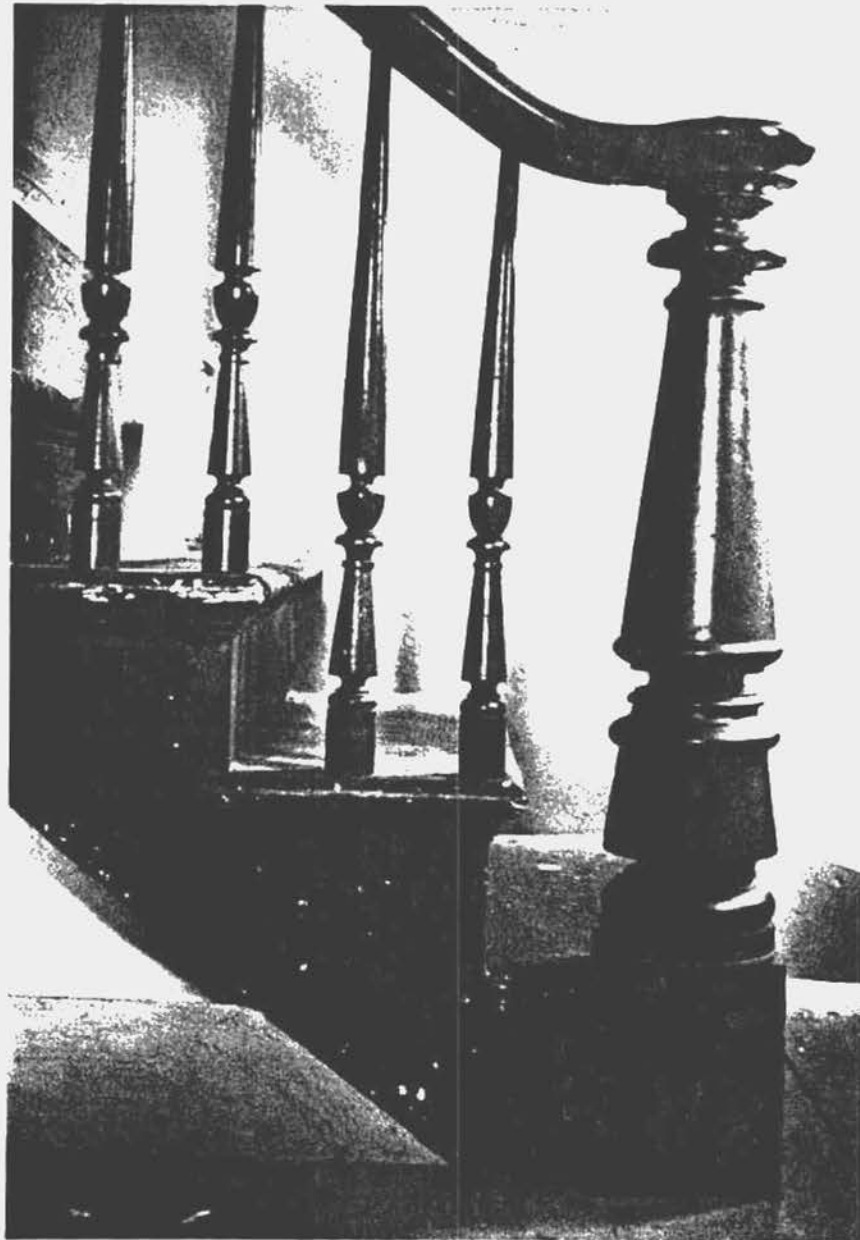
FRONT STAIR BALUSTRADE

1. Remove all modern additions and materials from the kitchen and restore plaster and wood surfaces.
2. Millwork
 - a. Repair front stair hand rail and other damaged wood trim.

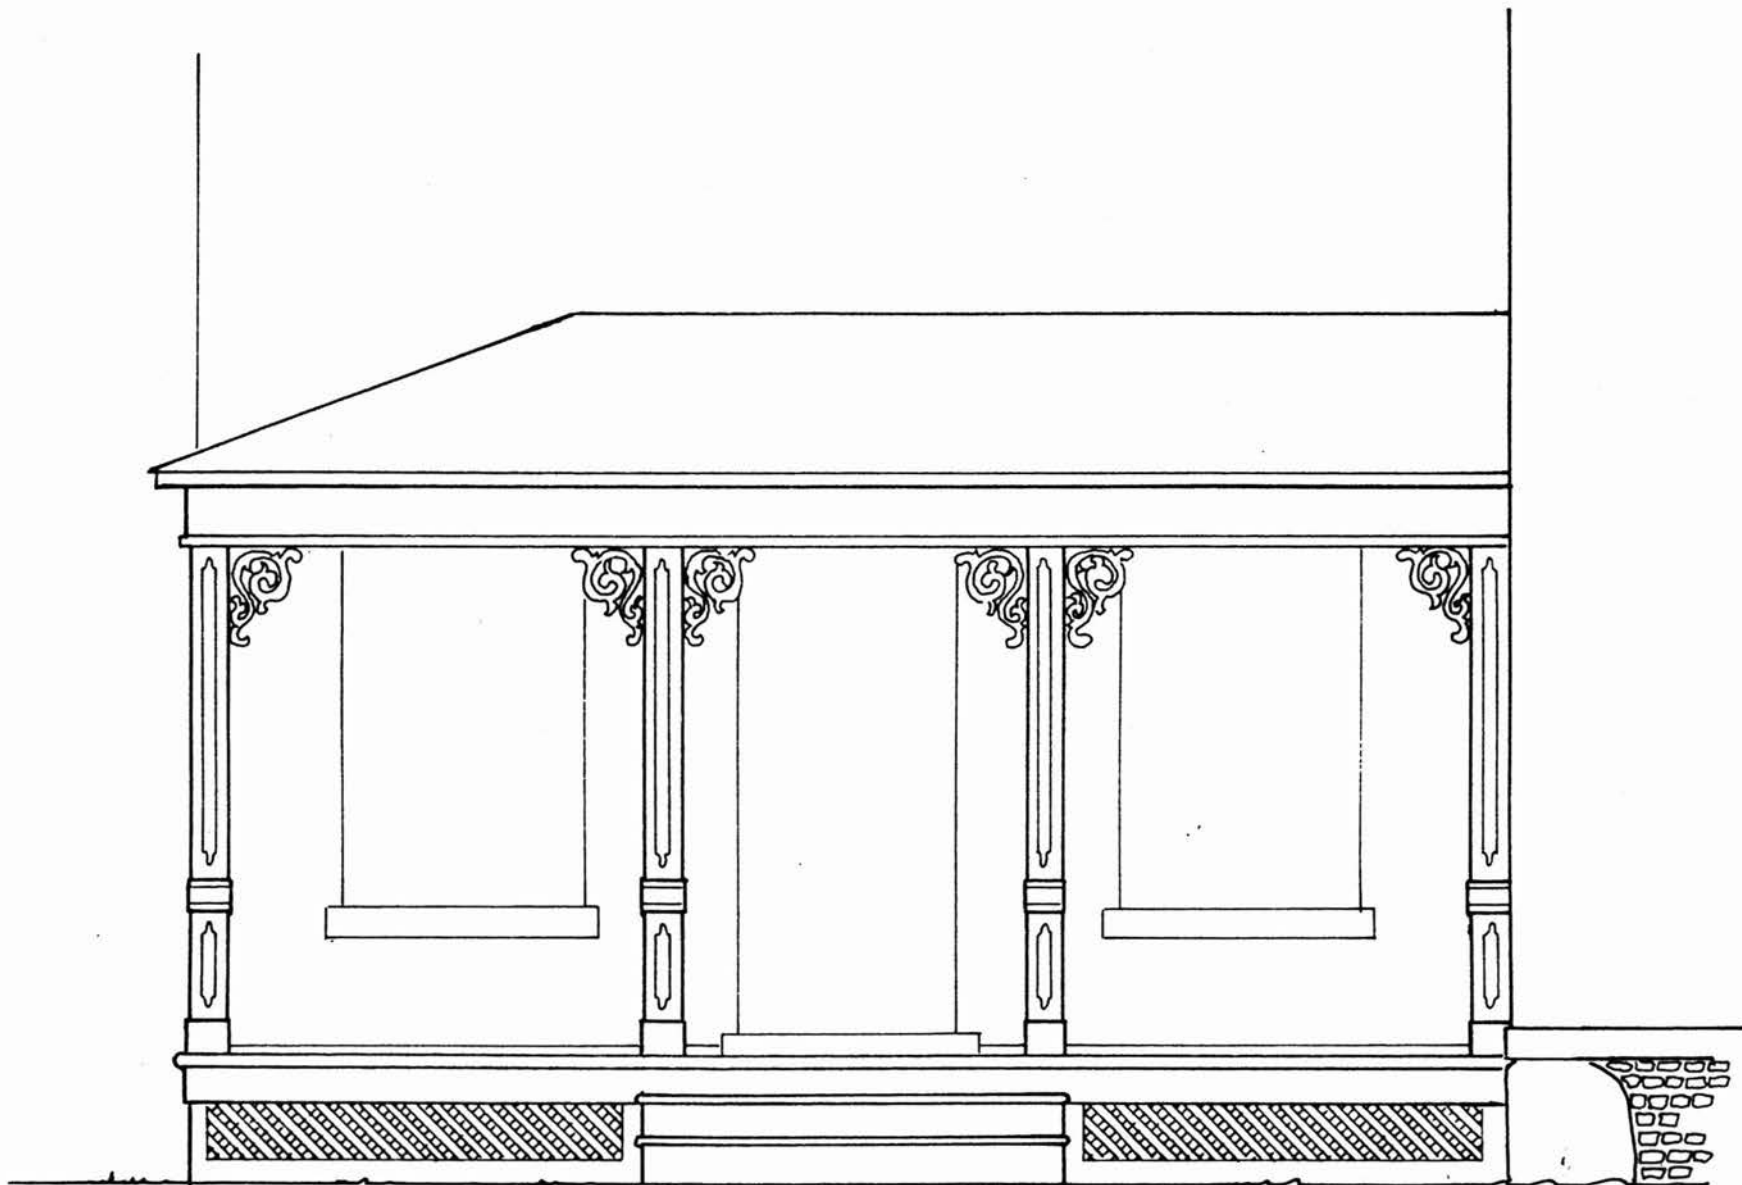
SK - R1

COL PALMER HOUSE
west porch

1. West porch can be reconstructed from the surviving physical evidence.
2. Porch of the clapboard wing should be reconstructed across the full width of the wing and in the same design as the west porch. This recommendation is not based on historical evidence but for appearance because the main approach to the house today is from the farm yard.
3. Front entrance porch, unless historical evidence is found, should be a simple wood stoop with stairs flanked by box plinths of flush boardsiding.

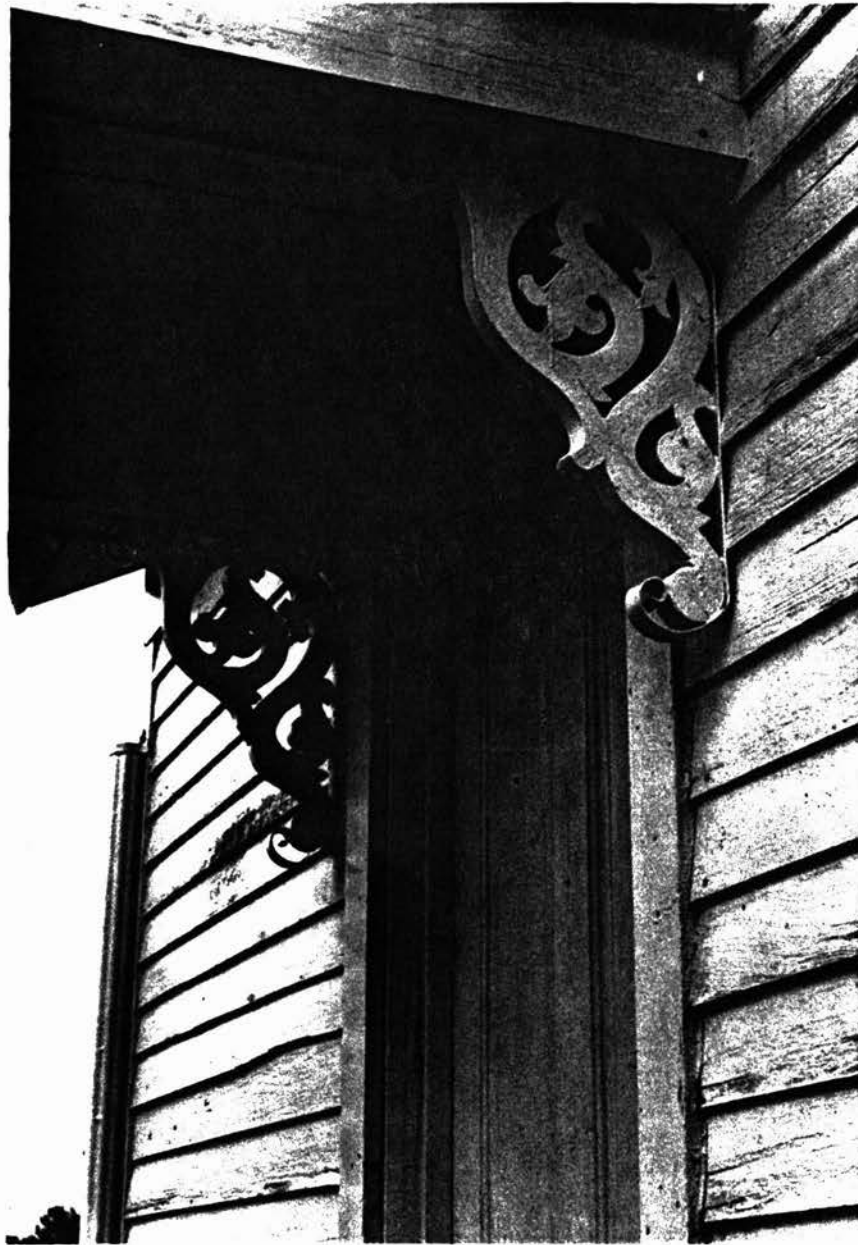
SCROLL BRACKET ORIGINALLY ON WEST PORCH

The original height of the back wing and existence of the west porch can be identified by scarring to the exterior brick wall. A comparative study between a fragment of porch post found in the barn with two scroll brackets on the clapboard wing and the marks on the brick wall, confirm the appearance of the west porch.

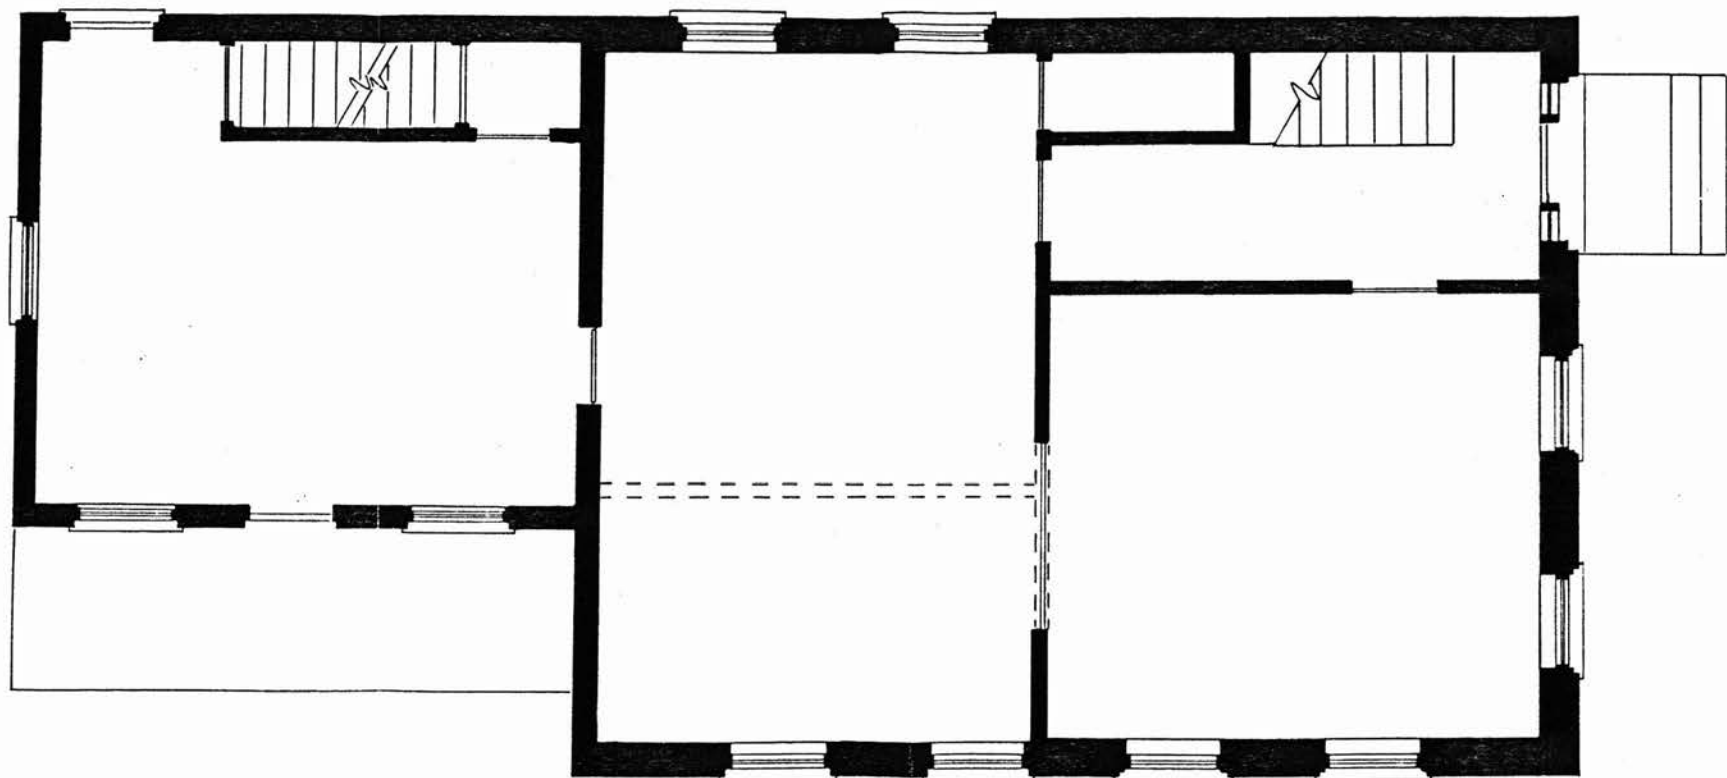
COL PALMER HOUSE
CRYSTAL LAKE, IL.
FIRST FLOOR PLAN

altered condition

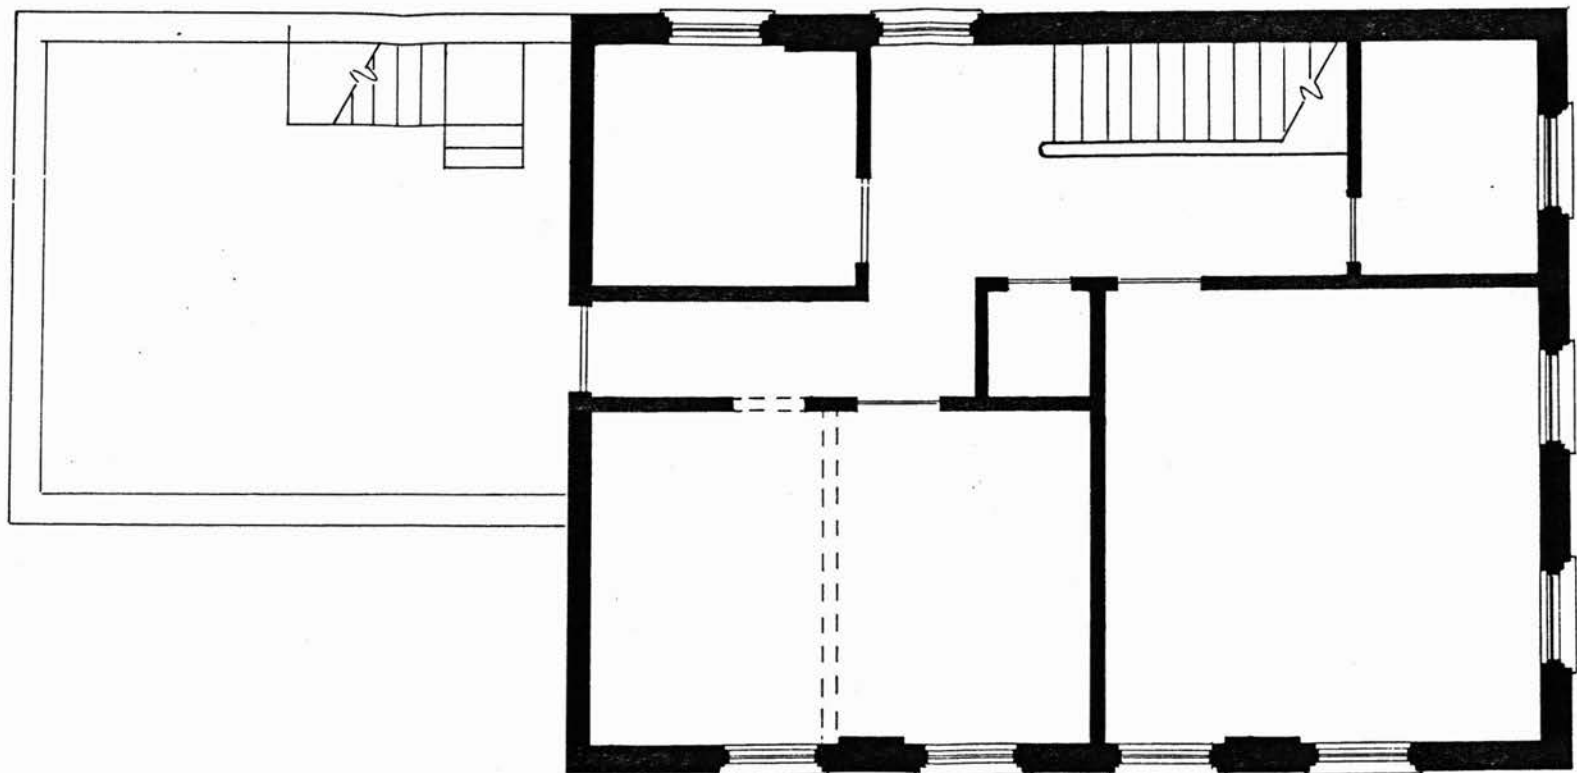
COL PALMER HOUSE
CRYSTAL LAKE, IL.
SECOND FLOOR PLAN

altered condition

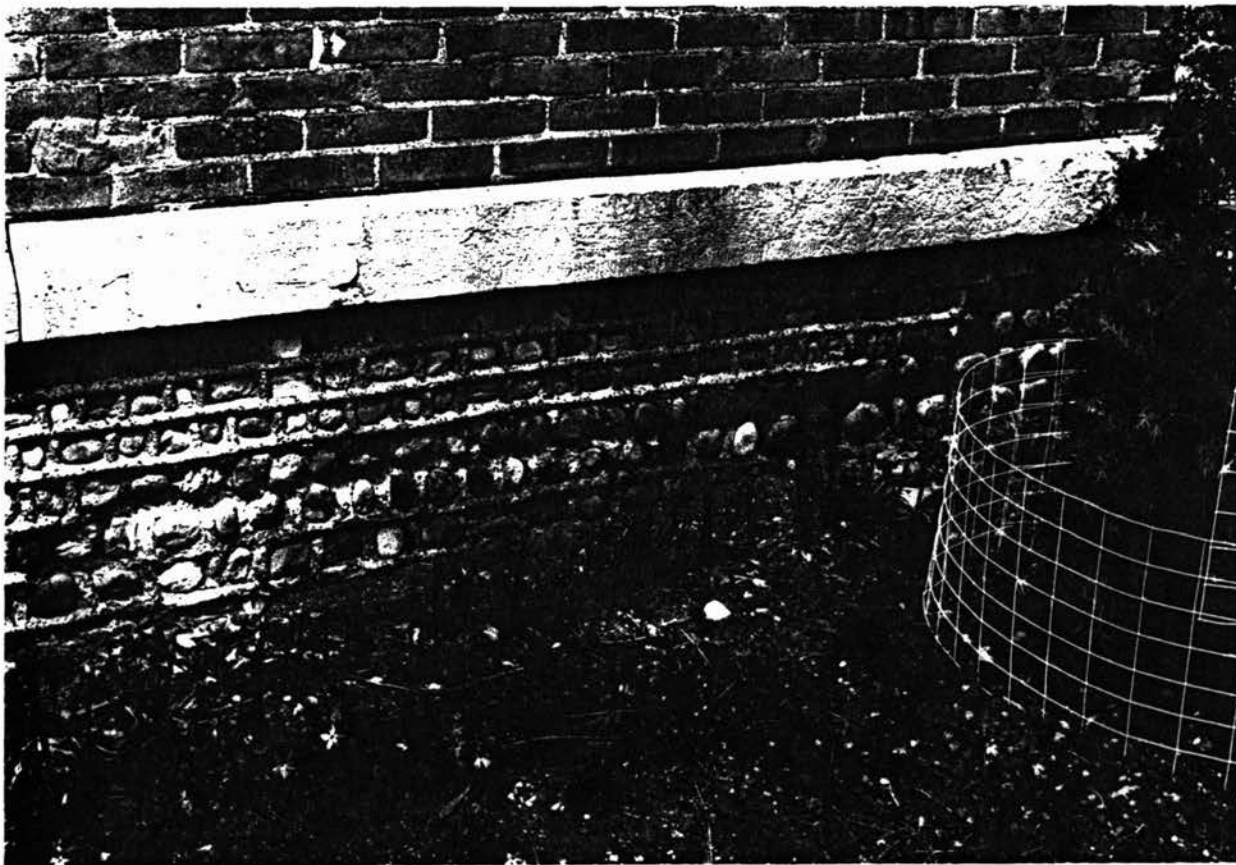
COBBLESTONE MASONRY - SOUTH ELEVATION - DETERIORATION

1. Obtain a brick and mortar analysis for specification of masonry restoration work and future maintenance.
This information is essential so that, when ever any repair, restoration or repointing is required, the new mortar has the same appearance, prosity and coefficient of expansion as the old mortar and is compatible with the old brick. This will avoid damage to the old brick and structure.

1. After mortar analysis, restore the raised bead mortar detail on south elevation foundation wall.
2. Repair south elevation, southeast corner of roof cornice. If shaped moldings are missing, replacement should match original trim. Repair could be temporary until phase two or phase three when additional reproduction trim will be needed.

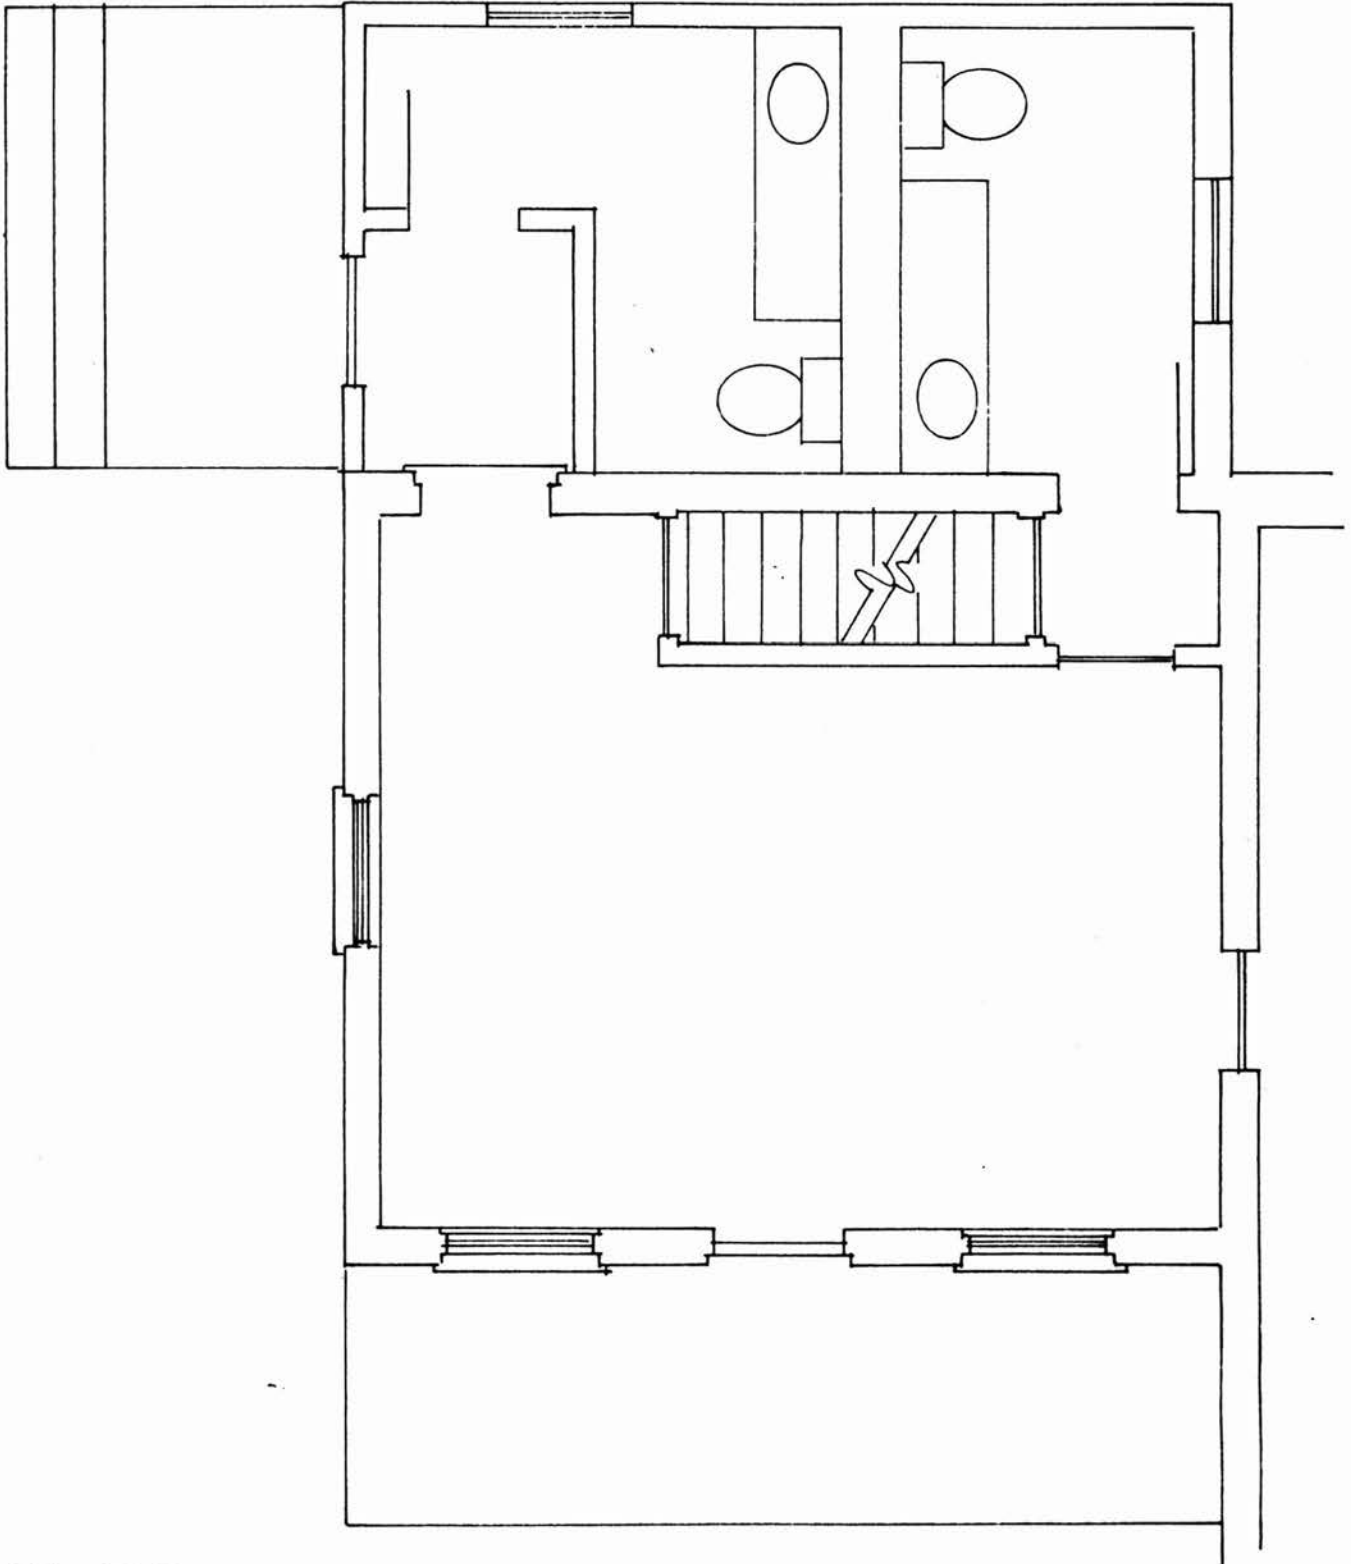
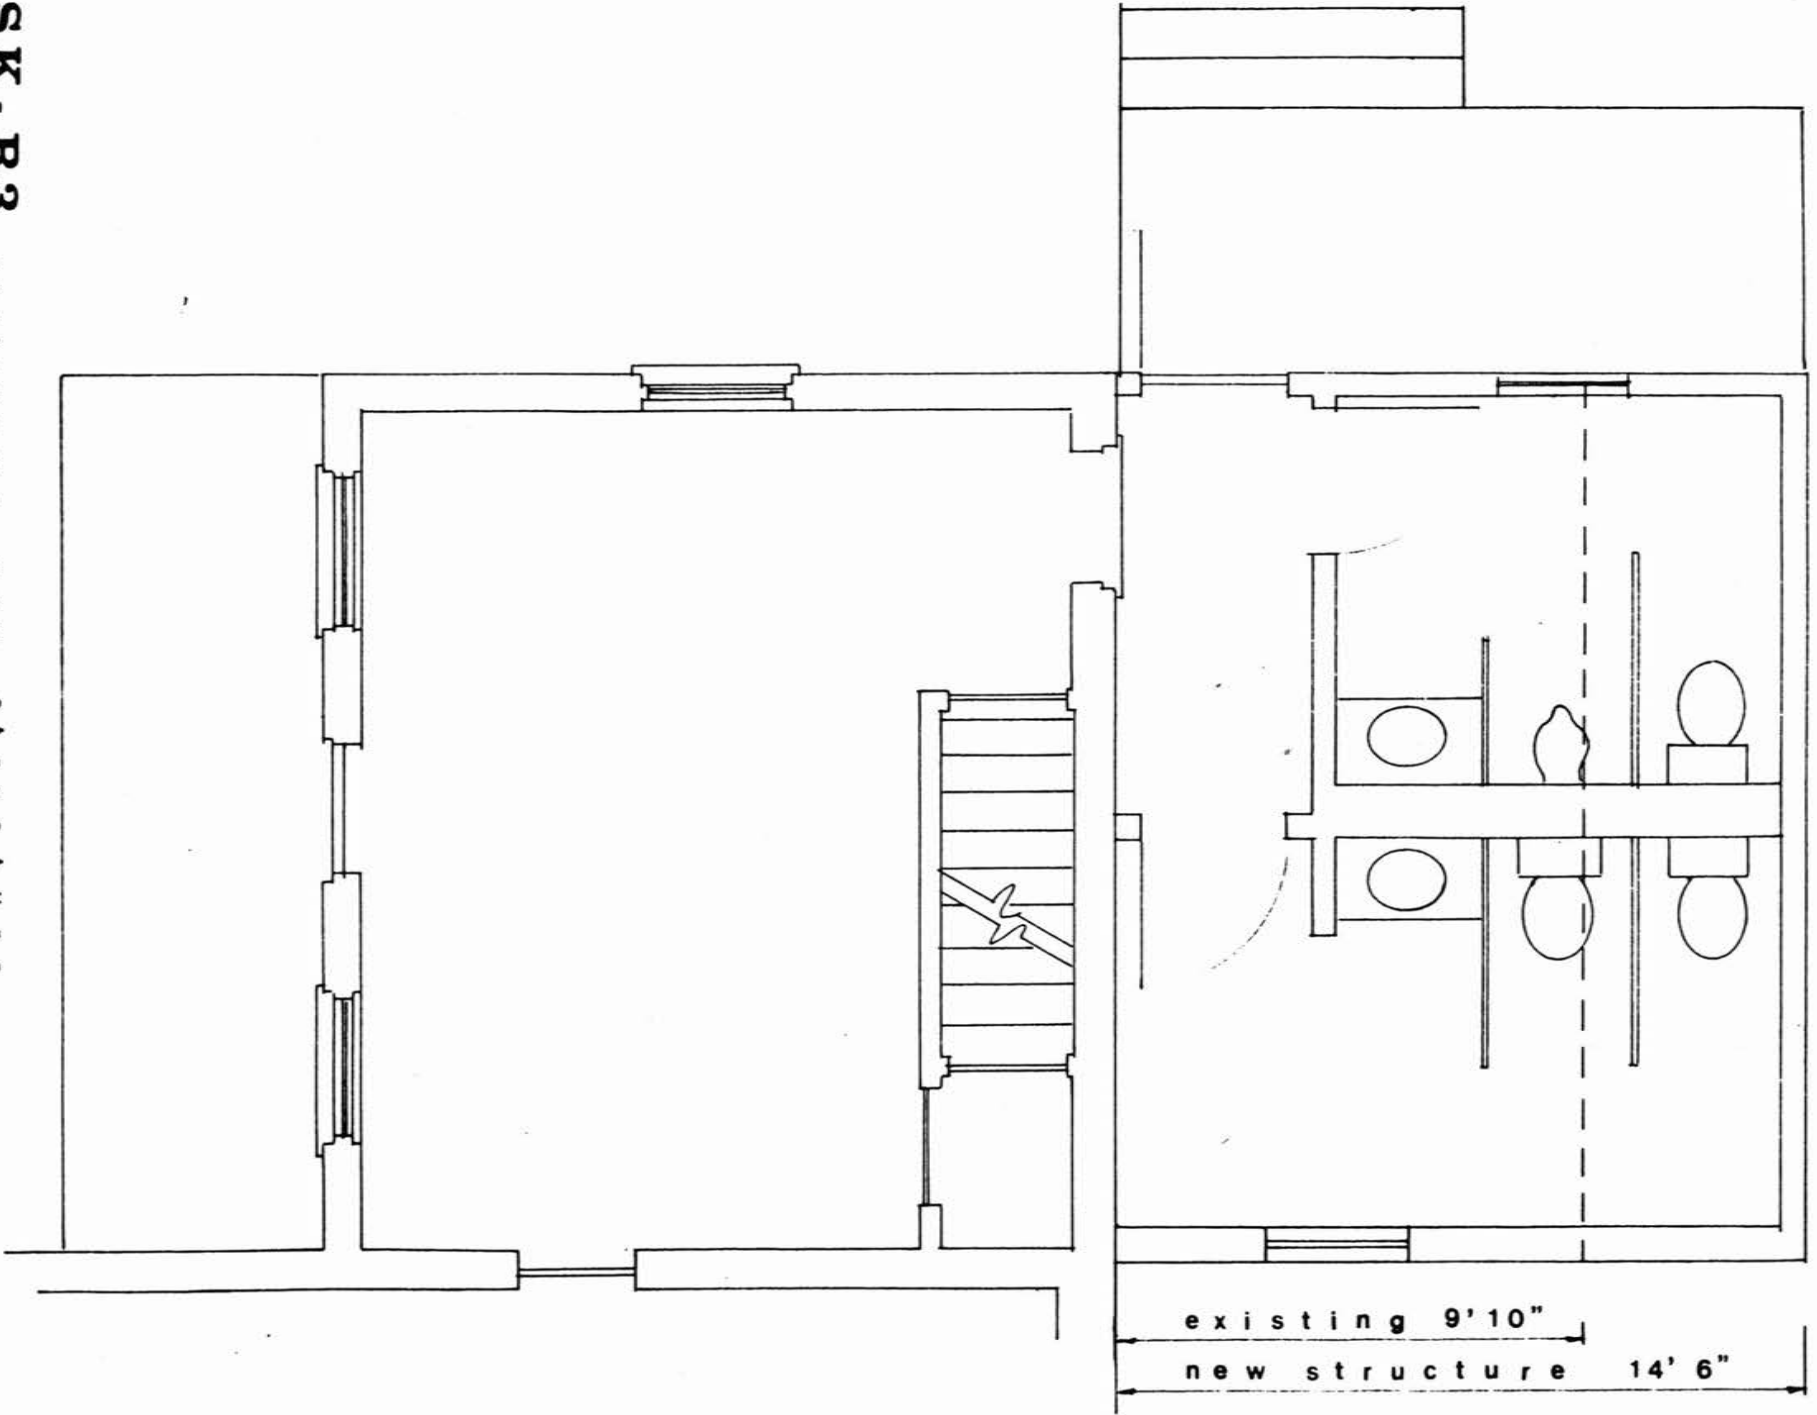
SK - R3

SK - R2 restrooms existing structure

restrooms new structure

Outdoor activities are also part of the intended program. The house can not be expected to provide the support facilities necessary for these large groups. Therefore I recommend the restoration of the existing barn. This rehabilitated structure would provide shelter and demonstration space and could be fitted with food preparation and restroom facilities.
