KENTUCKY HISTORIC RESOURCES  
Individual Inventory Form

Resource # 190  
Shelby County

1. Name of Resource: Chiles-Bailey House

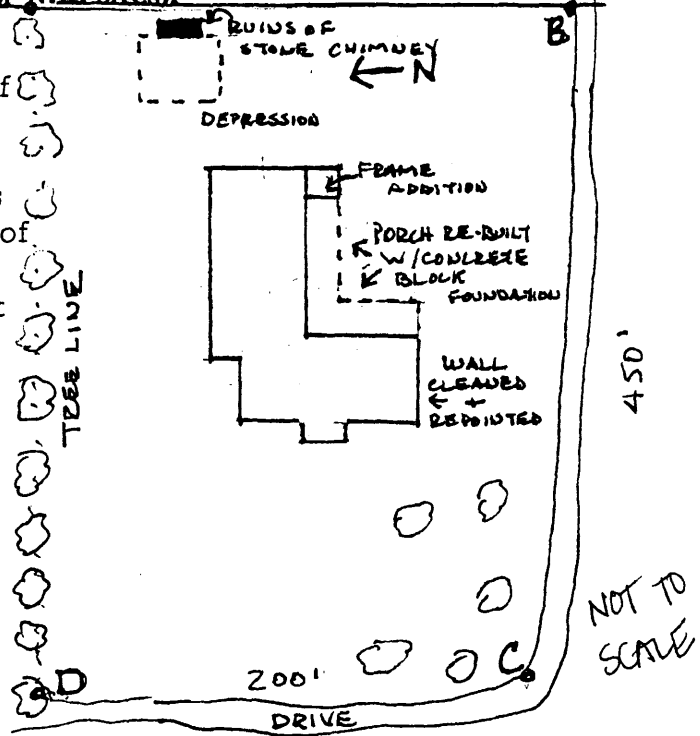
44. Site Plan (and boundary description and justification for N.R. sites):

Beginning at A, south 200' to the north side of the drive, thence west 450' along north side of said drive to C, thence north 200' along east side of drive to D, thence east 450' along a tree line to the point of origin. The boundaries were chosen to include the dwelling, the site of a contemporary outbuilding, and the yard with its early plantings, and to exclude more recent agricultural outbuildings behind the dwelling.

Point A is located at the intersection of a tree-lined defining the northern extent of the yard with a line parallel to and 450 feet east of the eastern edge of that portion of the drive lying in front (west) of the house. Point A is 87 feet northeast of the northeastern corner of the ell.

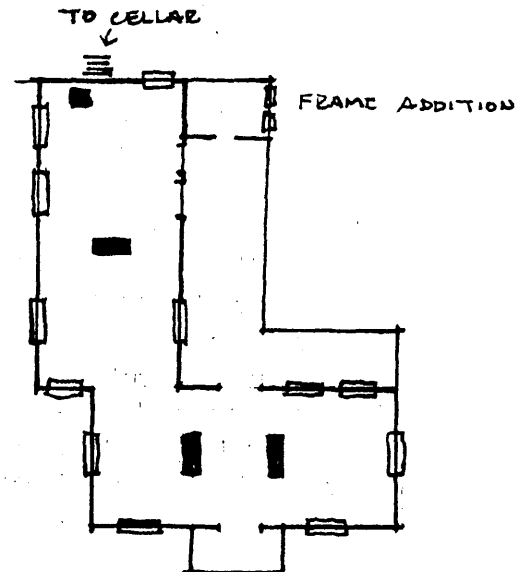
45. Description and House Plan:

2-story, 3-bay brick single-pile, center-passage brick plan. Original 2-story, 3-bay ell offset to north of main block. Brick foundation; hipped roof with slight flare at eaves and asphalt shingles. Interior chimneys flank passage in main block and have slight shoulders at corbelled tops; interior chimney between first and second bay of ell; also interior flue at rear of ell. Principal (west) facade laid in double-stretcher bond, that of other elevations and ell is common bond with Flemish bonding course every 7th row. 1-story flat roofed central portico with square supports and simply molded cornice. Corner brick pilasters with wood capitals; simple board cornice with wood brackets. Windows 6/6 double-hung sash with rectangular stone lintels and wood sills; some operable louvred blinds remain. Windows above portico paired and arched. Decorative iron vents in foundation. Shed-roofed porch at rear in angle

of main block and ell rebuilt to original configuration with concrete block foundation and small frame room at rear of ell. South end of main block chemically cleaned and repointed. Interior renovated to incorporate original woodwork (moldings) with imported elements (some mantels).
