KENTUCKY HISTORIC RESOURCES INVENTORY

Site No. L-W-SW-410

1. Historic Name(s)  Parkland Evangelical Church  
 Original Owner Parkland Evangelical Church

5. Location  1102 South 26th Street

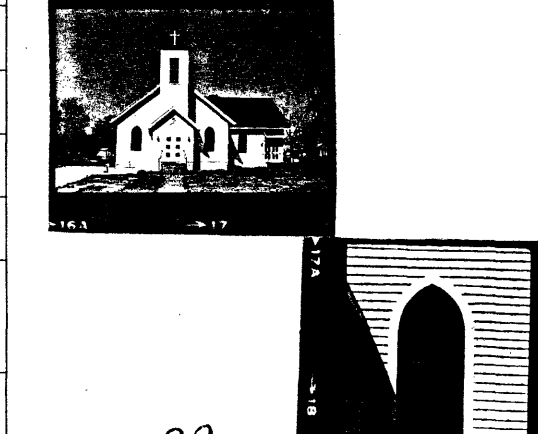
17. Condition excellent 1

18. Description  
 The Parkland Evangelical Church is a small calpboard structure which retains most of its original exterior features. The structure is L-shaped. The facade consists of a gable wing which has a small tower. A gable entry section projects with a double door (altered) set in a lancet wood surround. Lancet stained-glass windows with wood surrounds flank the entry (over)

18. section. Both gable roofs have deep overhanging eaves with wood braces. To the right of the wing is a wing which is set back. This contains a lancet stained glass window and another entry with a wood surround. The north facade of this wing contains a large lancet window and entry. The structure still retains a seamed metal roof. The detailing of the building is simple yet charming.
