B. Malaguerra Winery. Front view of the winery facility. The property was changed to a chicken ranch operation in the 1920's at which time the older stone structures on the left were converted to

Santa Clara County, Ca.

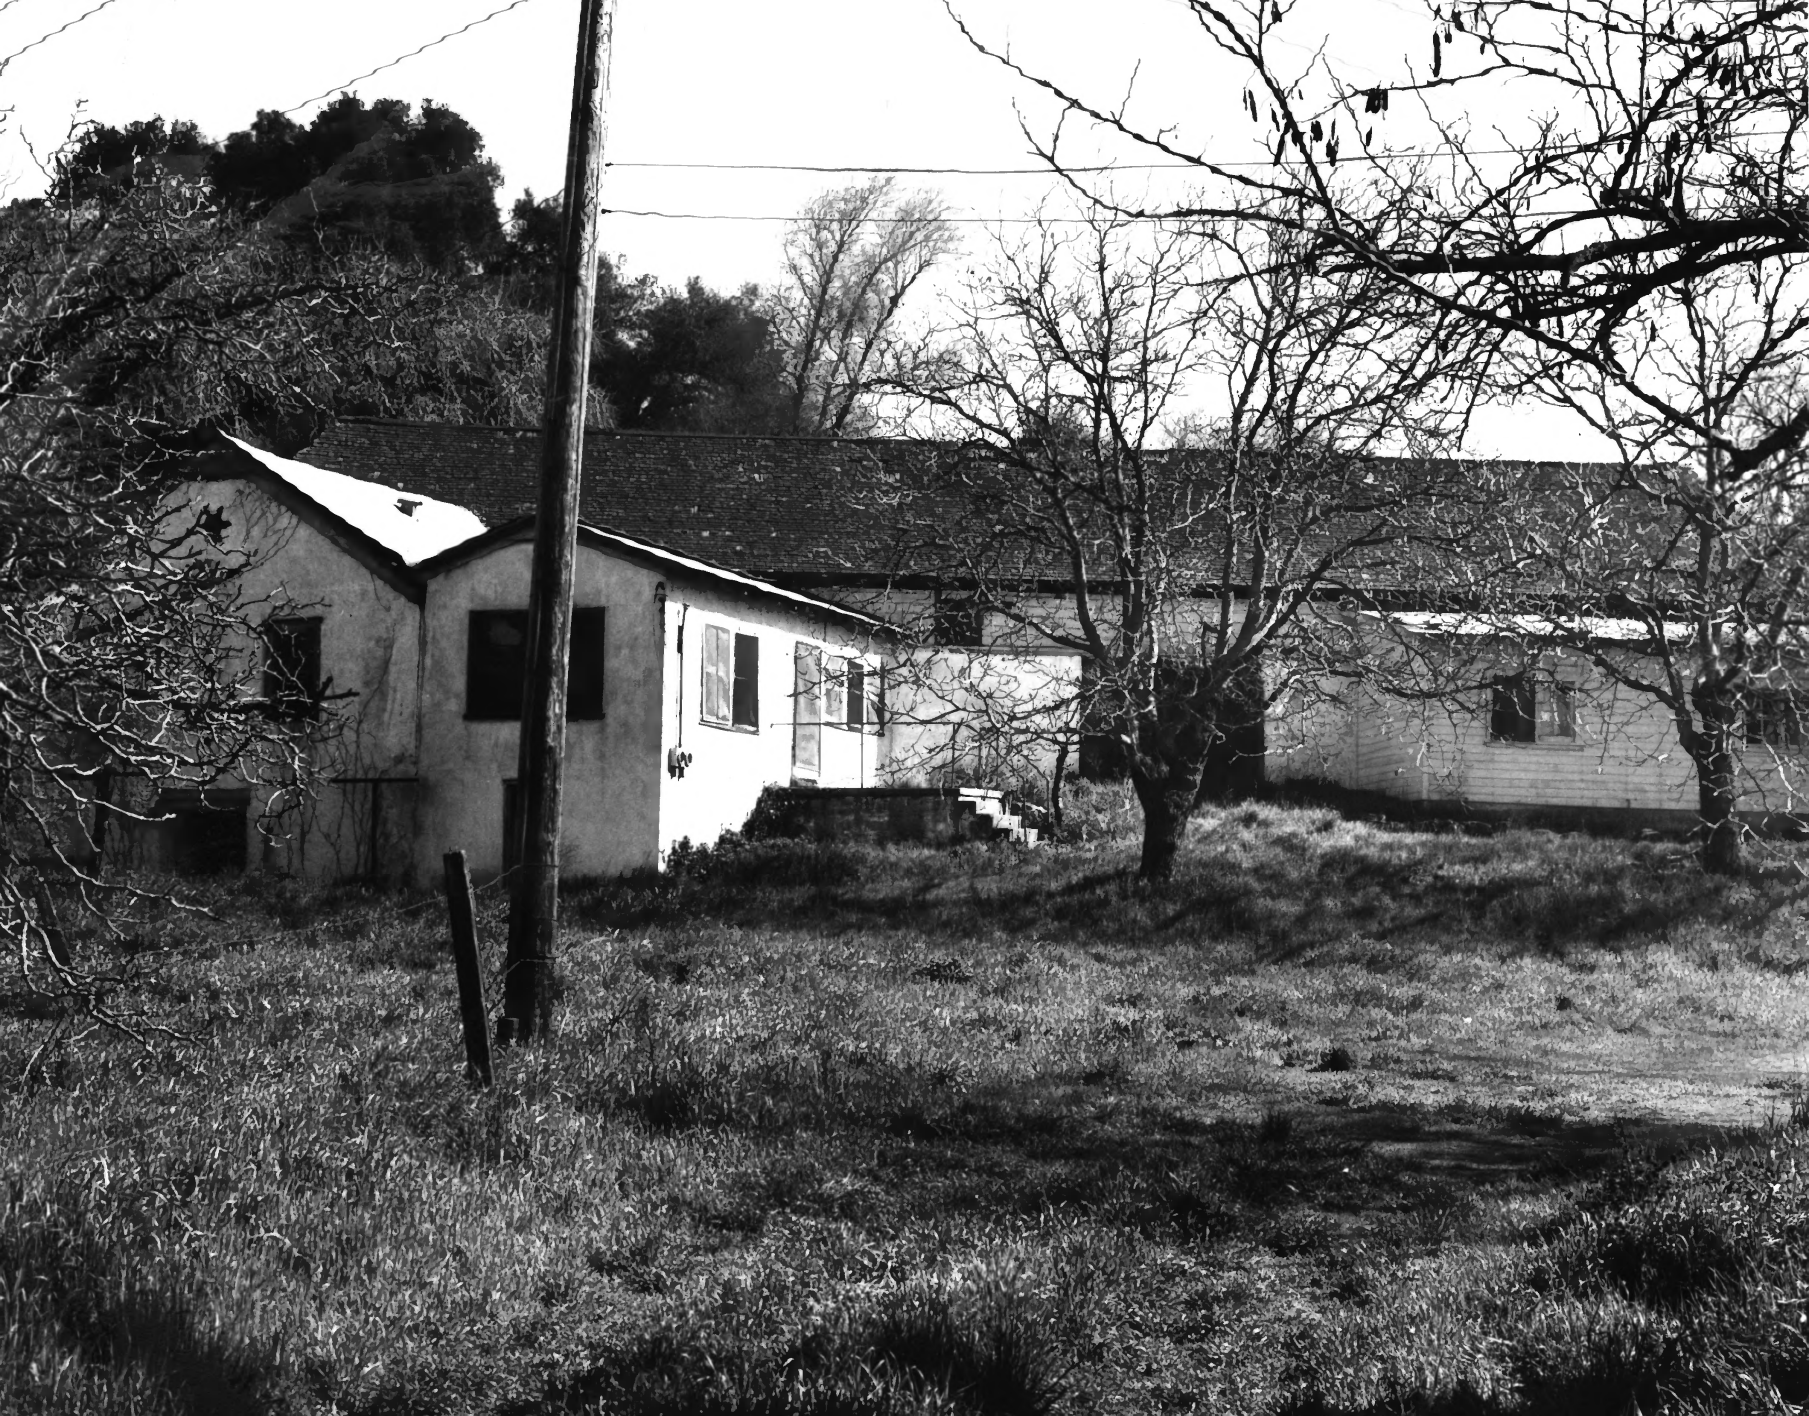
living quarters and the additional frame housing structure on the right was added. The structures have been unoccupied for several years. Photo taken in 1976.

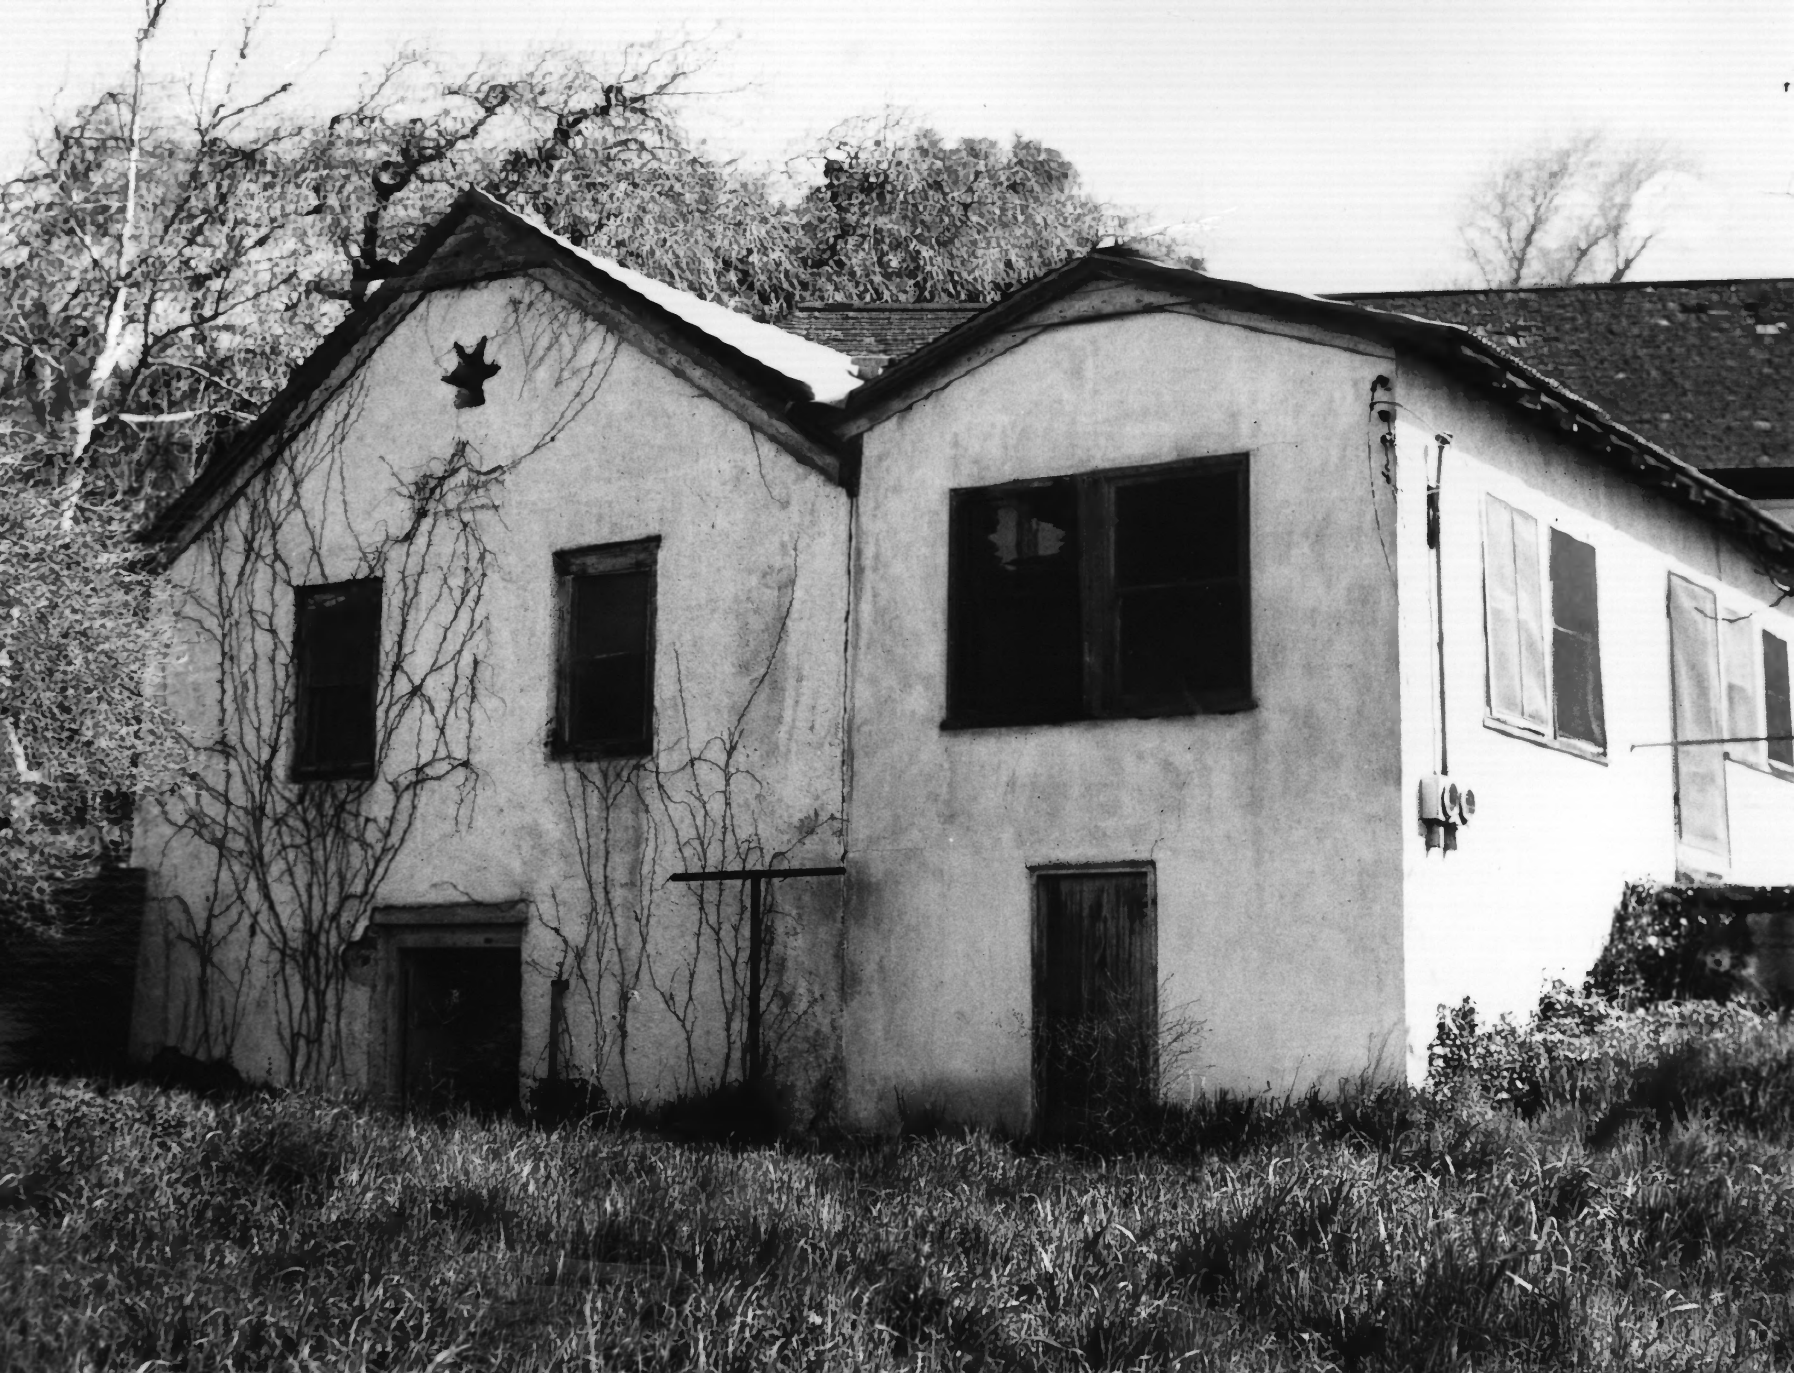
A. Malaguerra Winery. Close up of the front of the two-story stone Malaguerra Winery building. The oldest part of the structure built in 1869 is on the left. The newer part on the right was built after 1904. Part of the 1904 winery "barn roof" shows in the upper rear of the photo. Photo taken 1976.

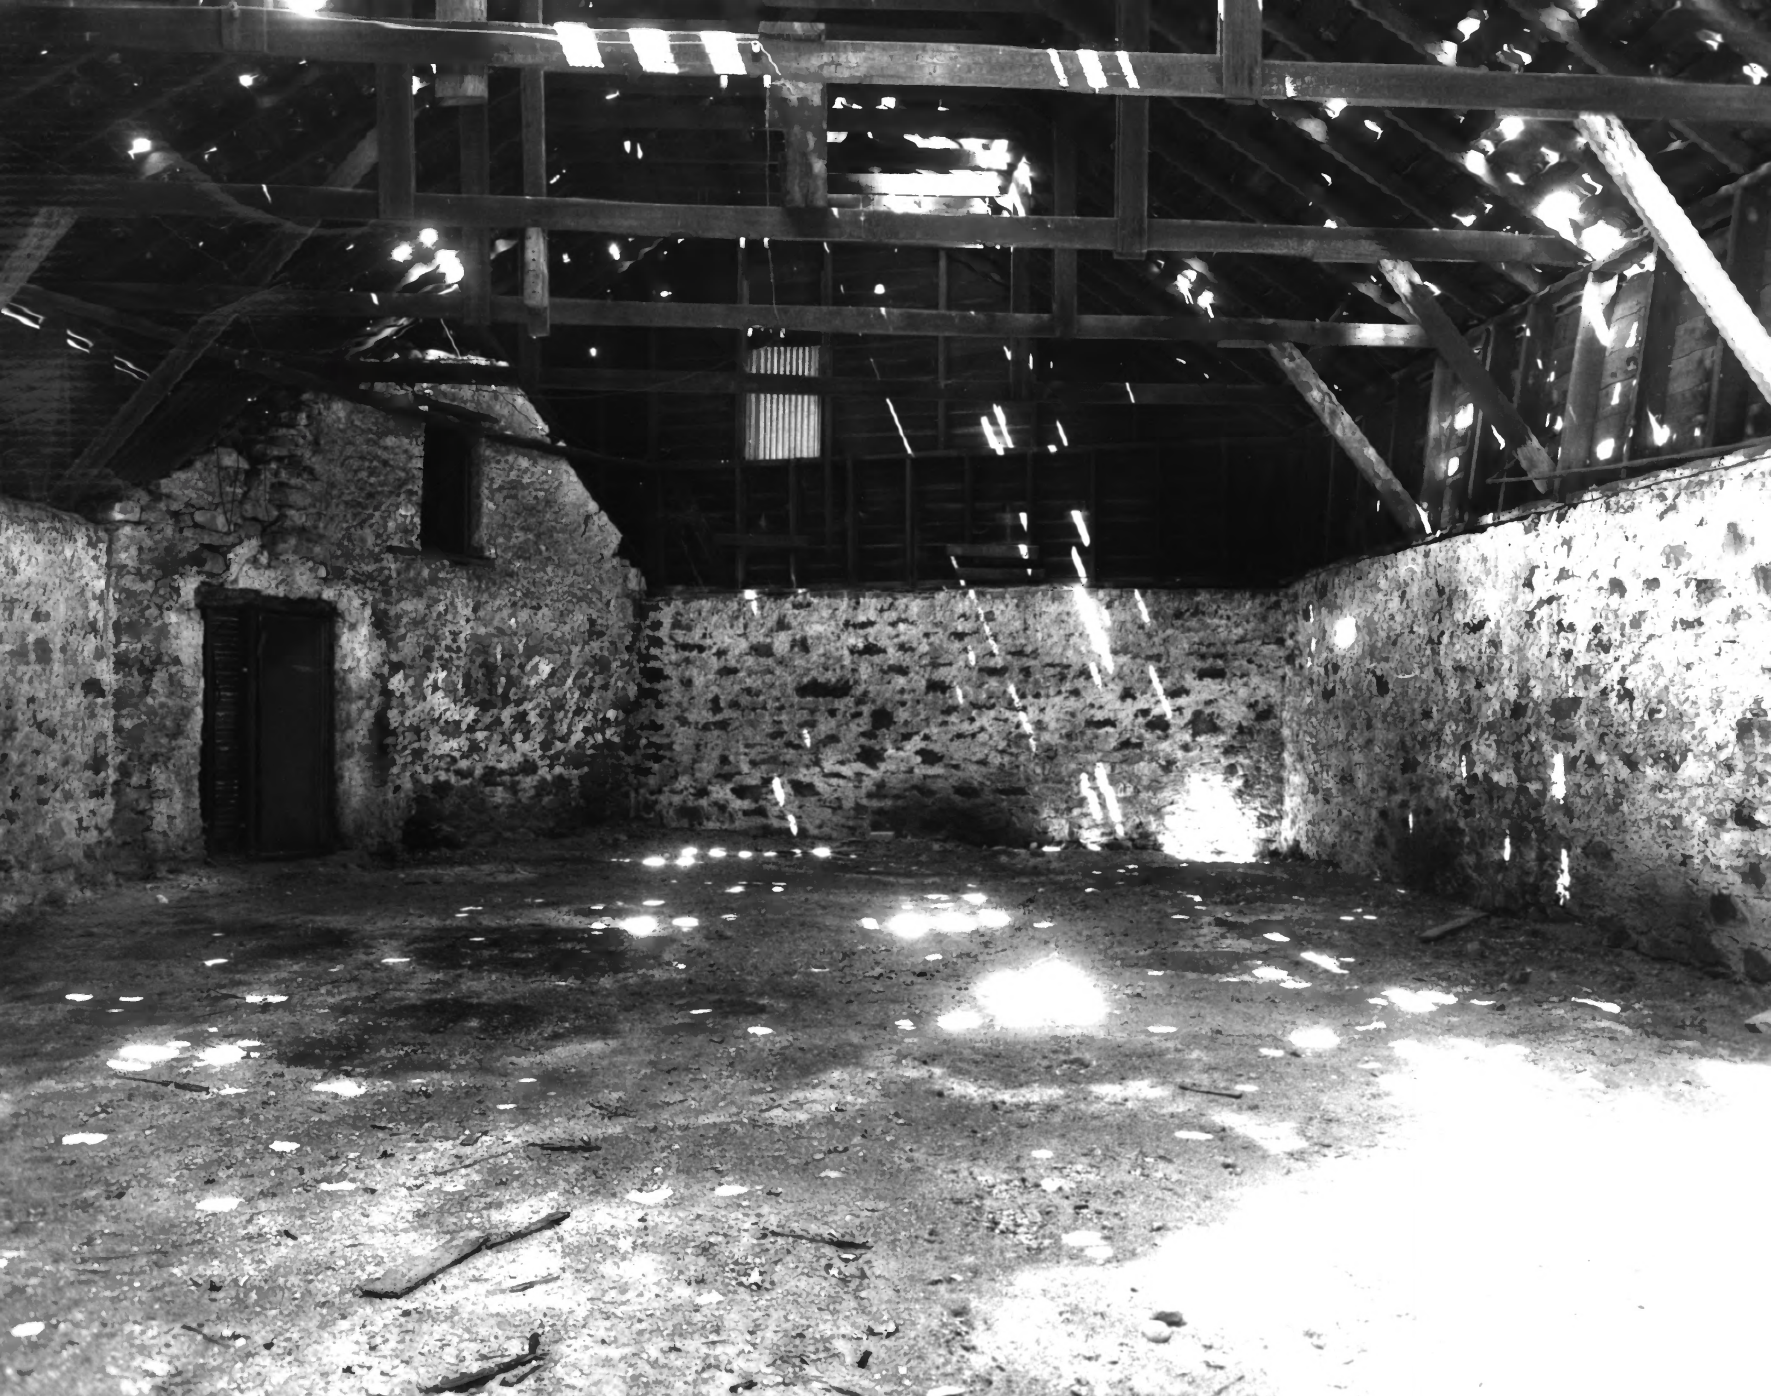
#1 of 14

Interior view of the easterly end of the  
904 structure. The 1904 structure  
envelops the 1869 Winery. The original

wall, roof and attic window in the  
original southern end wall at the second  
floor and above are shown in this picture

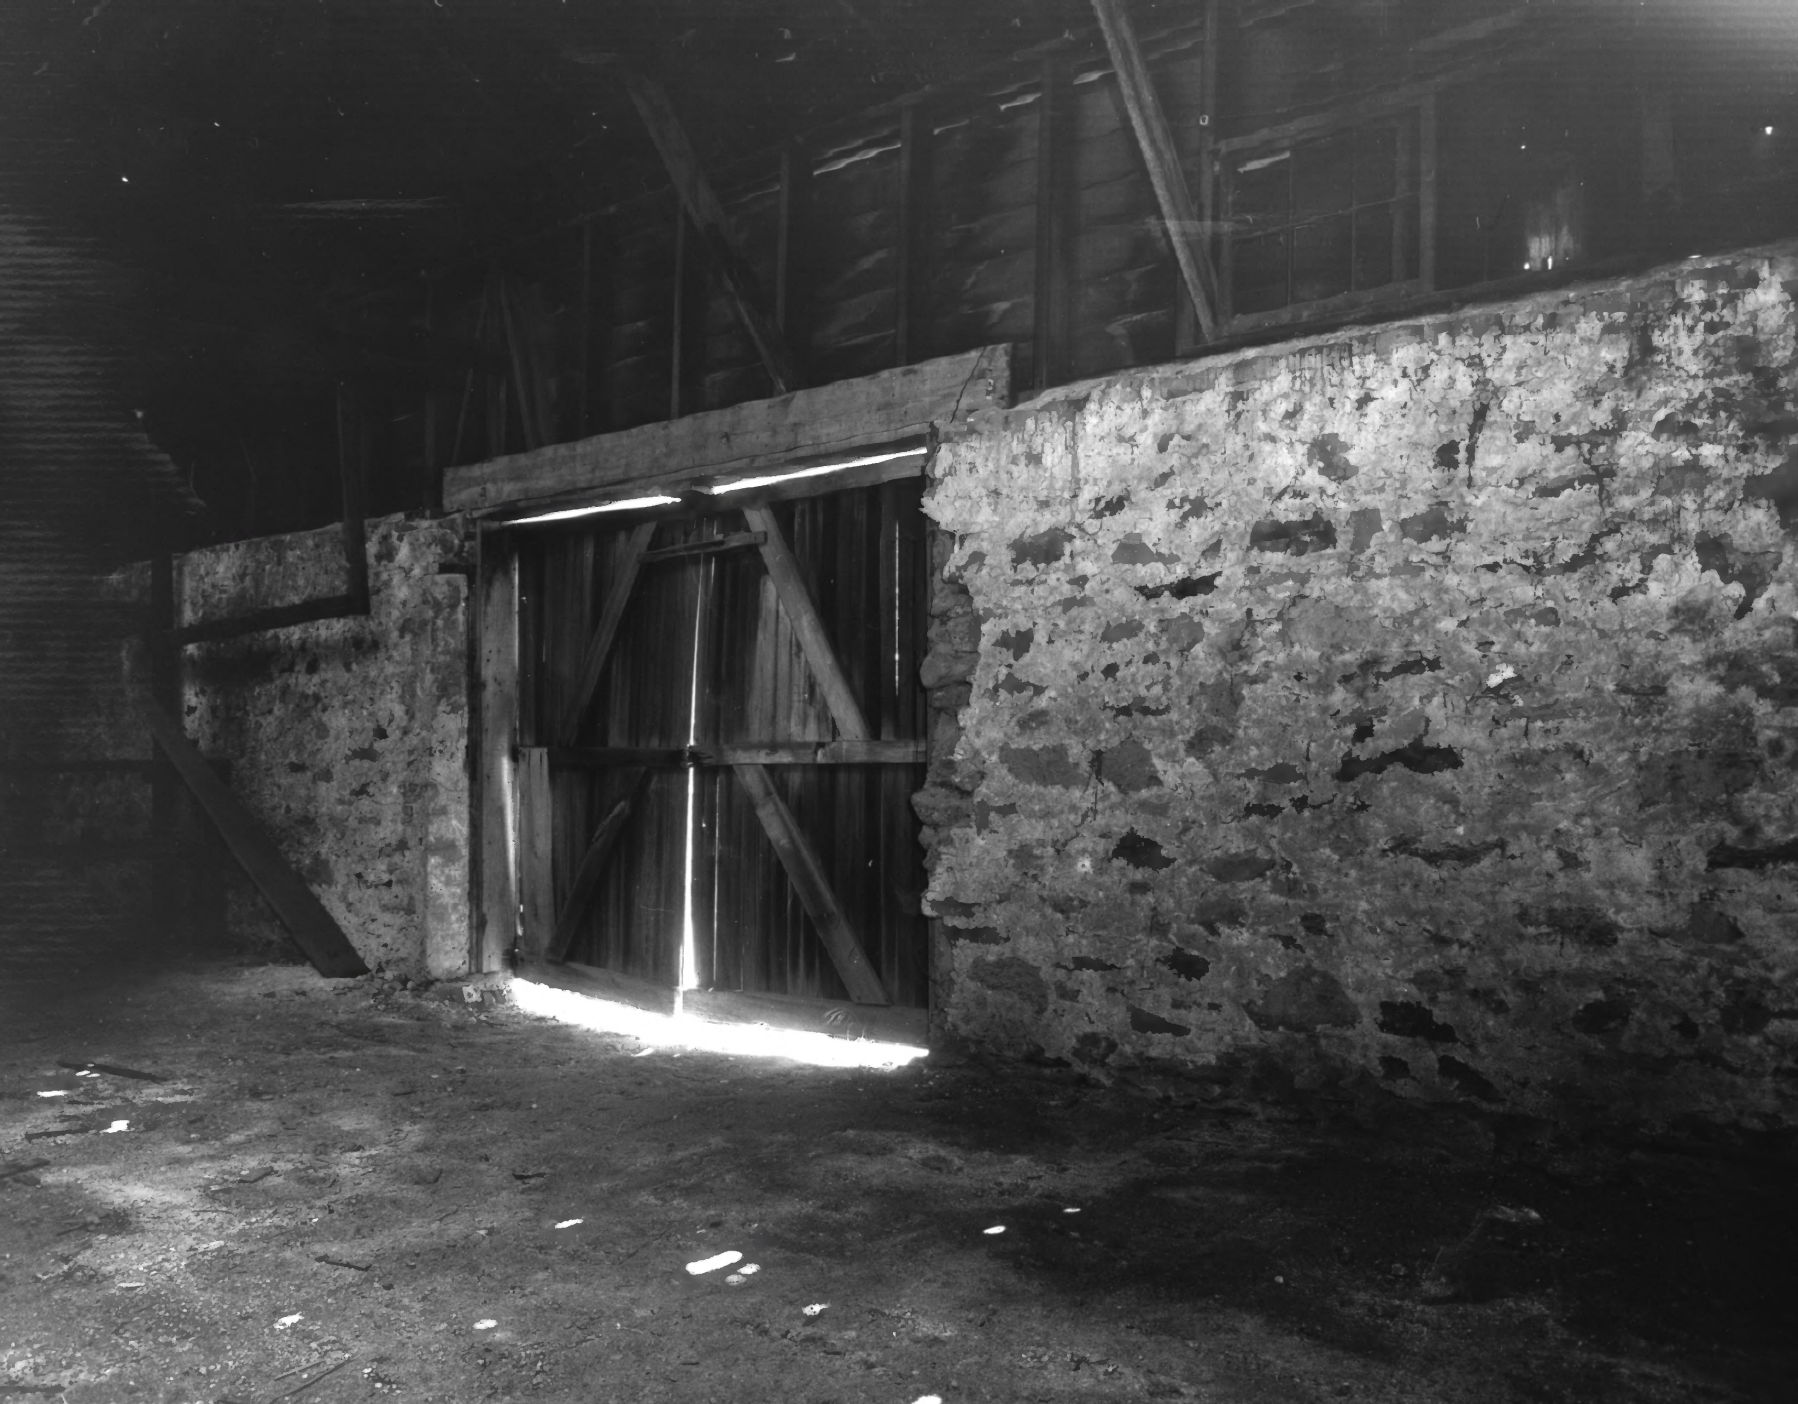
Interior shot of the 1904 addition showing the exterior double doors. 5 of 14

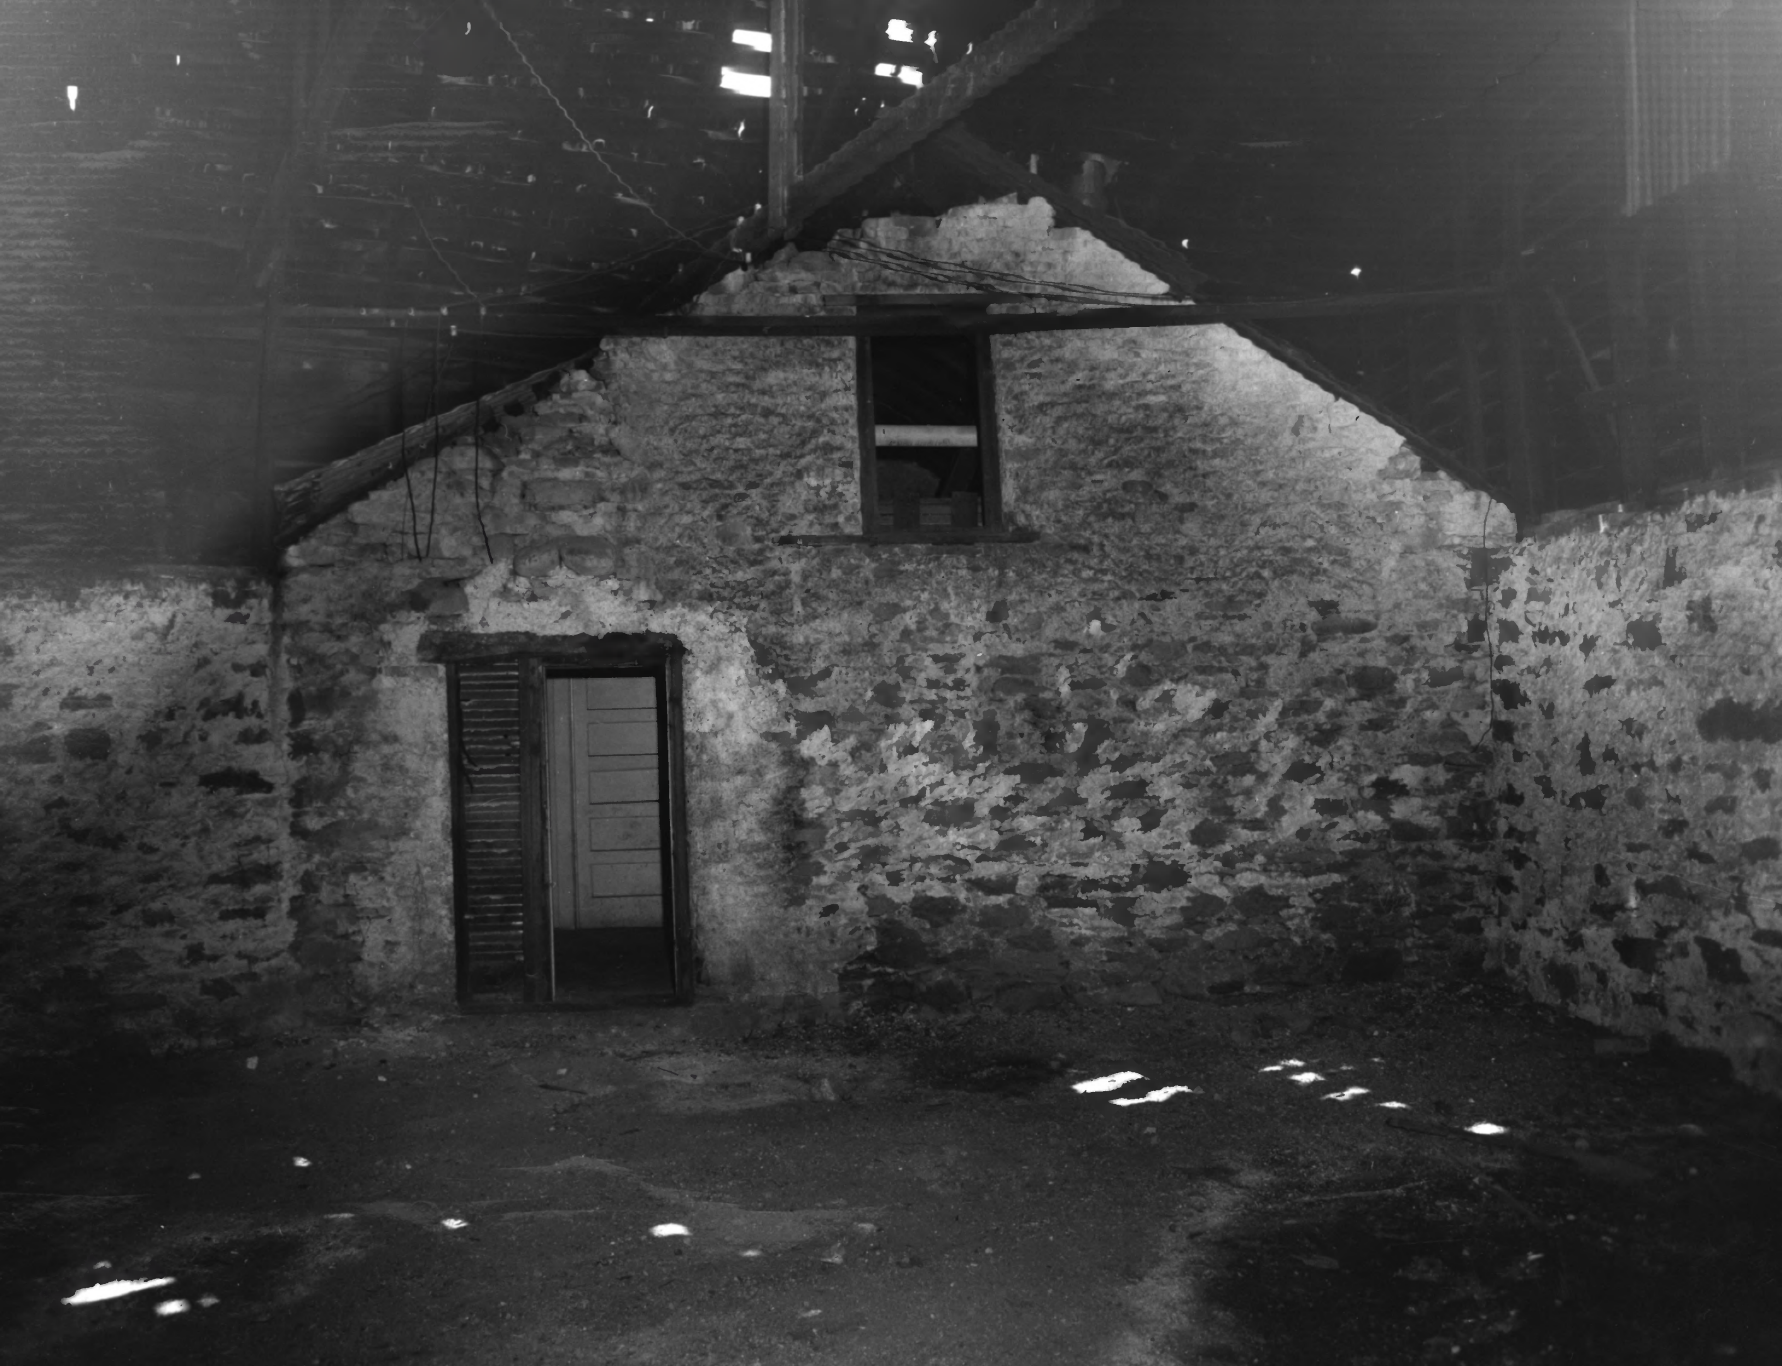
6 of 14

Interior of the 1904 addition shows the original second floor attic and roof of the 1869 structure.

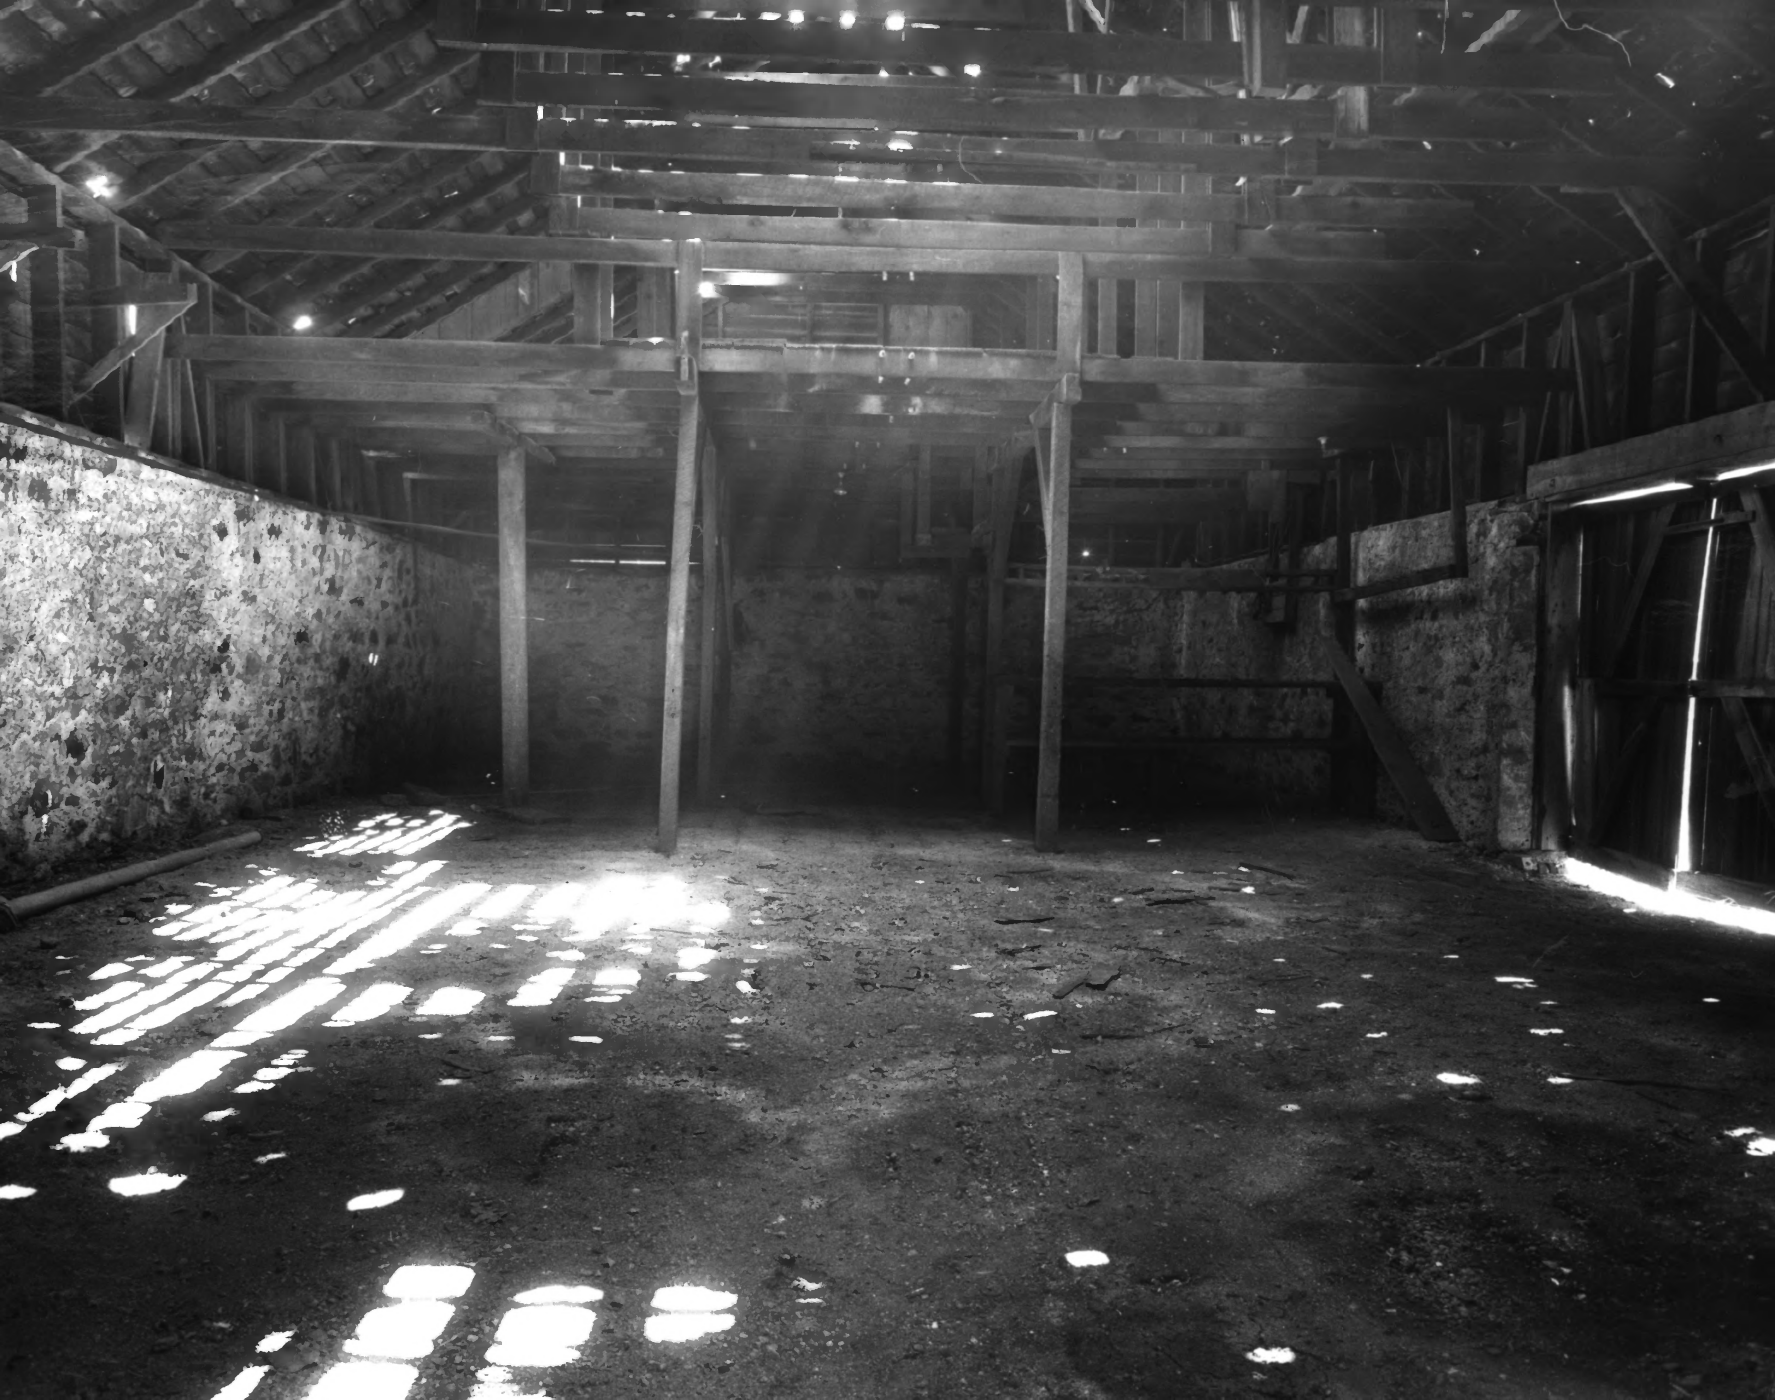
View of the interior of the 1904 addition showing the westerly end wall. There is an exterior access door on the left

providing direct access to the decked 'mezzaine' floor. (See stringers below roof joists)

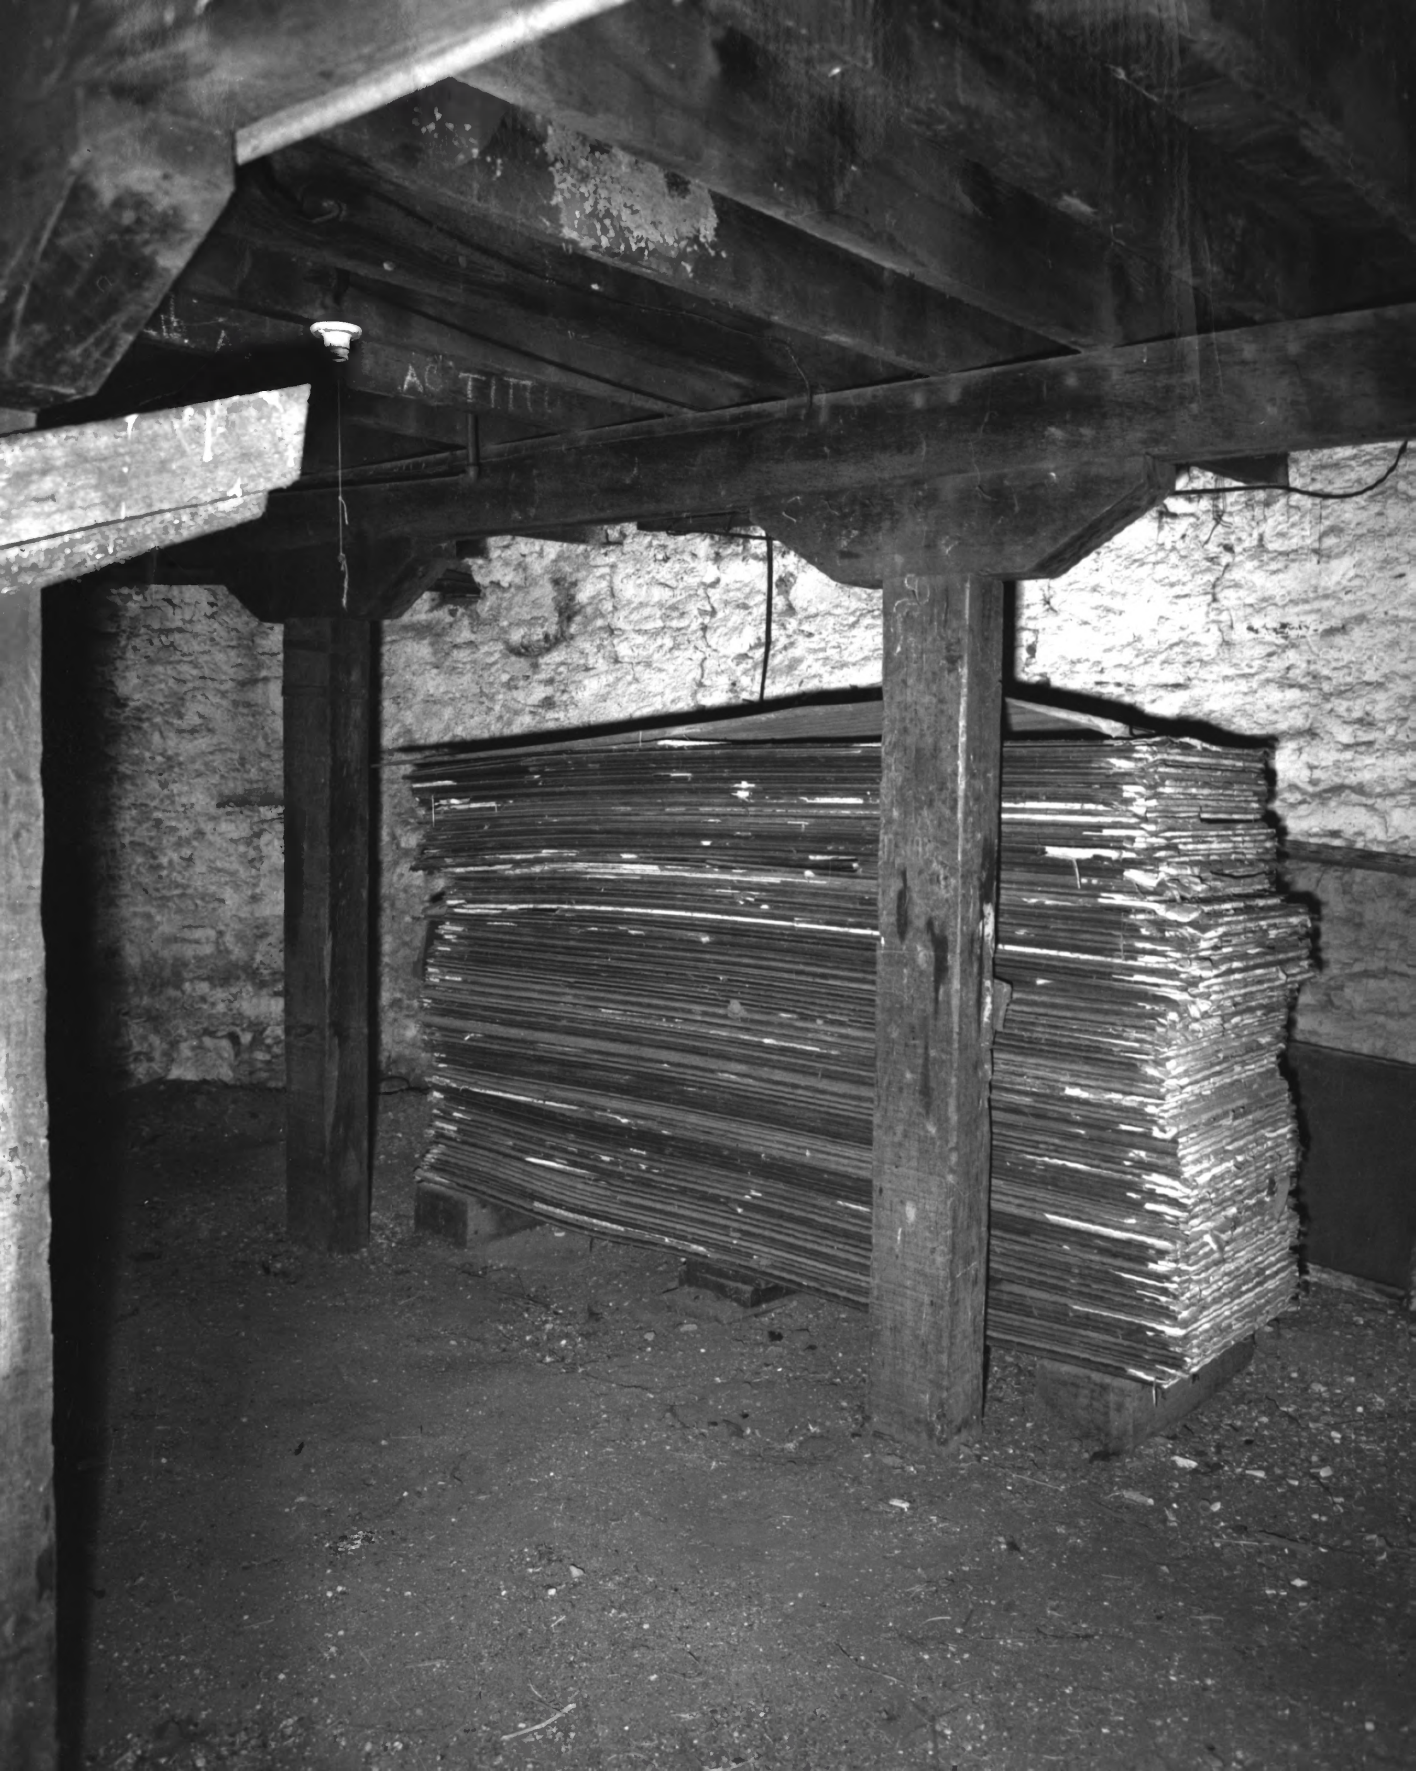
8 of 14

Interior view of the basement or first floor of the 1869 Winery structure.

Also shown is a part of the original

stone wall. It also shows the heavy redwood beams and joists.

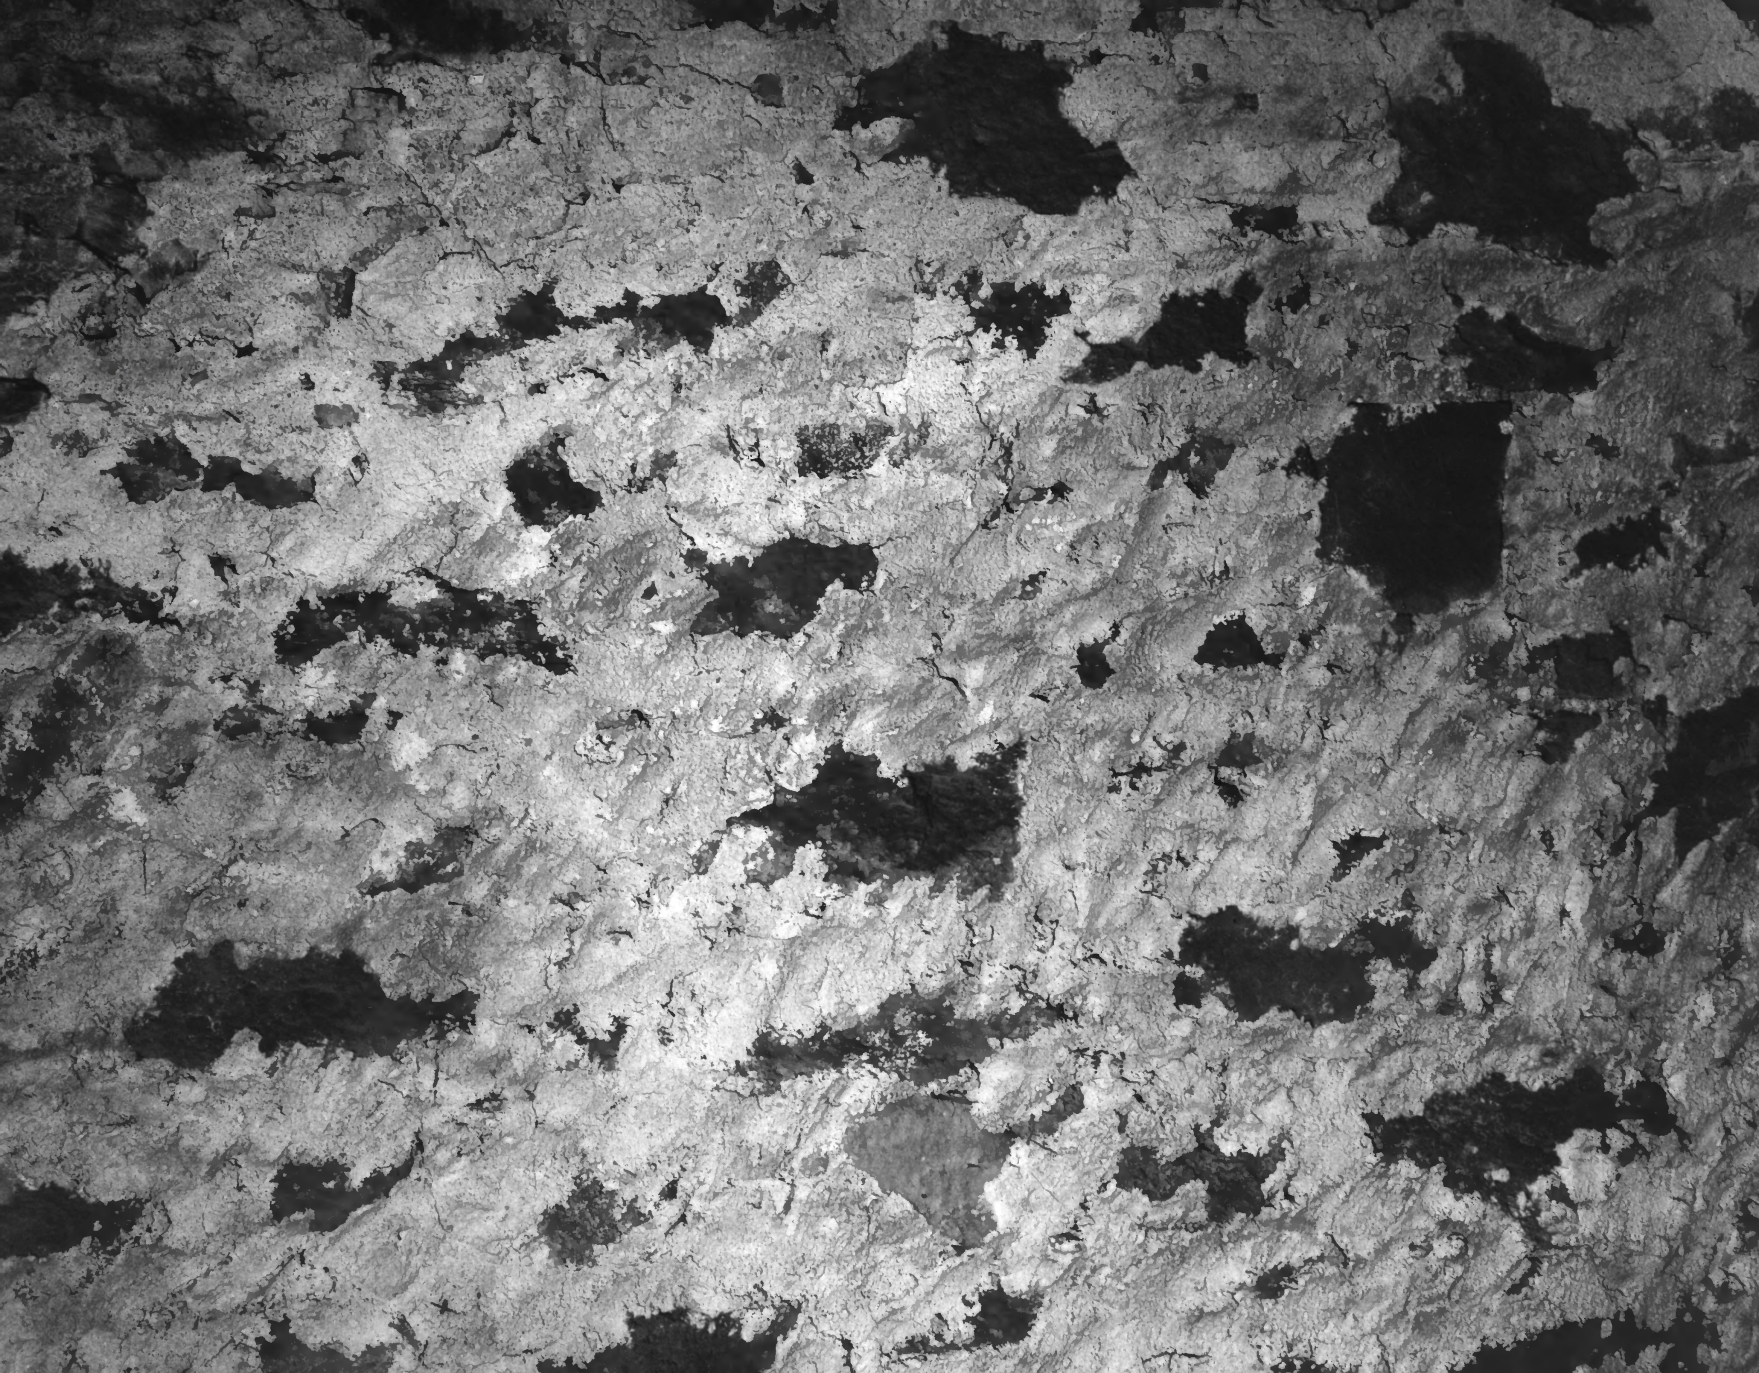
9 of 14

Close up view of the interior easterly end wall. The basalt stone (a native field stone) used in the walls is found

near the location. Basalt rock is rather scarce in this County.

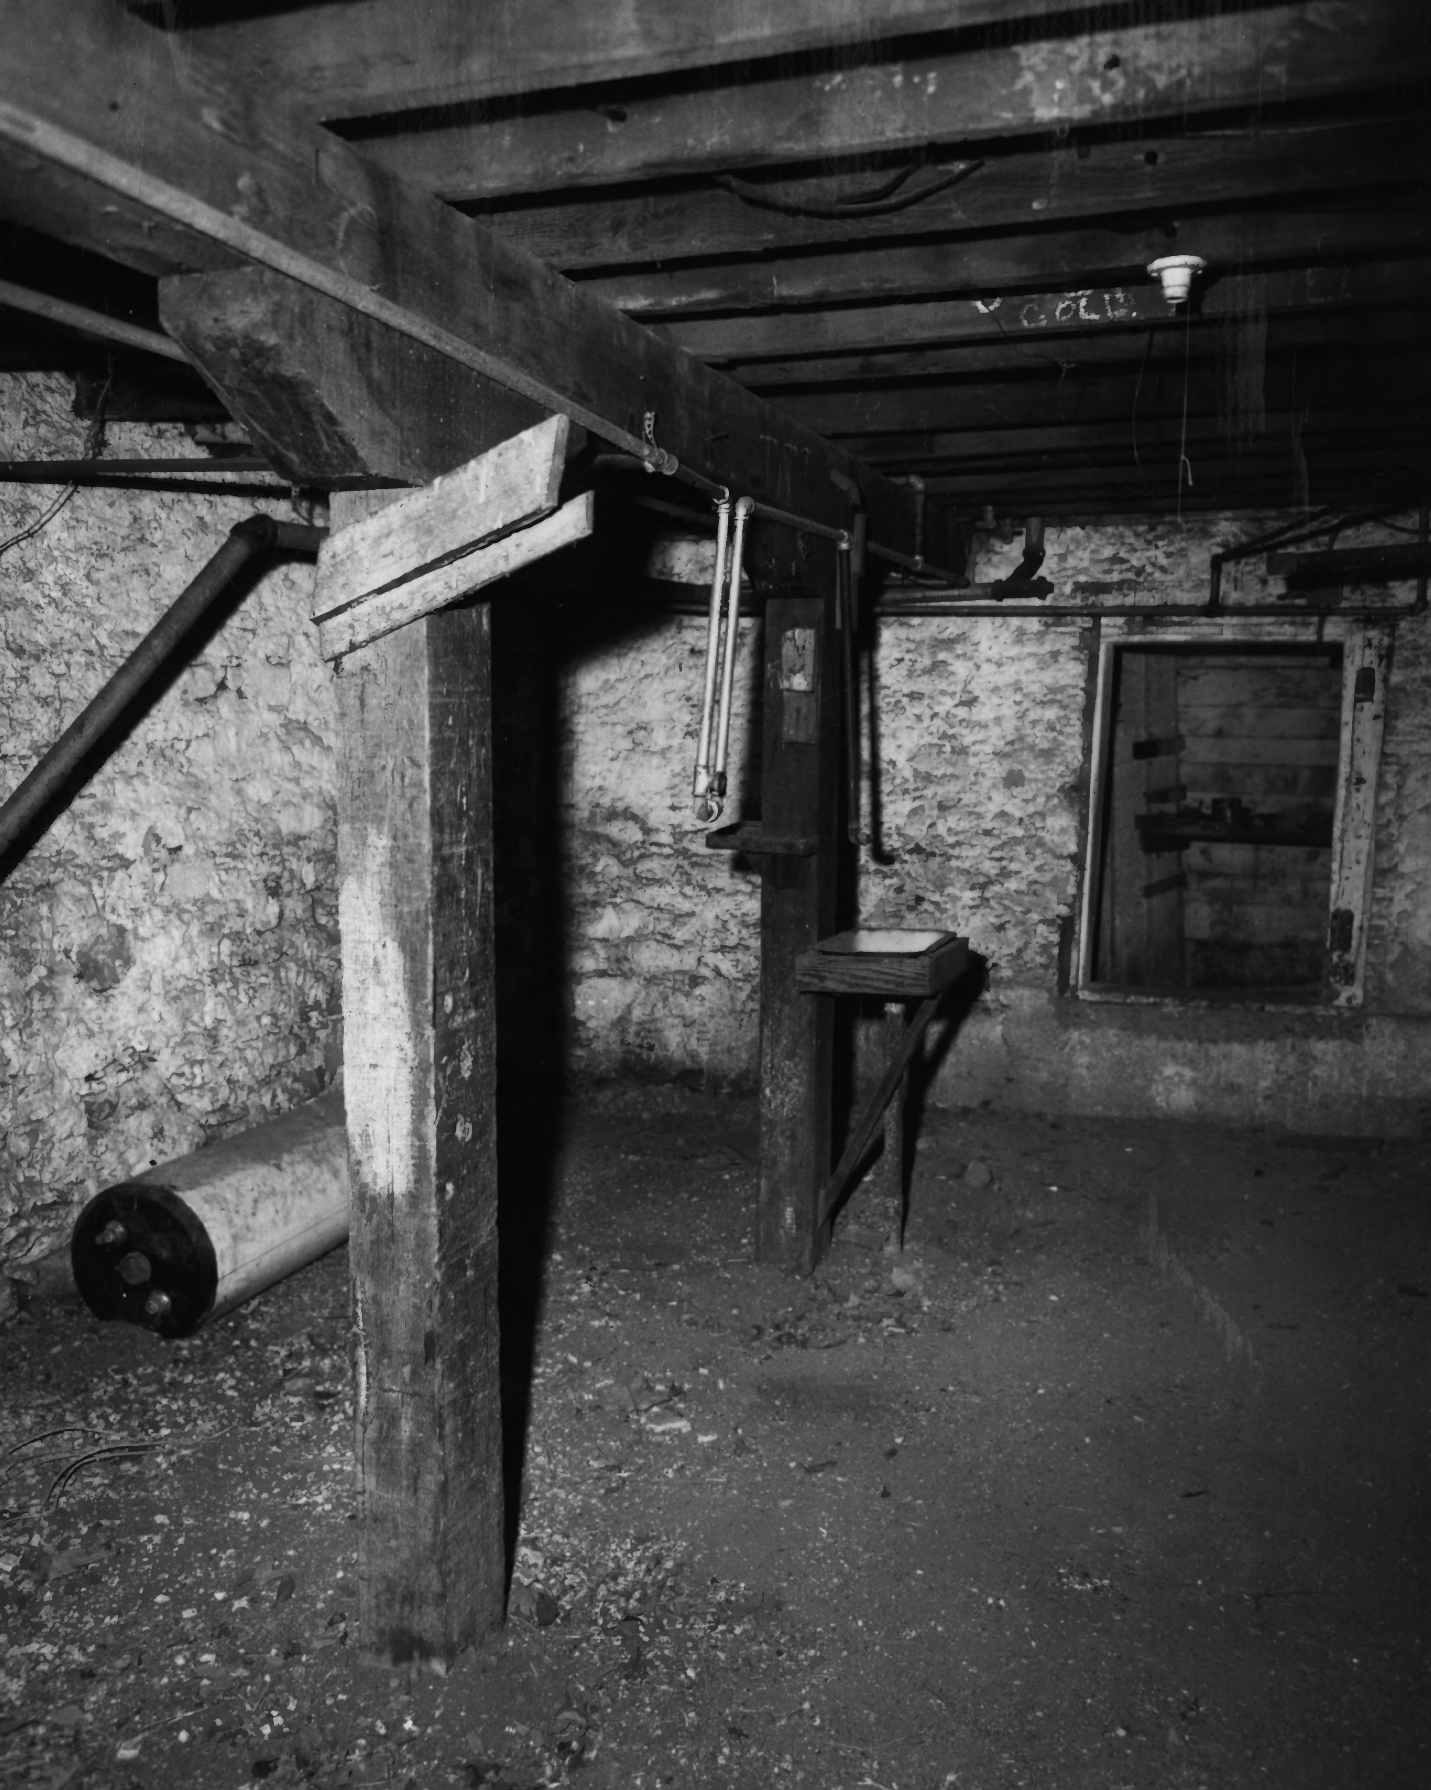
Interior view of the basement or 1st floor, 1869 structure showing part of the easterly and southerly stone walls.

It shows the heavy redwood posts, beams and joists. In rehabing the Winery, the exposed piping and wiring added circa 1922 will be removed.
