B. Malaguerra Winery. Front view of the winery facility. The property was changed to a chicken ranch operation in the 1920's at which time the older stone structures on the left were converted to

Santa Clara County, Ca.

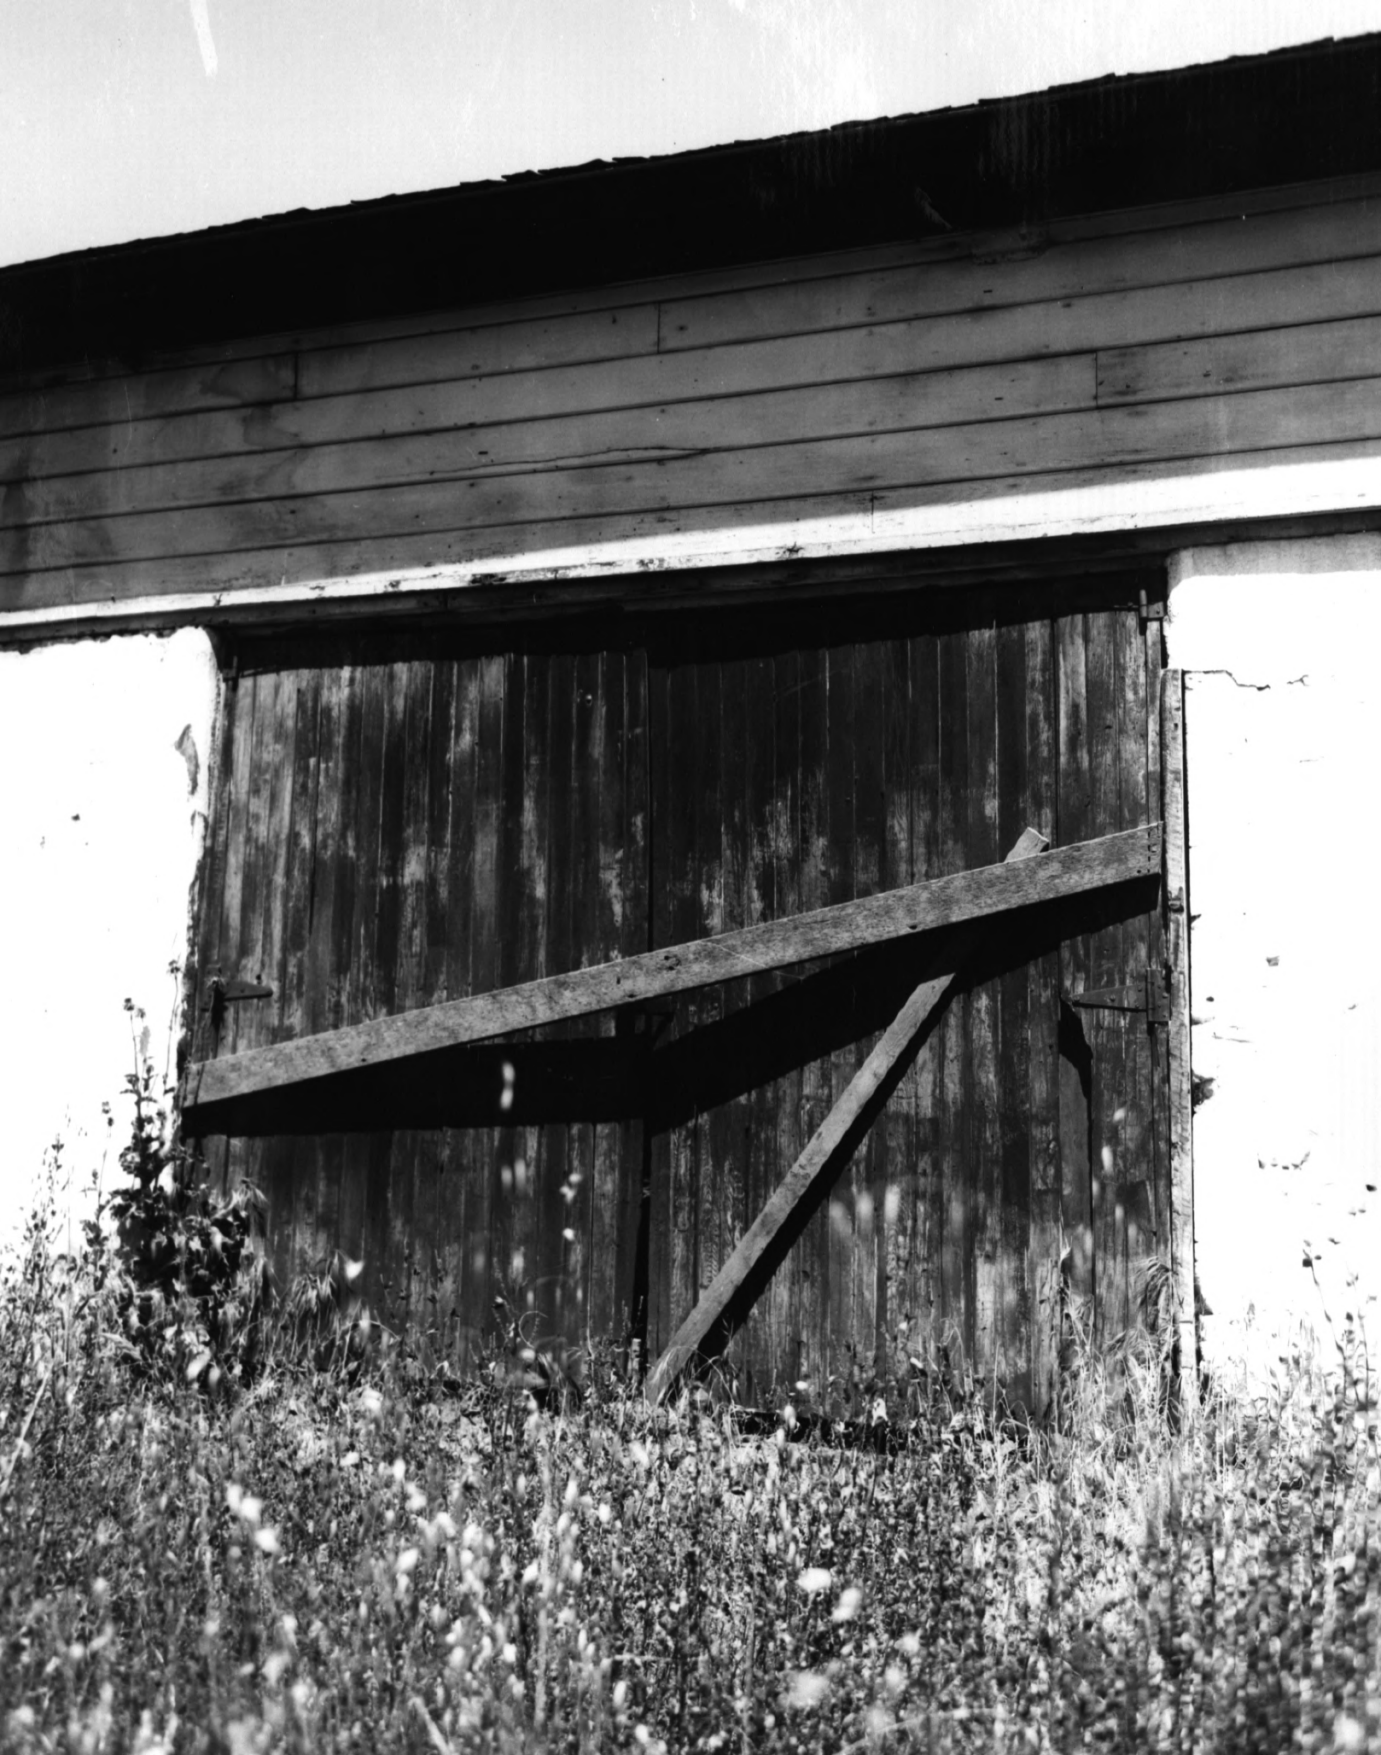
11 of 14

Exterior double doors to the 1904 addition.

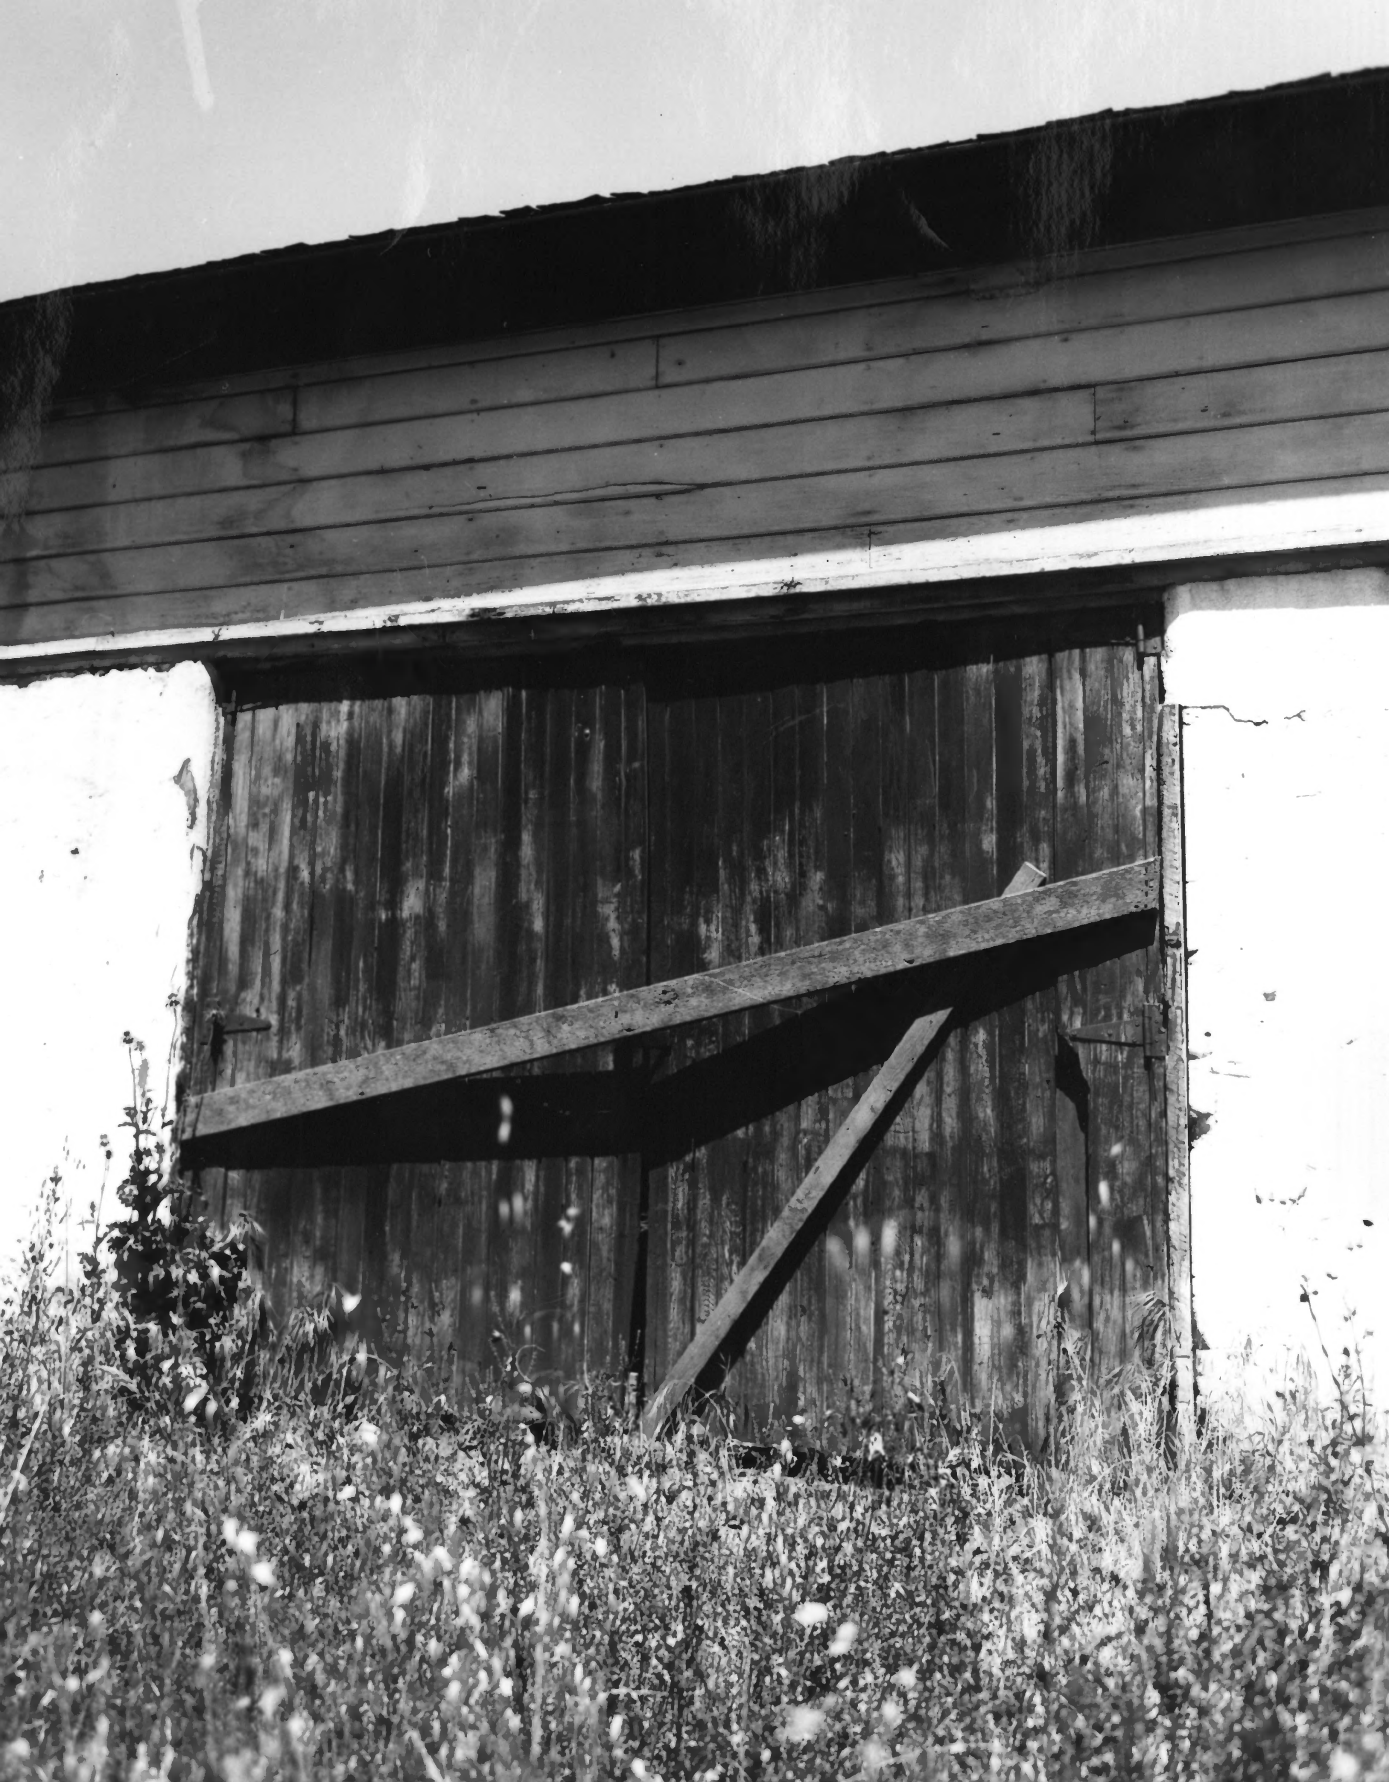
Exterior double doors to the 1904 addition.

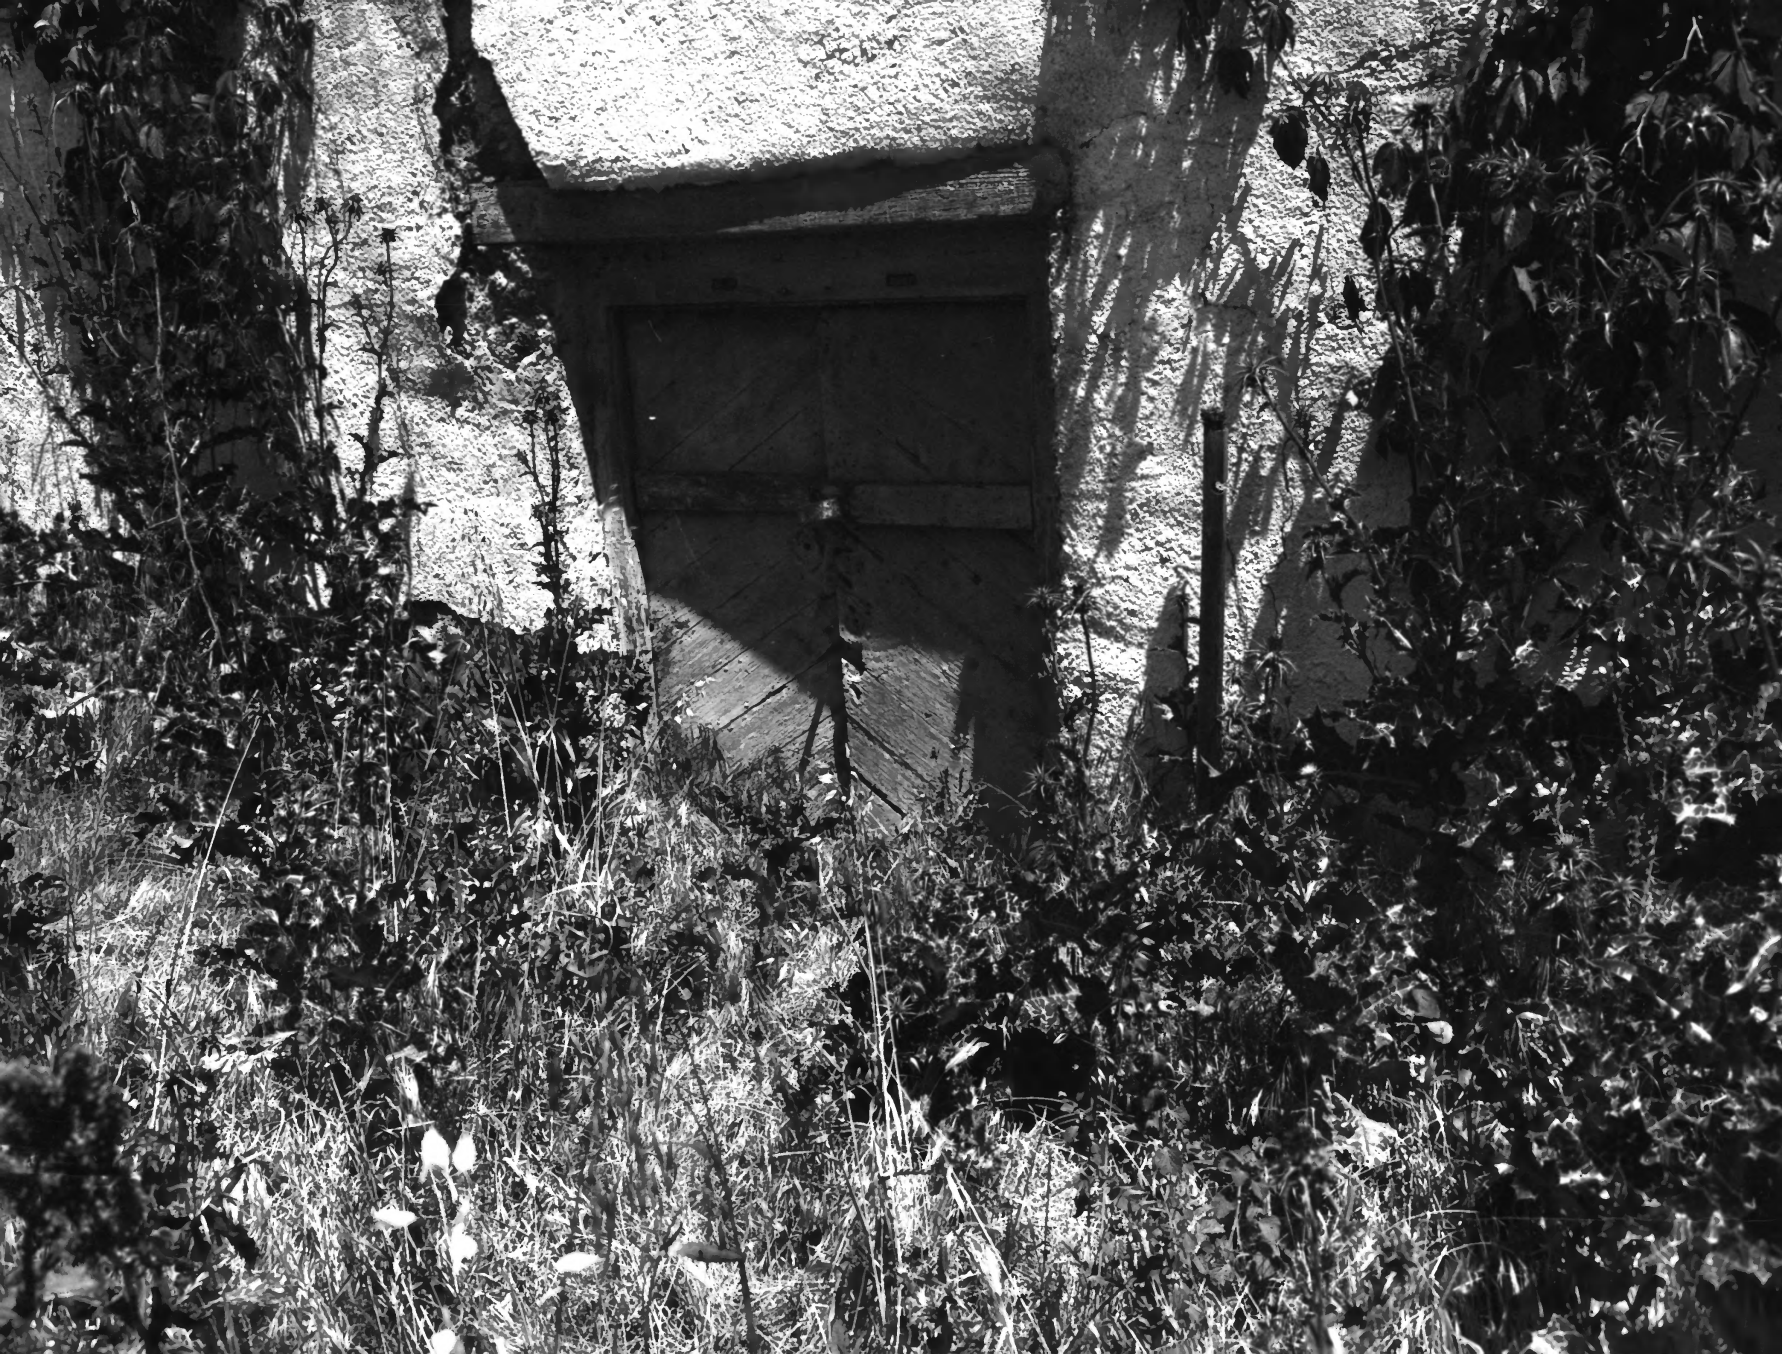
13 of 14

Picture of a portion of the lower portion northerly end wall showing the access double doors. The picture shows

the original stone and door beam. The plaster coat including the whitewash will be repaired in the rehabing to a Wine Museum.

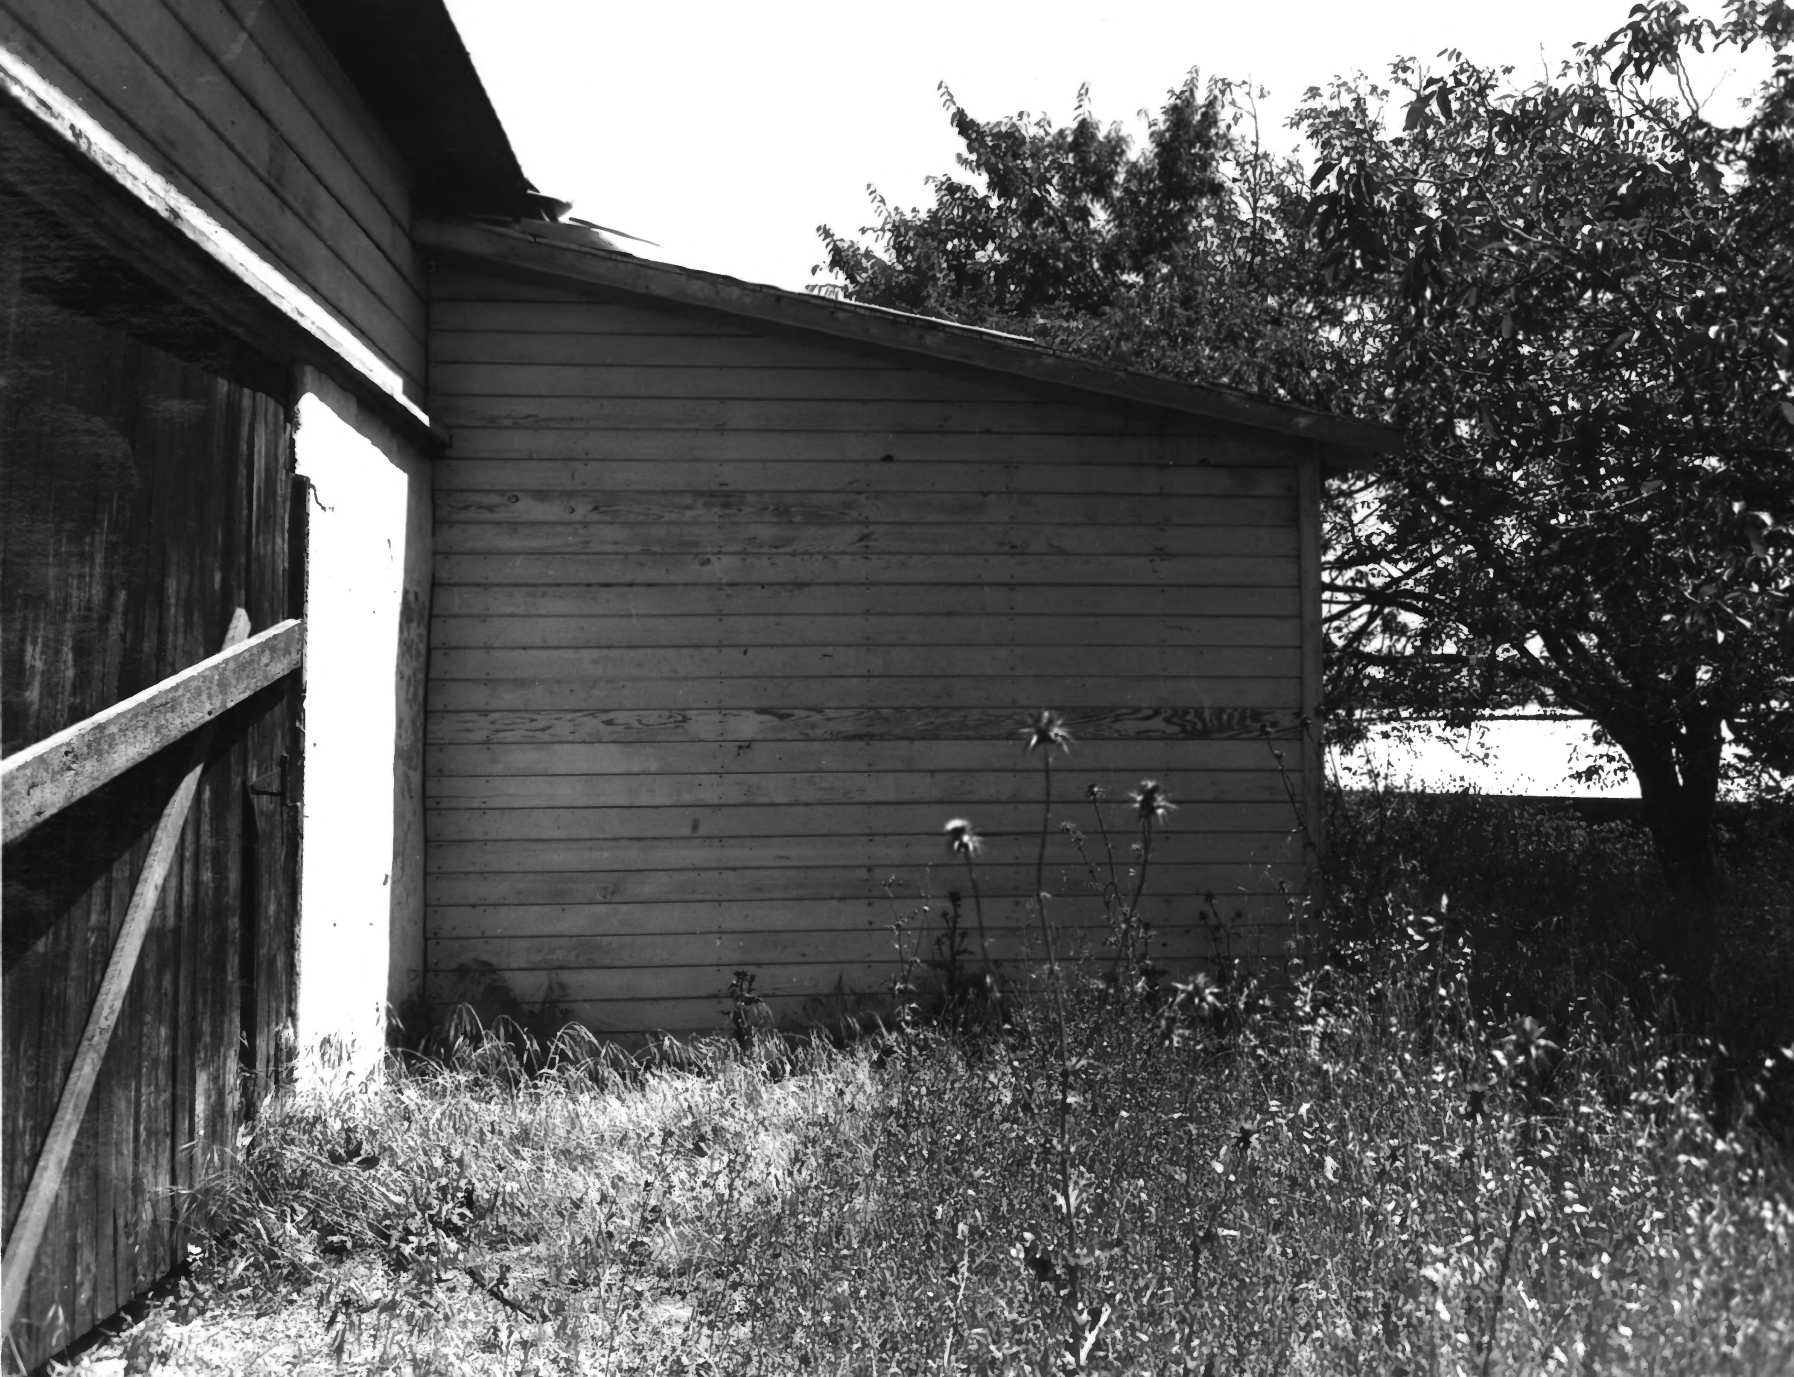
14 of 14

Picture showing the 1904 addition on the left. The circa 1922 frame construction tacked on the exterior wall and fits in

under the 1904 roof over hand and red wood wooden gutter. The 1922 circa <sup>addition</sup> will be completely removed in rehabing for a Wine Museum. The circa 1922 shed does not cut into the 1904 structure in any way.
