Lucy Hobbs Taylor Building

Lawrence, KS.

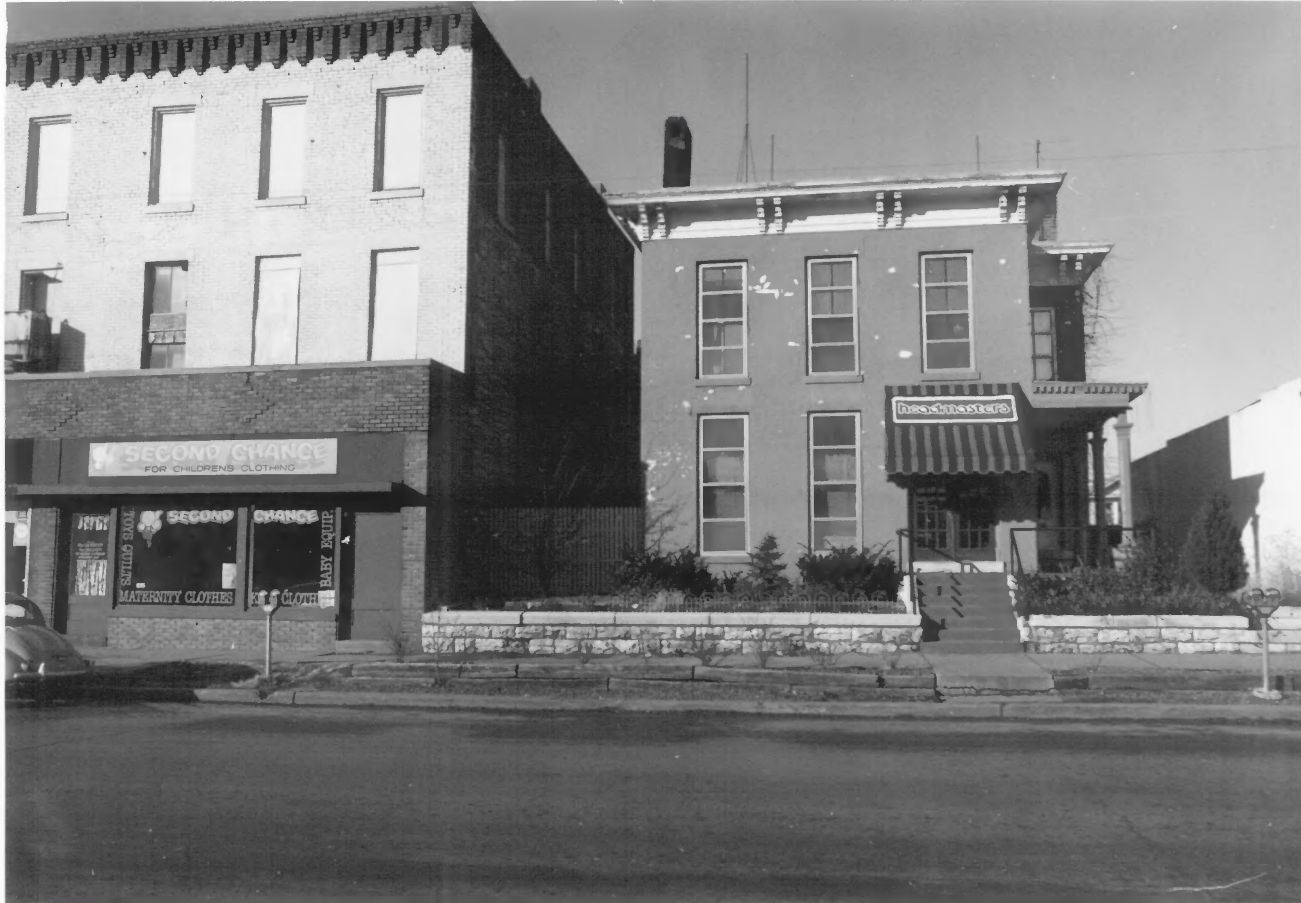
View from the east of the front facade. Wood window frames are beneath aluminum storms.

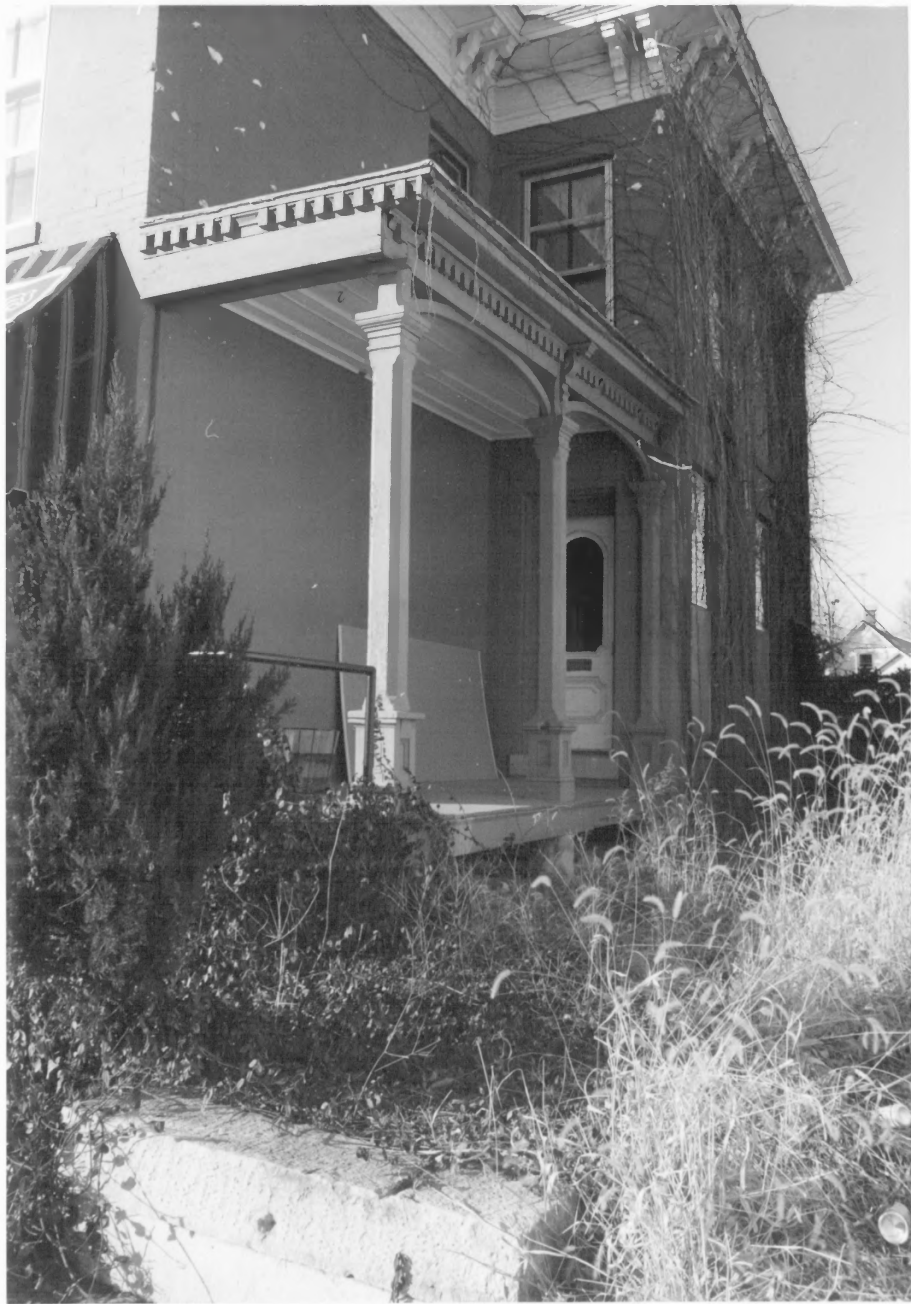
View from northeast of remaining porch.

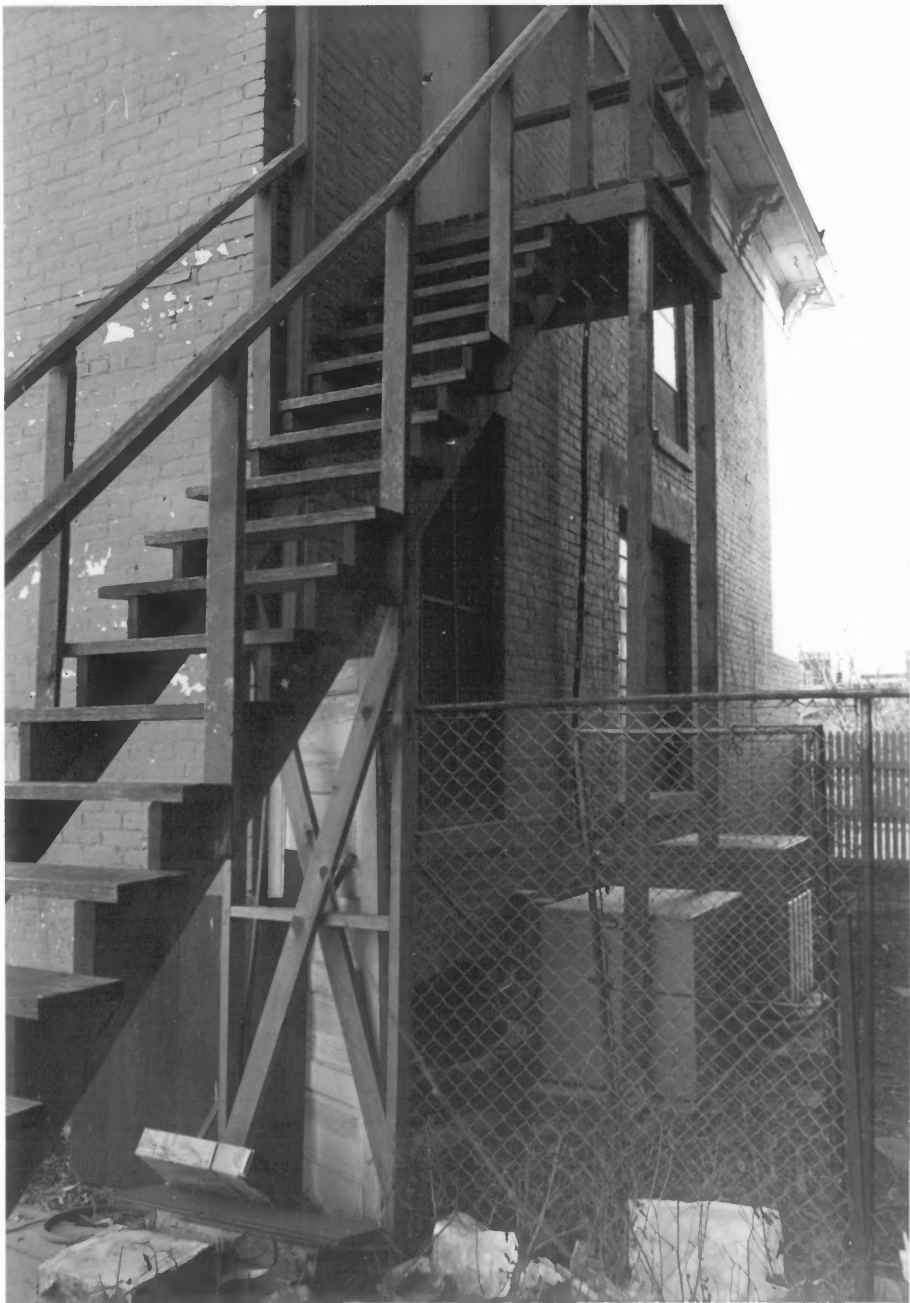
View of south facade. Note glass block window where bay window used to be.

Fire escape door on second floor was a window until recently.

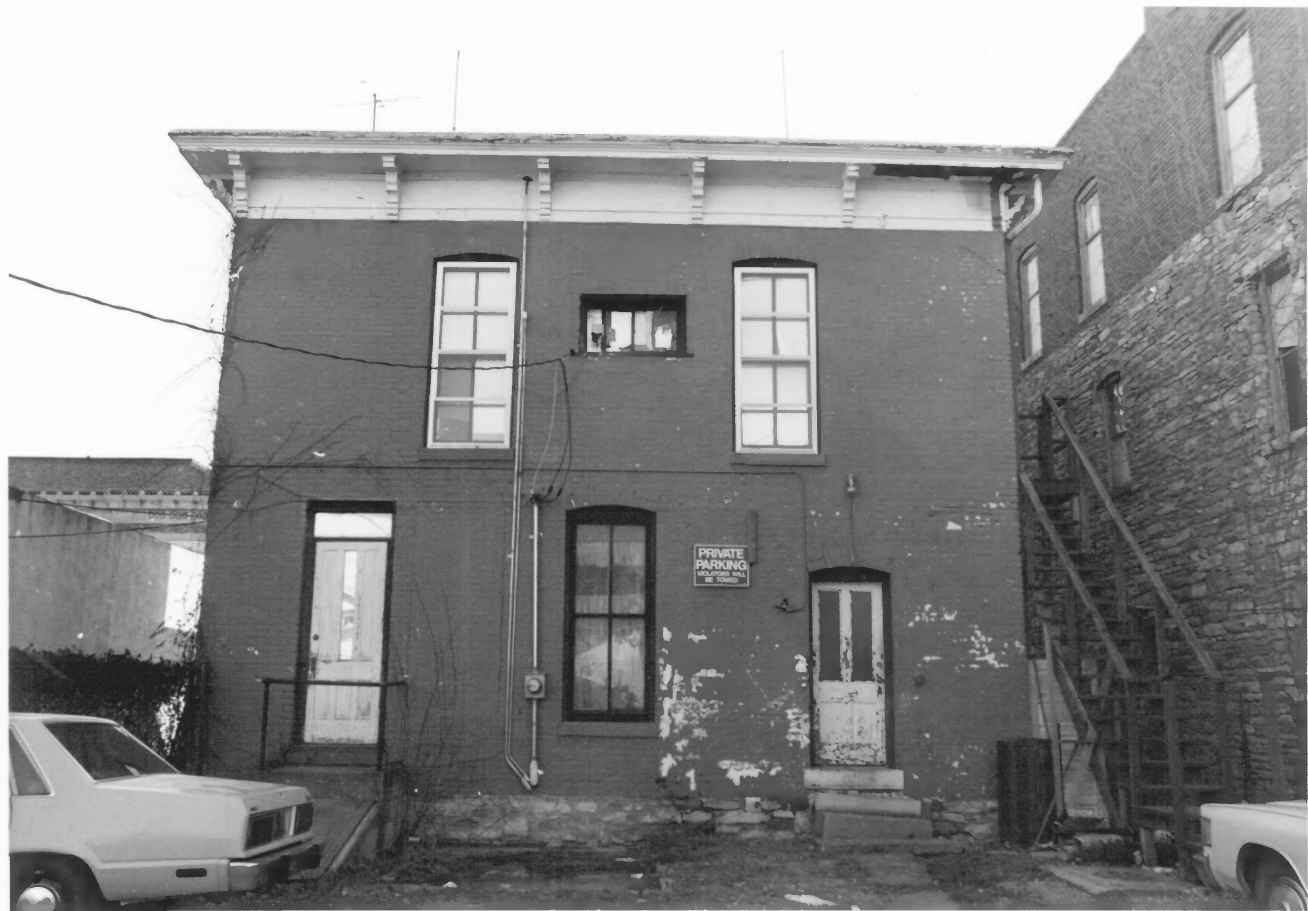
View of west facade

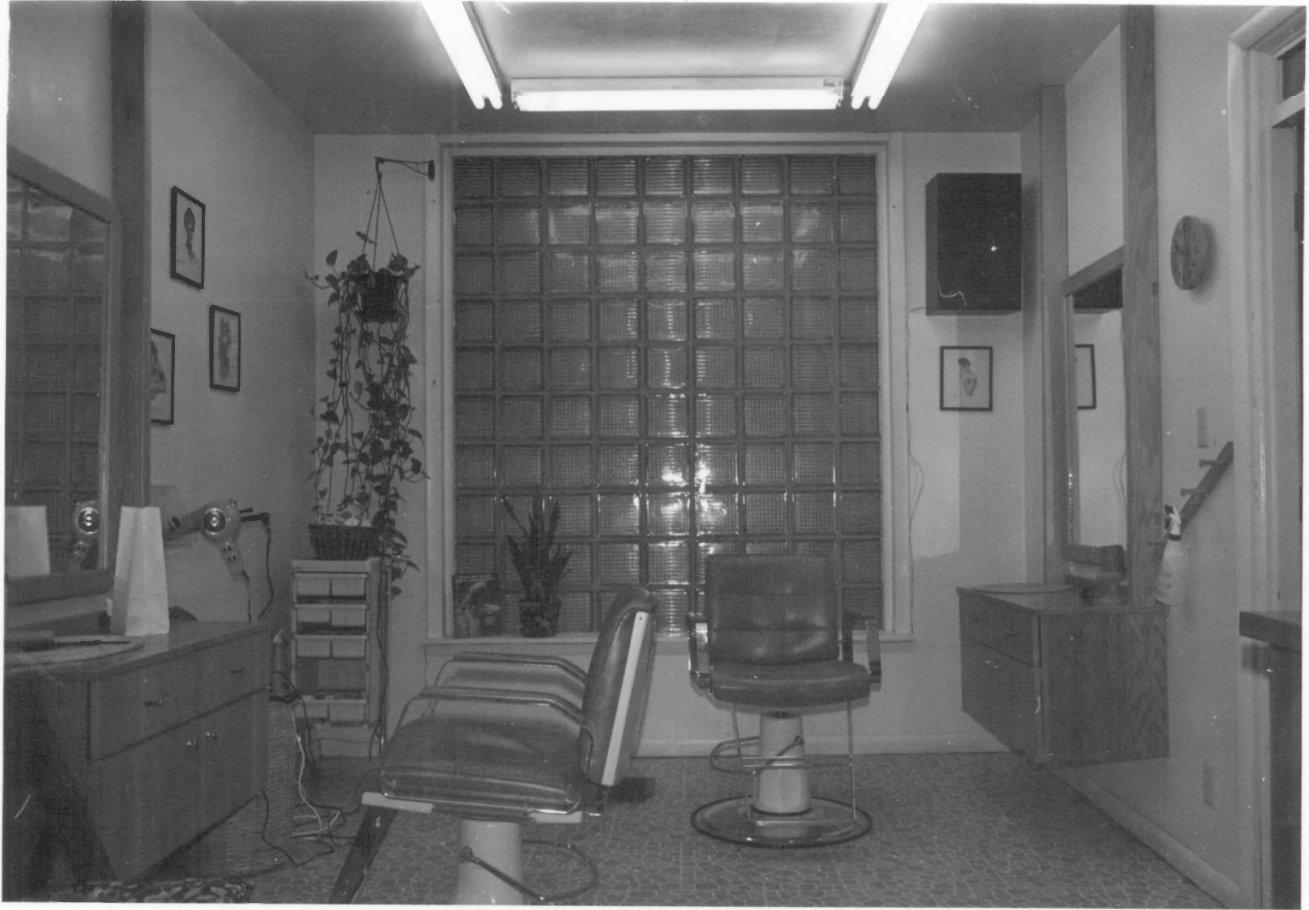
Interior-detail of former bay window
on south wall.

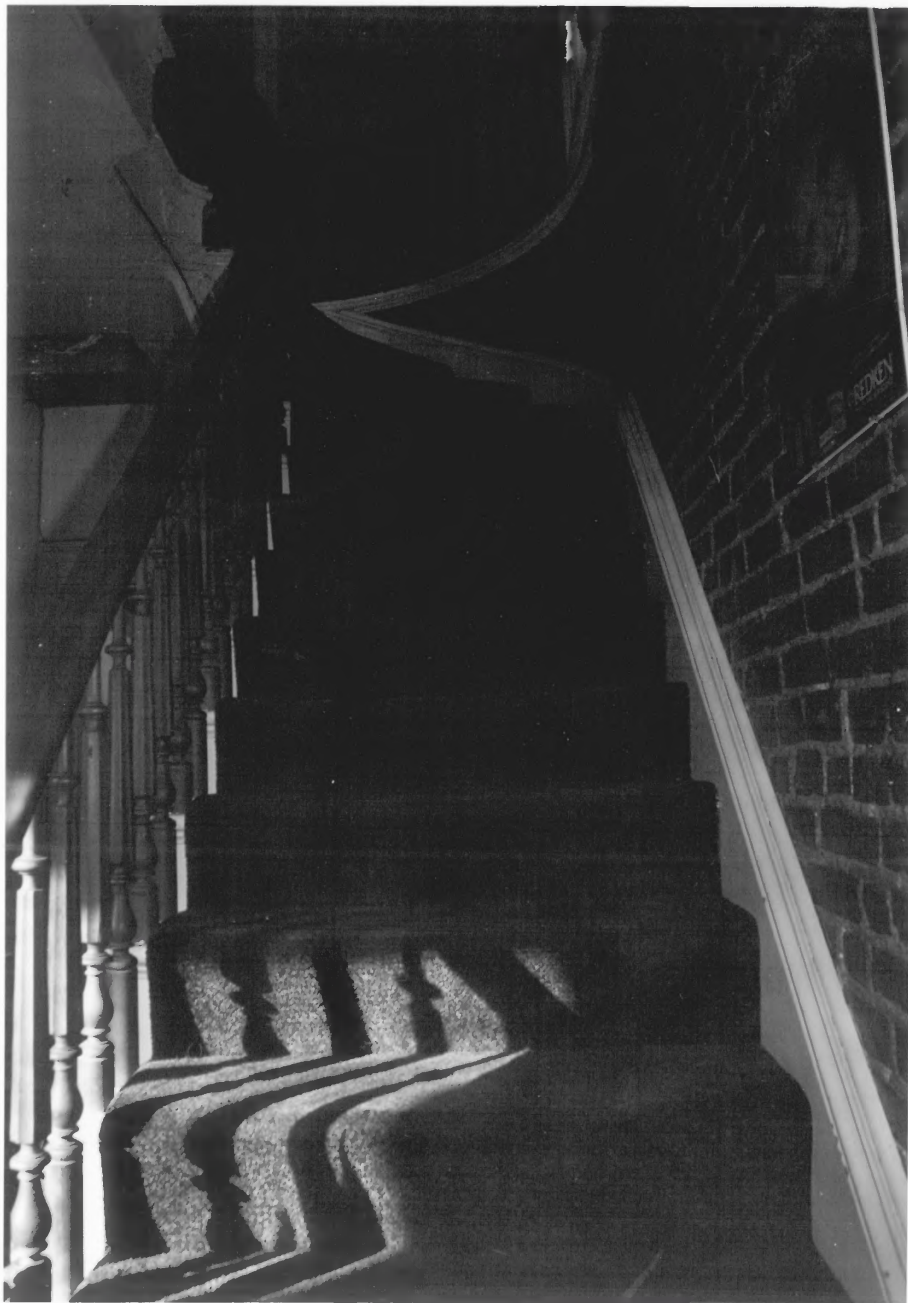
View of main staircase. Note original
woodwork. Wall plaster was removed by
current owner.
