St. John the Evangelist Roman Catholic
Church

Zigzag vicinity, Clackamas County,
Oregon

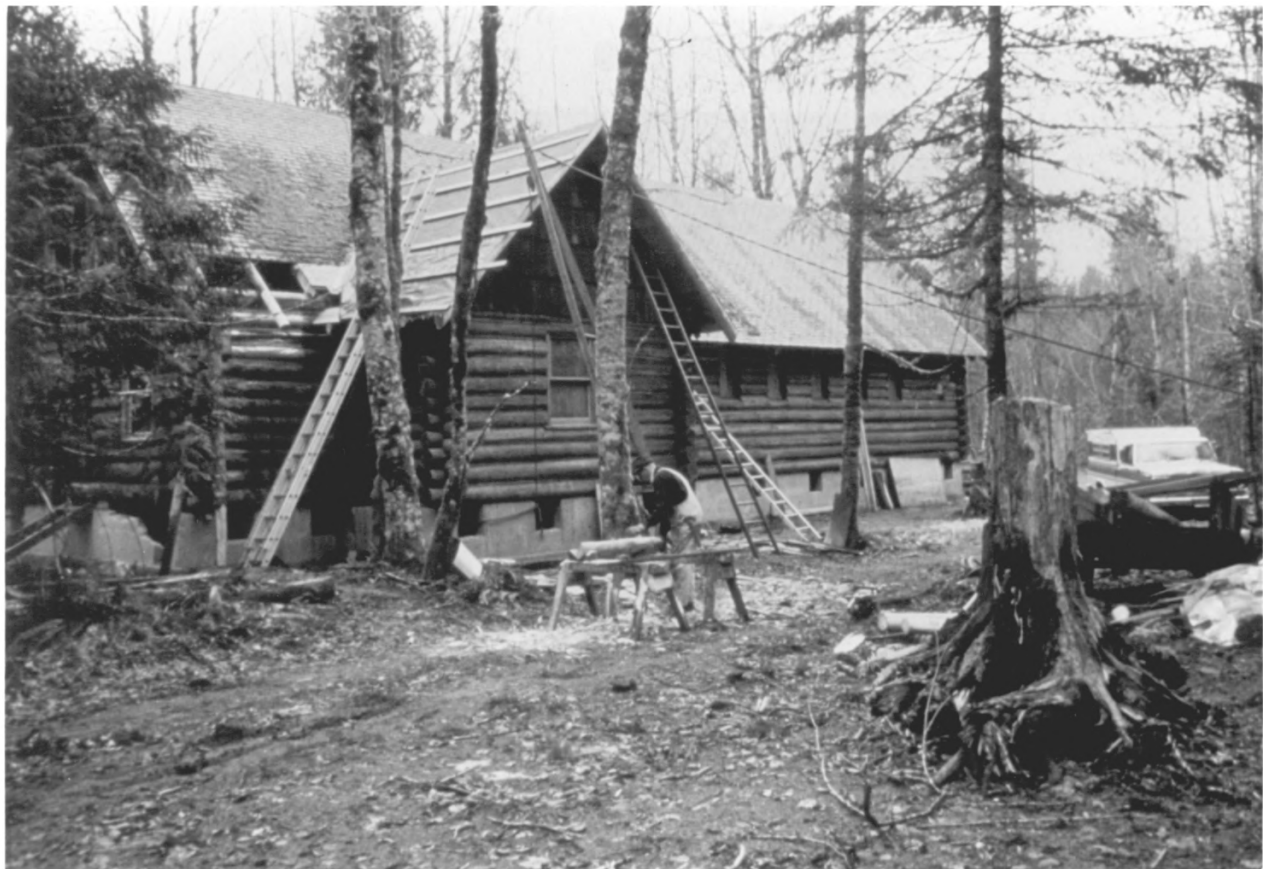
11 of 12 South and east elevations,
showing roof repair in progress

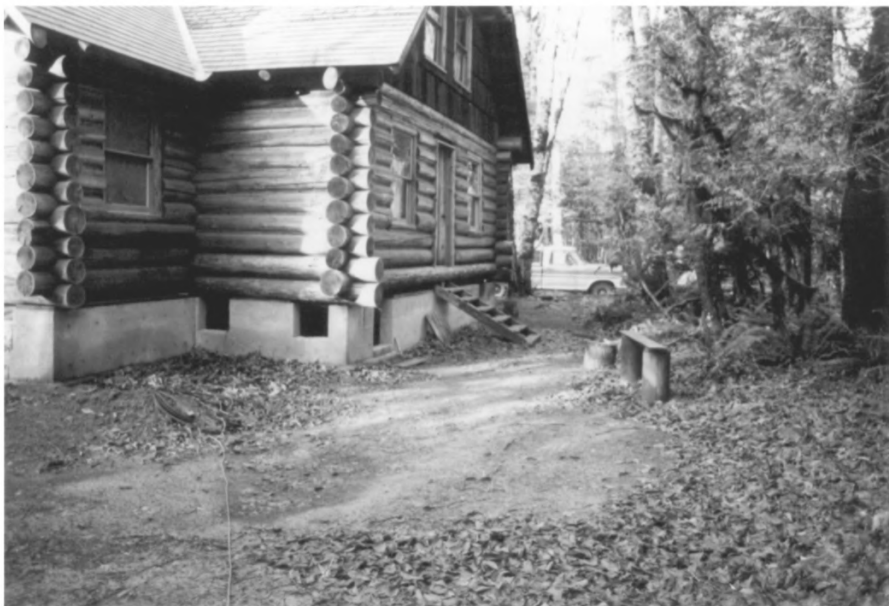
EAST END

REPAIR WORK OF
DAMAGED FOUNDATION
WALL WITH CRAWL
SPACE TEMPORARILY
LEFT OPEN FOR
PLUMBING AND
ELECTRICAL WORK
UNDER BUILDING.

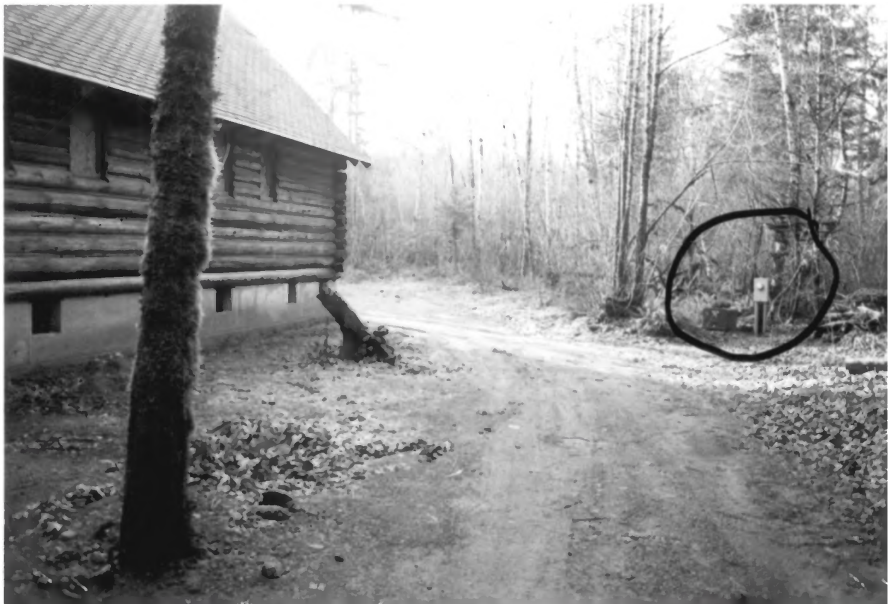
EAST END

NOTE THAT
EXISTING EAST GRADE
LENDERS ITSELF NICELY
TO ABOUT 19" OF
BACKFILL TO MAKE
AREA LEVEL. THIS
END AND SOUTH SIDE
WERE EXCAVATED
TO CLEAR A LEVEL
AREA FOR BUILDING.

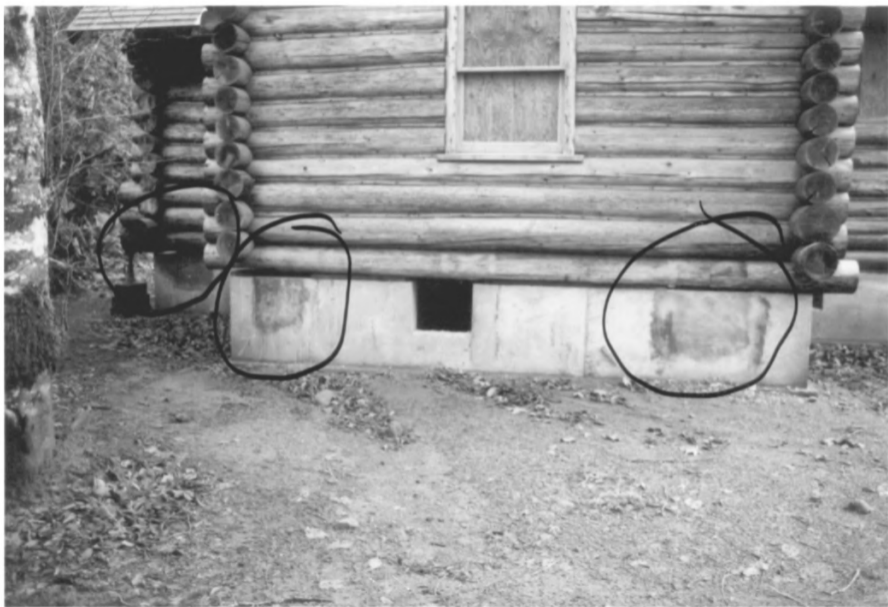
SOUTH SIDE

REPAIR WORK OR
BEAM POCKETS SHOWN
FILLED WITH TWO
VENT HOLES LEFT OPEN.

ALSO THIS SIDE WILL
TAKE BACKFILL NICELY
AS WILL THE SOUTH-
EAST AND EAST
END.

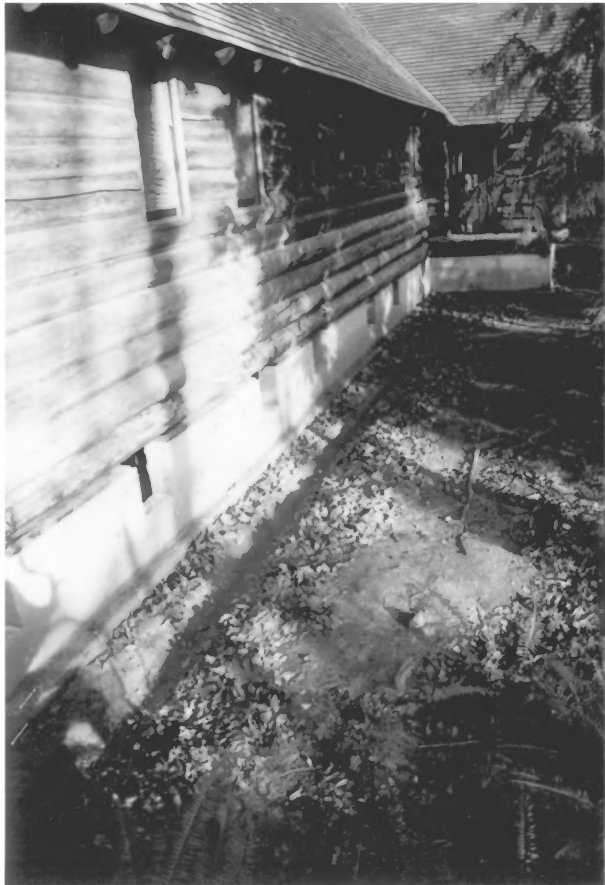
NORTH WING

THREE OF THE
BEAM POCKETS I
POURED IN PREPARATION
FOR ROCKWORK AND
BACKFILL.

ELECTRICAL PANELS
AND PHONE CONNECTION
ARE UNDER THIS
WING.
