**NATIONAL REGISTER OF HISTORIC PLACES  
PROPERTY PHOTOGRAPH FORM**

PATEE HOUSE

Patee House Museum

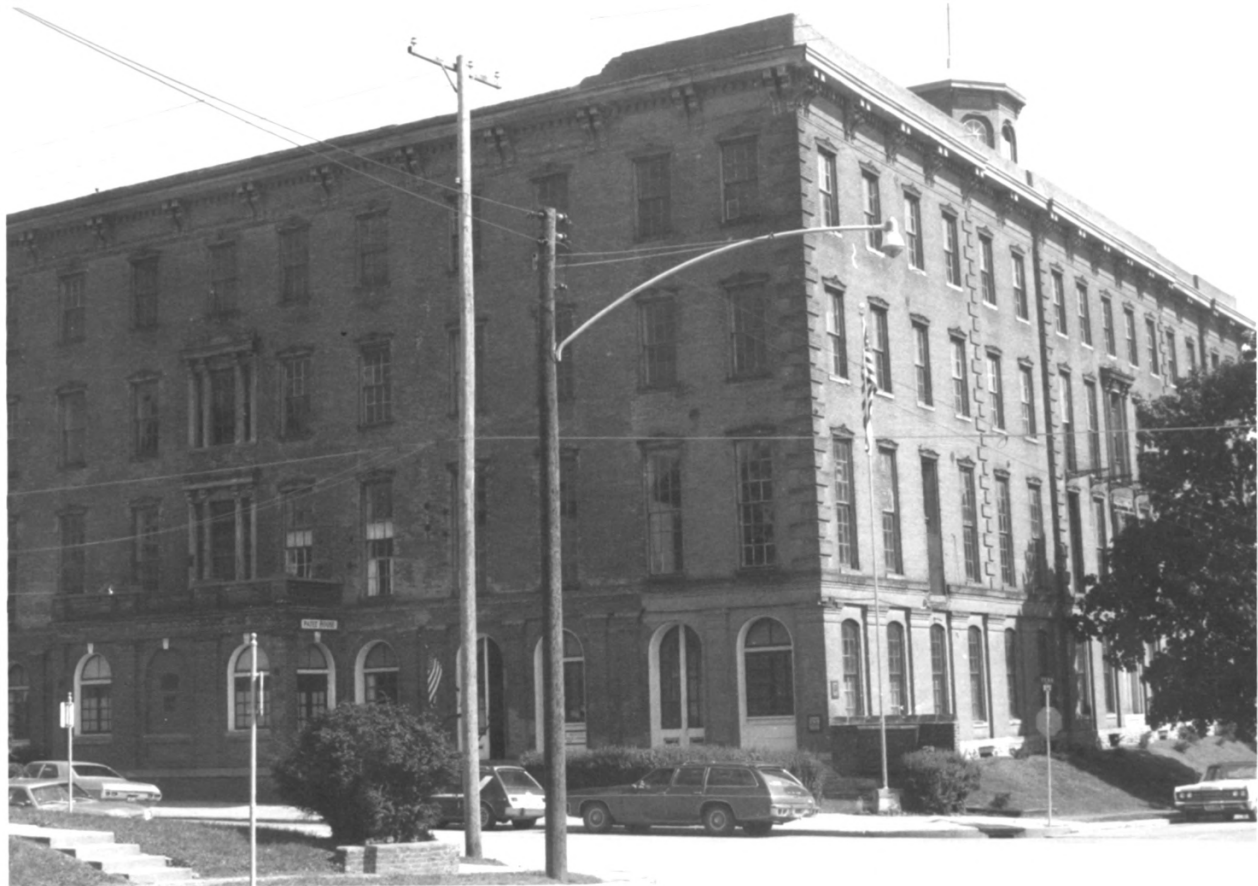
Facing south across 12th and Penn Streets to front entrance, Patee House

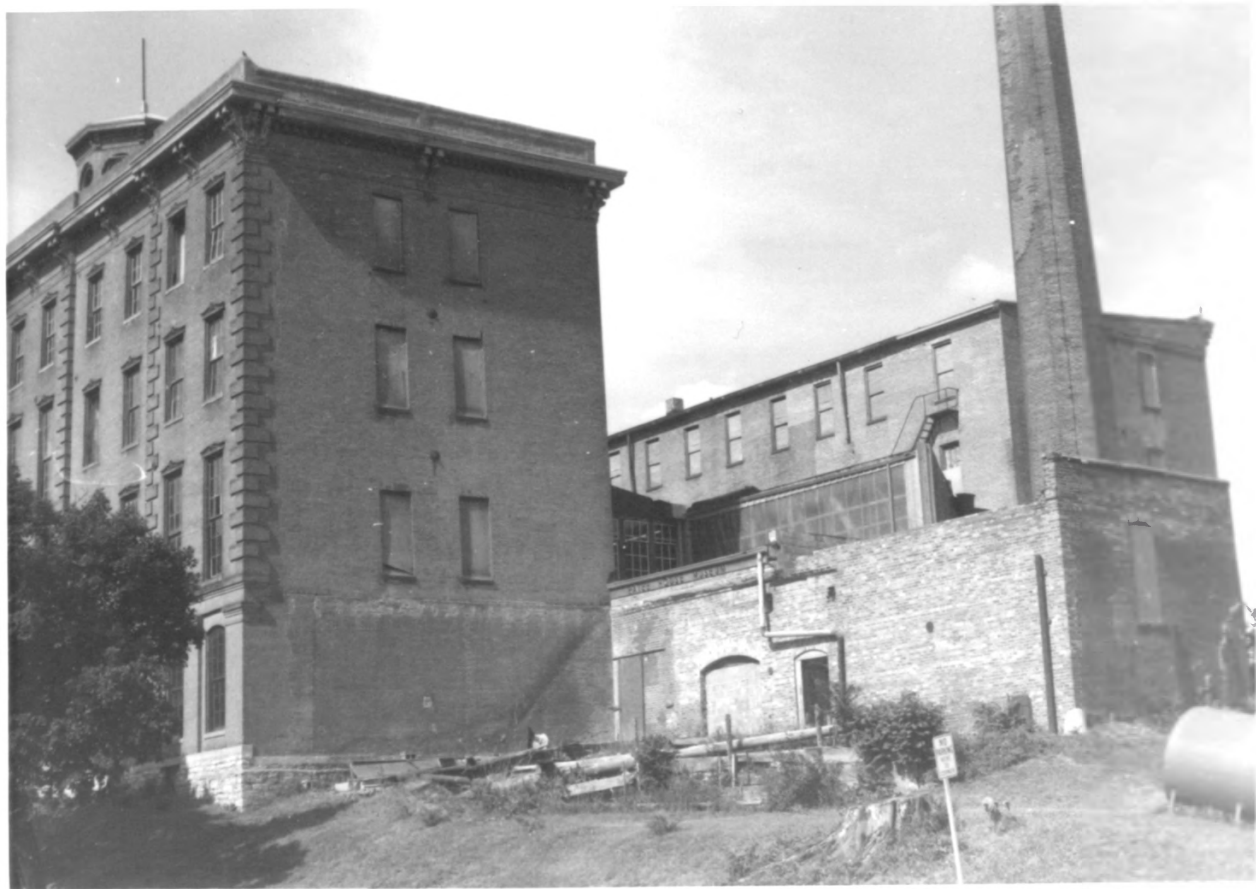
Facing northeast to rear section of Patee House. Note brick extension and smokestack from factory period.

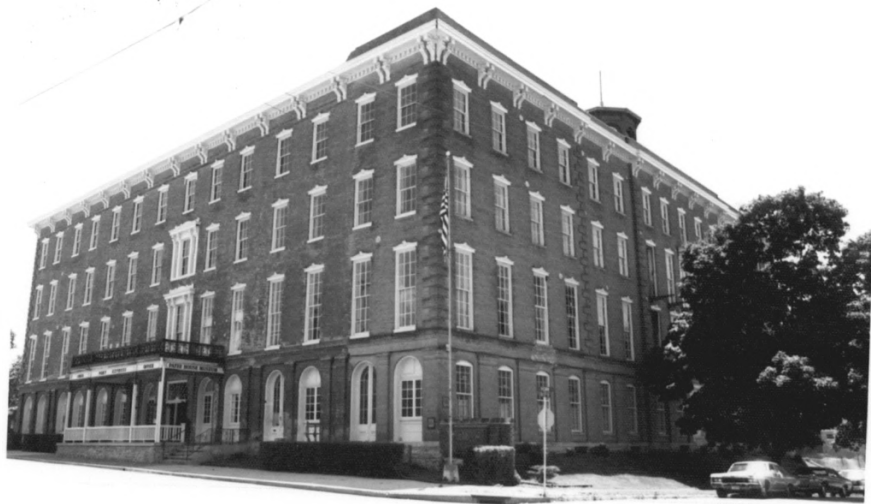
View SE, looking at N and W exposures of building. These two sides have been restored. Note new porch. Note brick work done to restore window, 3rd window S, 2nd floor, W exposure.

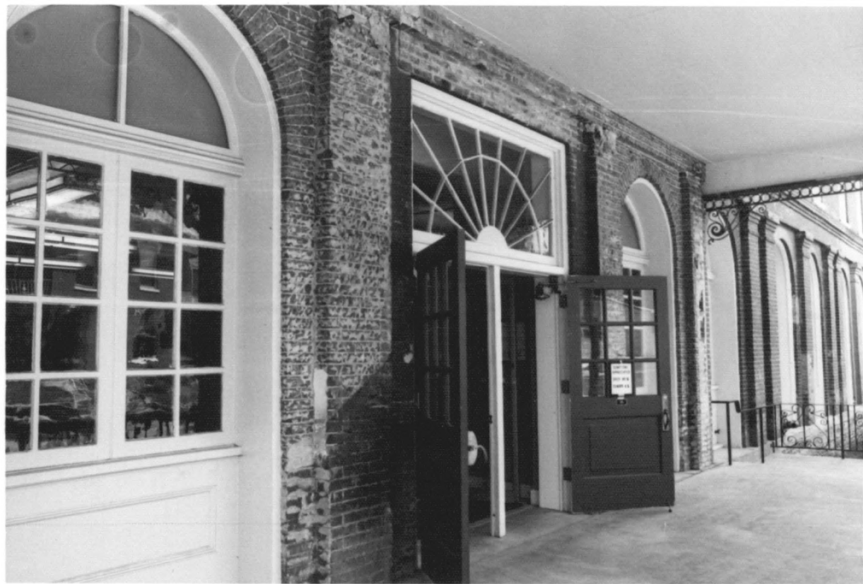
View of recently installed porch and restored main entrance. Plaque will be mounted on one of these brick columns. Note lighter brick, exposed during restoration - this brick in need of preservative treatment.

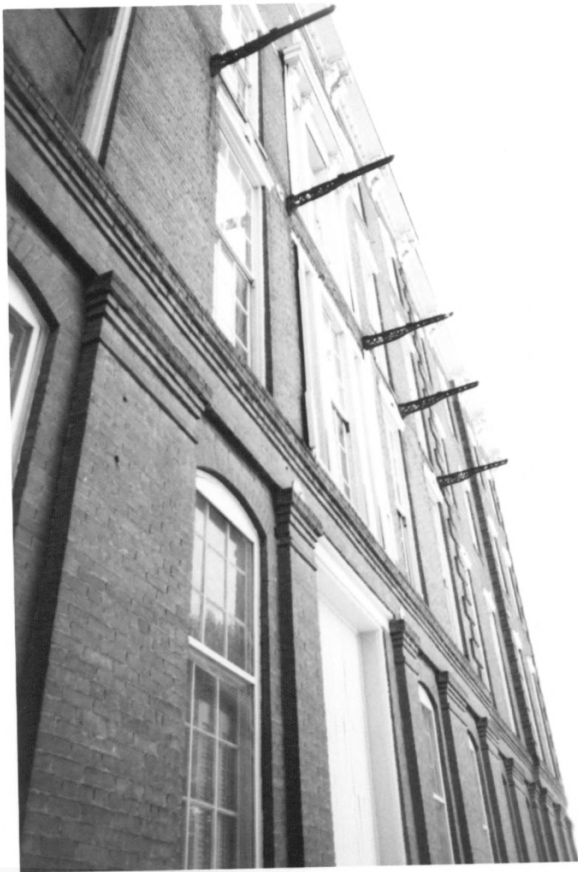
View of W exposure. Note woodwork separating from brick. Supports are for once extant balcony, planned for eventual restoration.

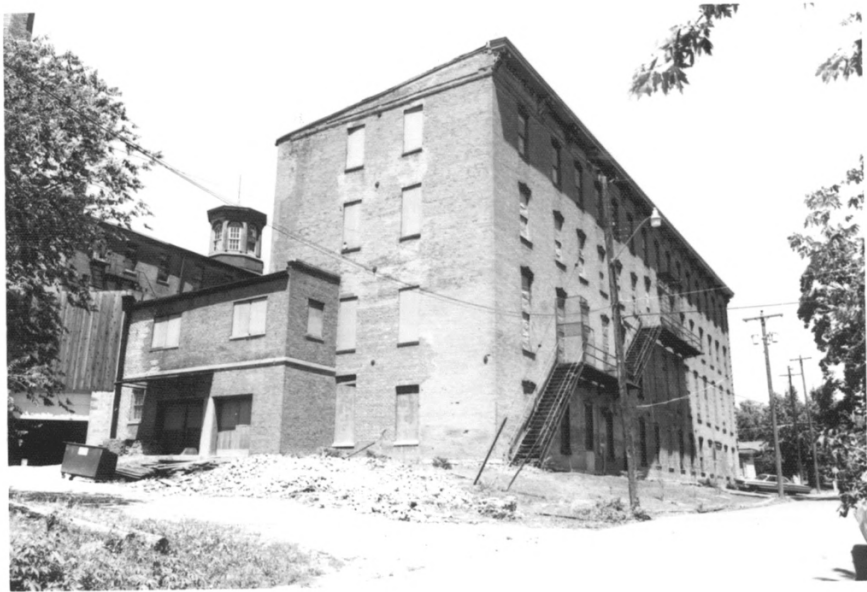
View NW, looking at S and E exposures. Pile of bricks is being used to build veneer over concrete blocks used when display area was enlarged. Note cupola.

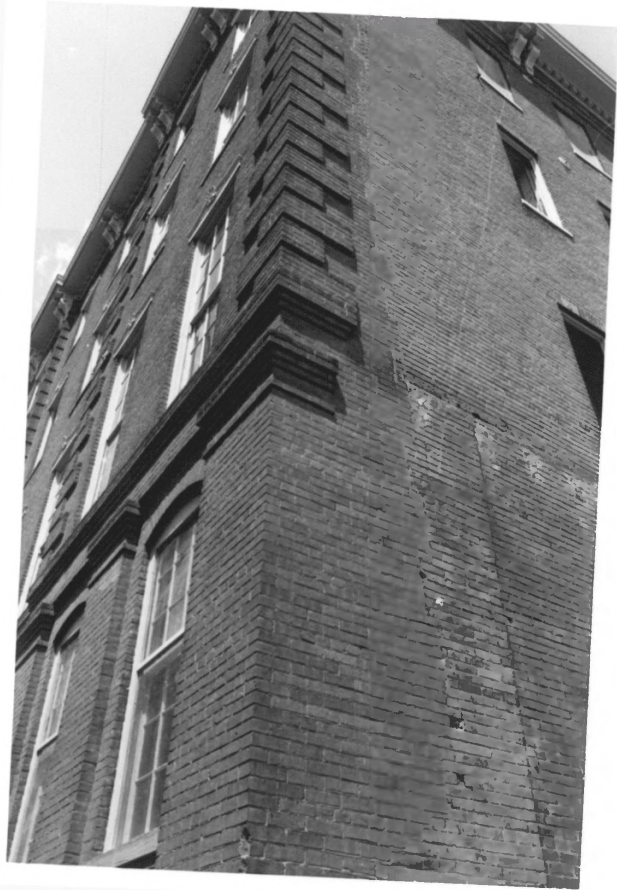
View of SW corner. Note contact line between very old (original?) brick and old brick. Entire W exposure was apparently rebricked sometime (unknown) in the past.

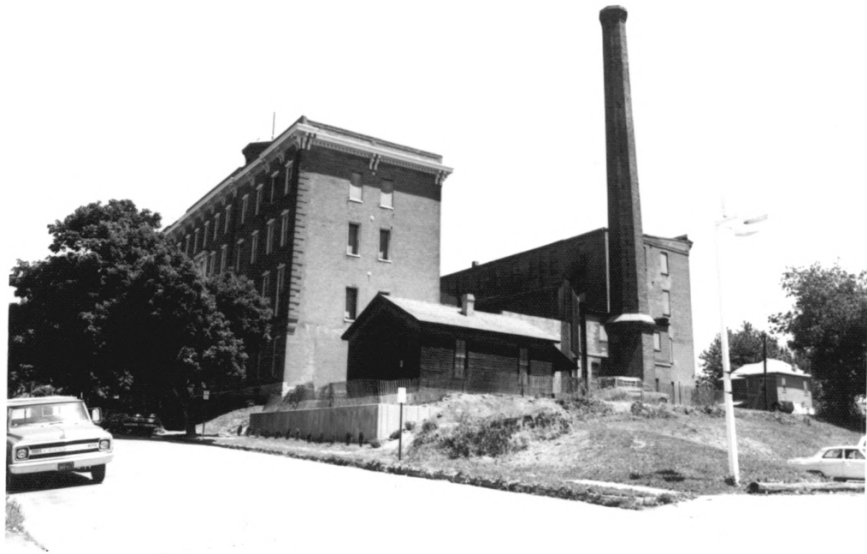
View NE, looking at S exposure. Note location of Jesse James House, recently moved to the grounds to keep it in the community. House does not intrude on visual integrity of the Patee House when Patee House is viewed from NE, prime visitor area.

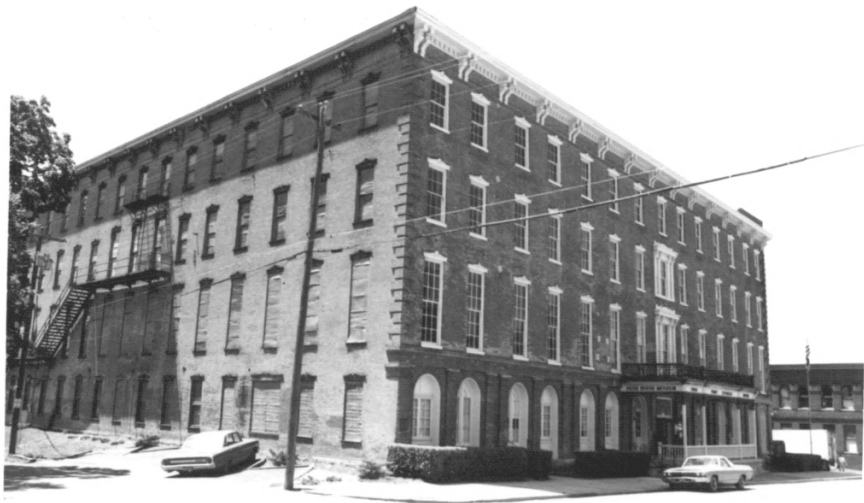
View SW, looking at N and E exposures. Restoration work is currently being planned for E and S exposures.
