**NATIONAL REGISTER OF HISTORIC PLACES
PROPERTY PHOTOGRAPH FORM**

PATEE HOUSE

St. Joseph

Missouri

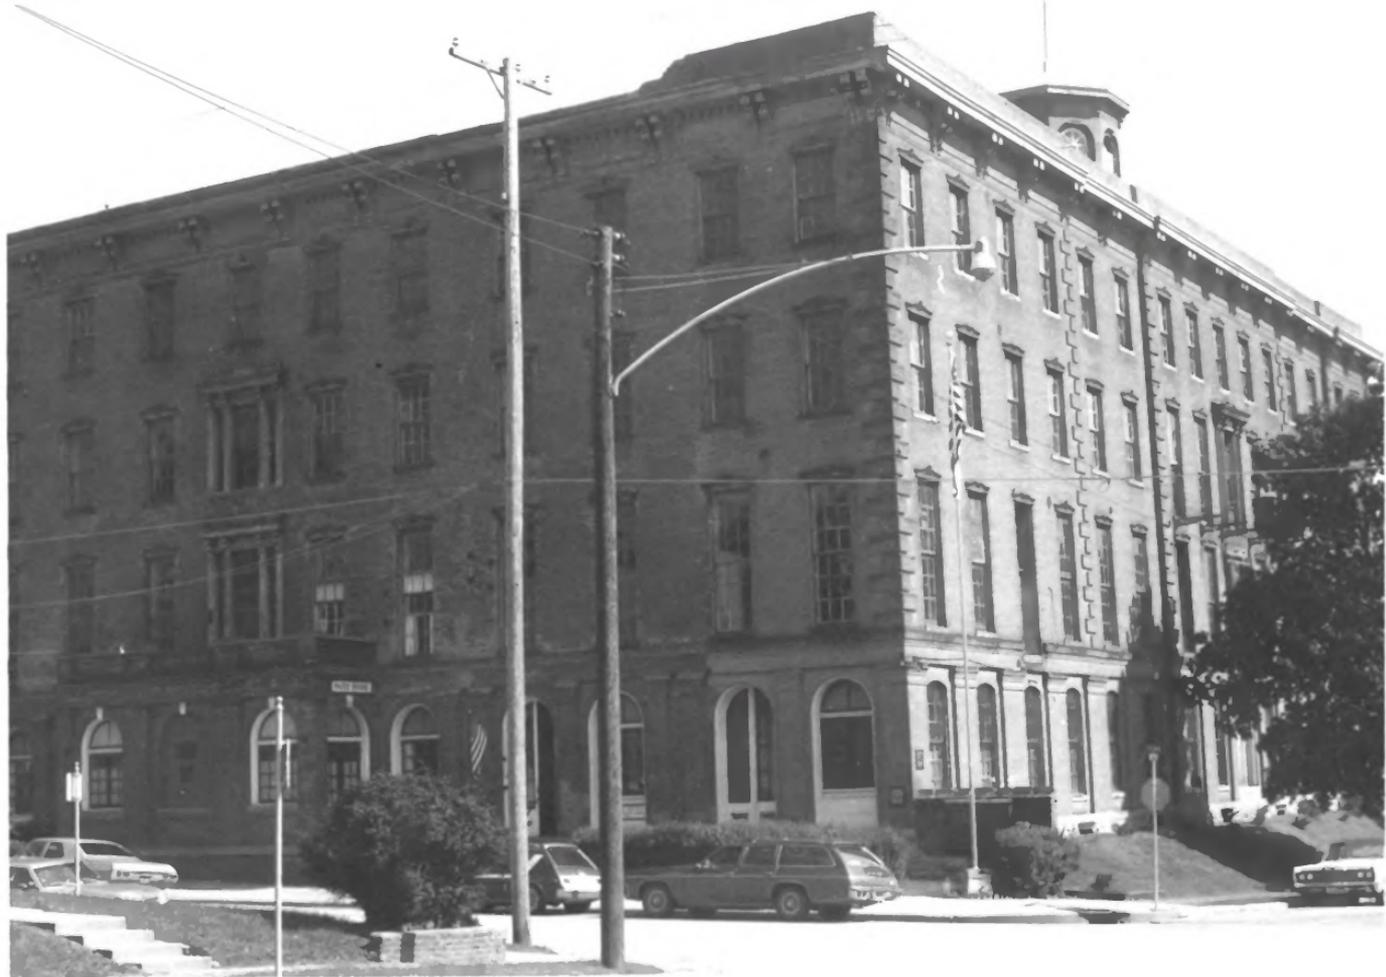
Facing south across 12th and Penn Streets to front entrance, Patee House

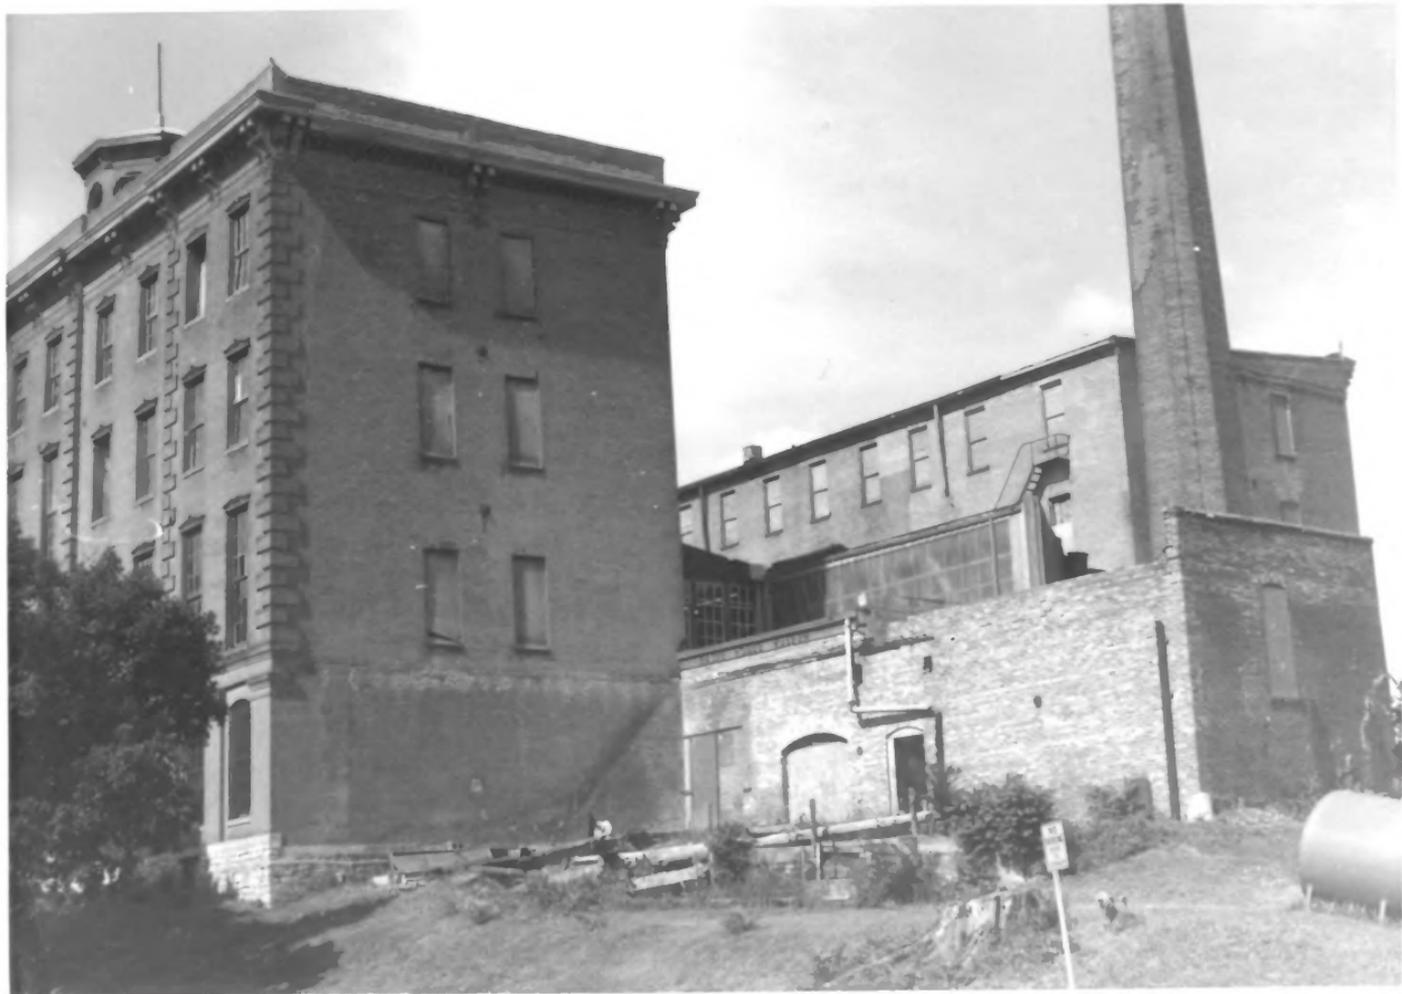
Facing northeast to rear section of Patee House. Note brick extension and smokestack from factory period.

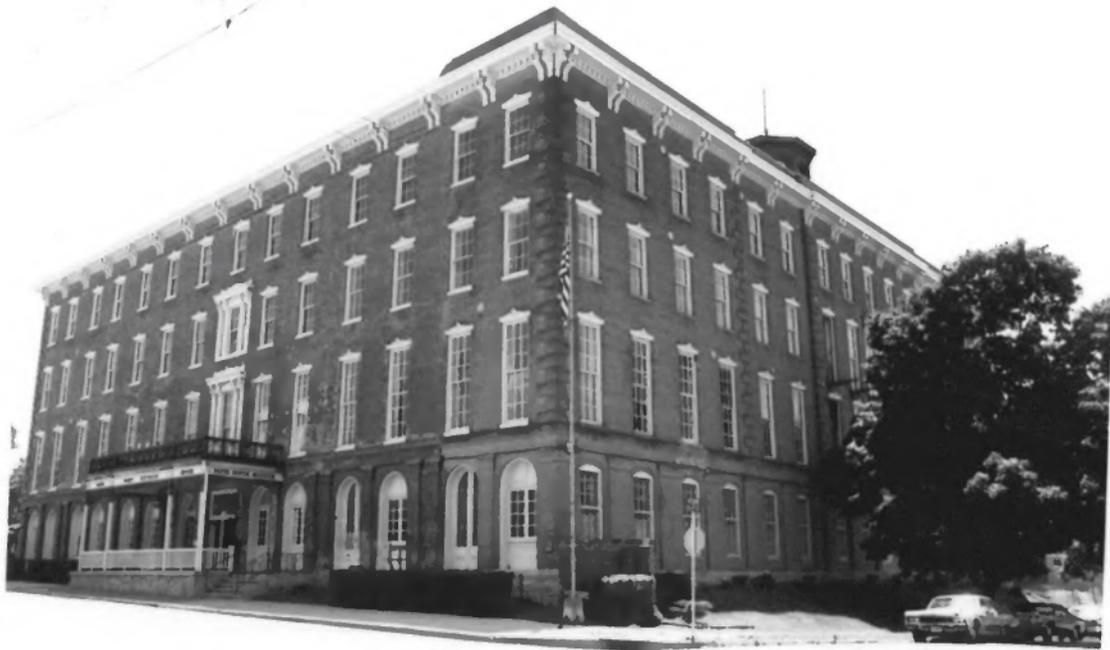
View SE, looking at N and W exposures of building. These two sides have been restored. Note new porch. Note brick work done to restore window, 3rd window S, 2nd floor, W exposure.

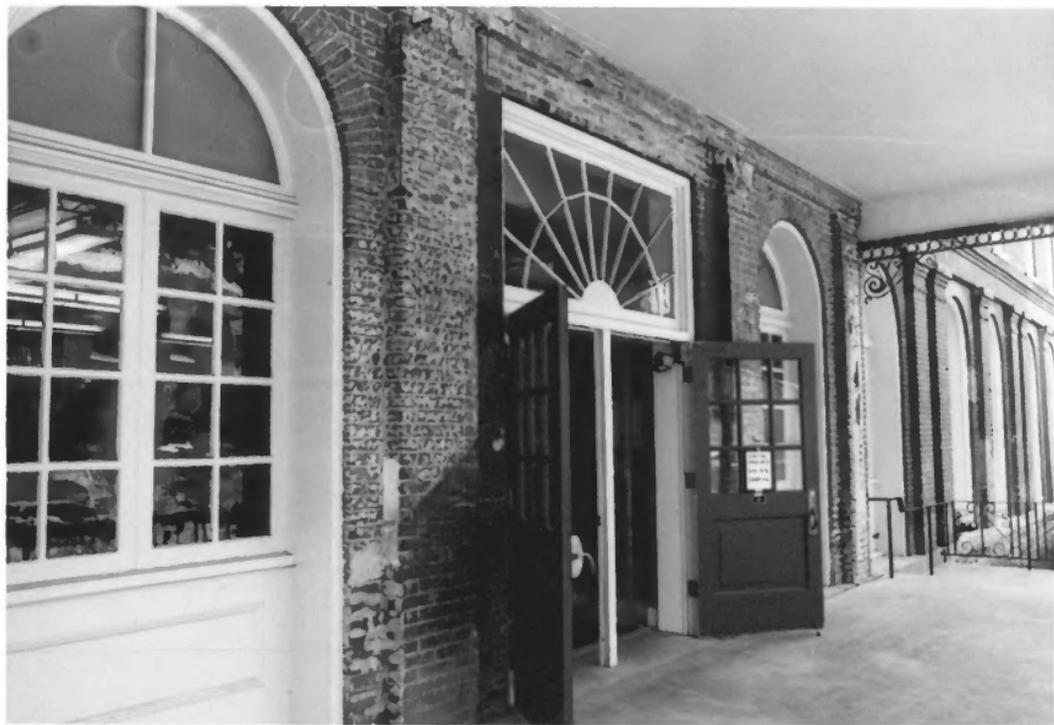
View of recently installed porch and restored main entrance. Plaque will be mounted on one of these brick columns. Note lighter brick, exposed during restoration - this brick in need of preservative treatment.

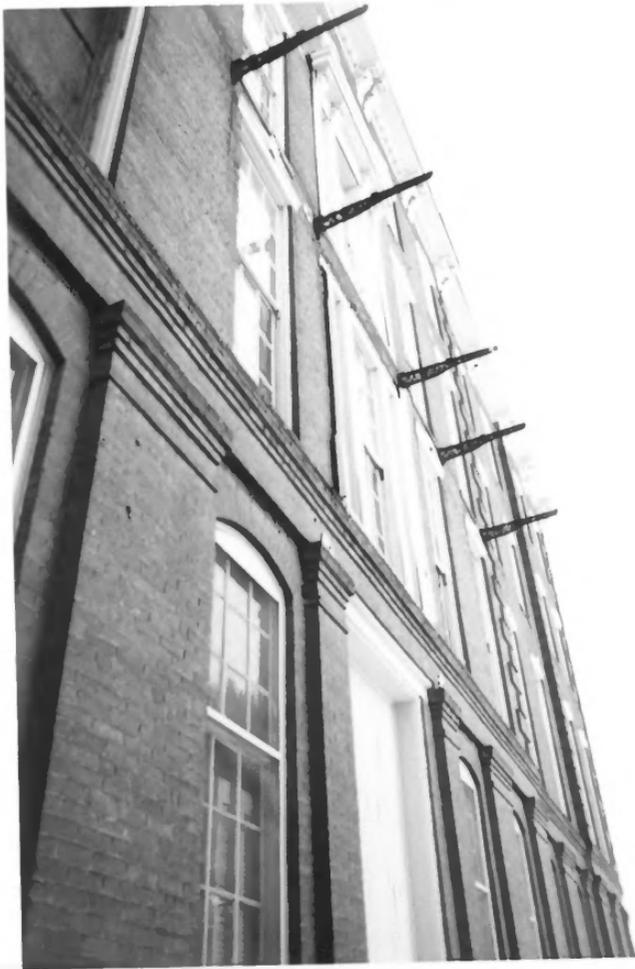
View of W exposure. Note woodwork separating from brick. Supports are for once extant balcony, planned for eventual restoration.

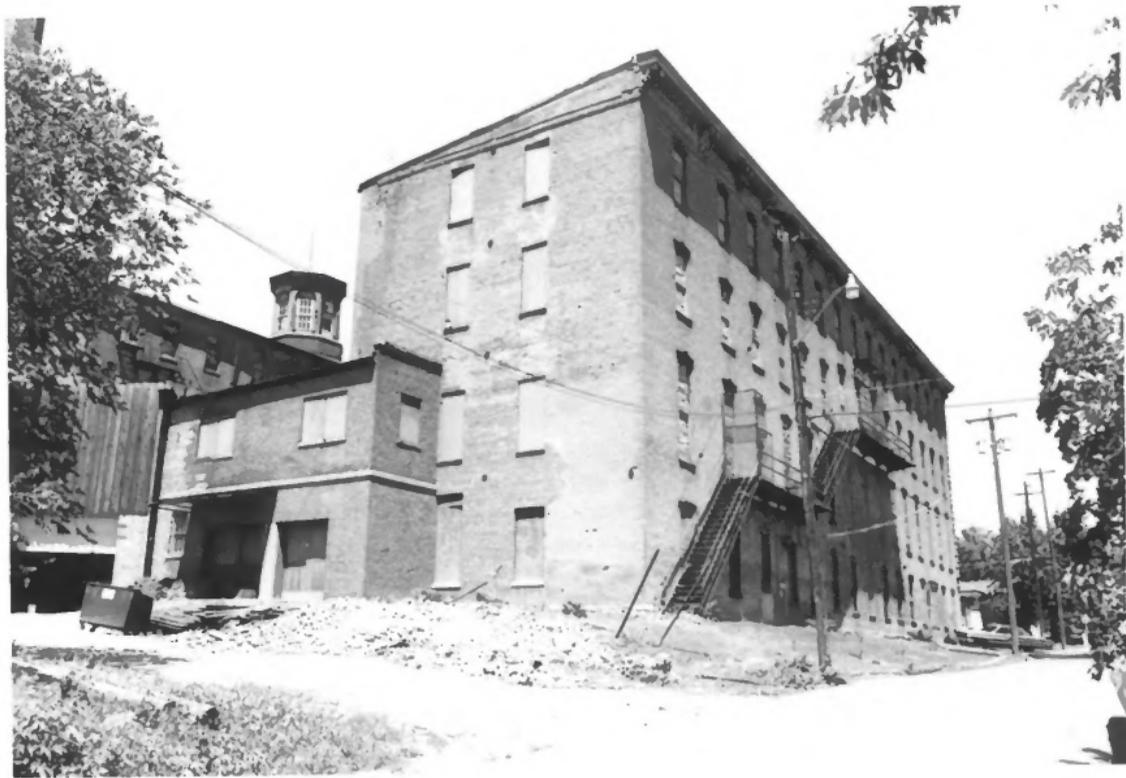
View NW, looking at S and E exposures. Pile of bricks is being used to build veneer over concrete blocks used when display area was enlarged. Note cupola.

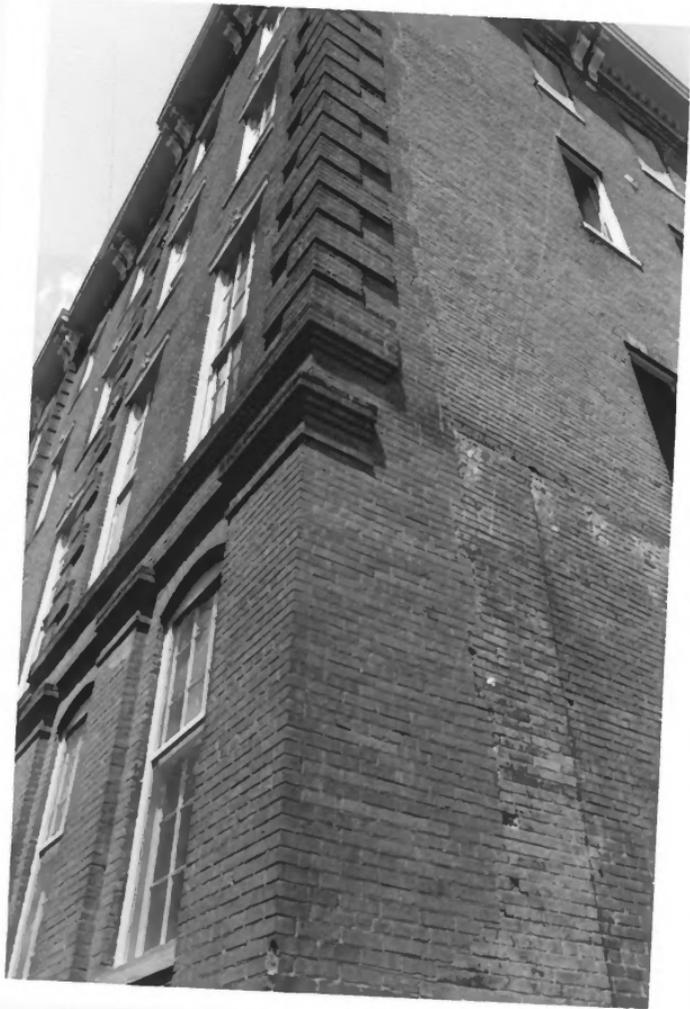
View of SW corner. Note contact line between very old (original?) brick and old brick. Entire W exposure was apparently rebricked sometime (unknown) in the past.

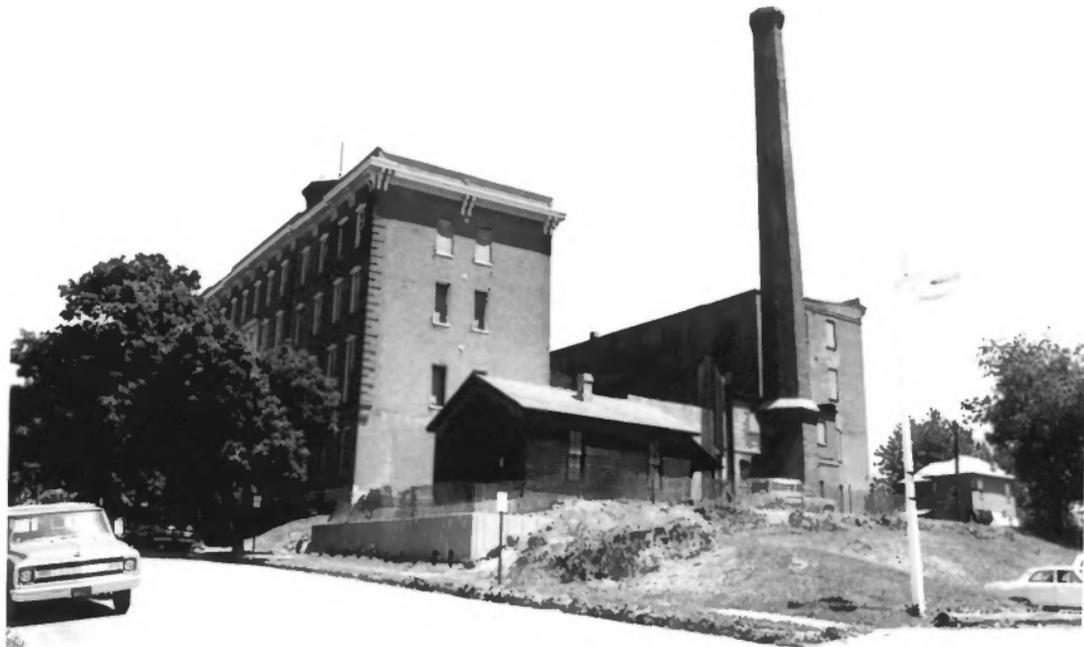
View NE, looking at S exposure. Note location of Jesse James House, recently moved to the grounds to keep it in the community. House does not intrude on visual integrity of the Patee House when Patee House is viewed from NE, prime visitor area.

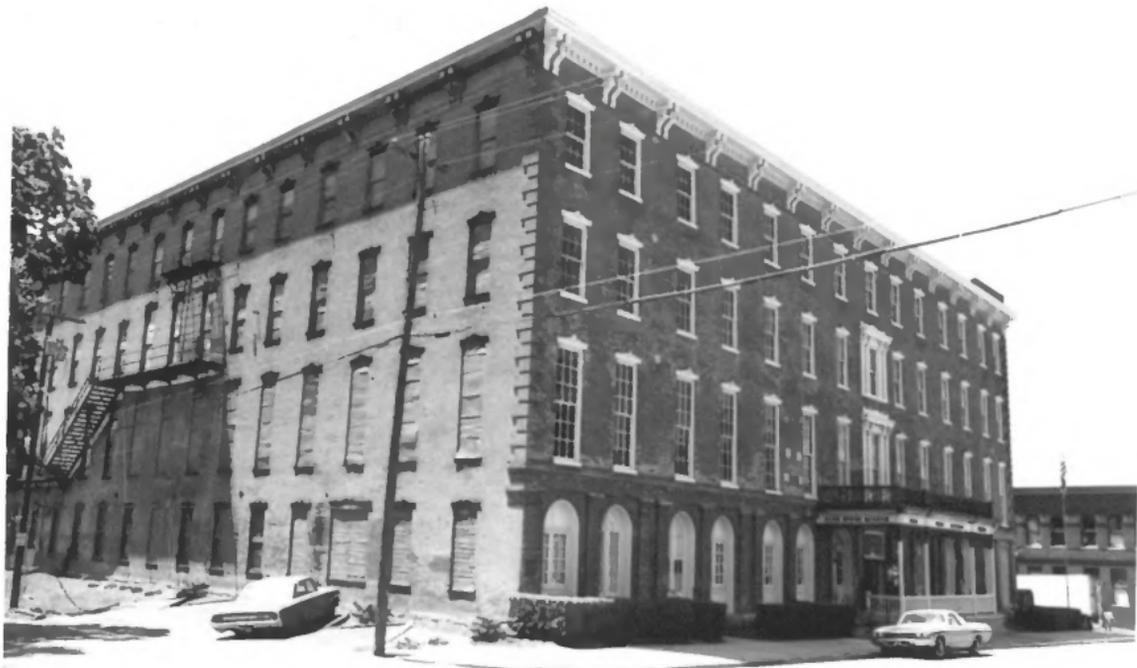
View SW, looking at N and E exposures. Restoration work is currently being planned for E and S exposures.
